Anchorage, A Municipal Corporation vs. United States

Assembly Briefing, April 26, 2019

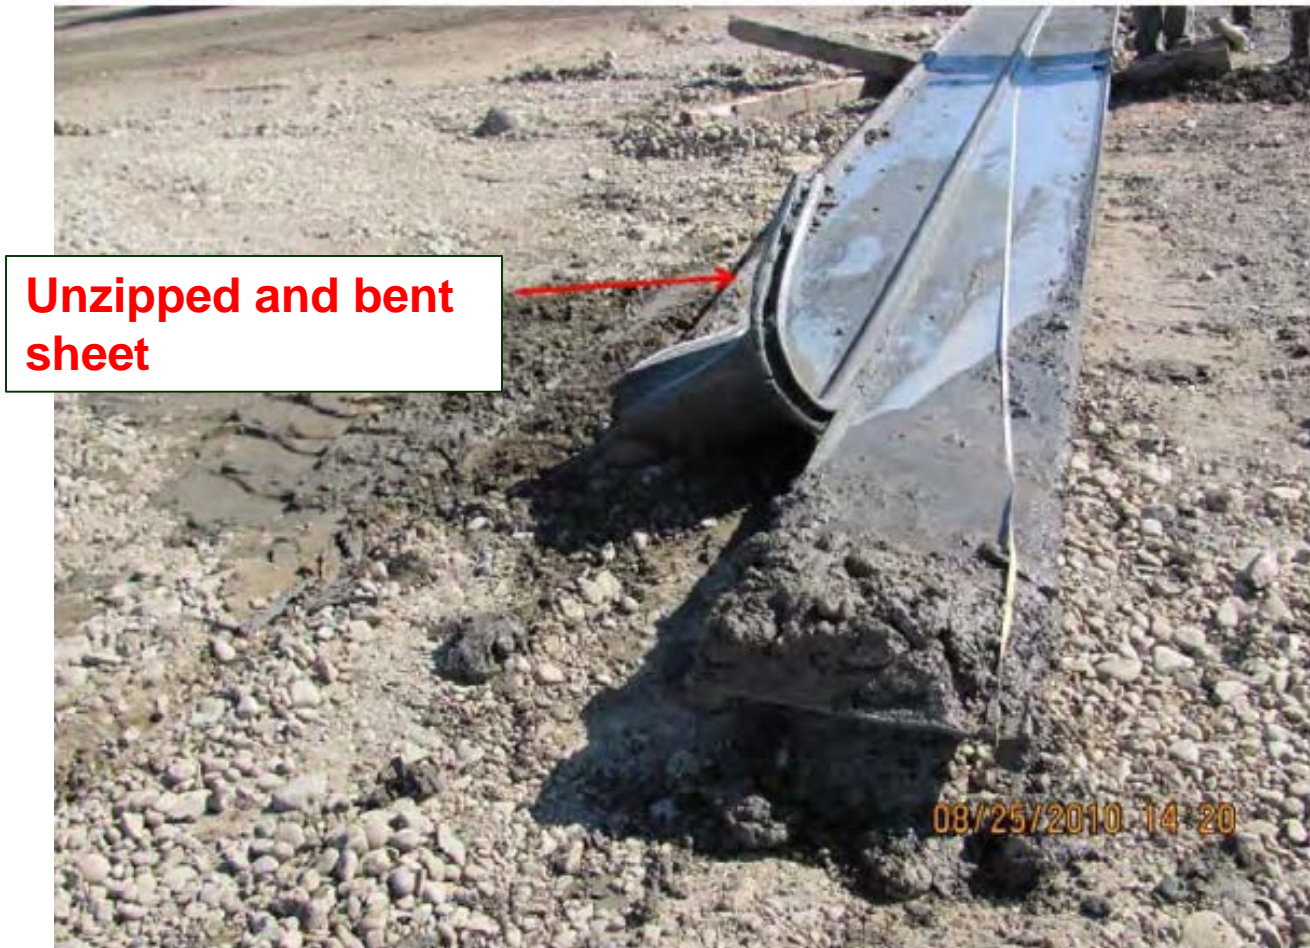
Example of Damaged Sheet Pile

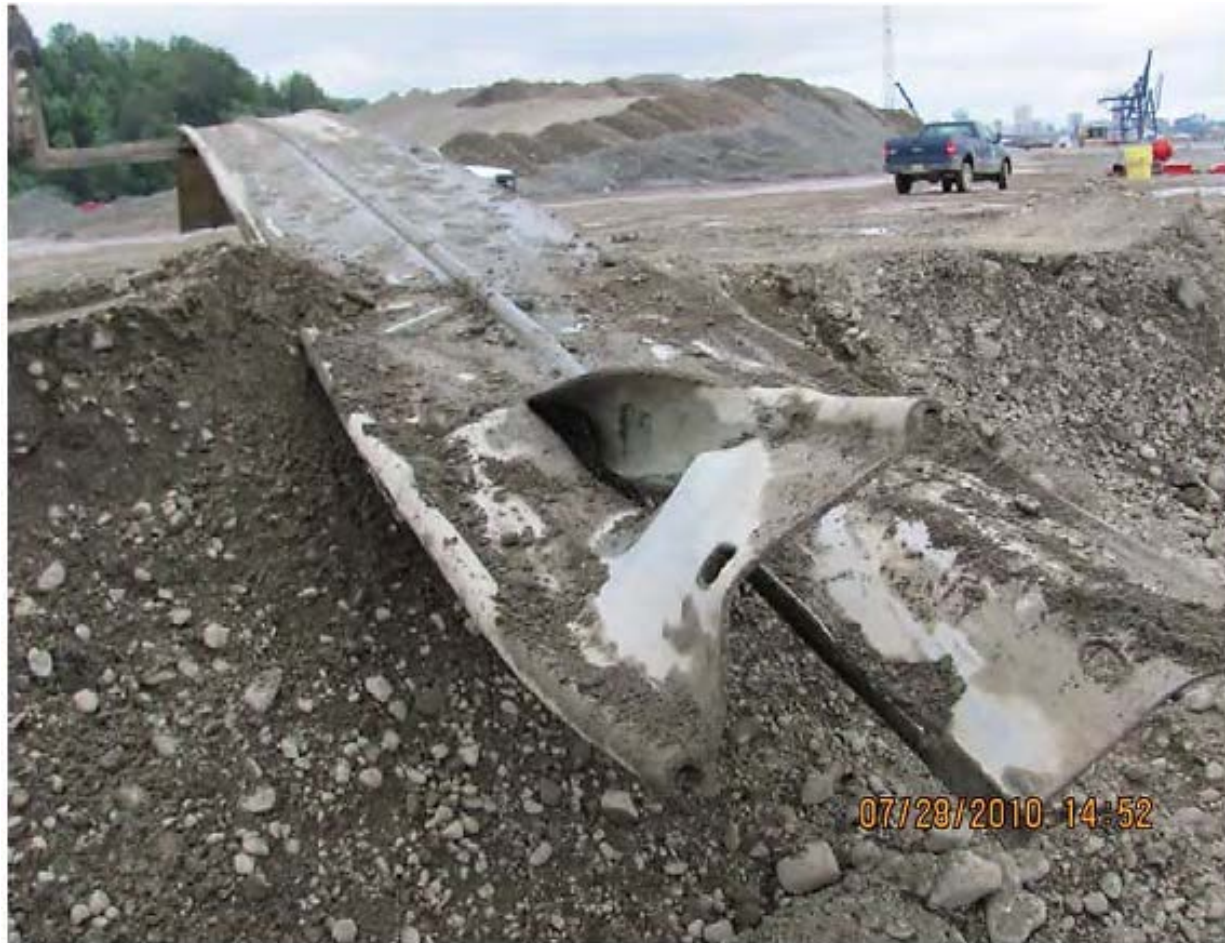
Example of Damaged Sheet Pile

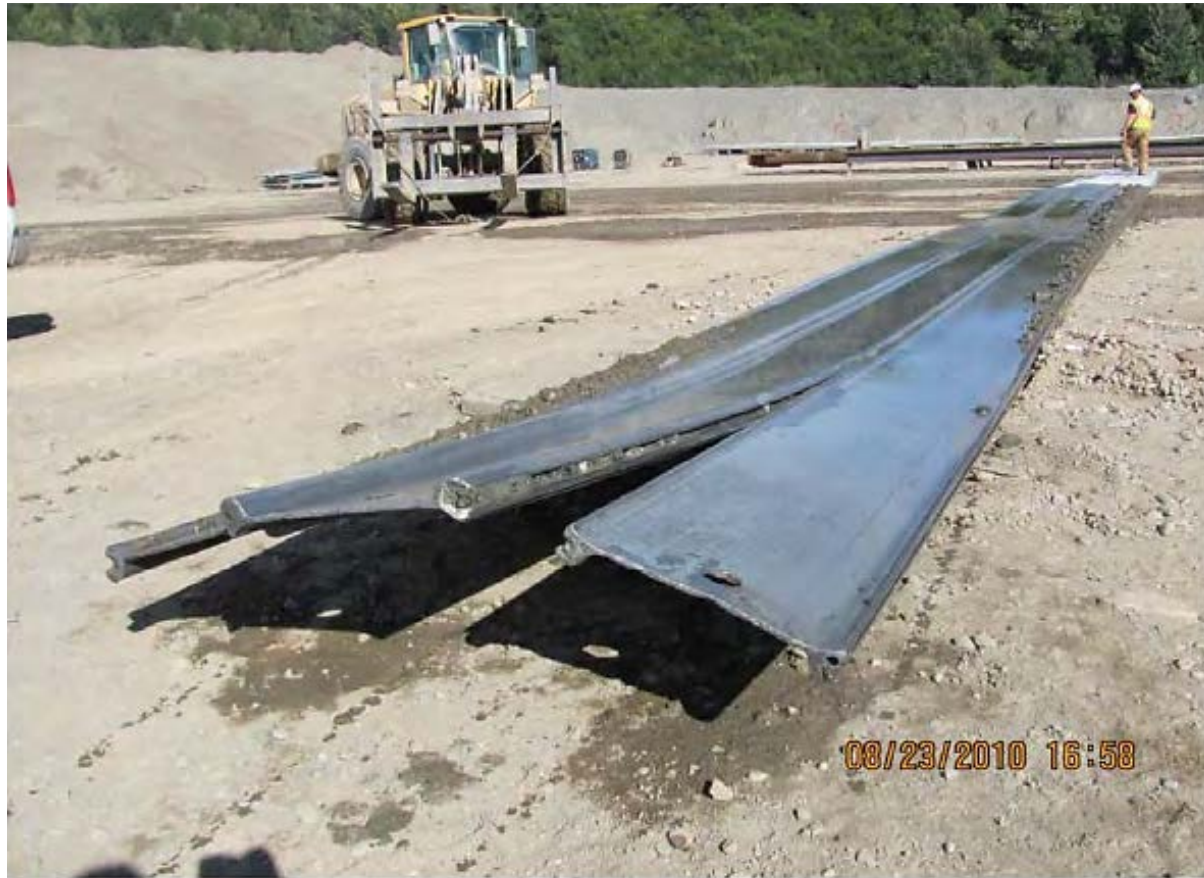
Example of Unzipped Sheet Pile

Sheet pile “unzipping”

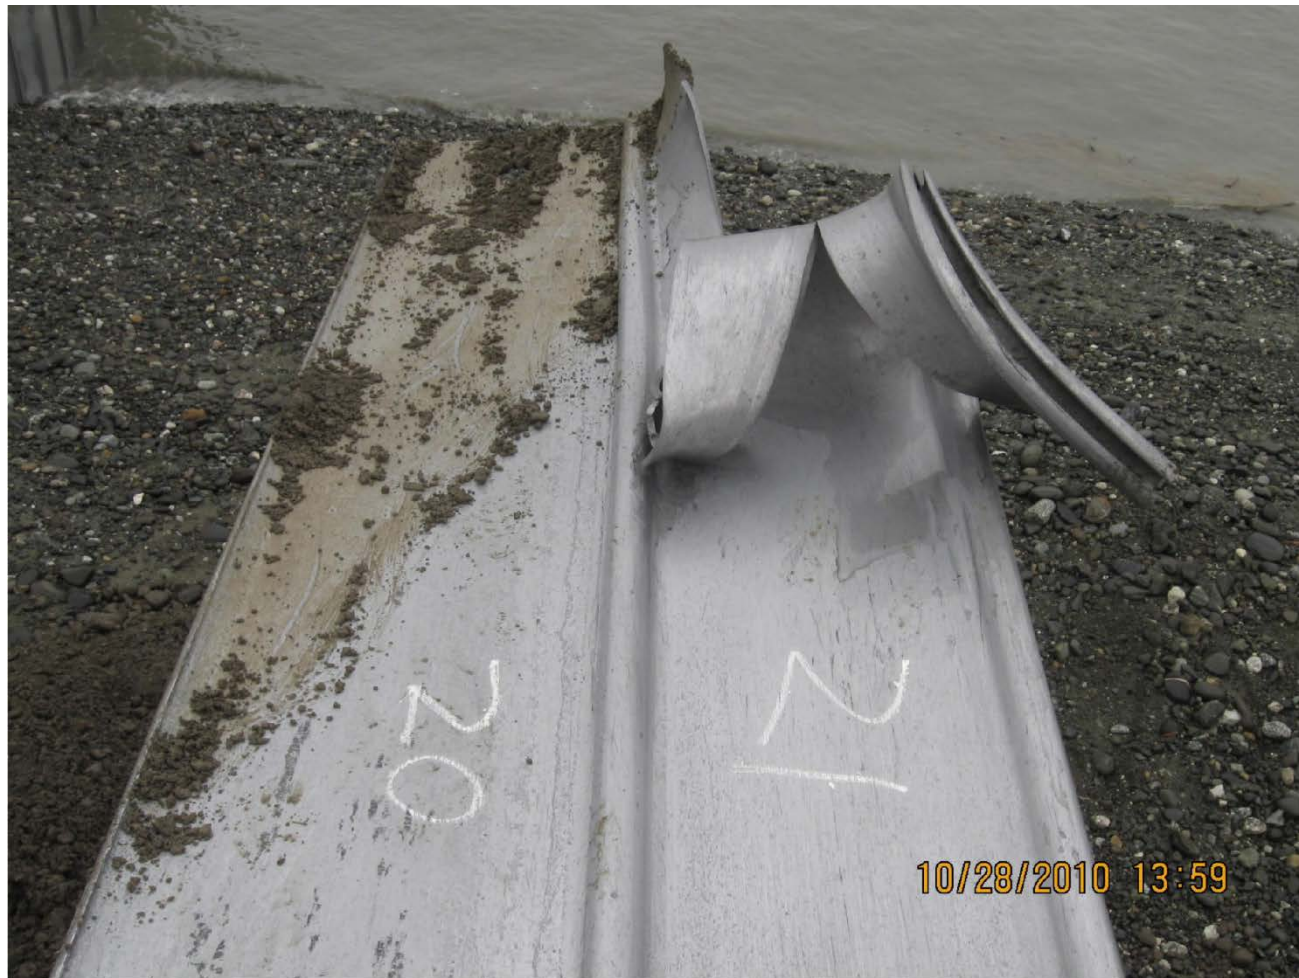
PND0380100

Example of Twisted Sheet Pile

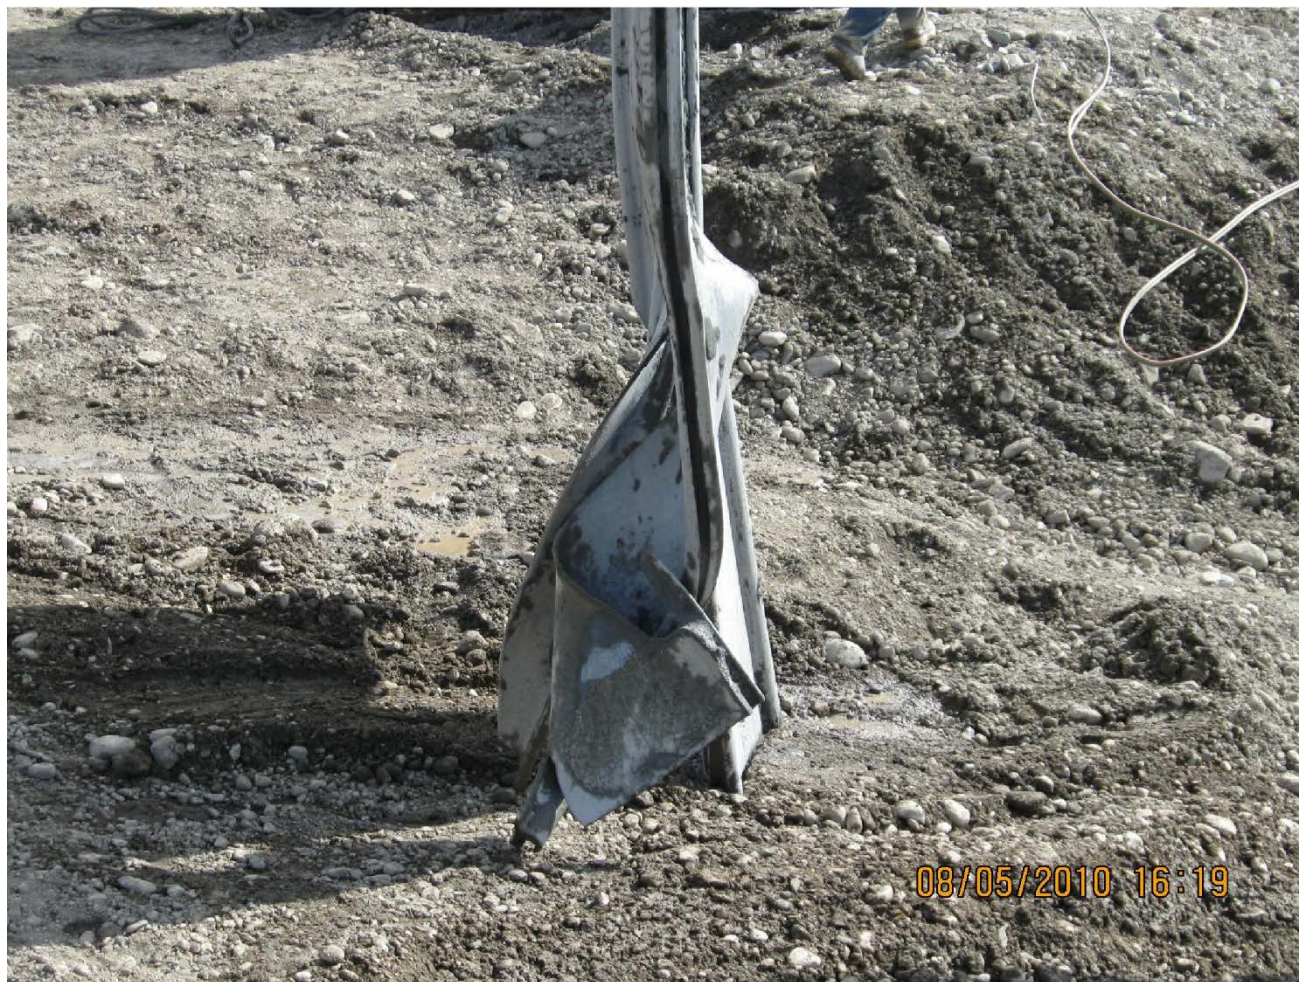
PN06450121

Example of Damaged Sheet Pile

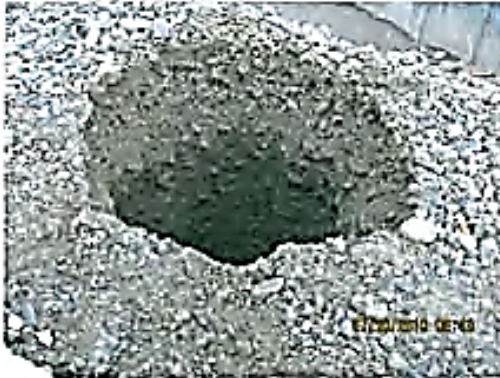
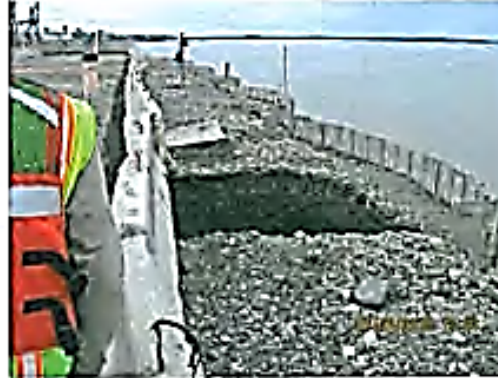
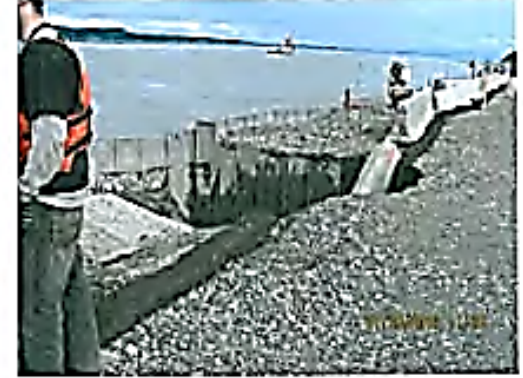
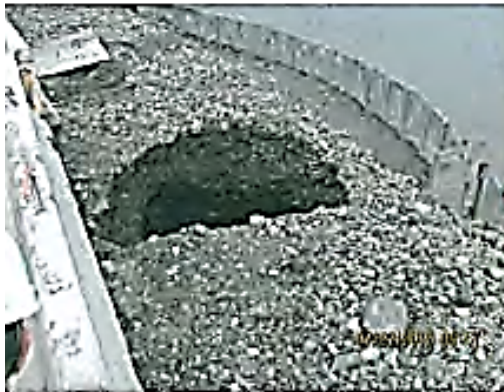
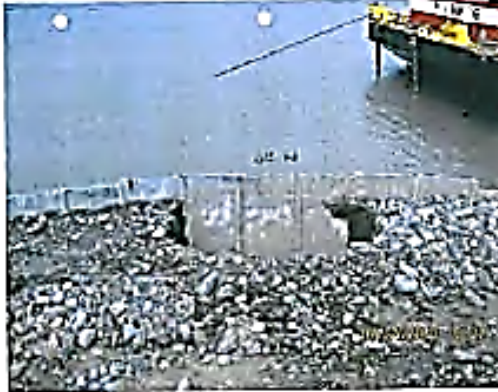
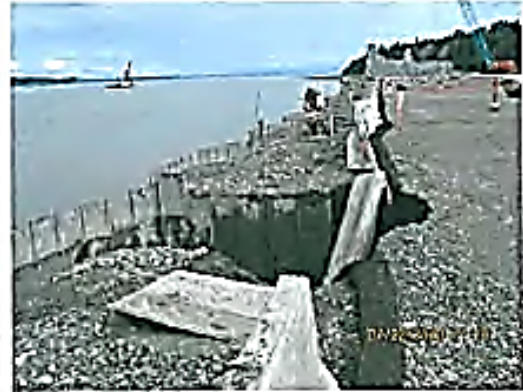
Sinkholes Resulting from Unzipped Interlocks

North Extension 2 (NE2). Only about 800 feet of the NE2 was constructed prior to suspension of construction. The NE2 has had the most dramatic construction defects, consisting of large sinkholes opening behind the sheet piling. The cause of the sinkholes is linked to sheet piles “out-of-interlock” below the water line, creating an opening for saturated backfill to easily pass through the openings. Underwater inspections and forensic explorations have documented the broken interlocks. The FS for static global stability is 1.13, which is significantly below the required FS=1.5.

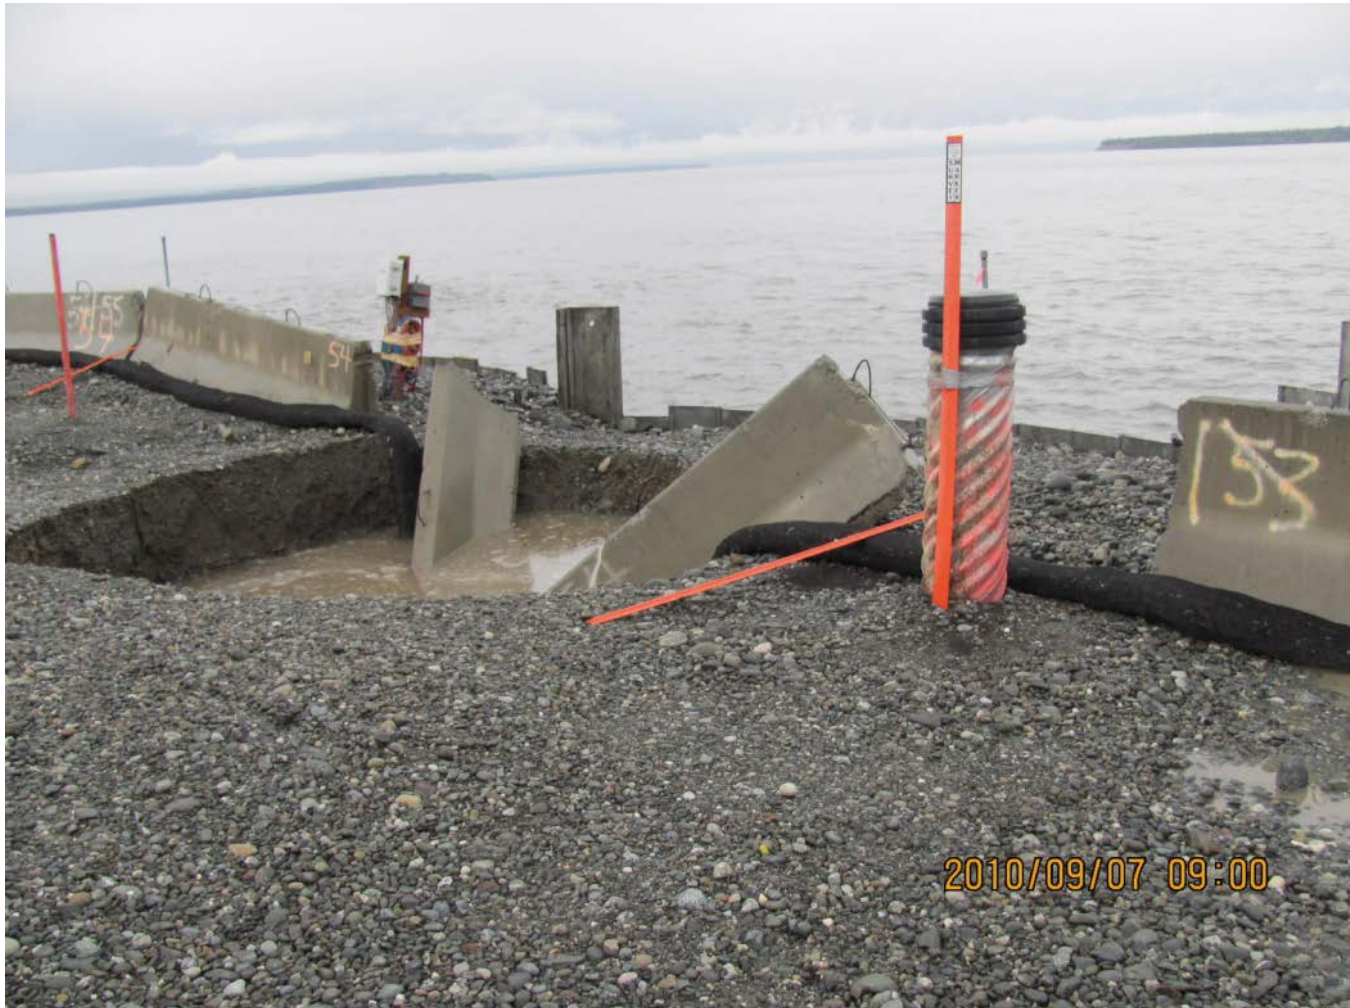
Sinkhole Damage

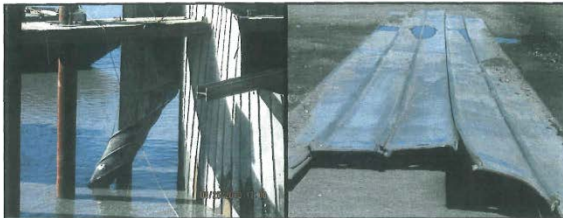
1. At the Wet Barge Berth, damage is present in every cell at face sheets or wyes at WBB cells 27-38. WBB cells 36-38 were removed during August-September 2010 and also found to have tailwall sheet damage.
2. At the North Extension cells 13-30, no damaged face sheets were found. NE cells 9-12, 31 and 32 were removed during August-September 2010 and were found to have face and tailwall sheet damage.
3. At the North Extension cells 41-66, damage is present at multiple cells spread throughout the entire area. NE cells 38-40 were removed during August 2010 and also found to have face and tailwall damage.

Examples of separated interlocks – WBB Cell 36 (left), face sheets pulled from NE Cell 39 (right).
