**Municipality of Anchorage  
Historic Preservation Commission**

The Municipality of Anchorage, on behalf of the Anchorage Historic Preservation Commission (HPC), retained True North Sustainable Development Solutions, LLC, (TNSDS) for professional services to prepare this condition report to assess the structural and physical condition of the buildings and recommend appropriate preservation actions and treatments. The intent of the conditions and structural report is to better understand which historic preservation treatment would be most appropriate for future development of the property that will comply with the recommended treatment standards from *The Secretary of Interior's Standards for the Treatment of Historic Properties*.

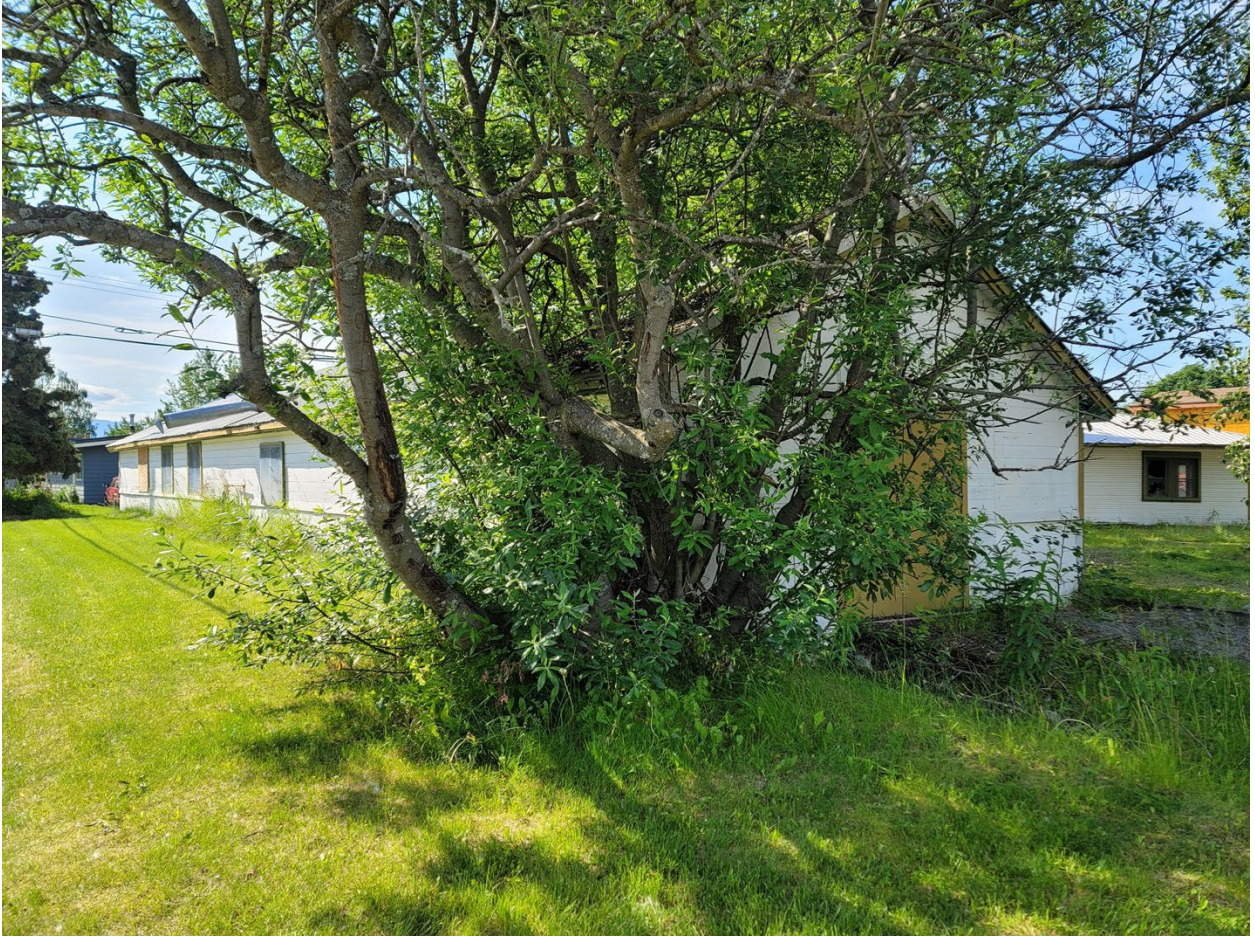
*Figure 5. Building B, view to the south-southwest. The photograph also shows the overgrowth of vegetation against the northernmost corner of the building (©TNSDS 2023).*

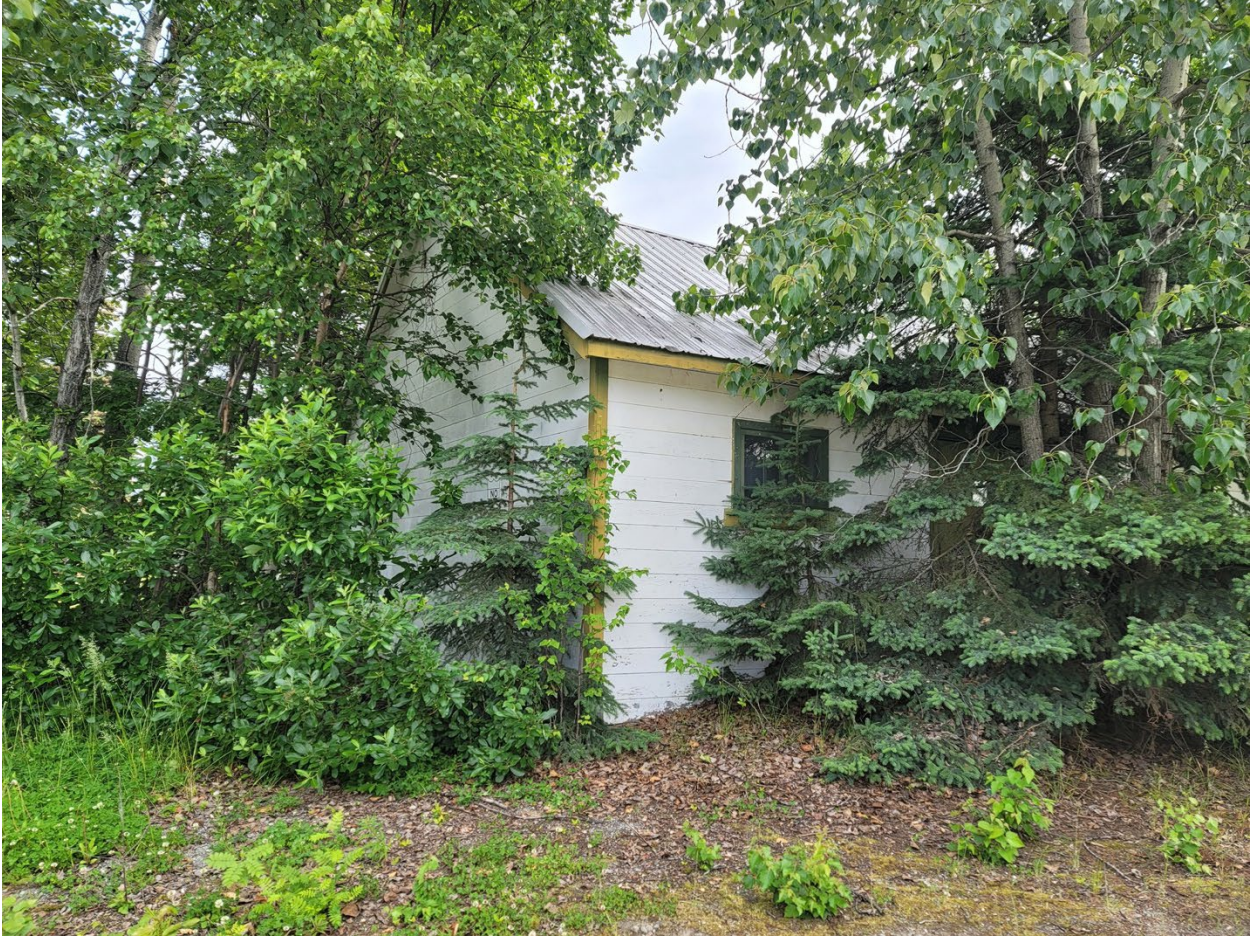
*Figure 10. Building C, view to the southeast. The photograph shows the dense overgrowth of vegetation that surrounds and obscures the building (©TNSDS 2023).*

The only recommended treatment option for the vegetation that dominates the landscaping of the Wireless Station is the removal of all trees and shrubs from the entire site. This treatment option is recommended as the only viable option under the *Secretary of the Interior's Standards for Preservation*. The preservation recommendation for a building site as defined by the *Secretary of the Interior's Standards* state that the building site will retain “the historic relationship between the buildings and the landscape.”<sup>8</sup>

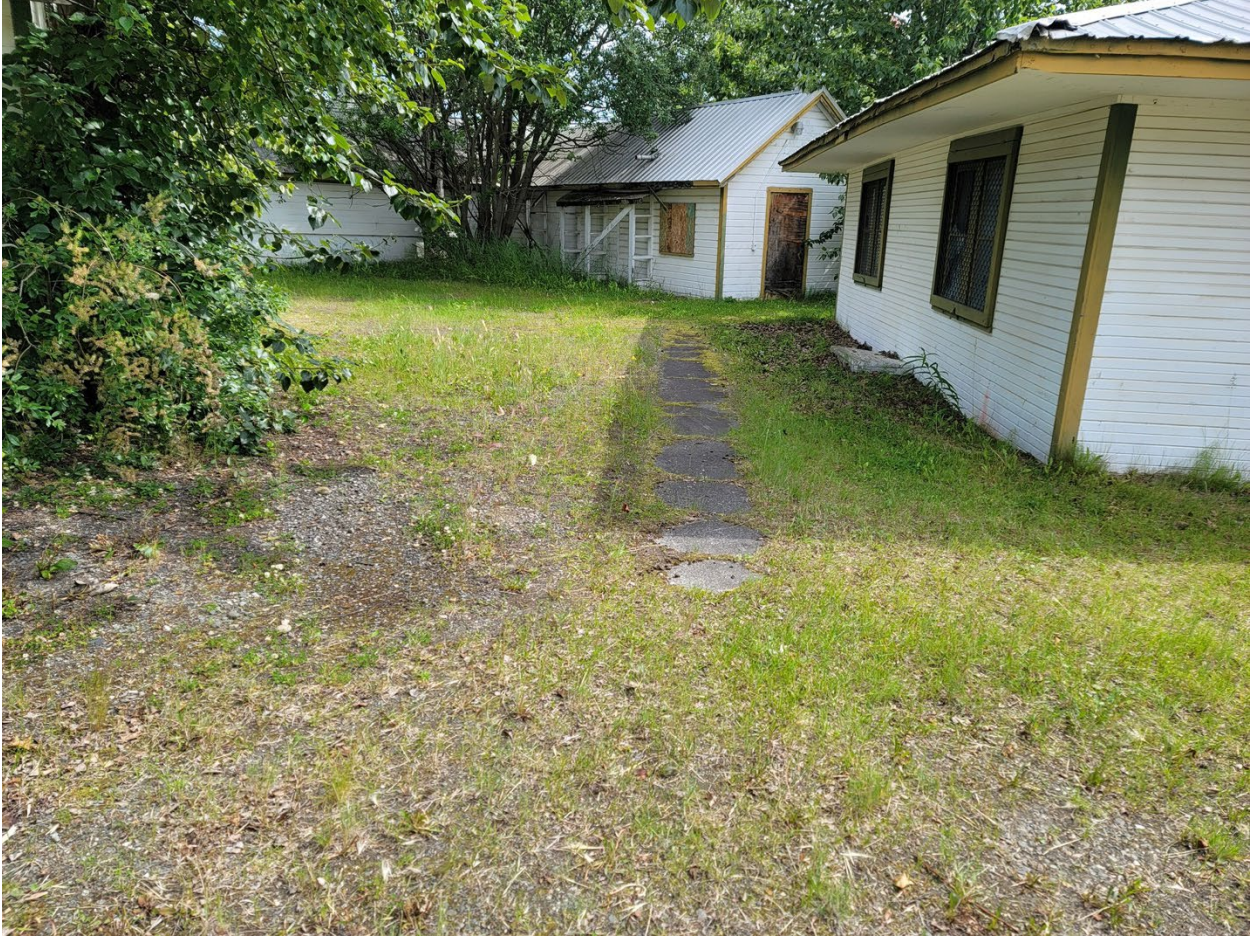
*Figure 11. Detail photograph of the most visible walkway on the site, running past the north façade of Building A towards Building B (©TNSDS 2023).*

The recommended treatment for the walkways is replacement. Under the restoration option for the treatment of historic properties, it is appropriate to replace “in kind an entire restoration-period feature that is too deteriorated to repair using the physical evidence as a model to reproduce the feature.”<sup>7</sup> The walkways can be located and laid out by on-the-ground survey, after which any existing damaged concrete can be removed. New walkways can then be installed, using modern concrete. Modern concrete is considered an appropriate in-kind replacement materials for this type of work.

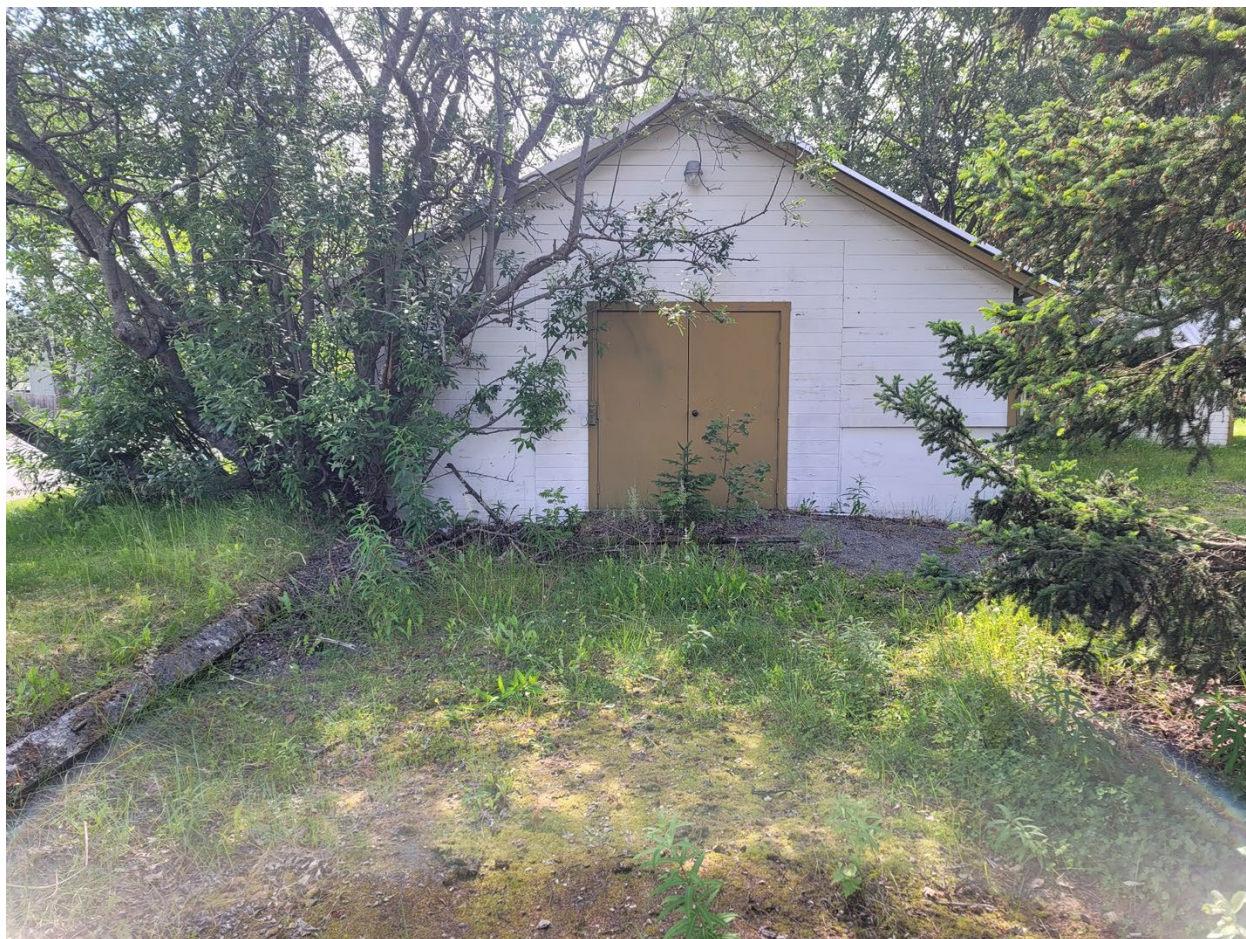
*Figure 12. Northwest façade of the long axis of Building B. The photograph shows the remains of the paved driveway and curbs that once made up a driveway into the vehicle bay of Building B (©TNSDS 2023).*

The recommended treatment option for the parking situation at the Government Hill Wireless Station site is a combination of options. The only planned parking in evidence at the site is the paved and curbed driveway that leads into the northwest end of Building B. Similar to the treatment option for the walkways, it is recommended that the driveway be replaced per the restoration treatment option. There is enough of the original driveway remaining that the new driveway can be constructed to match the original. Modern concrete is considered an appropriate in-kind replacement materials for this type of work. Any modern safety regulations related to the construction of driveways and curbs should be observed, however.

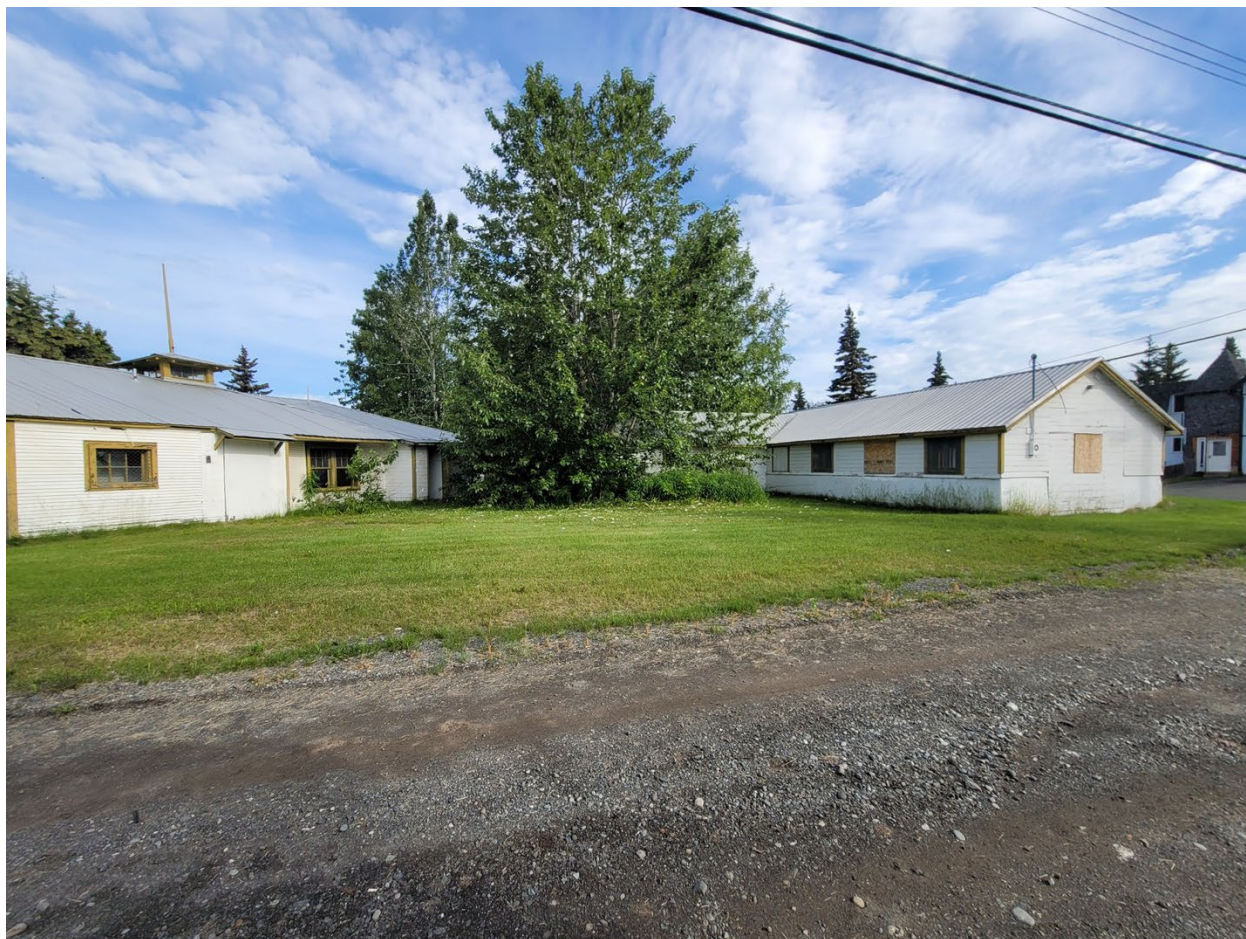
*Figure 13. Overview of the Wireless Station, showing the vegetation that has grown up at the site (©TNSDS 2023).*

Additionally, clusters of native trees and shrubs are growing up against all three buildings. Vegetative growth to the extent observed at the site has likely and will lead to further deterioration of the structural integrity of the buildings (Figure 20). Removing the vegetation from the site will not only return the original relationship of the buildings to the landscape but halt further deterioration of the buildings from vegetative growth.

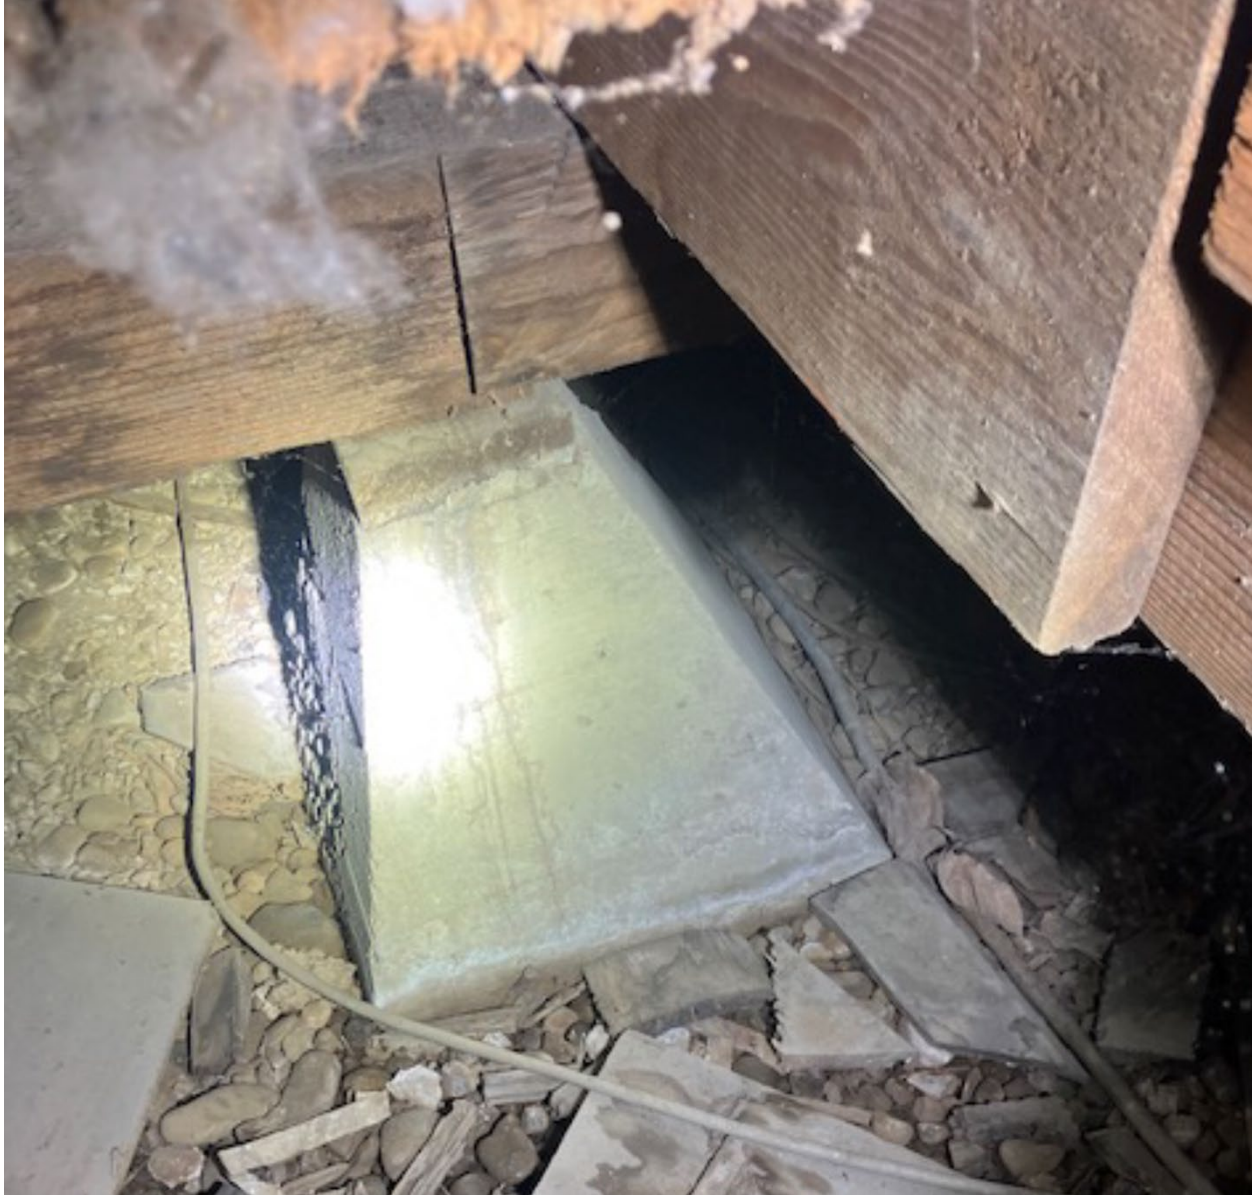
The foundation of Building A reflects the original building and two additions. The original building has a continuous perimeter concrete foundation supporting exterior walls. This concrete perimeter foundation is approximately 8" wide and extends approximately 2' below grade. On the interior of the original portion of the building, the foundation is a type of post-on-pad construction consisting of pyramid shaped, concrete pier blocks resting on a gravel pad. The piers support the floor framing (Figure 14).

The observable pyramidal concrete piers that support the original portion of the building appear to be later replacements for any original foundational supports. The foundation appears to be failing, however, as is

evidenced by the dramatic difference in settling levels between the original portion of the building and the additions on the north and south ends. The increased settling of the original portion of the building creates a saddle-bow appearance to the building, with the central portion sagging at a lower level than the concrete-supported additions. To correct this, the piers should be adjusted using hydraulics to lift the building, allowing for the piers to be stabilized, repaired, replaced, and/or adjusted as needed to provide increased support for the building above. This treatment option falls within the category of restoration work, and care should be taken to retain those structural elements that are in serviceable condition. Replacement in kind is appropriate for “large portions or entire features of the structural system from the restoration period that are either extensively damaged or deteriorated... the new work may be unobtrusively dated to guide future research and treatment.”<sup>9</sup>

*Figure 14. Detail photograph of one of the pyramidal concrete piers below the central portion of Building A (©TNSDS 2023).*

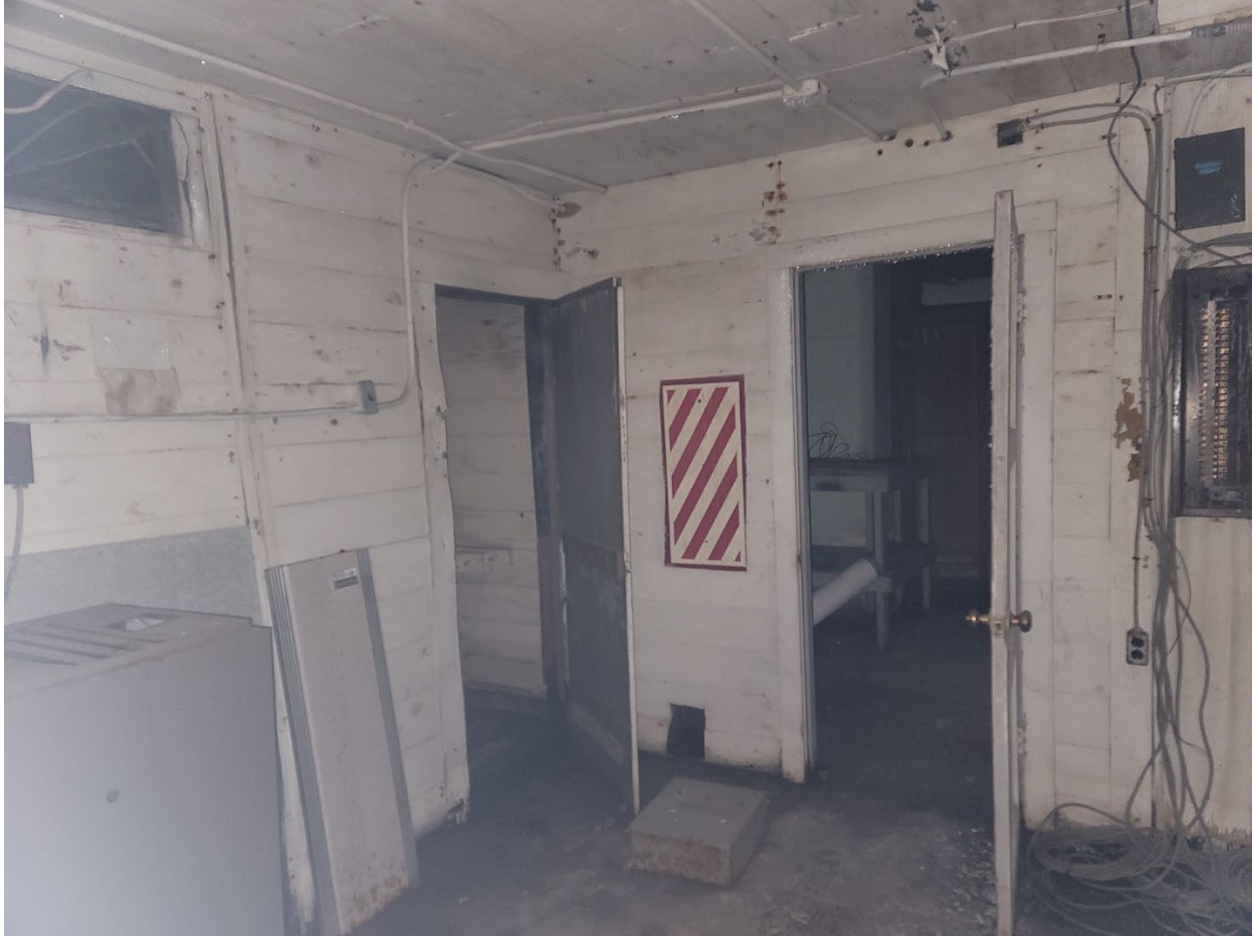
The southern end of the building, added to the original building in 1934, has a full concrete basement (Figure 15). The basement area includes a boiler room with an approximate 20' square area. The basement walls are poured-in-place concrete and the floor is a concrete slab. The walls and slab appeared in fair condition with some cracks. The concrete walls appeared plumb with no bowing or distress observed. The slab appeared level, but not troweled smooth, and no sections appeared to be settling. The framing for the floor above consists of with 2' by 10' joists and clad with decking. The framing is sagging and showed significant signs of decay at the time of inspection.

*Figure 15. Interior of the full basement below the southern addition on Building A (©TNSDS 2023).*

The recommended approach to the existing concrete portions of the foundations of Building A is preservation. The concrete basement and crawl spaces on the north and south ends of the building appear to be stable and in good structural condition; only one large crack in the exterior stairs on the east façade requires repair work. The crack should be probed to determine the cause; as it parallels the slope of the stair treads, it is likely that the crack resulted from settling of the ground below the stairs. The crack should be mapped to document the current extends of the damage and patched with concrete that matches the existing historic concrete material. Patching the crack will prevent infiltration by moisture, vegetation, and insects, thereby preventing further deterioration unrelated to the original cause of the crack.

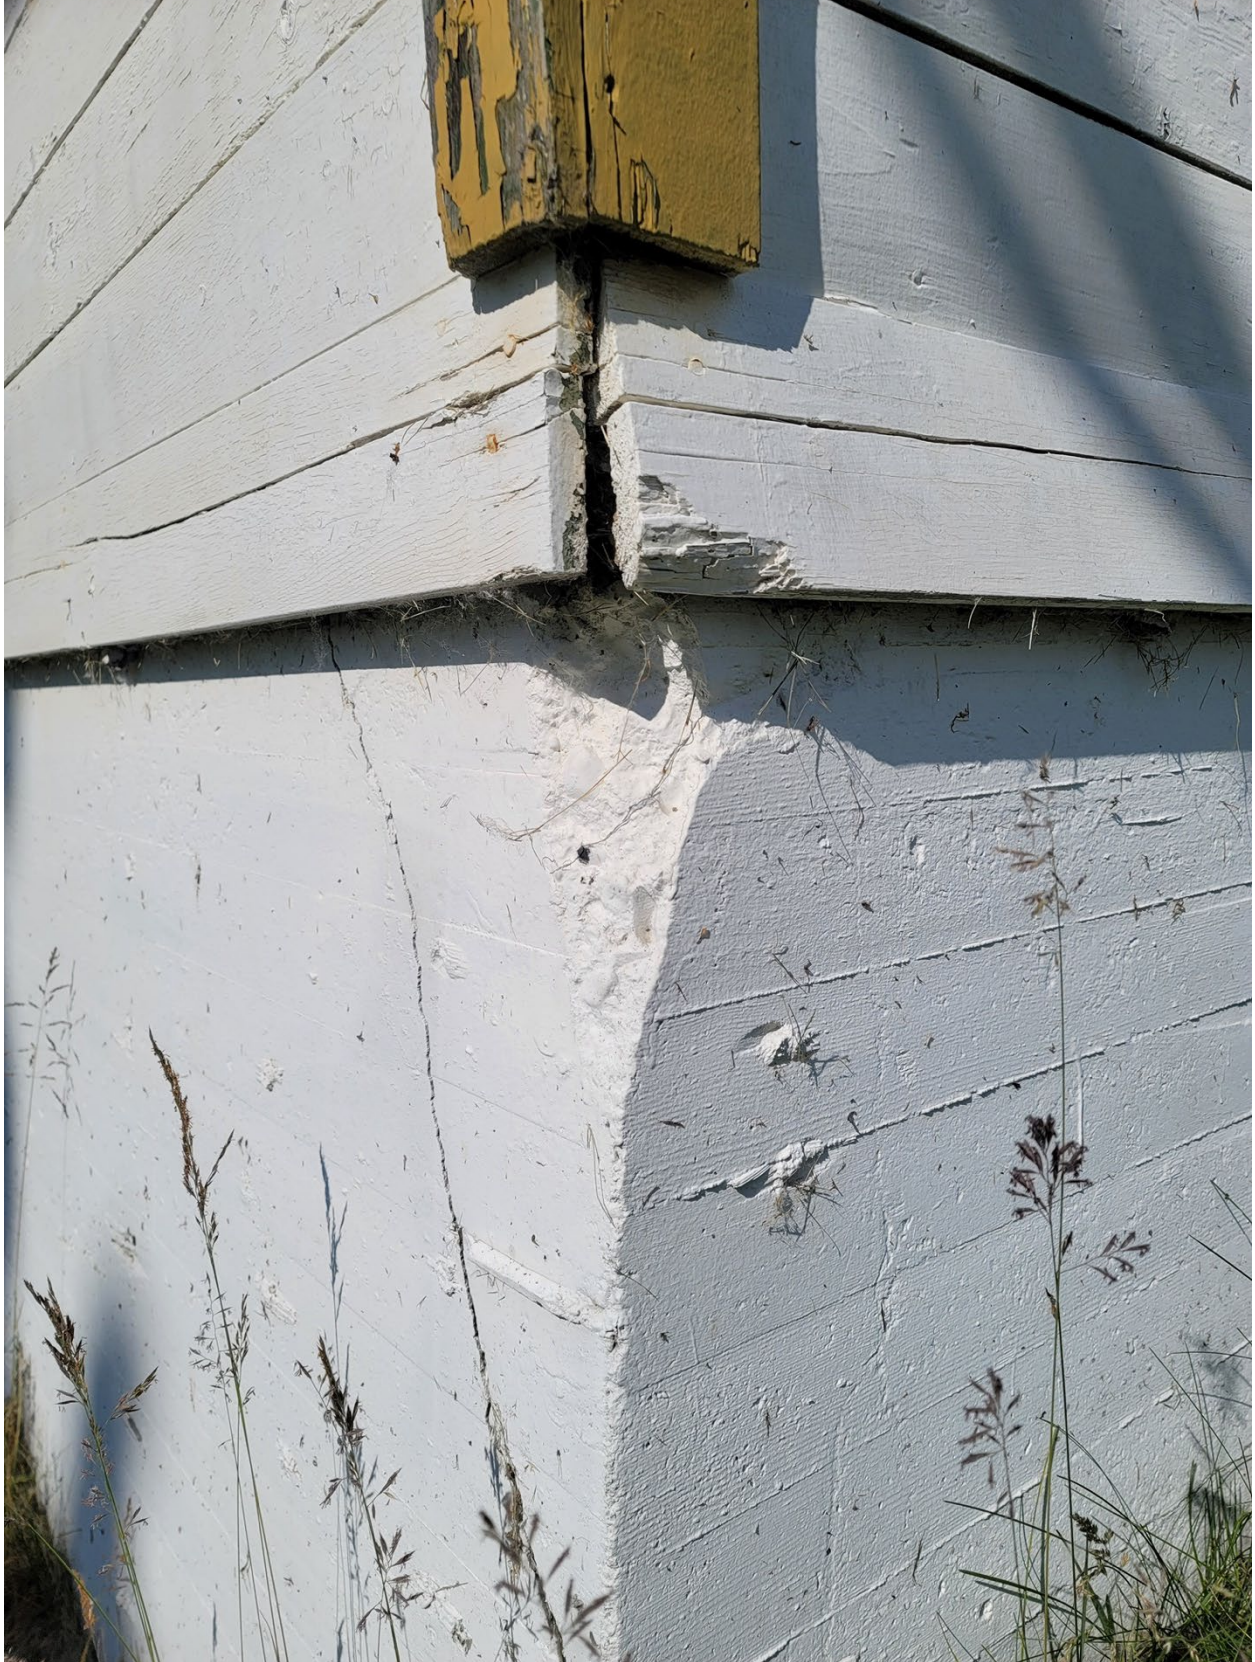
There is a continuous perimeter concrete foundation supporting exterior walls and is approximately 8” wide. The foundation extends several feet above grade along the main wing to form a foundation wall while the foundation ends at the ground level on the addition extending to the southwest. The foundation appears to extend 2’ below grade. The exterior foundation appeared plumb with no signs of settlement. The foundation is formed by poured-in-place concrete painted white where exposed above the ground level. Imprints of the wood planks that made up the concrete form are still visible on the exterior (Figure 16).

The recommended treatment approach for the foundation is Building B is preservation. The foundation is in good structural shape and does not show any signs of structural failure. There is evidence of minor spalling at the corners of building and in some areas directly below the skirtboard; this spalling is likely caused by infiltration of moisture. There are also small vertical cracks in several locations that correspond with the window framing; it is unclear what caused these cracks but the cause should be investigated.

*Figure 16. Detail photograph of the southeast corner of Building B. The photograph shows the concrete foundation, lap siding, and skirtboard and demonstrates the spalling happening to the foundation (©TNSDS 2023).*

The extent of the spalling and cracking should be mapped and monitored. The spalling and cracking can be patched with concrete that matches the existing historic concrete material to prevent further damage from moisture, vegetation, and/or insect infiltration. The areas should be monitored over time to ensure that the damage does not spread to surrounding areas.

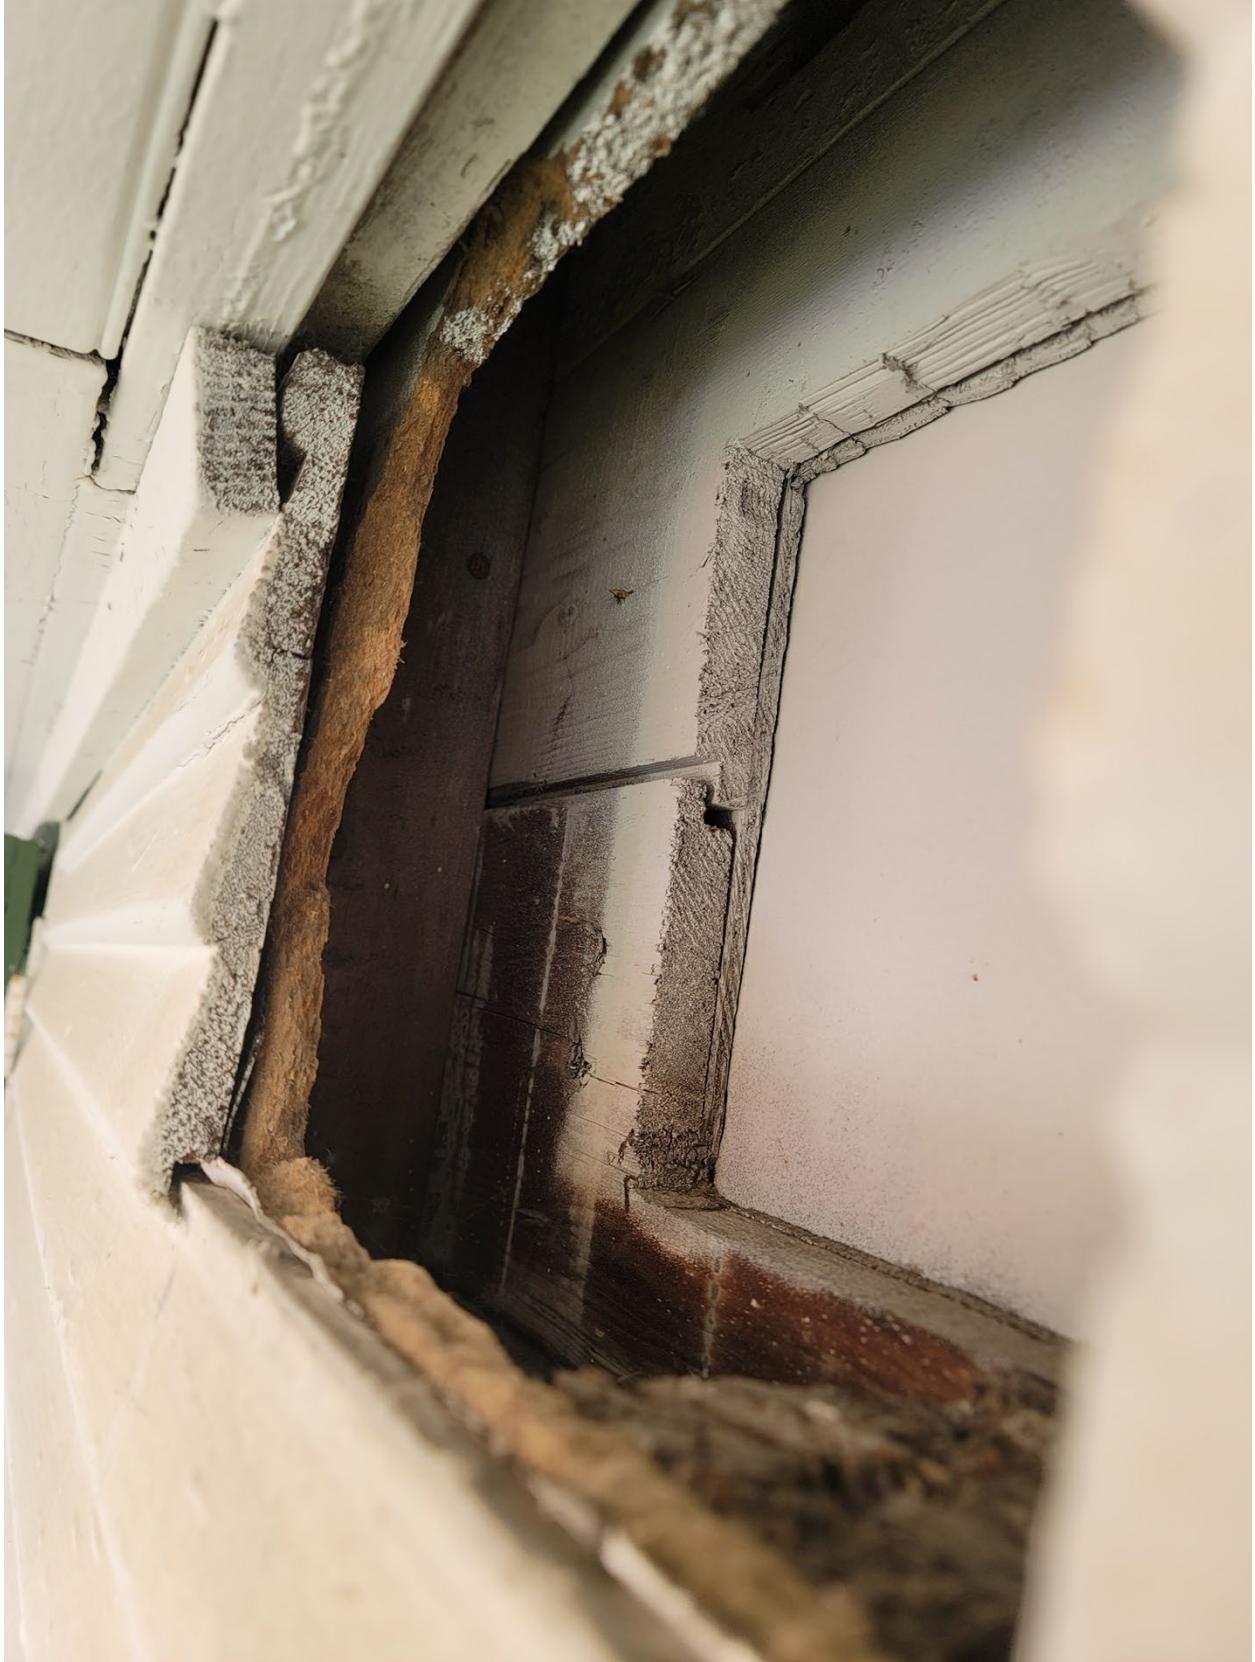
Figure 17. Detail photograph showing the current siding overlaying older siding layers on Building A (©TNSDS 2023).

It is also recommended that the underlying layers of insulation and siding be investigated to determine material makeup and purpose. Determining the insulation material in particular is helpful when trying to decide on future use, as it may need to be replaced in order to increase the R-Value to the point that the building is economical to heat. It would also be beneficial to determine if the channel groove siding visible inside the framing is the base for the interior wall finishes.

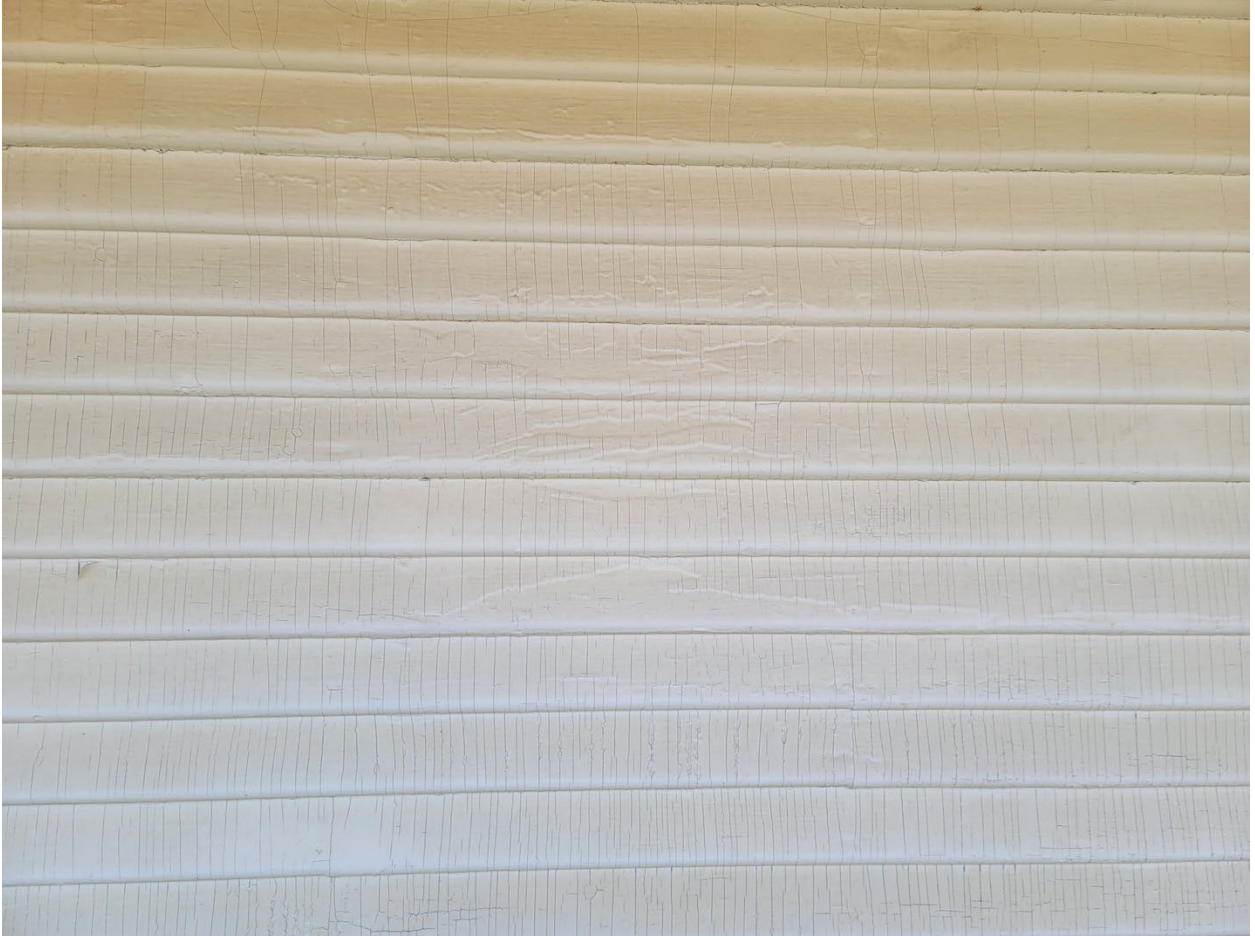
The current exterior siding is in serviceable shape, although not original to the building. The paint shows signs of crazing, a deterioration condition characterized by excessive cracking in the paint. Crazing is caused by thick paint that has become brittle and inflexible, no longer expanding and contracting with the wood underneath. The paint also shows signs of peeling caused by the crazing as well as environmental grim, particularly on the east façade. Following the guidance for preservation, it is recommended that the exterior paint be removed by hand-scraping or sanding, and a new layer of paint applied.<sup>10</sup> Paint helps to protect the wood siding from environmental factors like moisture, which can cause rapid deterioration of the wood siding material.

*Figure 18. The wrinkling, crazing, and peeling in the paint on the west façade of Building A (©TNSDS 2023).*

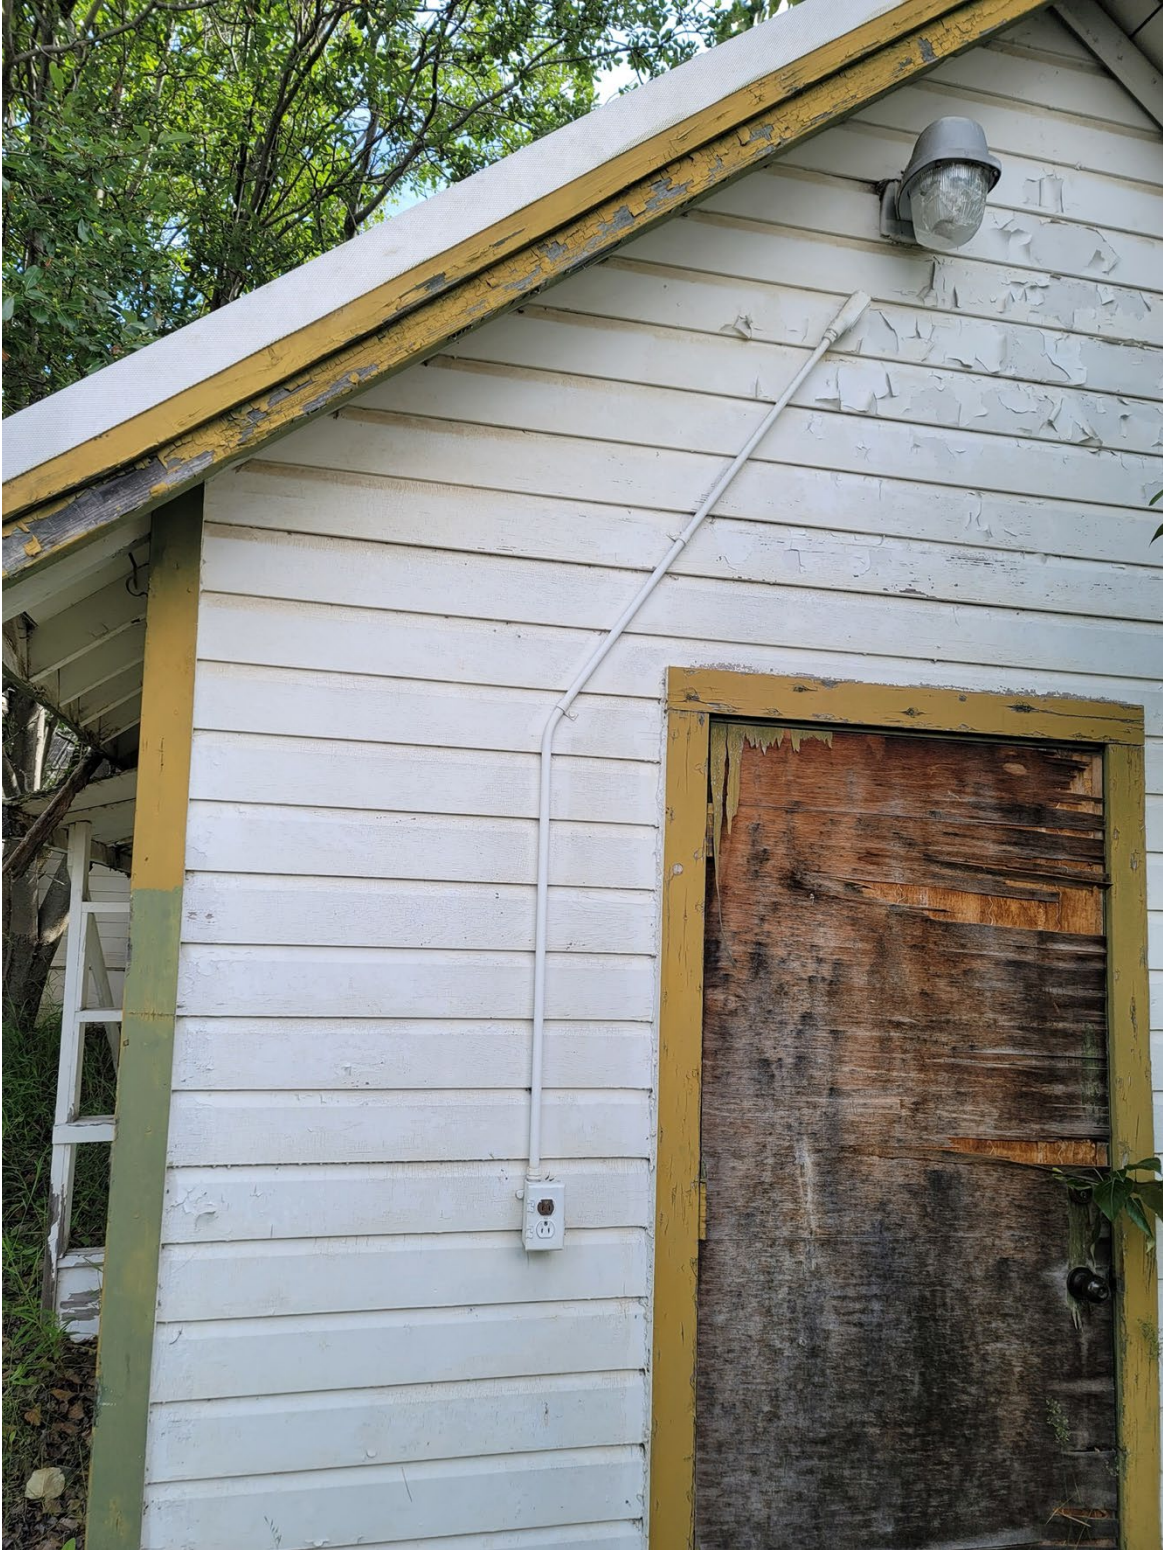
*Figure 19. The southwest façade of the addition to Building B, showing the cracking, crazing, and peeling of the paint on the siding (©TNSDS 2023).*

The siding on Building B is in good condition and should be treated with preservation practices only. No immediate areas of failure were observed, and thus, the recommended treatment for the exterior siding is preservation. The paint on the skirtboard is deteriorating, likely eroded by water over time. The paint is also peeling in some locations, especially the southwest façade of the addition, and other areas show cracking and crazing as well. The paint across the entire building, including the wood siding, trim, and the paint on the exposed concrete foundation wall, should be hand scraped and sanded to remove any loose or deteriorated paint and then repainted to protect the siding underneath. Additionally, it may be appropriate to install a gutter system along the edge of the roof to prevent further deterioration of the siding materials. If installed, however, the gutter should be sympathetic to the historic appearance of the building so as to not impact the integrity of the building.

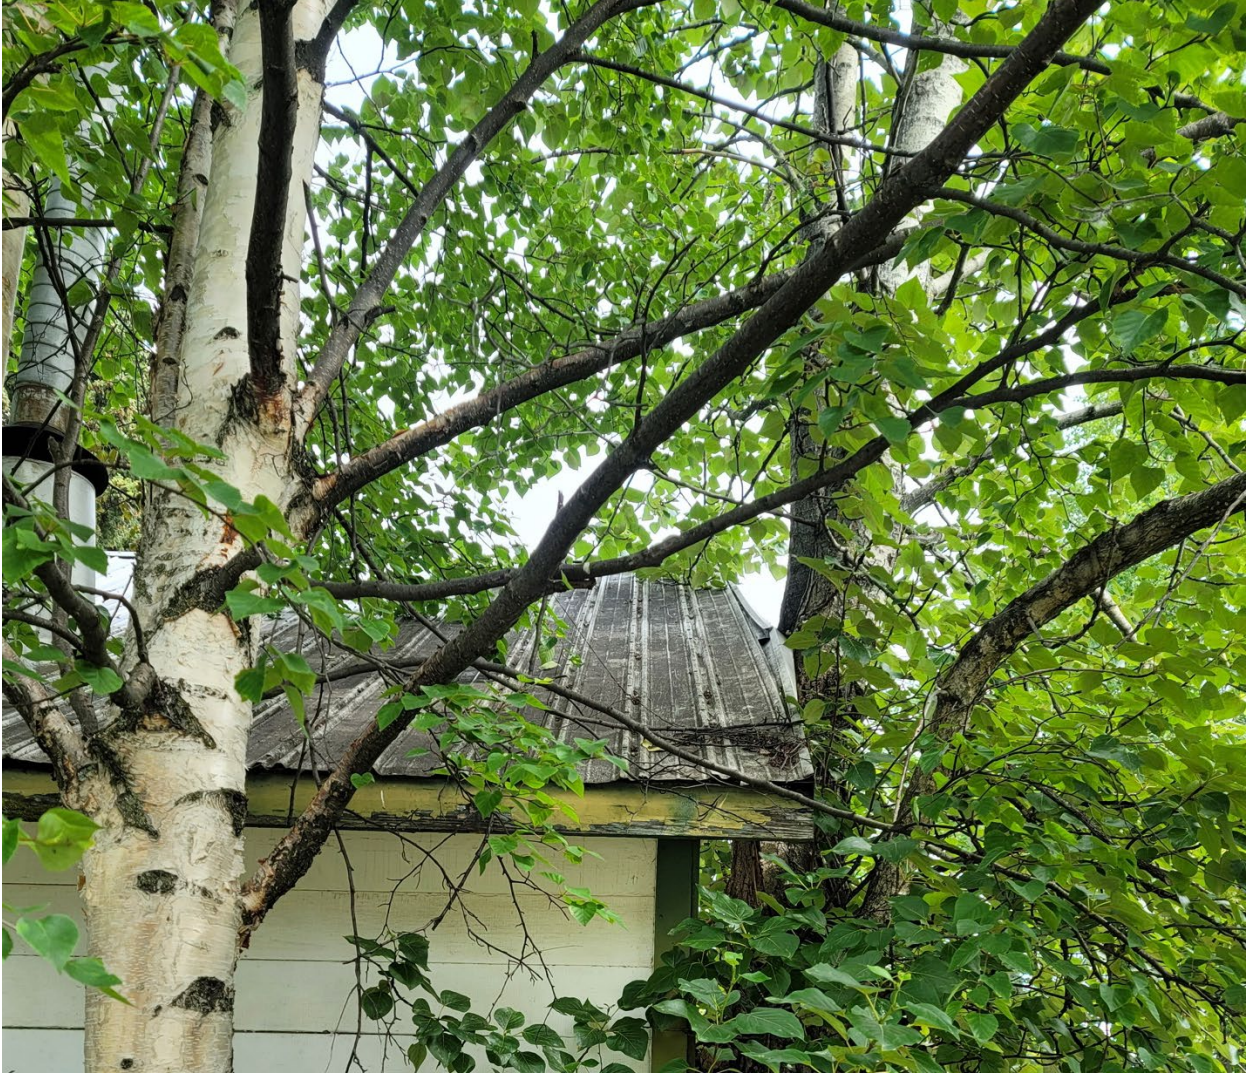
*Figure 20. Detail photograph of Building C. The photo shows how the birch tree that has grown against the southeast façade of the building has begun to displace the roofing materials (©TNSDS 2023).*

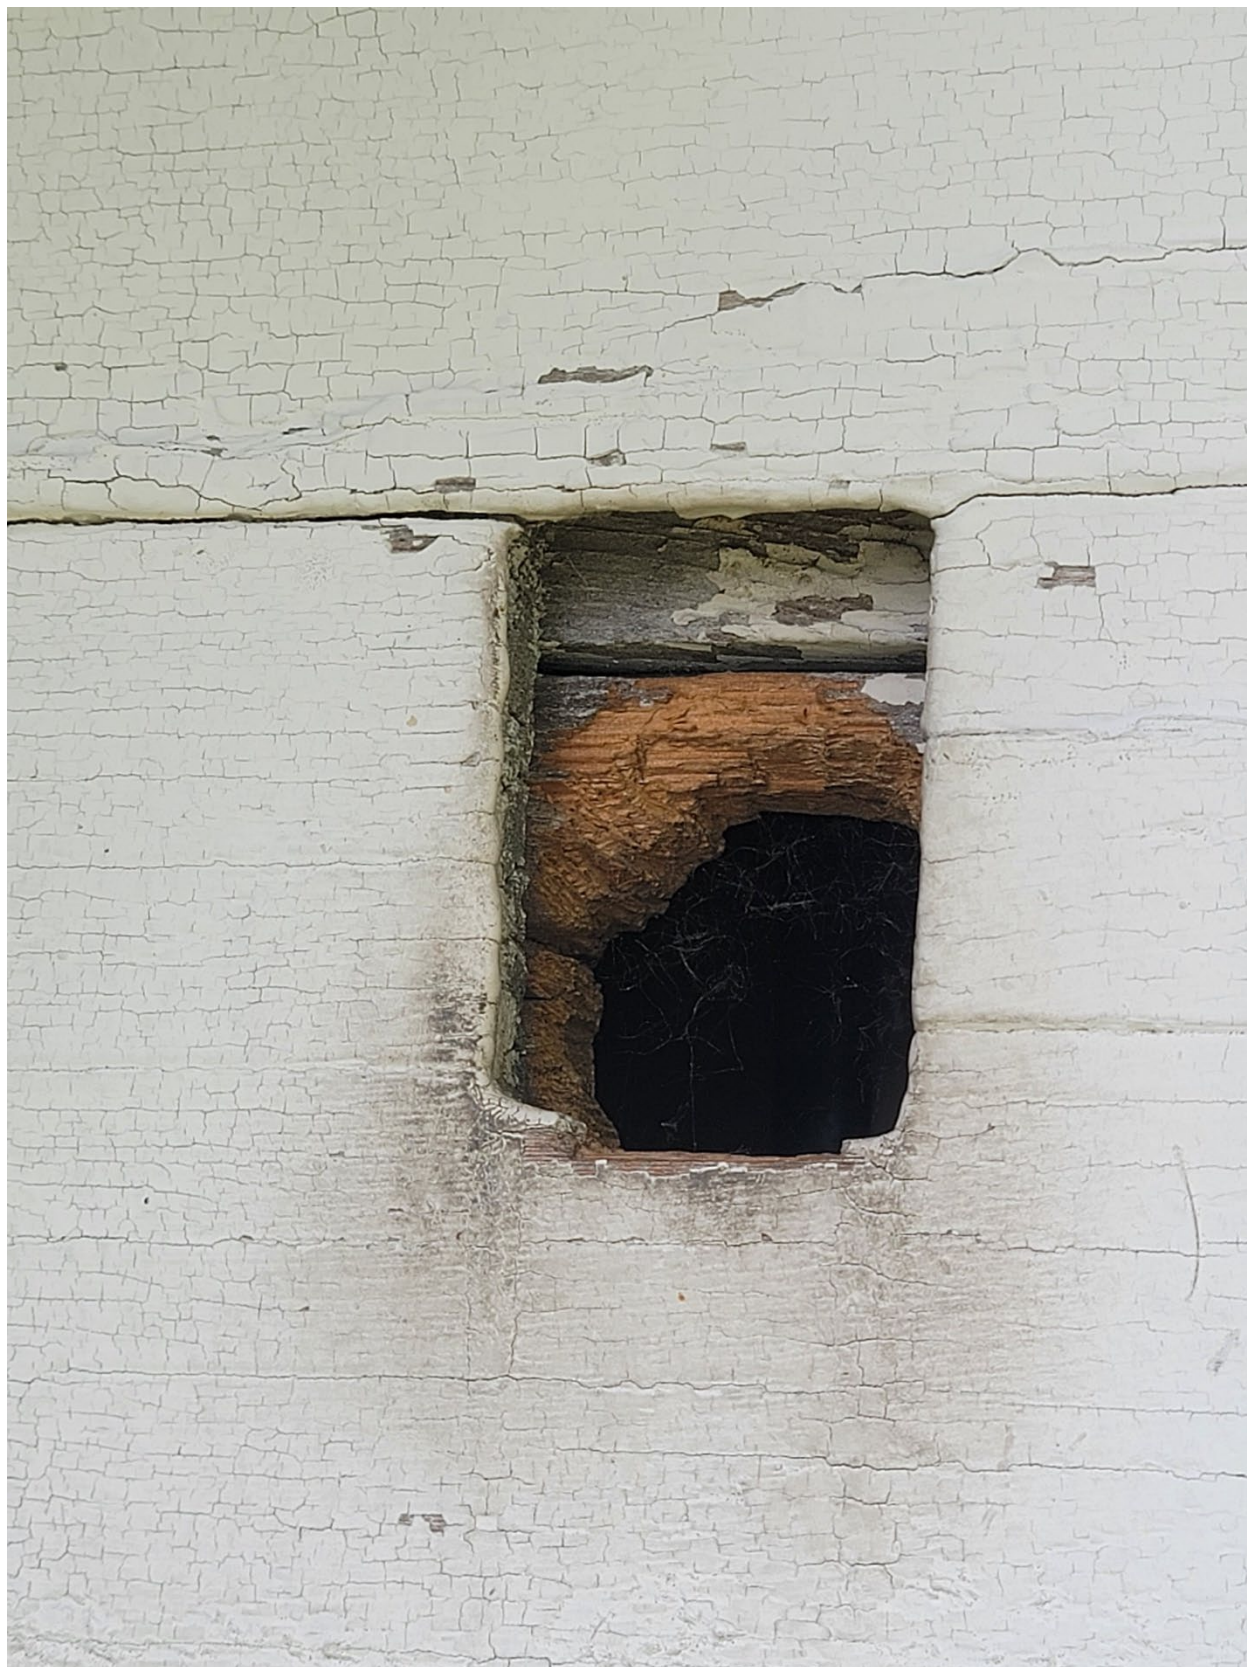
*Figure 21. Detail photograph of an opening the siding of Building C, exposing the interior wood planks (©TNSDS 2023).*
