**Municipality of Anchorage  
Historic Preservation Commission**

The Municipality of Anchorage, on behalf of the Anchorage Historic Preservation Commission (HPC), retained True North Sustainable Development Solutions, LLC, (TNSDS) for professional services to prepare this condition report to assess the structural and physical condition of the buildings and recommend appropriate preservation actions and treatments. The intent of the conditions and structural report is to better understand which historic preservation treatment would be most appropriate for future development of the property that will comply with the recommended treatment standards from *The Secretary of Interior's Standards for the Treatment of Historic Properties*.

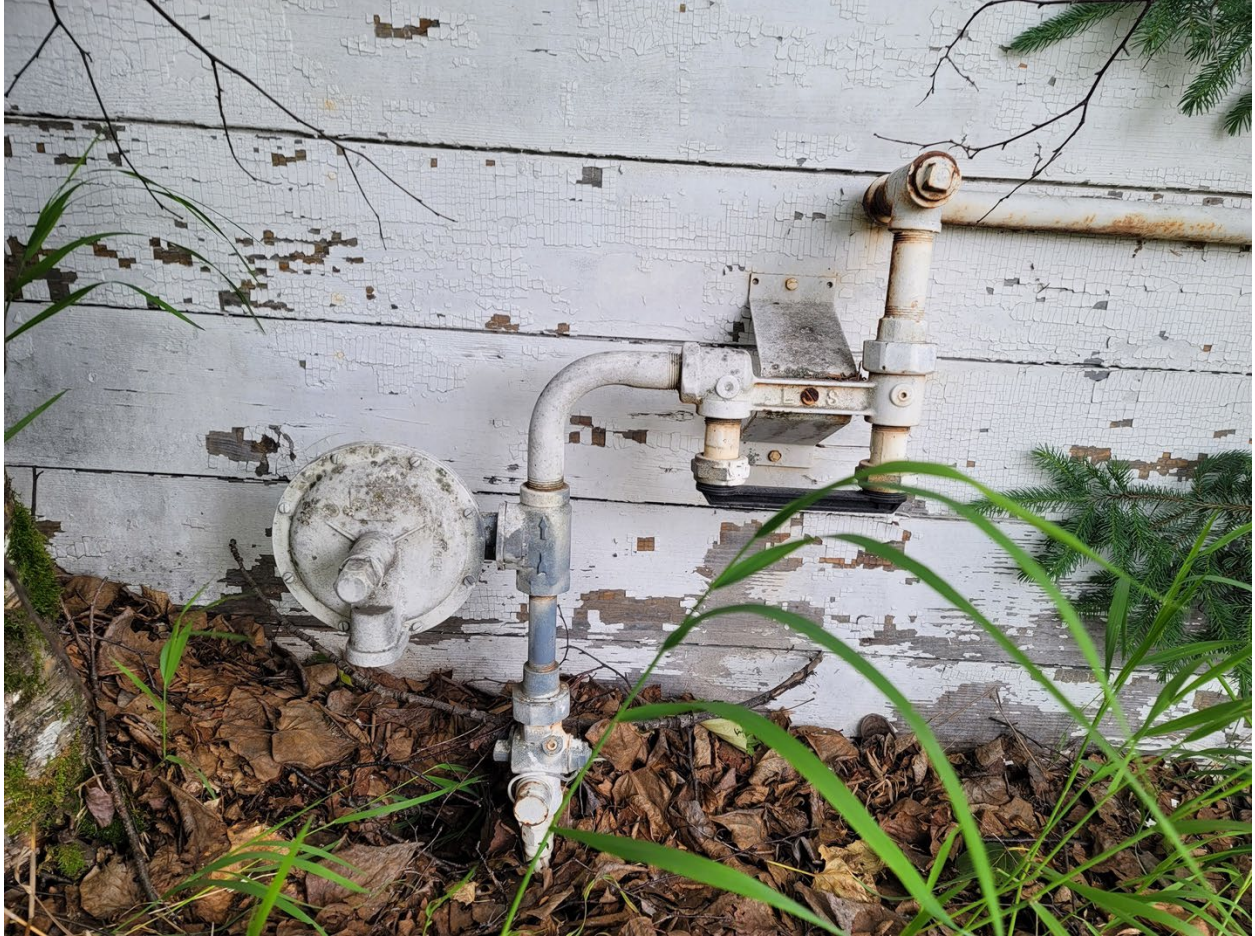
The wood plank siding on Building C appears to be in serviceable condition, with few signs of deterioration. The paint, however, is beginning to show signs of cracking and crazing, and has eroded from the boards

near the base of the exterior walls. This leaves the wood below more vulnerable to moisture and animal infiltration. There is evidence that the paint has been removed and reapplied in the past, with crack and crazing sections surrounded by smooth, newer paint (Figure 22).

*Figure 22. Detail photograph of the utilities installed on the southwest façade of Building C. The photograph shows the deterioration of the paint along the bottom boards of the building. It also demonstrates the crazing and cracking of the older paint as well as sections where the older paint has been removed and reapplied such that no cracking or crazing is present (©TNSDS 2023).*

It is important that the paint should be hand scraped and sanded to remove any loose or deteriorated paint and then repainted to protect the siding underneath. The vegetation surrounding the building should be removed, especially where it has built up along the southwest façade. The vegetation at this location has built up to the point that it is pushing the door inward and is likely exerting the same pressure on the lower walls. It may be appropriate that a gutter system or curtain drain should be installed around Building C to prevent further deterioration; if installed, it is important that the systems be sympathetic to the historic appearance of the building.

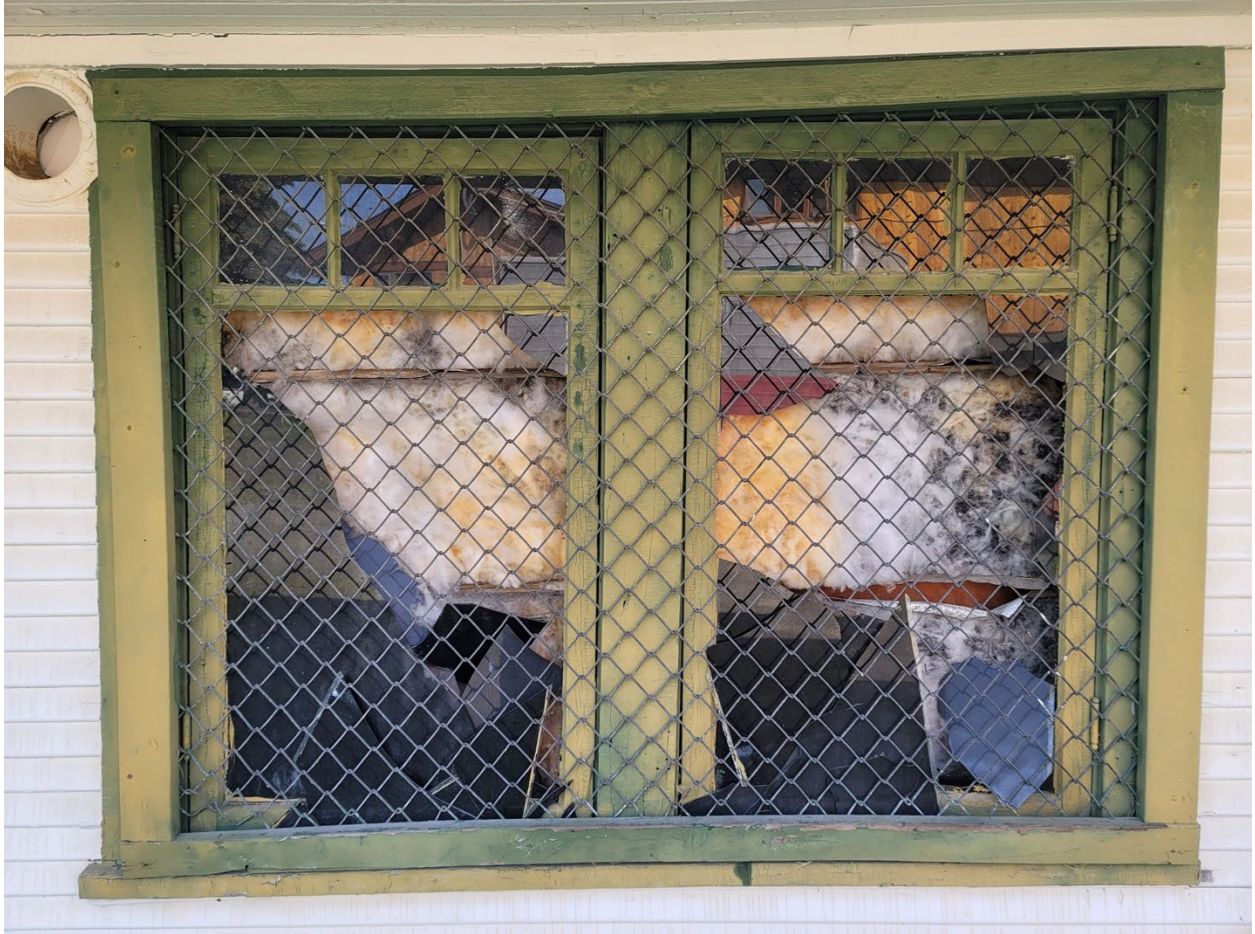
*Figure 27. The southernmost window on the west façade of Building A. The photograph shows the broken glazing as well as the misalignment of the window framing due to the building's uneven settlement over time (©TNSDS 2023).*

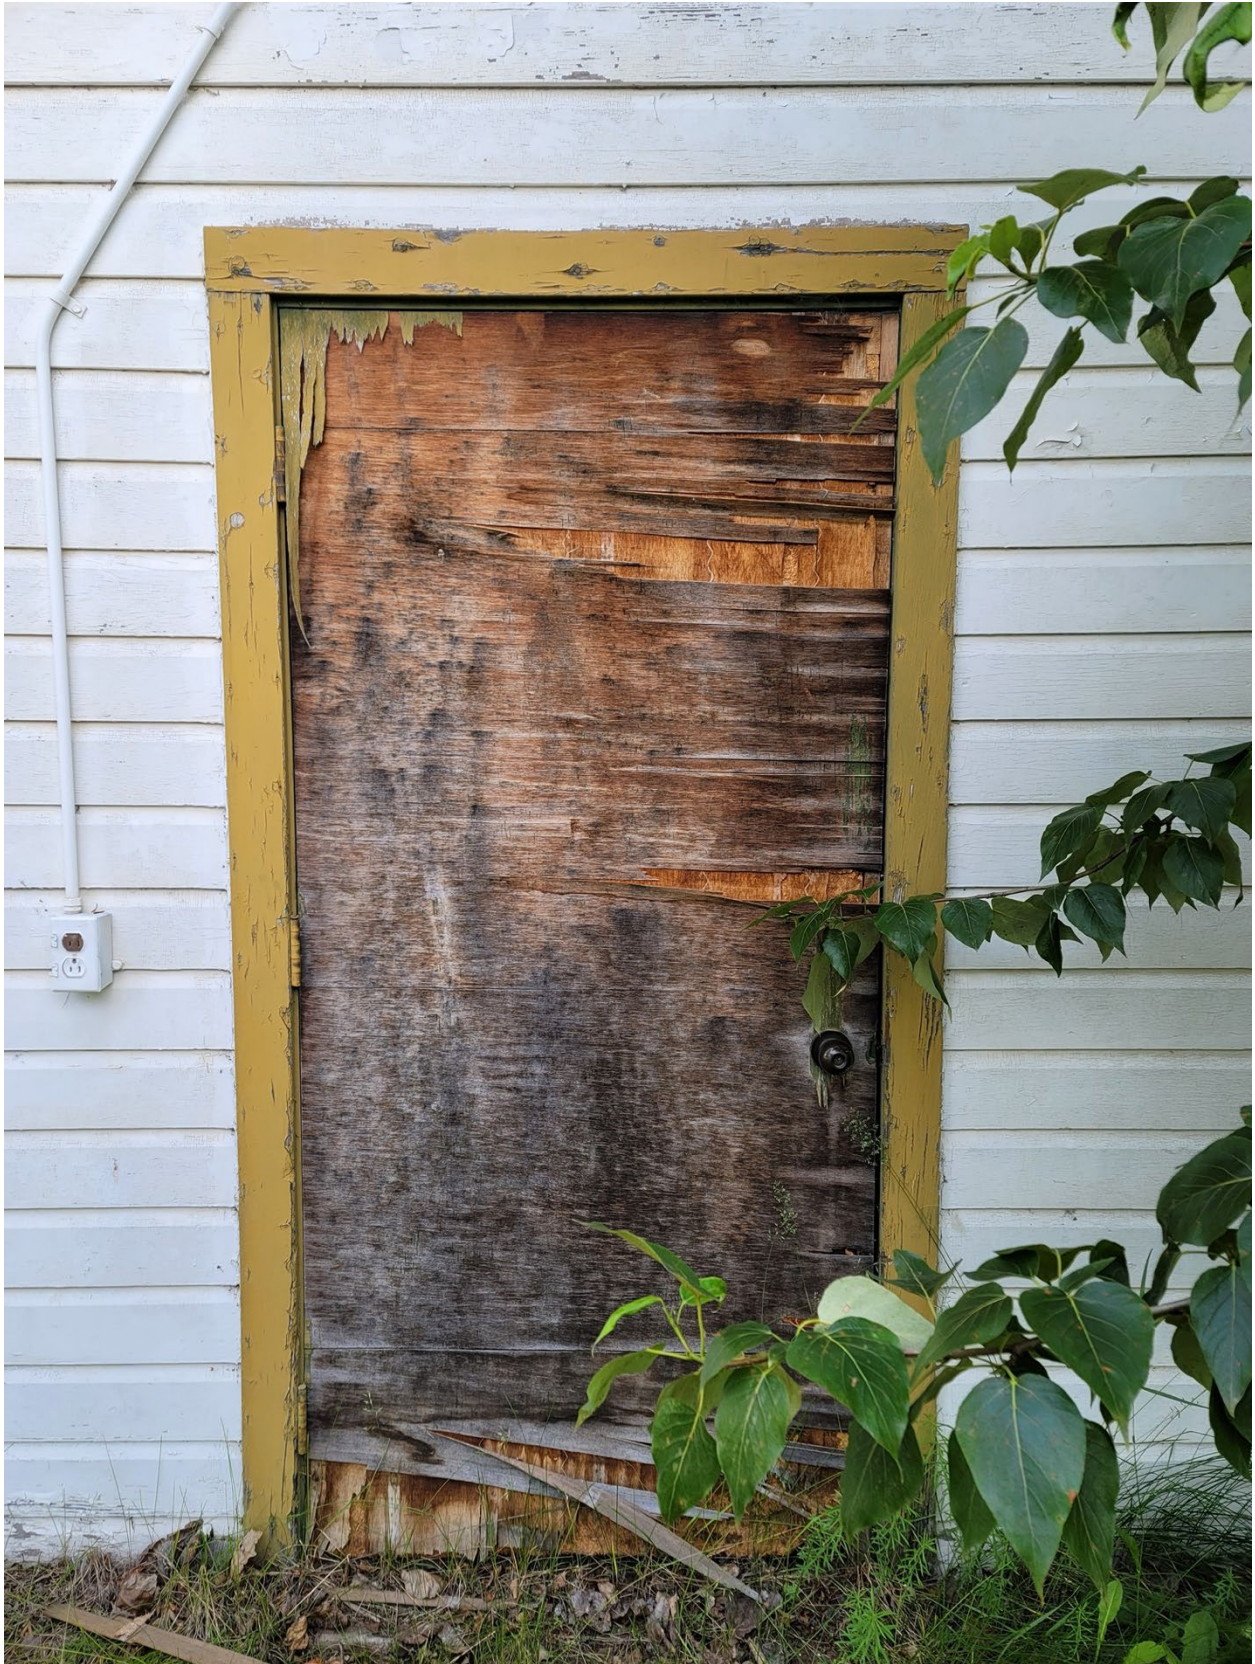
*Figure 36. Detail photograph of the door in the southwest facade of the addition of Building B. The photograph shows the significant deterioration of the door material (©TNSDS 2023).*

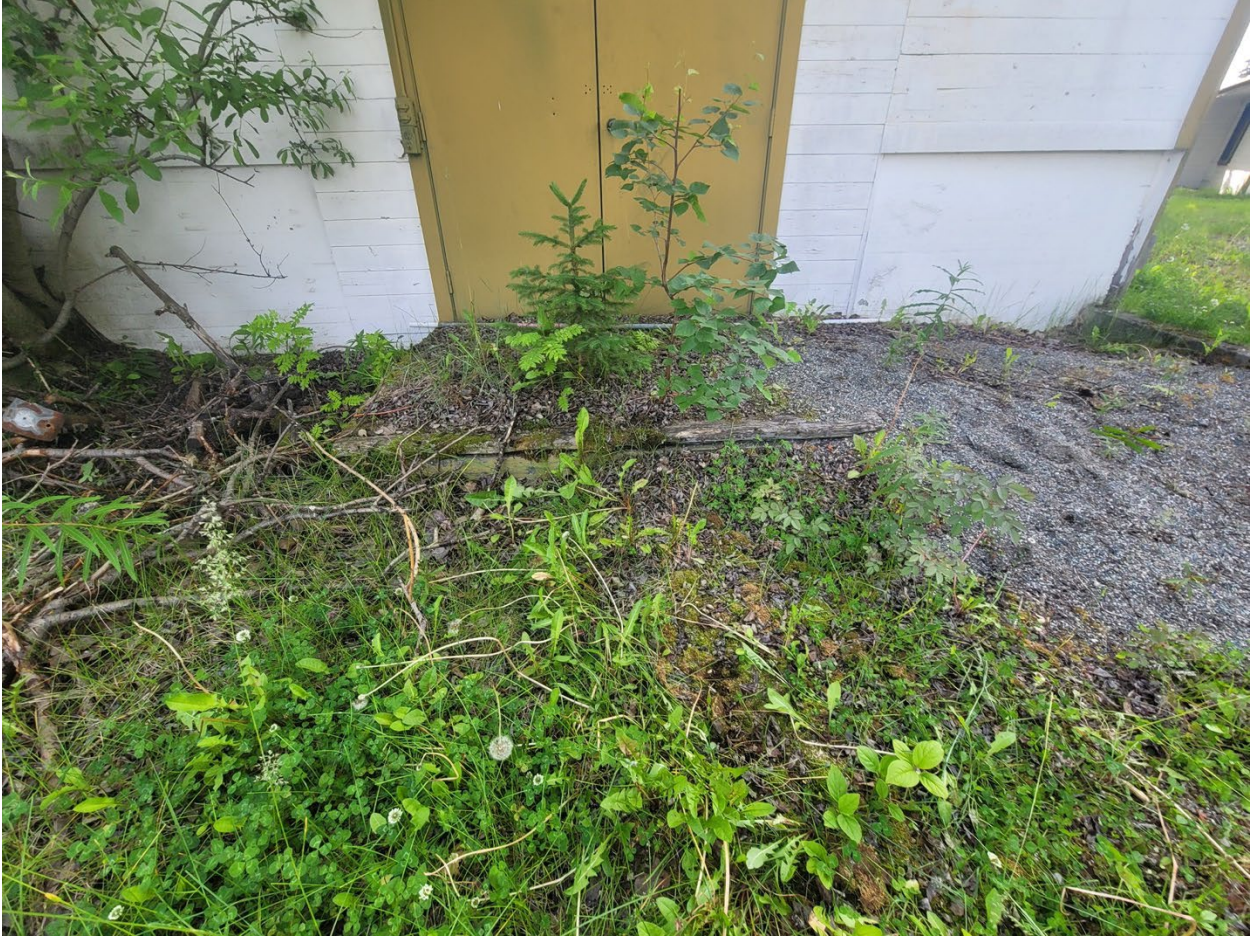
*Figure 43. Detail photograph showing the deteriorated, wood framed porch or stoop located in front of the entrance in the northwest façade of the long axis of Building B (©TNSDS 2023).*

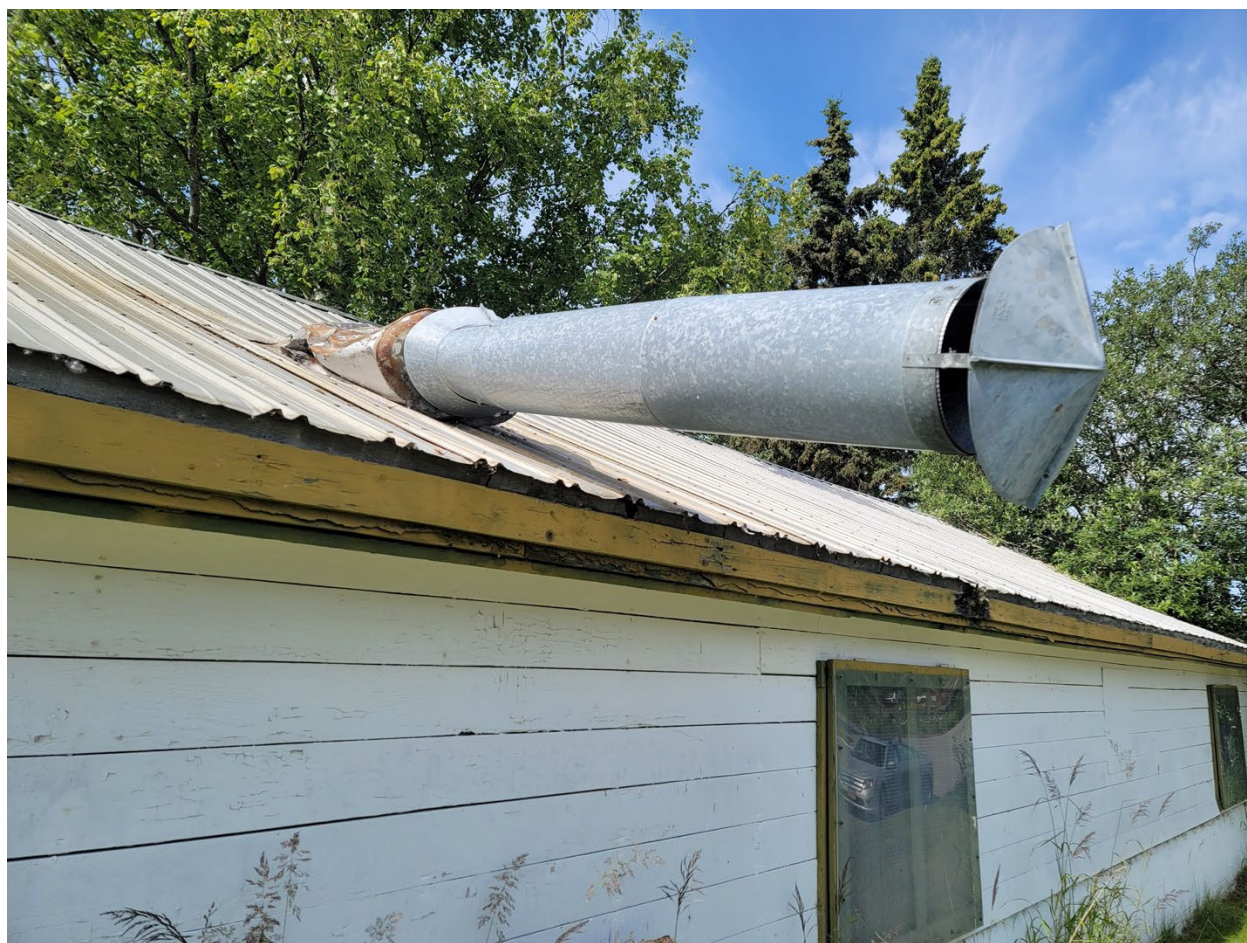
*Figure 47. Detail photograph of the collapsed chimney on Building B (©TNSDS 2023).*

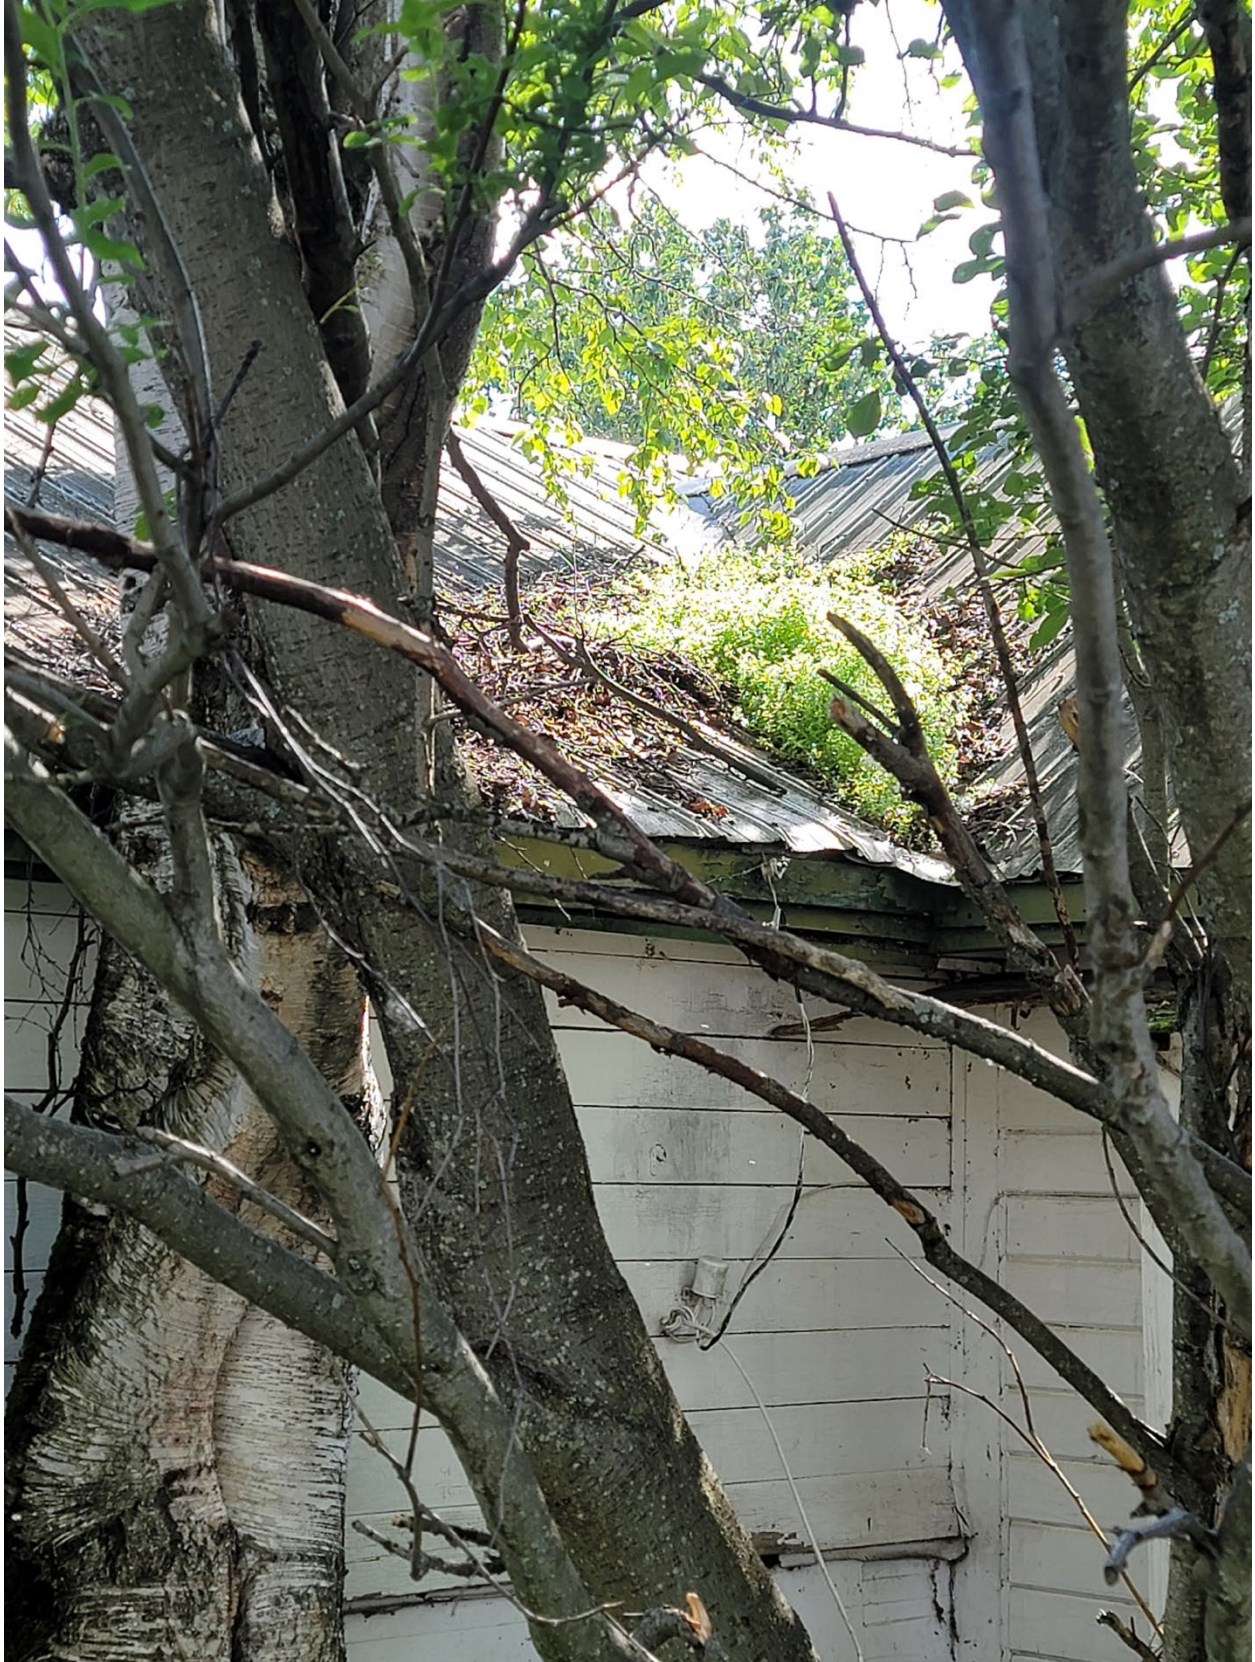
Figure 49. Detail photograph of the junction of the two sections of Building B. The photograph shows the roofing material, surrounding vegetation, and the vegetative debris growing on the roof valley (©TNSDS 2023).

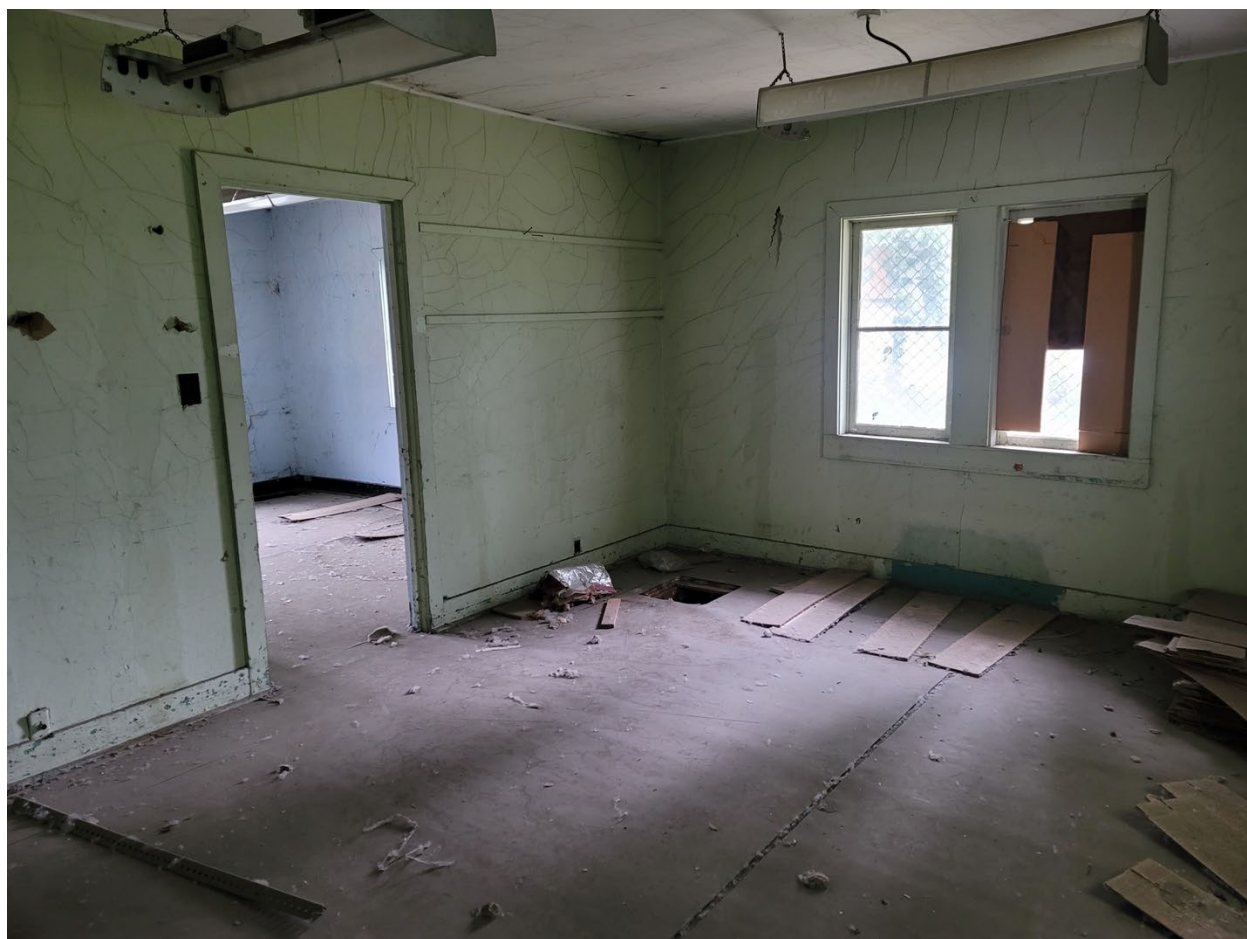
*Figure 51. Interior of the northernmost rooms in Building A. The photograph shows the holes and cracks in the flooring and wall finishes (©TNSDS 2023).*

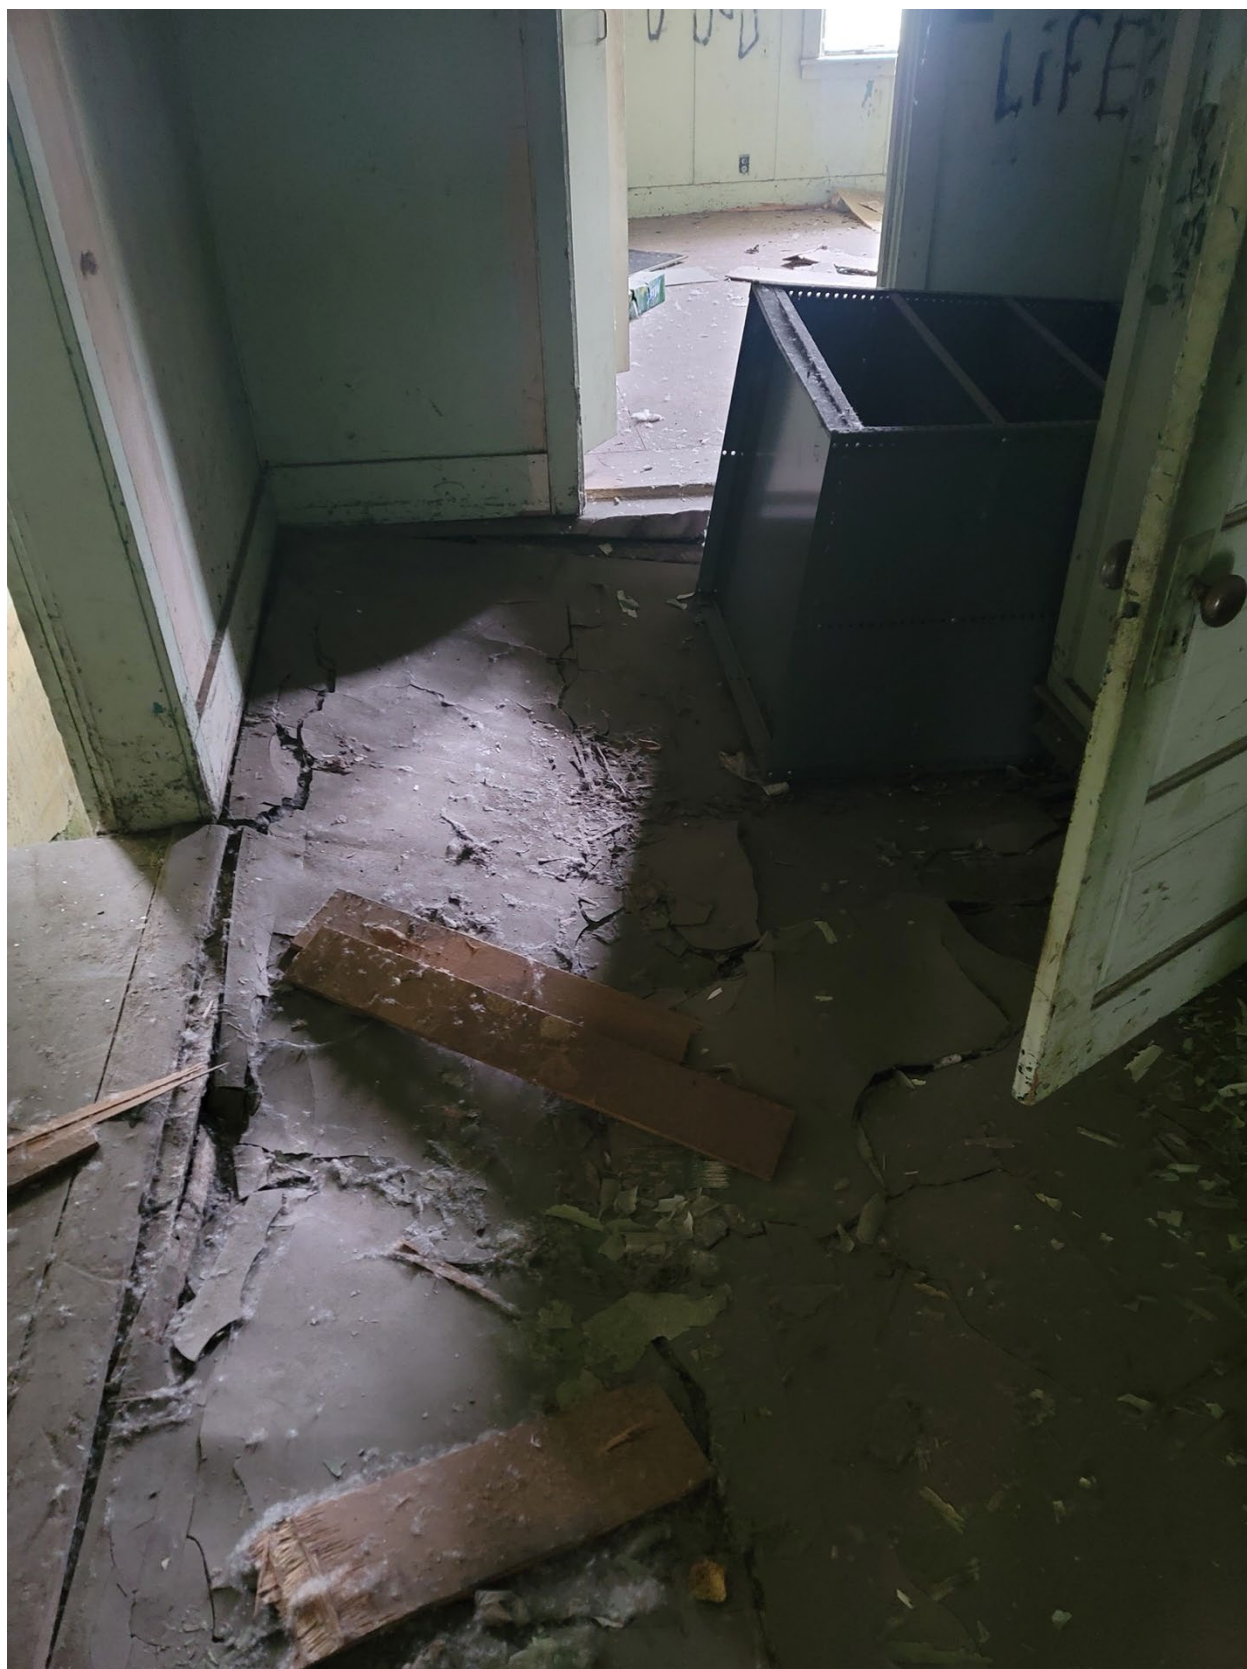
Figure 54. Photograph of one of the collapsed floors in Building A (©TNSDS 2023).

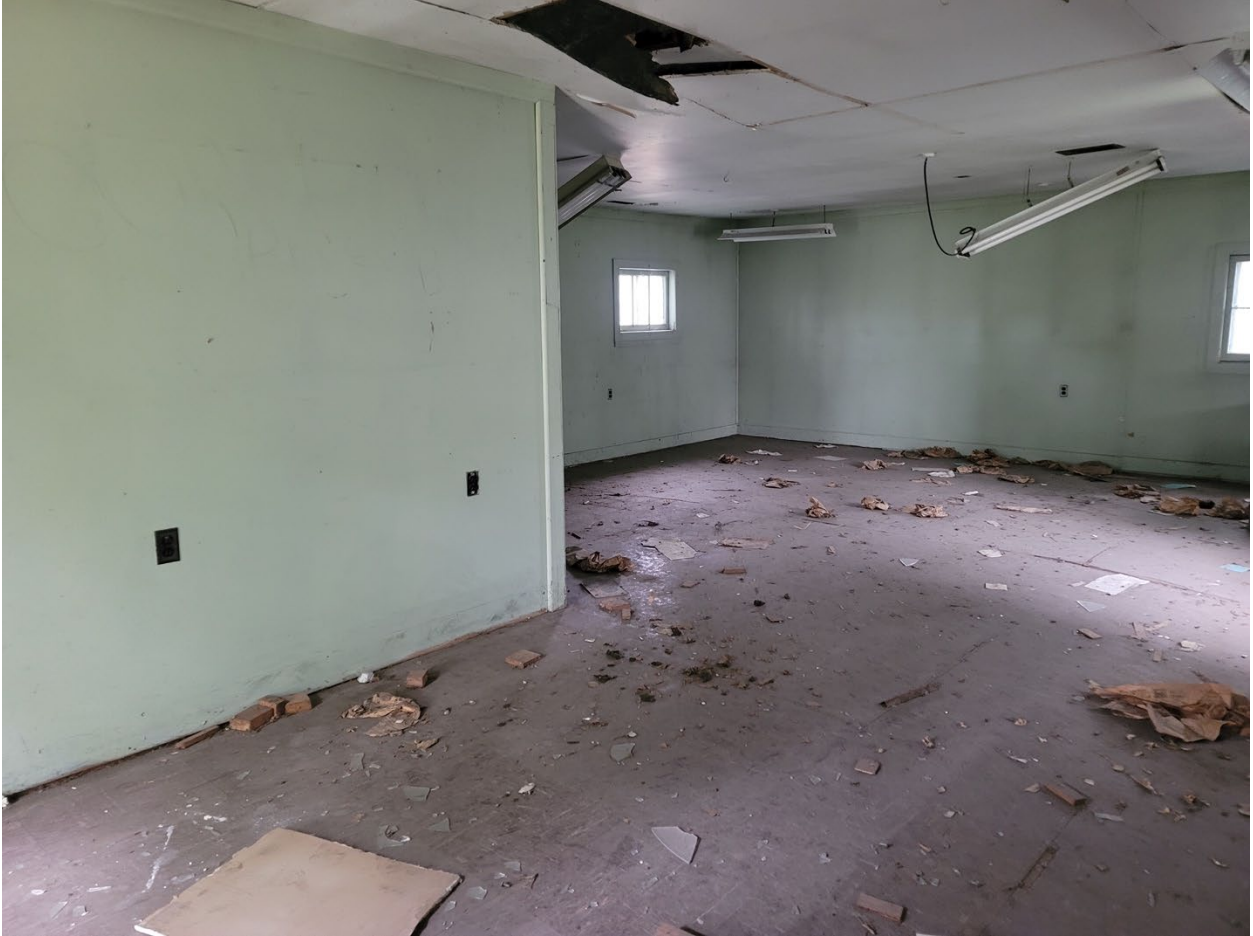
*Figure 55. View of the interior of Building C, showing the flooring, wall finishes, and deteriorating ceiling (©TNSDS).*

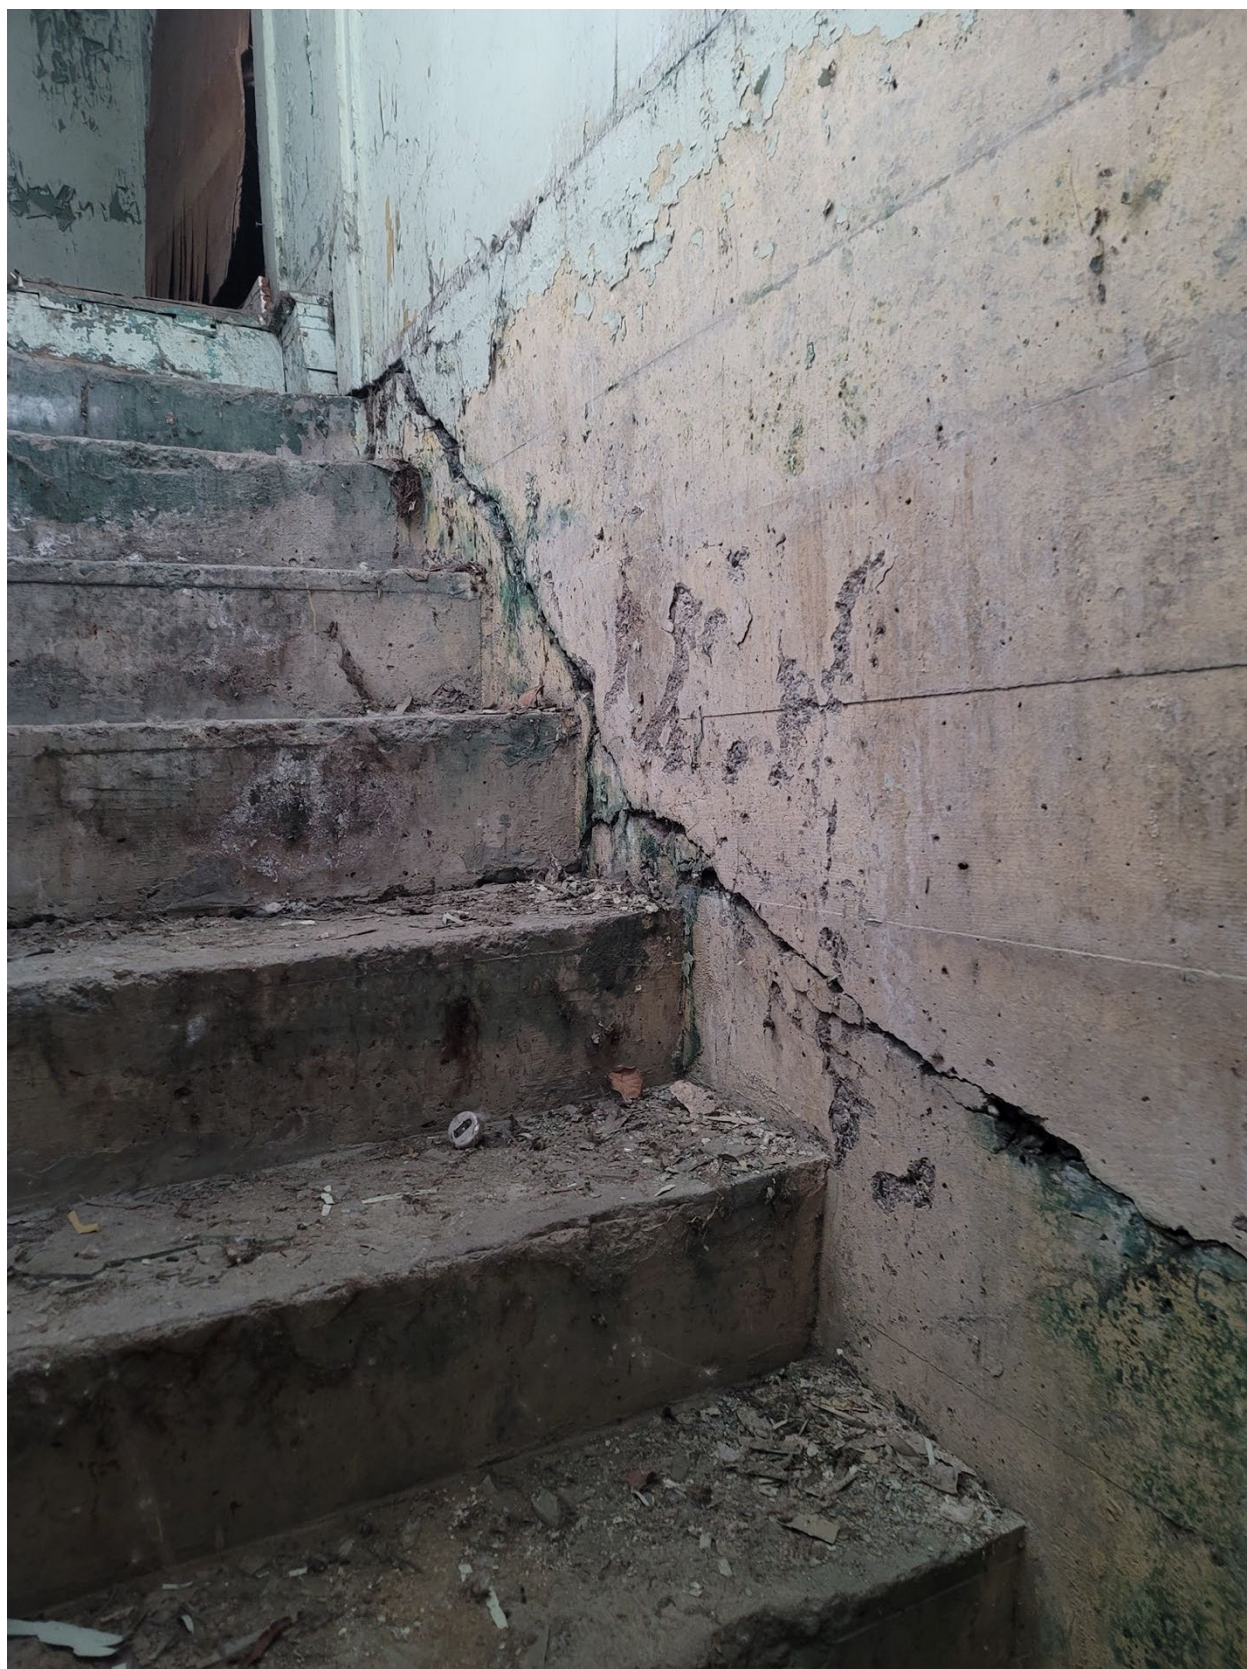
*Figure 56. Detail photo of the stairs that lead from the interior of Building A to the basement in the north addition. The photograph shows the slope of the crack paralleling the stair slope as well as spalling, vegetative growth, and staining from water infiltration (©TNSDS 2023).*
