# MERRILL FIELD AIRPORT MASTER PLAN UPDATE AND NOISE STUDY APPENDIX

Merrill Field Airport  
Municipality of Anchorage  
**Final December 2016**

HDR, Inc.  
with  
Harris Miller Miller & Hanson Inc. (HMMH),  
Hattenburg Dilley & Linnell LLC (HDL), and  
McClintock Land Associates (MLA), Inc.

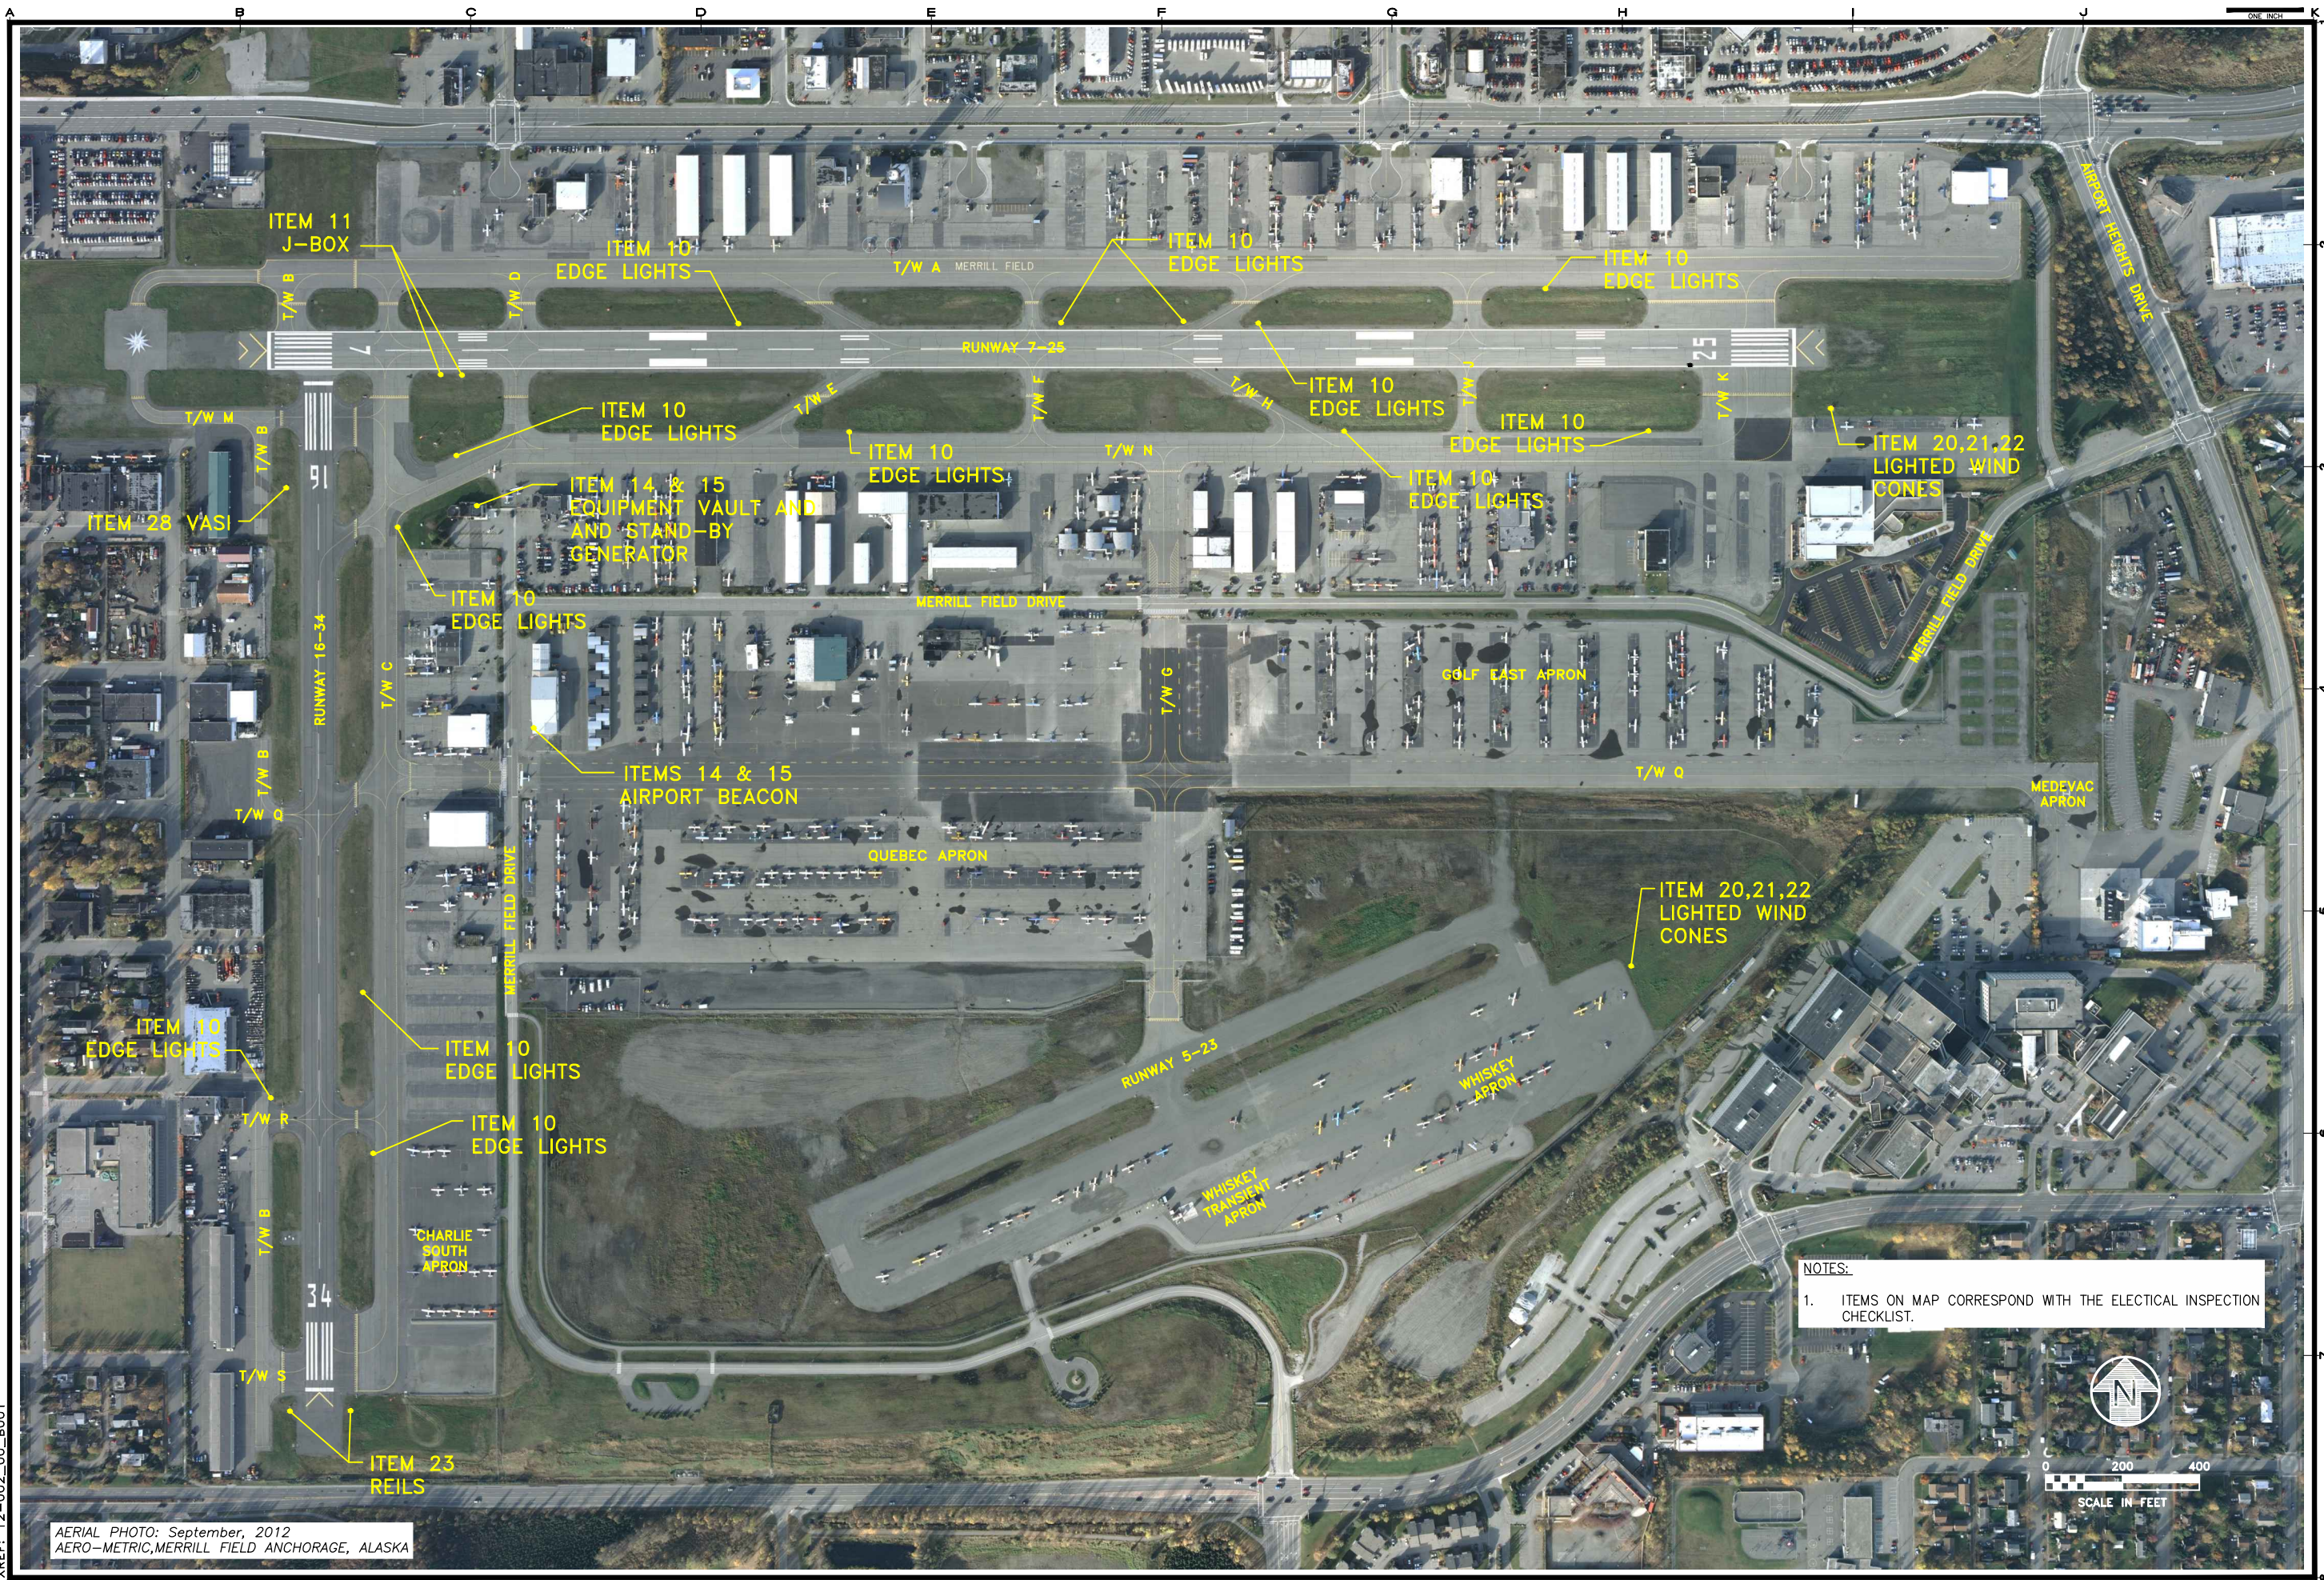
ELECTRICAL DEFICIENCY LOCATION MAP

The runway and taxiway edge lights consist of mid-intensity fixtures elevated 24 inches above grade. The fixtures are equipped with varying lens attachment methods including twist lock, clamp band, and pop top style attachments. The lighting was checked for conformance with FAA AC 150/5340-30G for color, siting criteria, and installation. The general condition and operation of the edge lighting were also evaluated. Non-conforming elements of the airport lighting system are noted in the Updated Electrical Inspection Checklist included in this section.

The 2013 inspection also included evaluation of the REILs and approach aids at each runway end. Each end of Runway 7/25 is equipped with VASIs and omni-directional REILs. Runway 34 was equipped with a precision approach path indicator (PAPI) and uni-directional REILs that face approaching aircraft. Runway 16 is equipped with a VASI and uni-directional REILs. The FAA owns and maintains the VASI and REIL navigational aids on both the runways at the airfield. The Runway 34 PAPI is owned and maintained by Merrill Field. The inspection verified that all NAVAIDs were operational and noted the general condition of the equipment. Equipment aiming and signal intensity were not measured during the inspection. New runway lighting conductors which supply power to the REILs were installed in the 2010 project. FAA technicians serviced the REILs on Runway 16/34 after the lighting conductors were installed but deficiencies identified in the 2007 Annual Airport Inspection were not addressed.

Updated Electrical Inspection Checklist							
✓	Item	Location	Inspection Activity	Code Reference	YES	NO	Comments
	10	Runway and Taxiway Edge Lights	Are all Inspected Edge Lights Intact, Secured, Sealed, and Gasketed?	AC 150/5345-46D		X	<p>Defects Were Noted in the Following Locations:</p> <p><u>-Runway 7/25:</u> Runway Light located near the northwest intersection with Taxiway E, lamp significantly dimmed or burned out.</p> <p><u>-Taxiway A, North of Runway 7/25:</u> Taxiway Light located between Taxiway J and Taxiway K, lamp significantly dimmed or burned out.</p> <p><u>-Taxiway B, West of Runway 16/34:</u> Taxiway Light near the north intersection with Taxiway R, stem and light fixture are missing.</p> <p><u>-Taxiway C, East of Runway 16/34:</u> Taxiway Light located near the south intersection with Taxiway N, top of light can is above surrounding ground in excess of 3 inches.</p> <p><u>-Taxiway C, East of Runway 16/34:</u> Taxiway Light located between Taxiway Q and Taxiway R, light is out of alignment.</p> <p><u>-Taxiway C, East of Runway 16/34:</u> Taxiway Light located near the south intersection with Taxiway R, top of light can is above surrounding ground in excess of 3 inches.</p> <p><u>-Taxiway F, North of Runway 7/25:</u> Taxiway Light located near the east intersection with Runway 7/25, lamp significantly dimmed or burned out.</p> <p><u>-Taxiway H, North of Runway 7/25:</u> Taxiway Light located near the west intersection with Runway 7/25, lamp significantly dimmed or burned out.</p> <p><u>-Taxiway H, North of Runway 7/25:</u> Taxiway Light located near the east intersection with Runway 7/25, lamp significantly dimmed or burned out.</p> <p><u>-Taxiway K, South of Runway 7/25:</u> Taxiway Light located near the west intersection with Runway 7/25, lamp significantly dimmed or burned out.</p>

Updated Electrical Inspection Checklist							
✓	Item	Location	Inspection Activity	Code Reference	YES	NO	Comments
	10 cont.	Runway and Taxiway Edge Lights	Are all Inspected Edge Lights Intact, Secured, Sealed, and Gasketed?	AC 150/5345-46D		X	<p><u>-Taxiway N, South of Runway 7/25:</u> Taxiway Light located between Taxiway C and Taxiway D, lamp significantly dimmed or burned out.</p> <p><u>-Taxiway N, South of Runway 7/25:</u> Taxiway Light located near east intersection with Taxiway E, lamp significantly dimmed or burned out.</p> <p><u>-Taxiway N, South of Runway 7/25:</u> Taxiway Light located near east intersection with Taxiway H, lamp significantly dimmed or burned out.</p> <p><u>-Taxiway K, South of Runway 7/25:</u> Taxiway Light located near west intersection with Runway 7/25, lamp significantly dimmed or burned out.</p>
	11	Runway and Taxiway Edge Lights	Are all inspected J-Boxes and Wiring Components Intact and in Working Condition?	AC 150-5345-42G		X	<p>Defects were noted in the Following Locations:</p> <p><u>-South side of Runway 7/25, Between Taxiway C and Taxiway D Intersections:</u> Abandoned wire and plug exposed on edge of runway. An orange cone was placed over the exposed wires.</p> <p><u>-South side of Runway 7/25, Between Taxiway C and Taxiway D Intersections:</u> Abandoned sign/light base exposed on edge of runway. An orange cone was placed over the sign/light base.</p>

23	REILs	Are REILs Operational?	AC 150-5345-51B	X		
	24	REILs	Are REILs in Good Physical Condition?	AC 150-5345-51B		X	Cabinets for REILs located on the Runway 34 are severely rusted and paint is significantly pitted and peeling. REILs are of an older style that is no longer typically used.

The corrective action list consists of (7) items to be completed including: 1) removing and replacing the standby generator with a new enclosure outside the airport lighting vault; 2) rearranging the regulator layout and hydronic heat piping in the airport lighting vault to meet code; 3) fixing broken or missing lights and junction boxes; 4) replacing edge light lamps, 5) upgrading remaining runway and taxiway edge lighting to LED fixtures; 6) improving grounding and bonding of beacon tower; and 7) replacing remaining lighted wind cones with LED, tilt down, fixtures. Action item descriptions are listed in the attached Updated Electrical Inspection Checklist. The locations of action items are depicted on Sheet 1.1. Preliminary construction costs are included below (2013 dollars).

Install New Standby Generator in New Enclosure Outside of Lighting Vault; Rearrange Lighting Vault.....		\$670,000
Repair Damaged/Missing Edge Lights and Junction Boxes 6 @ \$925 .....		\$5,550
Replace Edge Light Lamps 11 @ \$30 .....		\$330
Upgrade Airport Edge Lighting to LED Fixtures (approximately 150) @ \$750 ...		\$112,500
Improve Beacon Tower Grounding and Bonding .....		\$2,500
Replace Lighted Wind Cones 2 @ \$25,000 .....		\$50,000
		=====
Total .....		\$840,880

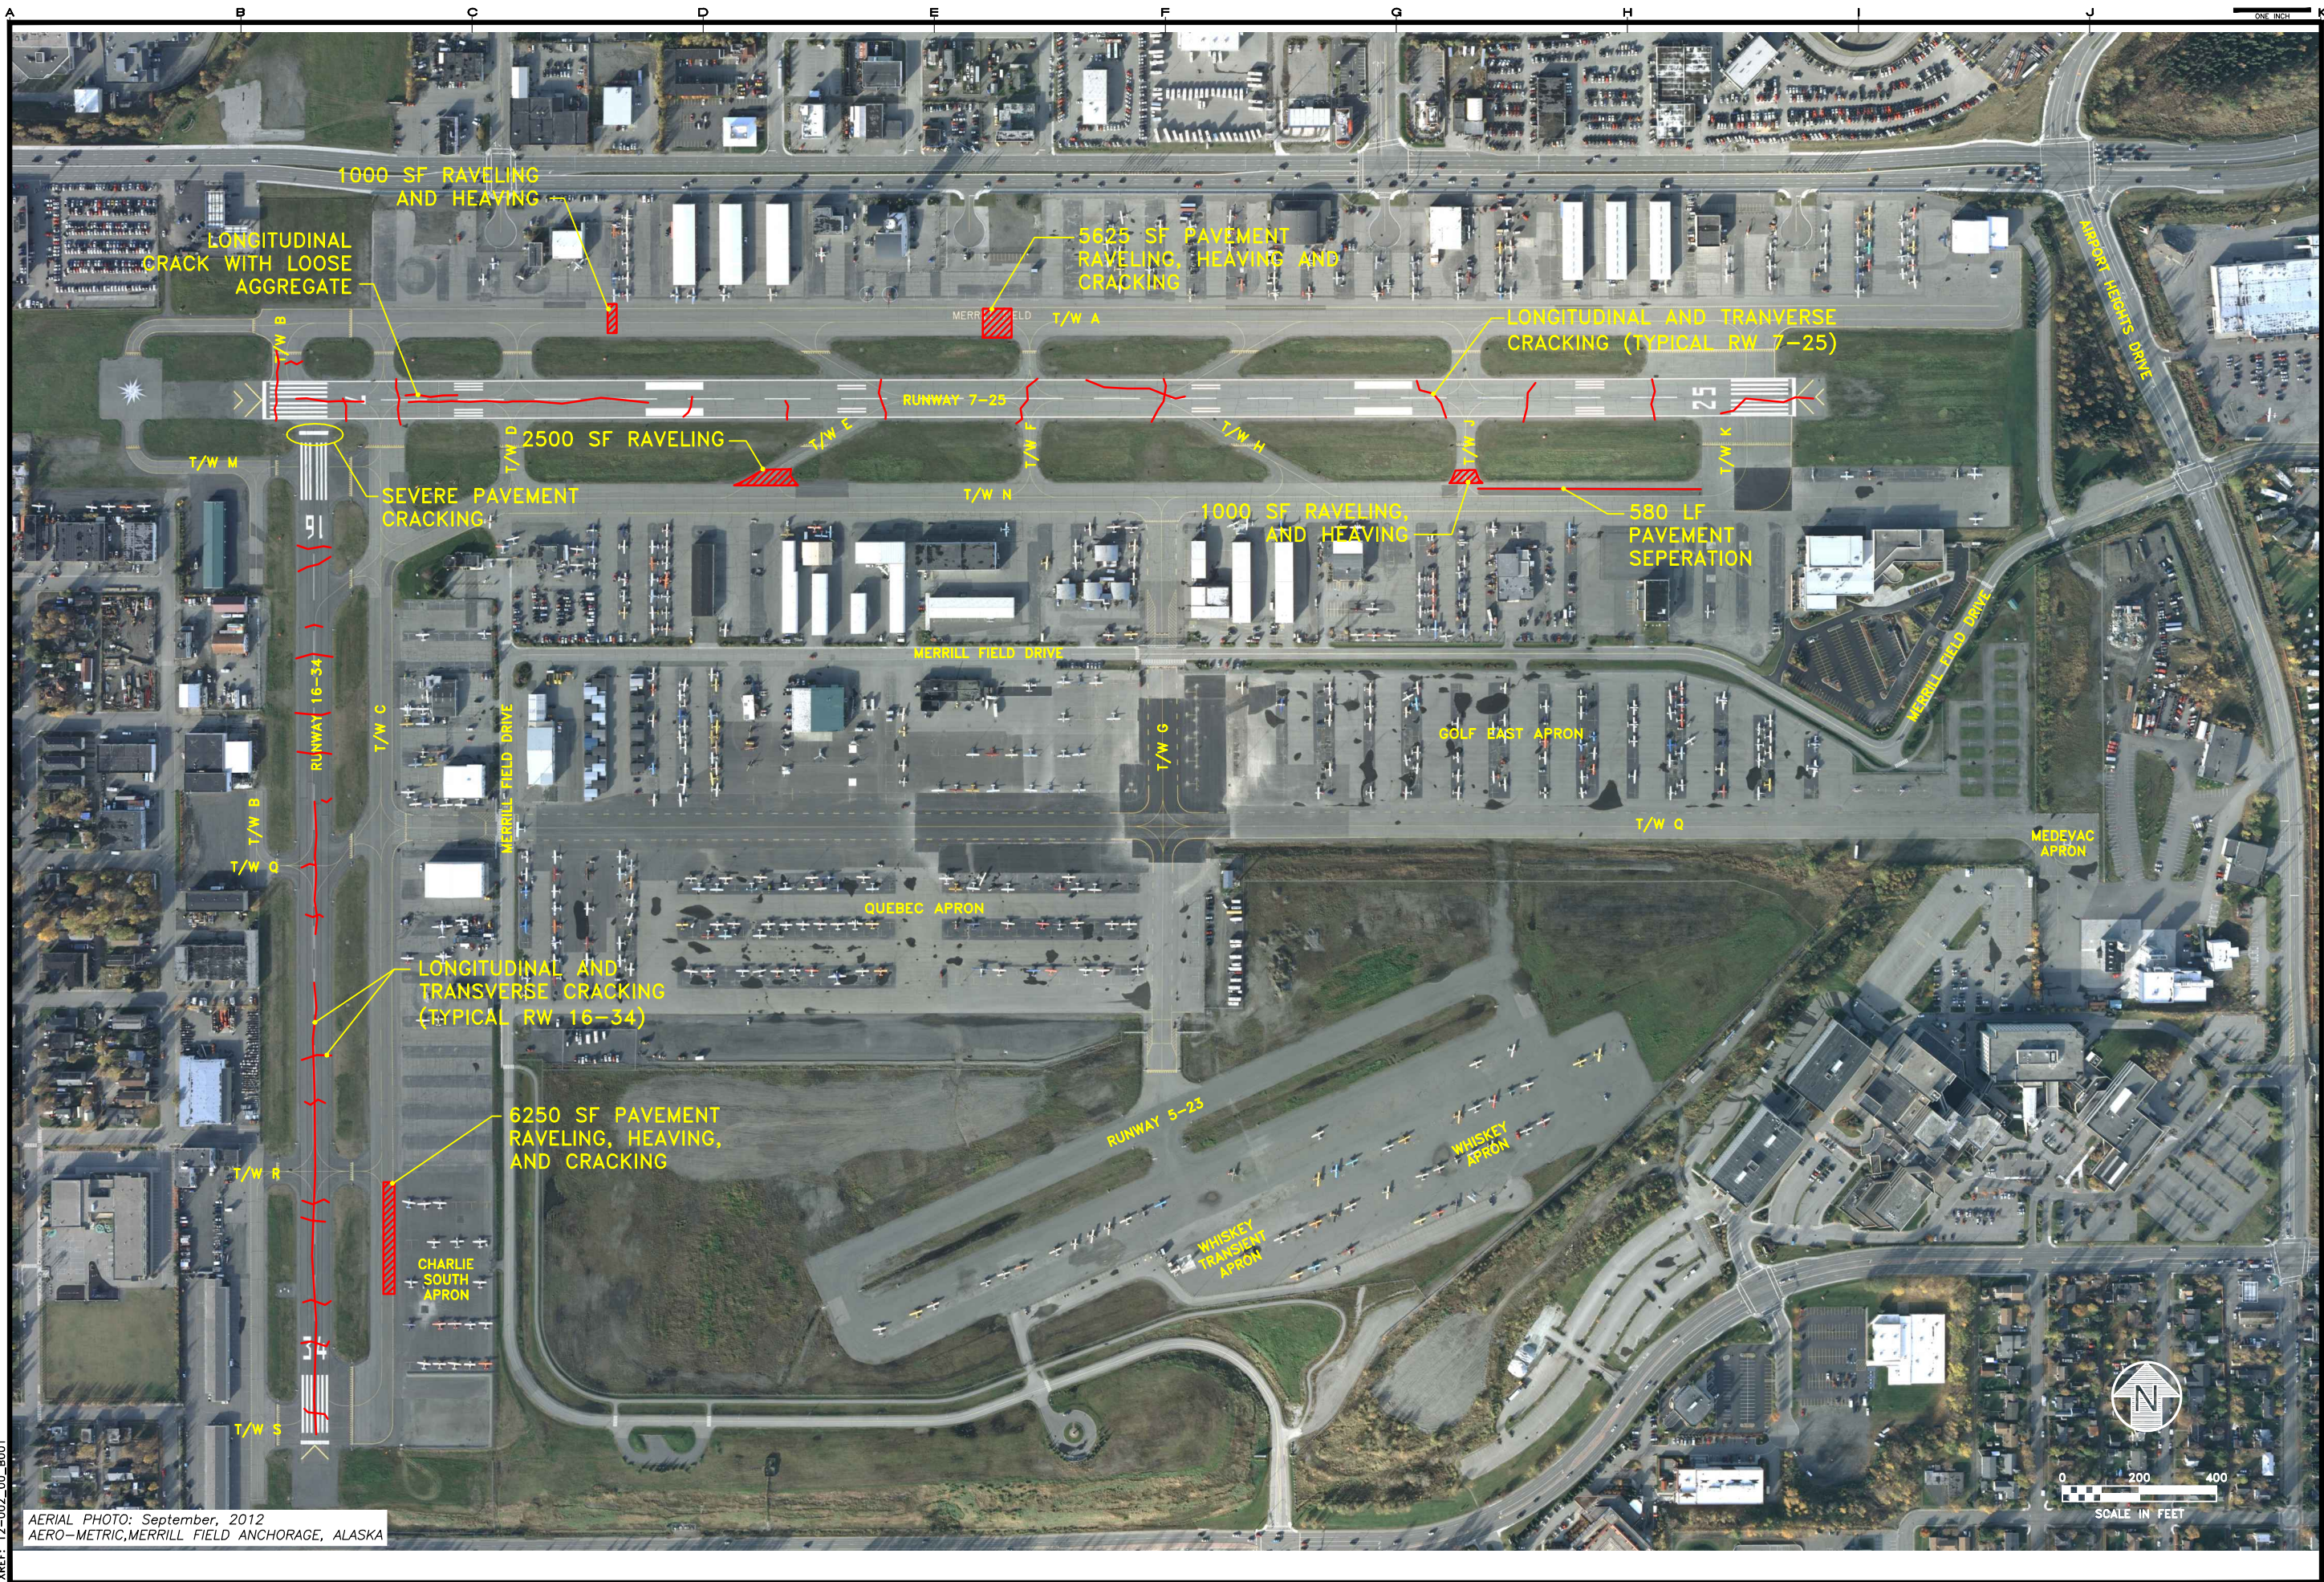
H:\Jobs\12-002 Merrill Master Plan\2013 Airfield Inspection\CAO\Drawings\12-002-FIG-1.2-AIRFIELD-PAVEMENT-IMMEDIATE-CORRECTIVE-ACTION, 1=100, 08/05/13 at 10:20 by unknown  
LAYOUT: Layout1  
XREF: 12-002\_CO\_8001

**Runways.** Runway 7/25 pavement was rehabilitated in 2005. An approximate 75-foot by 15-foot area of pavement along the south edge of Runway 7/25, between Taxiways C and D, contains multiple 1-inch diameter divots. These divots were formed from separation of the hot mix asphalt mixture during paving operations due to poor quality batch mixture or low temperature application. Repair of the area should be made within the next 24 months. Coating this area with a pavement sealer is recommended to fill in the existing divots and prevent future pavement degradation and water intrusion. Runway 7/25 contained extensive longitudinal, transverse and diagonal cracking that has been previously been sealed. Several cracks were severely spalled and aggregate was loose or missing causing definite FOD potential. Other Runway 7/25 pavement is generally in good condition and no signs of pavement heave or rutting were found.

The 2007 Annual Airport Inspection Report identified eight (8) locations on Taxiways A, C, K, and N that contained severely cracked pavement, poor drainage, or frost heaves. These areas were rehabilitated in 2010 as part of the Rehabilitate Runway 16/34 project. The project rehabilitated approximately 34,700 square feet of existing pavement and underlying subgrade. Pavement was removed, subgrade soils were excavated to a depth of 4 feet, and the structural sections were rebuilt with classified fill, leveling course, and pavement. Since 2010, the shoulder of the southeast intersection of Taxiway C and Taxiway N still experiences frost heaving in the winter according to Merrill Field maintenance personnel. Also, the northern pavement joint of Taxiway N, between Taxiway J and Taxiway K, has separated from the existing shoulder in excess of ½ inch along the entire length.

Areas of severe pavement raveling and mechanical damage caused by snowplows were identified on Taxiway A and Taxiway C.

recommended. The area is severely cracked, portions are raveling, and there is evidence of frost heaving.

Immediate crack sealing is recommended (runways, taxiways, and aprons) where crack widths and/or depths are 1 inch or greater or where aggregate is loose or missing. Perform routine routing and crack sealing annually.

The following corrective action summary includes pavement in critical areas that need repair as soon as possible to improve safety and functionality at the airport. The locations of action items are depicted on Sheet 1.2.

Runway 7/25 Immediate Crack Sealing 150 LF @ \$9.00 .....	\$1,350
Runway 16/34 Immediate Crack Sealing 300 LF @ \$9.00 .....	\$2,700
Runway 7/25 Pavement Edge Repairs 1,125 SF @ \$7.50 .....	\$8,440
Taxiway A Pavement Repairs 6,625 SF @ \$7.50 .....	\$49,690
Taxiway C Pavement Repairs 6,250 SF @ \$7.50 .....	\$46,875
Taxiway E Pavement Repairs 2,500 SF @ \$7.50 .....	\$18,750
Taxiway J Pavement Repairs 1,000 SF @ \$7.50 .....	\$7,500
Taxiway N Crack Sealing 580 LF @ \$9.00 .....	\$5,220
=====	
Total.....	\$140,525

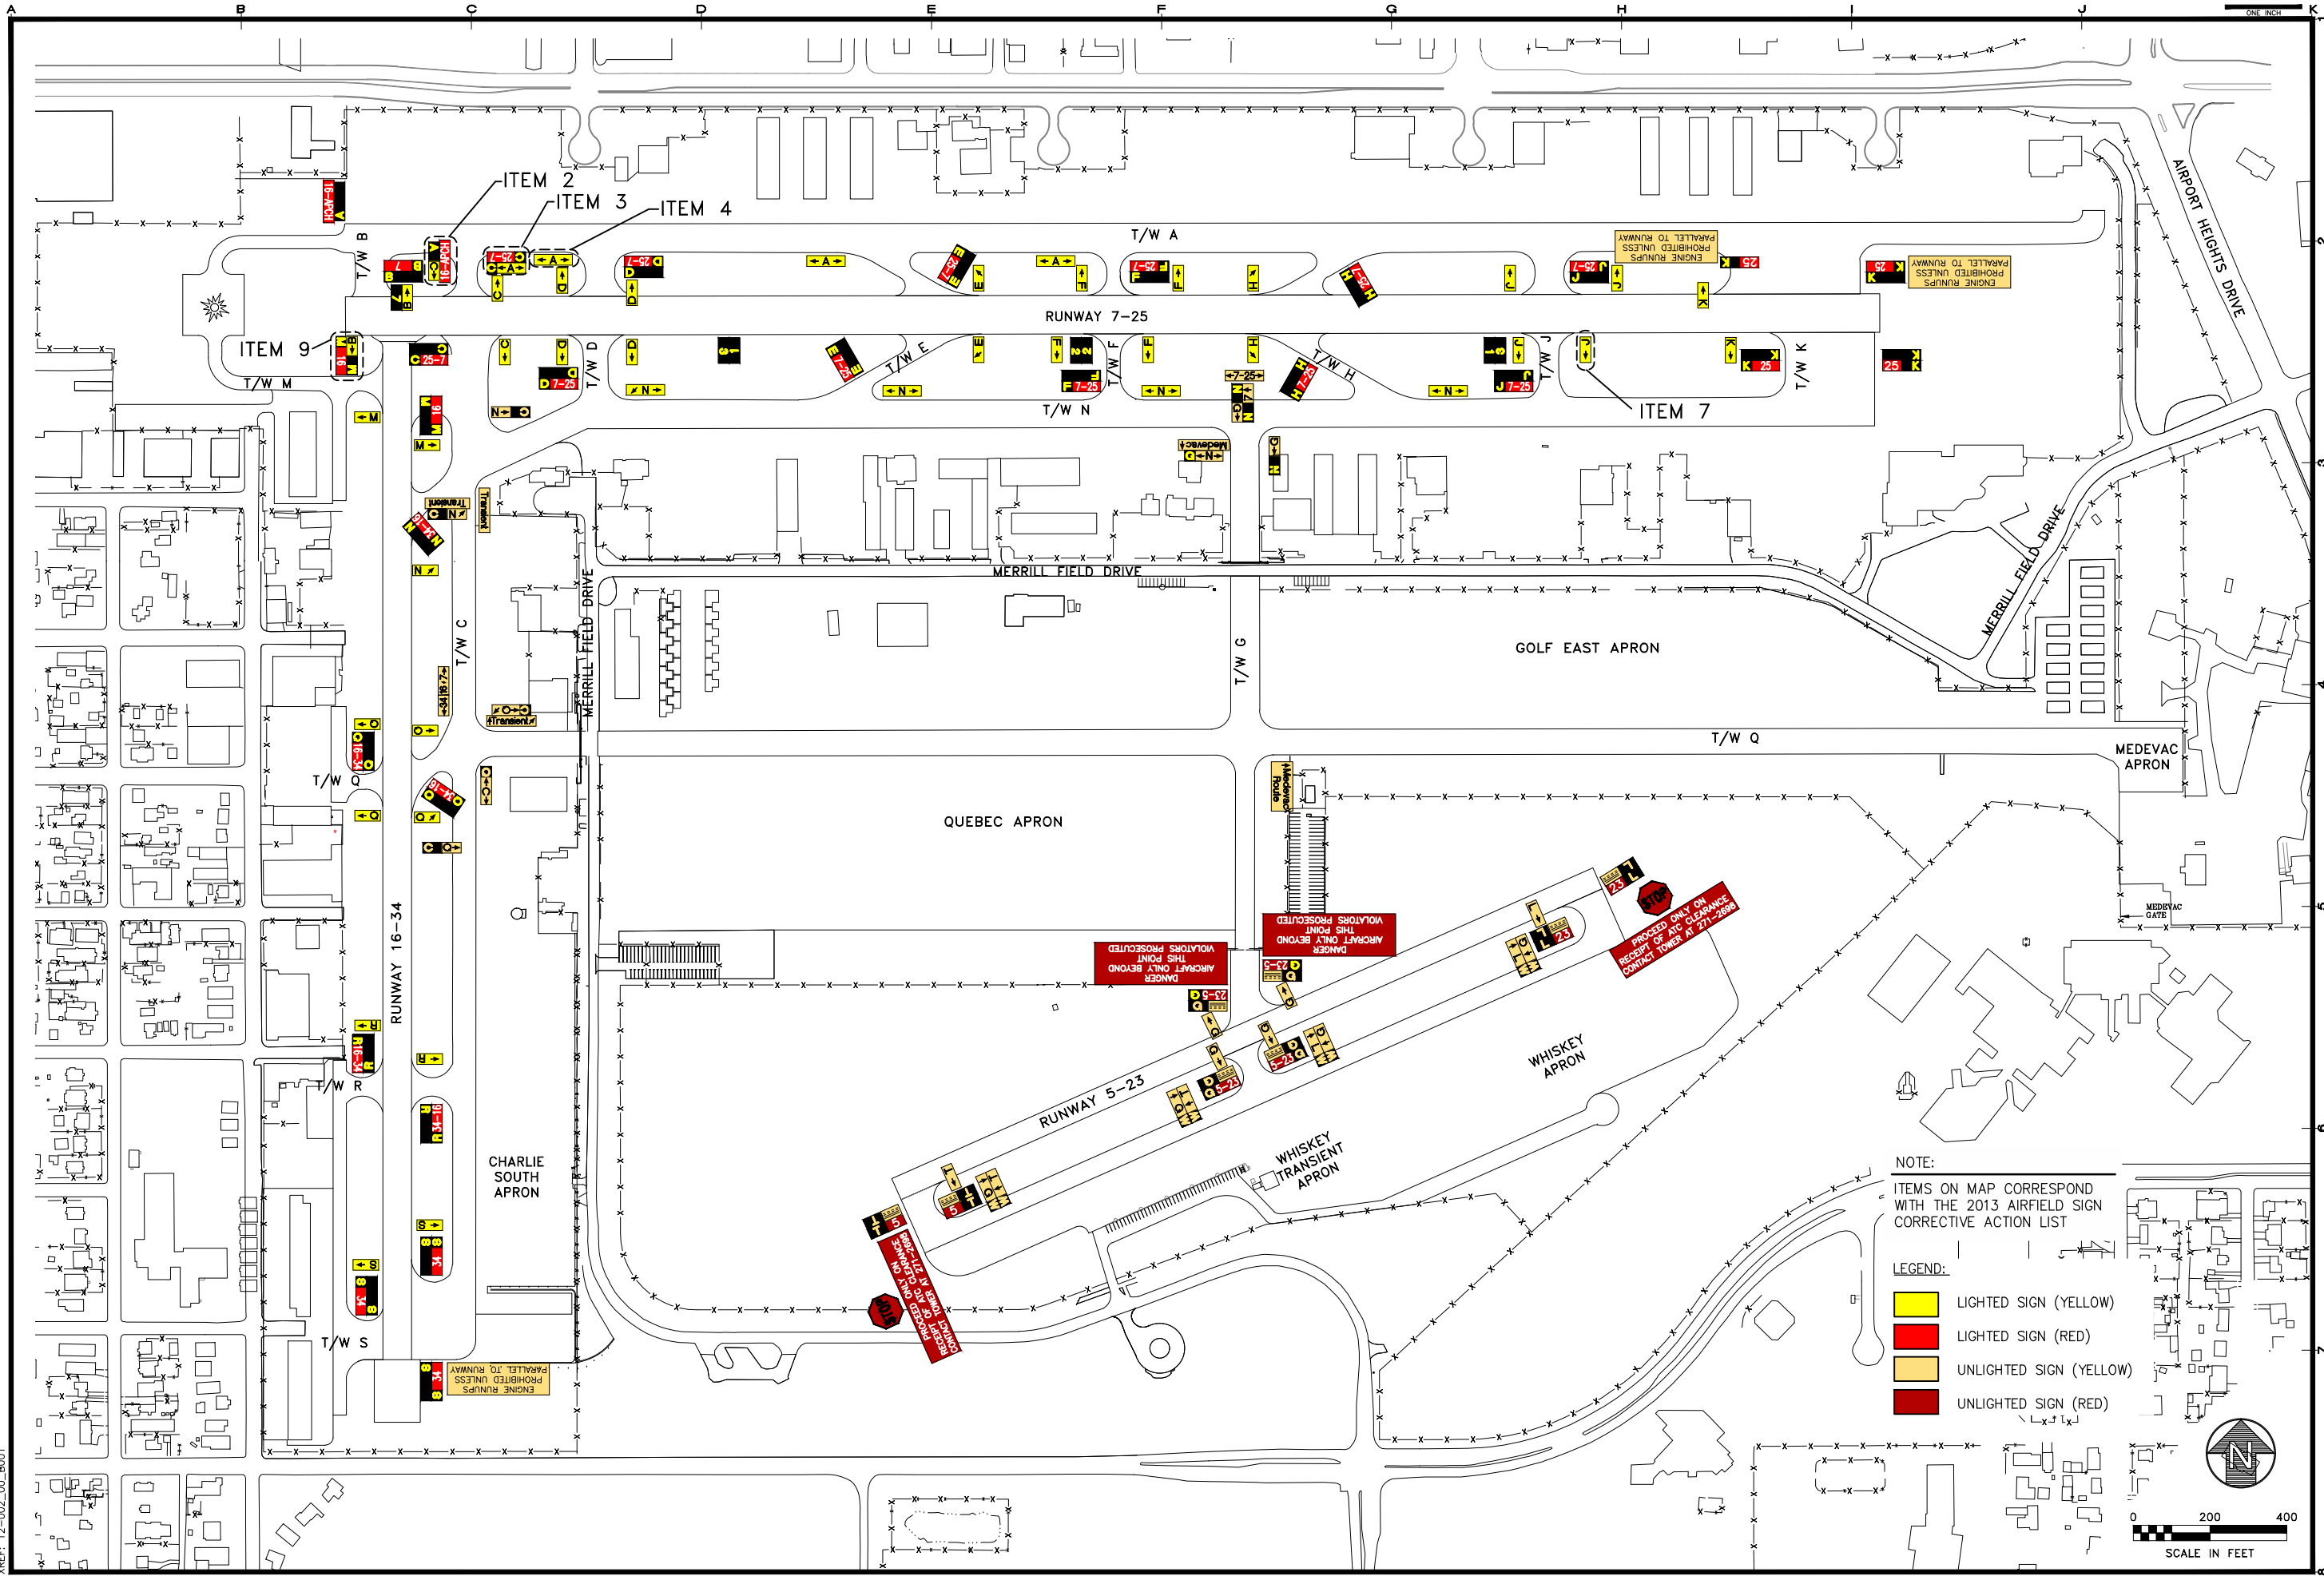
H:\Jobs\12-002 Merrill Master Plan\2013 Airfield Inspection\CAD Drawings\12-002-FIG-1.3-Airfield Sign Map. 1=1, 08/06/13 at 09:18 by jkk  
LAYOUT: Layout  
VIEW: SIGN501\_L\_F\_00800, SIGN501\_L\_L5000, SIGN501\_L\_X7700  
XREF: 12-002\_00\_8001

The 2013 Airport Inspection identified 17 airfield sign items that did not meet standards and are candidates for corrective action. The FAA regulations allow the Airport Manager to deviate from the standard where the standard signage application is impractical or presents additional safety concerns or confusion. Locations and explanations for noted items where no corrective action was taken are included in Table 1.3a below.

7	<b>TW Direction:</b> North Intersection TW D and RW 7-25 (West)	L	Yes	Yes	<-D				Yes	Yes	Yes	Yes	
8	<b>TW Direction:</b> Intersection TW D and TW A	L	Yes	Yes	<-A ->				Yes	Yes	Yes	Yes	Face of Sign was damaged
9	<b>RW Direction:</b> North Intersection TW D and RW 7-25	L	Yes	Yes	D		D	25-7	Yes	Yes	Yes	Yes	
10	<b>TW Direction:</b> North Intersection TW D and RW 7-25 (East)	R	Yes	Yes	D->				Yes	Yes	Yes	Yes	
11	<b>TW Direction:</b> Intersection TW E and TW A	L	Yes	Yes	<-A ->				Yes	Yes	Yes	Yes	
12	<b>RW Direction:</b> North Intersection TW E and RW 7-25	L	Yes	Yes	E		E	25-7	Yes	Yes	Yes	Yes	
13	<b>TW Direction:</b> North Intersection TW E and RW 7-25 (East)	R	Yes	Yes	E /				Yes	Yes	Yes	Yes	
14	<b>TW Direction:</b> Intersection TW F and TW A	L	Yes	Yes	<-A ->				Yes	Yes	Yes	Yes	
15	<b>TW Direction:</b> North Intersection TW F and RW 7-25 (East)	R	Yes	Yes	F->				Yes	Yes	Yes	Yes	
16	<b>RW Direction:</b> North Intersection TW F and RW 7-25	L	Yes	Yes	F		F	25-7	Yes	Yes	Yes	Yes

The Updated Airfield Signs Corrective Action List, Existing Airport Sign Layout Diagram, and Airfield Sign Inspection Checklist are included with this report. The Updated Corrective Action List identifies 17 items that did not meet the standard and are candidates for corrective action. No action was recommended on Items 1, 5, 6, 10, 11, 12, 13, 14, 15, 16, and 17 because the existing sign configuration provides clear information to the pilot, and reconfiguration to the standard would likely make information more confusing. The remaining 4 work items identified on the checklist were consolidated into 3 corrective action categories. These corrective action categories include fixing broken or missing signs, constructing new signs, and relocating existing signs to standardize sign layout in the vicinity of the intersecting runways and taxiways.

Repair Existing Sign Panels (1) @ \$1,500 .....	\$1,500
Construct New Signs (1) @ \$8,000 .....	\$8,000
Relocate Existing Lighted Signs (2) @ \$4,000 .....	\$8,000
	=====
Total .....	\$ 17,500

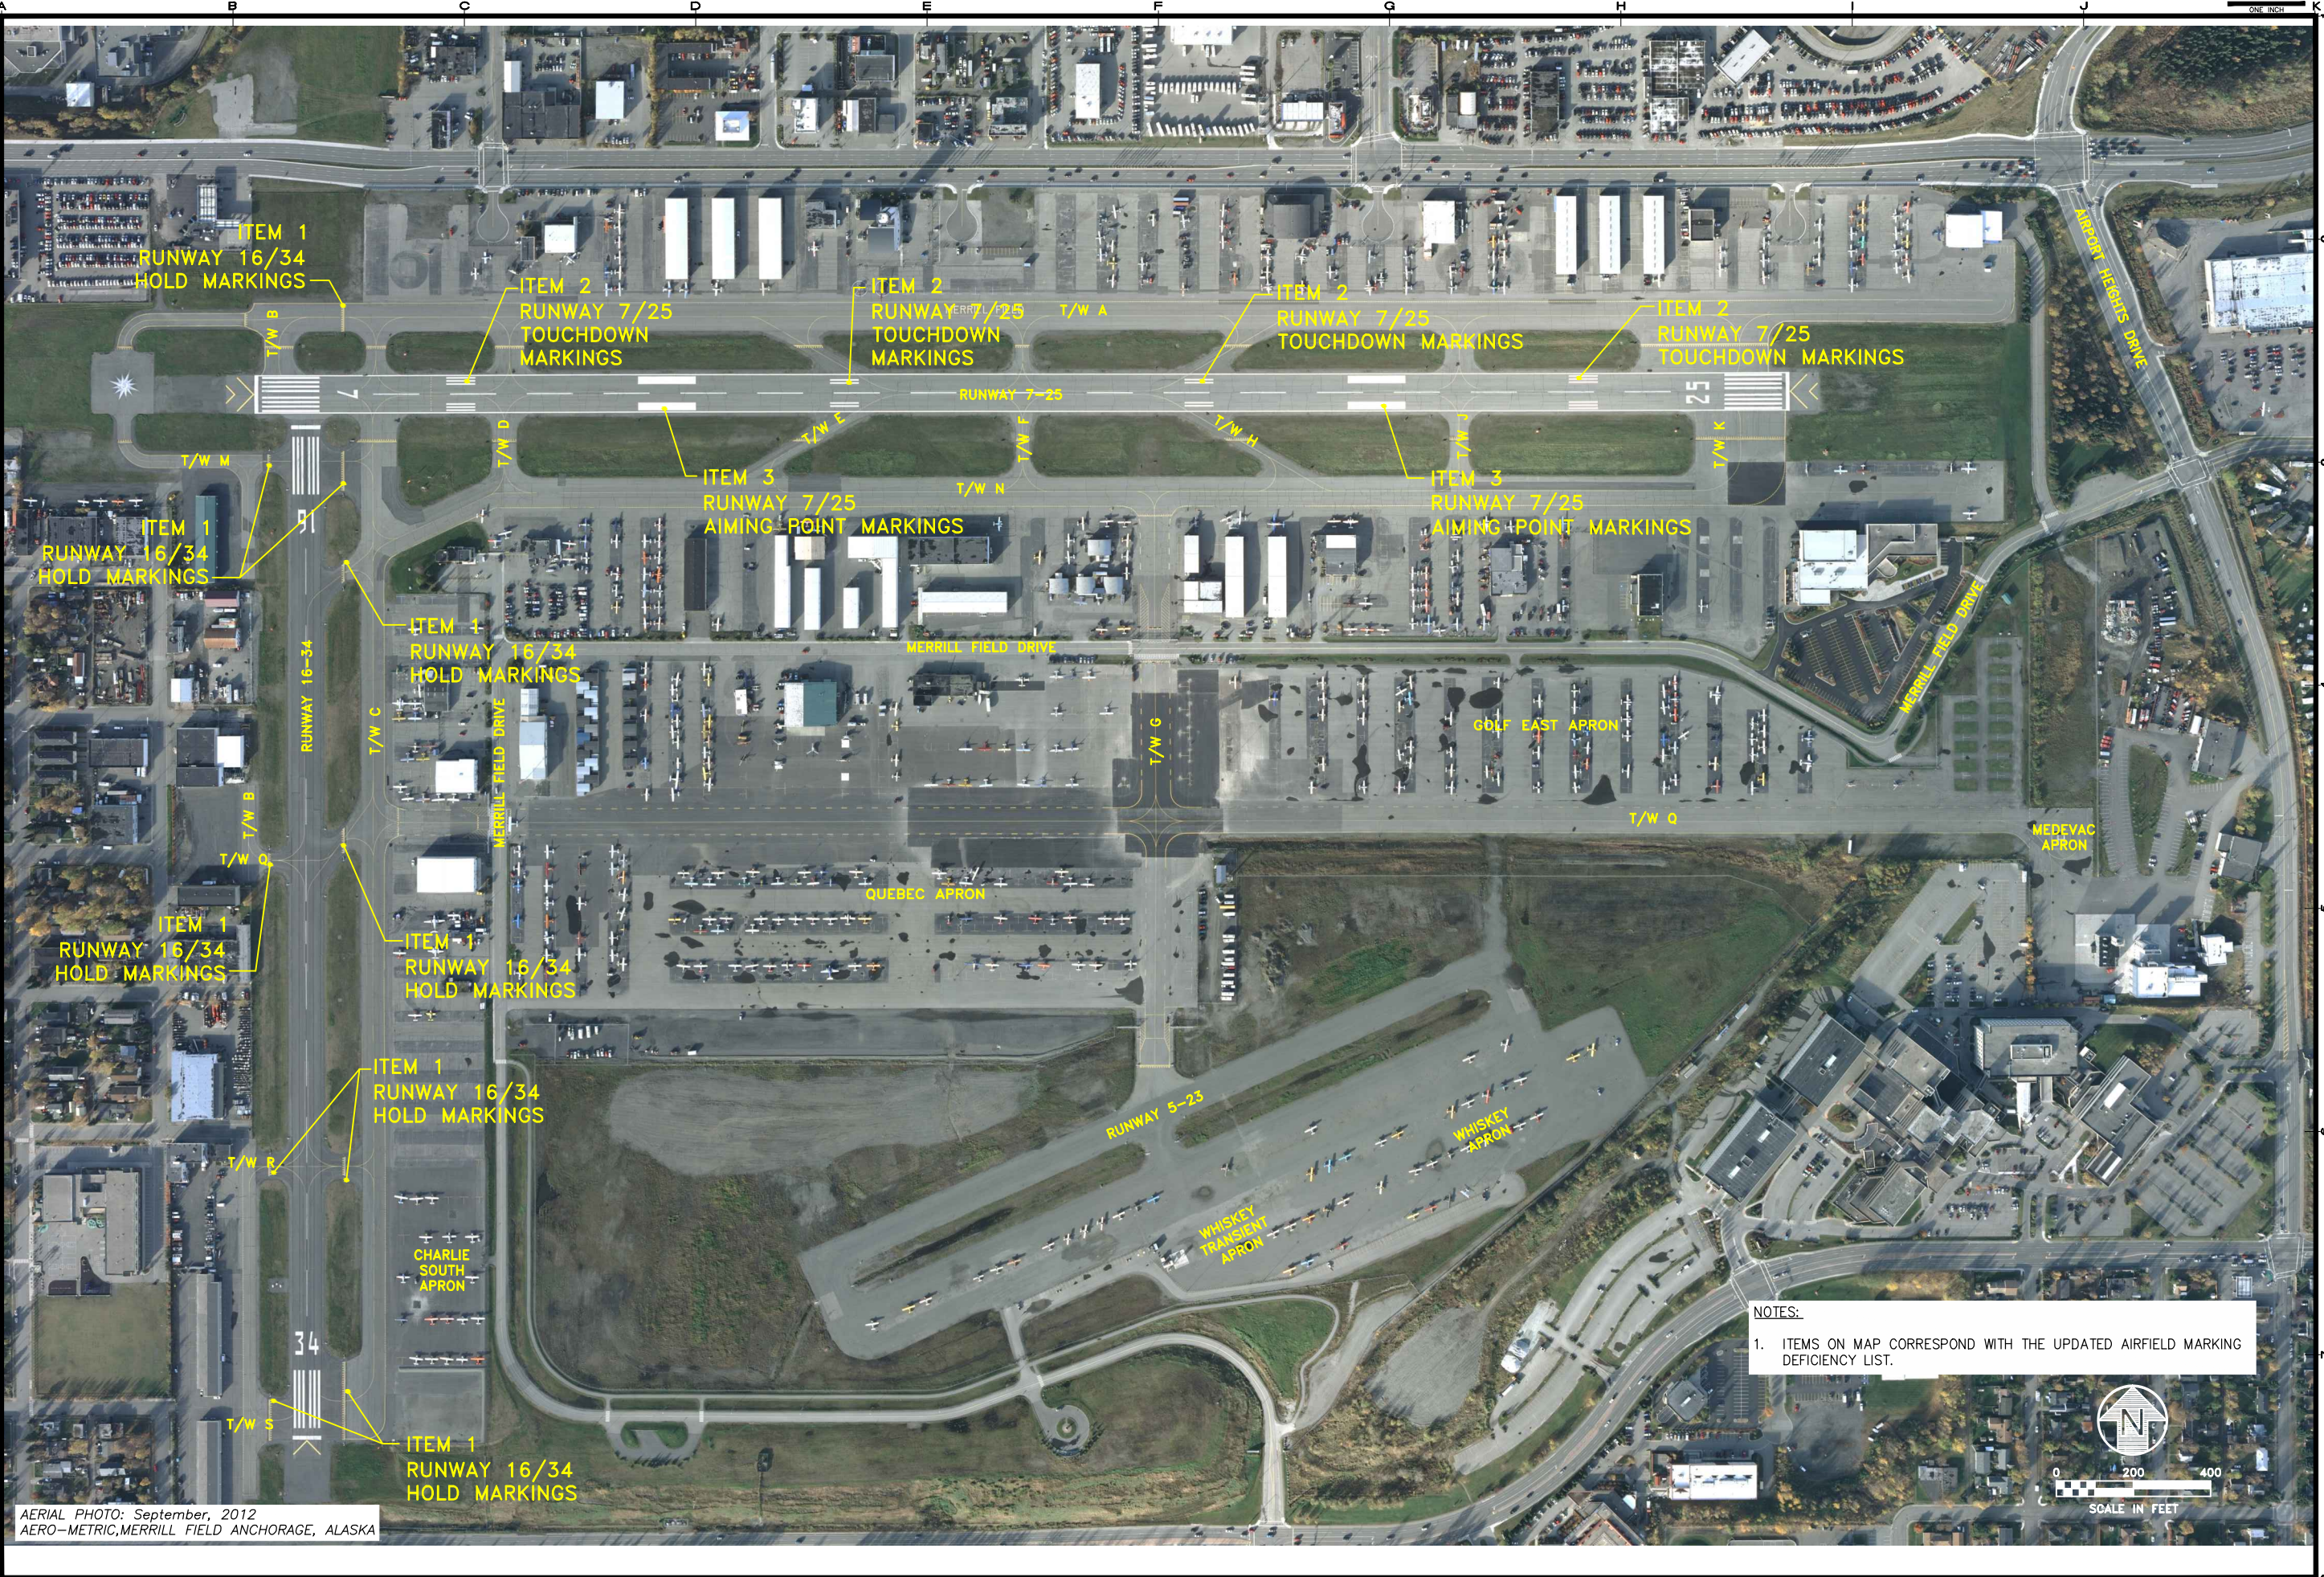
H:\Jobs\12-002 Merrill Master Plan\2013 Airfield Inspection\CAD Drawings\12-002-FIG-1.4-Airfield Pavement Marking, 1=100, 08/05/13 at 11:22 by unknown  
LAYOUT: Layout1  
XREF: 12-002\_00\_B001

Runway 7/25 is a visual runway marked with precision runway markings. Precision markings include threshold bars, threshold markings, runway designation markings, centerline and edge striping, aiming points, and touchdown markings. The precision marking of this runway exceeds the FAA standards for Merrill Field's circling GPS approach. The runway also contains lead-in chevrons on unusable pavement beyond the runway thresholds. The runway markings consist of white paint. The chevron markings consist of yellow paint. The attached Updated Airfield Marking Deficiency List identifies that touchdown zone markings and aiming point markings on Runway 7/25 are located approximately 20 feet down runway from the preferred location listed in AC 150/5340-1K. In 2010, the Runway 7/25 markings were re-applied in their current location to correct old and faded markings. Through discussions with the Owner, the decision was made to not relocate the aiming points and touchdown zone markings during the 2010 project because removal of the existing markings would damage the runway surface. Also, the VASIs, which are co-located with the aiming point markings, can be negatively impacted when the markings are shifted. It is recommended the 7/25 marking configuration be reevaluated during the next 7/25 runway surface rehabilitation project and relocation of the existing runway markings be performed at that time.

Updated Airfield Marking Deficiency List					
✓	Item	Location	Deficiency Noted	Code Reference	Recommended Corrective Action
	1	Interlink Taxiways to Runway 16/34	<u>Runway Hold Position Markings:</u> Hold position markings for Runway 16/34 are offset approximately 125 feet from Runway centerline. Standard Hold Position markings for a B-II runway are offset 150 from centerline.	AC 150/5300-13 Table A7-3 and AC 150/5340-18F Table 1	None: Hold position location necessary due to non-standard Taxiway seperation distance
	2	Runway 7/25	<u>Touchdown Zone Markings:</u> Markings are required to be installed 500 feet from beginning of Threshold Markings (which start 20 feet beyond Threshold Bar). Touchdown Zone Markings on Runway 7-25 are spaced 480 feet from the beginning of threshold markings (500 feet from the Threshold Bar).	AC 150/5340-1K	Remove and Relocate (4) Touchdown Zone Markings to meet standards

Removal and reinstallation of the Touchdown Zone and Aiming Point Markings is recommended when funding becomes available or during the next Runway 7/25 pavement rehabilitation project. The attached Updated Airfield Marking Deficiency List and Sheet 1.4 identify the corrective action items and locations.
