# MERRILL FIELD AIRPORT MASTER PLAN UPDATE AND NOISE STUDY APPENDIX

Merrill Field Airport  
Municipality of Anchorage  
**Final December 2016**

HDR, Inc.  
with  
Harris Miller Miller & Hanson Inc. (HMMH),  
Hattenburg Dilley & Linnell LLC (HDL), and  
McClintock Land Associates (MLA), Inc.

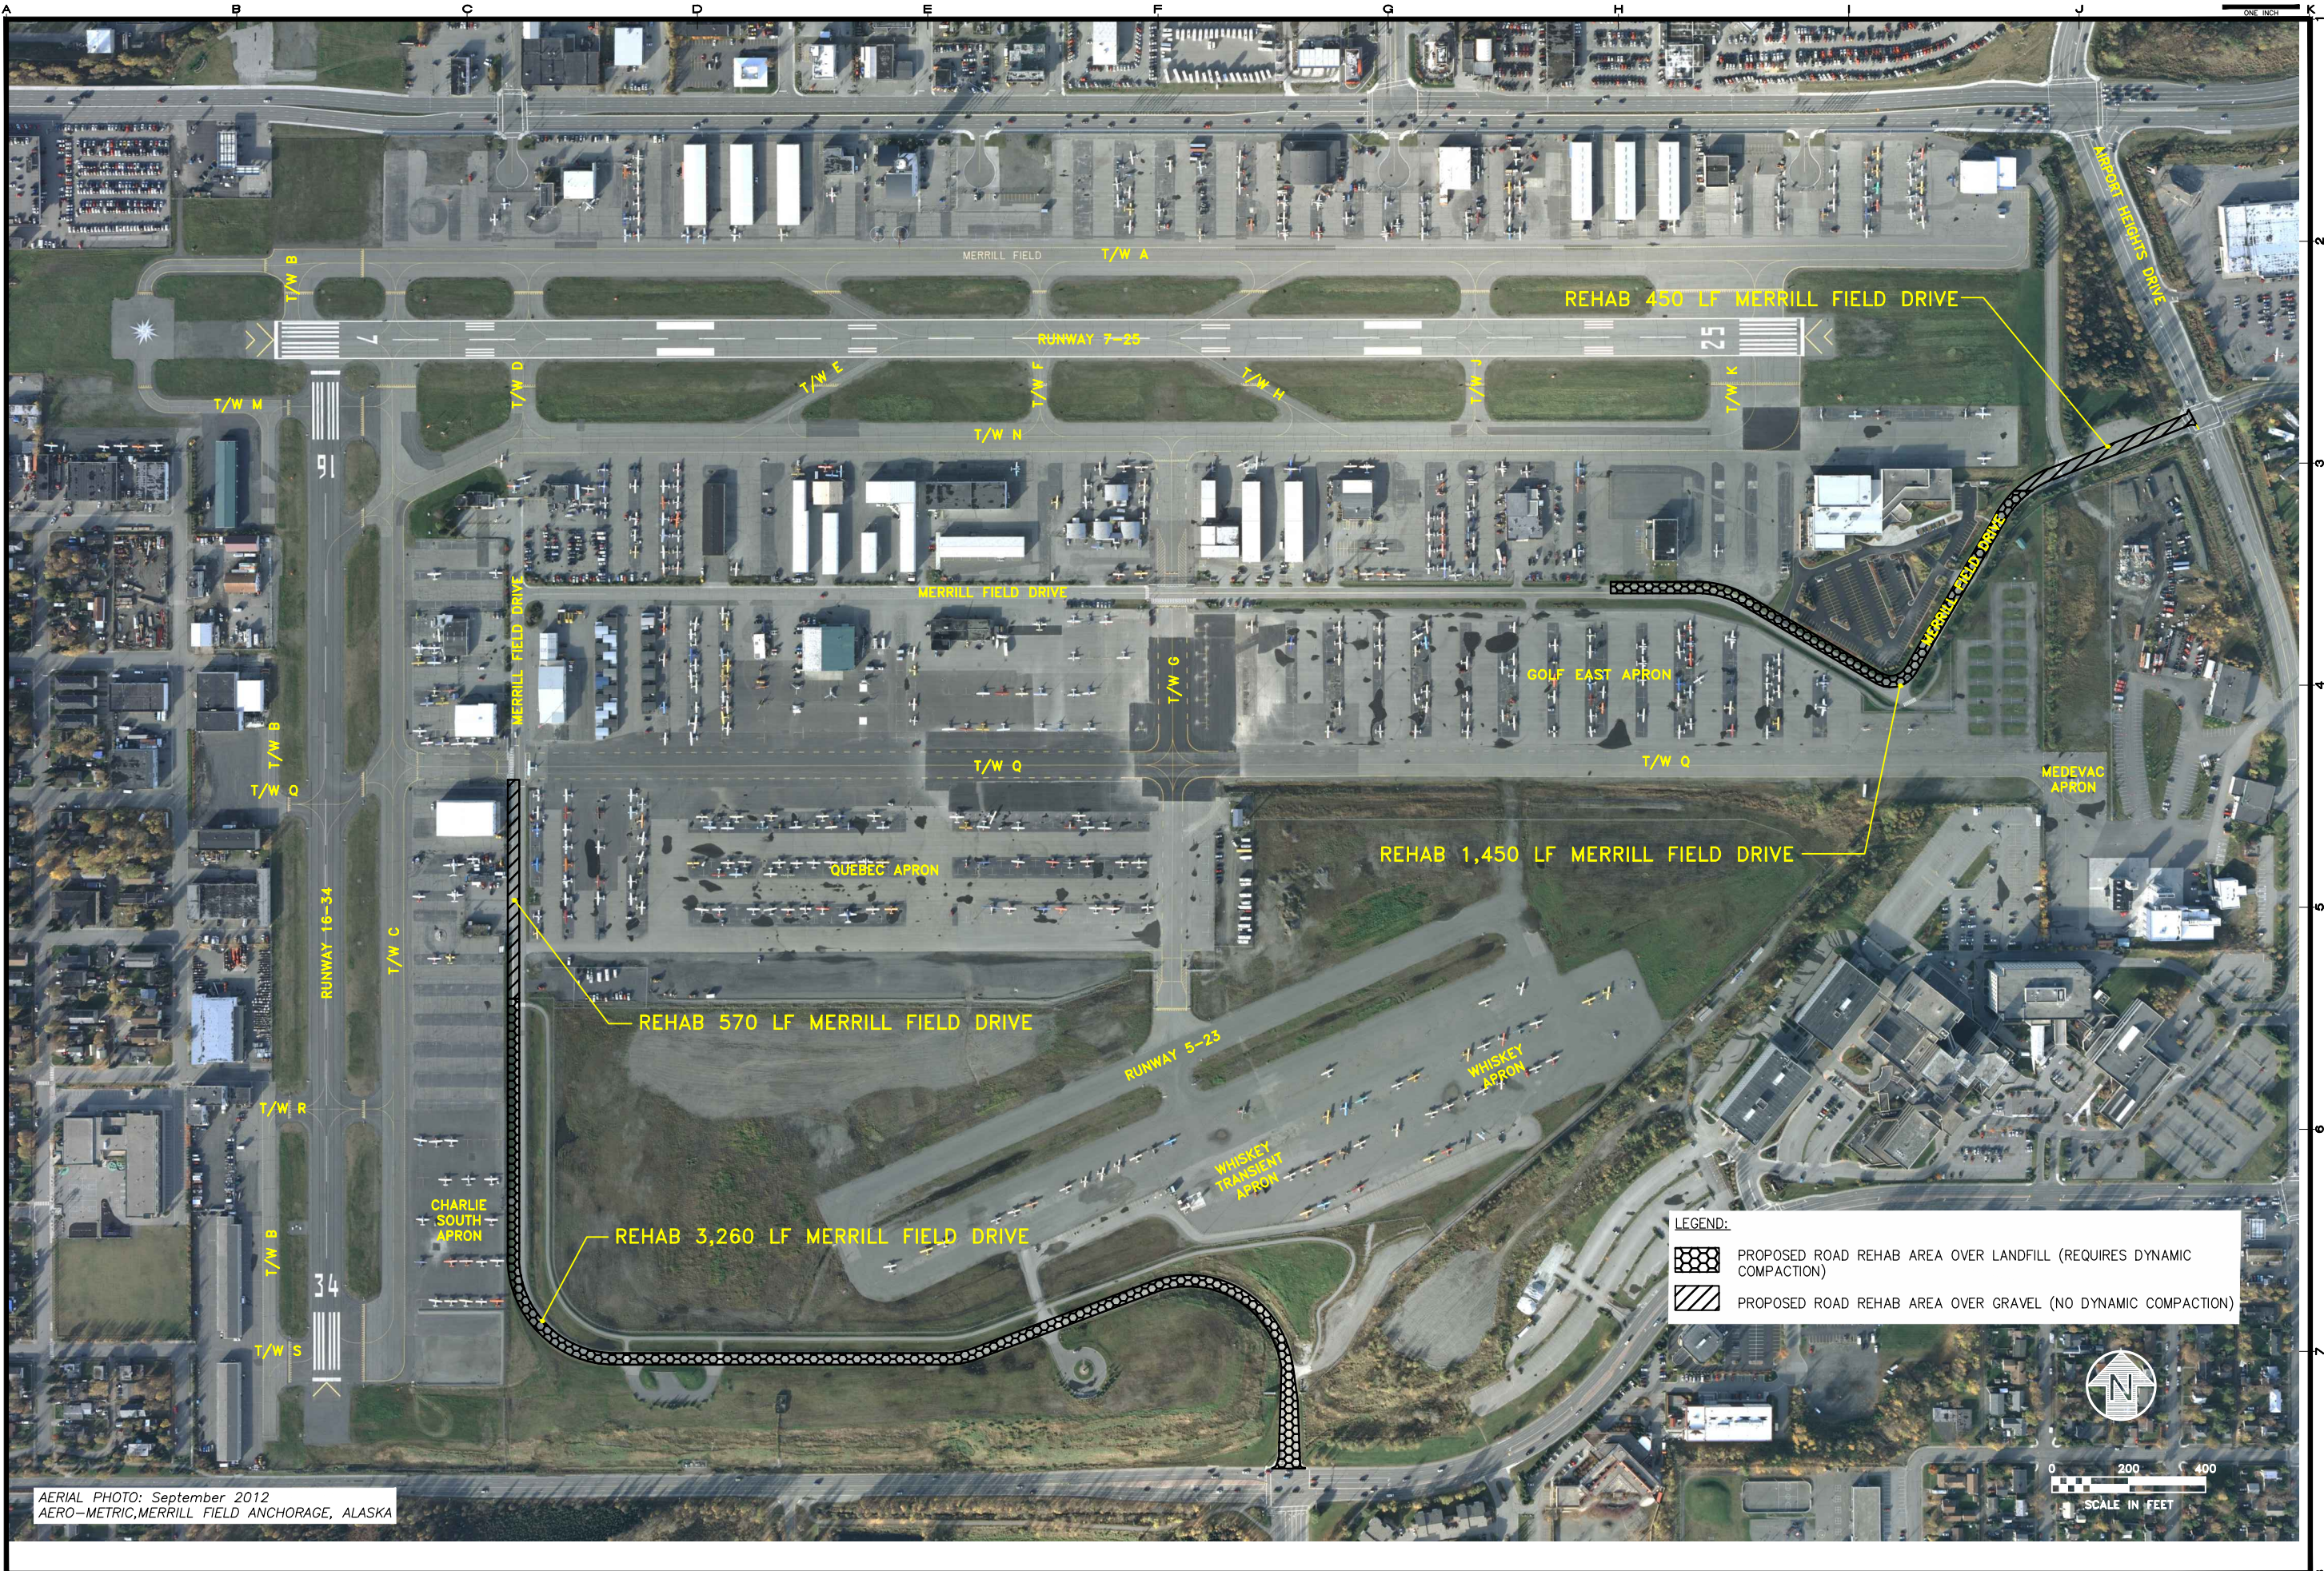
H:\Jobs\12-002 Merrill Master Plan\2013 Airfield Inspection\CAD\Drawings\12-002-FIG-2.1-Access Road Pav Rehab, 1=100, 08/05/13 at 10:52 by unknown  
LAYOUT: Layout1  
XREF: 12-002\_00\_8001

The 2007 pavement inspection revealed that the 1,080 linear feet of Merrill Field Drive to the east of Taxiway G performed well over the course of the past 8 years. This area was reconstructed using dynamic compaction to consolidate underlying refuse. Very little settlement, cracking, and rutting was noticed in this pavement section. However, settlement and pavement cracking was witnessed in the area near the south airport entrance that was also rehabilitated in 2000. Dynamic compaction was not used in the reconstruction of this area. The performance of the pavement in this area indicates continued settlement of the underlying soils from degradation, decomposition, and settlement of landfill refuse. Other pavement areas not located over landfill refuse showed signs of wear after years of routine airport traffic, heavy studded tire wear, and heavy construction vehicle traffic for airport improvement projects.

A 74 foot by 25 foot section of Merrill Field Drive near the end of Runway 34 was rehabilitated in 2009. Subgrade settlement of the road section caused a below-grade, abandoned, manhole to differentially settle yielding an uneven driving surface. The pavement was removed, the abandoned structure was completely demolished, backfill was compacted, and new pavement was installed. Continued settlement in this area has resulted in slight grade changes since the 2009 work.

Two airport access road rehabilitation projects are recommended based on the 2007 pavement inspection. The first project is to rehabilitate 3,830 LF of Merrill Field Drive from Taxiway Quebec to the intersection at 15<sup>th</sup> Avenue. Approximately 3,260 LF of this road section is located above the old landfill. Dynamic compaction of the landfill waste is recommended in this area to prolong the life of the pavement based on the results of the 2000 Merrill Field Drive rehabilitation projects. Construction of this project would include removing the existing road structural section to a depth of 3 feet, performing high energy dynamic compaction of underlying landfill refuse, placing granular fill to re-establish crown and grade, and installing new AC pavement. This project should be performed within the next three years to repair damaged pavement areas that continue to degrade. The second project is to rehabilitate approximately 1,900 LF of Merrill Field Drive from the intersection at Airport Heights Drive to the limits of the 2000 Airport Access Road Rehabilitation Project. Approximately 450 LF of access road to west of Airport Heights entrance is founded on good gravel and dynamic compaction is not recommended. The remaining 1,450 LF of Merrill Field Drive is constructed above the old landfill and dynamic compaction is recommended to consolidate the underlying refuse. Sheet 2.1 attached at the end of this section identifies the project locations. Construction methods for the dynamic rehabilitation of the dynamic compaction areas and rehabilitation of the gravel areas will be the same as described above. It is recommended that the remaining portions of Merrill Field Drive be rehabilitated within 10 years.

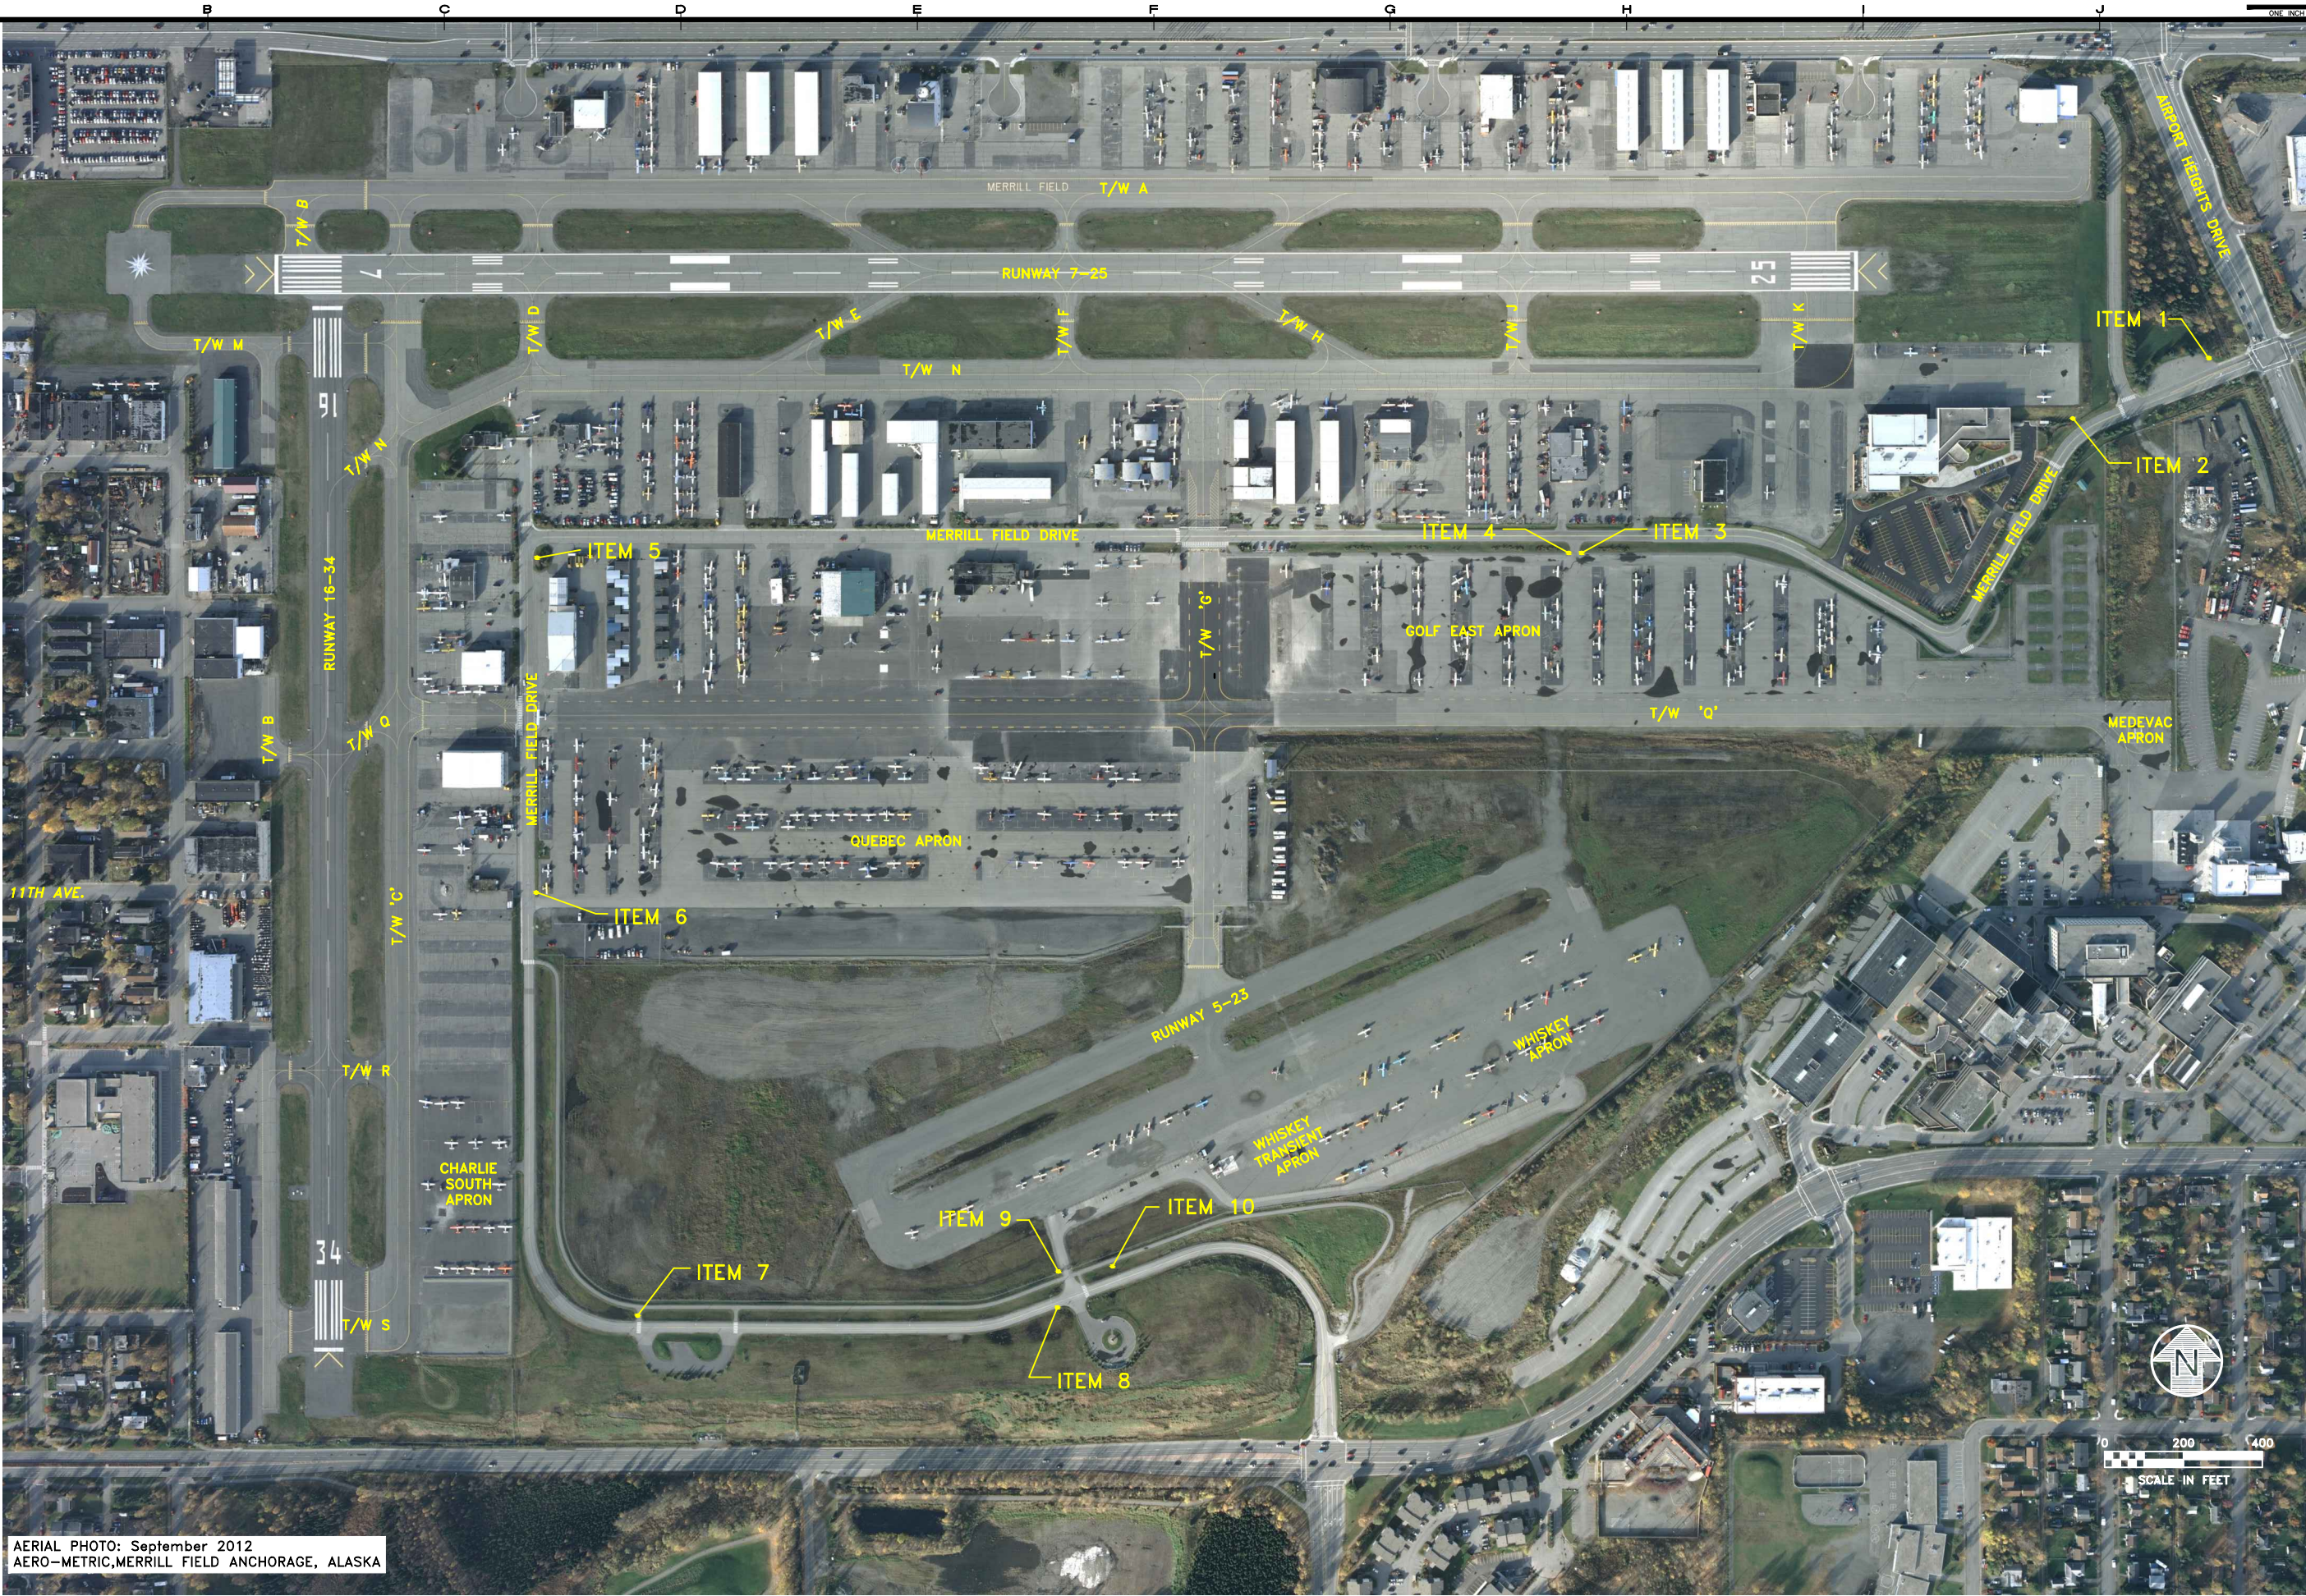
H:\Jobs\12-002 Merrill Master Plan\2013 Airfield Inspection\CAD\Drawings\12-002-FIG-2.2-Annual Inspection Sign Deficiency Location Map, 1-50, 08/05/13 at 13:23 by unknown  
LAYOUT: Layout1  
XREF: 12-002\_00\_B001

2013 Updated Access Roads Signs and Markings Deficiency List							
Item	Sign or Making Type	Location	Description of Deficiency	Pictures	Referenced Standard	Recommended Corrective Action	Number of Signs
1	Crosswalk	See attached Sign Deficiency Location Map.	Excessive use of signs.

The Updated Inspection Checklist was reduced to 10 items that did not meet the standard and are candidates for corrective action. The corrective action items include: 1) upgrading all signs to meet new reflective standards; 2) removing unwarranted signs; 3) adding markings and signs as required to meet standards; 4) placing informational signs at apron entrances; 5) general maintenance; and 6) standardizing sign layout. See the attached Updated Access Road Signs and Markings Deficiency List and the corresponding Sheet 2.2 location map.

Upgrade Signs to New Reflective Standards.....	\$12,000
Place Stop Bars and Crosswalk Ladder @ \$625 each .....	\$3,000
Install Informational Signs @ \$70 per sq. ft.....	\$3,500
Aircraft Turn Around Warning Sign @ \$70 per sq. ft.....	\$2,800
Replace Taxiway Stop Signs @ \$70 per sq. ft. ....	\$4,500
Remove Unwarranted Signs @ \$225 each .....	\$1,800
Update Reader Boards.....	\$3,000
=====	
Total.....	\$ 30,600
