Phase 2 Environmental Assessment of the Government Hill Wireless Station

December 11, 1997

**PHASE 2 ENVIRONMENTAL SITE ASSESSMENT
GOVERNMENT HILL WIRELESS STATION
132/140 EAST MANOR AVENUE
ANCHORAGE, ALASKA**

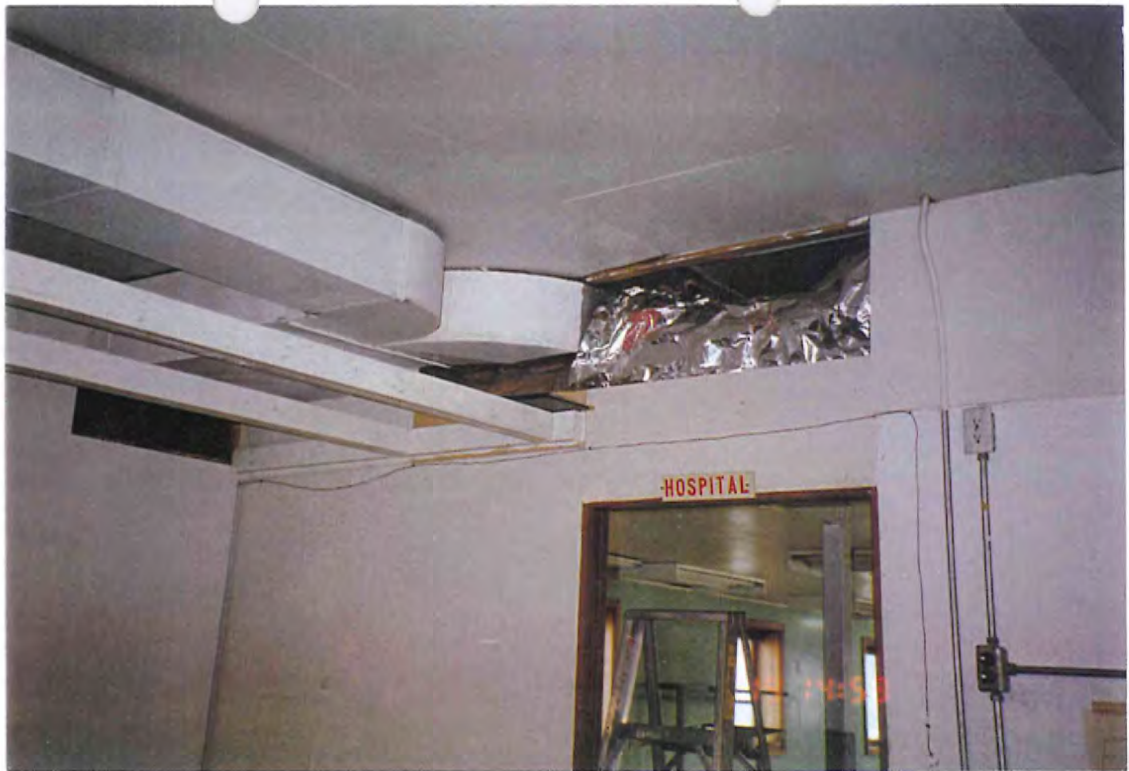
Plate 1 Looking south in north room of Building 1. Gypsum wall board walls and ceiling without joint compound. Note ducts exposed with lead seal at seams, and concealed ducts in south room. South room has gypsum wall board walls and ceiling with asbestos-containing joint compound, and fluorescent light fixtures with PCB Ballasts.

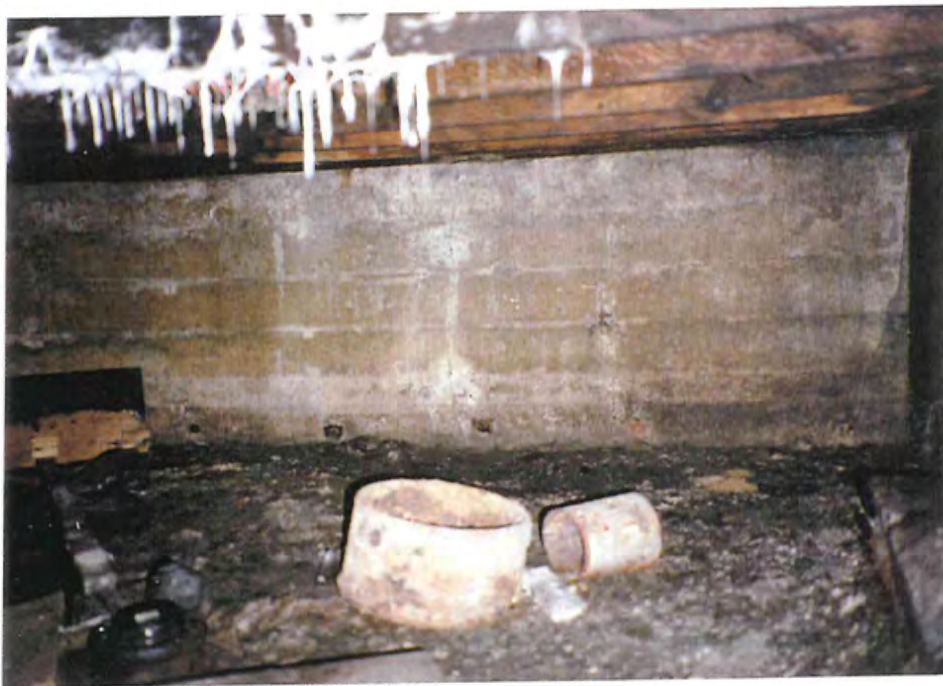
The crawl spaces of the buildings were typically shallow, unventilated and had dirt floors. Because the buildings have not been heated for the past decade or more, and because of additional stresses from storage of heavy drill cores of rock samples, portions of the floor structures are in advanced stages of decay caused by "dry-rot". The damage is limited, with areas in each building having failed. However, there is obvious evidence of further water damage presently occurring. There was water soaked subflooring in Building 2 with condensation and advanced visible fungal growth in the crawl spaces of all three buildings.

Plate 2 Note debris and fungal growth in crawl space of west wing of Building 1.

The lack of crawl space venting and water infiltration will require immediate attention to halt the on going deterioration. If deterioration is allowed to continue at it's present rate, more costly structural repairs may be required.

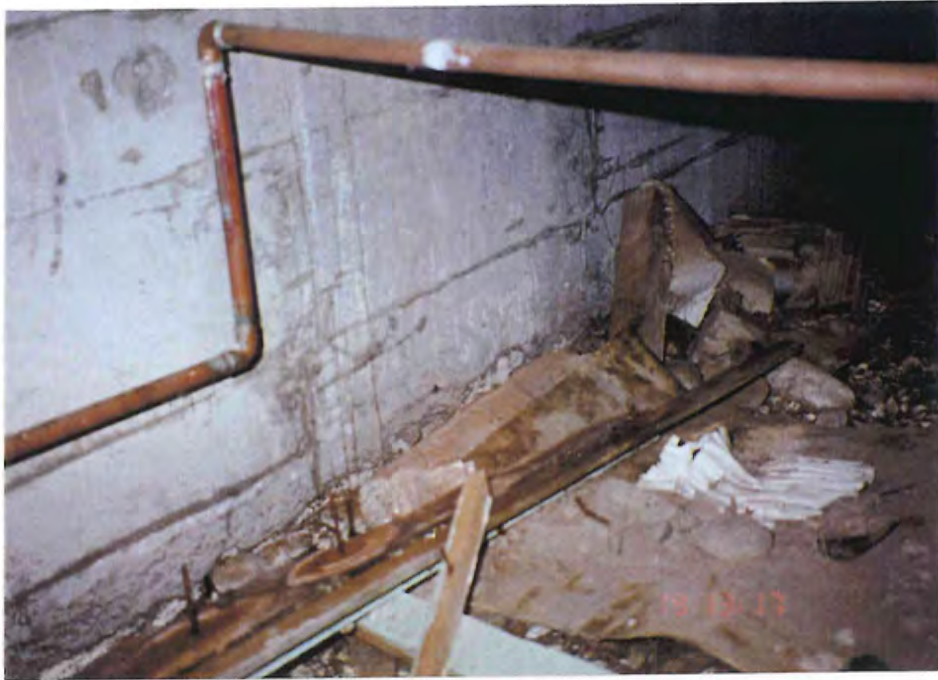
Building 1 had an electric water heater located in the kitchen with exposed bare piping to the sink. The original iron domestic water piping in the central crawl space had been removed and replaced with uninsulated copper piping. There was friable asbestos-containing pipe insulation debris in that crawl space that is assumed to be associated with the removed piping.

Plate 3 White asbestos-containing pipe insulation debris under central crawl space of west wing of Building 1. Note copper pipe replaced insulated steel pipe.

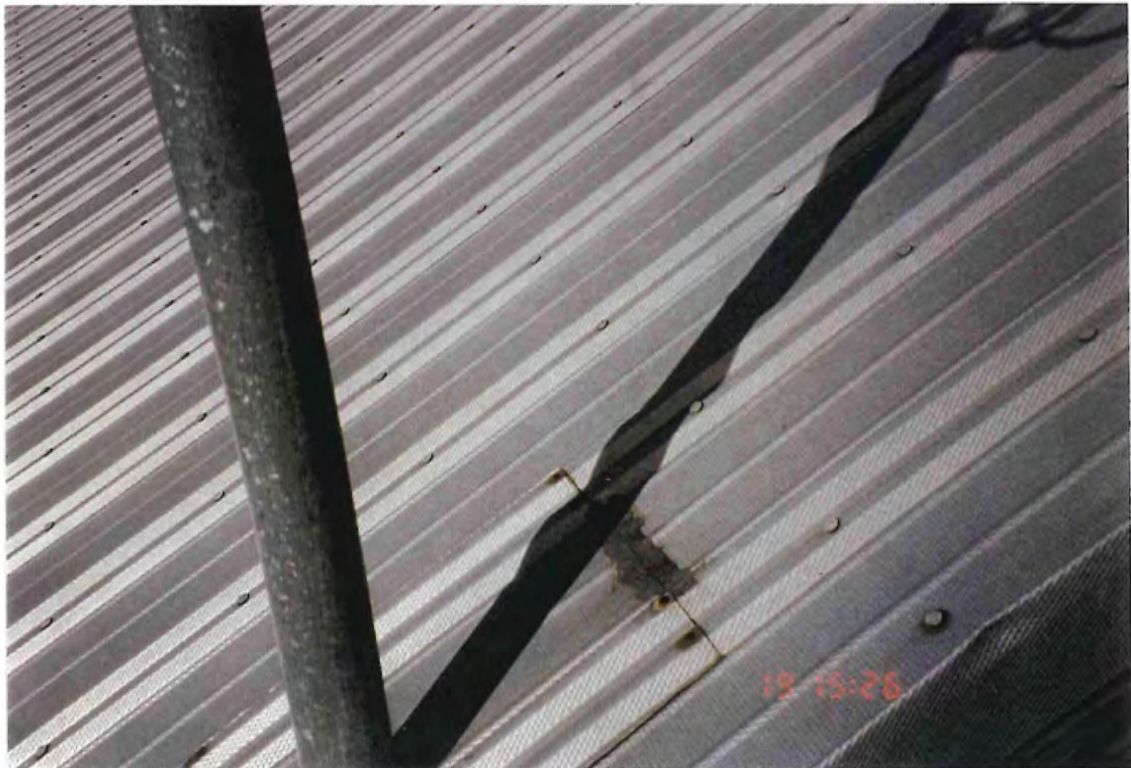
The buildings had similar aluminum roofing installed within the past decade to prevent further deterioration of the building structures. That aluminum roofing had asbestos-containing sealants applied at penetrations. In all three buildings, the metal roofing had been installed over the existing roofing. Representative samples of the roofing materials were taken, however, not all areas of the existing roofing were accessible for inspection.

Plate 4 Asbestos-containing gray fibrous patching on aluminum roofing of Building 1.

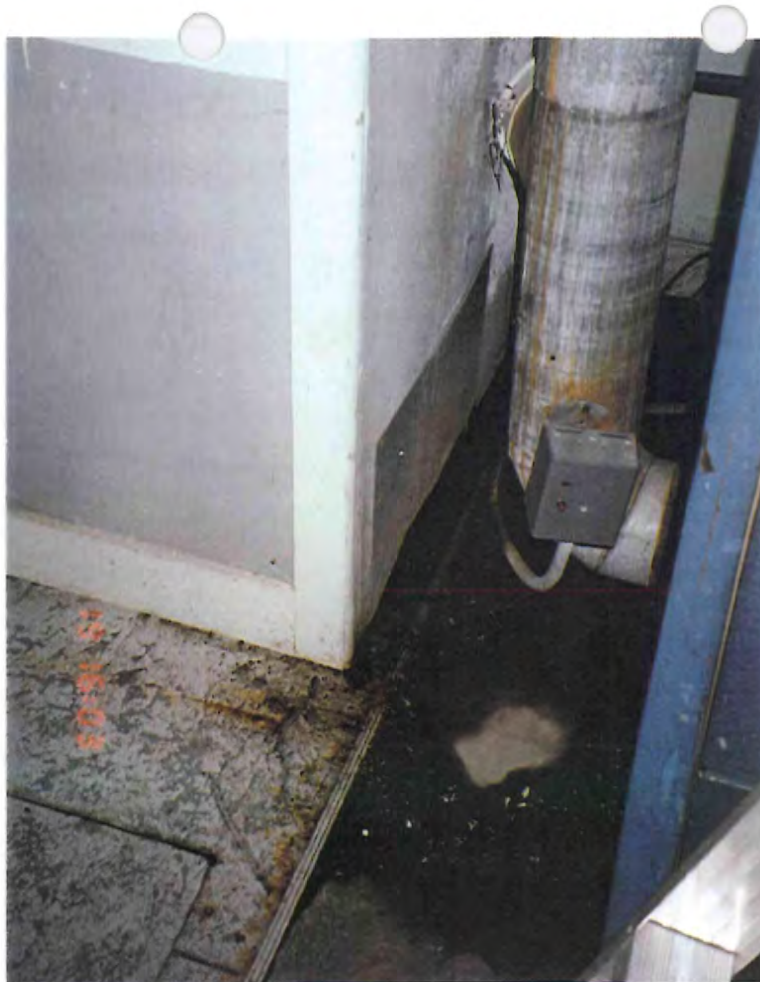
Paints in Building 2 were typically in good condition, with peeling paint noted at holes in the ceiling of the main room, and in the furnace room where it was damaged by water leaks at the furnace flue.

Plate 5 Cement asbestos board behind and below furnace in Building 2. Note rust stains on flooring and wet stains due to water leakage around furnace chimney.

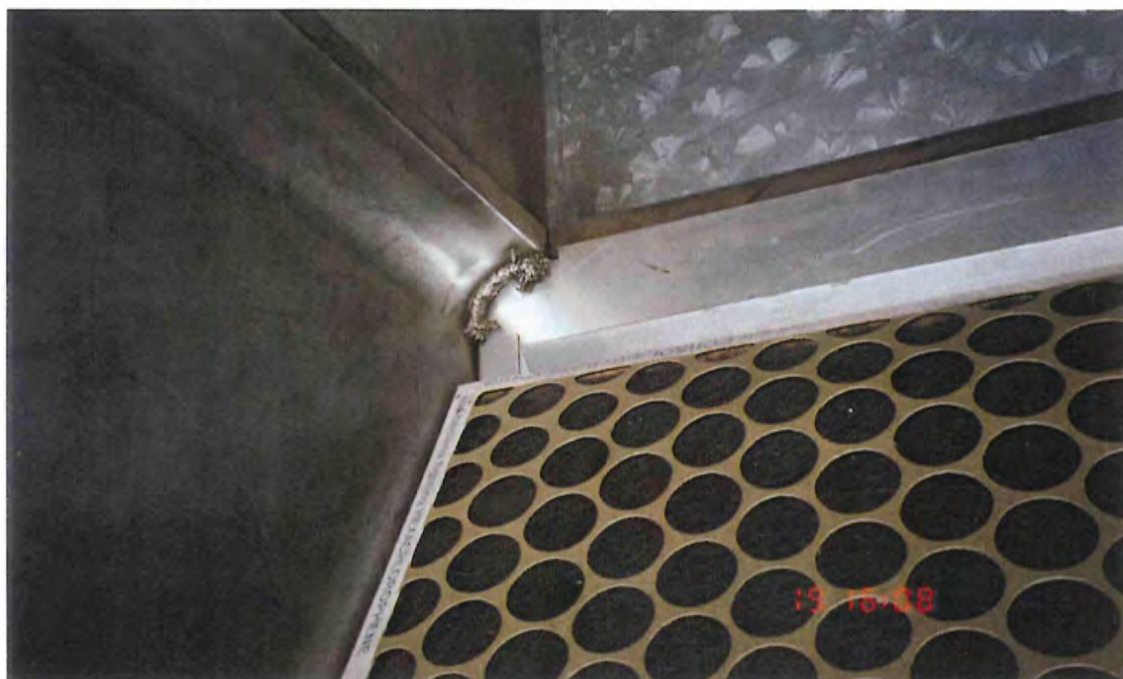
Plate 6 Asbestos-containing gasket in return air plenum of furnace in Building 2.

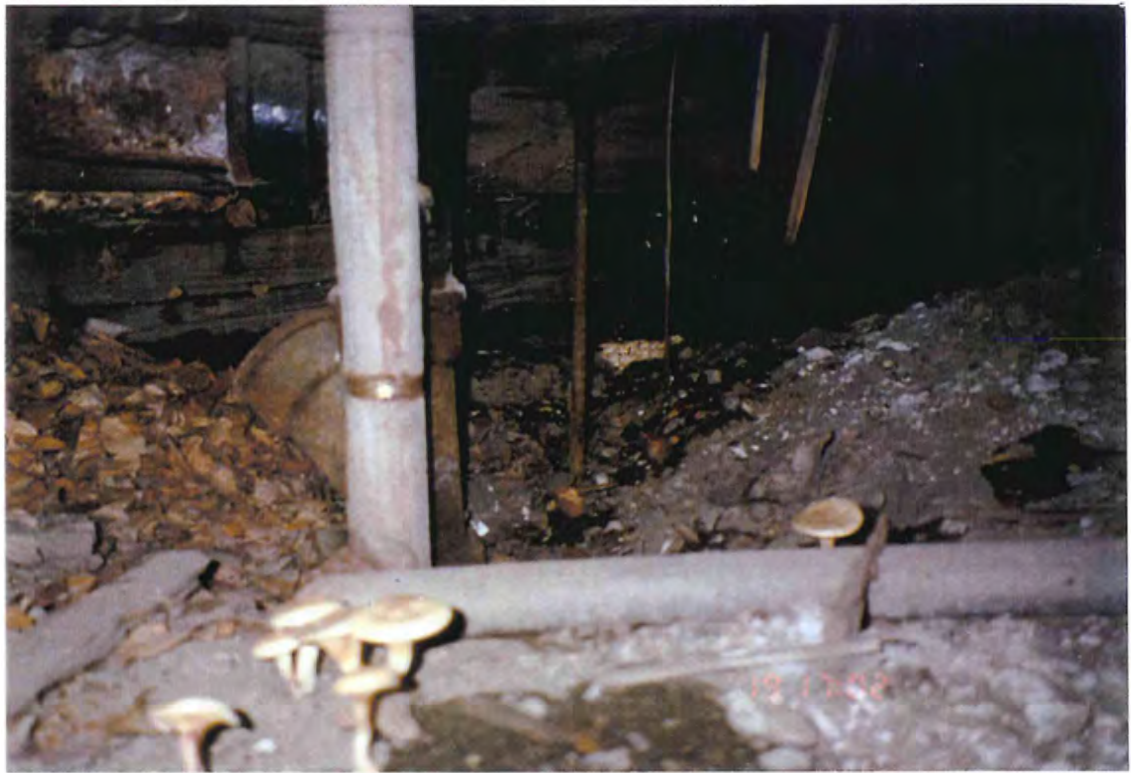
Building 2 was supported on wood timber pads with wood skirting that extended to the ground at the perimeter. The crawl space was partly ventilated by holes in the perimeter skirting, however the subflooring was saturated with water at the floor hatch in the furnace room. The center of the main room had been raised approximately 8 inches by differential movement. The remaining structure did not have any apparent structural damage, except where the roof thimble of the building furnace had been damaged by sliding snow.

Plate 7 White asbestos-containing pipe insulation in crawl space of Building 2. Note wet floor beams, leaves blown into crawl space through wood skirting, and fungal growth.

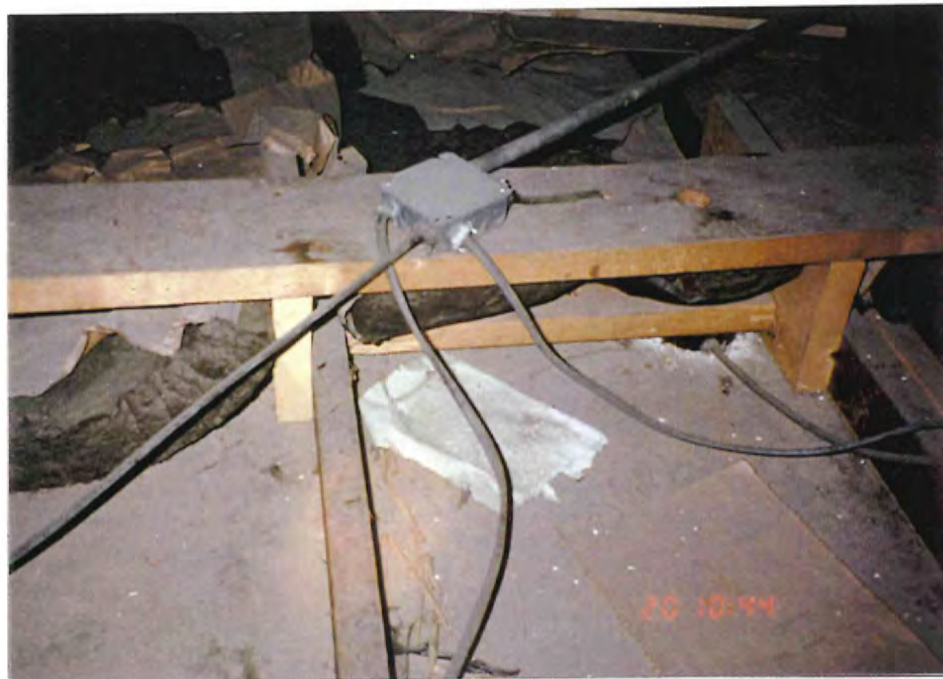
probably at the same time as the other buildings, approximately 1980. The attic was partly insulated with fiberglass and mineral wool insulation. Two sheets of friable asbestos-containing paper were noted in the attic space, and more may have been concealed under the insulation. The previous use of this paper was not apparent, but may have been used as a heat shield.

| <u>Material</u> | <u>Asbestos content</u> |
|---|---|
| 7. White thin paper, loose in attic, noted in 2 places, may be concealed elsewhere. | 95% Chrysotile |

Plate 8 Asbestos-containing white paper in attic of Building 2.

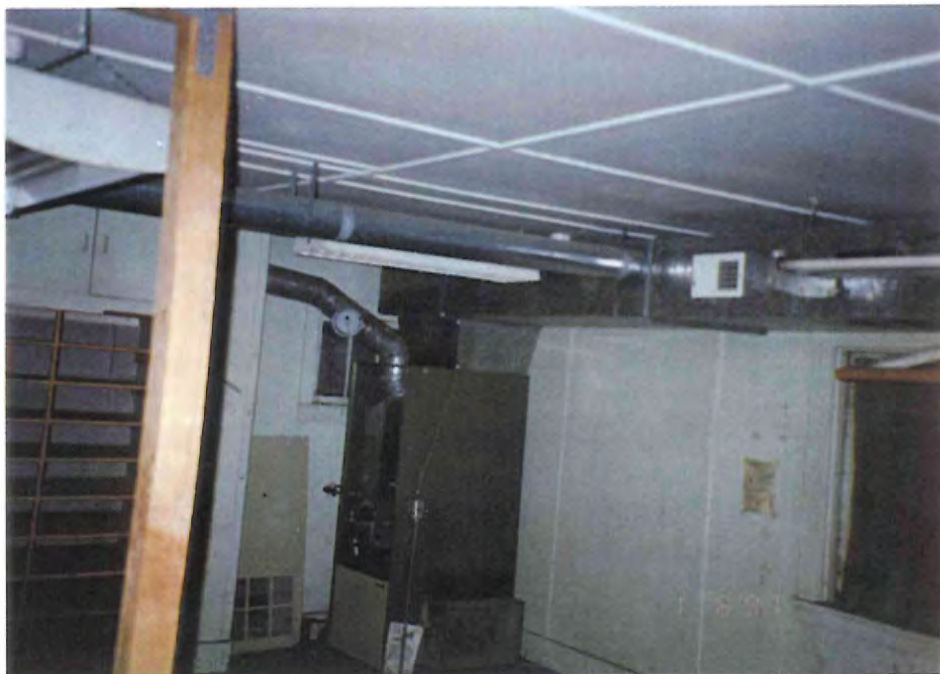
Plate 9 South room of Building 3. Note furnace with attached gas line and abandoned oil piping and filter. Note fluorescent lights with PCB-containing ballasts and shelved cabinet with cement asbestos board lining.

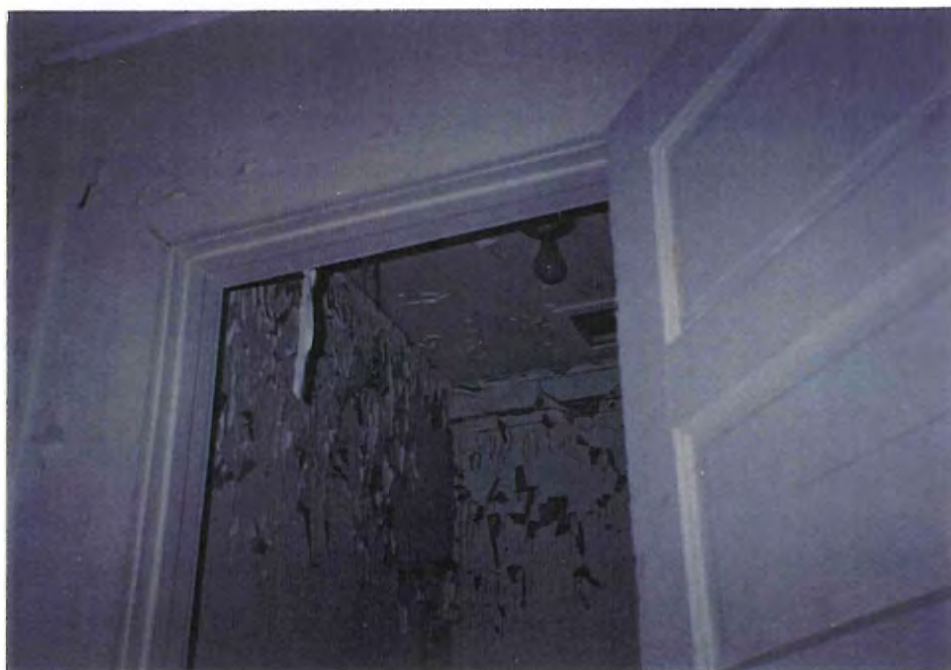
Paints in Building 3 were typically in poor condition, with peeling paint noted throughout the building, apparently due to high moisture content in the building. The basement area in particular had peeling paint on all of the concrete walls.

Plate 10 Peeling paint in bathroom of Building 3.

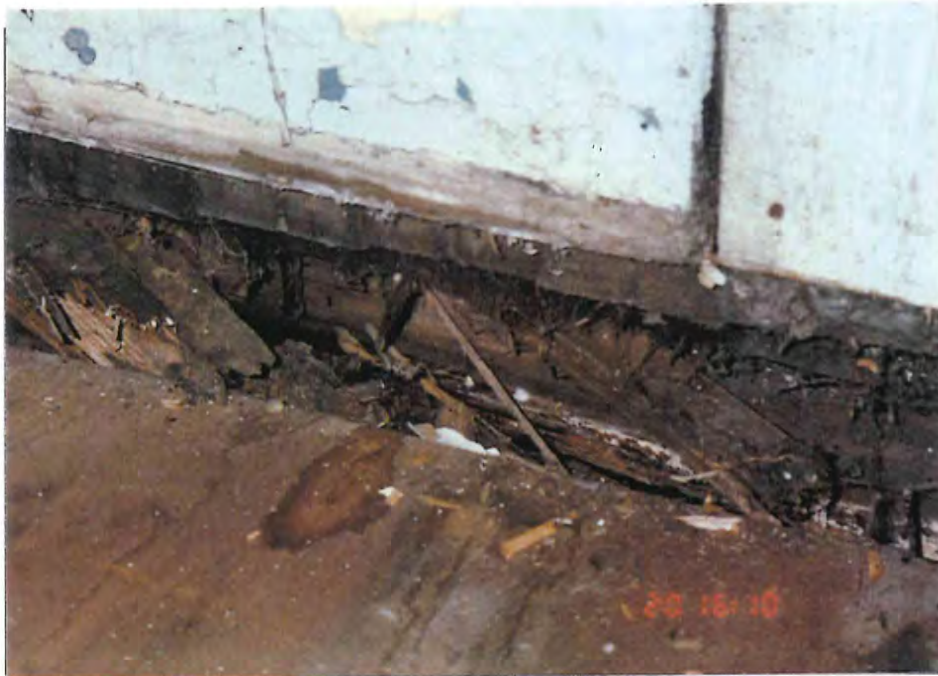
The original portion of the building had a concrete exterior foundation, apparently with central pier footings. The dirt floor of this crawl space was partly excavated to allow the installation of the perimeter heating piping. The flooring along the west wall has subsided at least 8 inches along the entire 28 foot length of the original building. The slumping of the west wall of the original structure is also evident at the eave line.

Plate 11 Exterior wall, west central room of Building 3. Note floor dropped 4 inches, exposing horse hair and tar paper between layers of wood. Note dry rot.

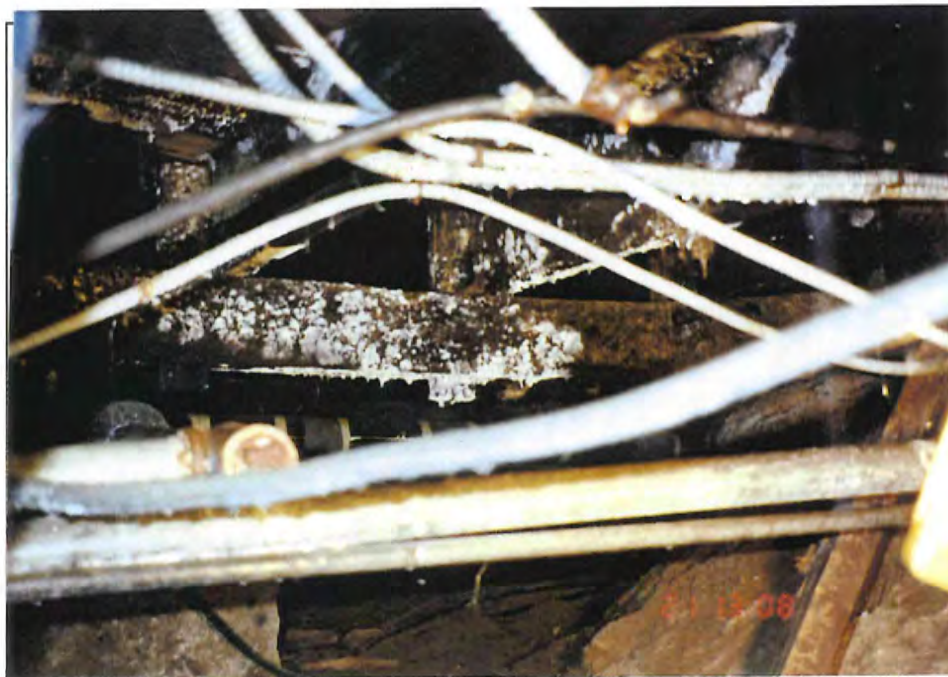
Plate 12 Crawl space from access hatch at stairs to basement, Building 3. Note moisture drops and fungal growth on wood structure.

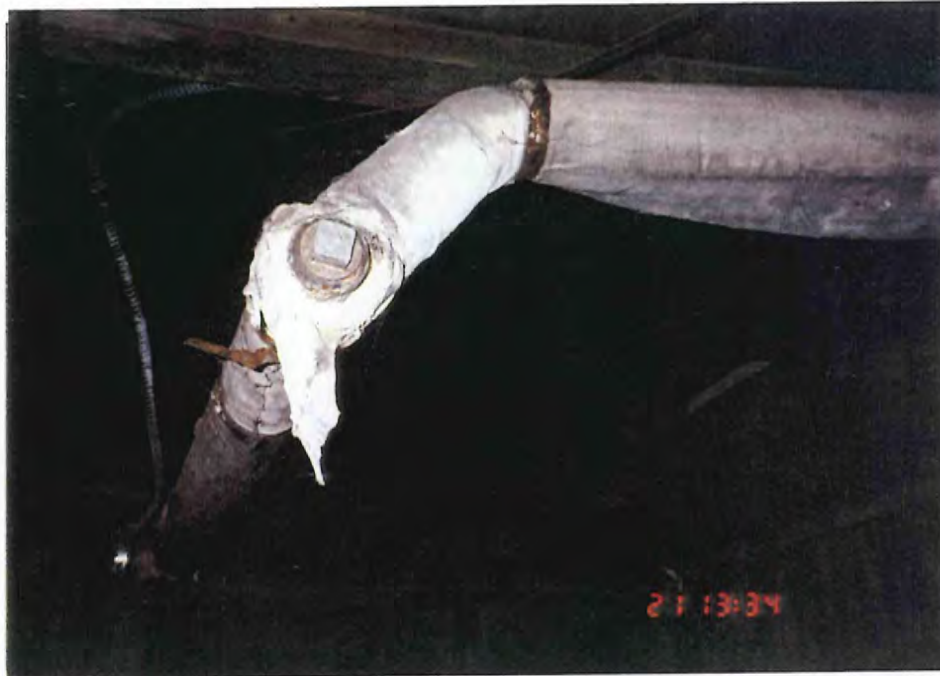
The heating piping from the boiler was insulated in the basement area with an asbestos-containing "aircell" cardboard like insulation. Portions of the heating piping were uninsulated, and other portions had an asbestos-free cellular glass insulation that was adhered together with a white compound that was assumed to contain asbestos. This white compound was only noted at the center of the crawl space where it was inaccessible for sampling.

Plate 13 Damaged white asbestos-containing pipe insulation in basement of Building 3.

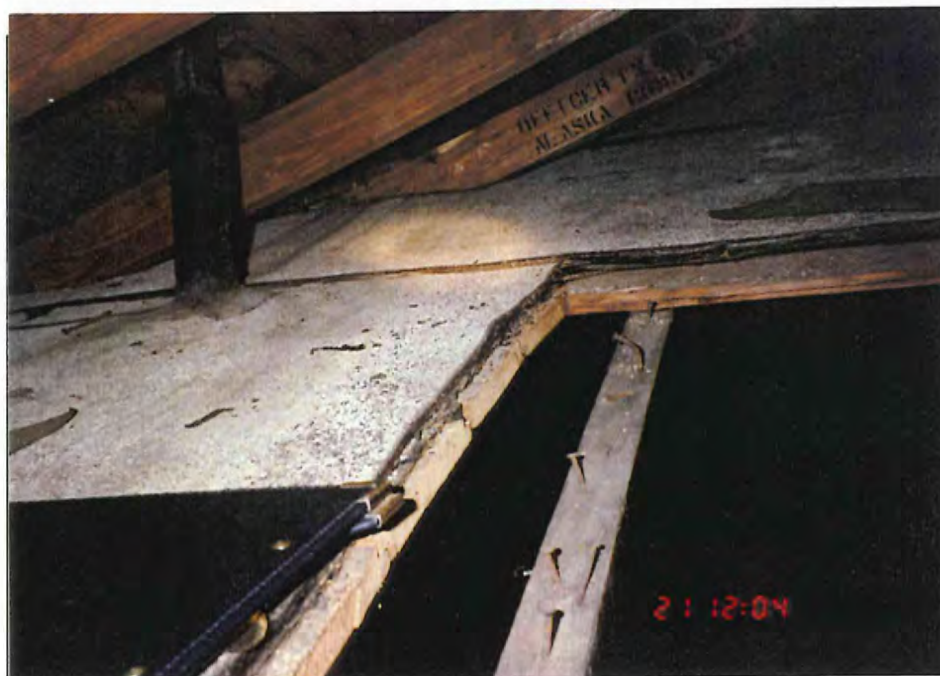
Plate 14 Asbestos-containing grit surfaced roofing of original section of Building 3. Note lead flashing on plumbing vent pipe and "new" rafters laid on "old" roofing.
