CAP GENERAL CONSERVATION ASSESSMENT REPORT  
OSCAR ANDERSON HOUSE MUSEUM  
ANCHORAGE, ALASKA  
*September 2019*

**CAP Assessment Report**

Oscar Anderson House Museum  
September 2019

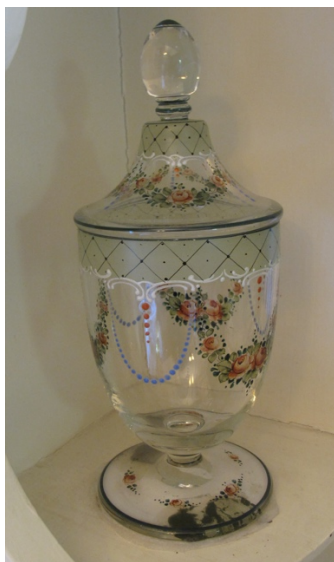
Decorative glass vessel in the dining room built-in cabinetry with darkened safety wax.

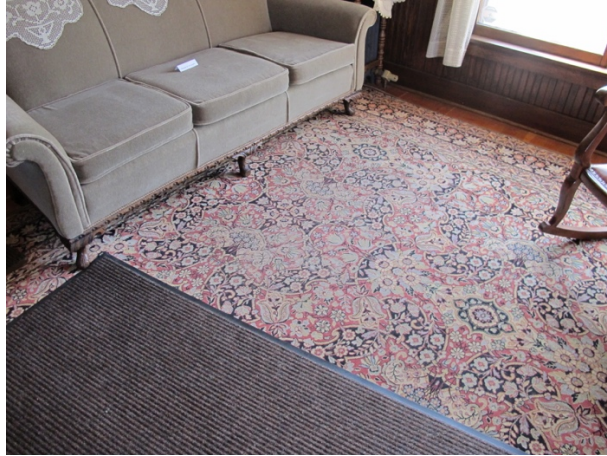
Detail view of wool floor rug with significant fading caused by bright light and lack of UV protection on the windows.

The environment inside of the Living Room is warm for visitor comfort levels at around 78°F, but the humidity levels are within the normal parameters for organic object preservation at about 50% RH. However, the high temperature can accelerate insect life cycles, causing infestations to worsen. The light levels across the space are variable with the highest reading of 651 Lux immediately in front of the south windows and the lowest reading of 74.6 Lux in front of the player piano. While the area in front of the player piano is within an adequate range, all other readings in the room are above the recommended light level of 200 Lux. All tested areas in the Living Room had positive UV readings with a high of 560  $\mu\text{W}/\text{Lumen}$  in front of the west window. Any UV level above 0 is considered unacceptable for a museum environment. The high visible and UV light levels in the room are the most likely causes of the observed fading of the wool rug. It was also noted by former docent Mary Flaherty during the house tour that the restored wallpaper in the room had faded significantly from the light exposure.

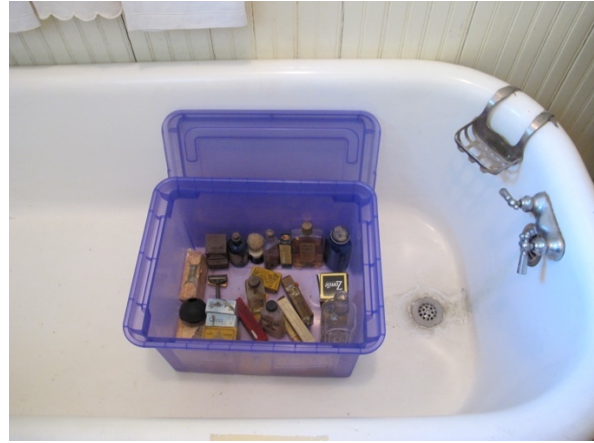
Museum collection objects stored in a plastic tub in the bathtub.

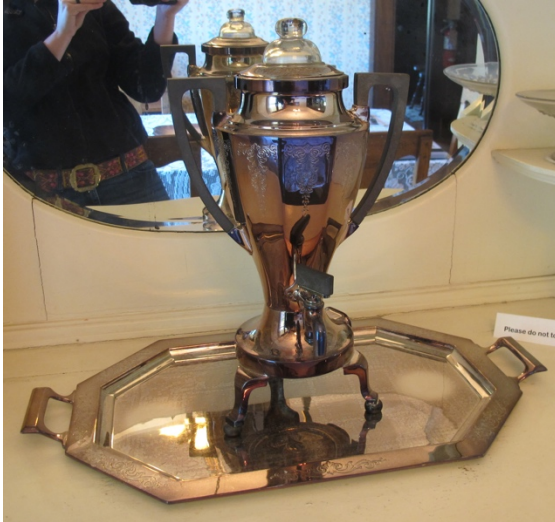
Tarnished ewer and tray on display in the built-in cabinetry.

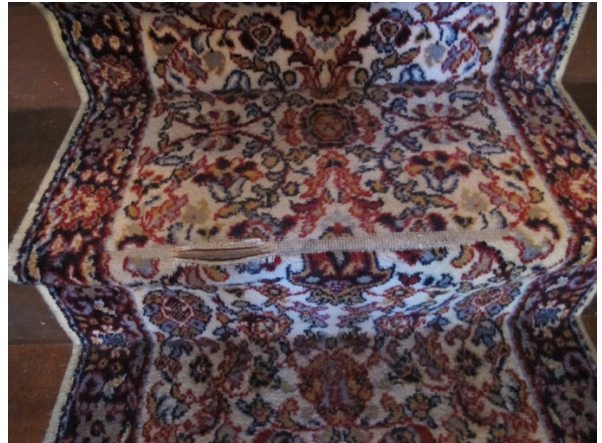
Wear and tear at the edge of the stair runner from foot traffic. The gap in the weave is a trip hazard.

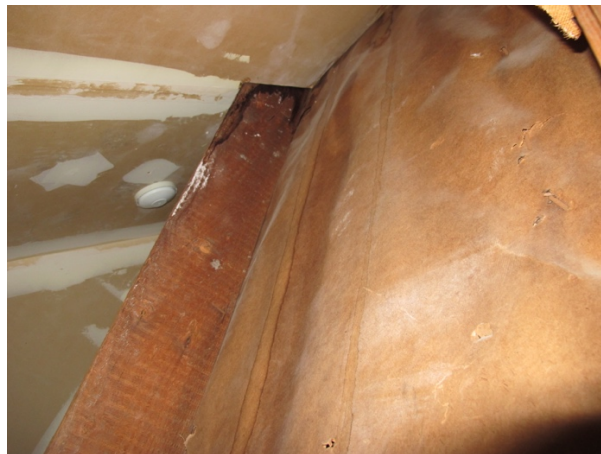
West wall of girl's room cubby with water damage.

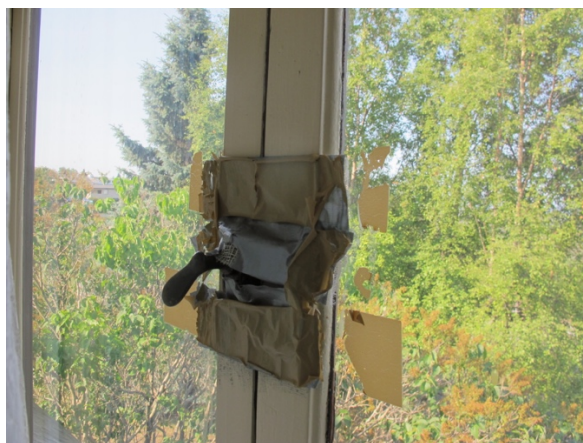
Broken window that has been duct taped shut.

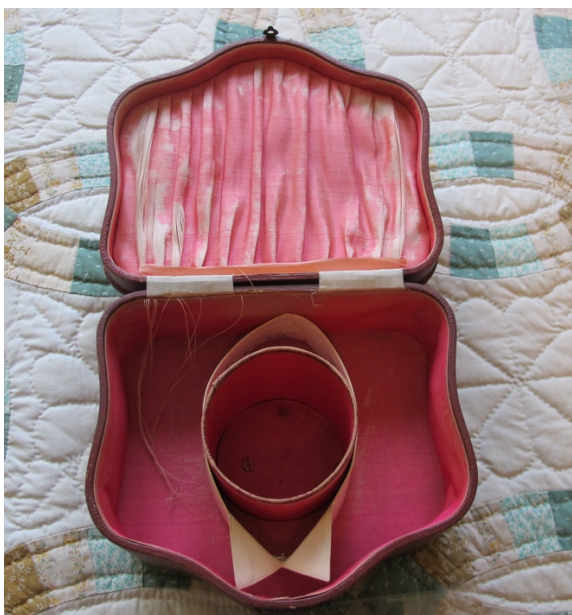
Historic silk-lined collar box showing the effects of UV damage in the form of silk embrittlement and thread deterioration. Visible light has caused the red lining to fade to pink.

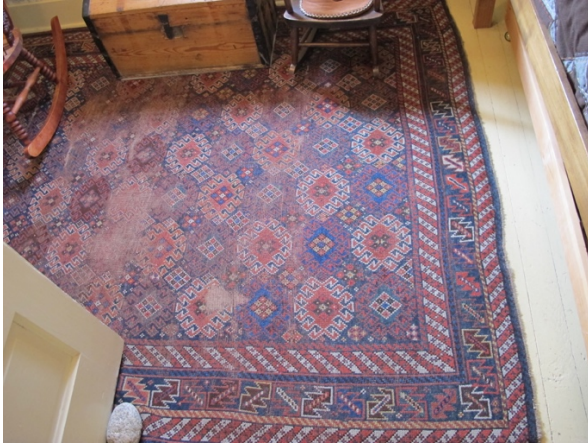
Detail of rug damage caused by UV damage and repeated foot traffic.

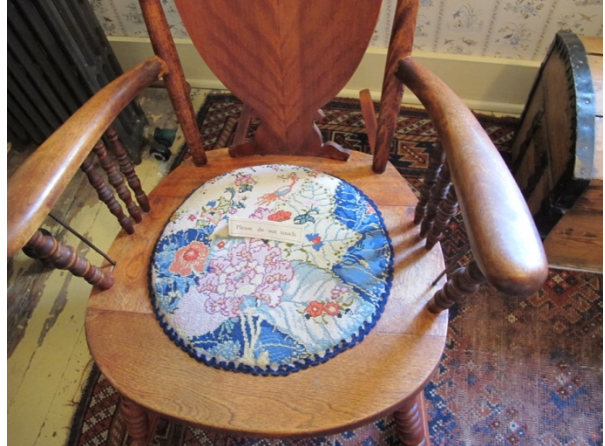
Fading of a seat cushion caused by UV and visible light damage.

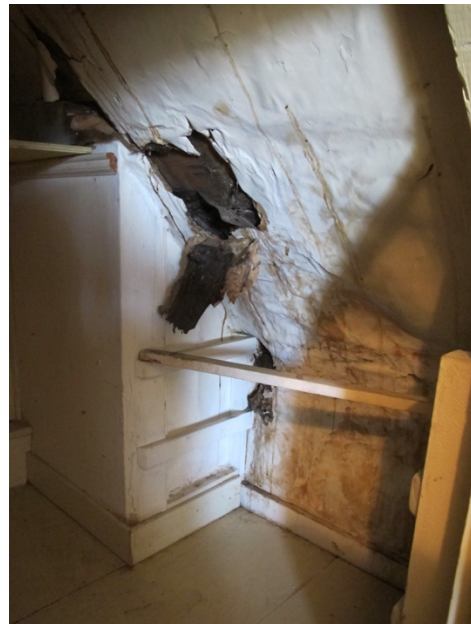
Interior of boys' room cubby with significant water damage in the eastern wall.

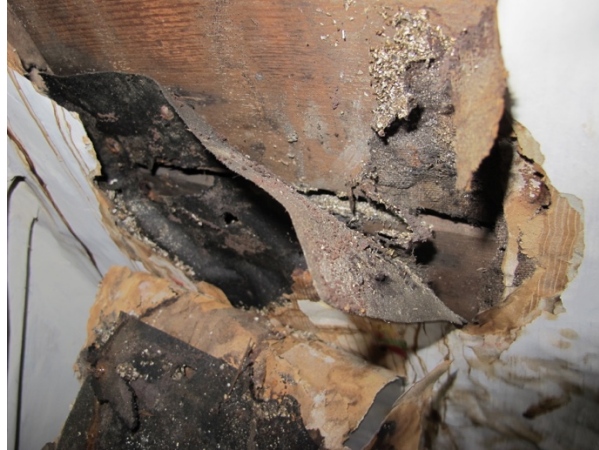
Detail of exposed roof elements revealed by the water damage.

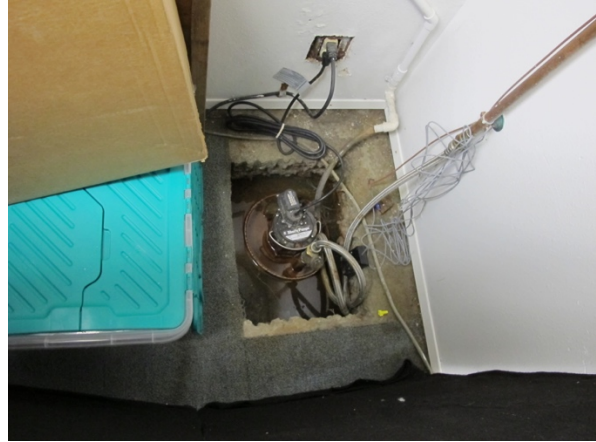
Also of concern is the presence of an open sump pump in the southeast corner of the basement, inside of the conference room. Because of the Museum's location at the bottom of a slope, the building frequently has problems with flooding from the hill. The water table in the area is also very high, which can further the flooding problem. To address the flooding, a sump pump has been installed in the corner of the conference room to help with removal of the water. However, the sump pump hole is open, with standing water exposed. A small barrier has been placed around the pump so that visitors do not see it. This barrier is not an effective means of preventing rodents and pests from entering the space through the open hole.

Exposed sump pump with standing water in the southeast corner of the basement conference room.

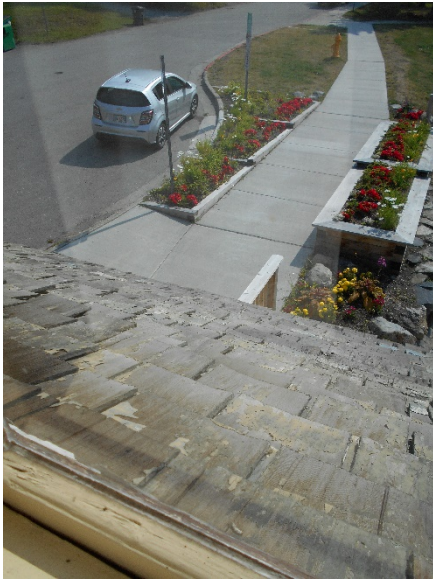
- **PRIORITY 1 (Weatherization) - Roof leaks:** Inspection of attic and cubby areas on the second floor of the museum show moisture staining and rot from water leaks. The existing wood shingles, replaced in the 1990s, are deteriorated, some are missing or rotted, and others covered with mold or moss. At one time, they were painted (paint remnants still remaining on some shingles) which is not appropriate for wood shingles, which can weather without an additional (non-historic) finish on top.

**South Porch Shingles**  
(discolored, broken, paint chips)

Reroofing with new wood shingles over a mesh ventilation layer, then over a moisture barrier (ice & water shield) installed over the existing 1x8 roof boards and 2x4 rafters, with new flashings at chimney penetrations and at eaves, should provide a long-term dry solution. Special care should be taken on the edges and penetrations on the north and west roofs, which receive saltwater driven rain from the nearby ocean. Additional flashings may be required, especially at existing chimneys and vents. The shingles should be cleaned regularly, to remove moss or salt buildup, accumulated leaves from adjacent trees, and general detritus.

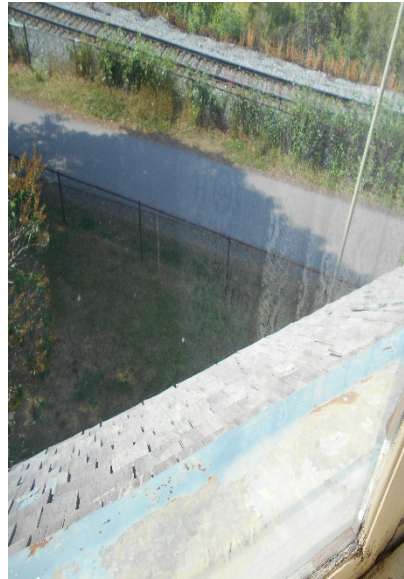
**West Dormer Shingles**  
(faded, broken shingles)

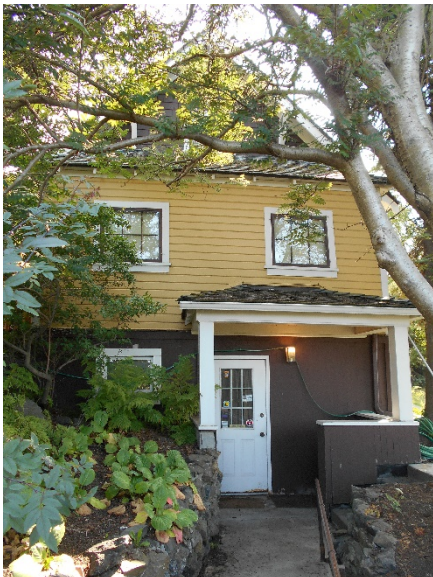
**North Roof Shingles**  
(moss, leaves)

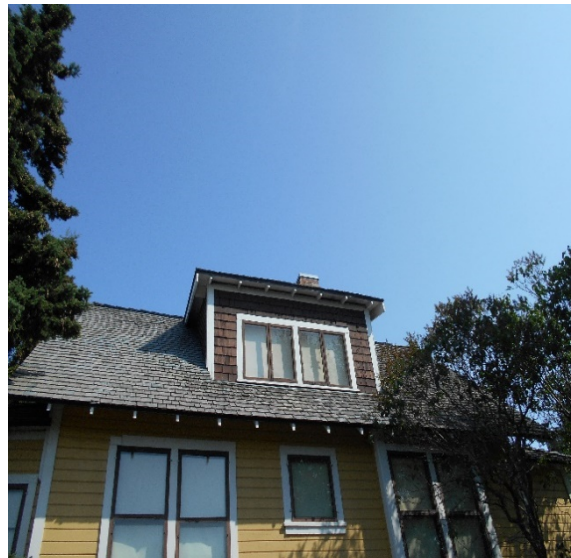
**West Dormer (no storm panes)**  
(storm panes on 1<sup>st</sup> floor windows)

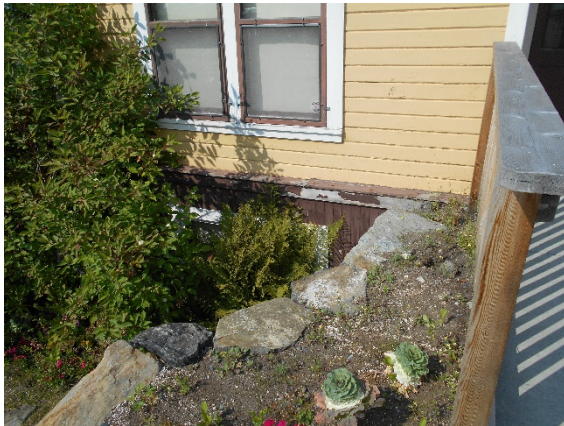
**Peeling Paint – south basement**

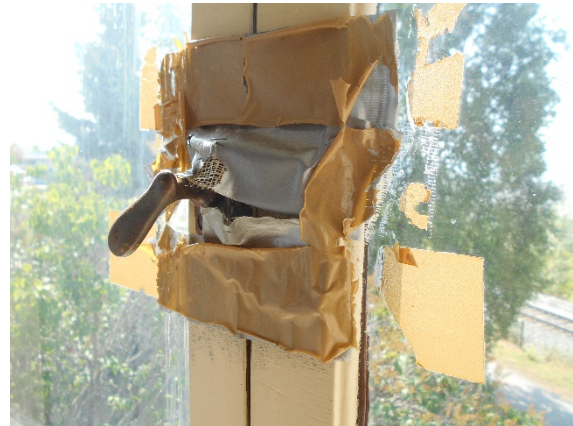
**Damaged Window Hardware- dormer**

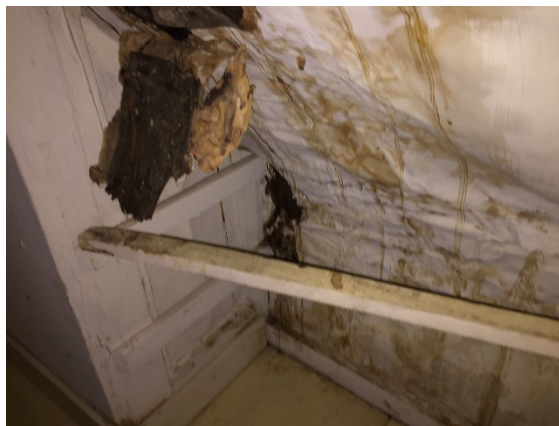
**Damaged Attic Insulation -  
Boys Bedroom Cubby  
(Girl's Bedroom Cubby similar)**

Below the roof, water-stained areas in the attic and cubbies (enclosed storage areas under the roof, off the bedrooms) should be thoroughly cleaned. Additional insulation should be considered if these areas are to be used, as well in the main attic, where only 4" was installed above the flat portions of the second floor ceilings. Reassess attic ventilation with existing wall vents and eave construction.

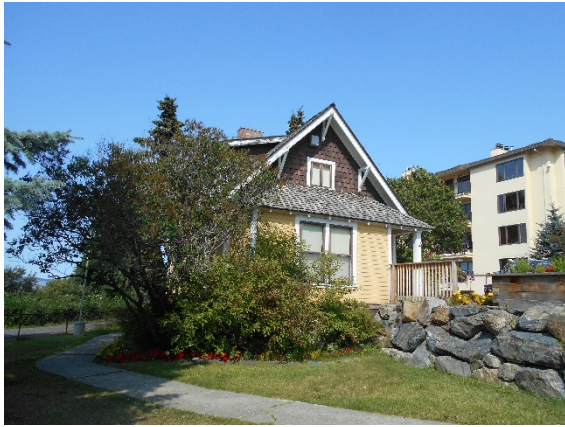
**Southwest View of House  
(rock infill next to basement)**

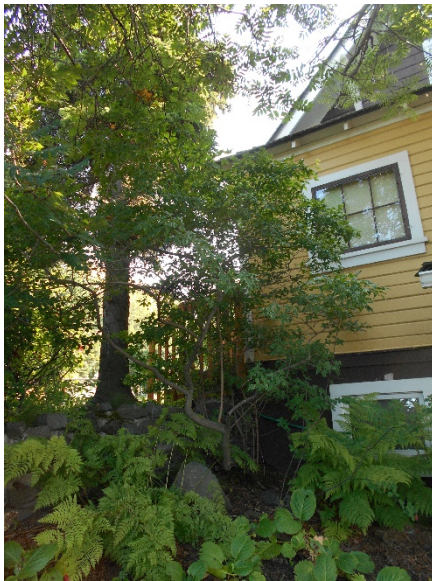
**Trees at NE corner of house  
(remove for clearance from  
roofs & foundation & walk)**

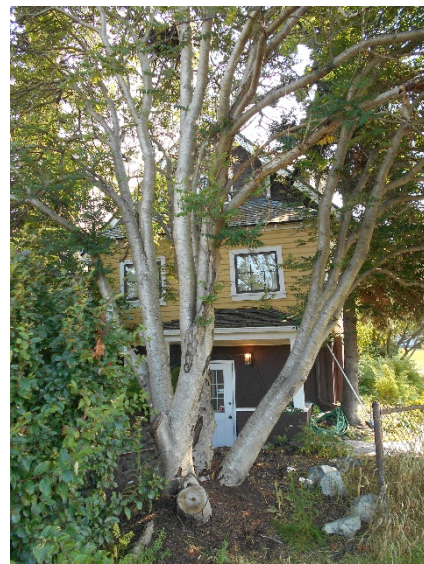
**Trees NW of house  
(remove for clearance from  
roofs & foundation & walk)**

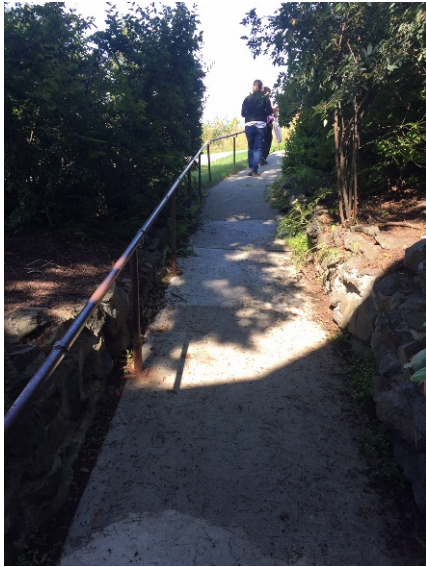
**Concrete sidewalk to north  
(repair/replace railing/trim shrubs)**

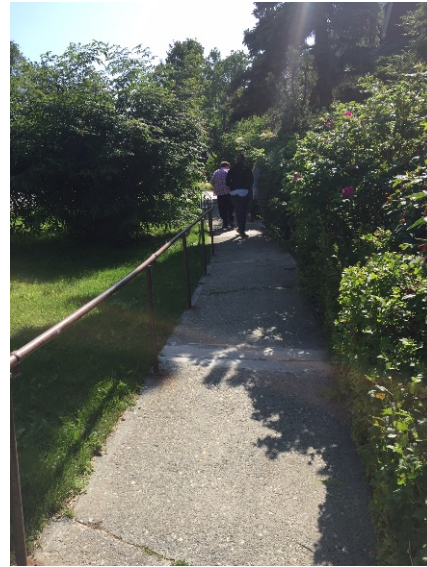
**Concrete sidewalk to east  
(repair/replace railing/trim shrubs)**

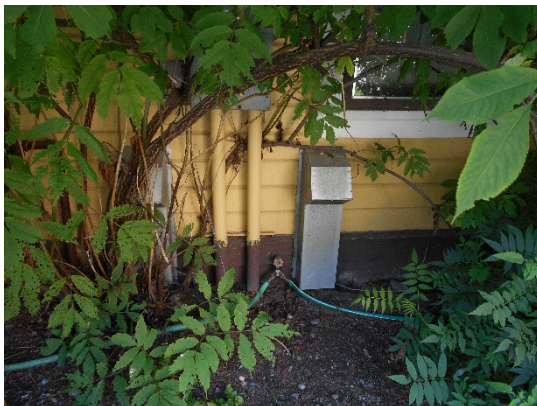
**Shrubs at east wall of house  
(remove from utility entrances)**

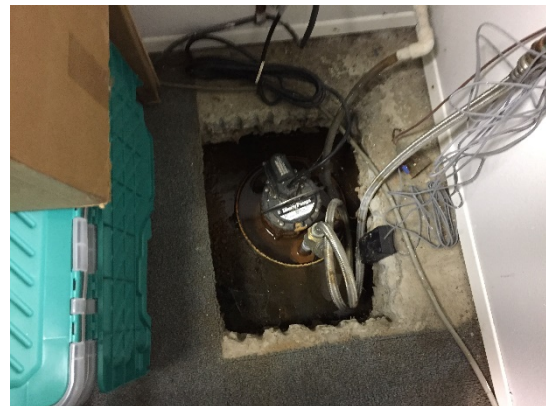
- **PRIORITY 2 (Sitework) - Basement flooding/wet basement:** There have been repeated floods of the basement level, resulting in wet carpets and the possibility of mold growth. There is an open sump in the southwest corner of the basement conference room, which contributes to high humidity levels in the basement.

**Open Sump- Basement Conference Room  
(remove when site drainage repaired)**

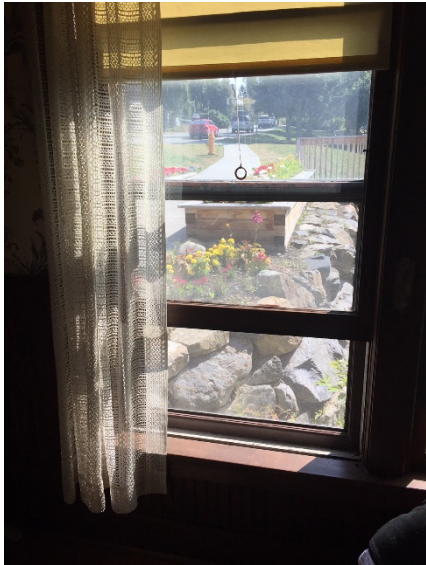
**Typical Roller Blinds & Curtains  
(provide UV filters on windows)**

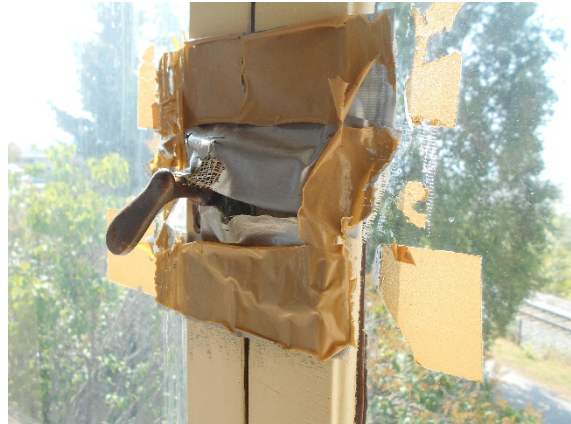
**“Bandaged” casement operator  
(repair & refinish windows & hardware)**

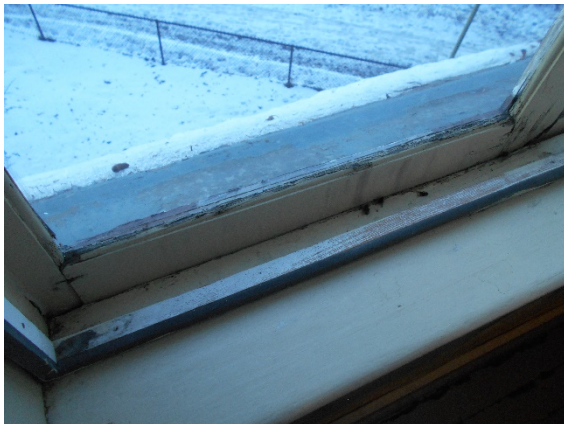
**Deteriorated sash (December, 2017)  
(repair, reseal, and repaint)**

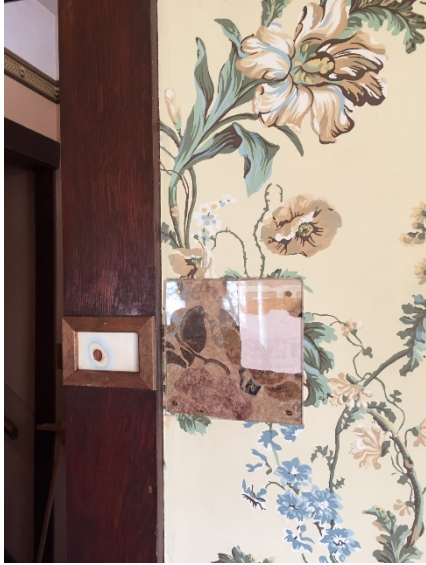
**Wallpaper comparison –  
Living Room (review condition)**

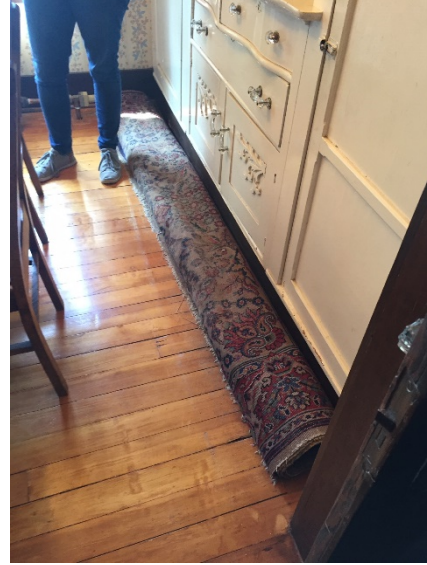
**Dining Room Carpet (to remove)**

- PRIORITY 4 (Interior Improvements) – Interior Finishes Repairs:
  - Carpets: deaccession & remove beetle-infested dining room carpet. Remove other similarly infested carpet pads.

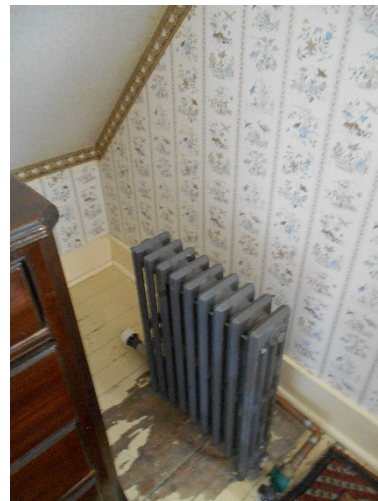
**Floor Repair at radiators**

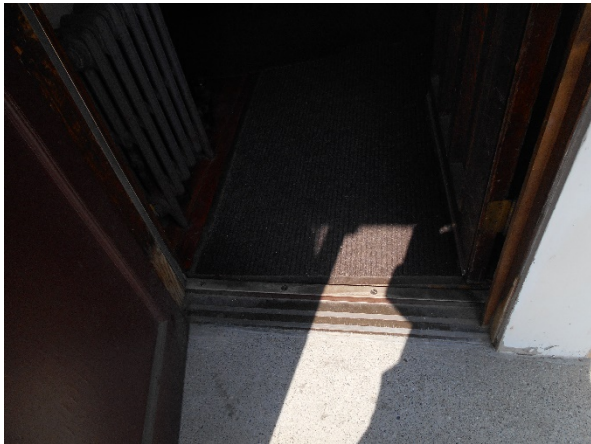
**Front Door (worn surfaces  
to refinish or upgrade)**

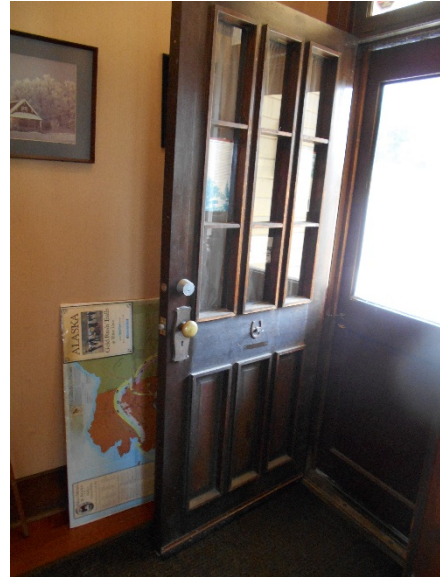
**Front Door Hardware  
(mismatched finishes – replace)**

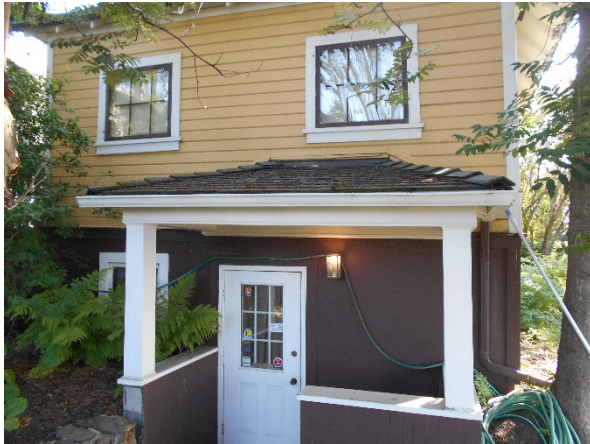
**Repair north porch railing caps**

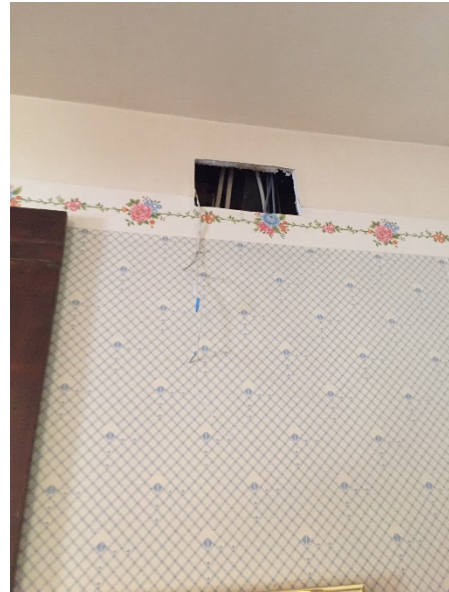
**Reinstall kitchen wall vent**

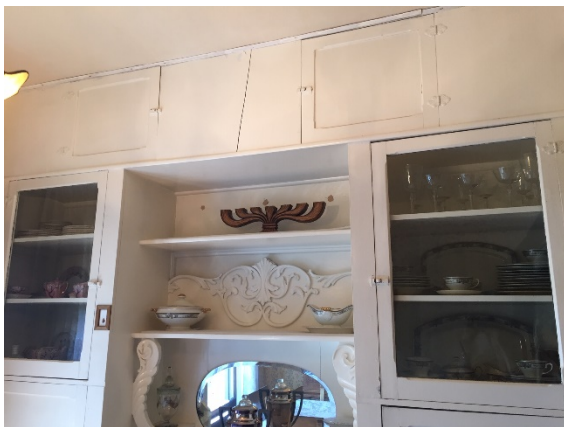
**Repair cracked wall finishes  
(Dining Room)**

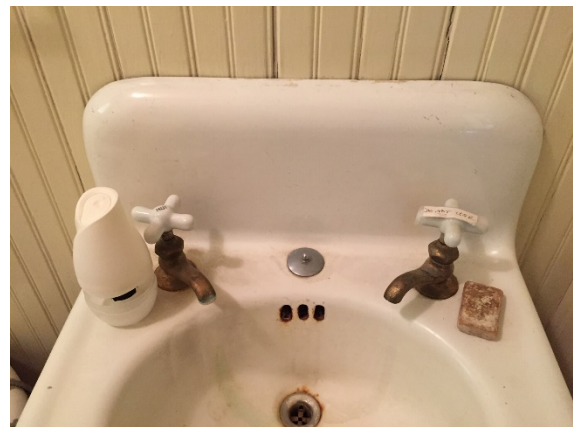
**Repair cracked beadboard panels  
(Bathroom & North Entry)**
