Appendix B: Photographs

Documentation of Present Appearance

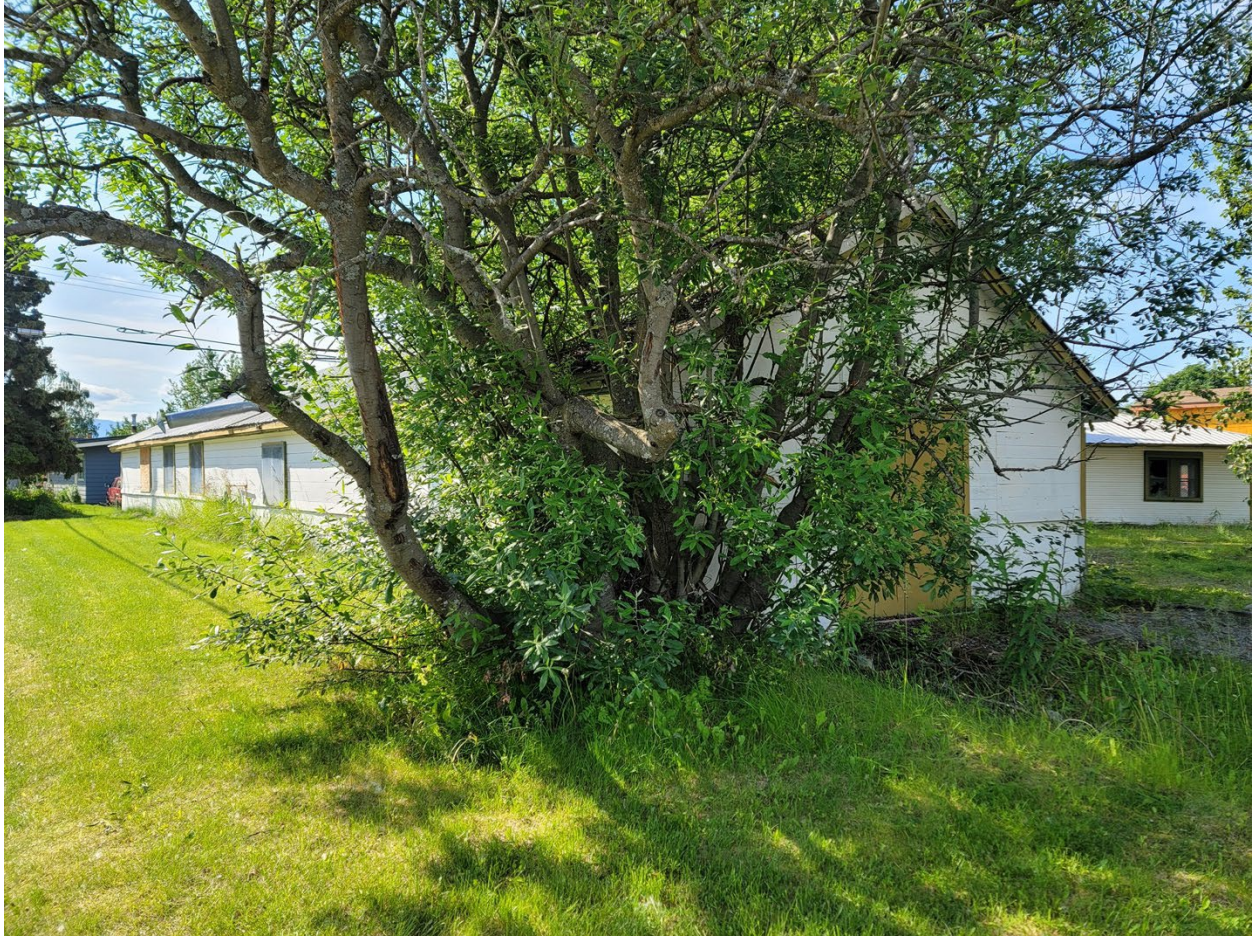
Figure B5. Building B, view to the south-southwest. The photograph also shows the overgrowth of vegetation against the northernmost corner of the building (©TNSDS 2023).

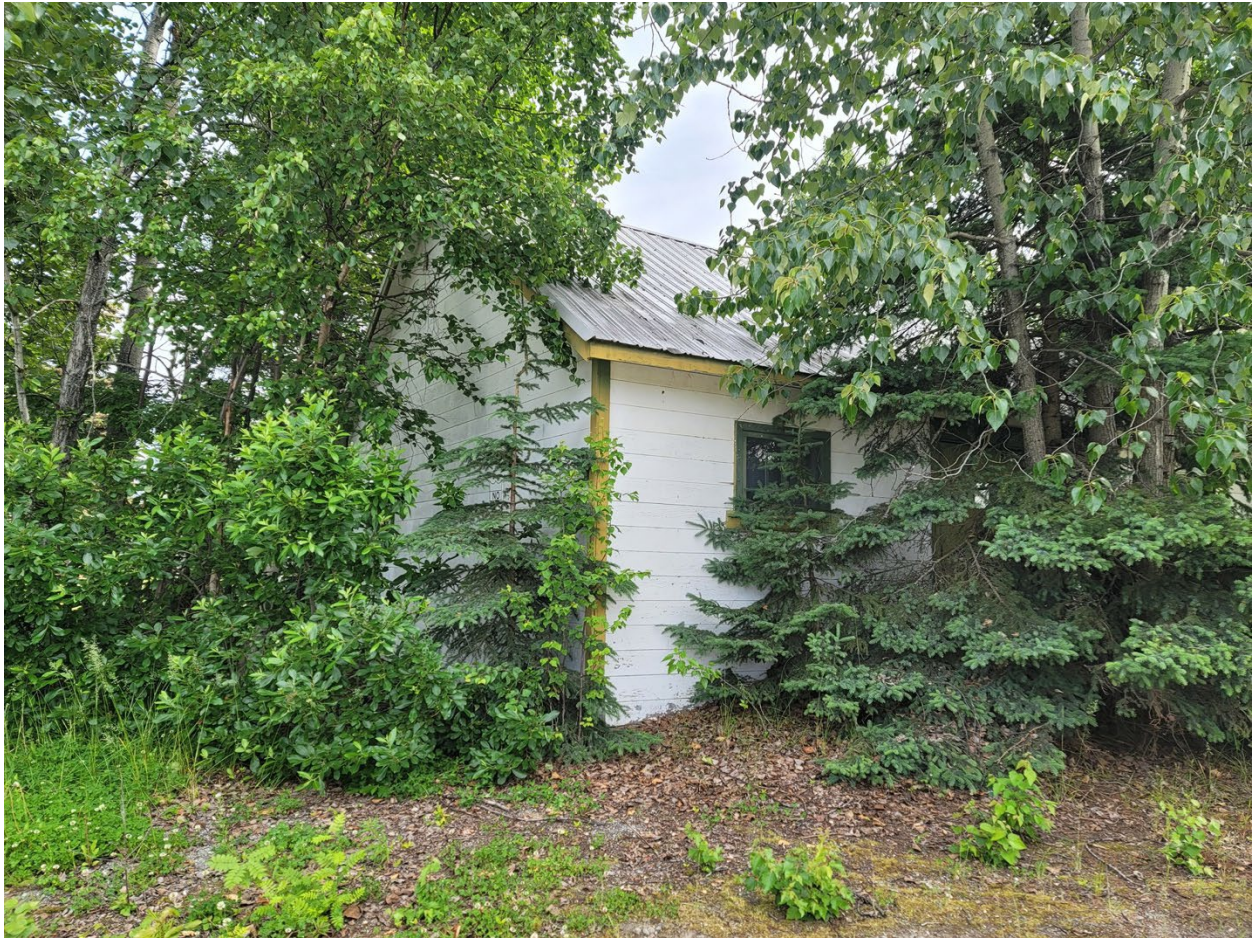
Figure B10. Building C, view to the southeast. The photograph shows the dense overgrowth of vegetation that surrounds and obscures the building (©TNSDS 2023).

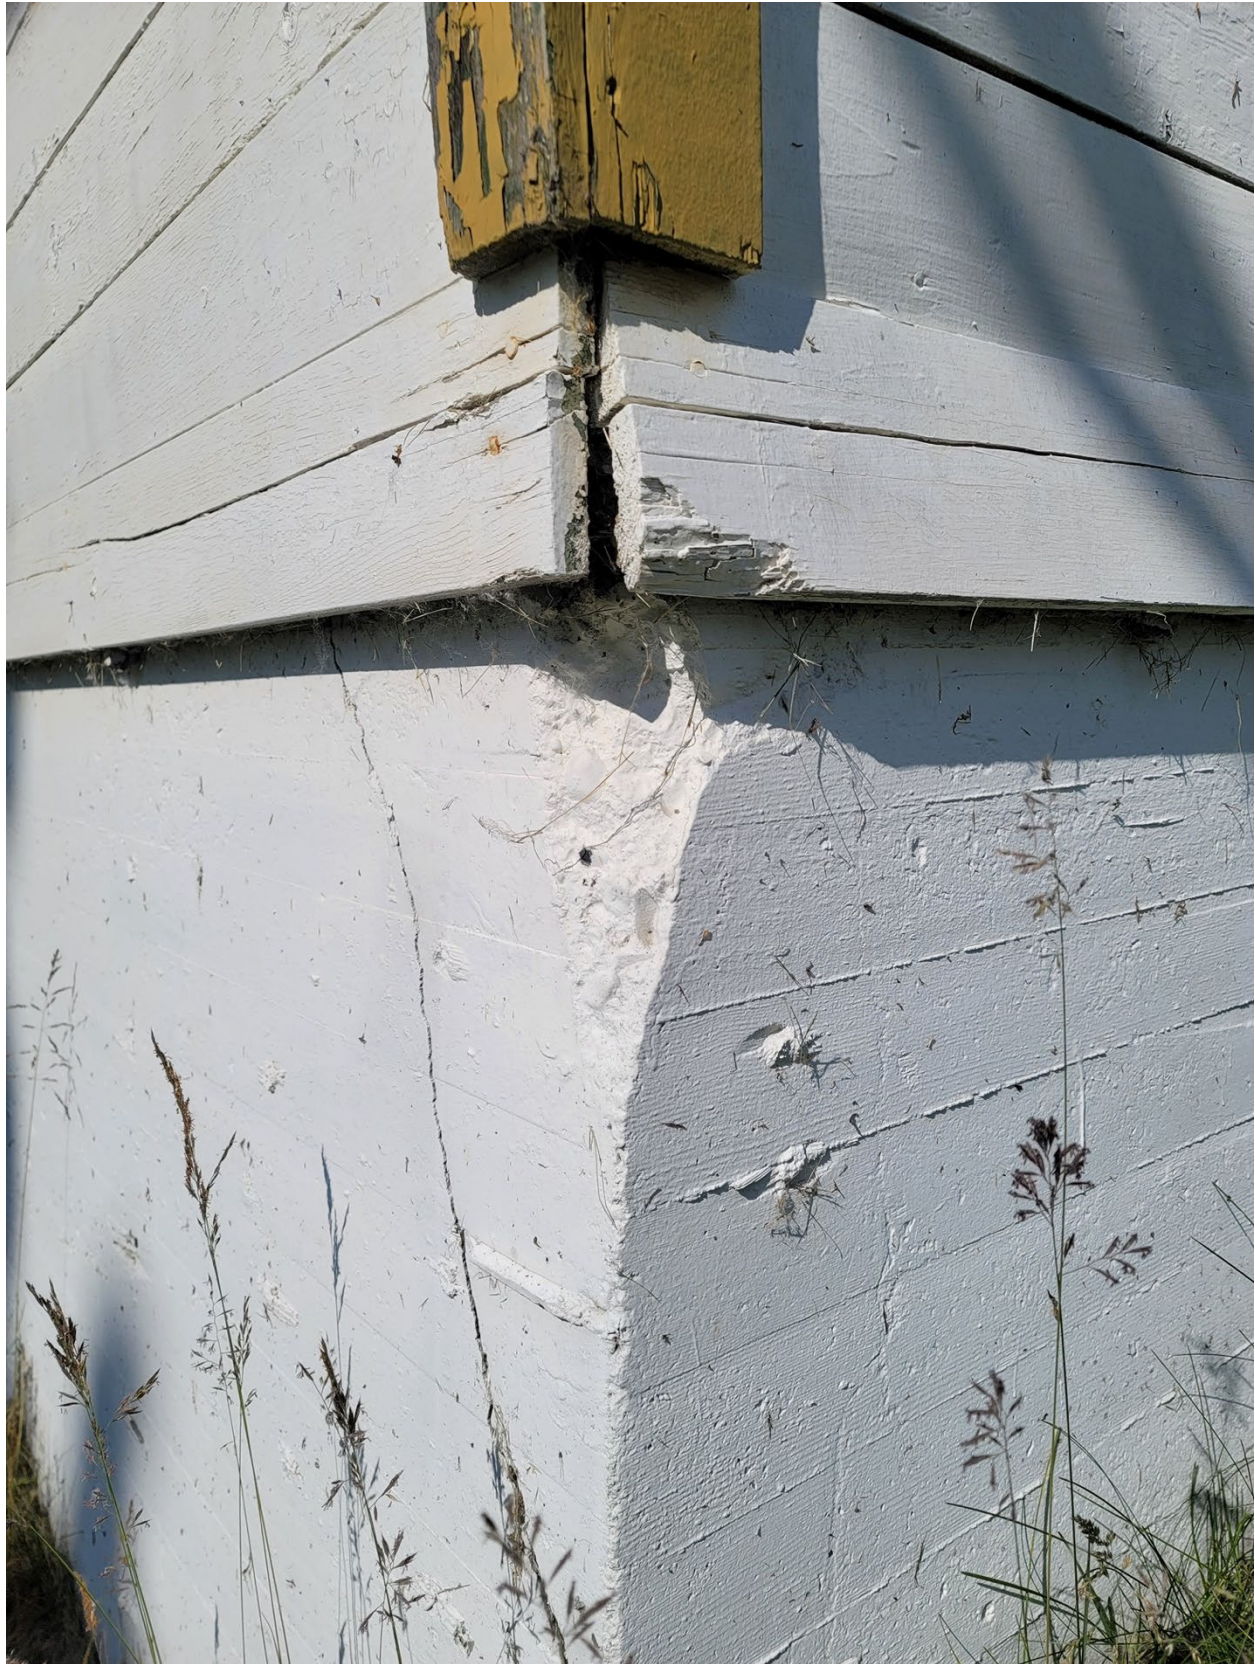
Figure B16. Detail photograph of the southeast corner of Building B. The photograph shows the concrete foundation, lap siding, and skirtboard and demonstrates the spalling happening to the foundation (©TNSDS 2023).

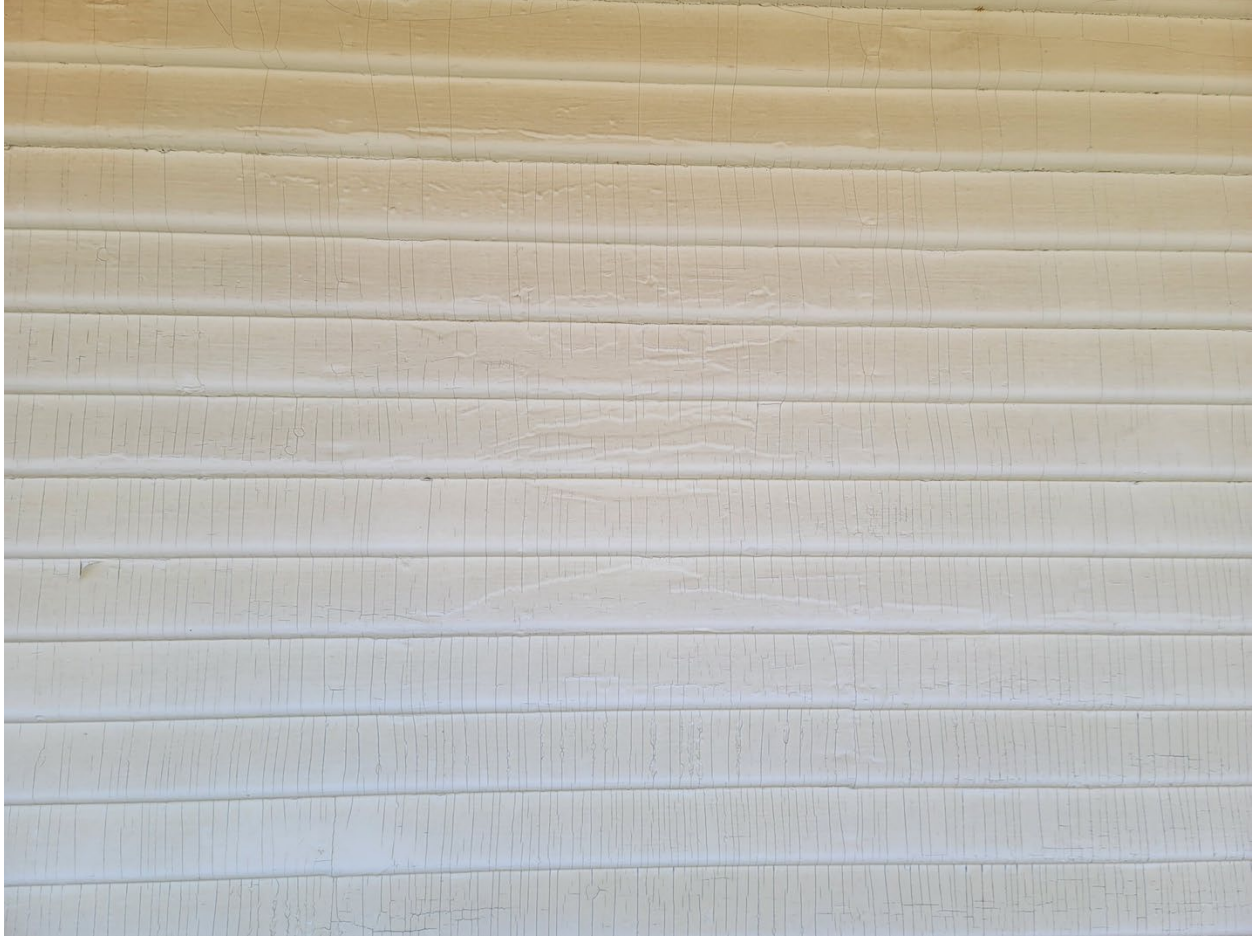
Figure B18. The wrinkling, crazing, and peeling in the paint on the west façade of Building A (©TNSDS 2023).

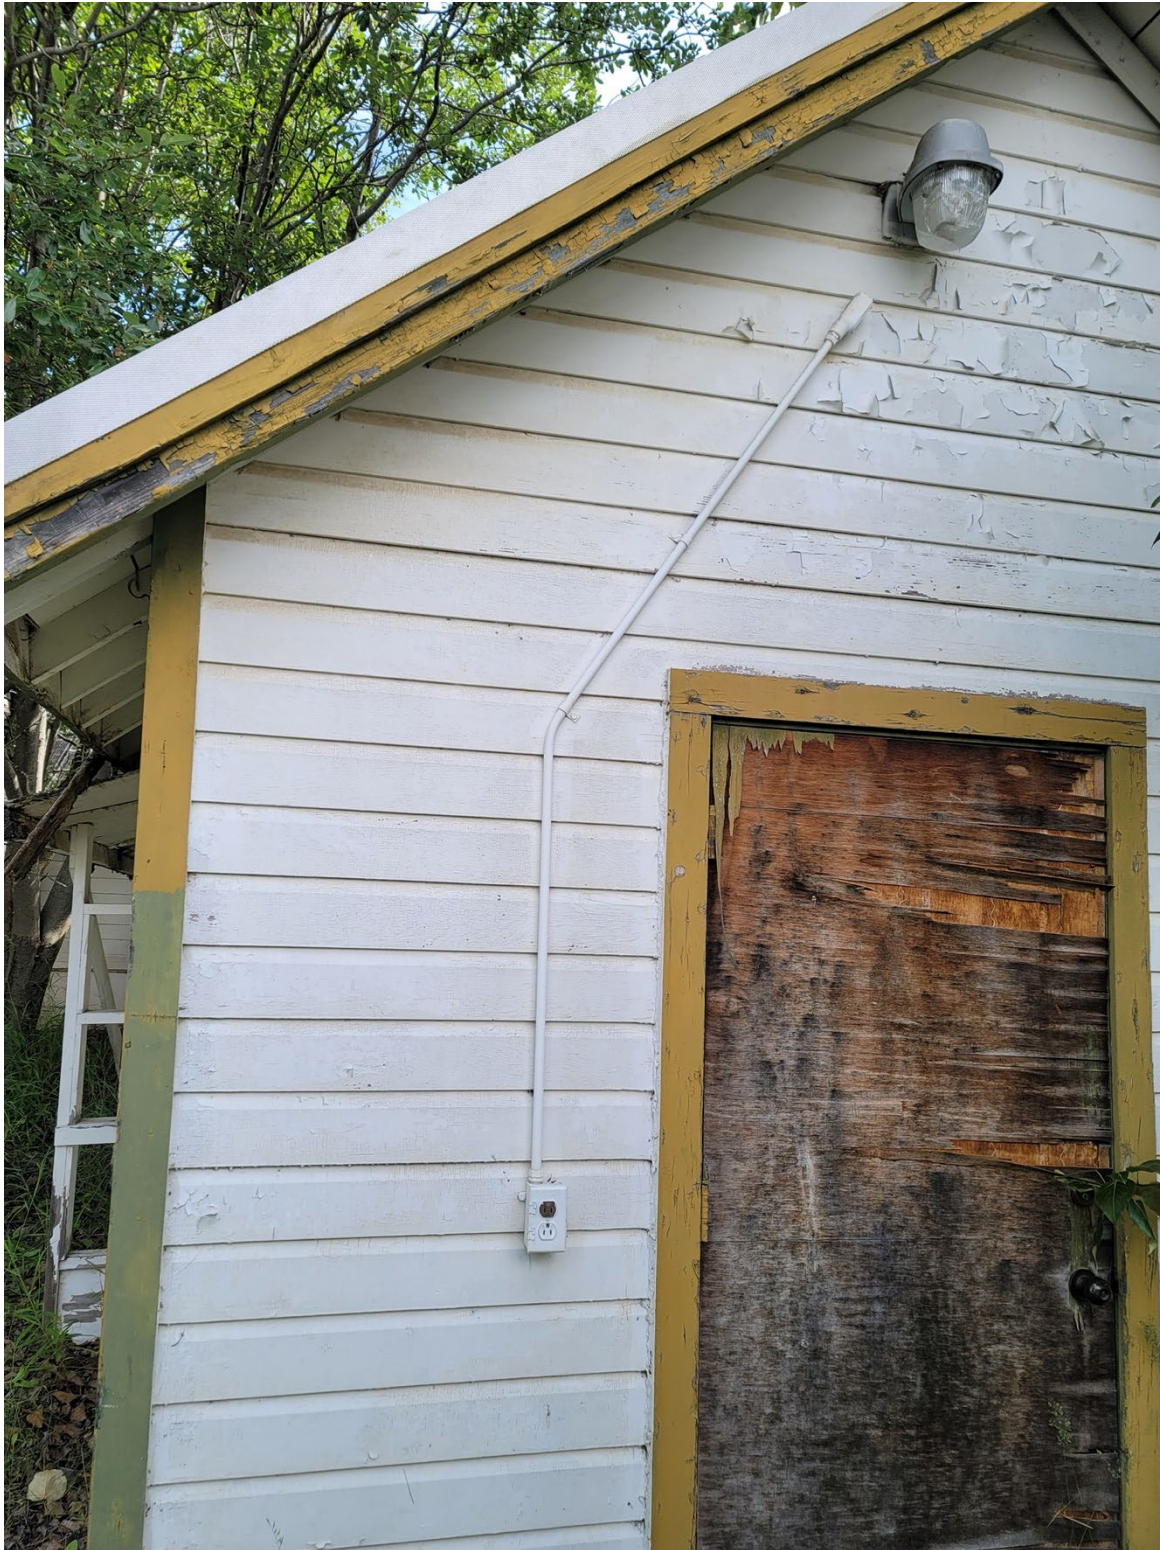
Figure B19. The southwest façade of the addition to Building B, showing the cracking, crazing, and peeling of the paint on the siding (©TNSDS 2023).

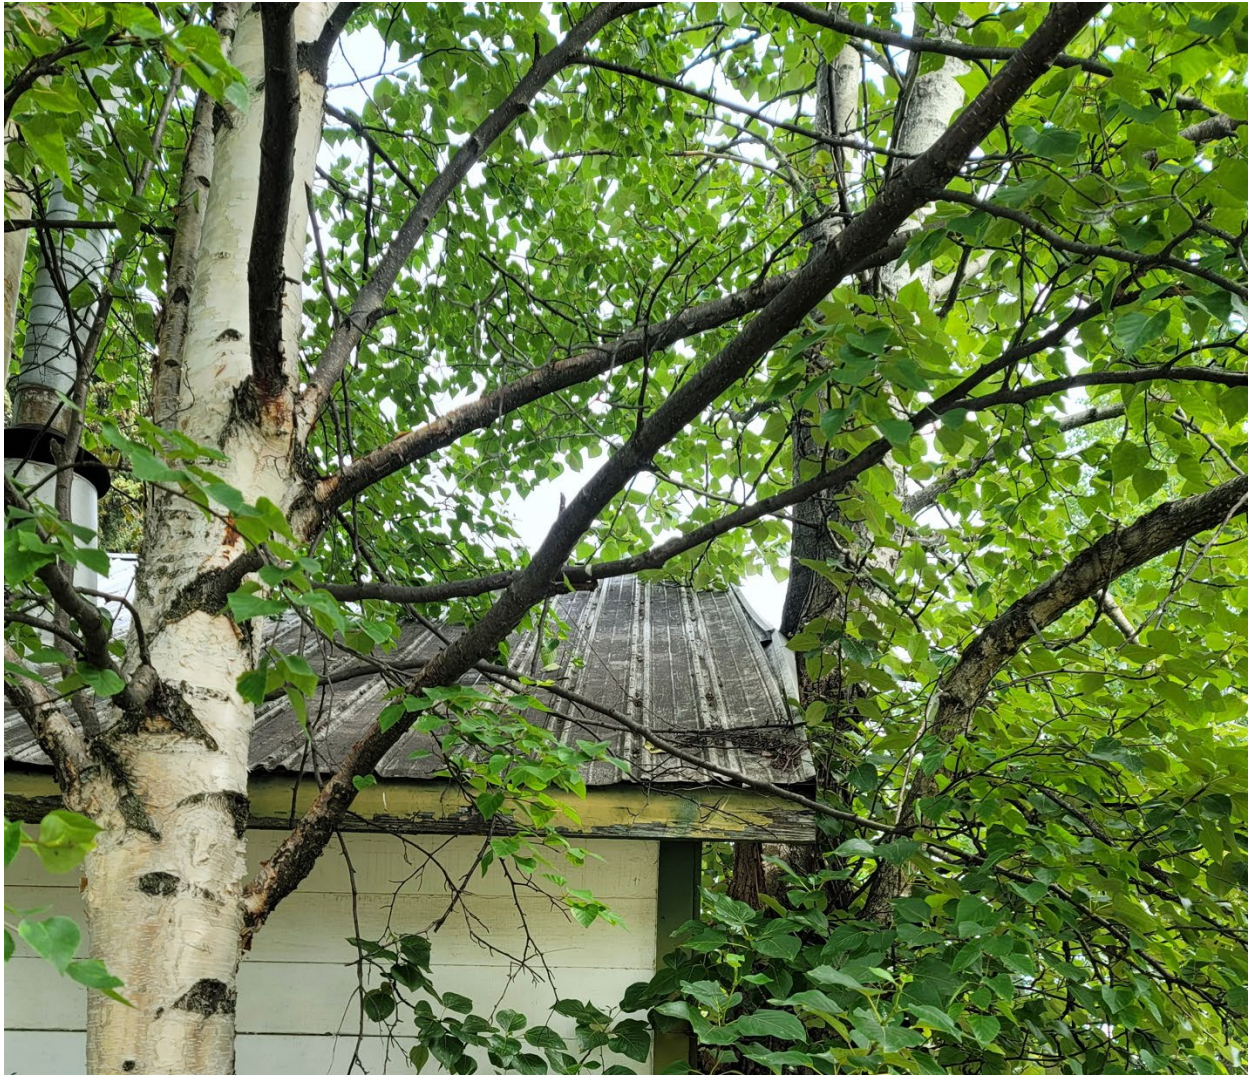
Figure B20. Detail photograph of Building C. The photo shows how the birch tree that has grown against the southeast façade of the building has begun to displace the roofing materials (©TNSDS 2023).

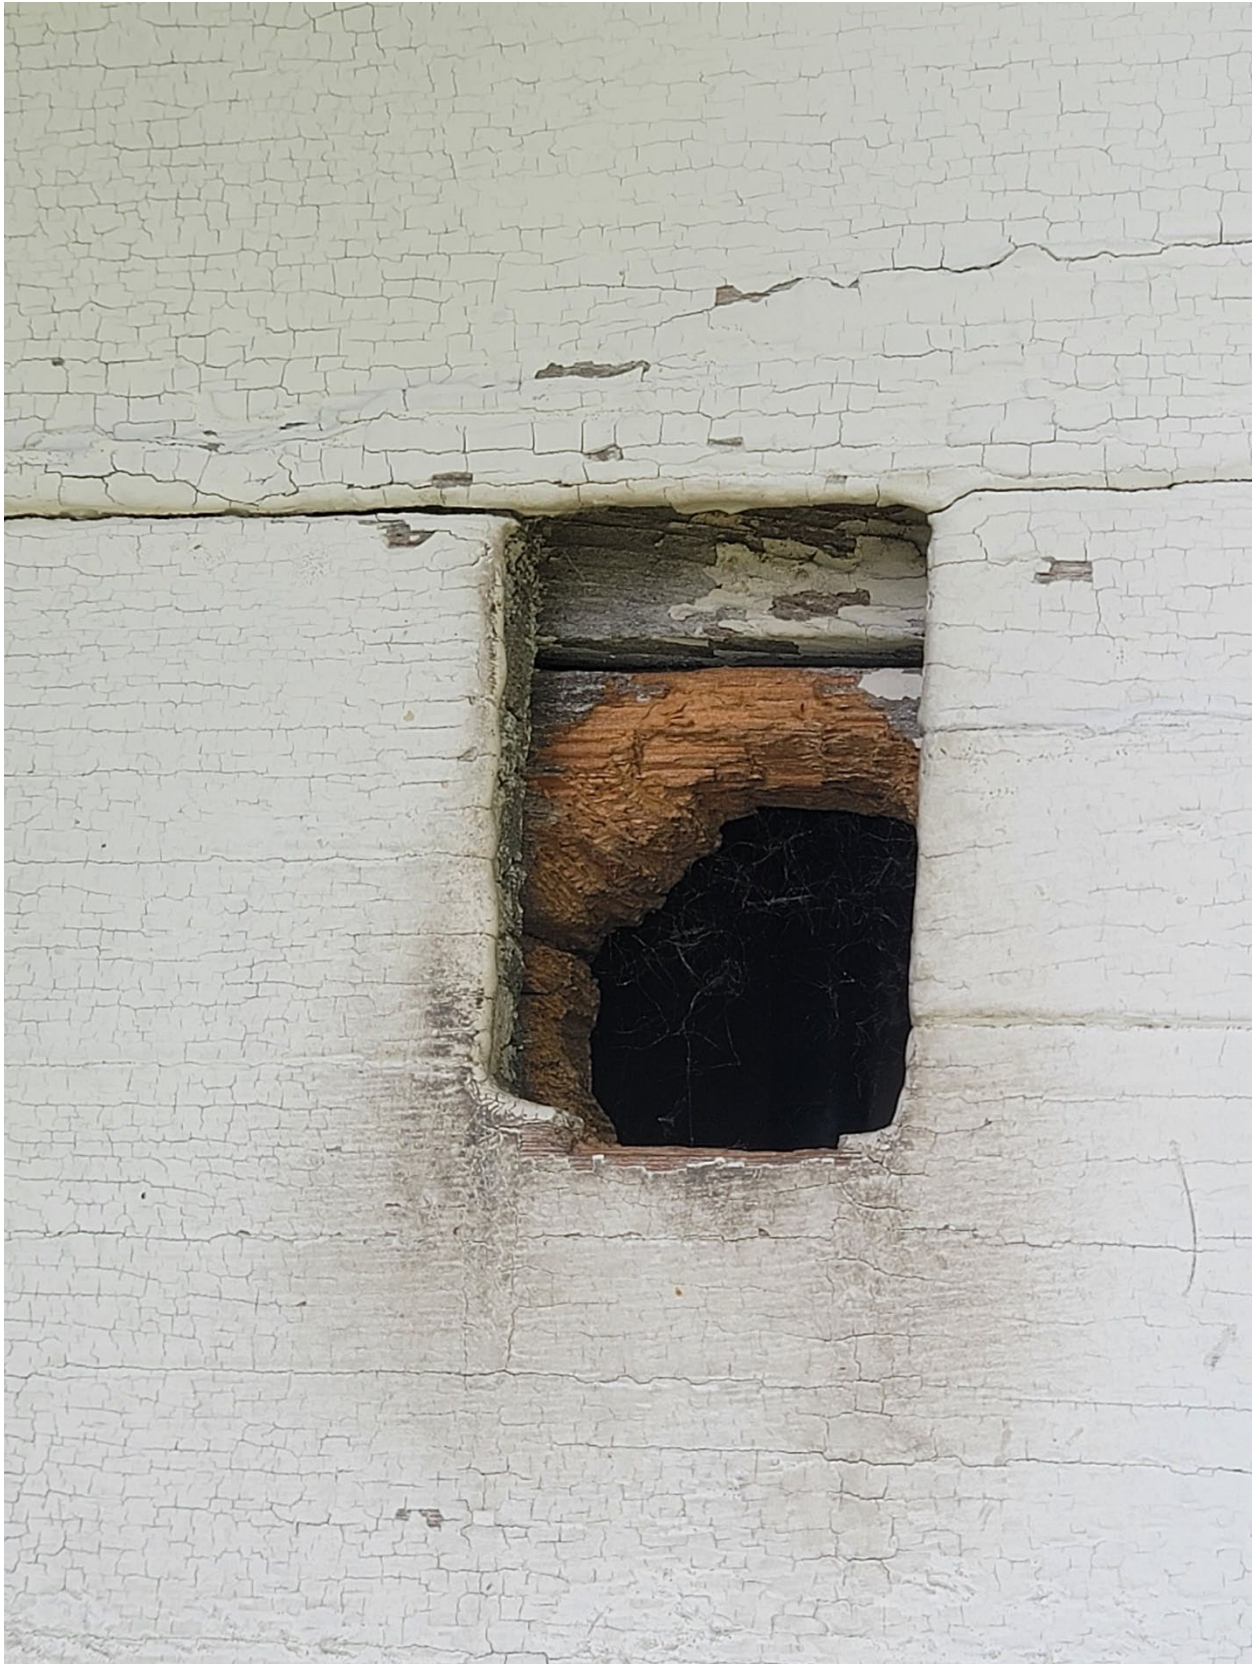
Figure B21. Detail photograph of an opening the siding of Building C, exposing the interior wood planks (©TNSDS 2023).

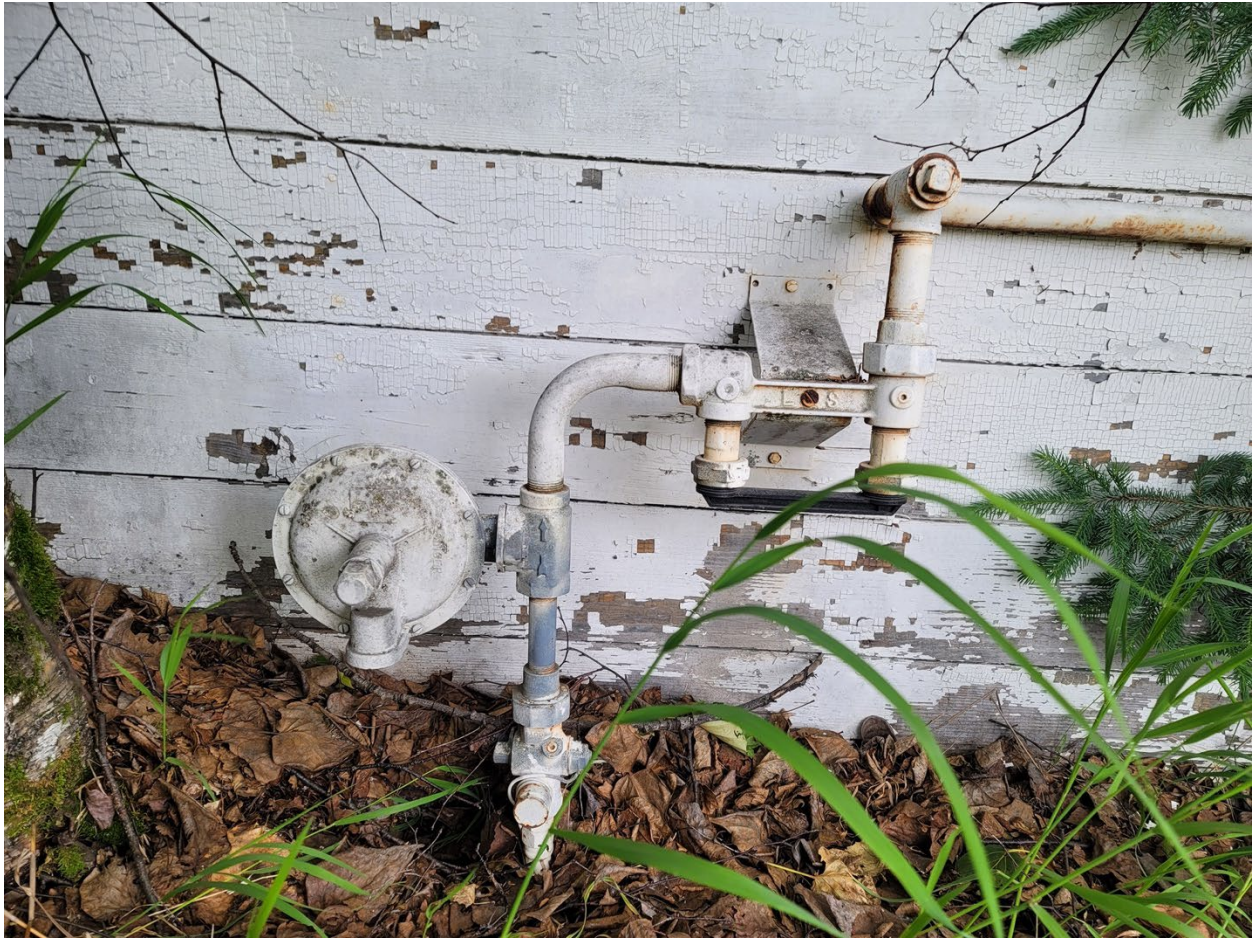
Figure B22. Detail photograph of the utilities installed on the southwest façade of Building C. The photograph shows the deterioration of the paint along the bottom boards of the building. It also demonstrates the crazing and cracking of the older paint as well as sections where the older paint has been removed and reapplied such that no cracking or crazing is present (©TNSDS 2023).

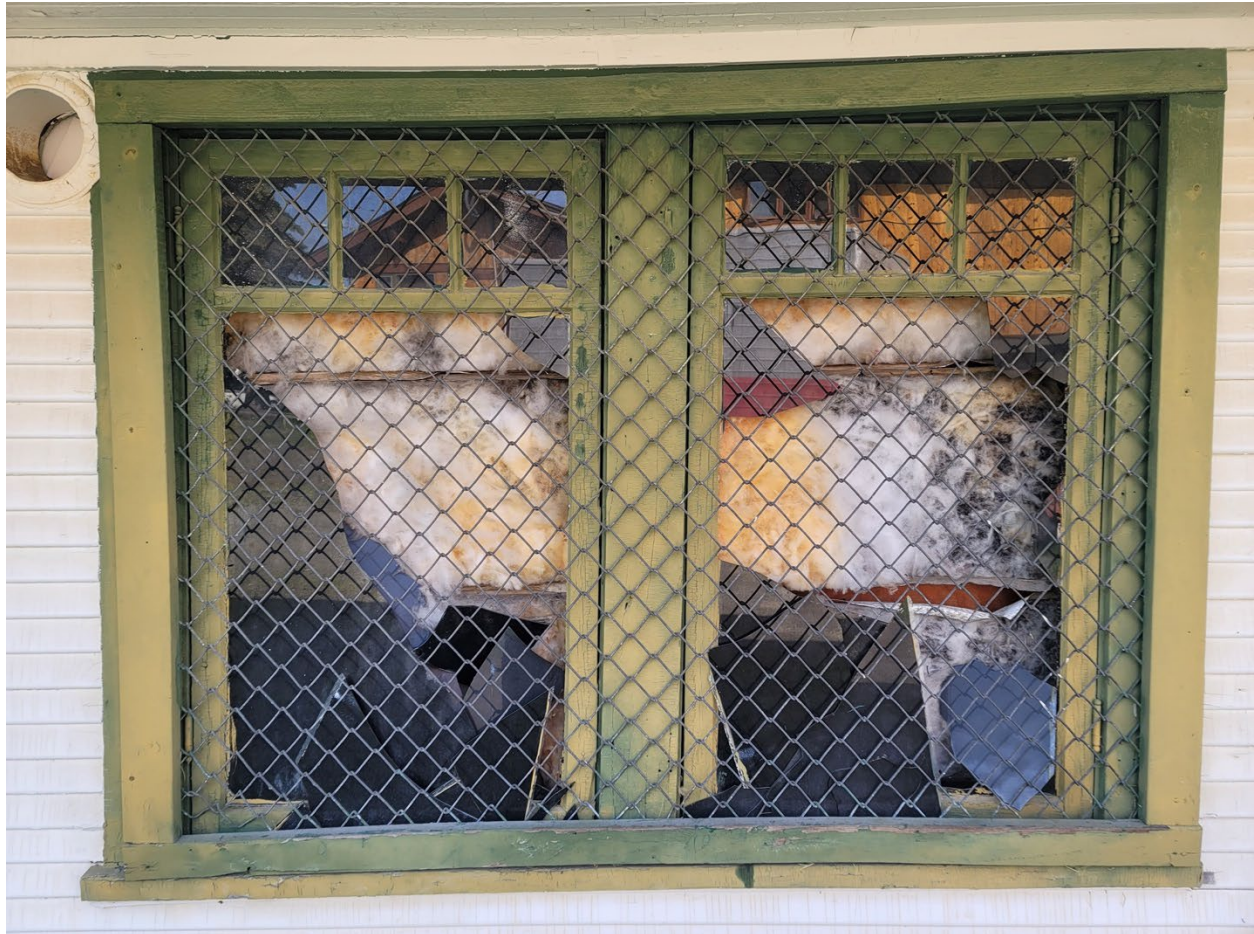
Figure B27. The southernmost window on the west façade of Building A. The photograph shows the broken glazing as well as the misalignment of the window framing due to the building's uneven settlement over time (©TNSDS 2023).

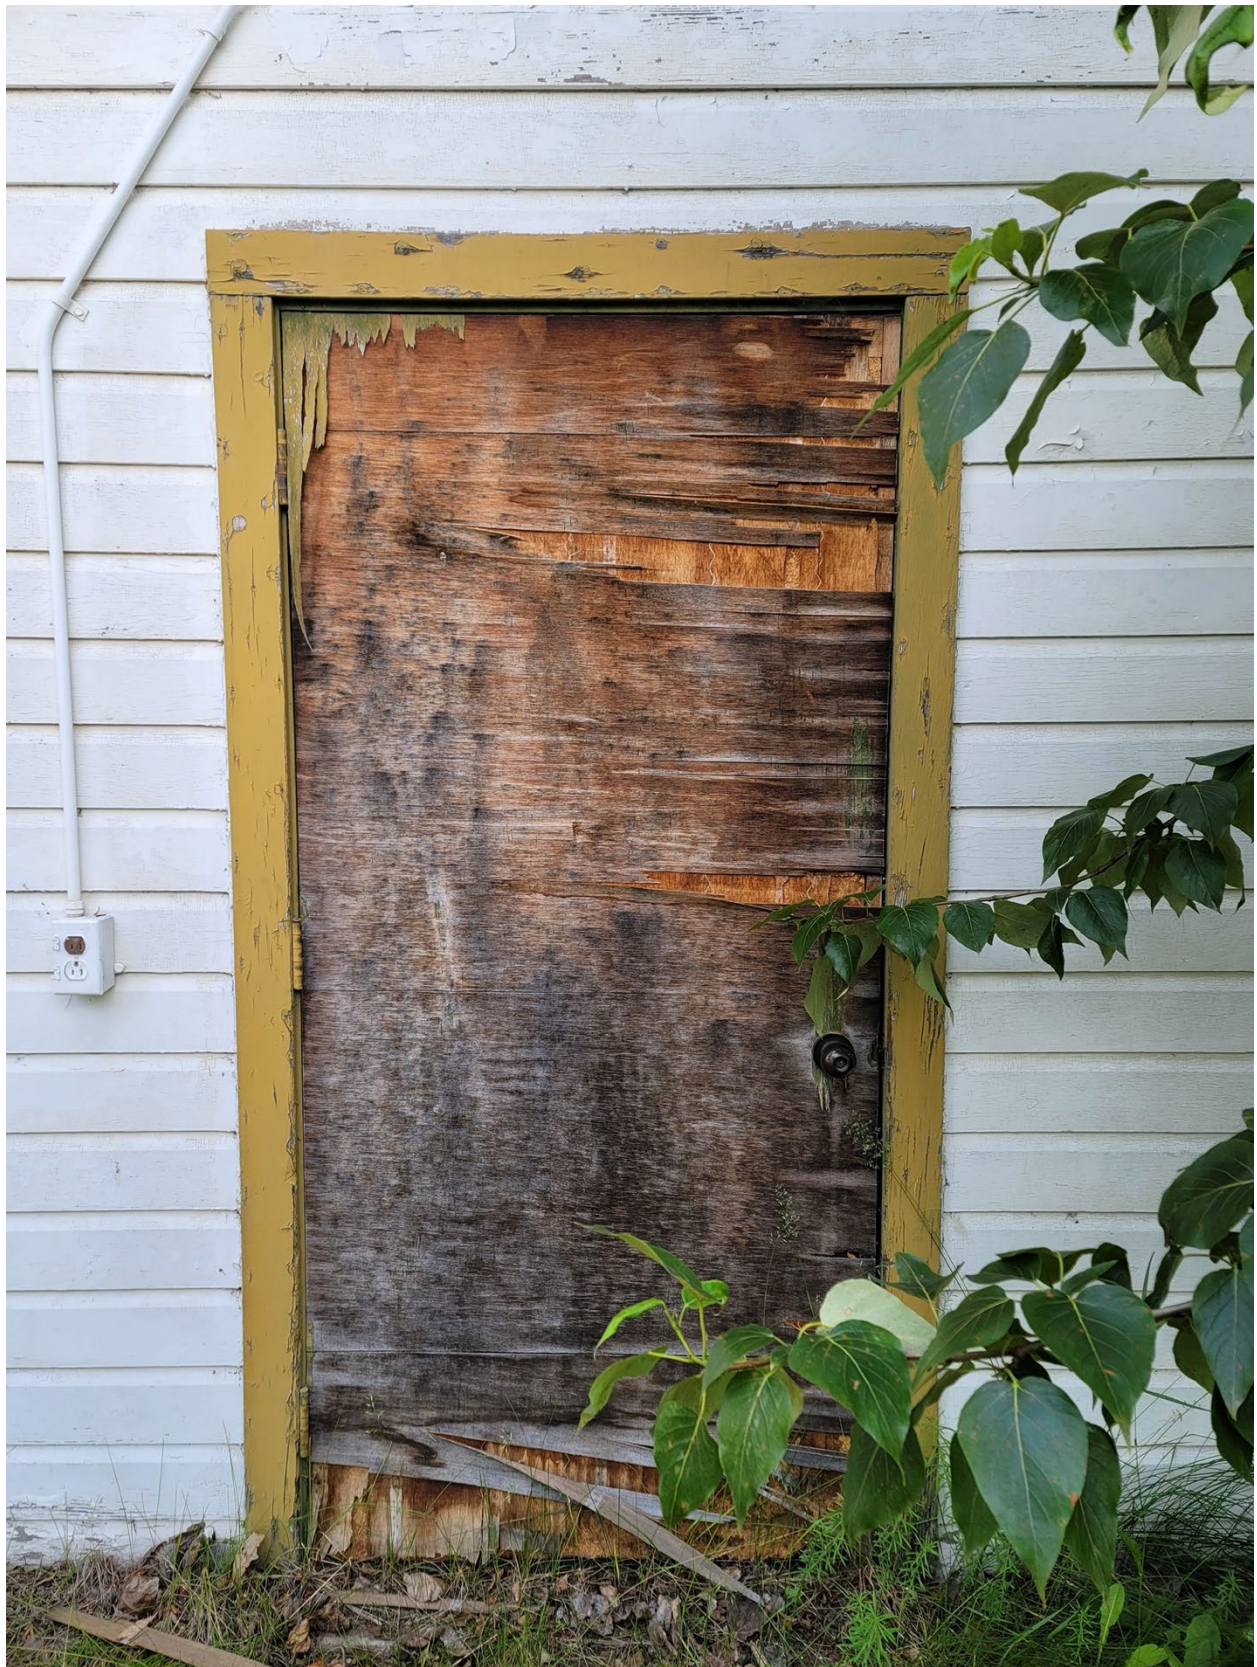
Figure B36. Detail photograph of the door in the southwest facade of the addition of Building B. The photograph shows the significant deterioration of the door material (©TNSDS 2023).

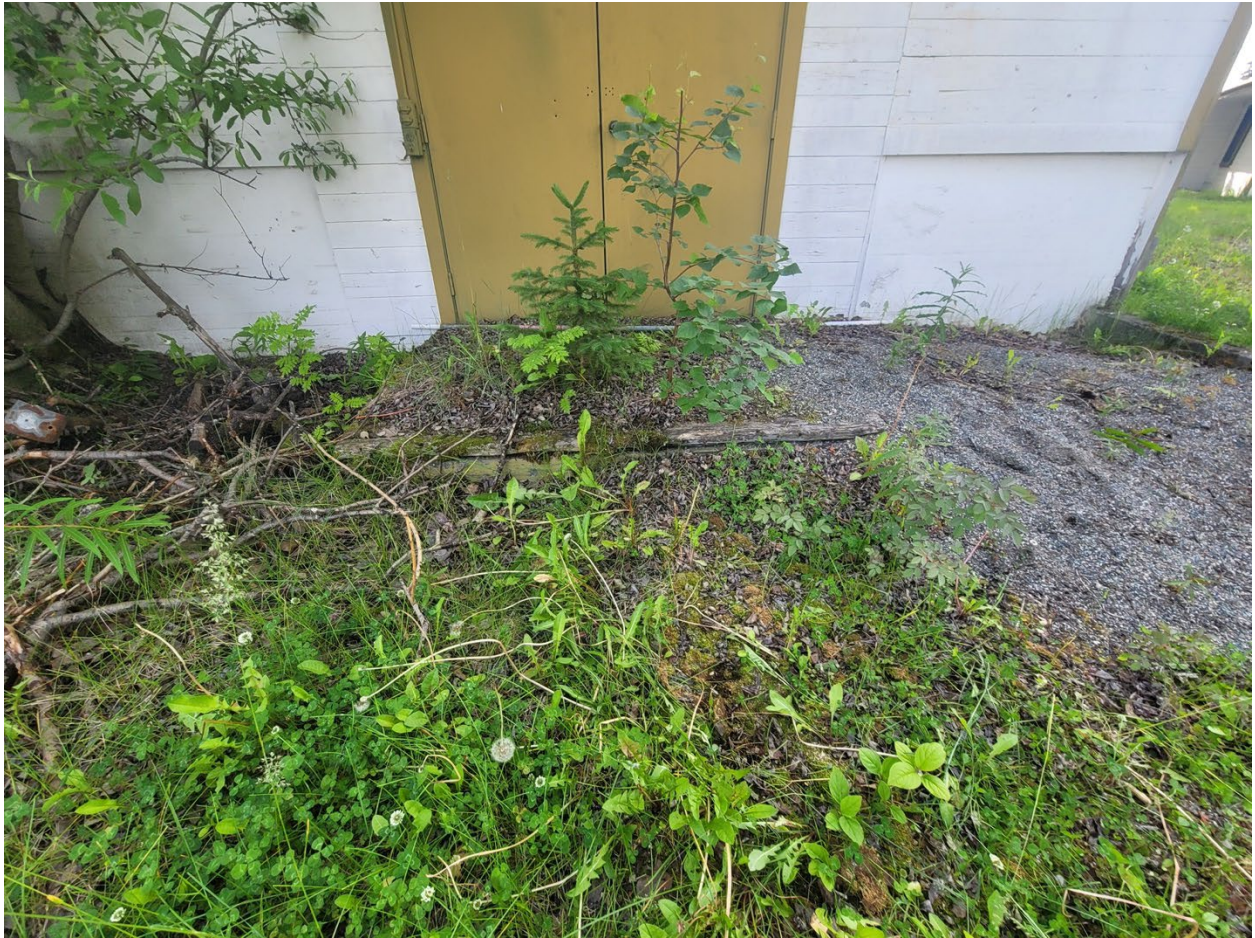
Figure B43. Detail photograph showing the deteriorated, wood framed porch or stoop located in front of the entrance in the northwest façade of the long axis of Building B (©TNSDS 2023).

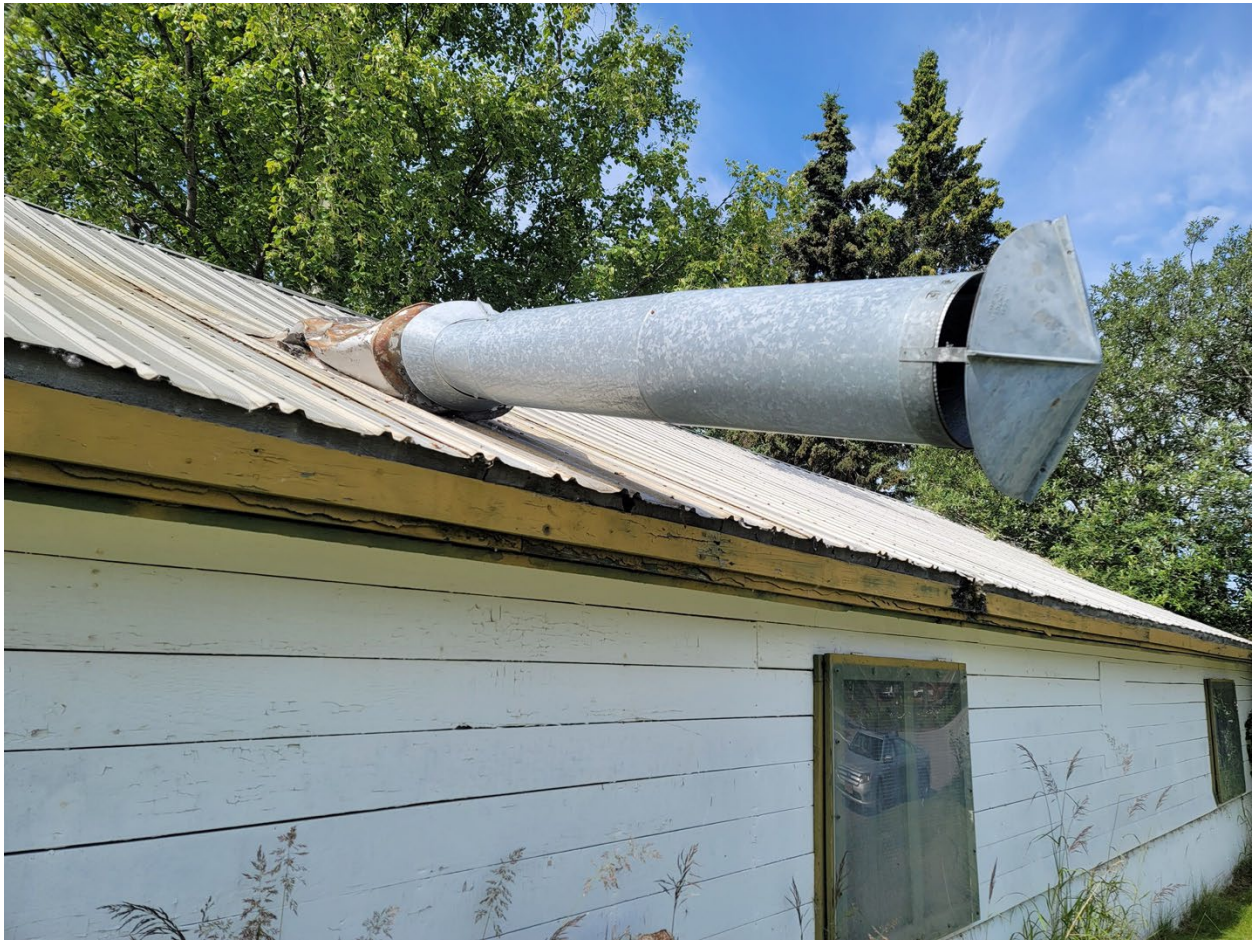
Figure B47. Detail photograph of the collapsed chimney on Building B (©TNSDS 2023).

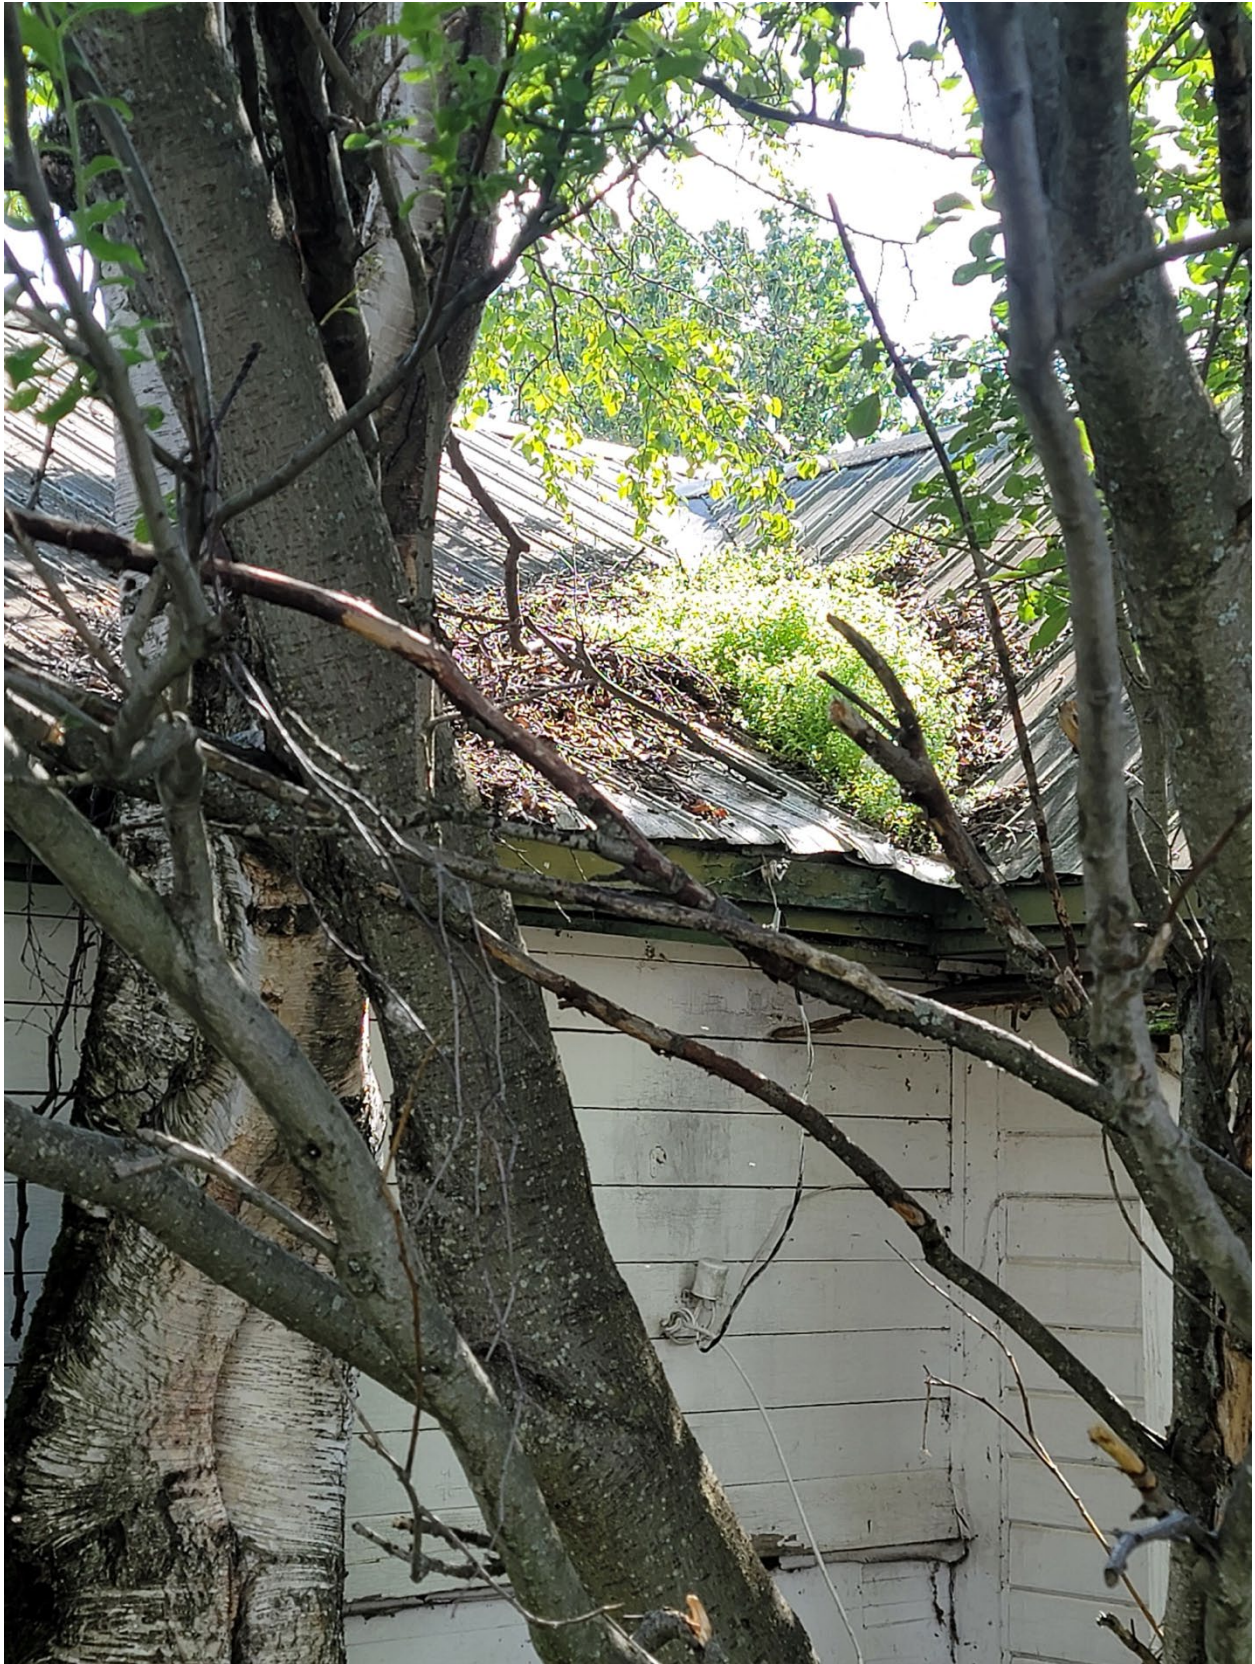
Figure B49. Detail photograph of the junction of the two sections of Building B. The photograph shows the roofing material, surrounding vegetation, and the vegetative debris growing on the roof valley (©TNSDS 2023).

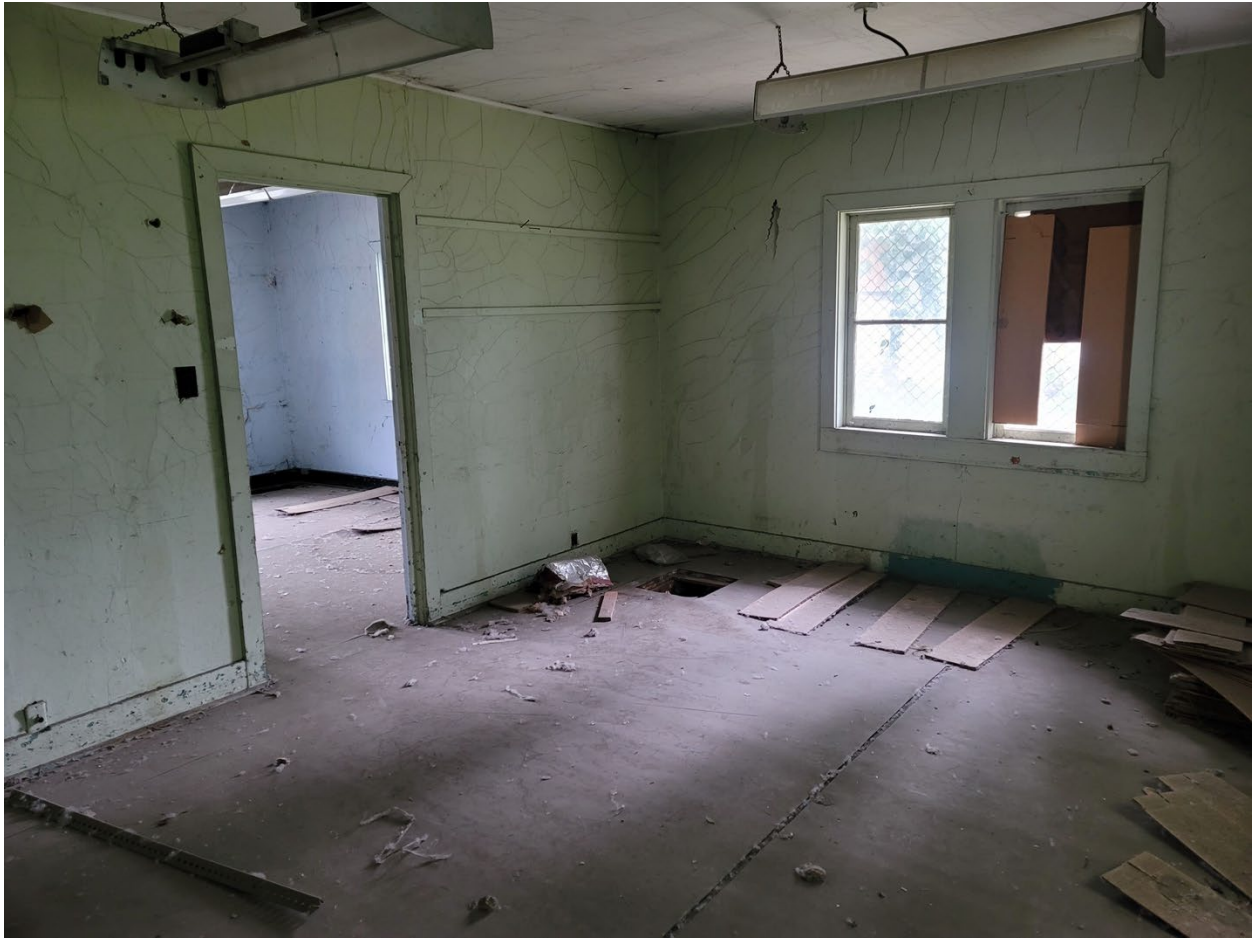
Figure B51. Interior of the northernmost rooms in Building A. The photograph shows the holes and cracks in the flooring and wall finishes (©TNSDS 2023).
