Appendix B: Photographs

Documentation of Present Appearance

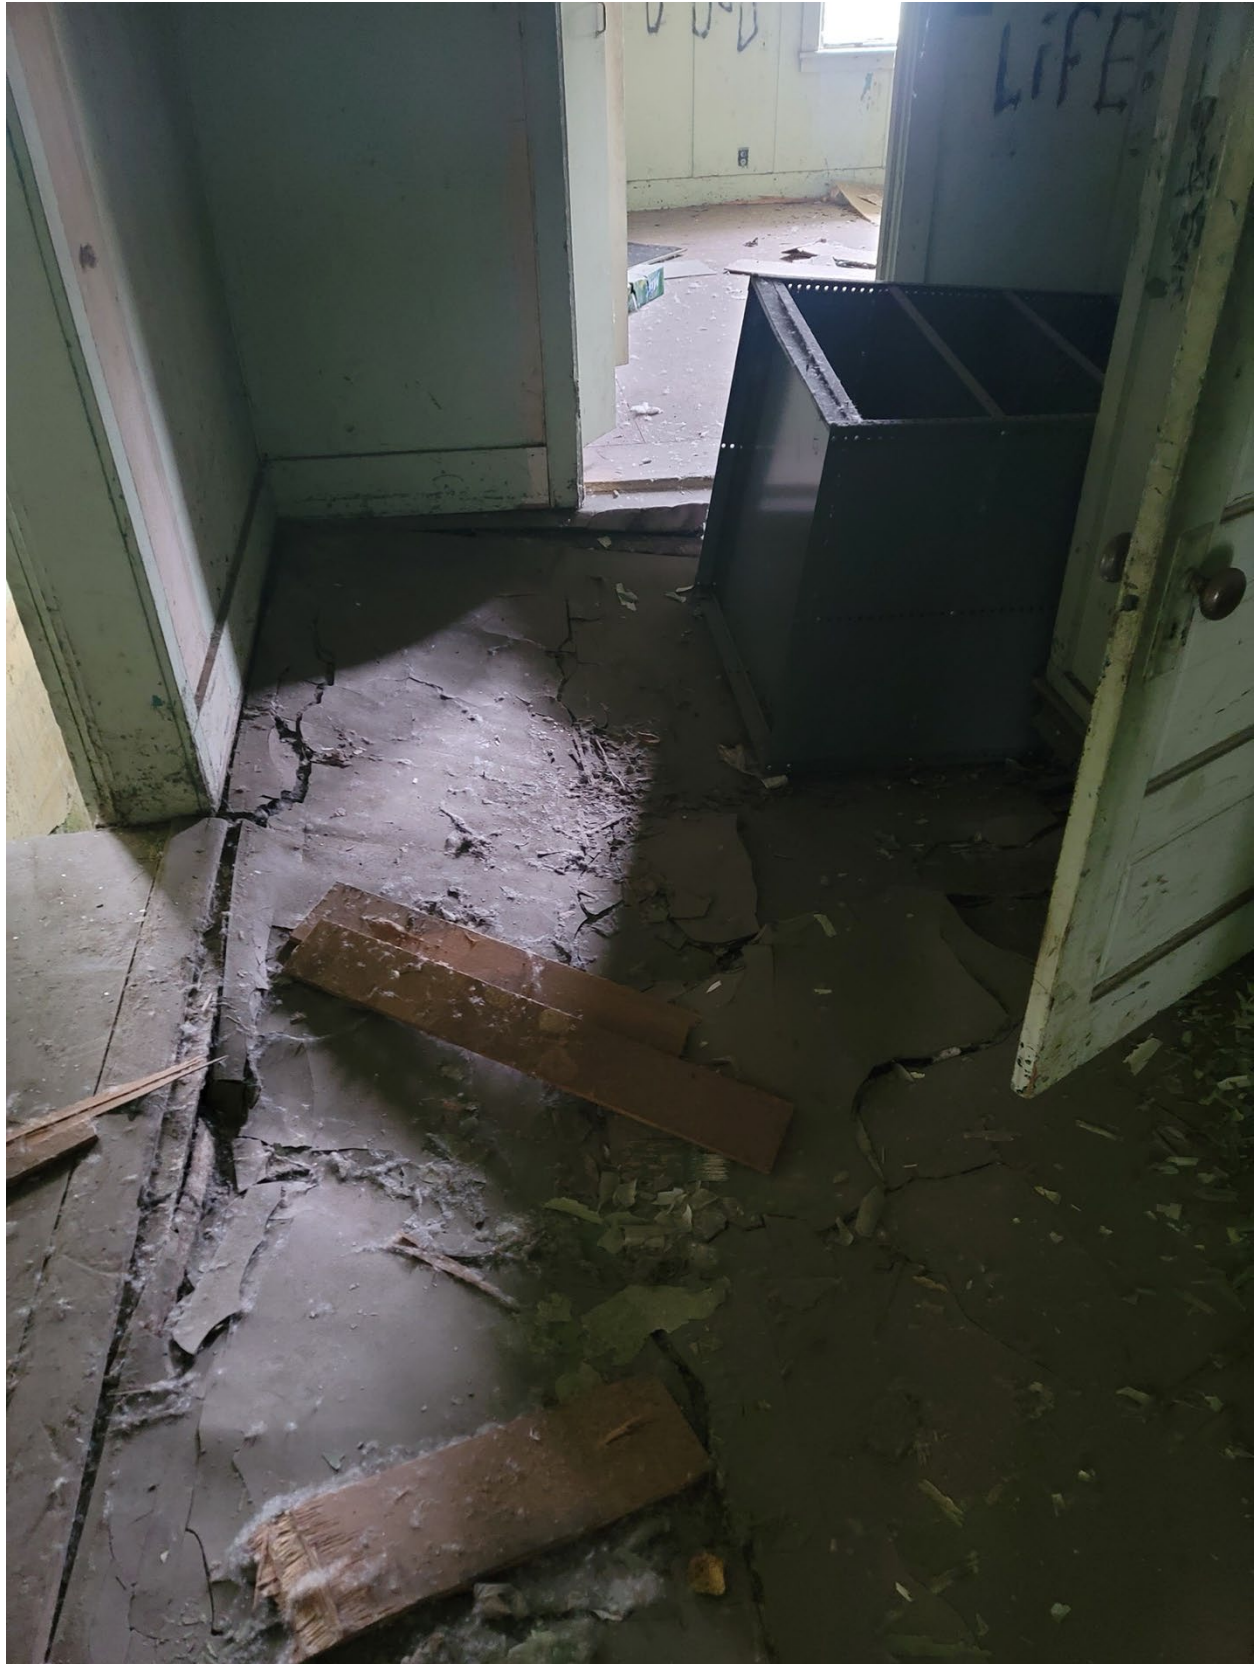
Figure B54. Photograph of one of the collapsed floors in Building A (©TNSDS 2023).

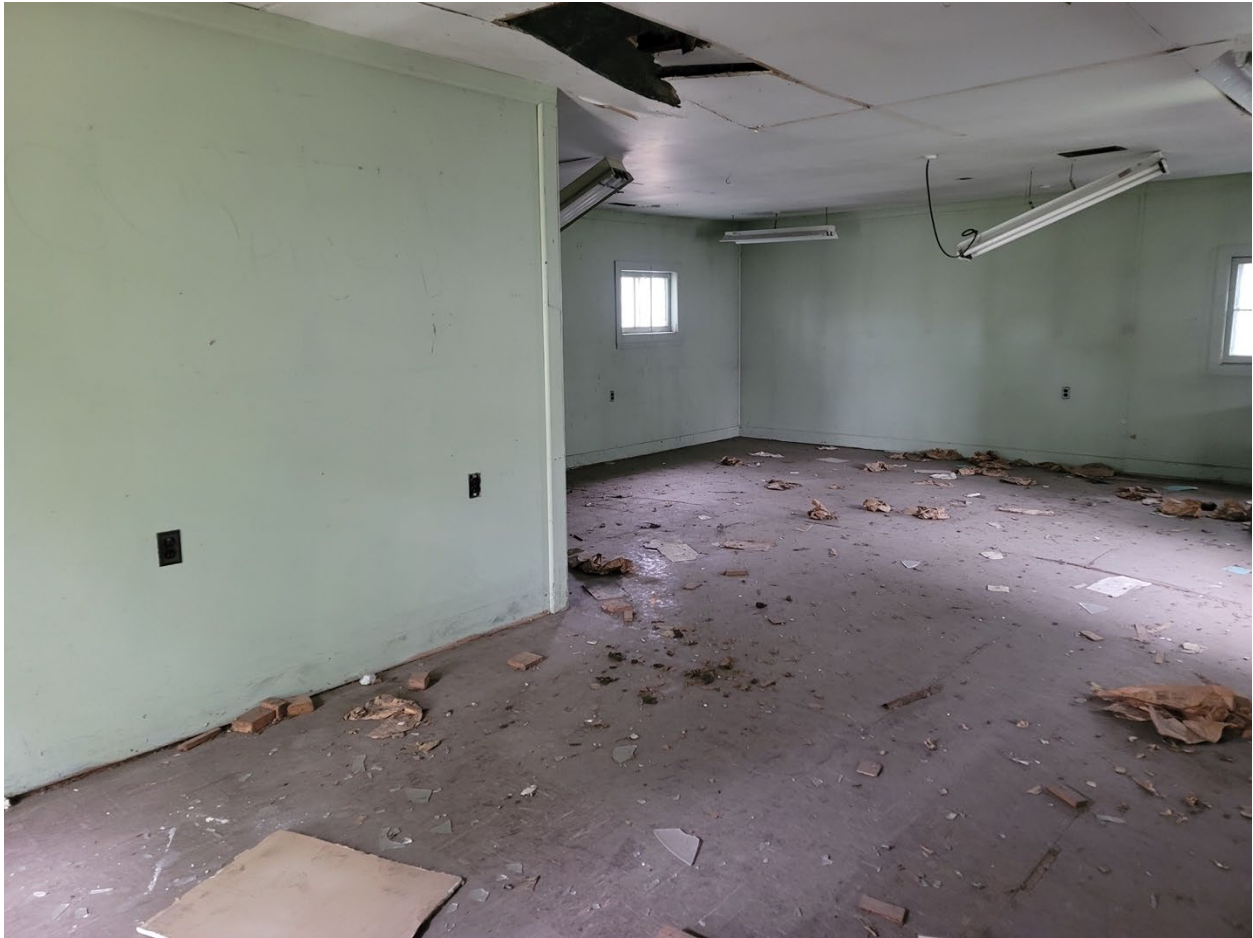
Figure B55. View of the interior of Building C, showing the flooring, wall finishes, and deteriorating ceiling (©TNSDS).

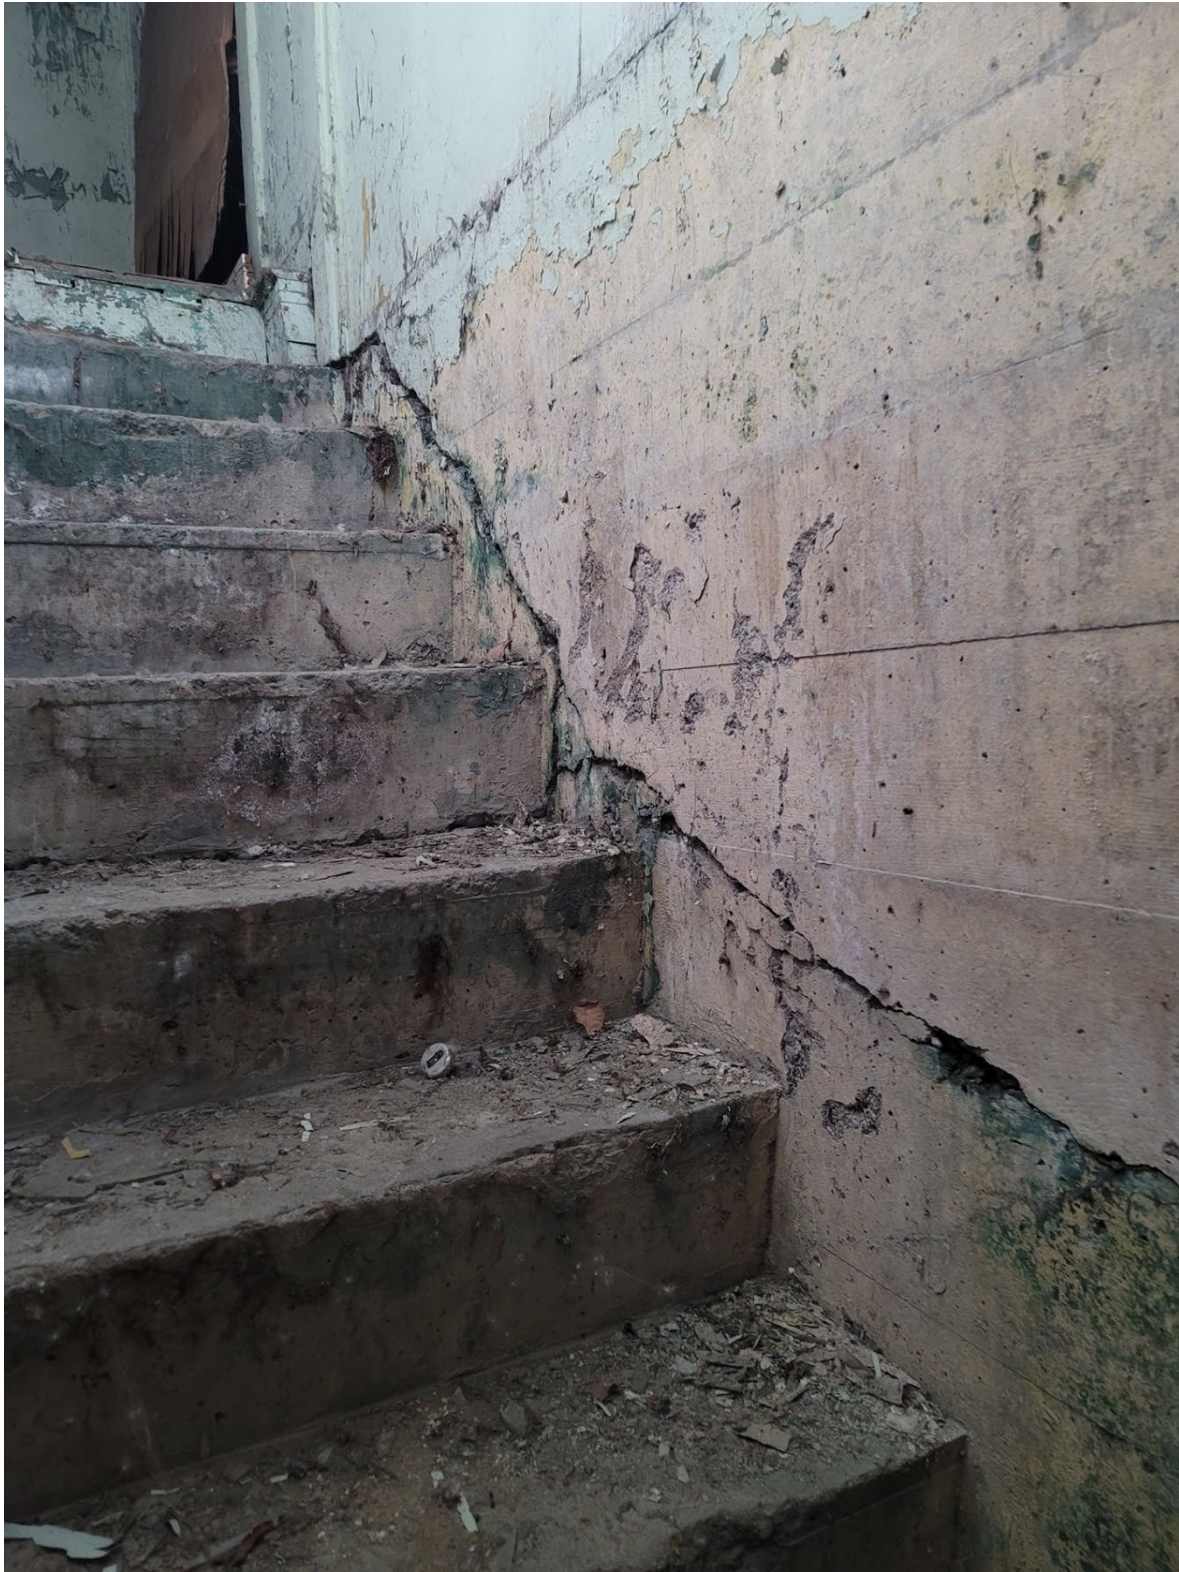
Figure B56. Detail photo of the stairs that lead from the interior of Building A to the basement in the south addition. The photograph shows the slope of the crack paralleling the stair slope as well as spalling, vegetative growth, and staining from water infiltration (©TNSDS 2023).
