Historic Structure Report (HSR) for the Government Hill Wireless Station (ANC-00306)

July 25, 2024

Prepared for the Municipality of Anchorage

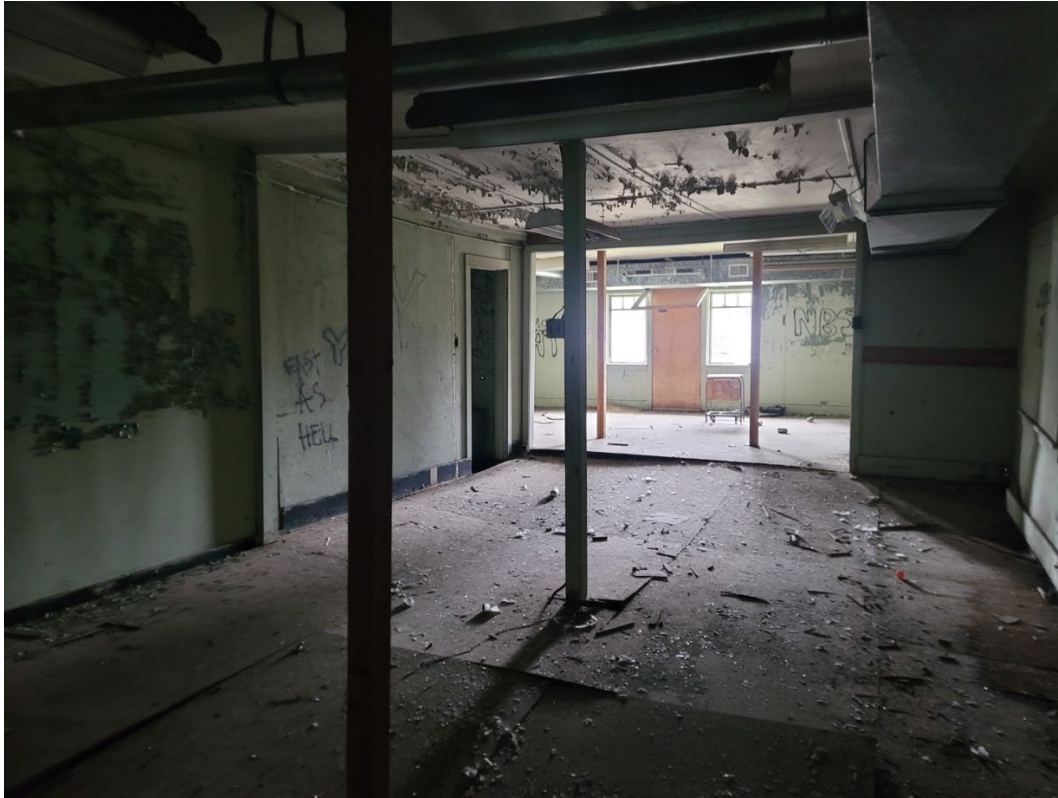
Figure 12: Photograph of the interior of the southern rooms in Building A (2023)

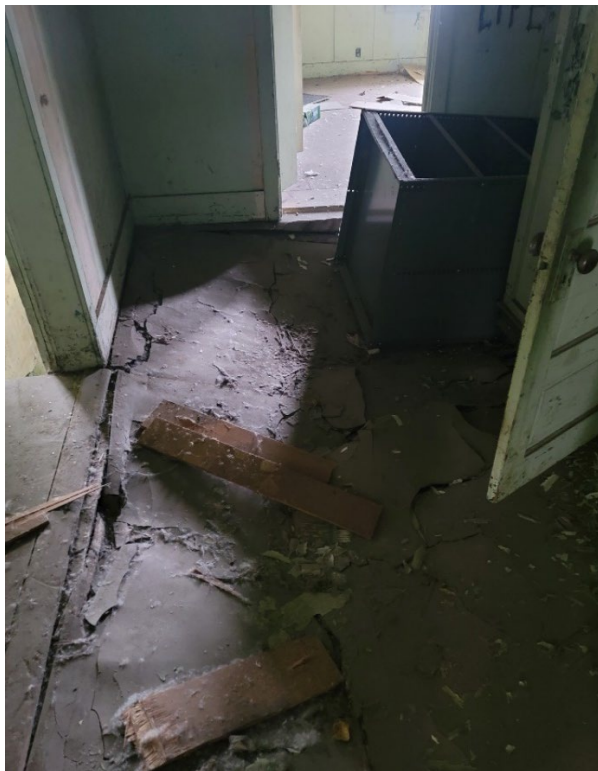
Figure 13. A collapsed floor in Building A (2023)

The 1997 environmental site assessment (Appendix E) reported that the flooring along the west wall had subsided along the entire 28-foot length of the original building. The slumping of the west wall of the original structure was also evident at the eave line. It also reported that the flooring structure had failed in the northeast corner of the building due to dry-rot damage. The report observed that the crawl spaces of Building A (and the other buildings) were shallow and unventilated, with water infiltration occurring resulting in floor joist decay, or “dry-rot.” In addition to the lack of crawl space venting, the absence of building heating in recent decades likely contributed to the damage.³⁰

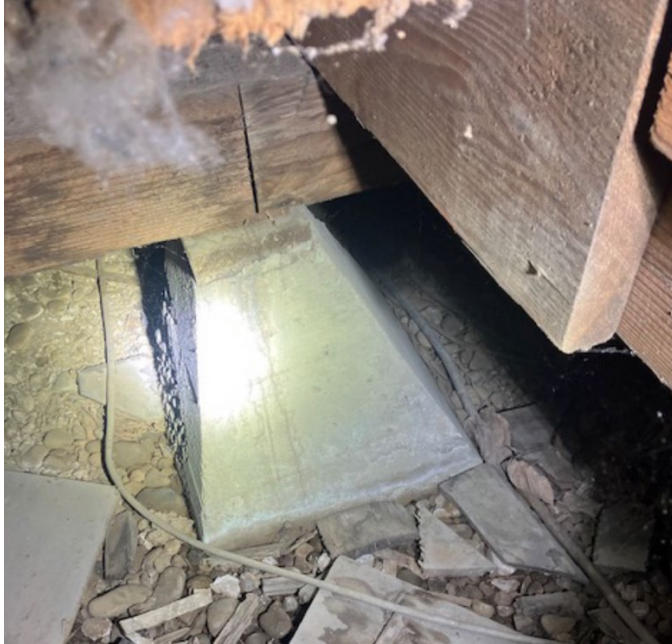
Figure 13. One of the pyramidal concrete piers below the central portion of Building A (2023).)

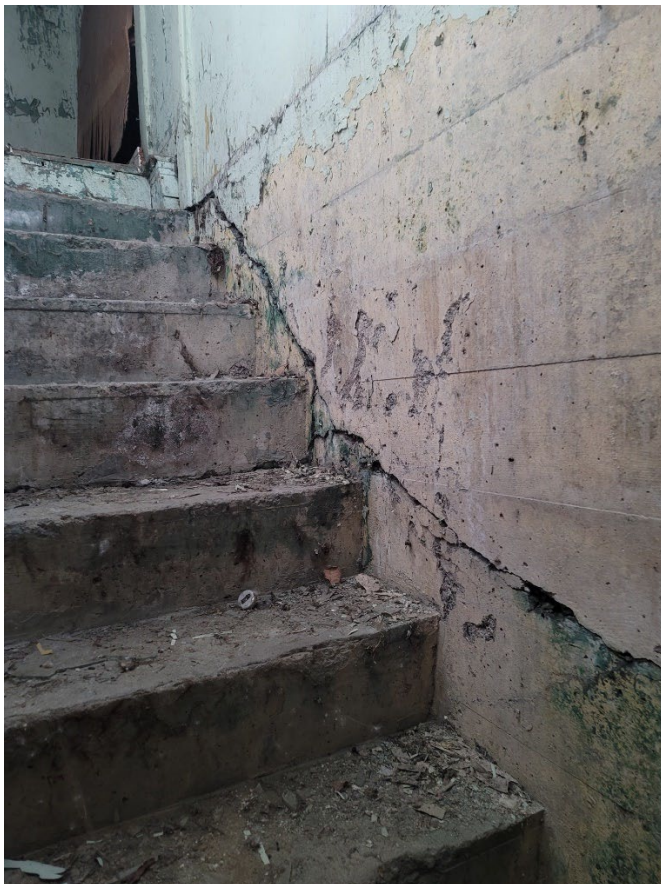
Figure 14. The stairwell to the basement in the south addition of Building A. A crack parallels the stair slope as well as spalling, vegetative growth, and staining from water infiltration (2023).

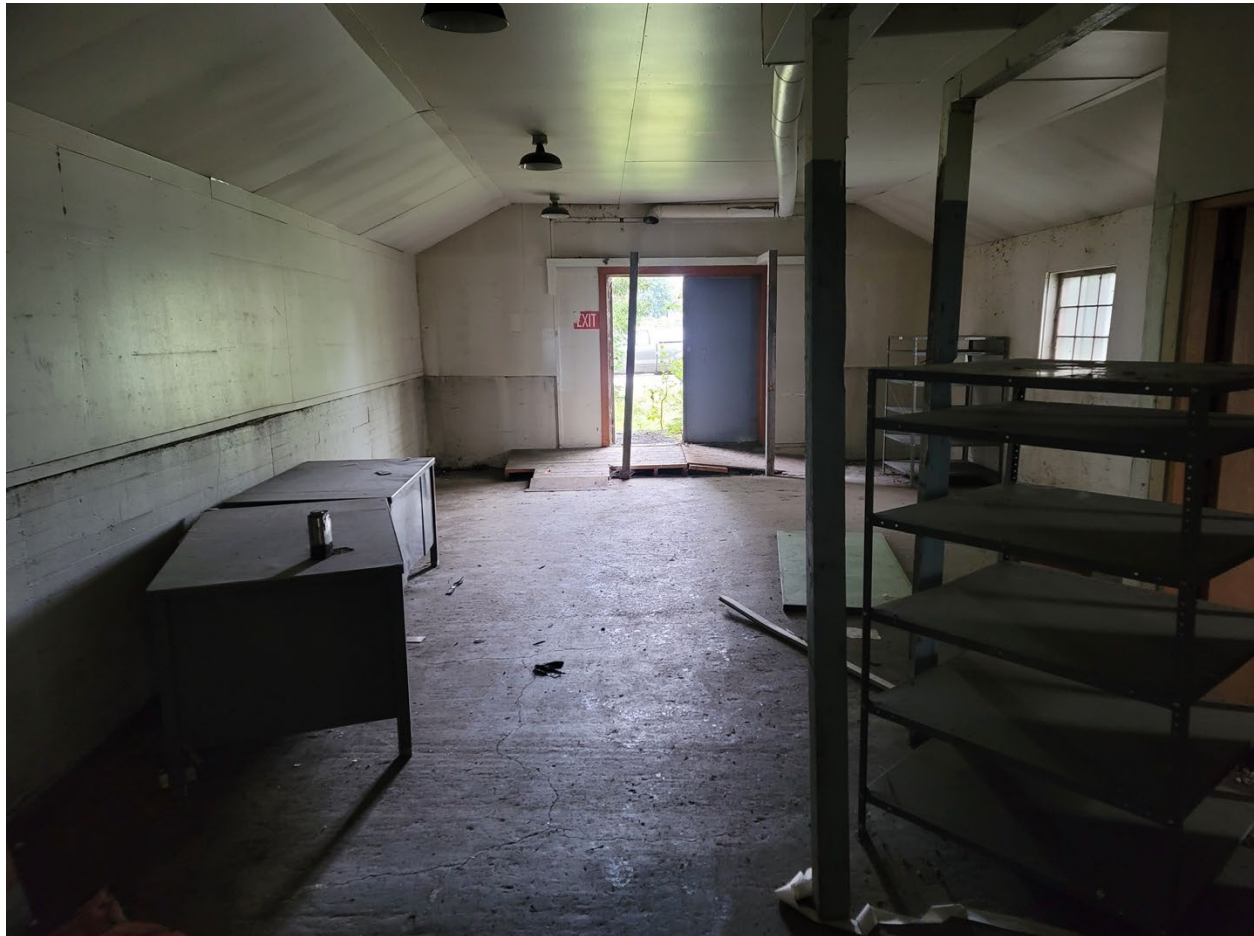
Building C and the north section of the long axis of Building B is more stable; the floor in this section of Building B is the bare concrete slab foundation, ensuring that it is structurally stronger than its corresponding framing members. It may not be necessary to replace the flooring in the northern section of Building B.

Figure 20. Bare concrete foundation serves as the floor in the northernmost section of Building B (2023).

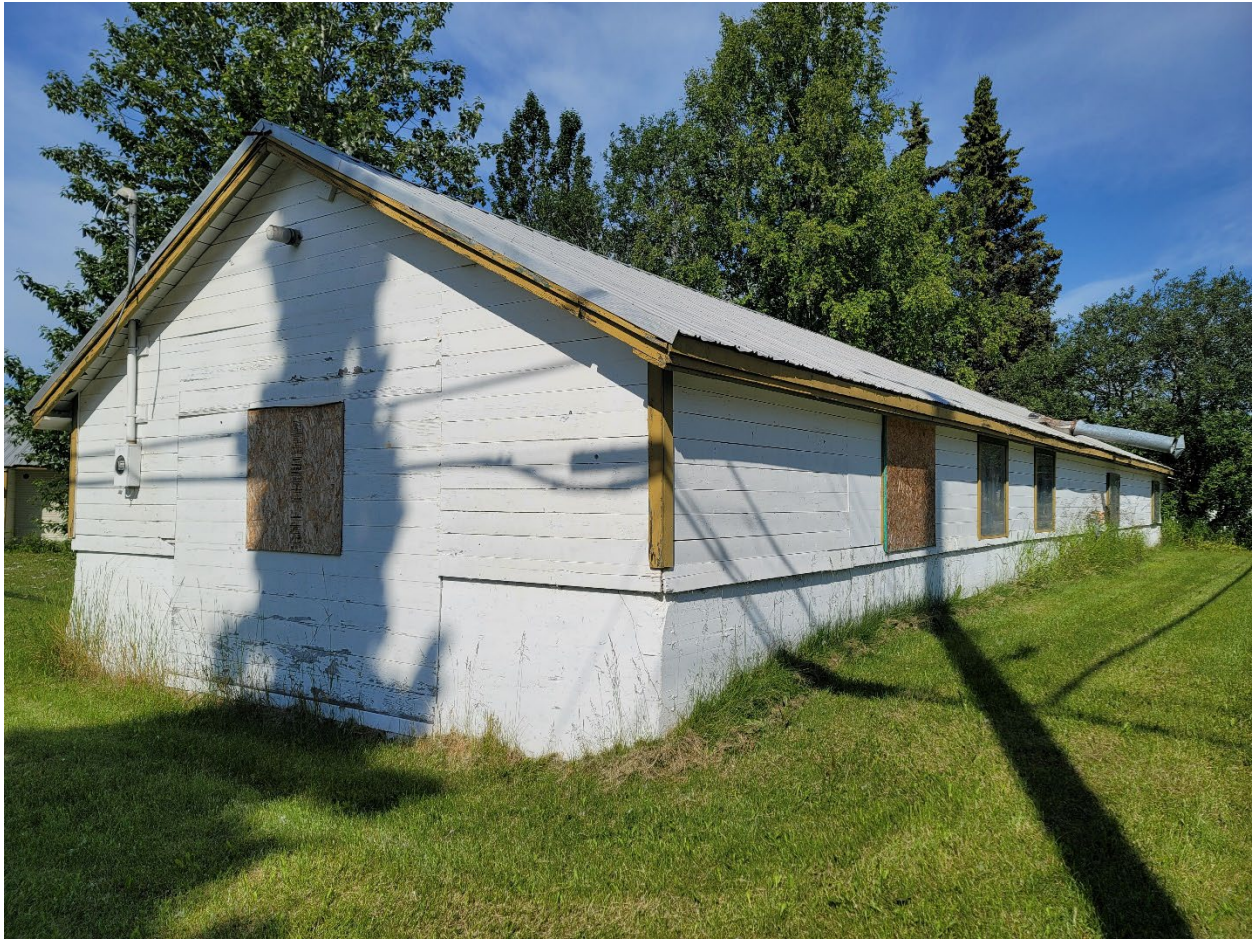
Figure 22: Building B viewed from the south-southeast

The structural report notes that the roof framing on Building B has deteriorated to the point where the estimated snow load is limited to 15 pounds per square foot. This is significantly less than the required 40 pounds per square foot required by municipal building codes. As previously discussed, the framing can be replaced by new framing members, if they are made of wood and have the same form as the original members. It is recommended that this approach be taken to ensure that the roof and the building both survive.

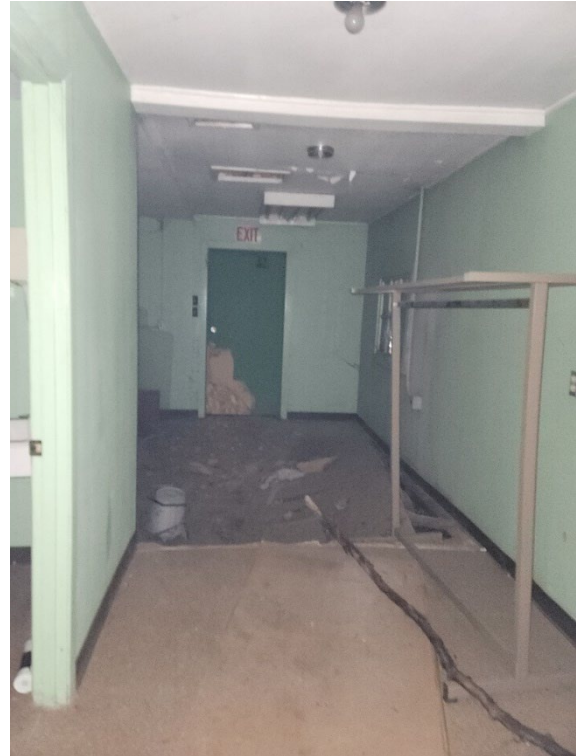
Figure 24: Building B interior, looking into the stem of the "T."

The treatment recommendations for the interior walls of all buildings are aggressive by necessity and falls under the restoration treatment guidelines. If possible, more research should be undertaken to determine what finish materials were present during the period of significance, and all other post-period materials should be removed. All deteriorated finish materials should be removed as well, which will expose nearly all the interior framing for inspection and repair as necessary. The replacement finish materials should follow the same types of materials as were originally installed in the building, even though this may mean replacing plywood panels with more permanent finish materials. All replacement materials should be modeled after original finishes.⁶¹

It should be noted that the extent of interior wall repair will be dictated by the proposed future use of the buildings. Reconfiguration of the interior spaces to adapt to a new use is allowed under *The Secretary of the Interior Standards for the Treatment of Historic Properties*, as the existing spaces do not contribute to the historic integrity of the buildings.
