MUNICIPALITY OF ANCHORAGE

Policy S.12 Wood Truss Roof Framing Due Diligence Investigation

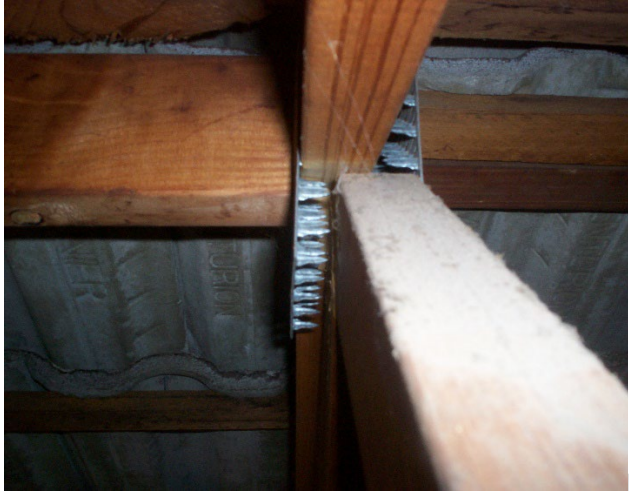
Item A: Incomplete plate connection.

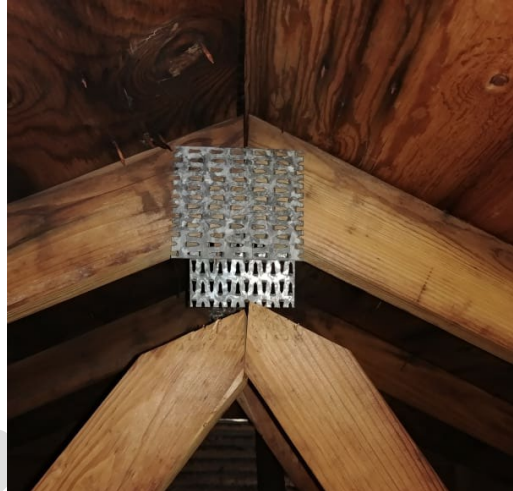
Item B: Fully detached plates.

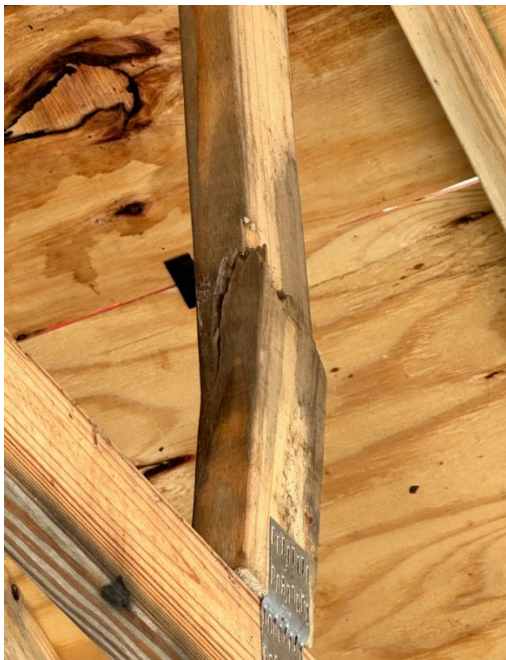
Item C: Web chord broken (likely during construction).

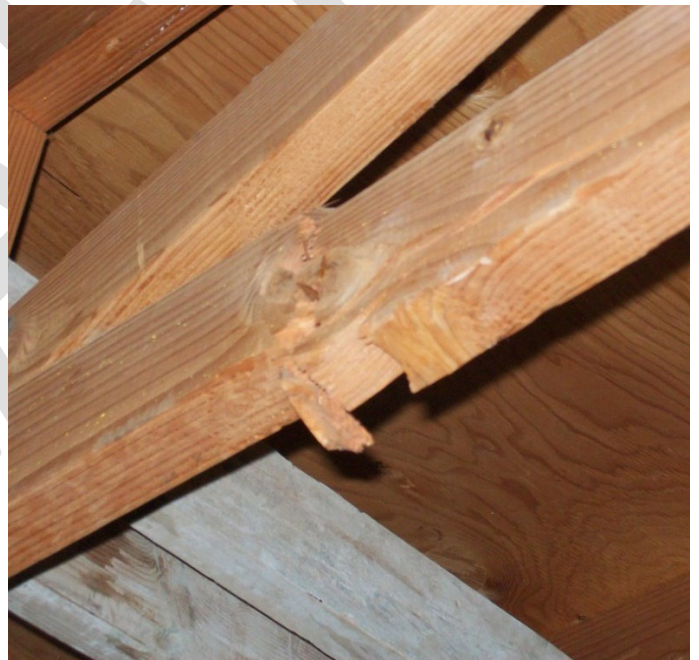
Item D: Bottom chord failure at large knot.

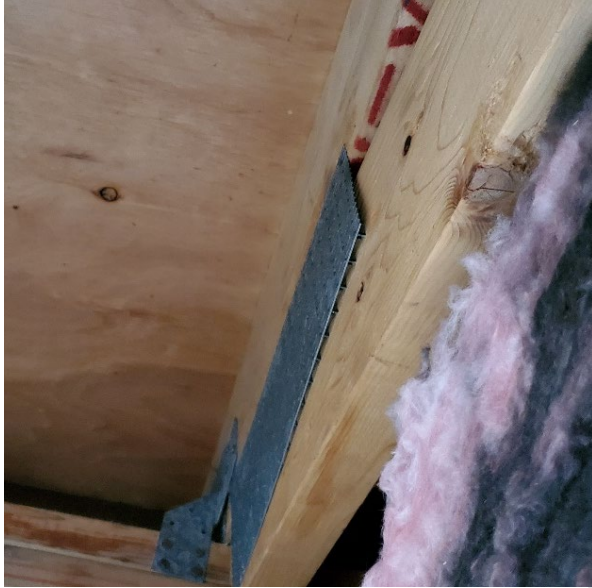
Item E: Truss plate peeling (maximum gap of plate allowed = 1/32", TPI 1-2014).

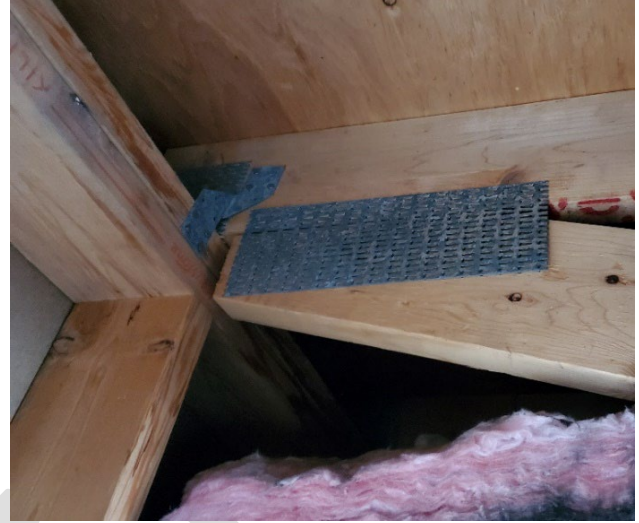
Item F: Truss plate not extending high enough at bearing location (beyond middle depth of the top chord at a minimum)

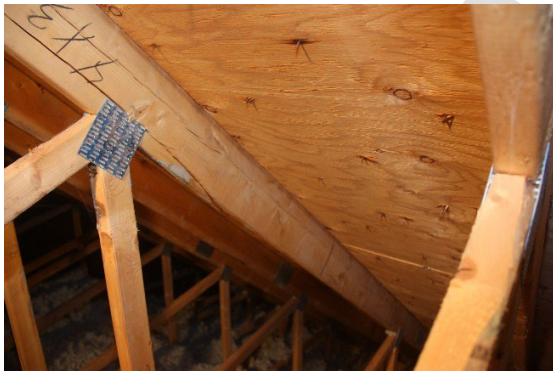
Item G: Example of short truss plate causing cross grain tension failure of truss top chord.

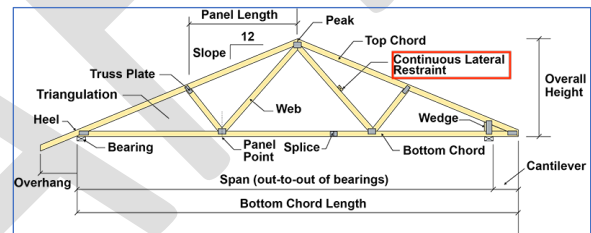
Item H: Continuous lateral restraint on a web member, typically required on 2x compression members longer than 6 feet.

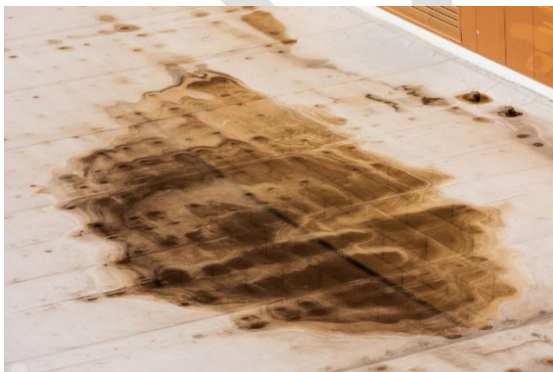
Item I: Evidence of ponding, dark stains from standing water away from drainage systems.

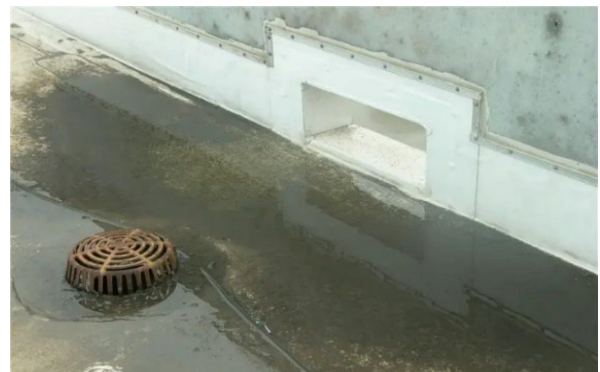
Item J: Primary roof drain next to secondary roof scupper. It is not required that they be next to each other.
