# EERI Earthquake Reconnaissance Report: M7.1 Anchorage Earthquake on November 30, 2018

Wael M. Hassan, John Thornley, Janise Rodgers, and Christopher Motter

July 2021

*A product of the EERI Learning from Earthquakes Program*

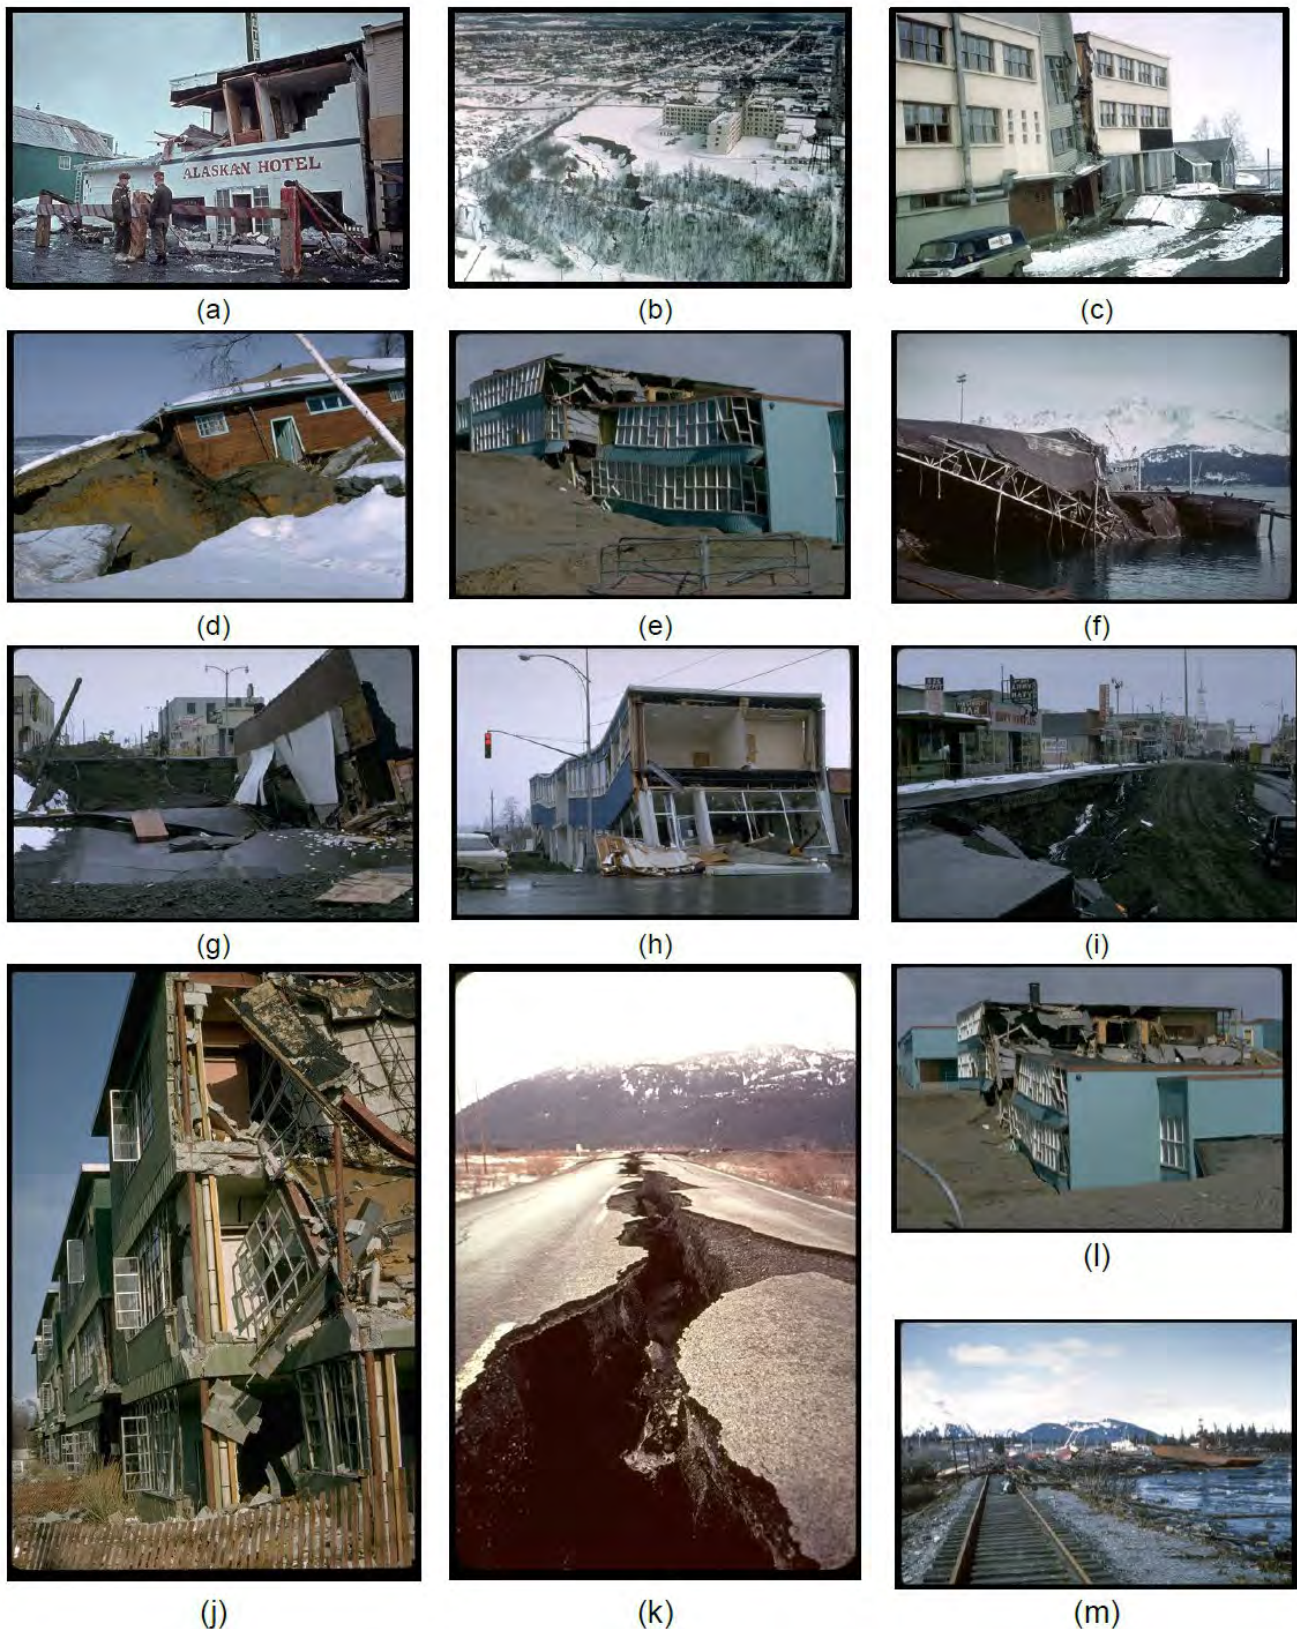
Figure 2.4. Major damage resulted from the 1964 M9.2 Earthquake (source: Mosalam et al., 2018<sup>44</sup>; National Information Service of Earthquake Engineering NISEE).

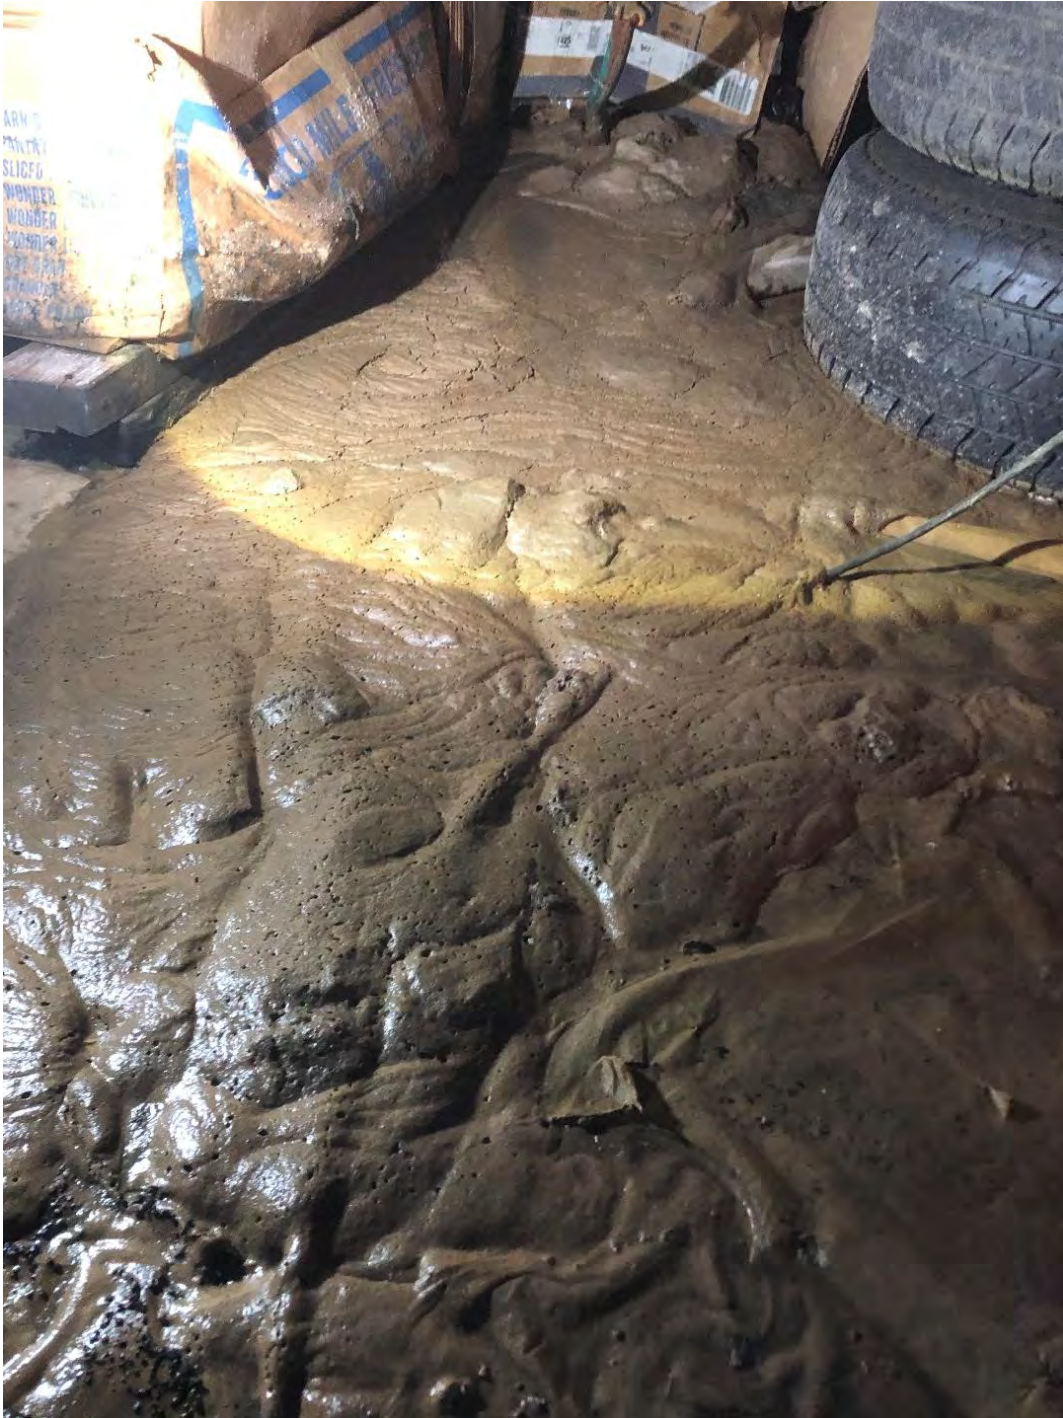
Crawl spaces below the ground level floor of residential structures are common within Southcentral Alaska. In areas affected by liquefaction, numerous homeowners found fine sand had filled portions of crawl spaces (Figure 3.1). In other homes where basement floors consisted of a concrete slab on grade construction, fine sand was found to have come through the joints (Figure 3.2) at the edge of the floor slab, and obvious settlement of the concrete slab was observed (Figure 3.3). Settlement of shallow foundations was also observed, and door and window openings were askew. Utility services, especially for gravity-fed sewer lines, were also impacted, and repairs were required to reestablish proper flow direction (Figure 3.4).

*Figure 3.1. Liquefaction sand ejecta in residential crawl space (photo: Howard Weston).*

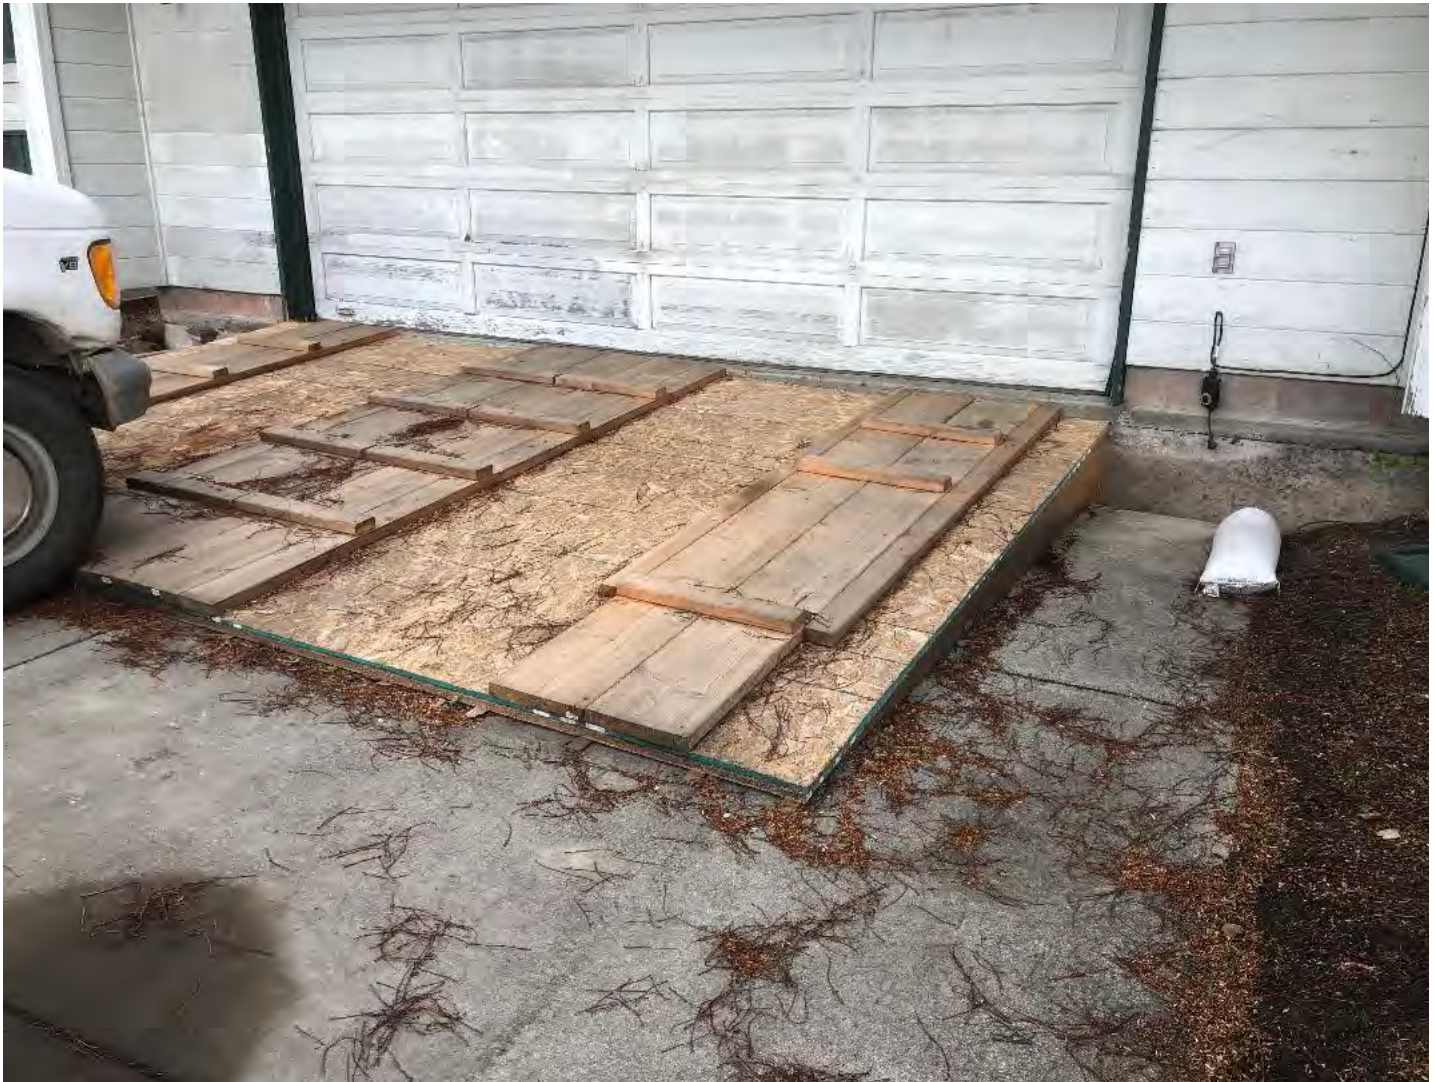
Figure 3.5. Driveway settlement at a residential driveway (photo: Howard Weston).

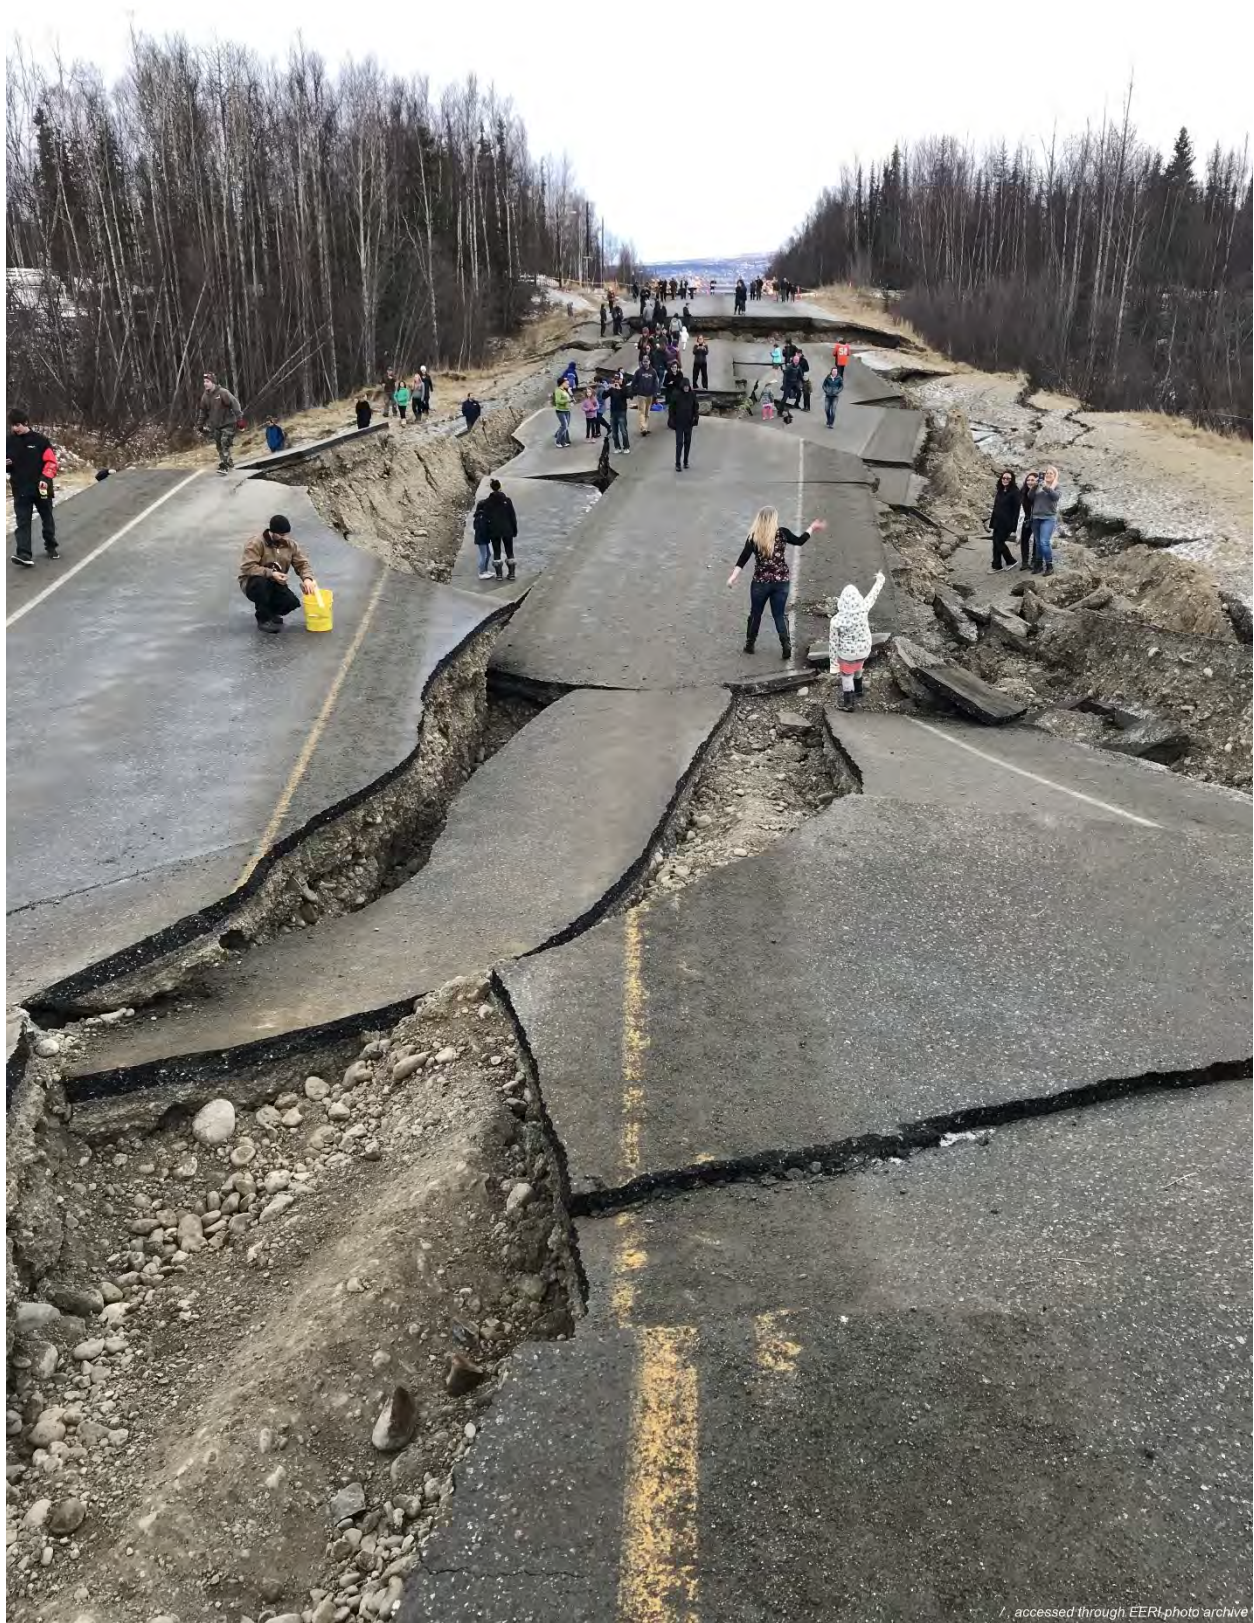
failure mechanisms, it appears that in both cases the foundation soils failed and caused rotational failures of the overlying embankments.

Figure 3.6. Vine Road failure (photo: Earthquake Engineering Research Institute (EERI) Clearinghouse).

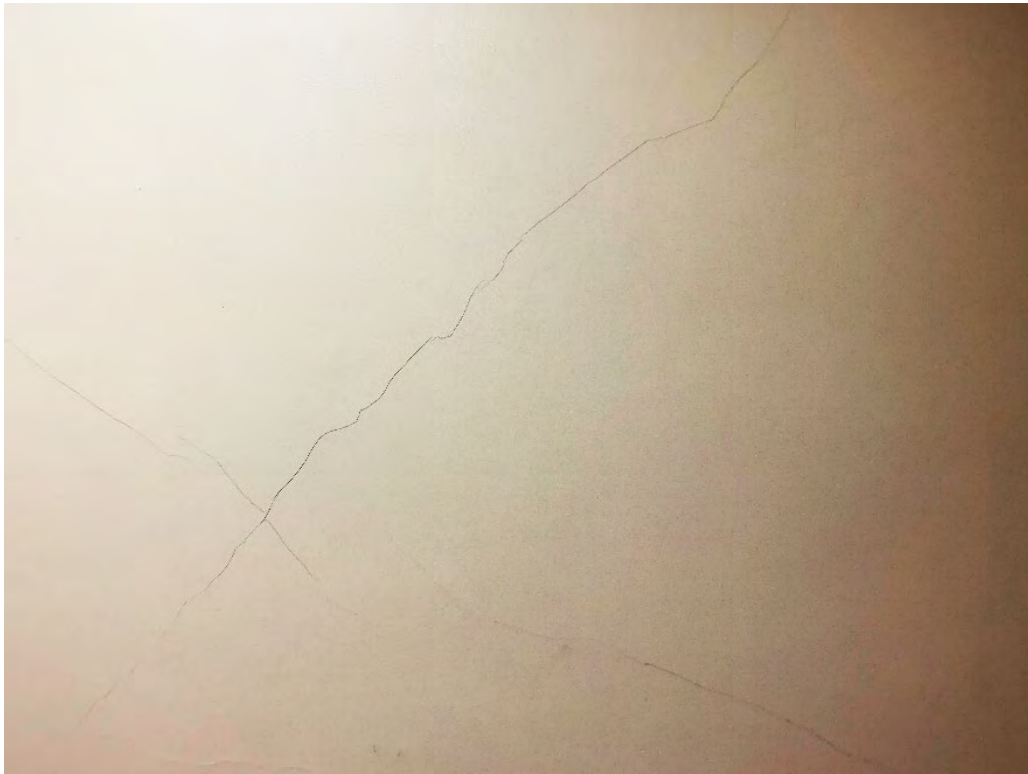
The most common observed structural damage was shear cracking in structural walls, flexural and shear cracking in some girders, flexural and splitting cracking in columns, slab-on-grade cracking, and flexural cracking in topping slabs in composite construction. In particular, diagonal and cross shear cracks in concrete shear walls, especially in older construction, were observed in several buildings, including schools, hospitals, and office buildings. In some of these buildings, structural review found these walls to be under-designed. Figures 4.13 and 4.14 show concrete shear wall extensive shear cracking in a hospital and a school buildings in Anchorage and Mat-Su, respectively. Vertical cracks and diagonal cracks in concrete walls around openings were also observed. The hospital building shear wall cracks in Figure 4.14 were concentrated in the core wall over the first two stories on both faces of each individual wall of the building core wall.

*Figure 4.13. Concrete core wall with cross shear cracks in a multistory Anchorage building (photos: Wael Hassan).*

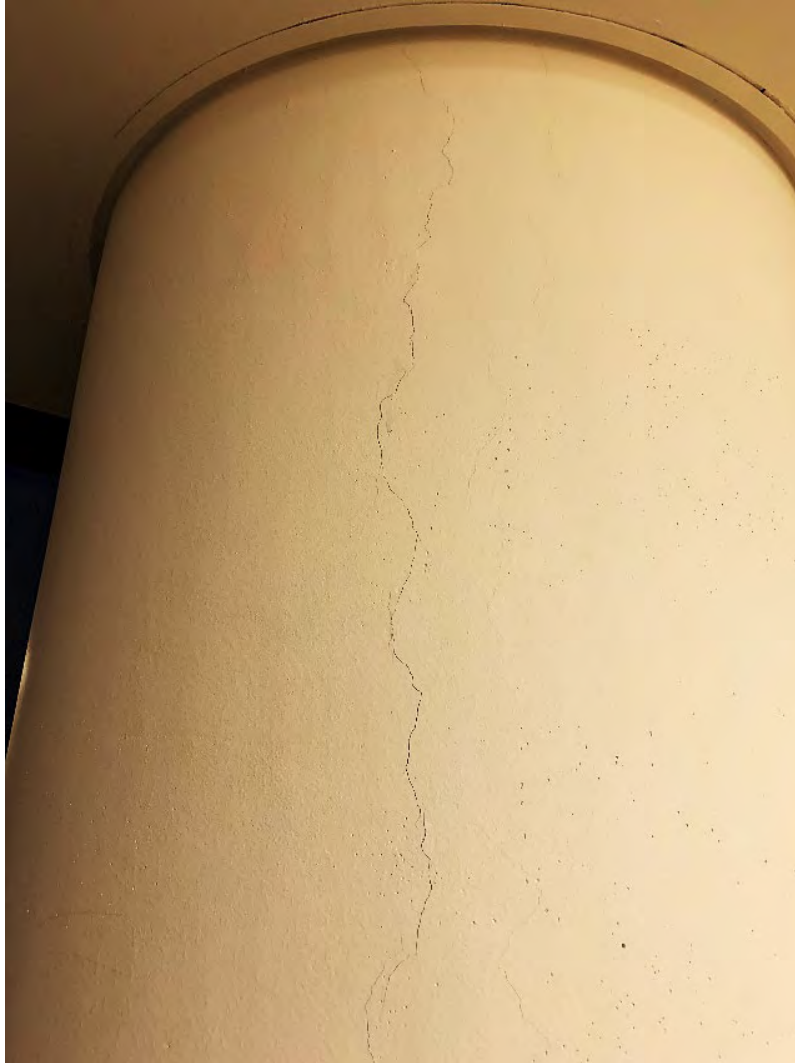
Vertical-column splitting cracks in moment-resisting concrete frames were observed in a few cases. The Frontier Building in Anchorage is worth mentioning. The 14-story 1981 moment-resisting-frame concrete building experienced hairline to minor overstressing concrete cover splitting cracks in many of the circular exterior and corner columns at stories three, four, and five (Figure 4.16). The crack length ranged from 3 inches to 20 inches, while the crack width was about 1/32 to 1/16 of an inch. The estimated fundamental period of the building (Çelebi, 2020<sup>9</sup>) is 2.2 seconds. The building experienced a relatively low PGA of 0.193g; however, the shaking was strong, perhaps because of its relatively higher stiffness as a concrete-frame building. A few other examples for concrete column–overloading splitting and flexural cracks are depicted in Figure 4.17.

*Figure 4.16. Typical splitting crack in exterior-column cover. Most exterior and corner columns on levels one through three exhibited such cracks with variable sizes (photo: Wael Hassan).*

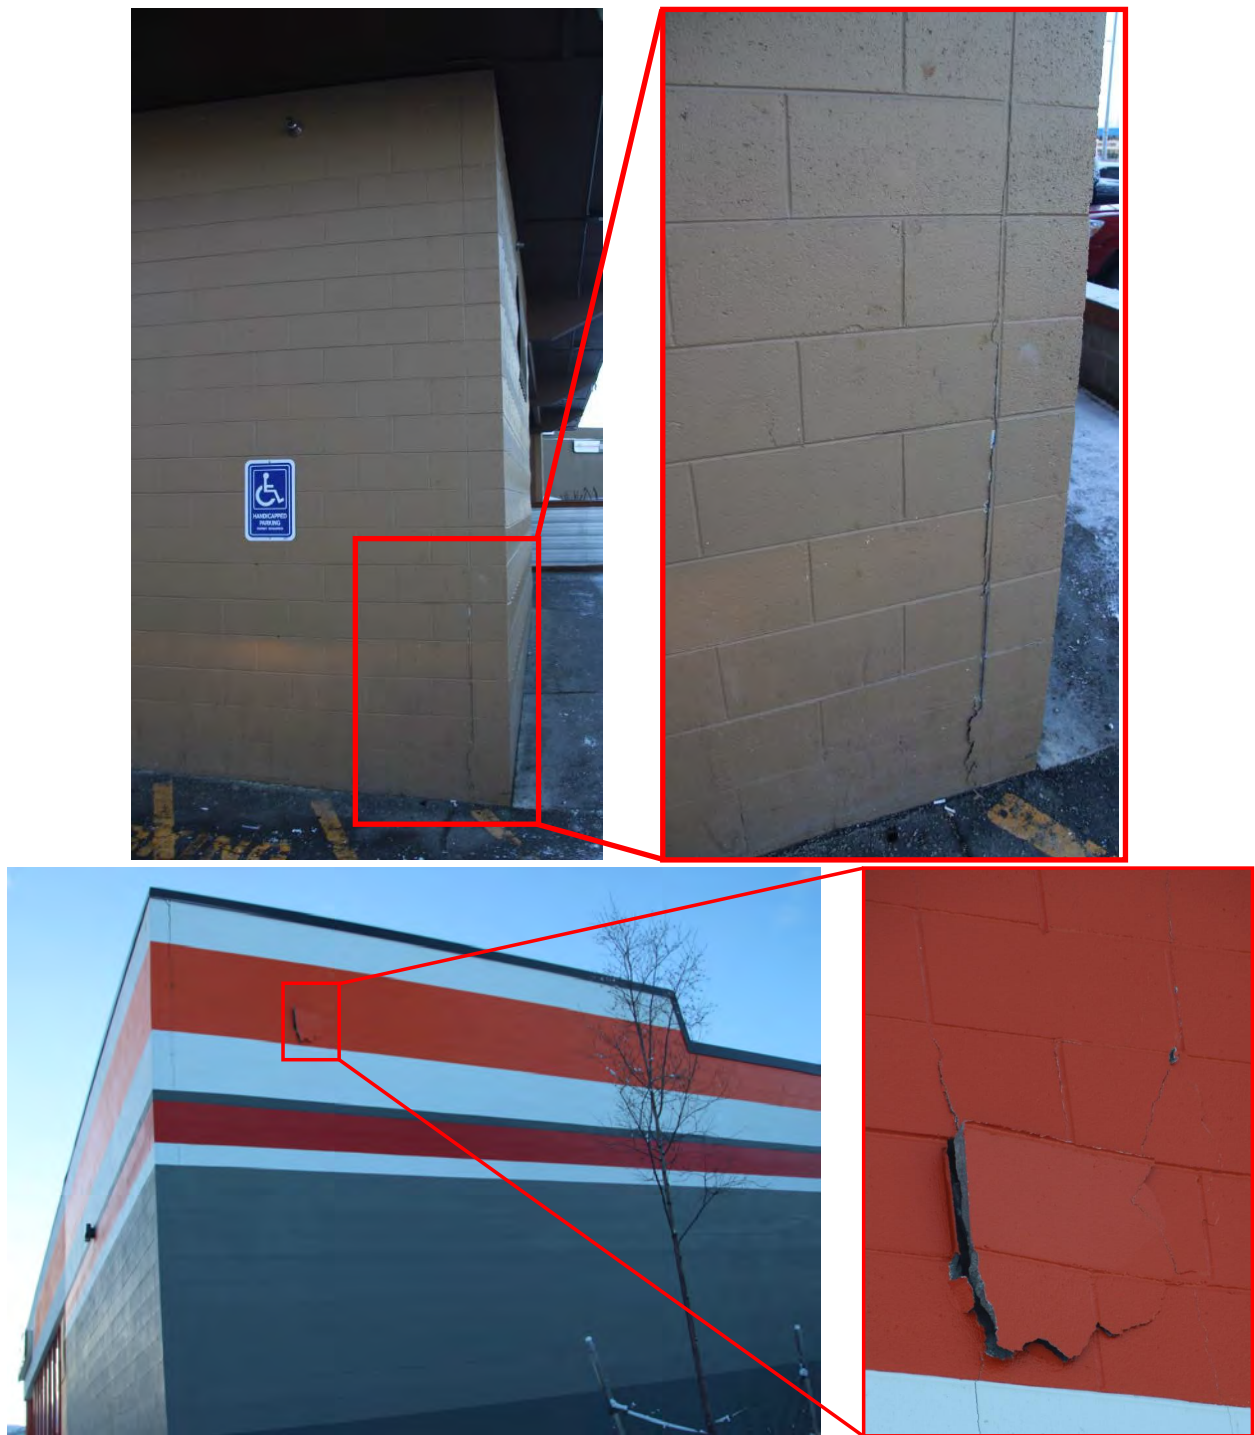
Figure 4.28. Damage in masonry walls, including damage at interfaces of perpendicularly oriented walls (photos: Chris Motter).

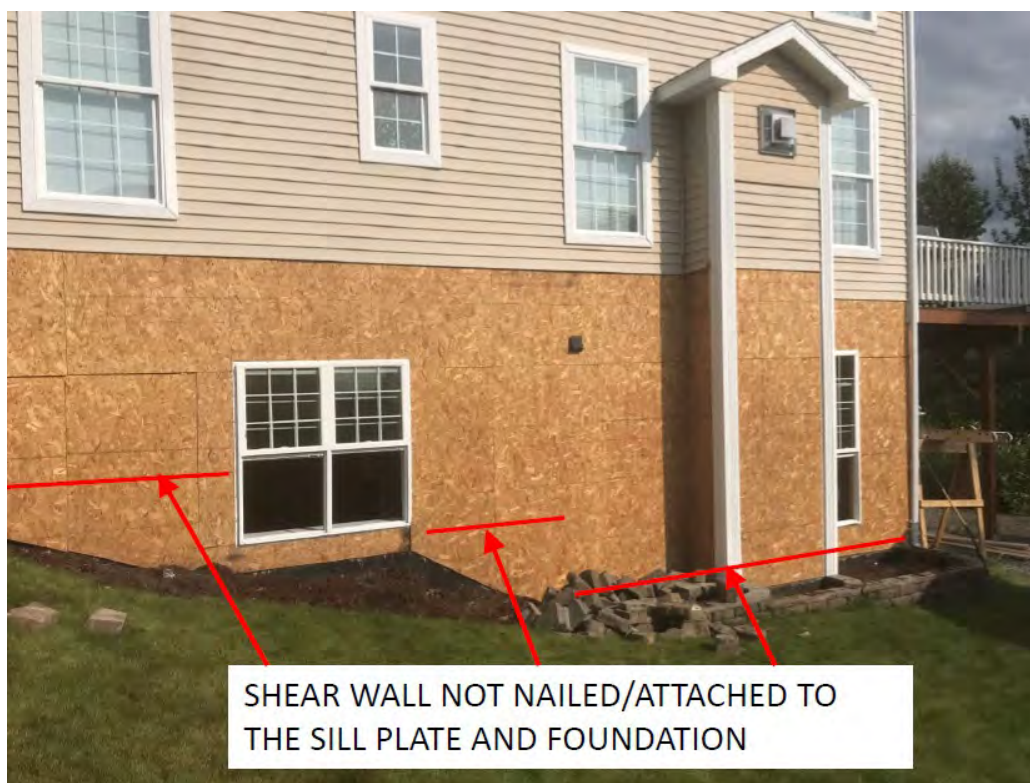
Figure 4.35.b. Shear wall damage in wood-frame residential building in Eagle River (photos: PND Engineers).

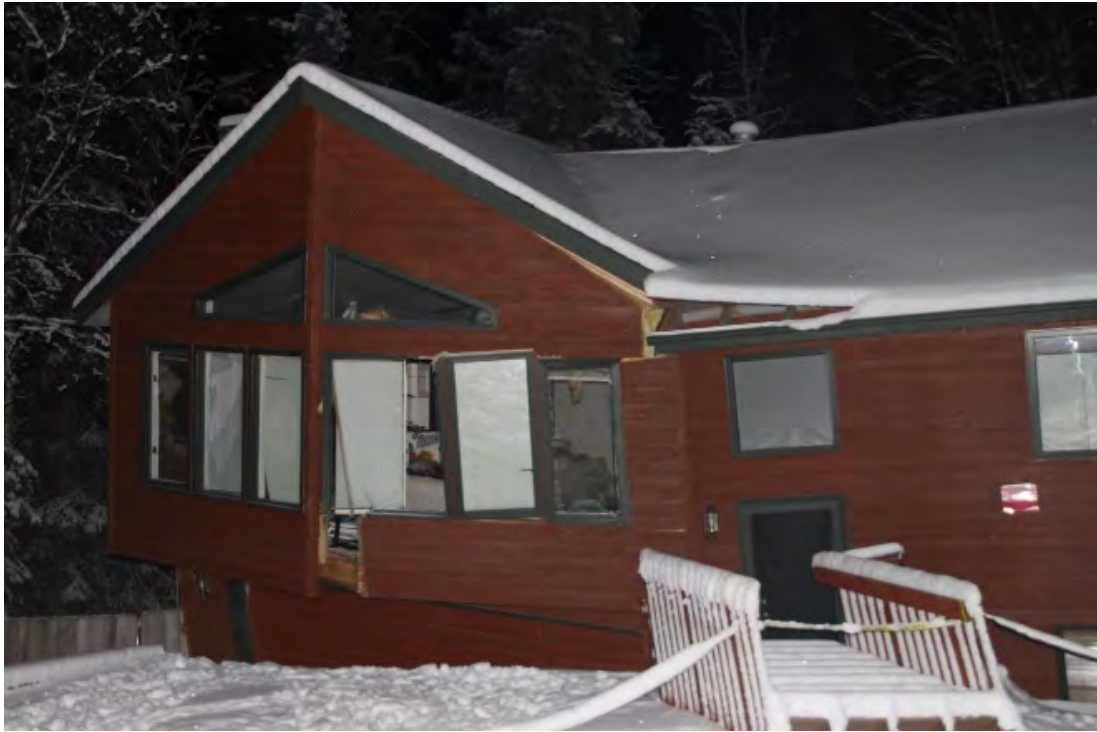
Figure 4.38.a. Residential building damage in Eagle River (photos: Chris Motter).

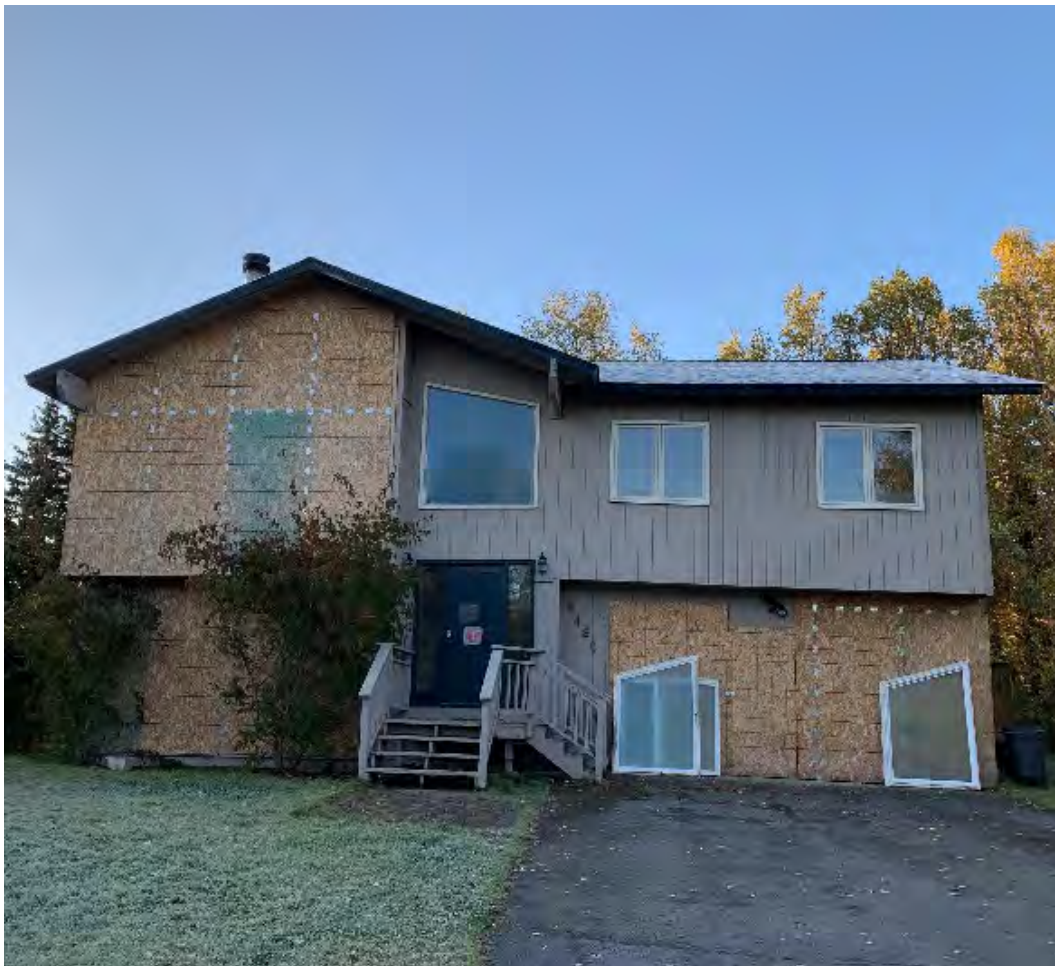
*Figure 4.39. Severe shear wall and nailed-connection damage in a residential building in Anchorage (photos: Wael Hassan).*

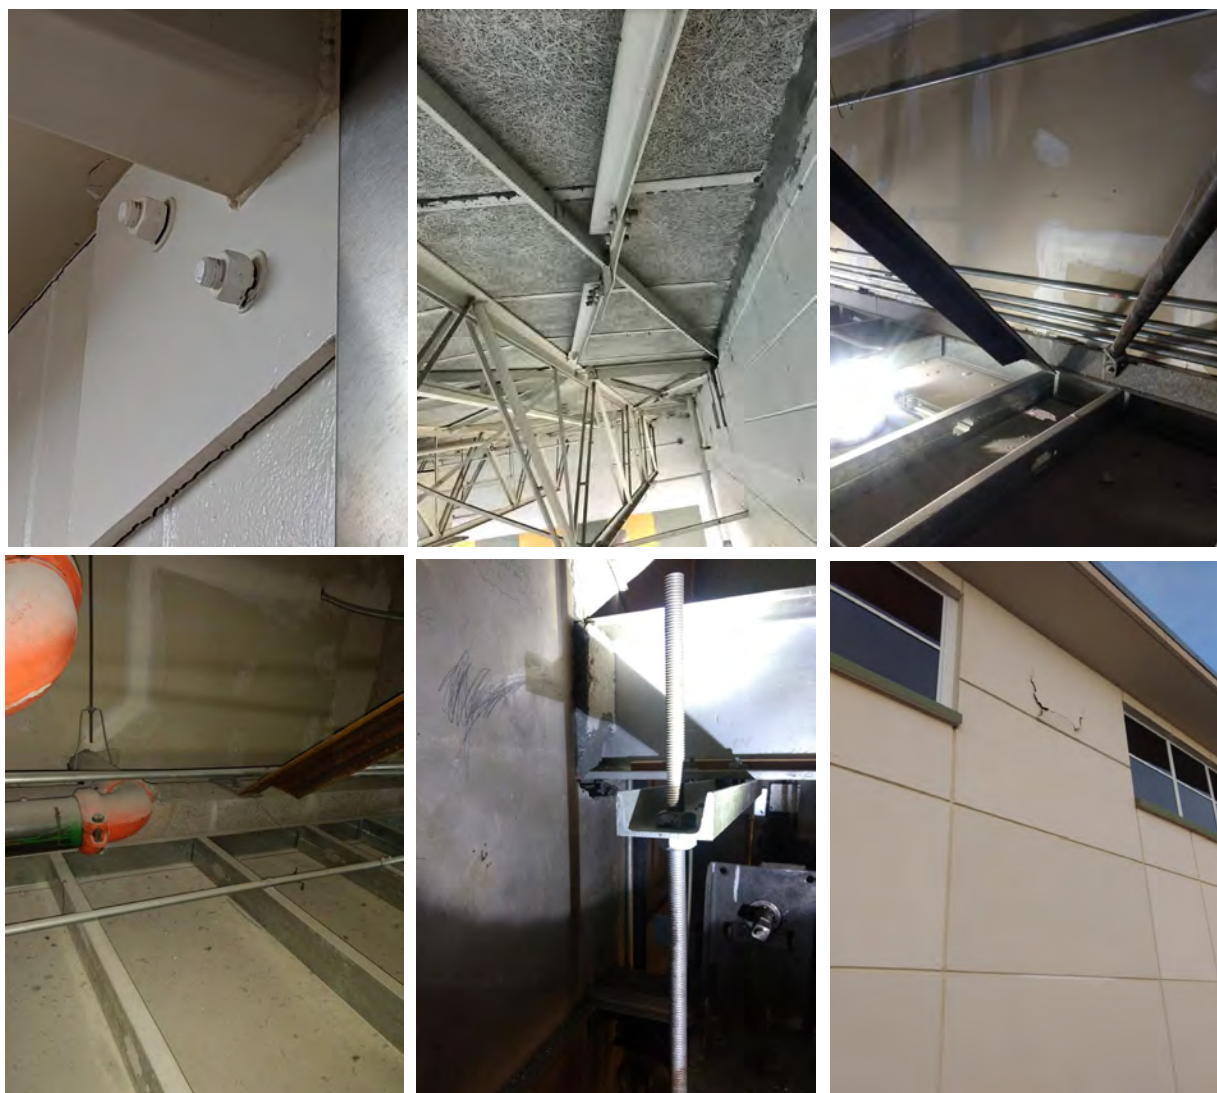
Figure 4.45. Steel component damage reported by Anchorage School District; (a) Bear Valley Elementary School strut bolts loosened in a connection with CMU wall; (b) Buckled X-bracing in Chugiak High School; (c) Failed weld and (d) Pull-out of a bolt at anchorage of ceiling lateral braces at Mirror Lake Middle School in Chugiak; (e) I-beam to wall interface in Gymnasium in West High School, Anchorage; and (f) damage visible in an exterior view of the I-beam interface; (photos a-f: Reid Middleton, ASD)

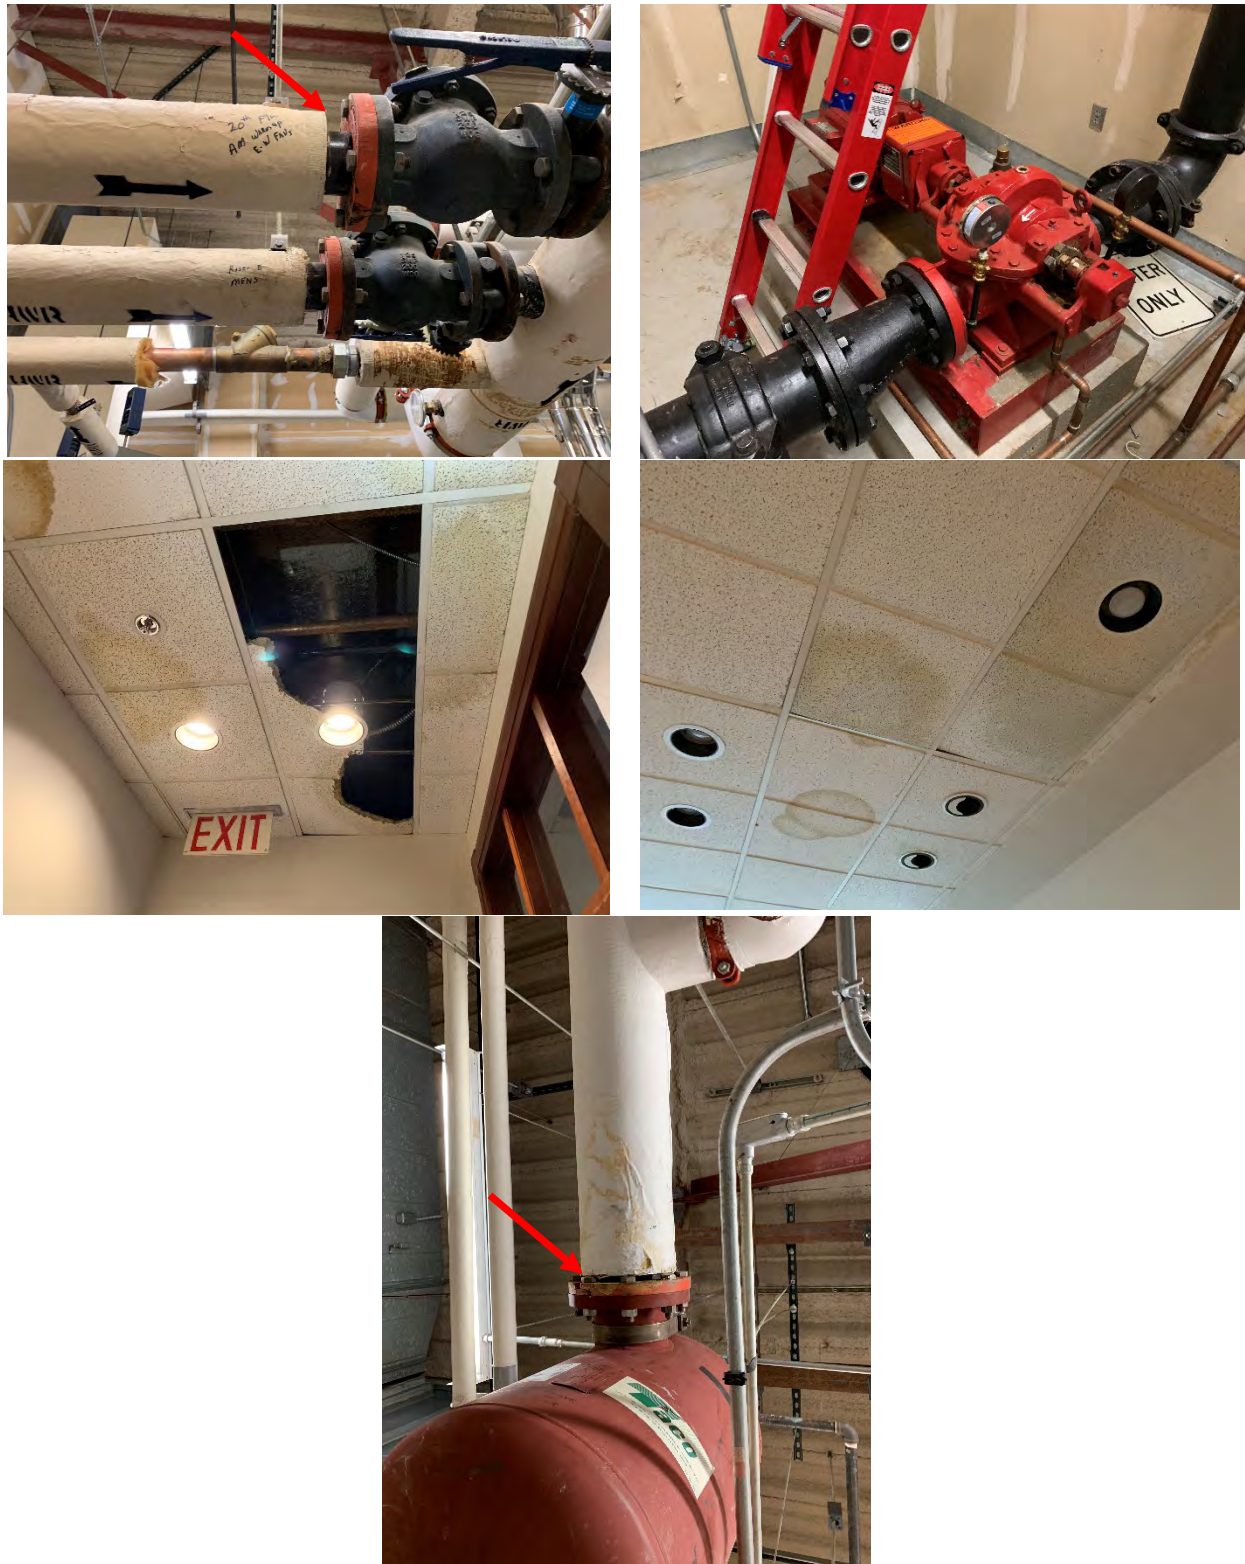
Figure 4.50. Mechanical-room piping failure and water flooding at Atwood Building (photos: Wael Hassan).

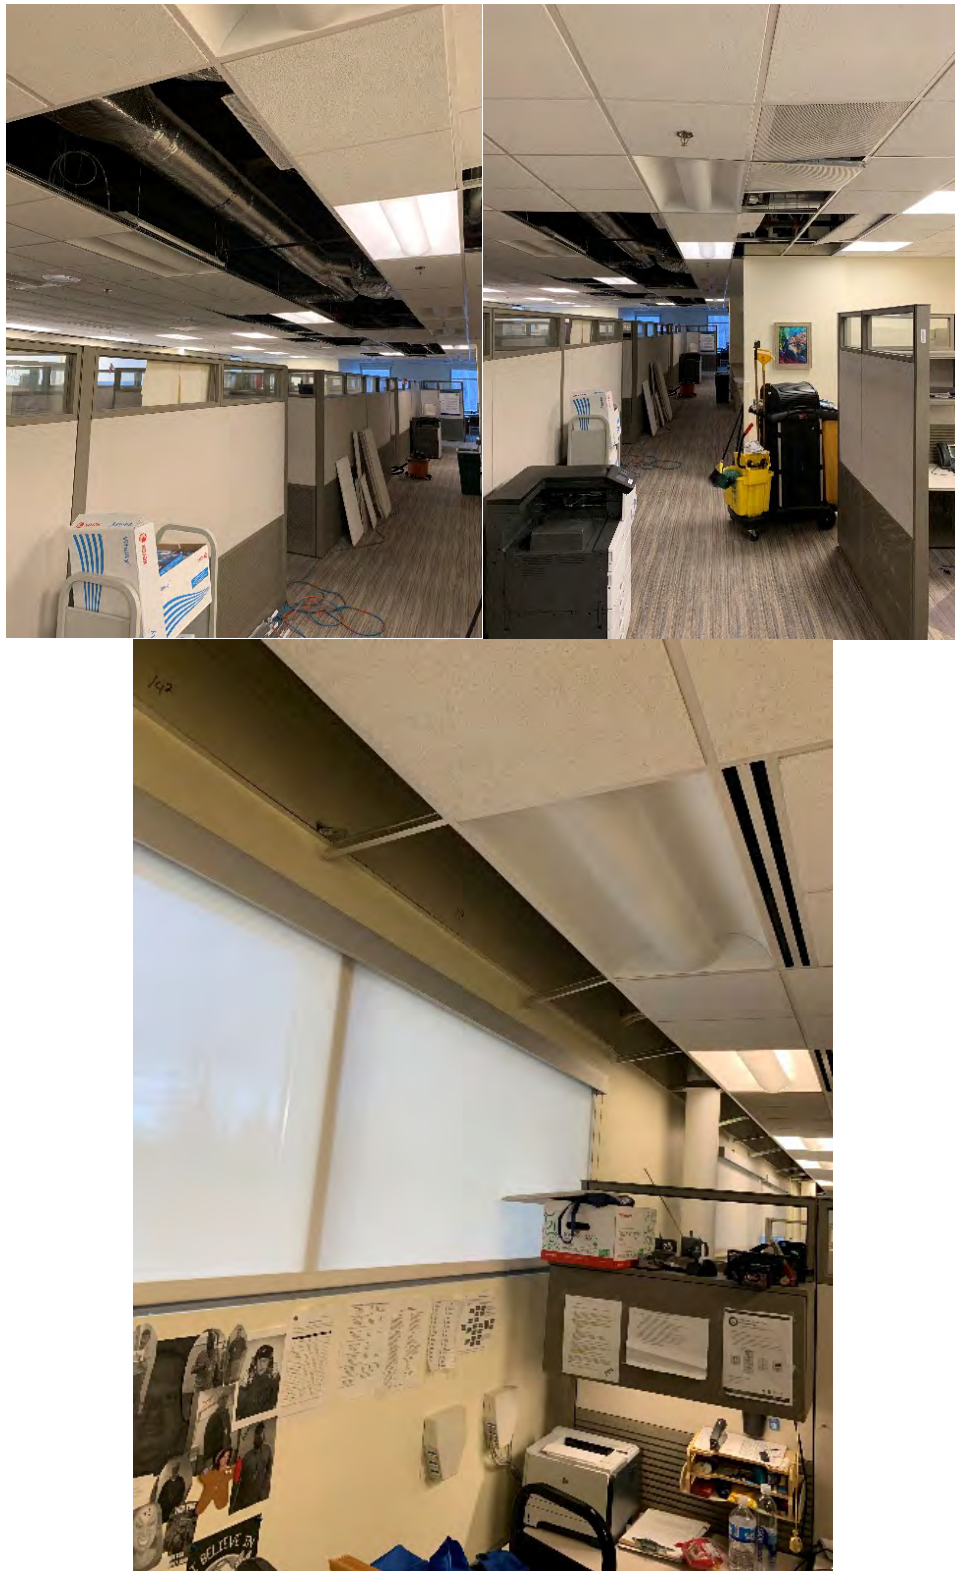
Figure 4.61. VA hospital second-floor ceiling damage (photos: Erol Kalkan).

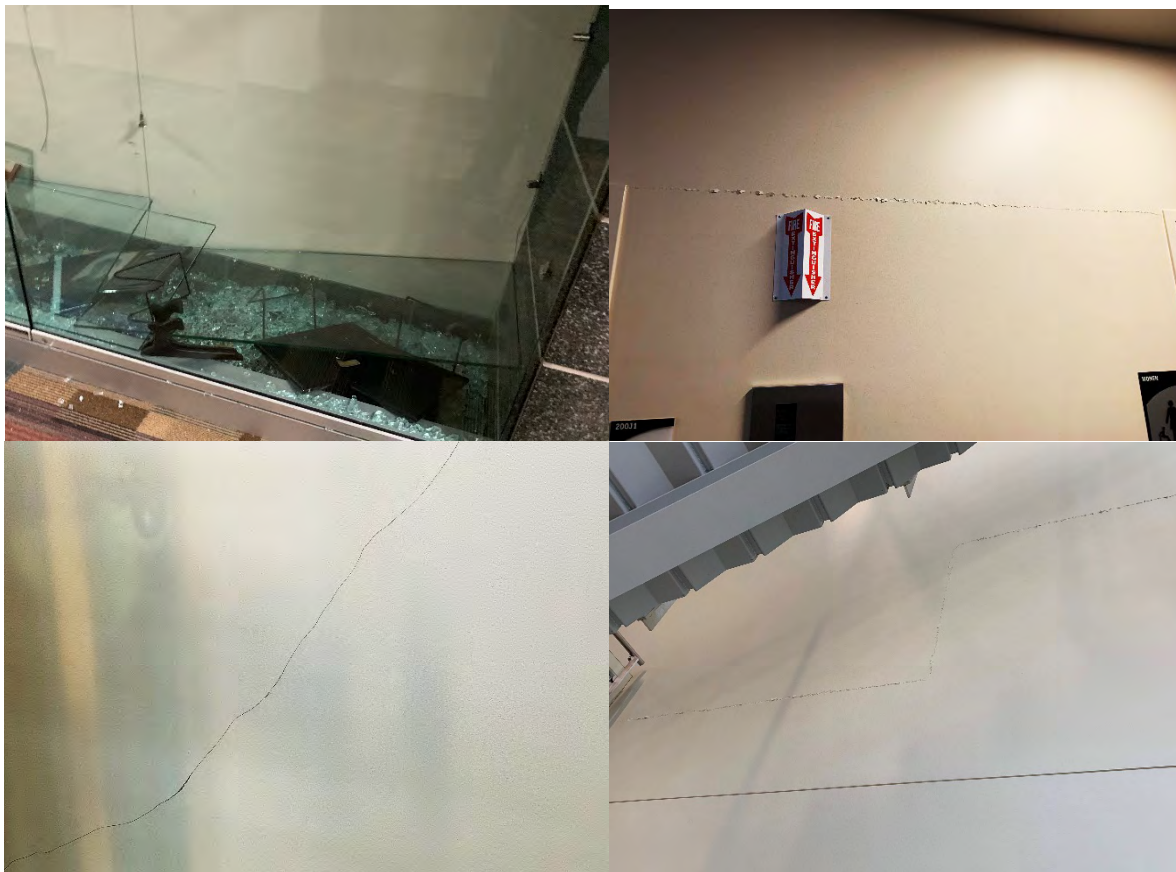
Figure 4.62. EIB, UAA, non-structural sheetrock damage throughout the building and a glass cabinet damage in the fourth floor (photos: Wael Hassan).

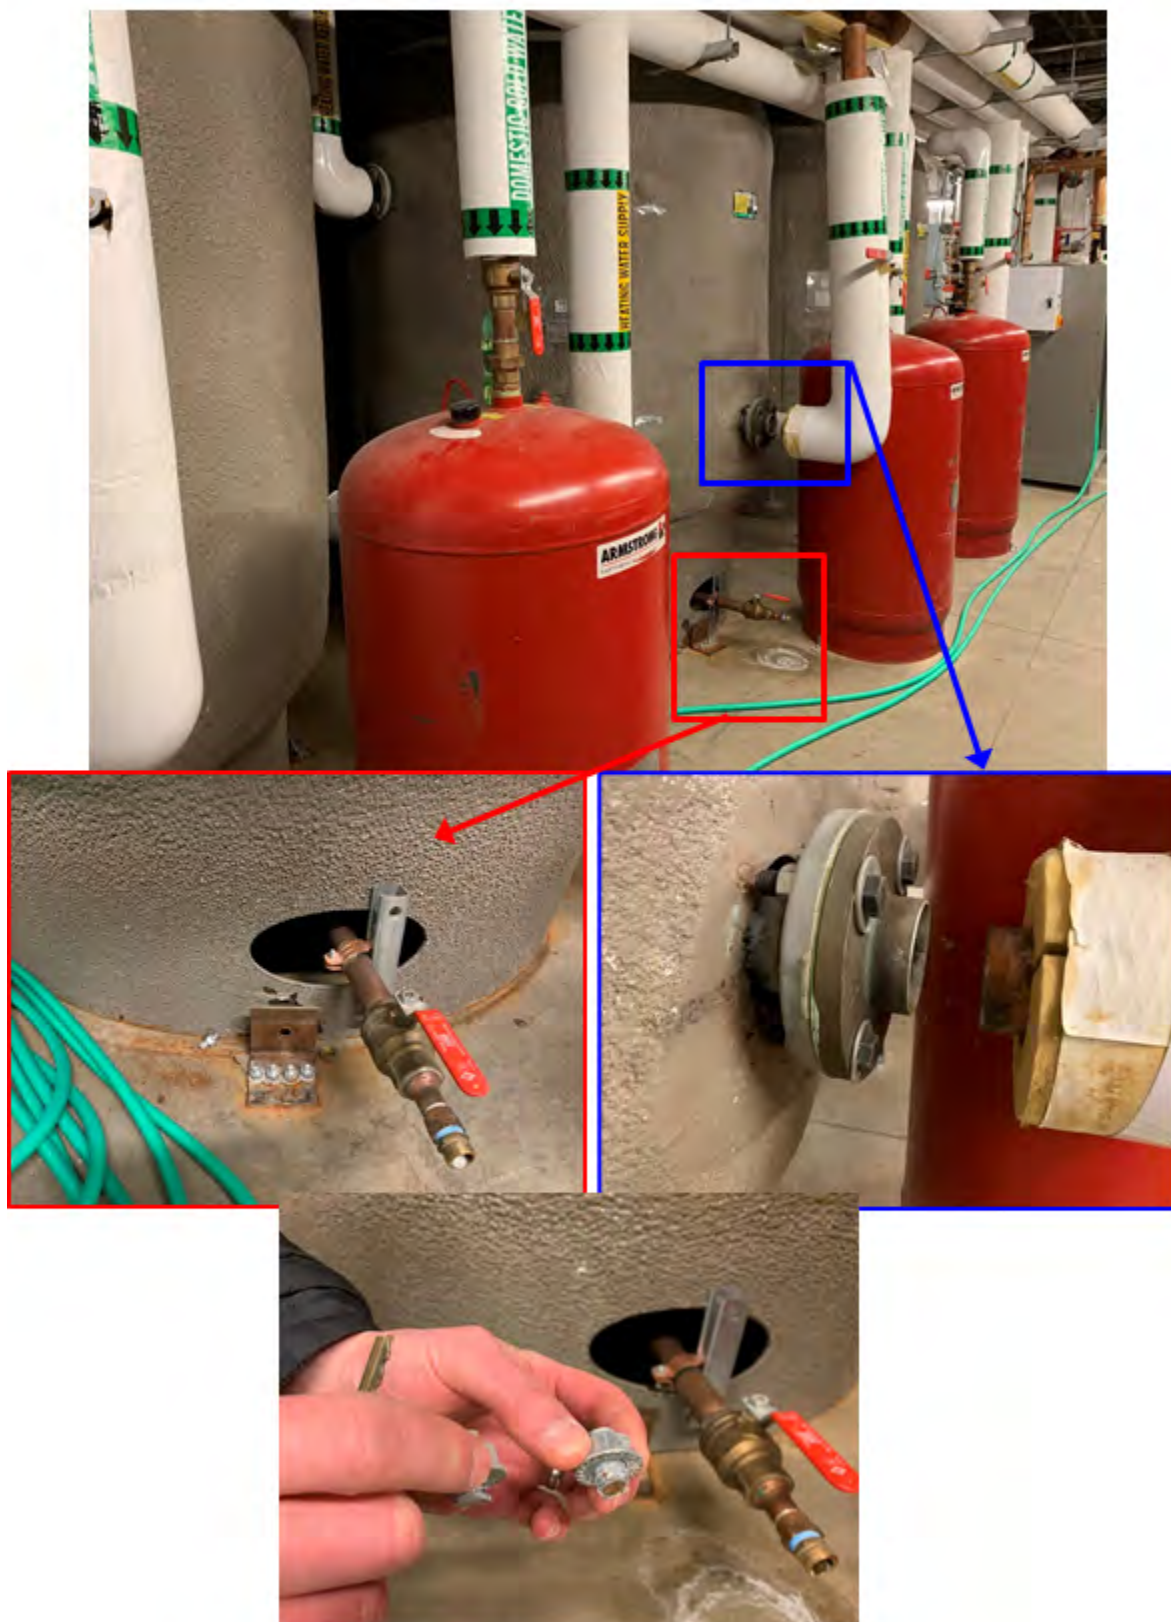
Figure 5.8. Eleven thousand-gallon water tanks at an Eagle River senior-citizen facility slid, shearing off pipe connections and restraining angle bolts, causing water leaks (photos: Wael Hassan).
