# EERI Earthquake Reconnaissance Report: M7.1 Anchorage Earthquake on November 30, 2018

Wael M. Hassan, John Thornley, Janise Rodgers, and Christopher Motter

July 2021

*A product of the EERI Learning from Earthquakes Program*

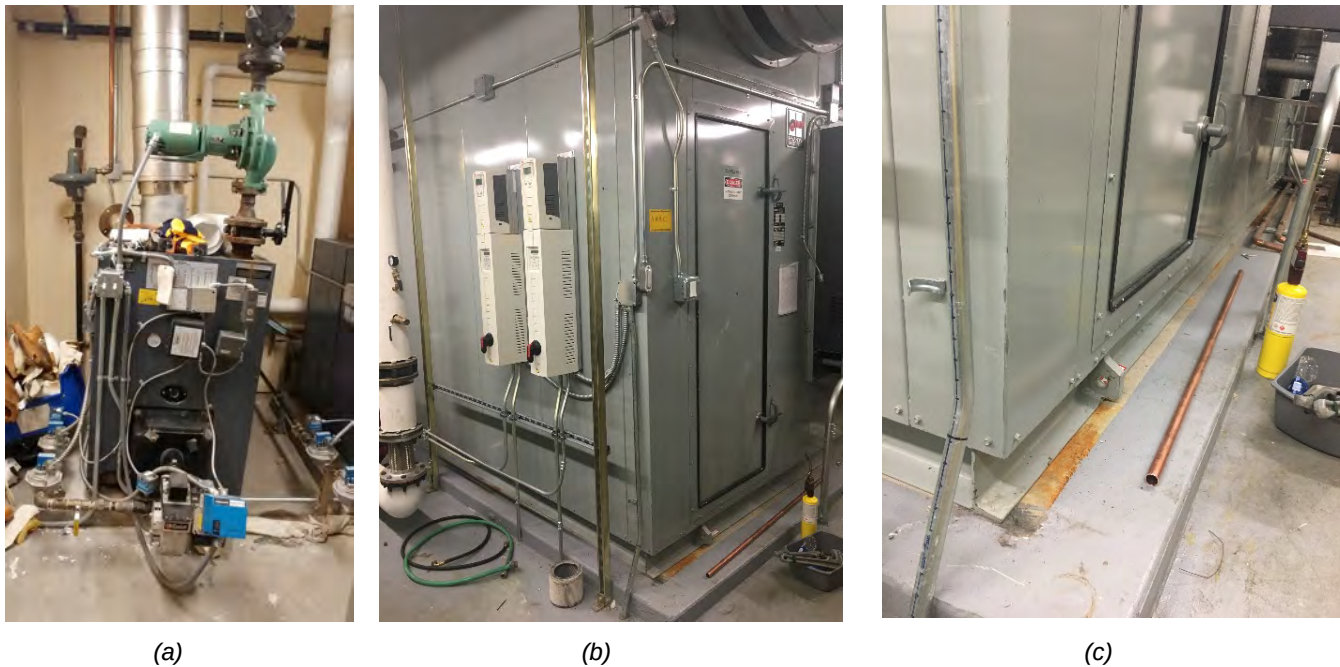
Figure 5.12. (a) Mechanical equipment damage, (b), (c) Mechanical unit sliding for a few inches: fourth floor of a hospital building, Anchorage (photos: (a) Greg Latreille; (b), (c) Wael Hassan).

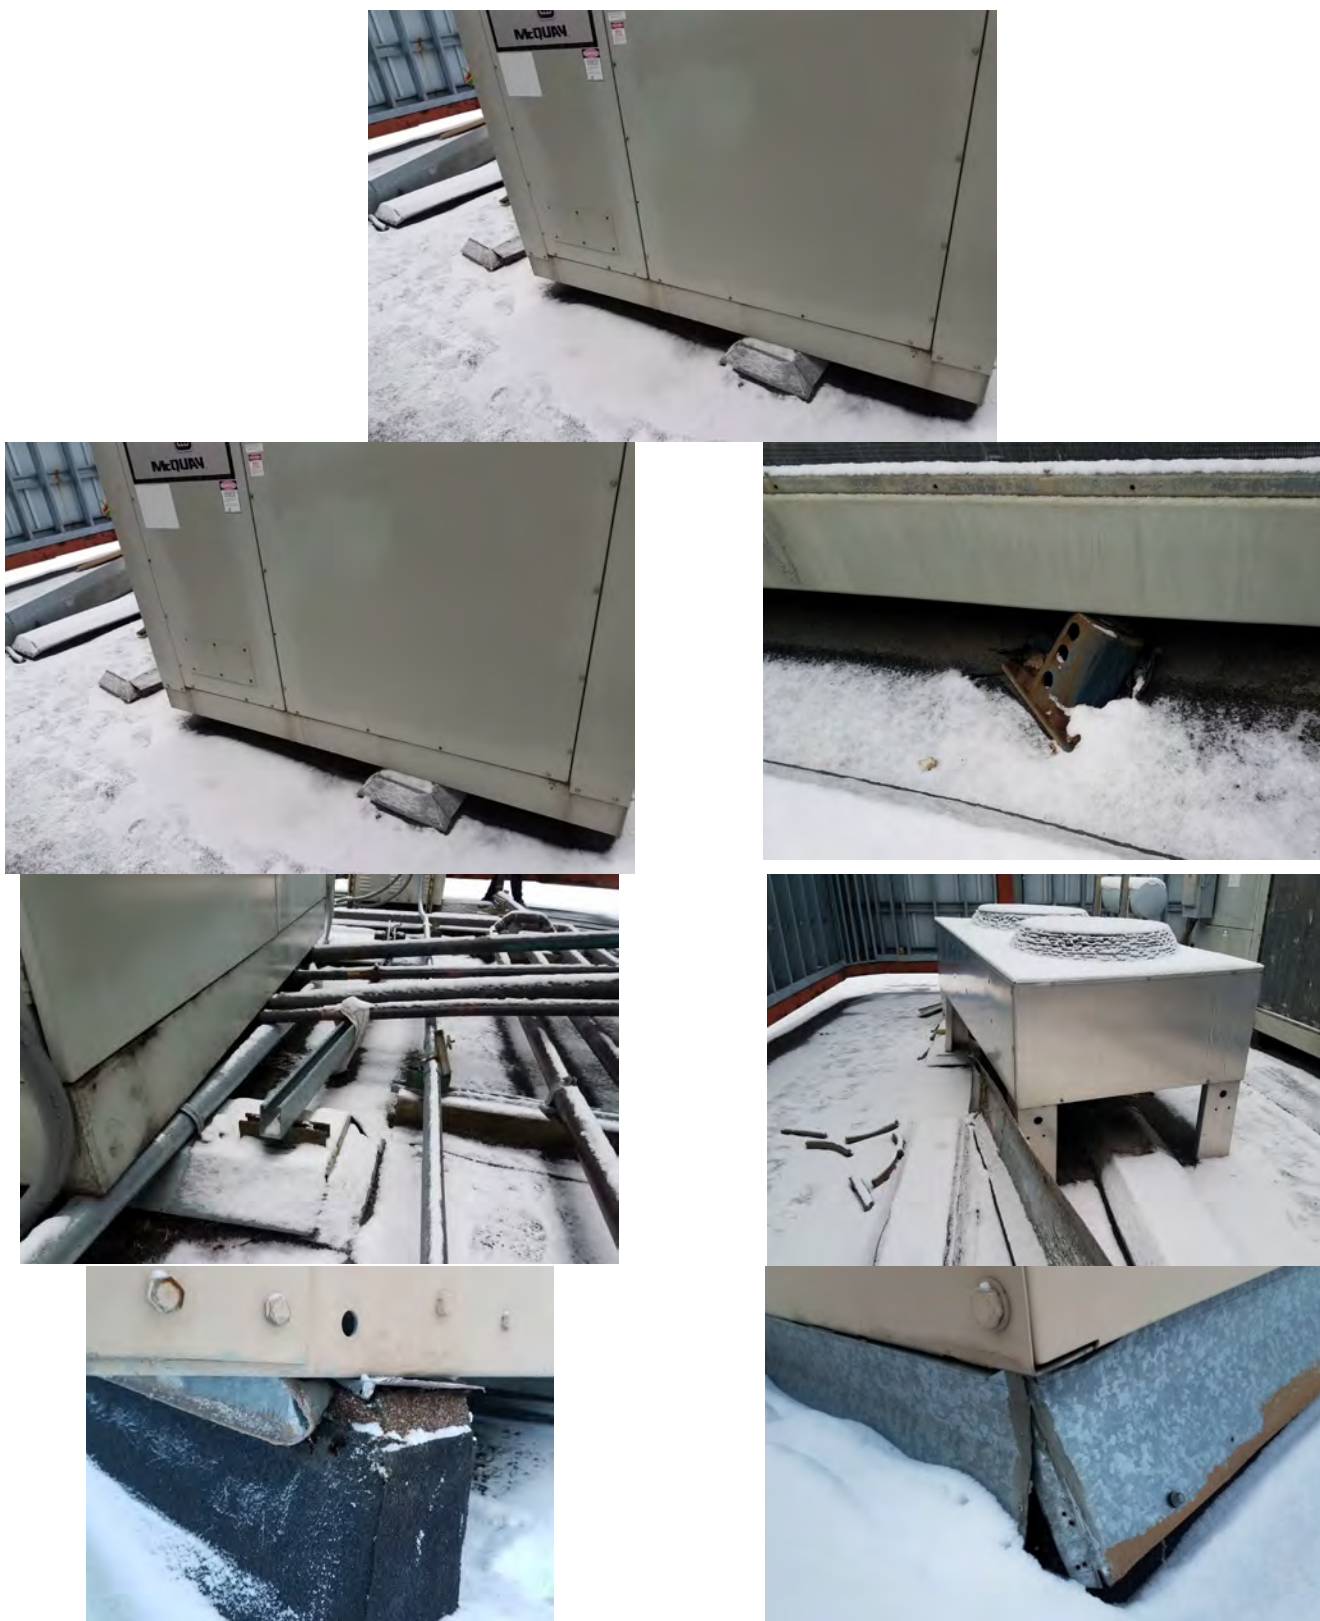
Figure 5.16. Mechanical-equipment sliding and anchorage failure on roof (photos: Randall Williams<sup>2</sup>).

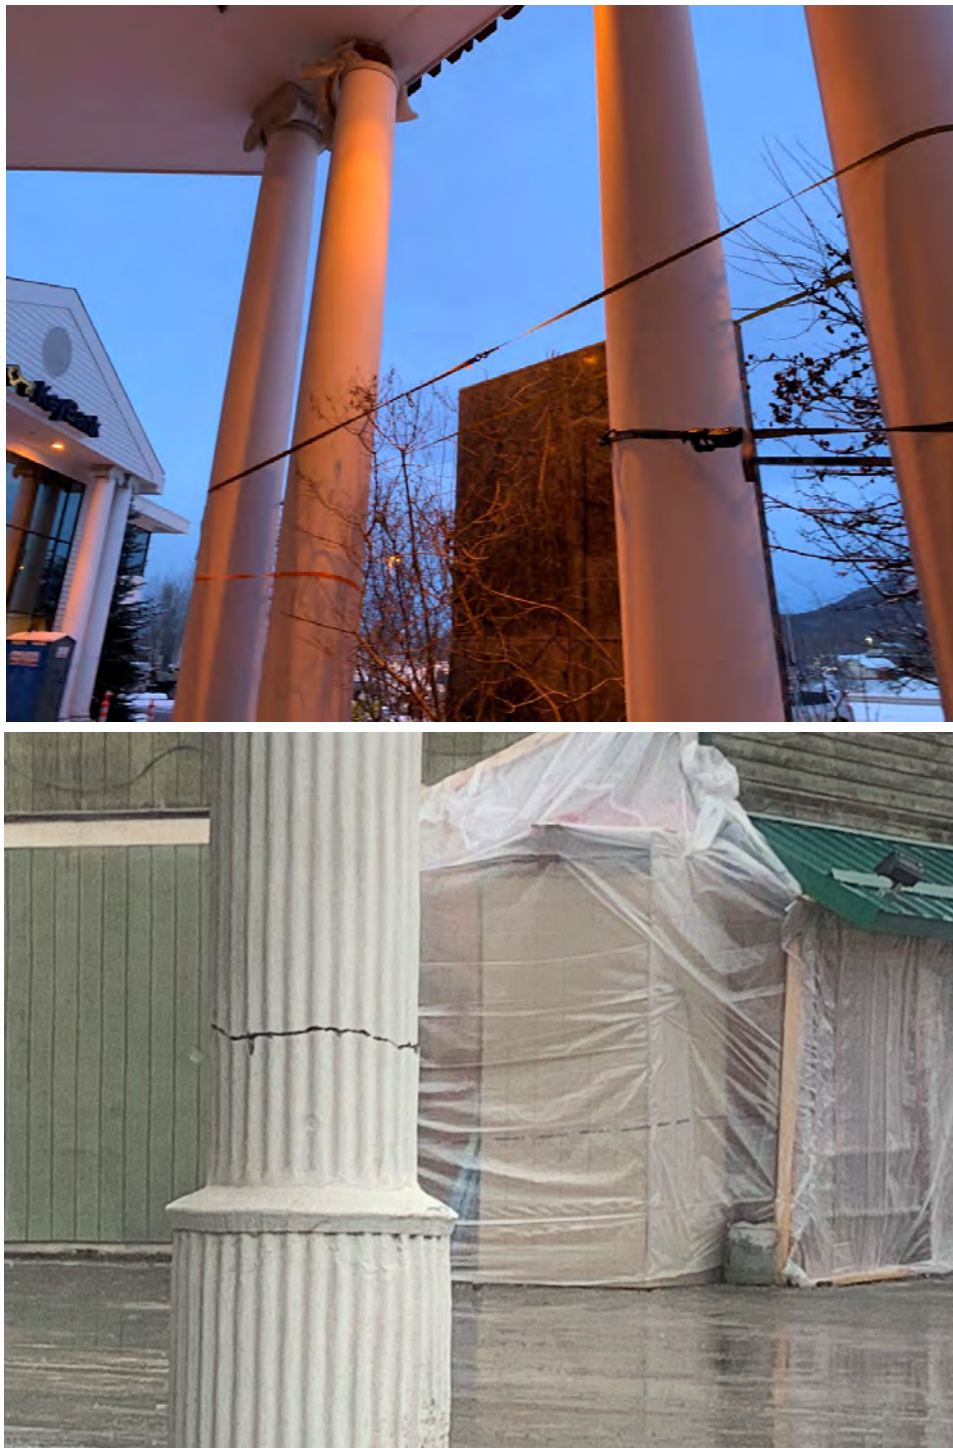
*Figure 5.24. Damage in architectural columns at an Eagle River business building (photos: Wael Hassan).*

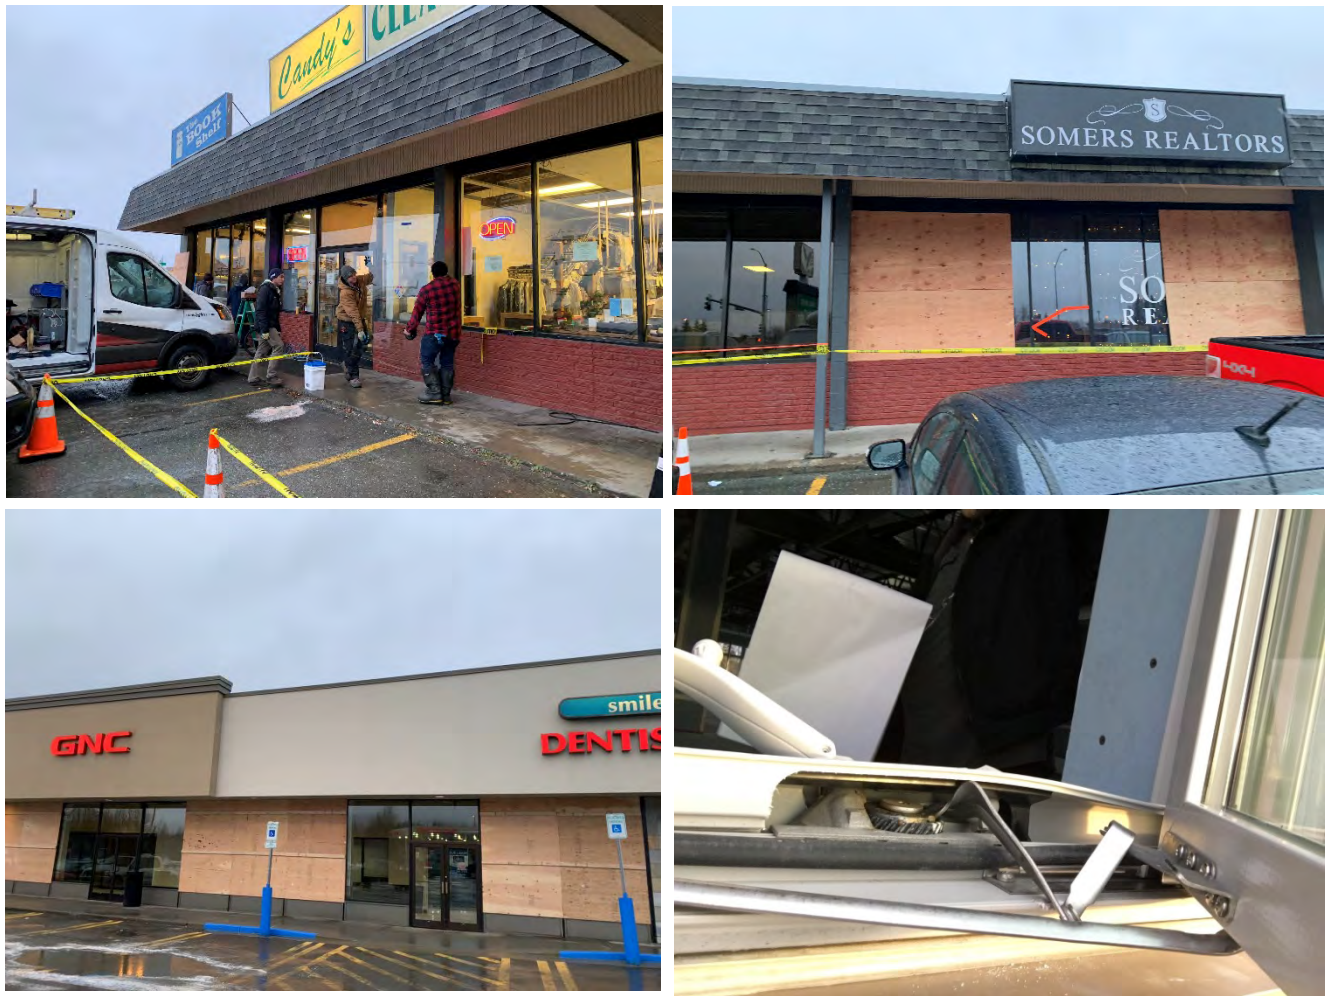
Figure 5.26. Damage to windows at retail and commercial buildings in Eagle River and a hospital in Anchorage (bottom right) (photos: Wael Hassan).

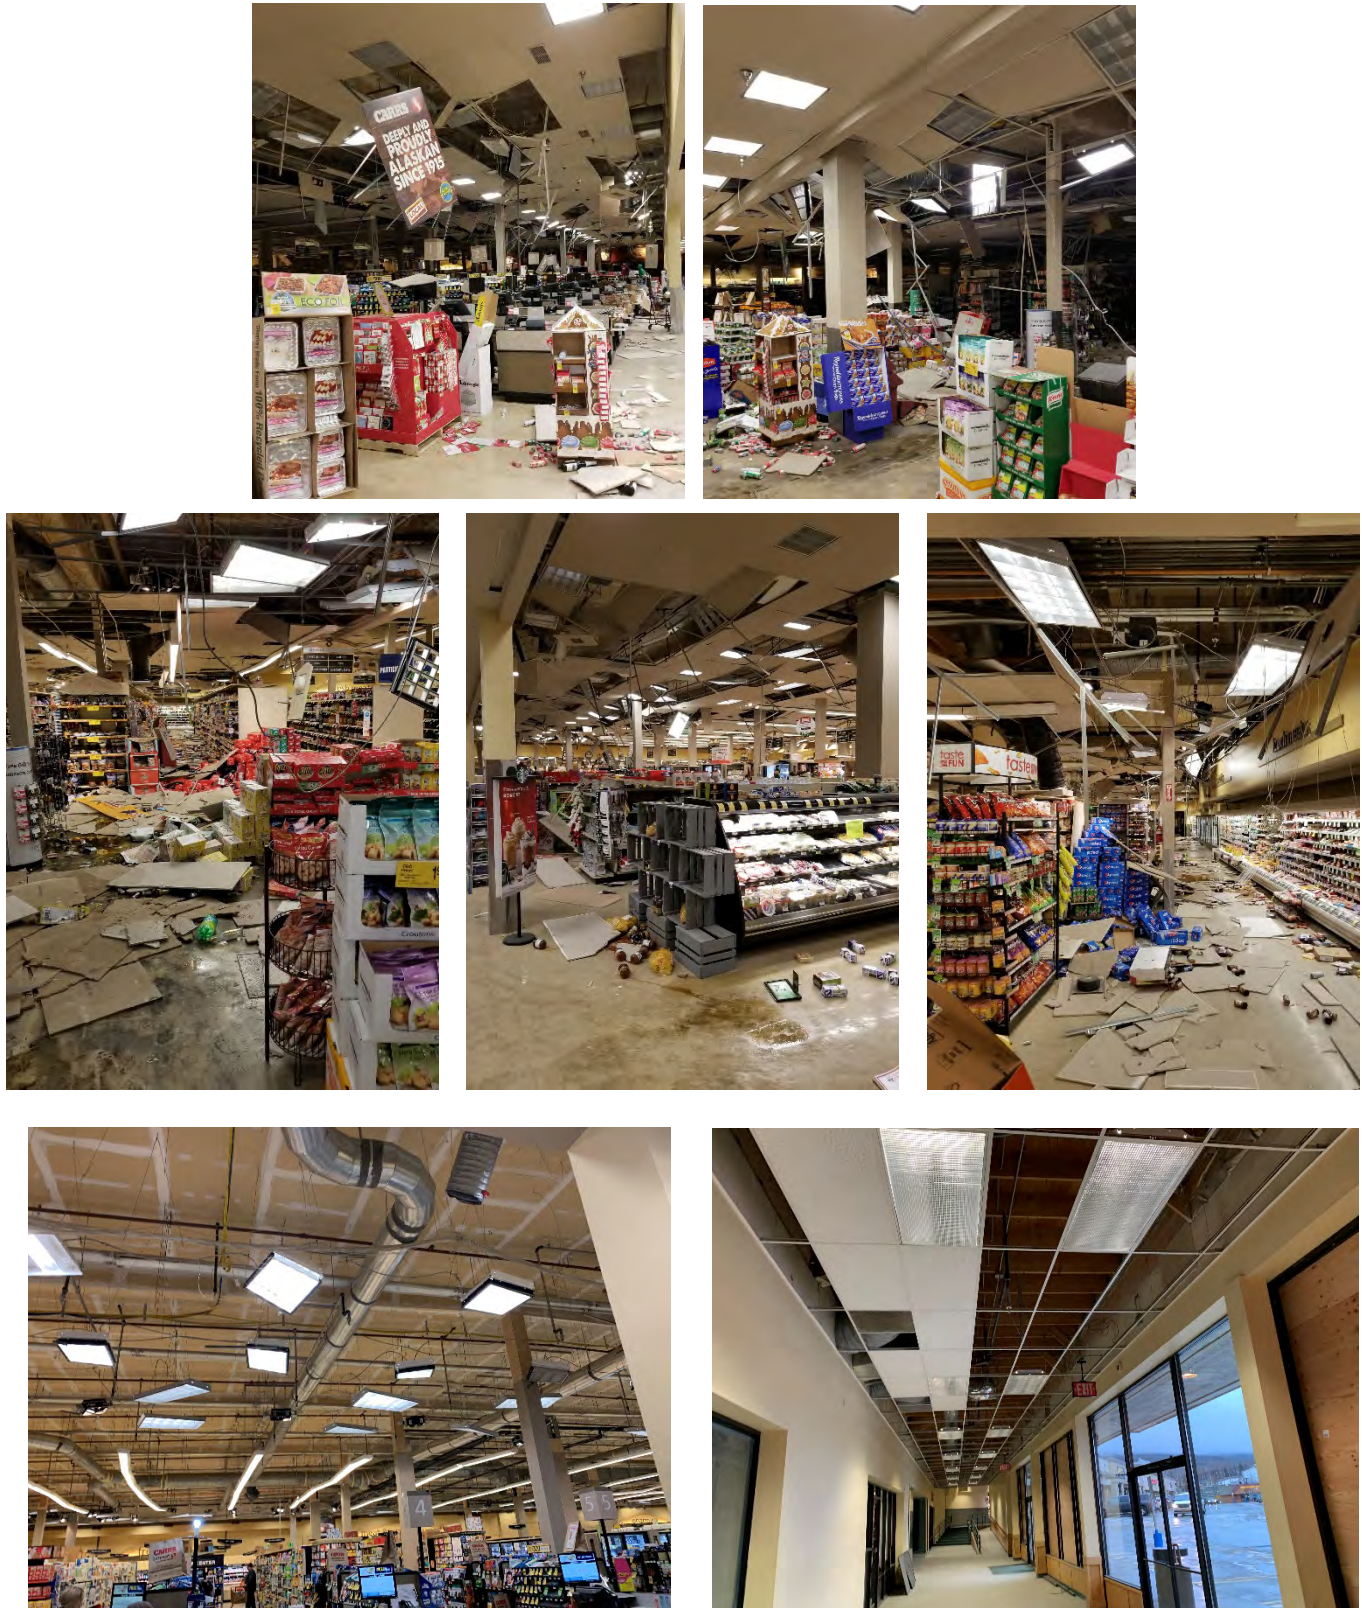
Figure 5.27. Heavy ceiling damage in Eagle River commercial buildings leading to complete ceiling removal (photos: Carr's, Wael Hassan).

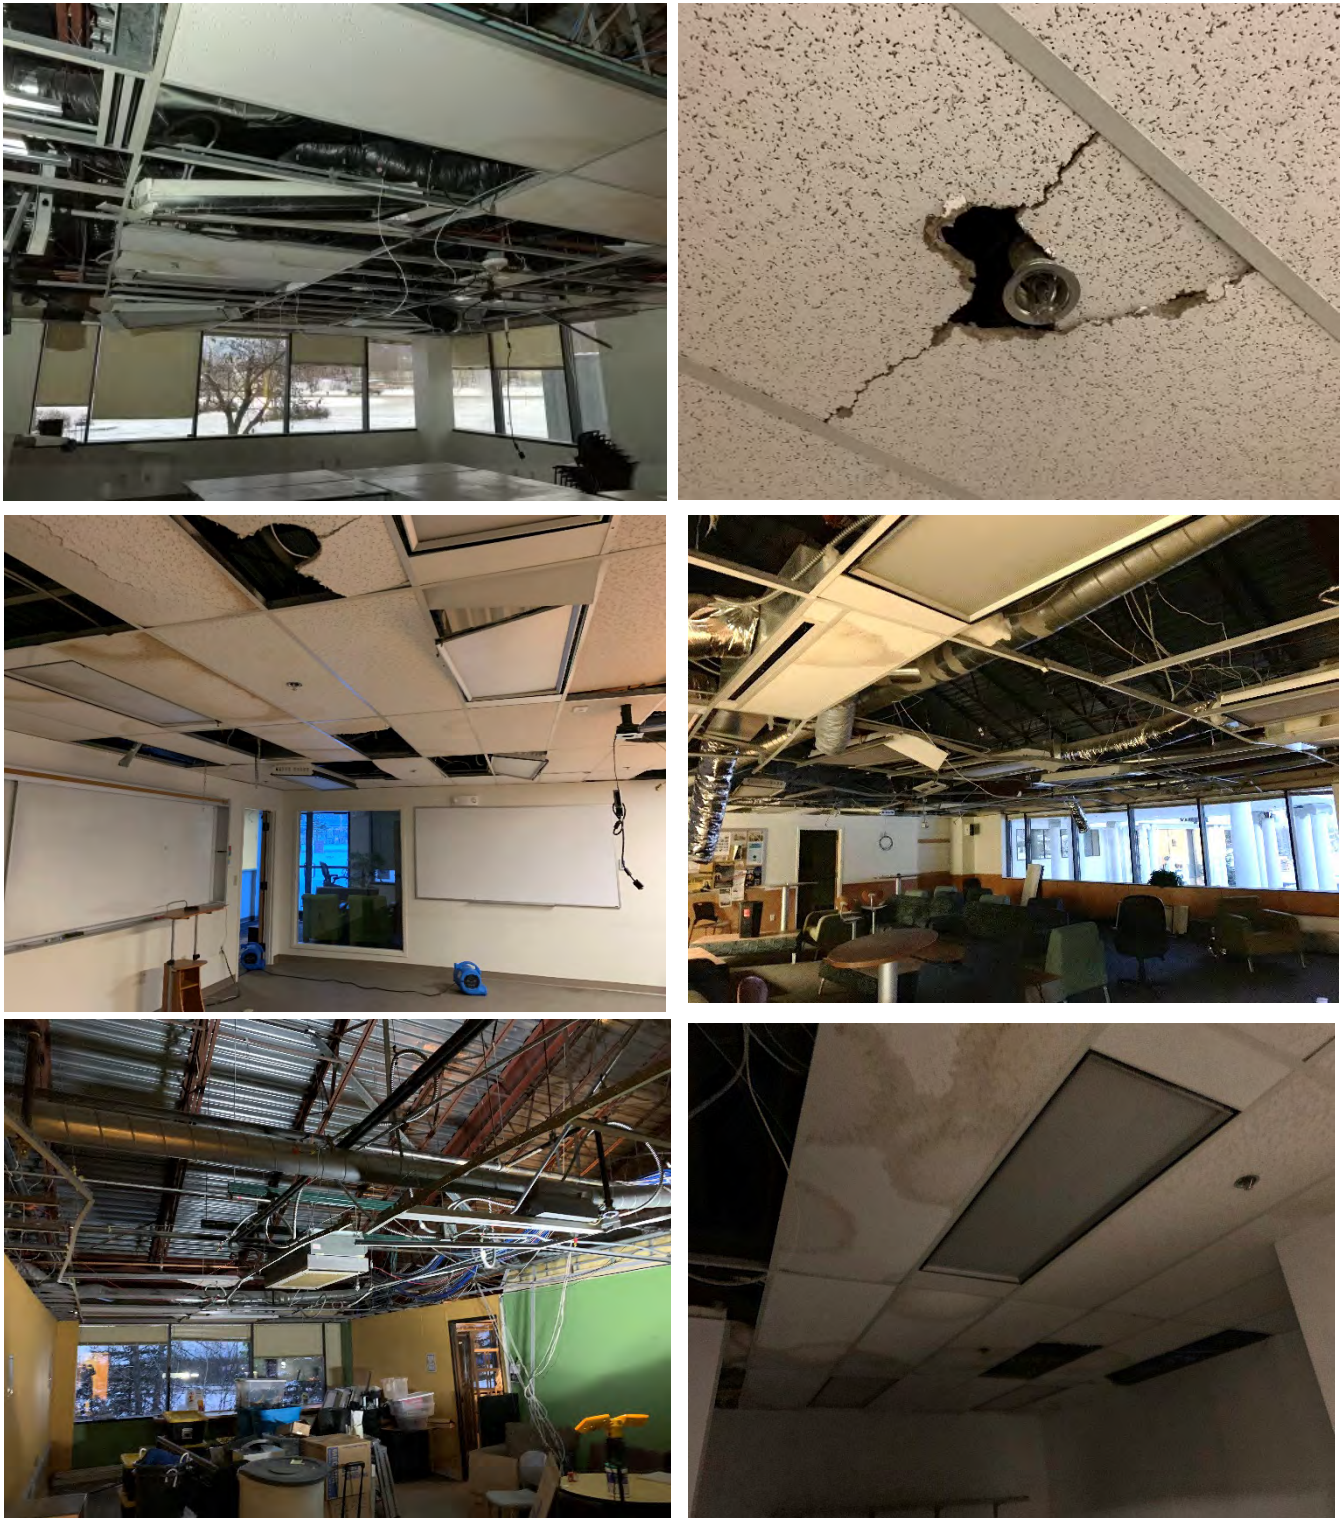
*Figure 5.31. Eagle River campus of UAA with various degrees of ceiling damage; the second-floor ceiling suffered extensive damage from shaking and poor bracing, while the first-floor ceiling damage was more related to water flooding from sprinkler system failure (photos: Wael Hassan).*

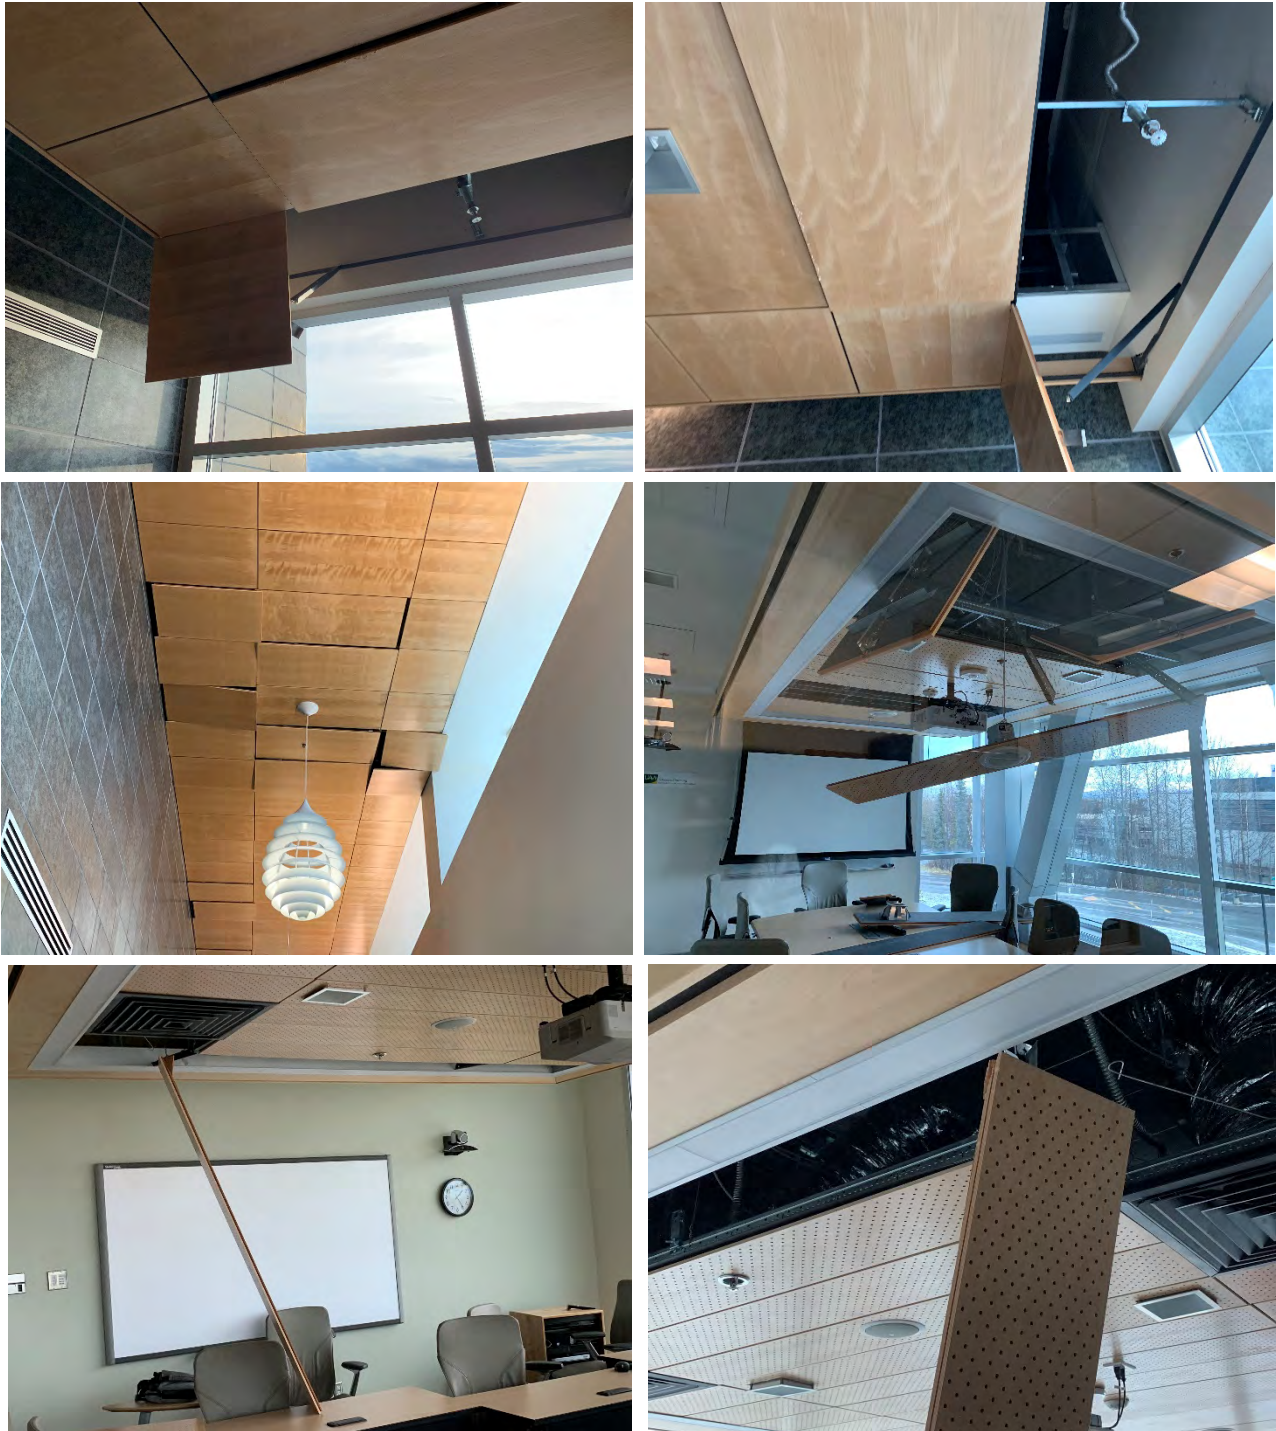
*Figure 5.32. The 2015 UAA HSB (PGA 0.21g) ceiling damage. Large, heavy wooden ceiling tiles fell, and the grid failed because of wire snapping; however, in the same building, the acoustic light tiles and grid had minimum damage (photos: Wael Hassan).*

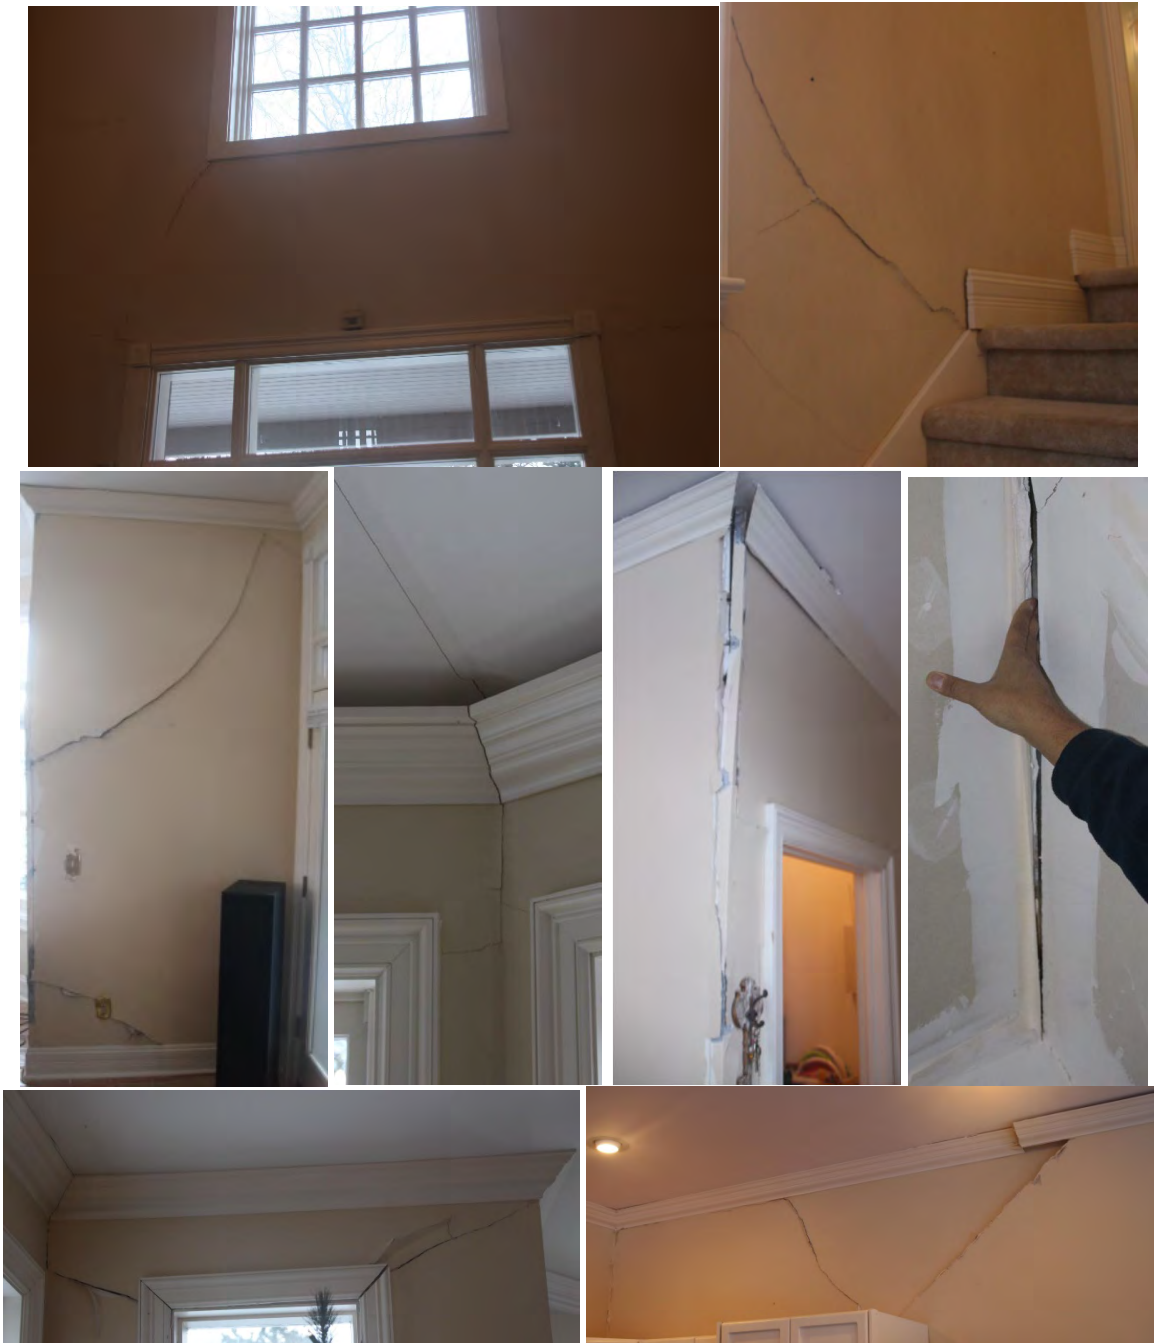
Figure 5.37. Wall damage in a house in Mat-Su near Finger Lake (photos: Chris Motter).

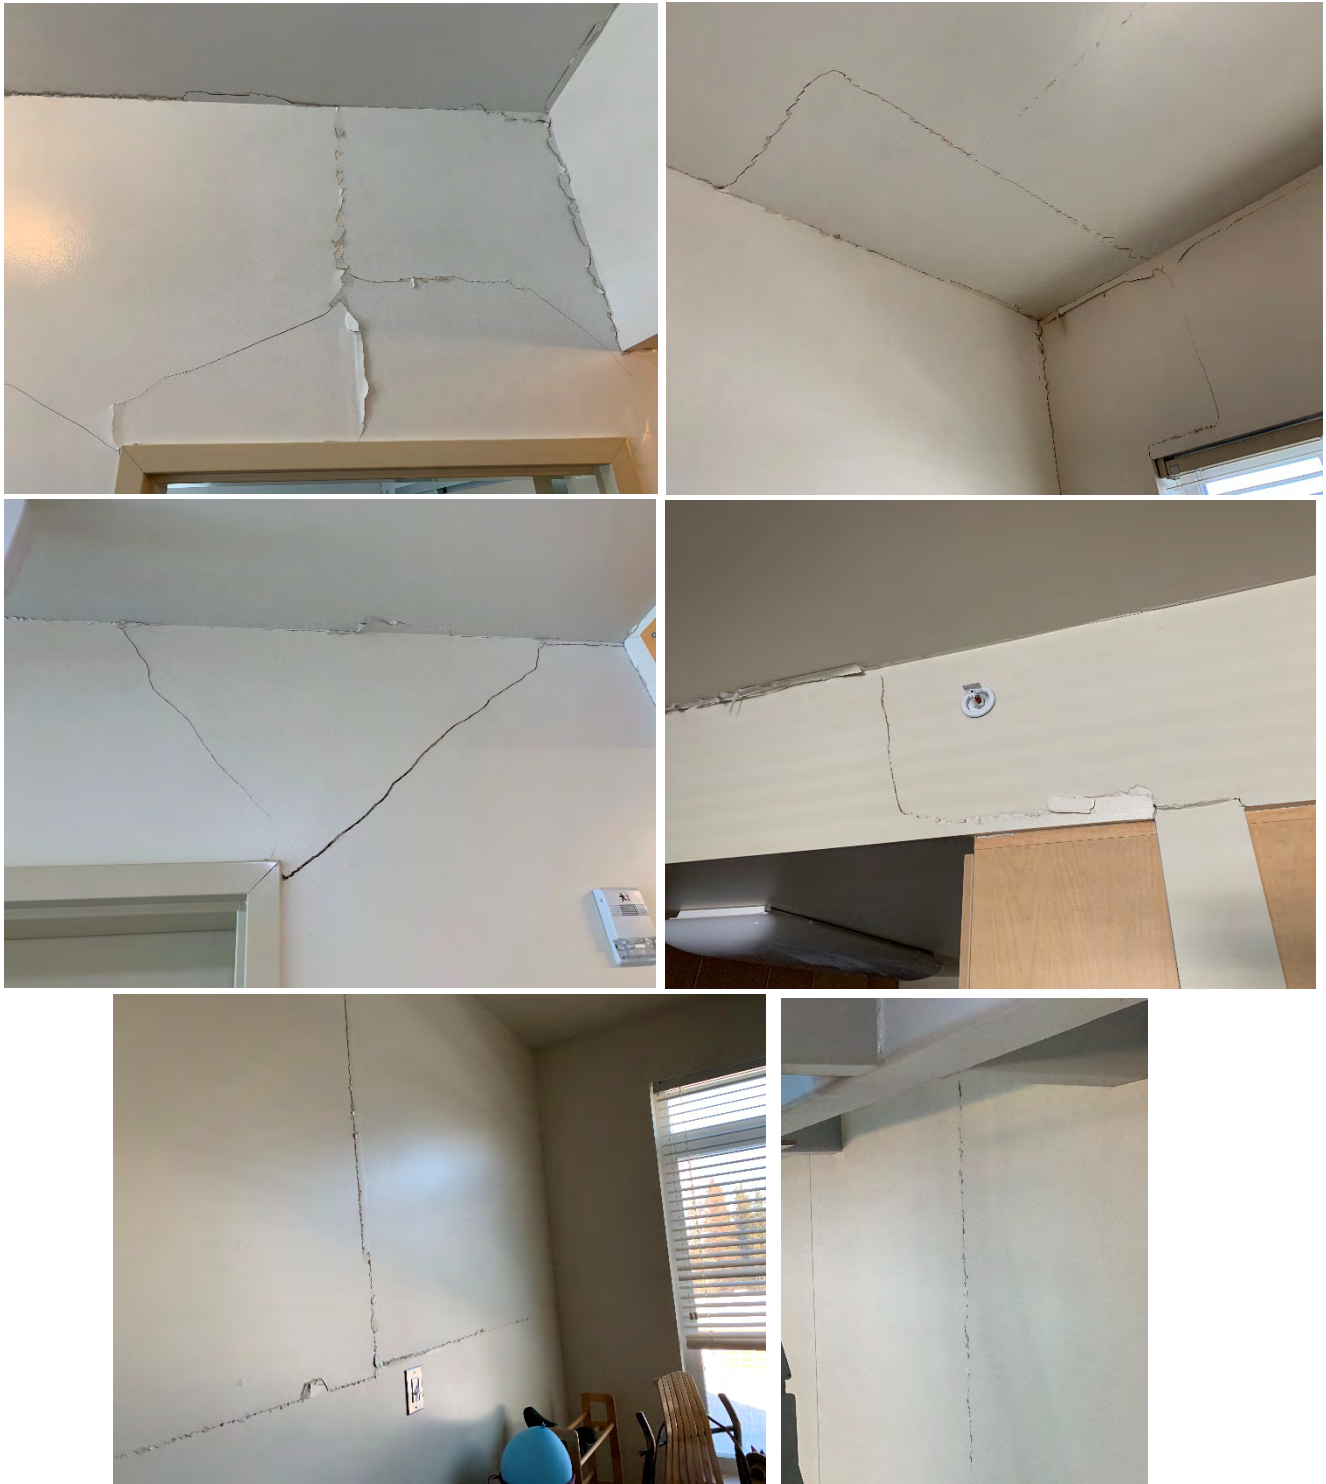
*Figure 5.40 Typical partition-wall sheetrock damage in office, hospitality, religious, and educational buildings in Anchorage and Eagle River (photos: Wael Hassan).*

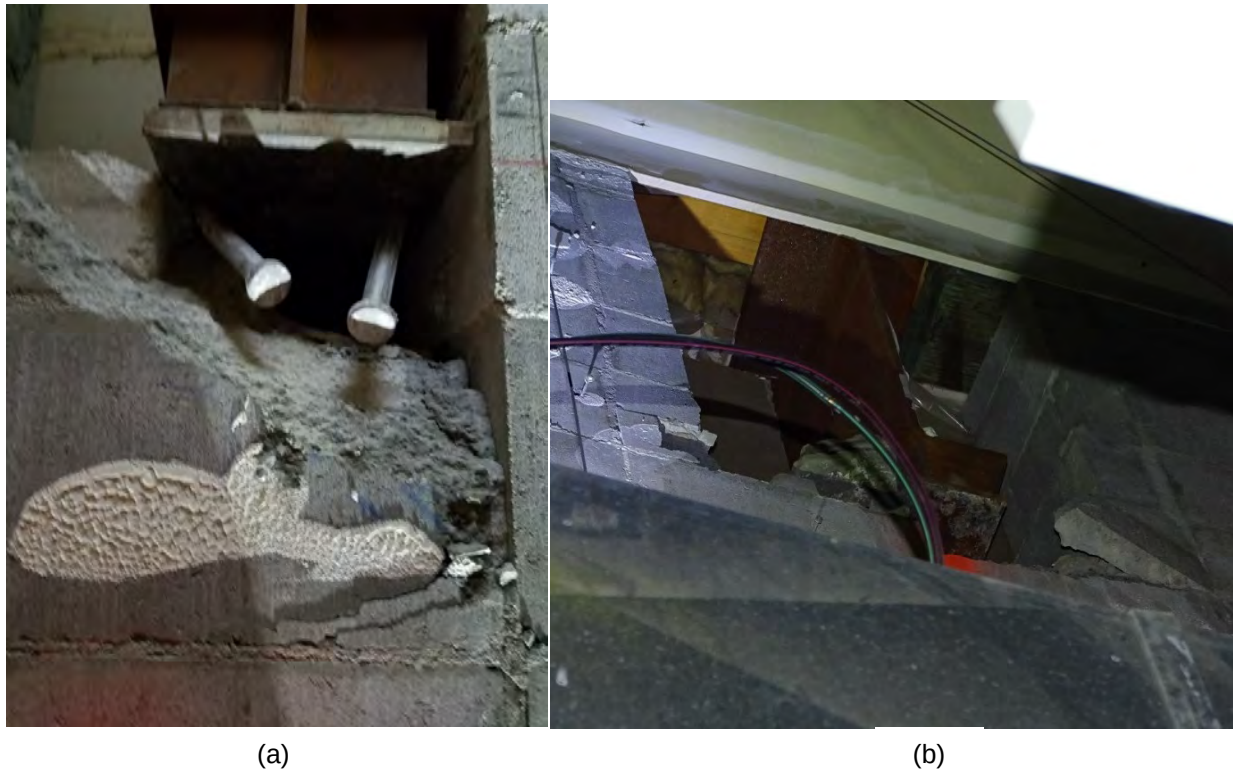
Figure 6.2. Failed connection between a steel roof girder and a CMU wall at Houston Middle School: (a) second story of classroom wing (photo: Bill Noyes) and (b) similar failed connection (photo: Janise Rodgers).

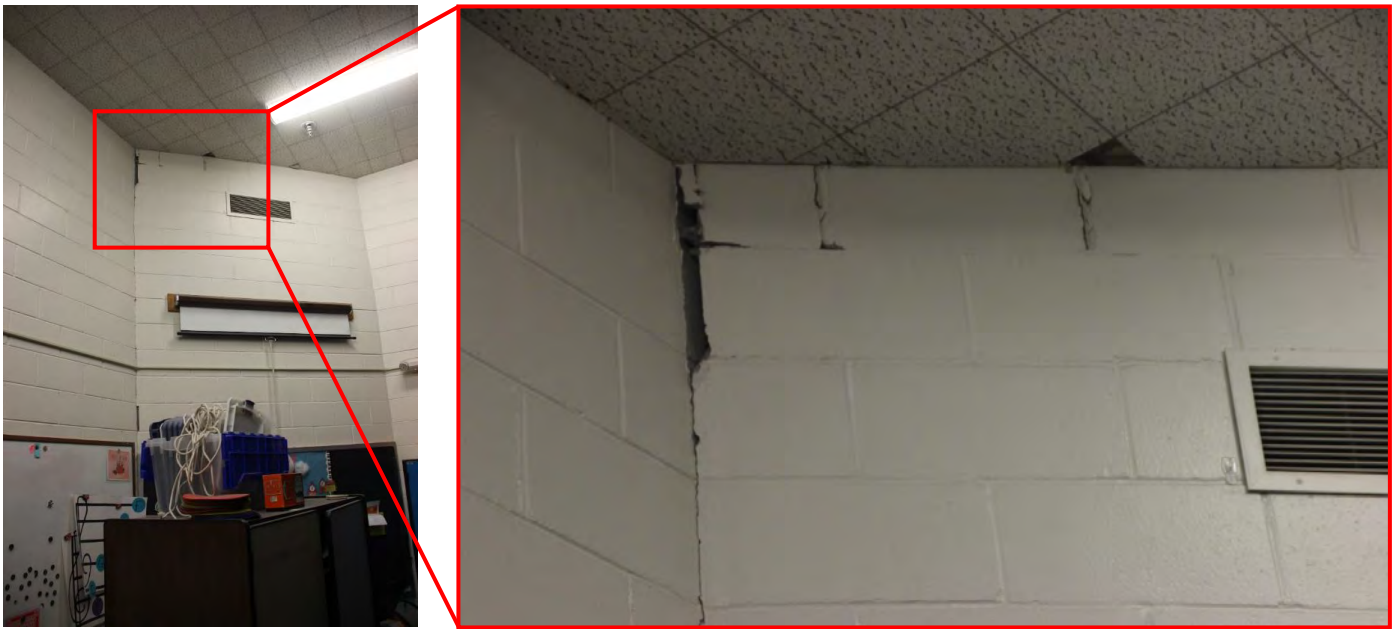
Figure 6.5. Damage to masonry walls at Eagle River Elementary (photo: Chris Motter).

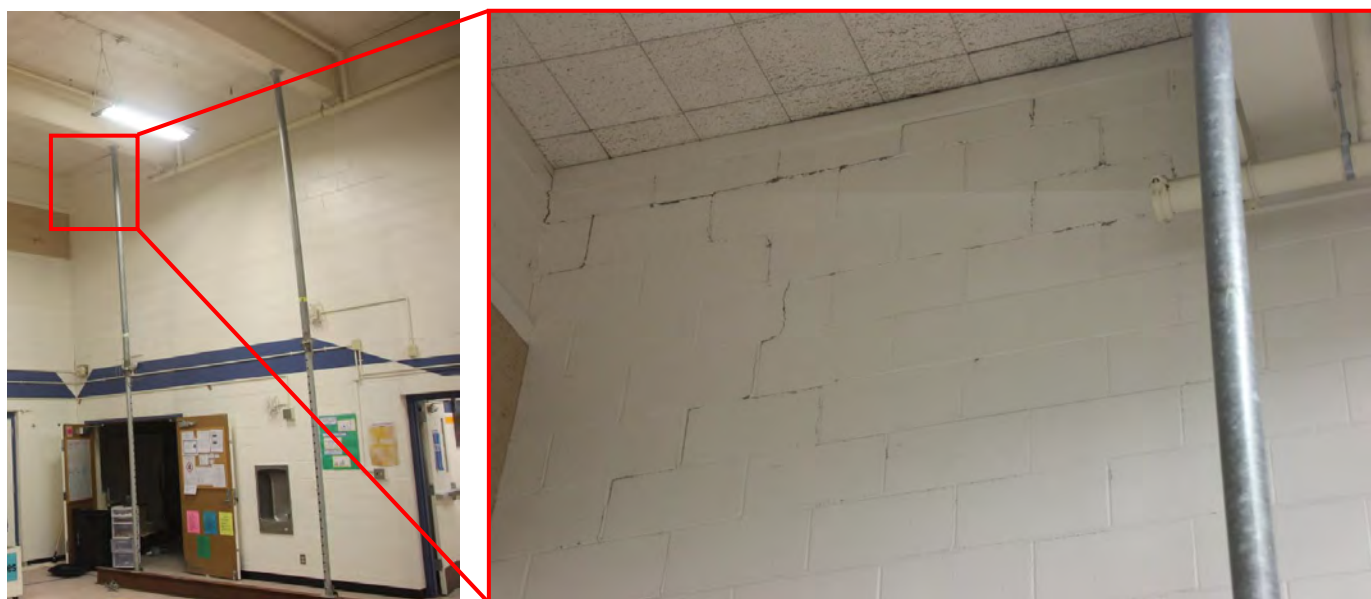
Figure 6.8. Cracking at upper corner of masonry wall at Eagle River Elementary; note vertical shoring due to failed roof-wall connections (photo: Chris Motter).

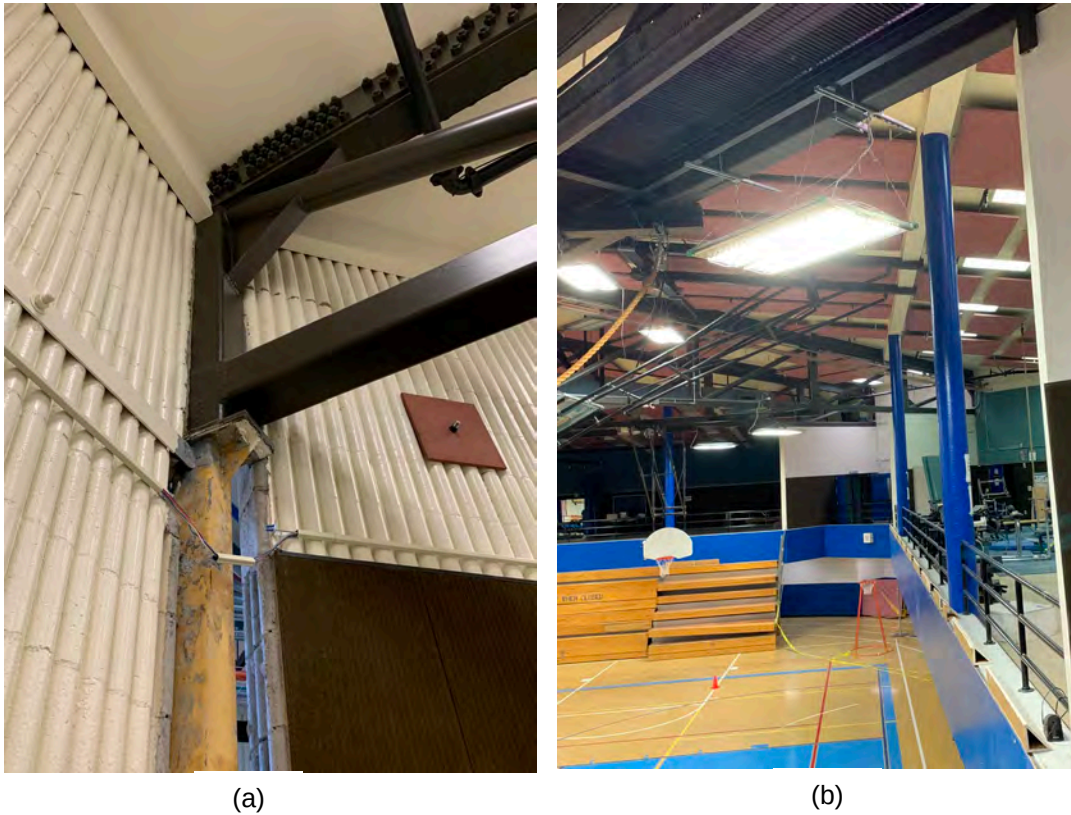
Figure 6.13. (a) Steel column supporting truss separation from CMU wall and (b) permanent drift at Gruening Middle School gymnasium steel columns (Photos: Wael Hassan).

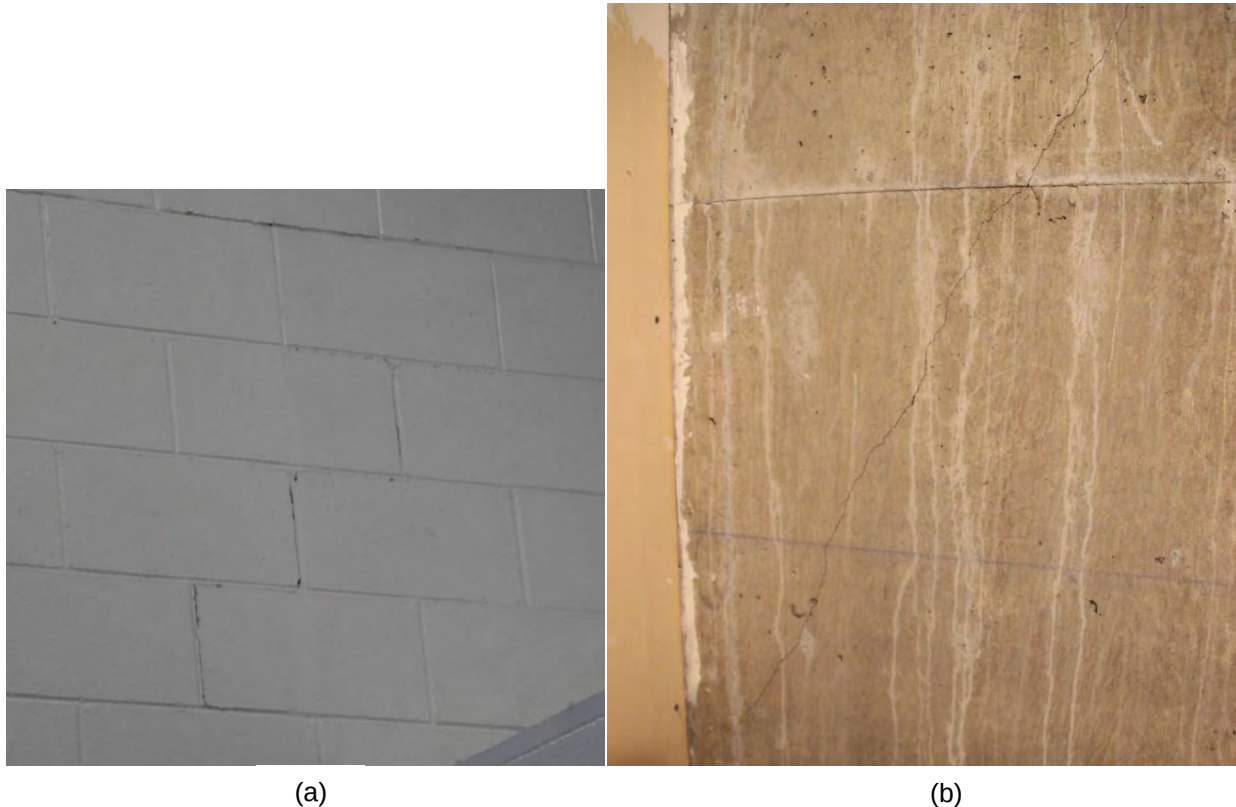
Figure 6.15. Typical minor cracking in reinforced CMUs: (a) Finger Lake Elementary and (b) shear crack in reinforced concrete shear wall, Colony Middle (photos: Chris Motter).

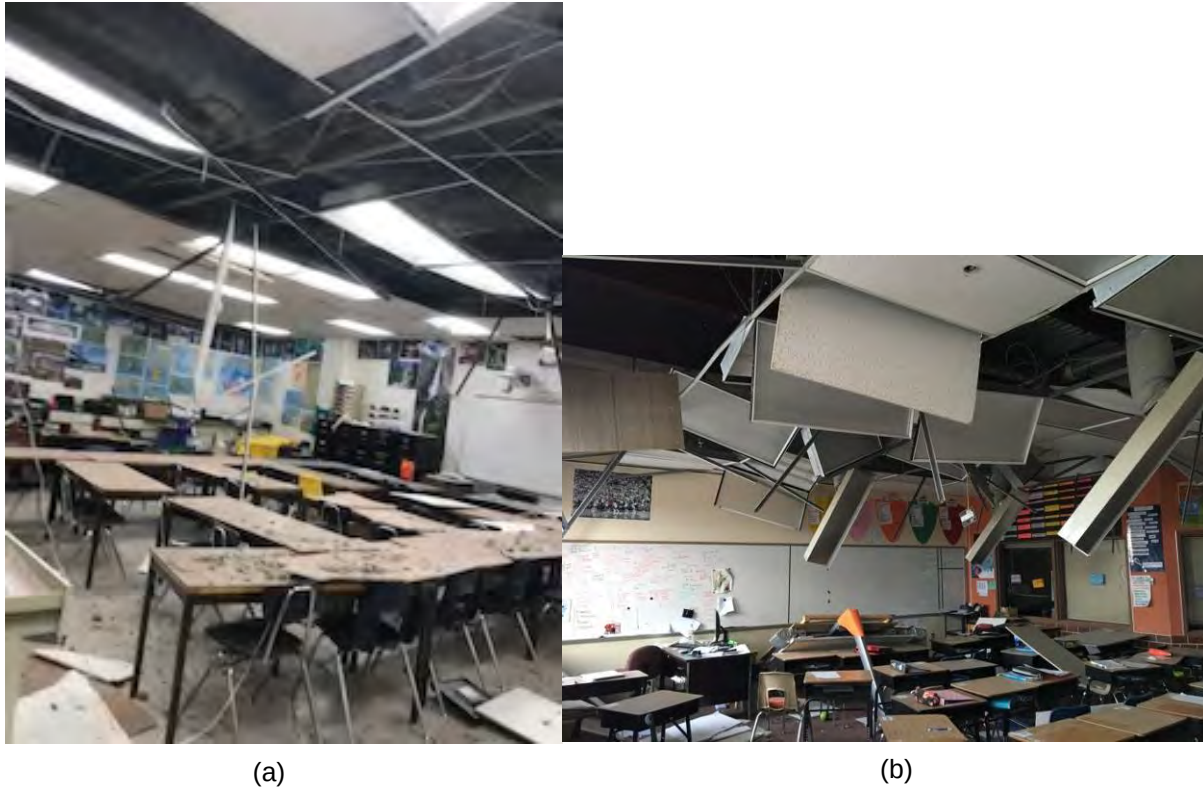
Figure 6.16. Major ceiling damage at (a) Bartlett High fifth floor with fallen grid (note lack of seismic bracing) and (b) at second floor of Colony Middle (photos: (a) ASD and (b) MSBSD).

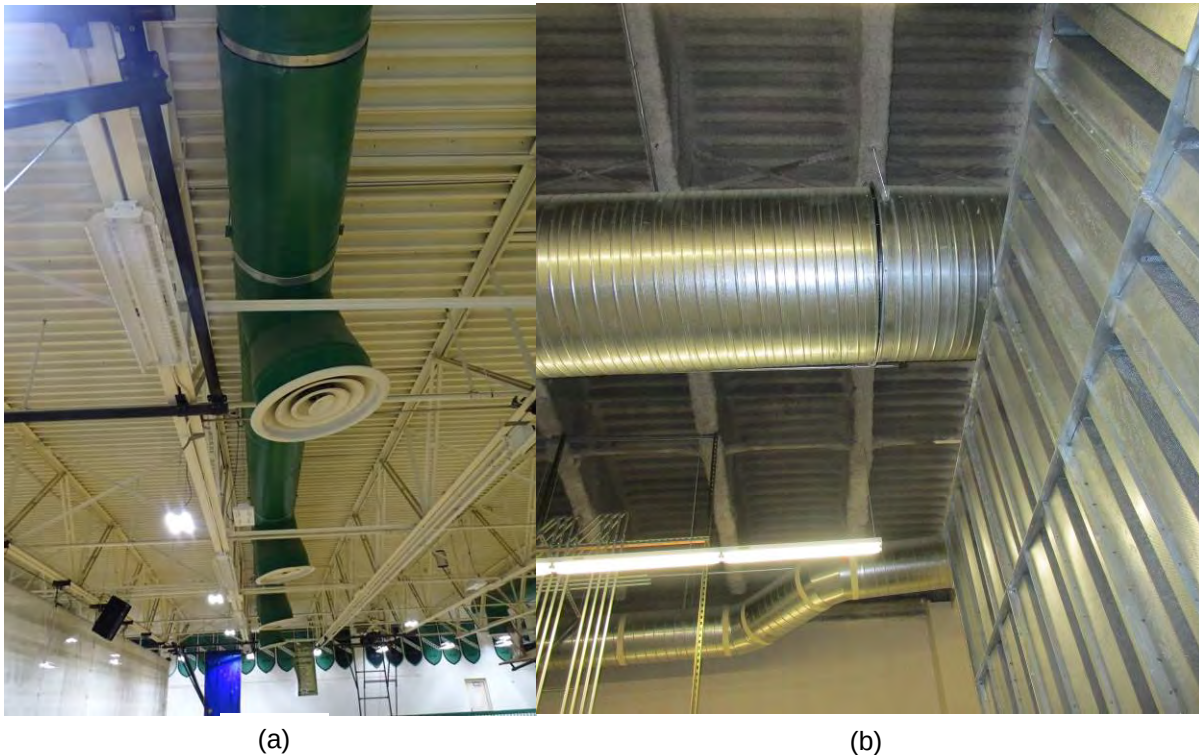
Figure 6.22. (a) Rotation and separation of large duct and diffusers in Colony High gymnasium; (b) separated duct sections at Dimond High (photos: (a) Janise Rodgers and (b) ASD).

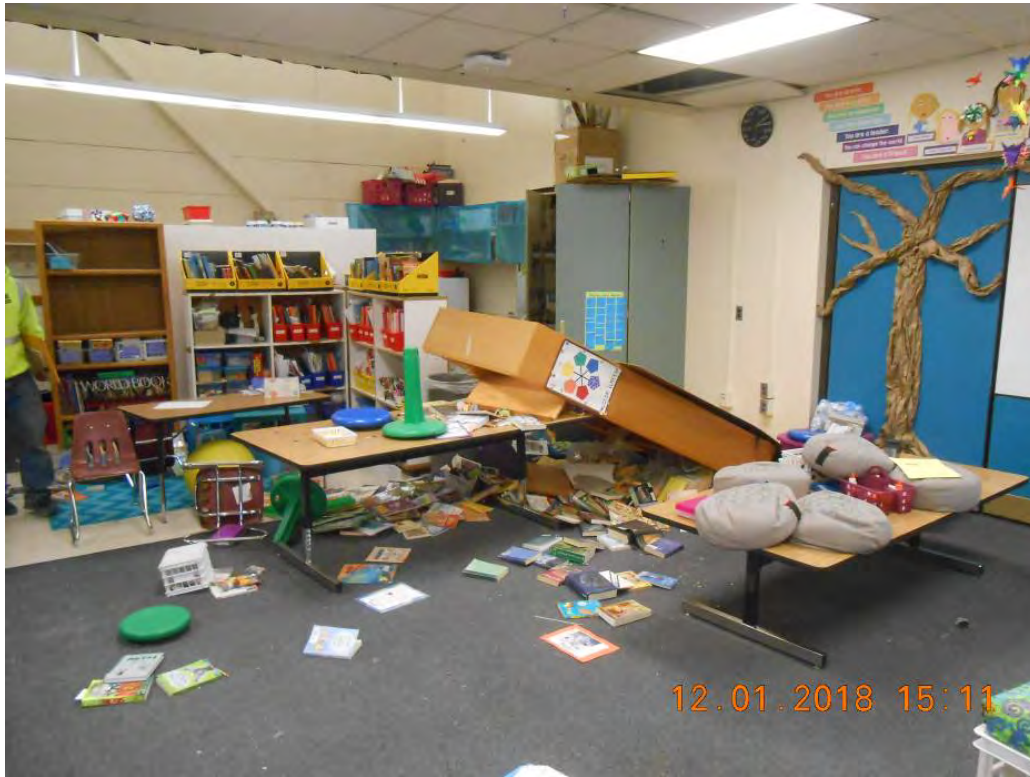
Figure 6.26. Toppled bookcase, Bear Valley Elementary (photo: ASD).
