# EERI Earthquake Reconnaissance Report: M7.1 Anchorage Earthquake on November 30, 2018

Wael M. Hassan, John Thornley, Janise Rodgers, and Christopher Motter

July 2021

*A product of the EERI Learning from Earthquakes Program*

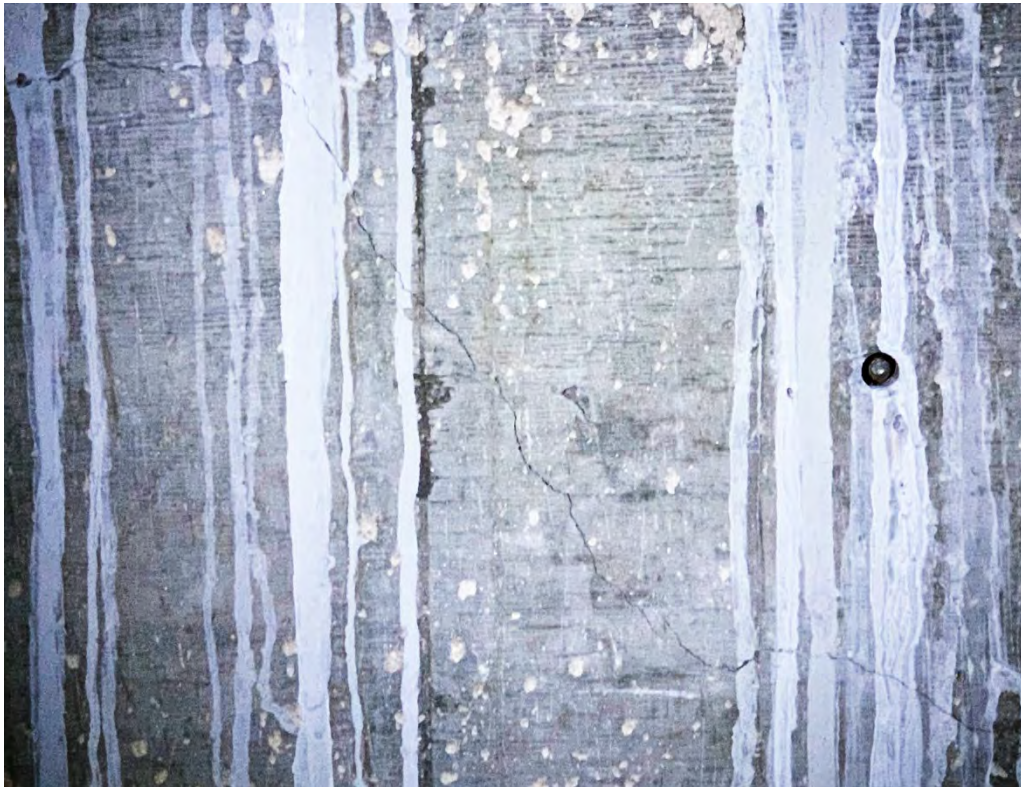
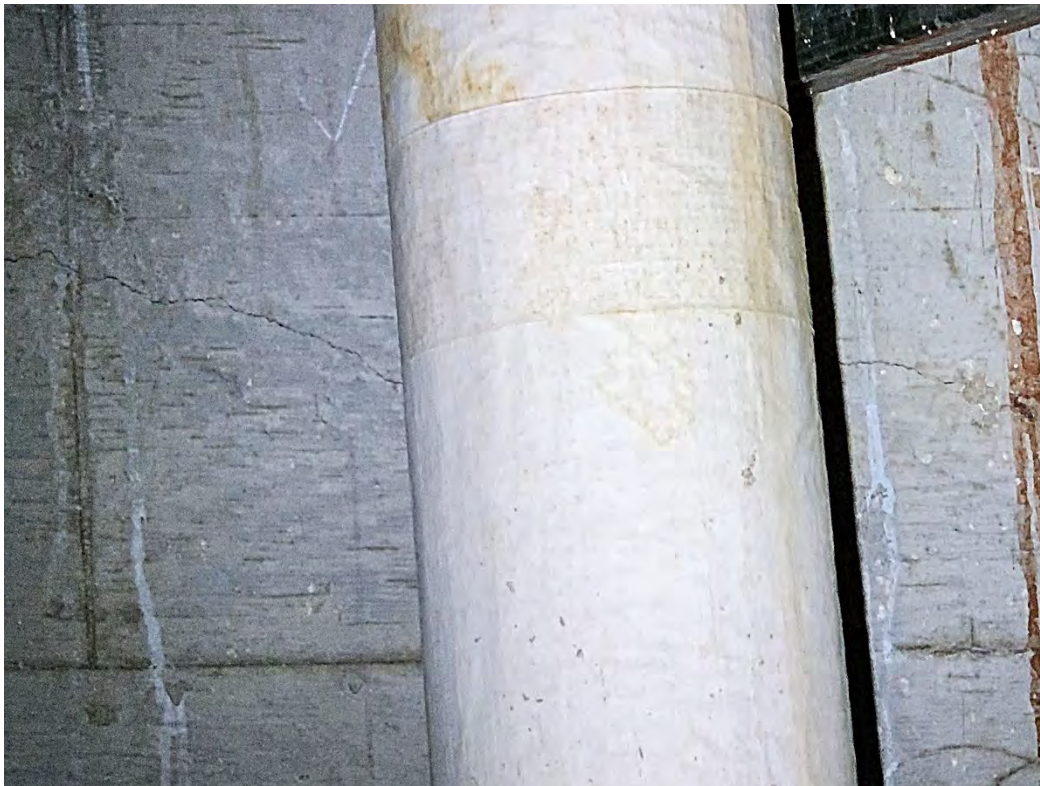
*Figure 7.4. Minor concrete core wall diagonal shear crack in the main building of an Anchorage hospital; photos were taken inside the elevator shaft (photos: Wael Hassan).*

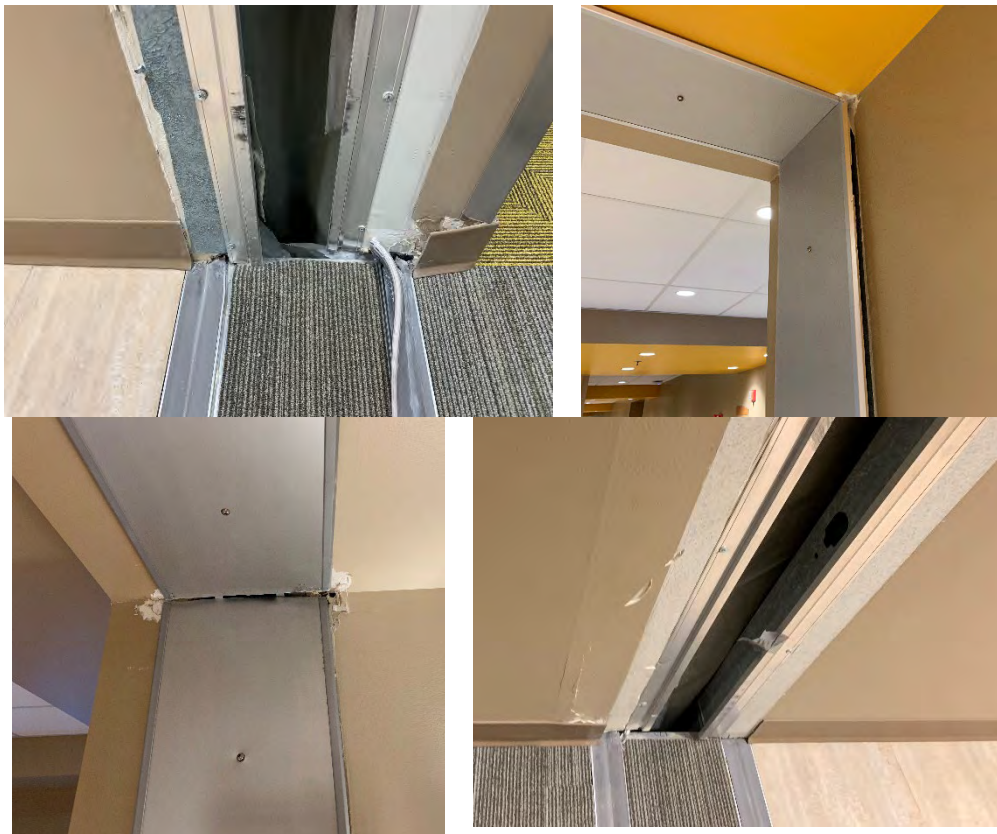
Figure 7.6. Examples of seismic joint damage at an Anchorage hospital (photos: Wael Hassan).

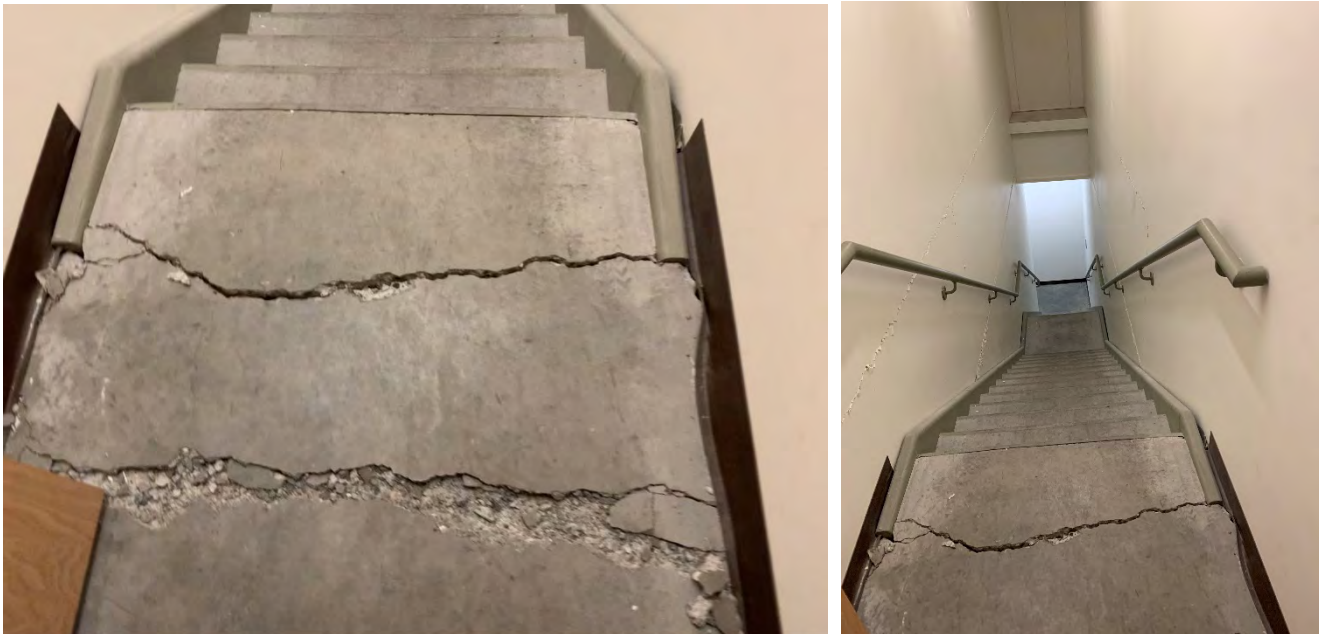
Figure 7.11. Cracking and crushing of concrete at stair flight-landing interface, BBA (photos: Wael Hassan).

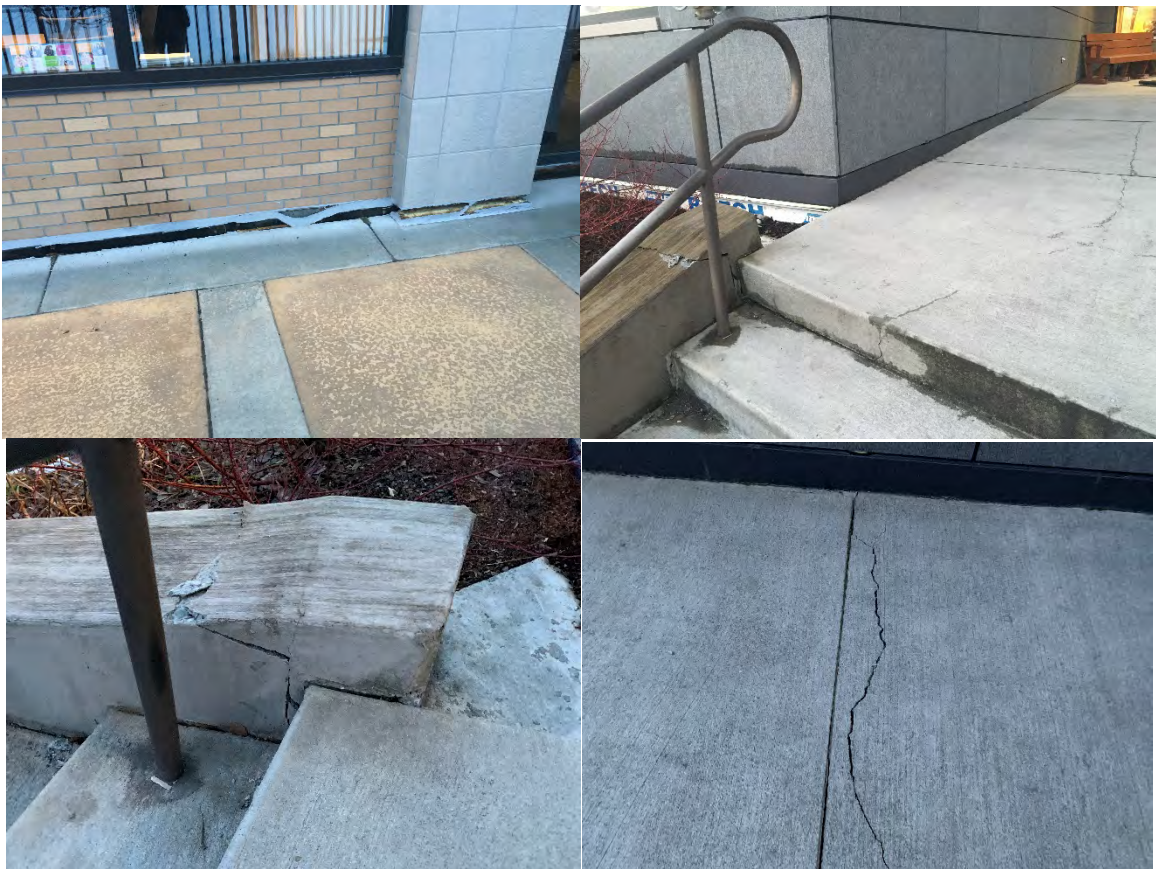
Figure 7.12. Geotechnically related structural damage in a hospital in Anchorage (photos: Wael Hassan).

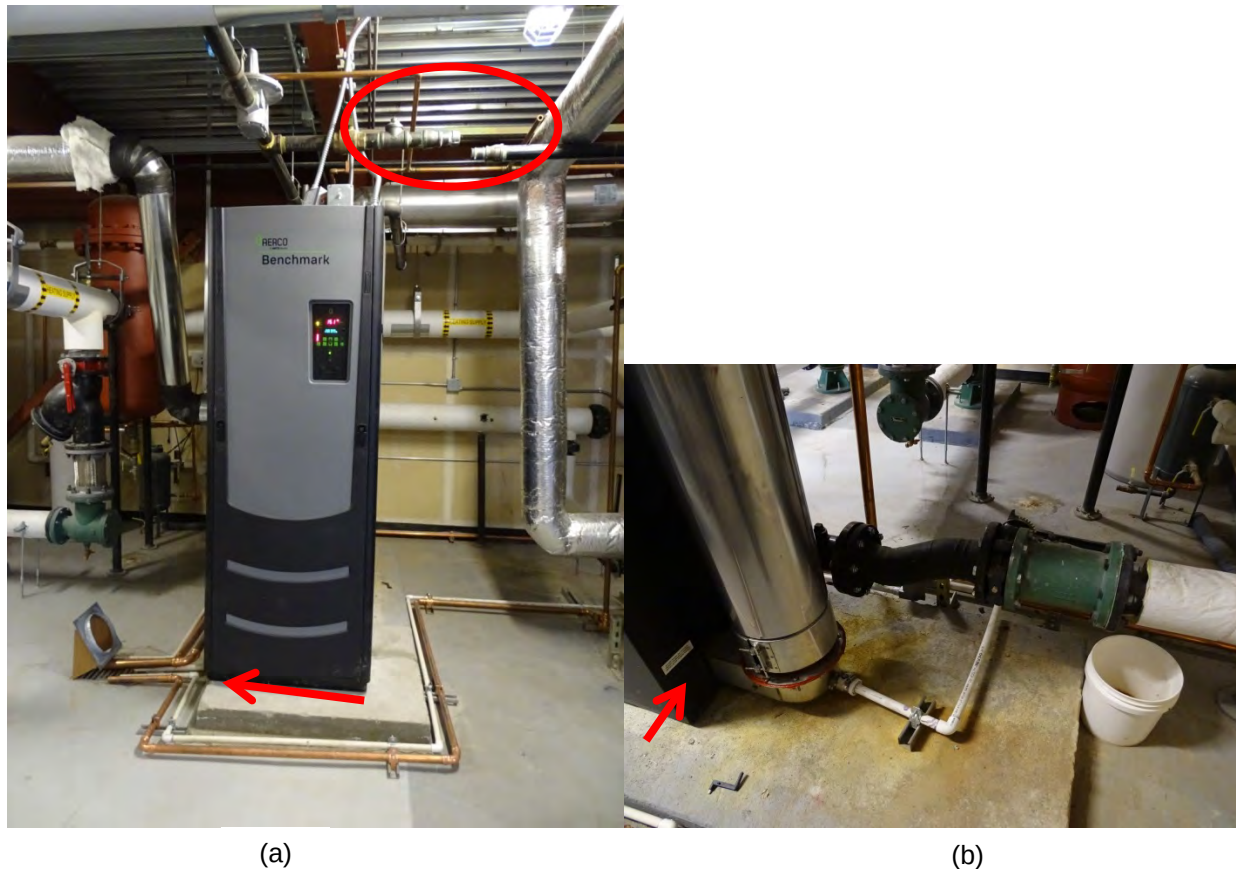
Figure 7.15. (a) Boiler in Mat-Su Regional MOB 1 penthouse shifted to left, with breaking gas line at top right. The ensuing major gas leak forced a building evacuation. (b) Back of same boiler with PVC pipe bent past 90 degrees because of movement (photos: Janise Rodgers).

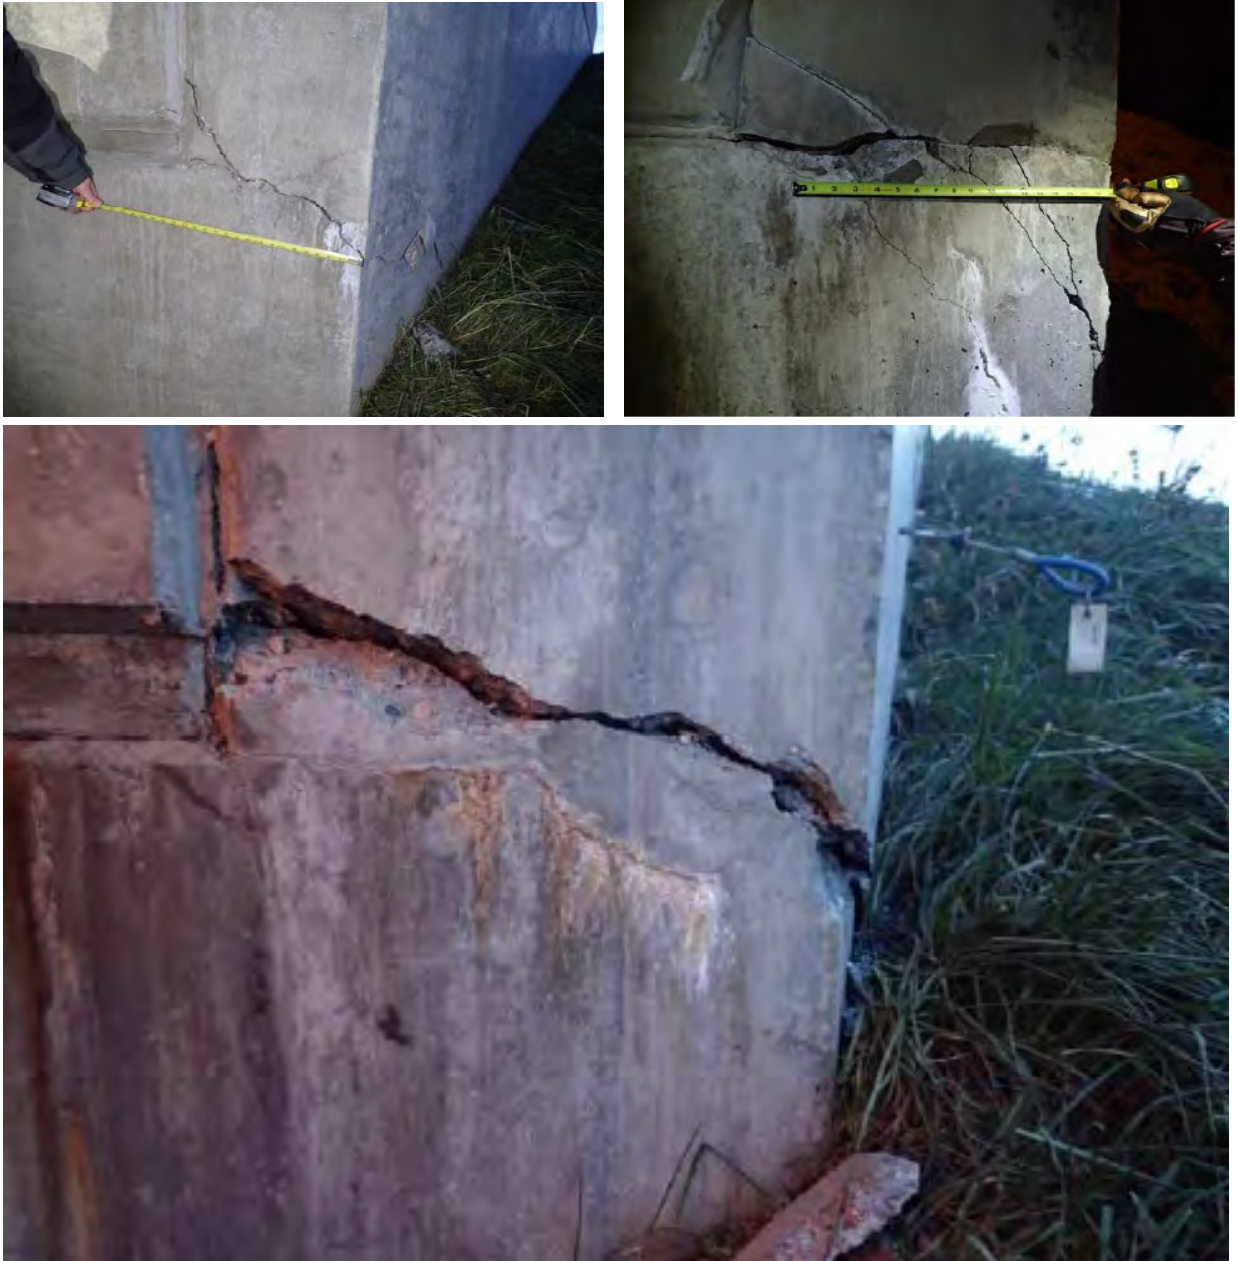
Figure 8.7. Hider wall cracks (photos: Nick Murray and Ben Still).

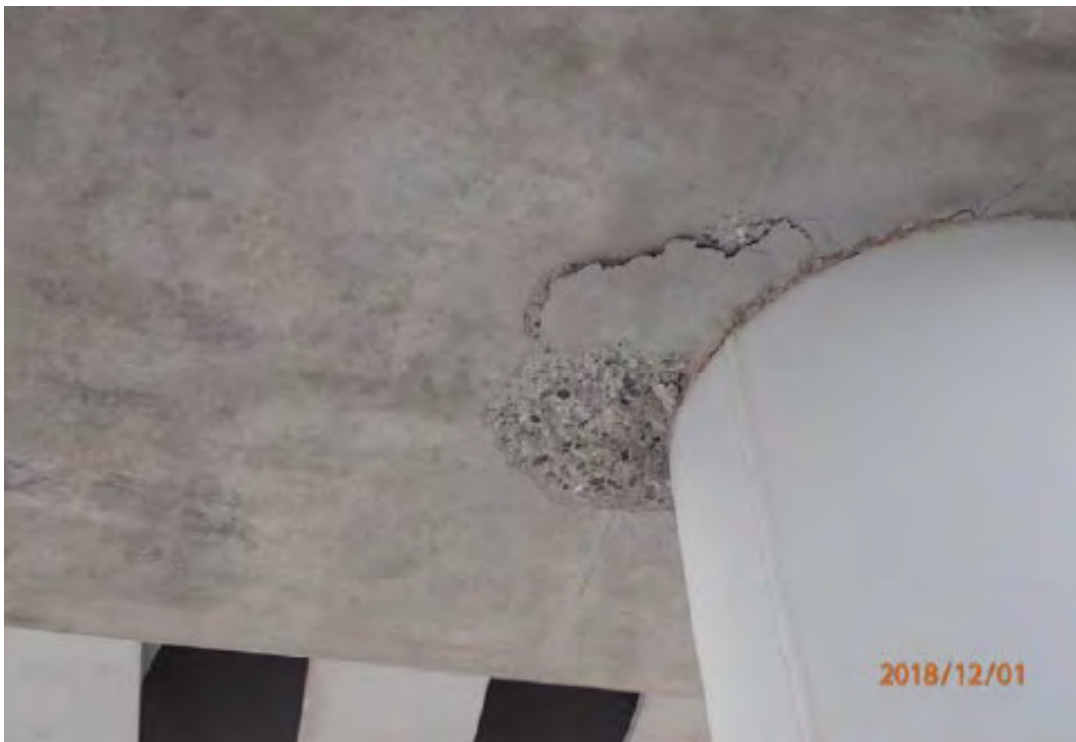
Figure 8.10. Spalling at pile pier cap (photo: Sara Manning and Fred Paulsen).

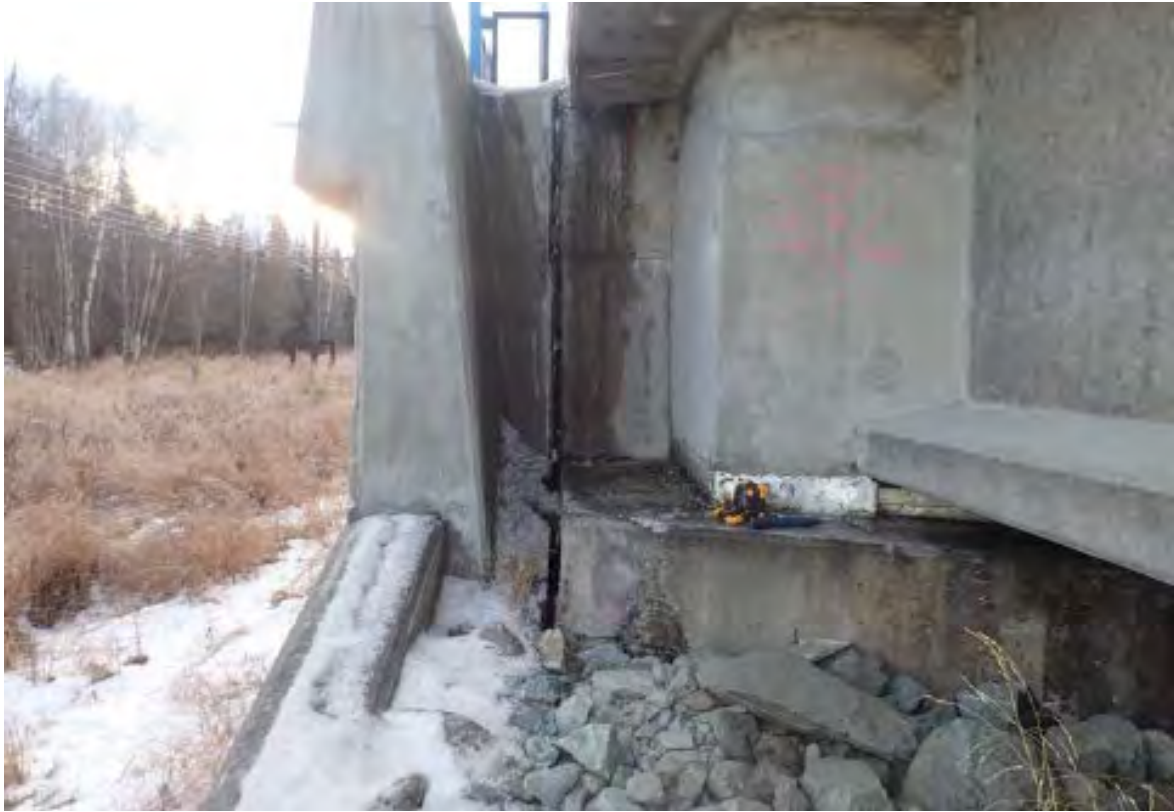
Figure 8.13. Wing wall 1.5-inch displacement for 20 feet (photo: Nick Murray and Ben Still).

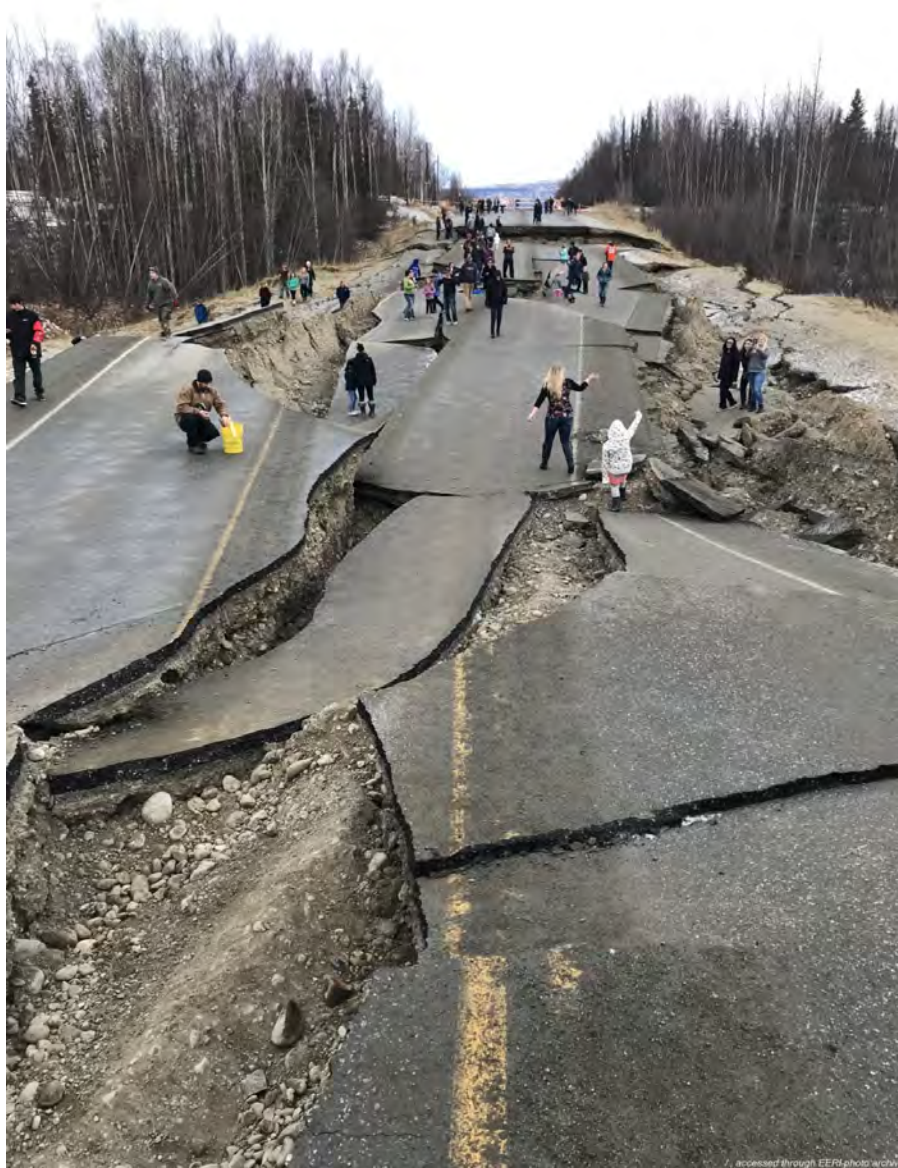
Figure 8.20. Vine Road earthquake damage (photo: EERI Clearinghouse).

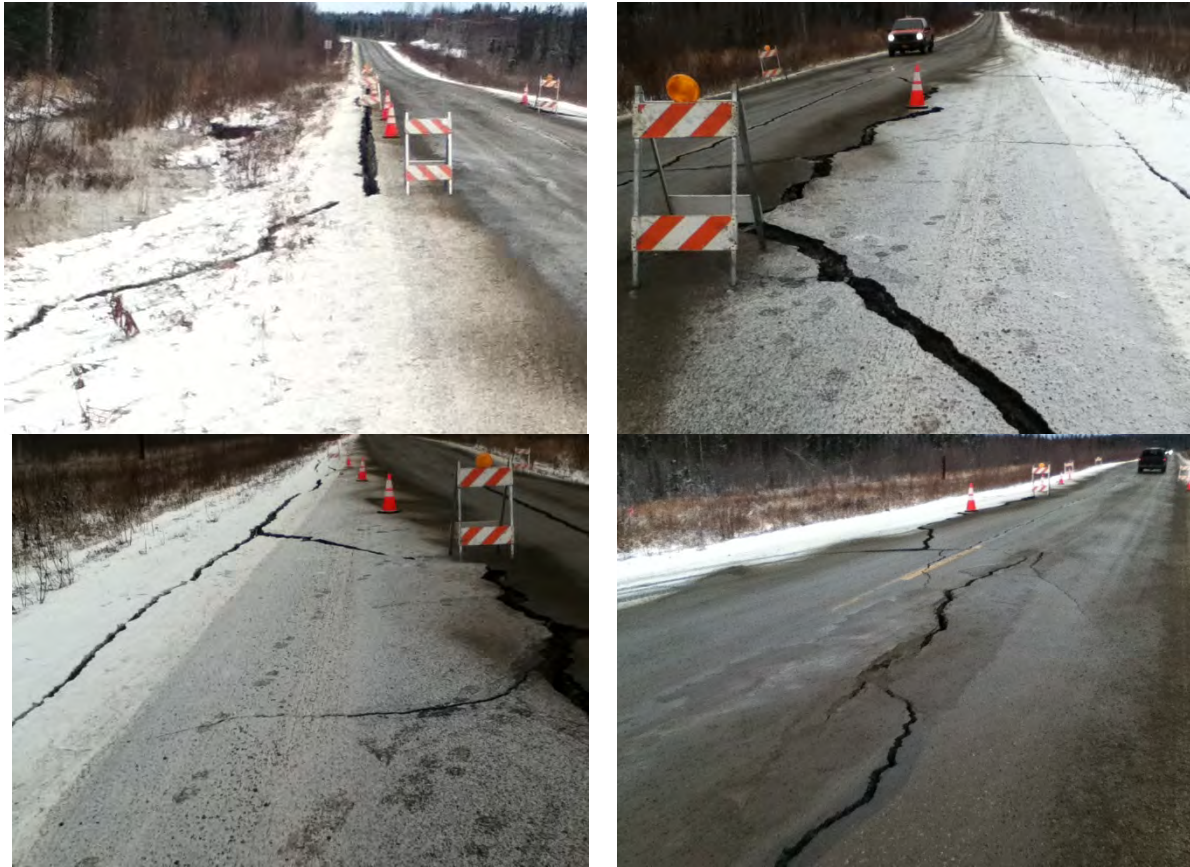
Figure 8.26. Damage to Point Mackenzie Road.

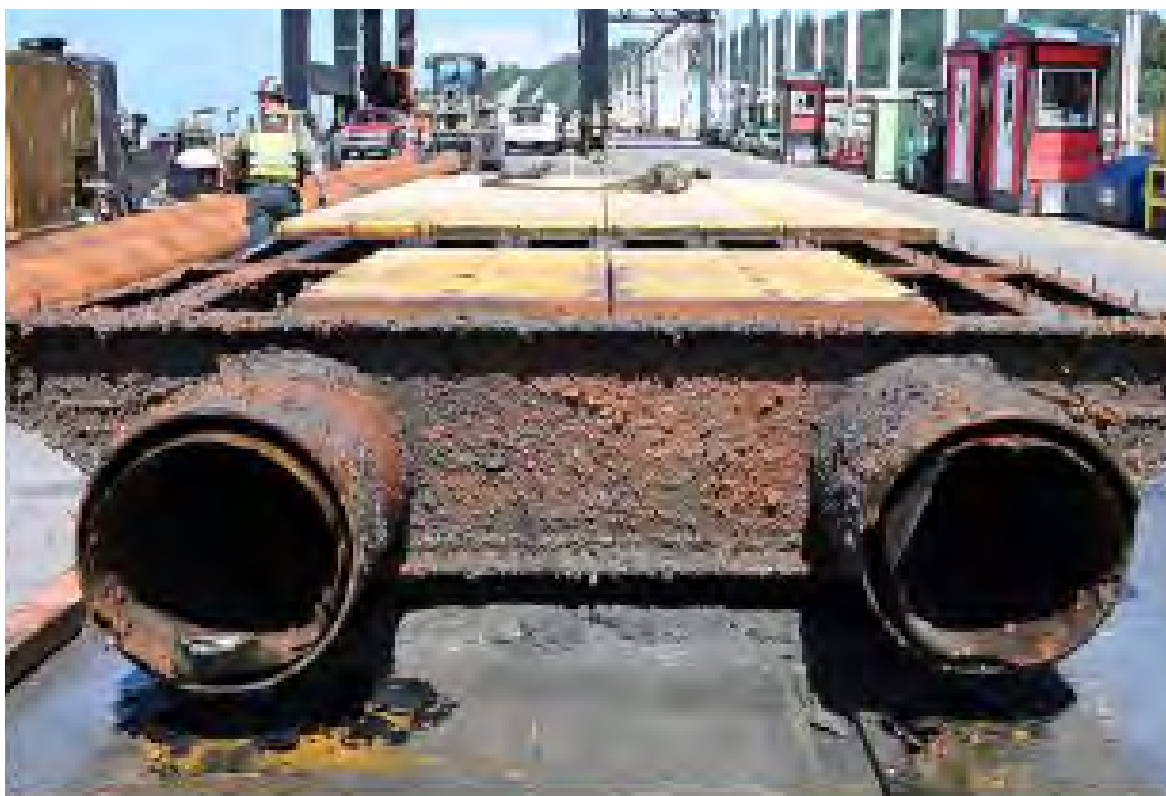
Figure 9.18. Fender pile failures and dock repairs (photo: Port of Alaska).

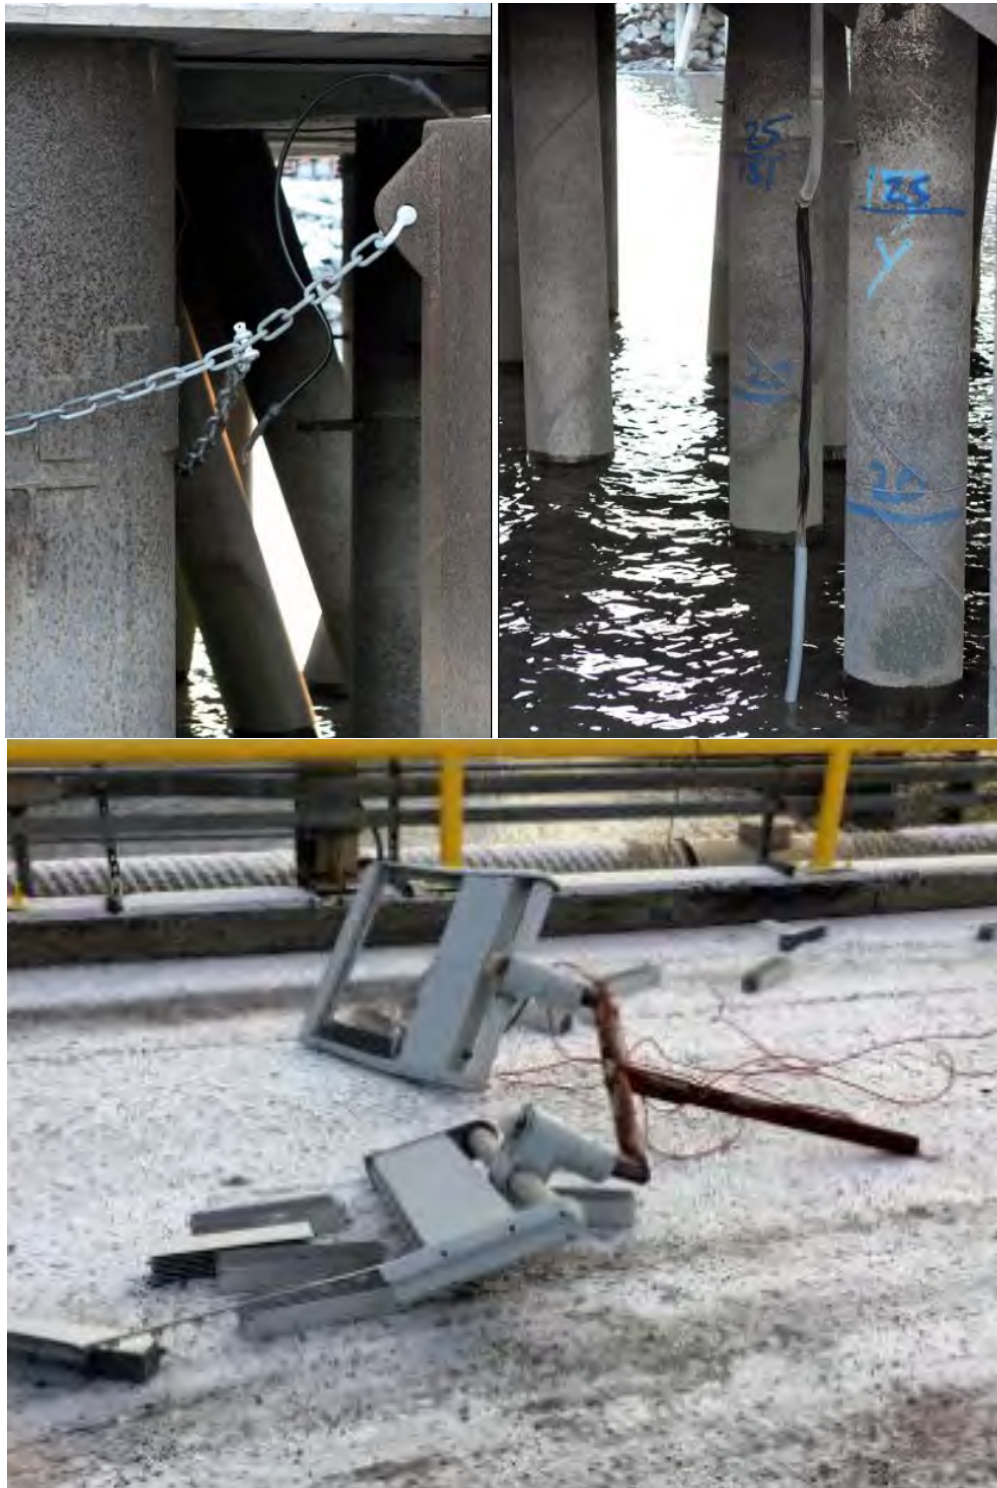
*Figure 9.19. Nonstructural damage to dock lights, cameras, and connections and wires of cathodic protection systems (photos: Port of Alaska).*

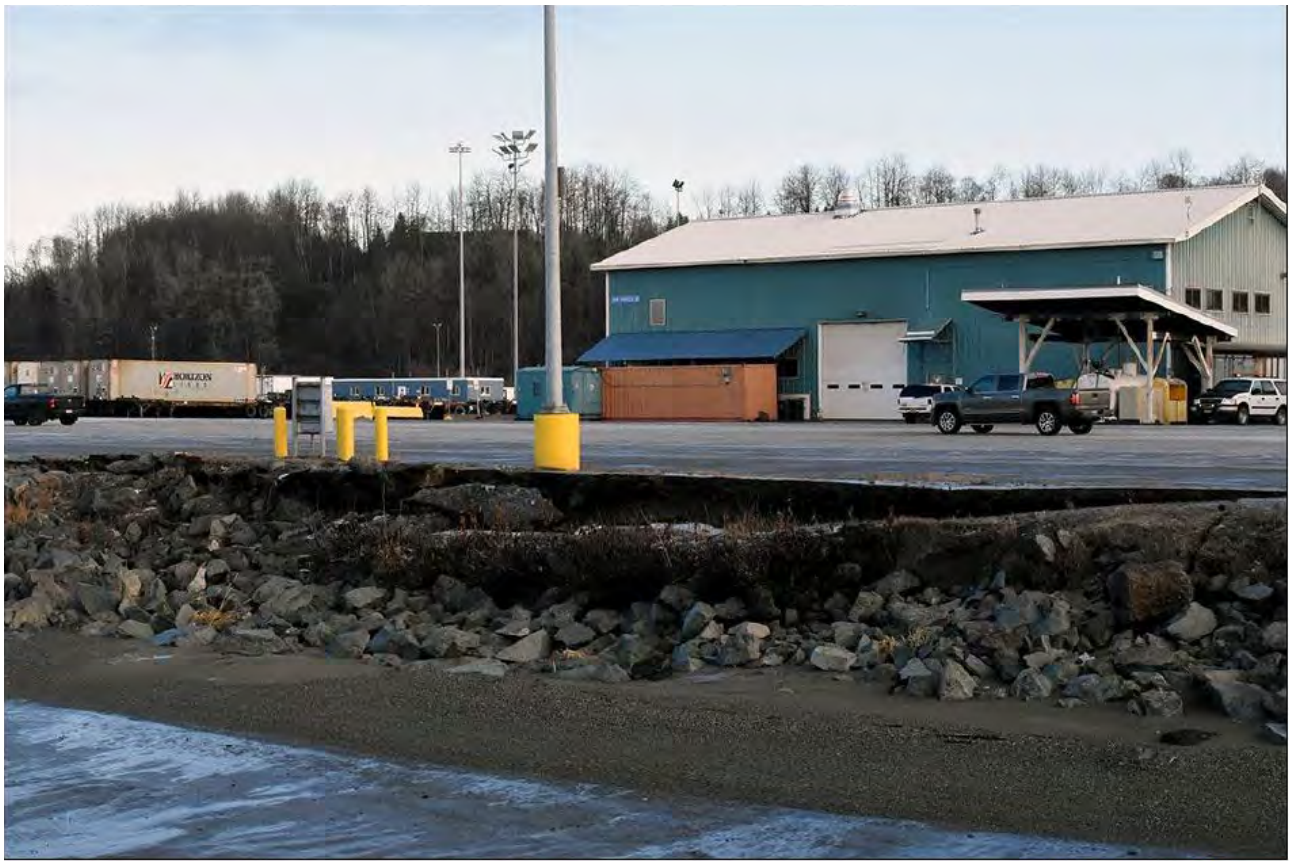
Figure 9.20. Shore failure near Terminal 1 (photo: Port of Alaska).

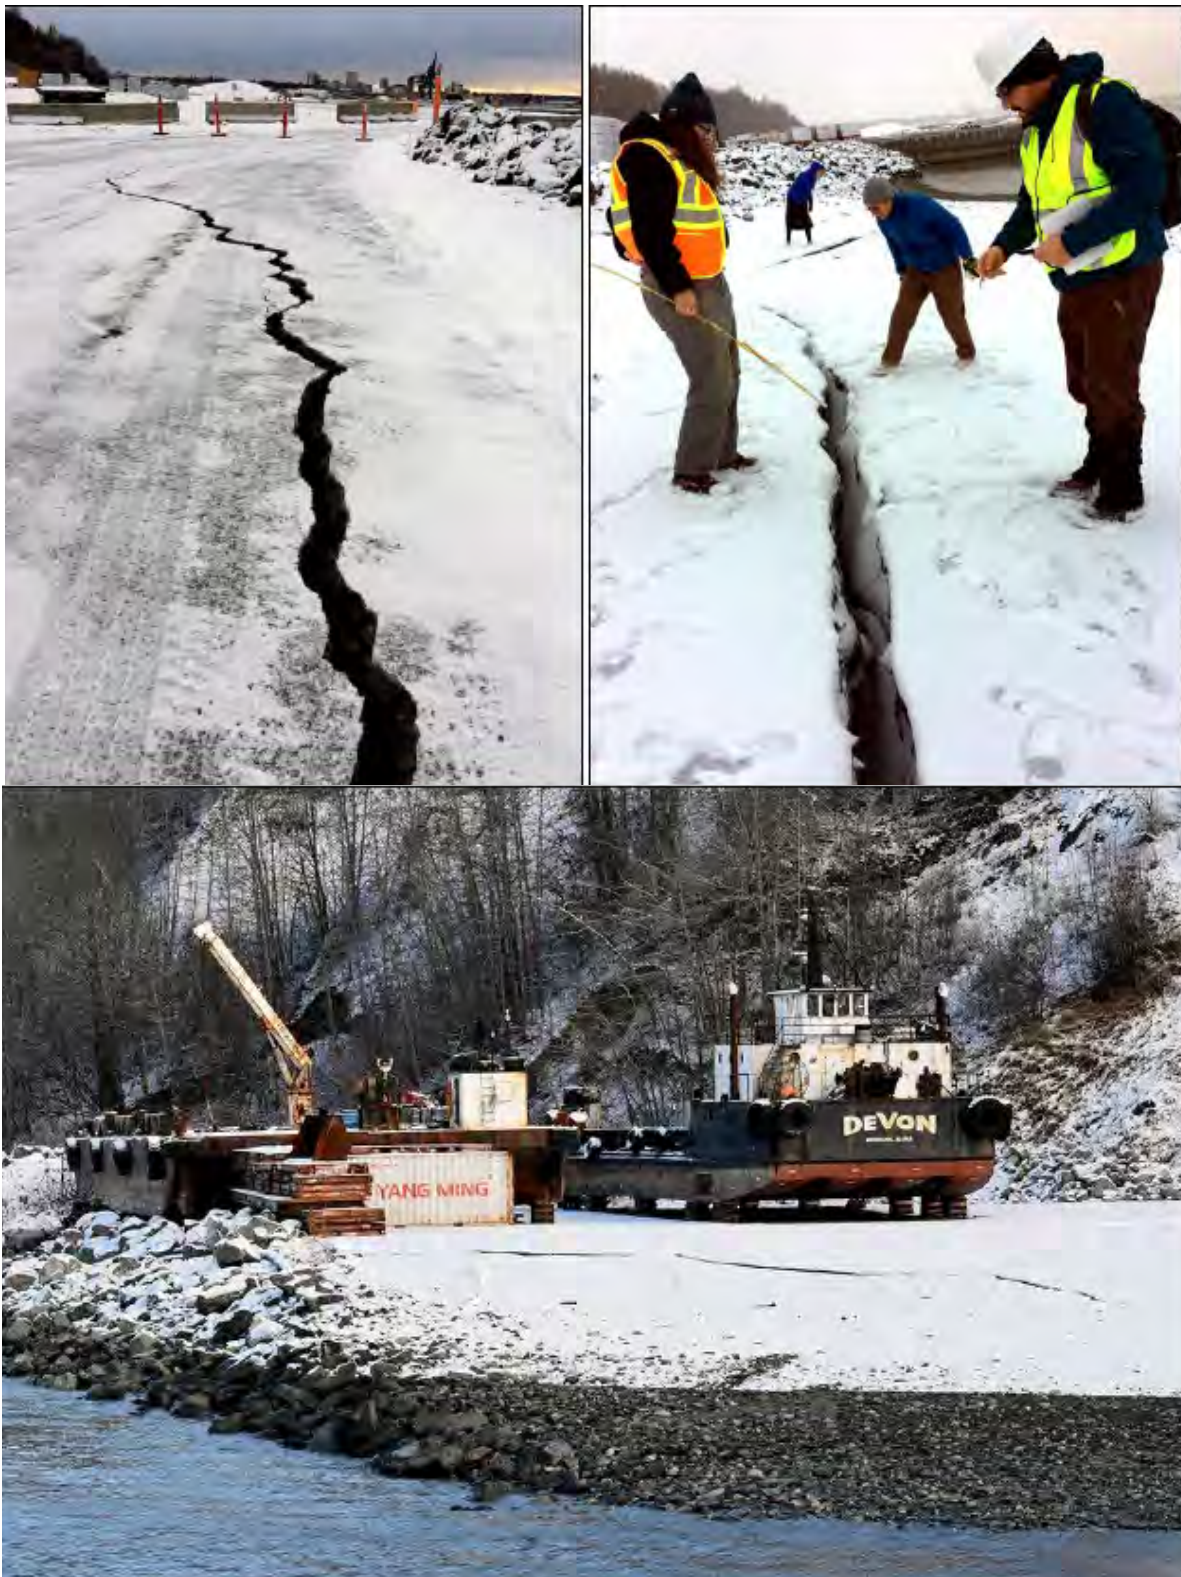
Figure 9.23. A barge and tugboat remain on their blocks despite being in close proximity to slope failures (photos: Port of Alaska).
