**FINAL**  
**FAILURE INVESTIGATION**  
**WESTCHESTER NORTH LAGOON BRIDGE**  
**Anchorage, Alaska**

August 2014

*Prepared for:*  
Municipality of Anchorage  
Project Management and Engineering  
P.O. Box 196650  
Anchorage, Alaska 99519-6650

*Prepared by:*  
*USKH Inc. now Stantec*  
2515 A Street  
Anchorage, Alaska 99503  
Phone (907) 276-4245  
Fax (907) 258-4653

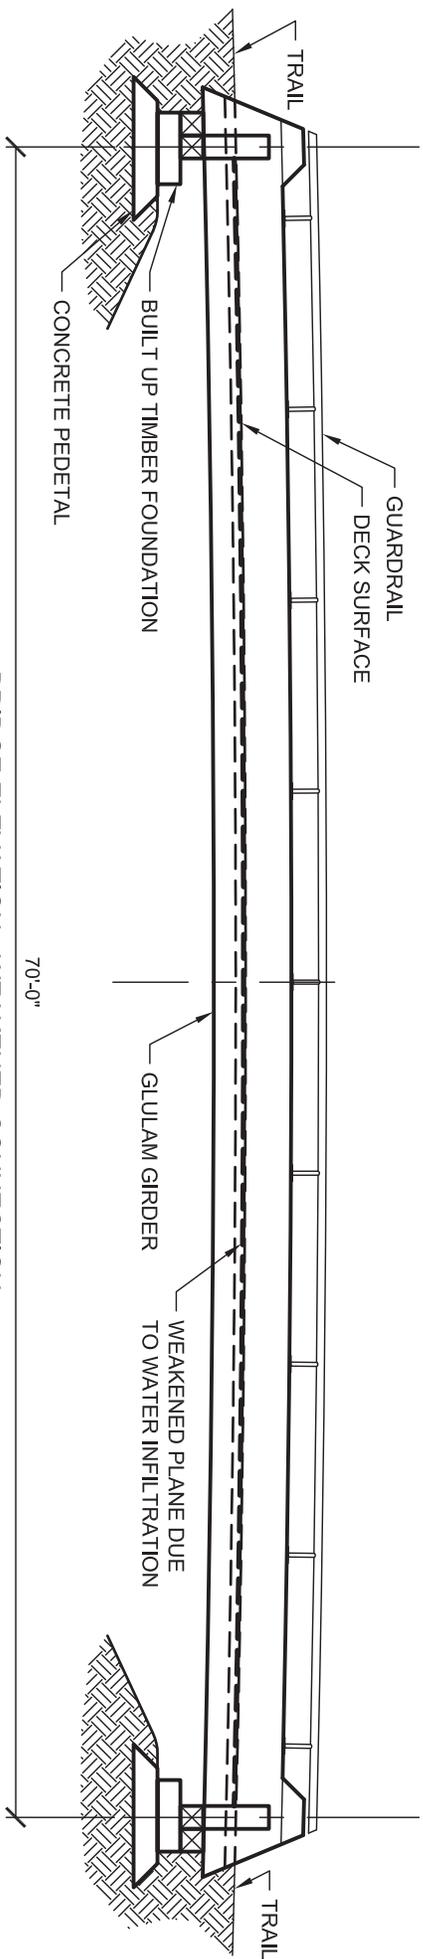
BRIDGE ELEVATION - WEAKENED CONNECTION

The failure mode, confirmed by analysis and site observations, appears to be cross-grain tension in the glulam beam. The ledger is set inboard of the glulam from 3/4- to 1-inch near the bottom of the glulam beams. The location means the bottom of the beam is loaded inducing cross-grain tension in the glulam. The NDS does not recognize this type of loading since wood is extremely weak in cross-grain tension, so designing connections that rely on cross-grain tension is not a recommended practice. The NDS gives recommendations for radial tension in curved glulam beams, which is basically the same as cross-grain tension. Using the allowable radial tension stress limitations given in NDS, and an assumption for length influenced by the tire loading, gives a Demand-Capacity Ratio of about 1.4. This means under the assumptions listed, the stress caused by the tire exceeds the allowable stress by about 40%. The code has a typical average factor of safety of 2, so in practice the vehicle loading did not cause failure until the plane was weakened when moisture infiltration and decay reduced the strength.

A review of the as-built drawings and site investigation shows how this plane of weakness developed. Water drains off the deck onto the ledger below and eventually migrates down to the lag bolts drilled into the glulams. While in the glulams, the moisture collects in the wood and although some moisture will dissipate through the wood and back to the surface, most will stay. This results in this location of the glulam remaining in a saturated condition over time causing decay. The black/brown stains and the moistness of the beams at this area confirm this decay zone. The ledger detail relies on cross-grain tension developed in the bottom of the beam to transfer the load. This load transfer detail is not recommended as wood is weakest in this loading condition. A calculation using some assumptions showed that this was the weak link of the design. The connection held until strength reduction from wood decay reduced this capacity gradually over time.

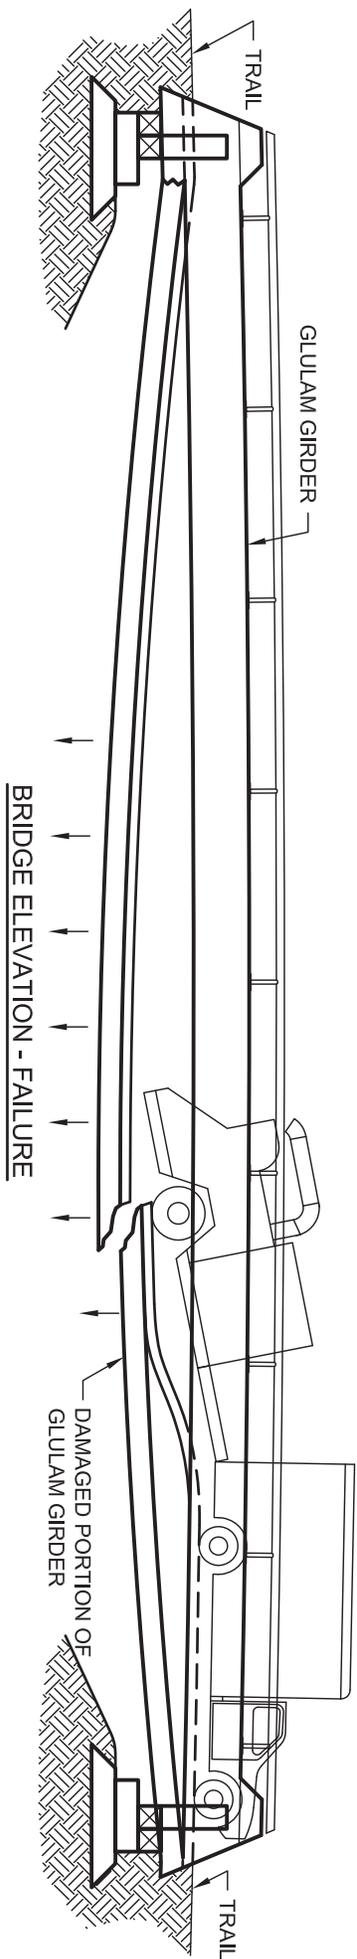
BRIDGE ELEVATION - FAILURE

The North Lagoon Bridge failed under vehicle load. The failure mechanism was cross-grain tension along the plane of the lag bolts attaching the deck support ledger to the main glulam beams. Although this was not a recommended detail, it did not fail until years of water infiltration and decay weakened a plane defined by a line of lag bolts through the ledger.

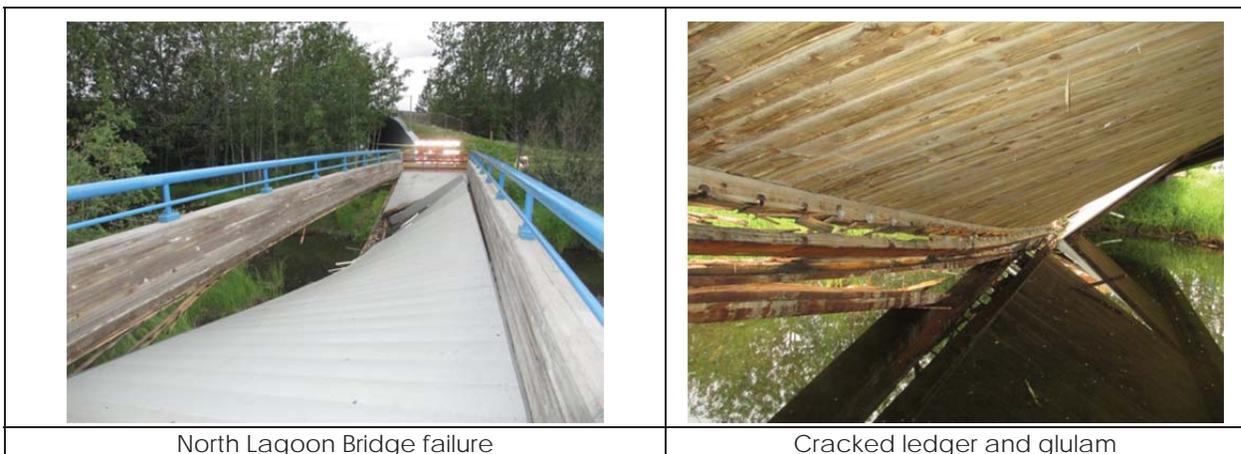
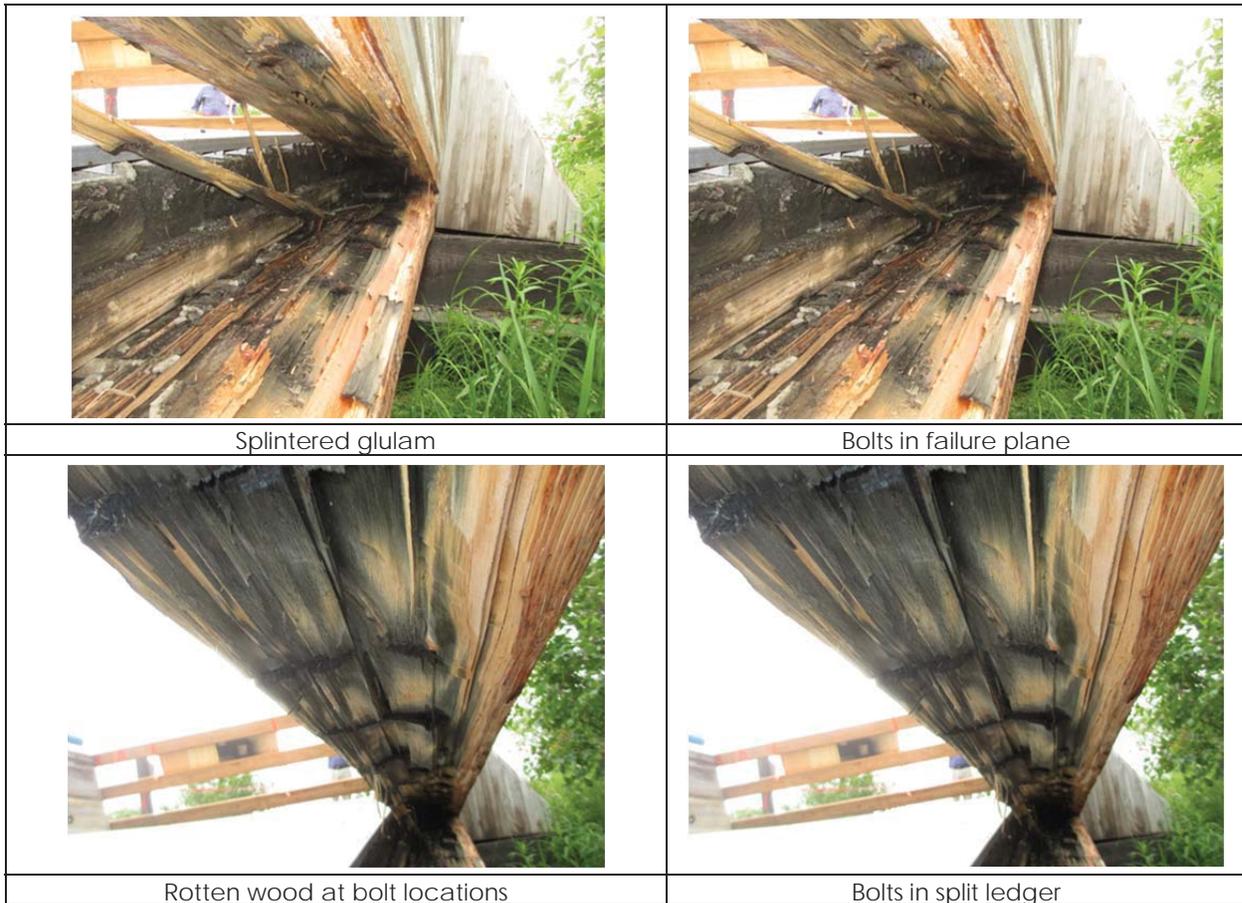
The east side glulam beam failed when the bottom part of the beam split off from the main beam and came to rest in the wetlands. Most of the deck ledger was split. A portion remained connected to the glulam while other portions remained connected to the deck. The upper portion of the west glulam was still intact spanning the wetland. The east glulam appeared undamaged. The east ledger was rotated with the twisted surface of the decking and had a crack in line with the bolts at the points of maximum twisting.

The surfaces of the glulam at the exposed failure plane were closely examined. The surfaces appeared moist and brown; stained from infiltrated moisture. The lag bolts were corroded, indicative of having been exposed to moisture. The darkest staining of the failure plane was near the point where the deck collapsed beneath the wood chipper, as shown in the newspaper photos.

The outside both glulam beams were weathered and grey. There was some minor checking and cracking in the sides of the remaining beam. There was larger checking and splitting in the top of the beams in line with the lag bolts that secure handrail mounts. The east ledger has areas of water staining and moisture on the surface. The top of the wood decking could not be observed because it was covered by the fiberglass deck overlay.

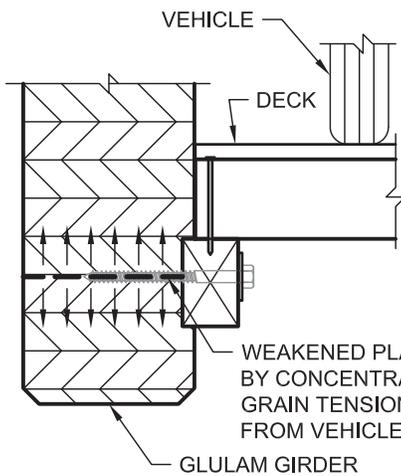
**WEAKENED CONNECTION**

Water draining off the deck onto the ledger below and eventually migrated down the lag bolts drilled into the glulams. The constant influx of moisture into the glulam beam kept the plane in a saturated condition and decayed over time. The ledger detail relied on cross-grain tension developed in the bottom of the beam to transfer the load. The highly concentrated force from the chipper tire applied a significant shear load across a relatively small area of glulam beam. A local failure developed at one point, then like a zipper, the failure plane spread outward down the beam both sides from the initial point of failure. This bottom side of the beam, ledger, and decking tumbled into the wetland.

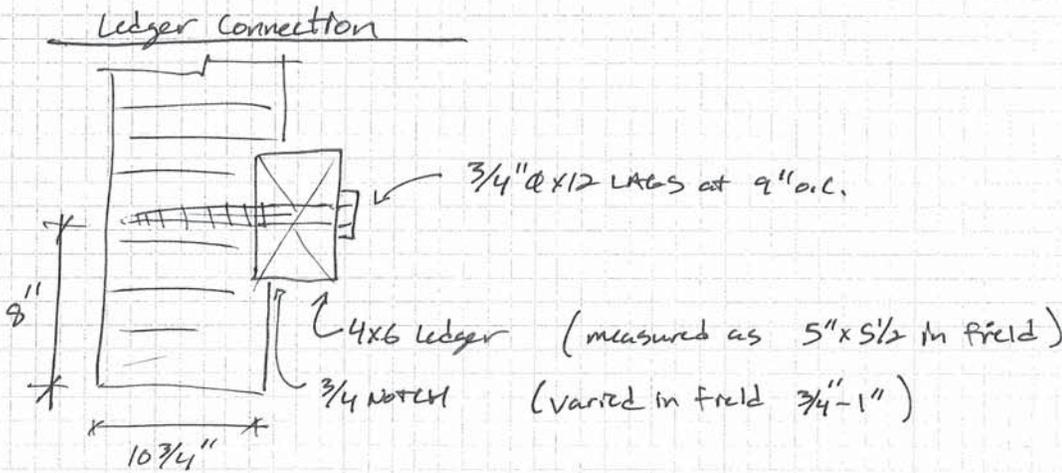
Ledger connection did not fail, the glulam failed  
so load transfer must have occurred by direct bearing  
on the  $\frac{3}{4}$ " to 1" notch in the glulam

By loading on bottom section of beam, will induce cross-grain tension stress. → Actual failure mechanism observed
