# Lanie Fleischer Chester Creek Trail (West)

## 2013 Existing Conditions Assessment Exhibit (1"=200')

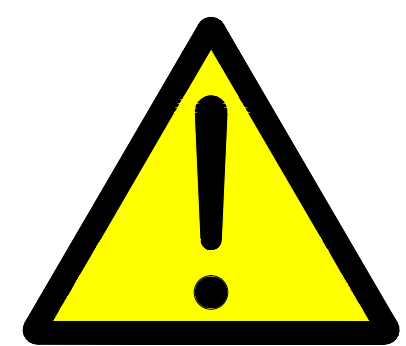
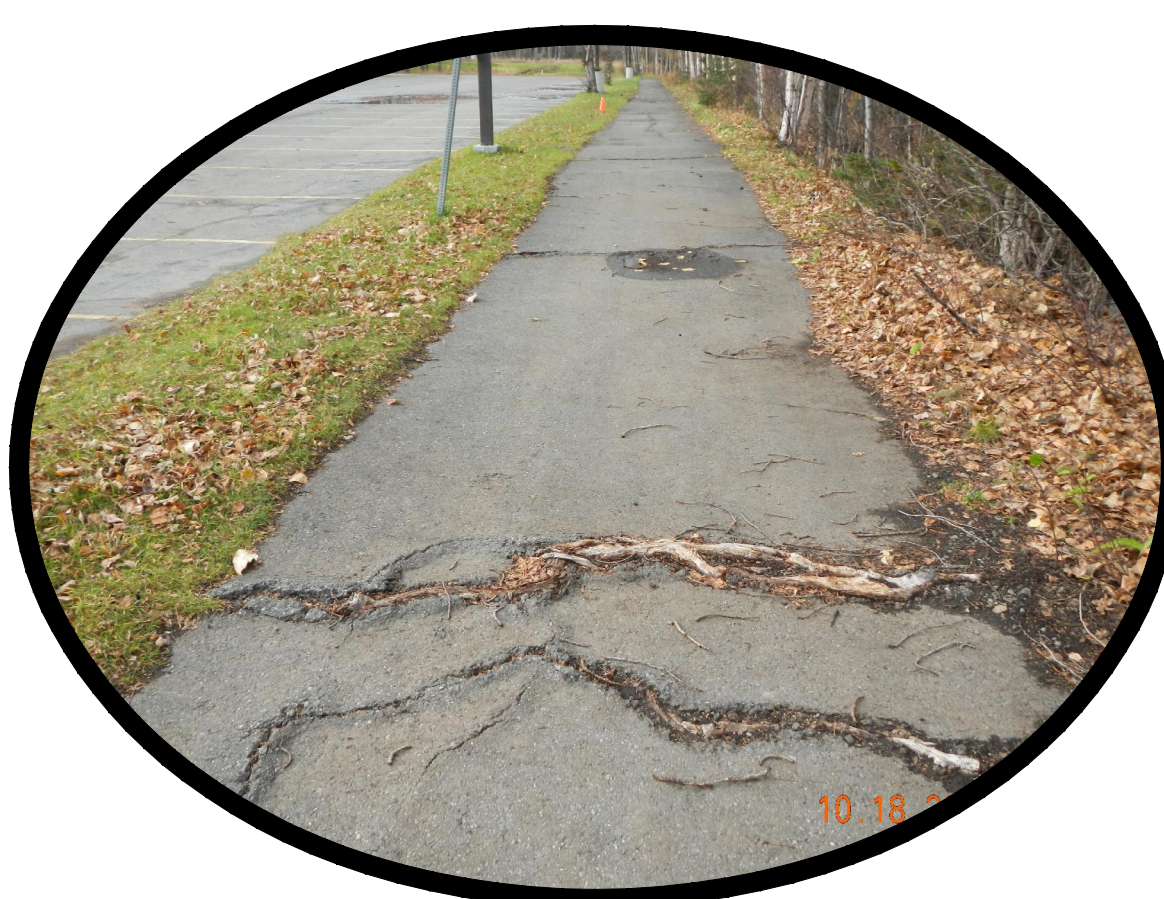
#### TREE ROOTS:

Tree roots, both exposed and shallow, cause the pavement to uplift and crack. They exist sporadically throughout the trail and are typically caused by Cottonwood trees. Cottonwood tree roots grow rapidly and shallow and will continue to degrade the trail until they are removed or trail construction allows for the continued root growth. They can be difficult to traverse, cause trip hazards and are hard on trail user equipment.

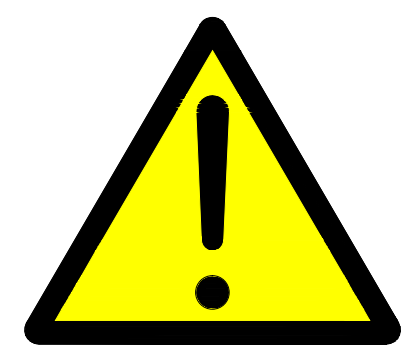
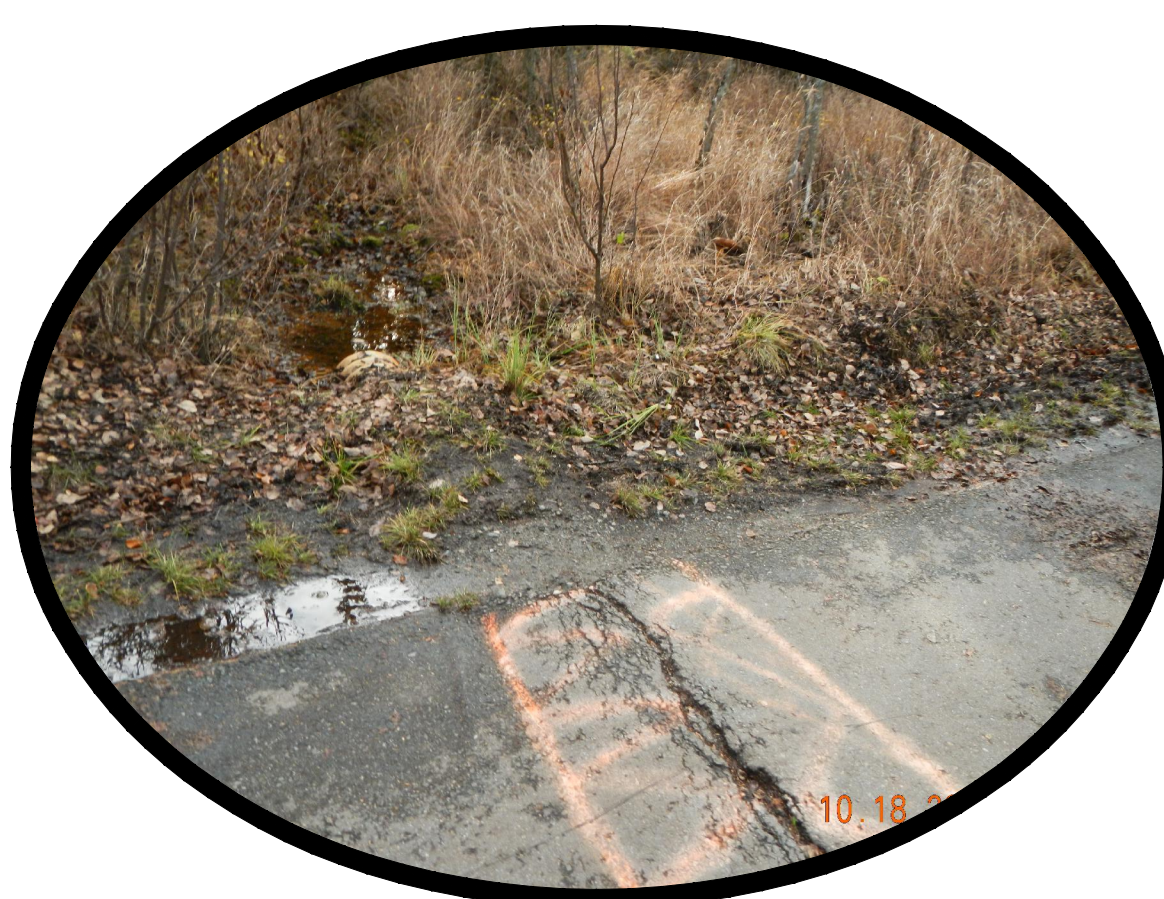
#### UTILITIES:

Several shallow underground utilities (UGU) cross under the trail. A few include: culverts; electrical and communication conduits; sewer and storm drain. Shallow UGU's create conduits for underground water to move similar to fissures. Water trapped at shallow depths are susceptible to freeze-thaw action which results in heaving. Heaves can be a trip hazard and can be difficult to traverse with wheeled equipment such as road bikes and inline skates.

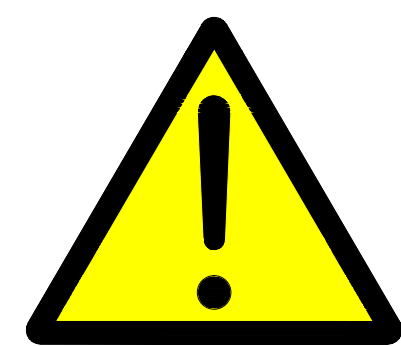
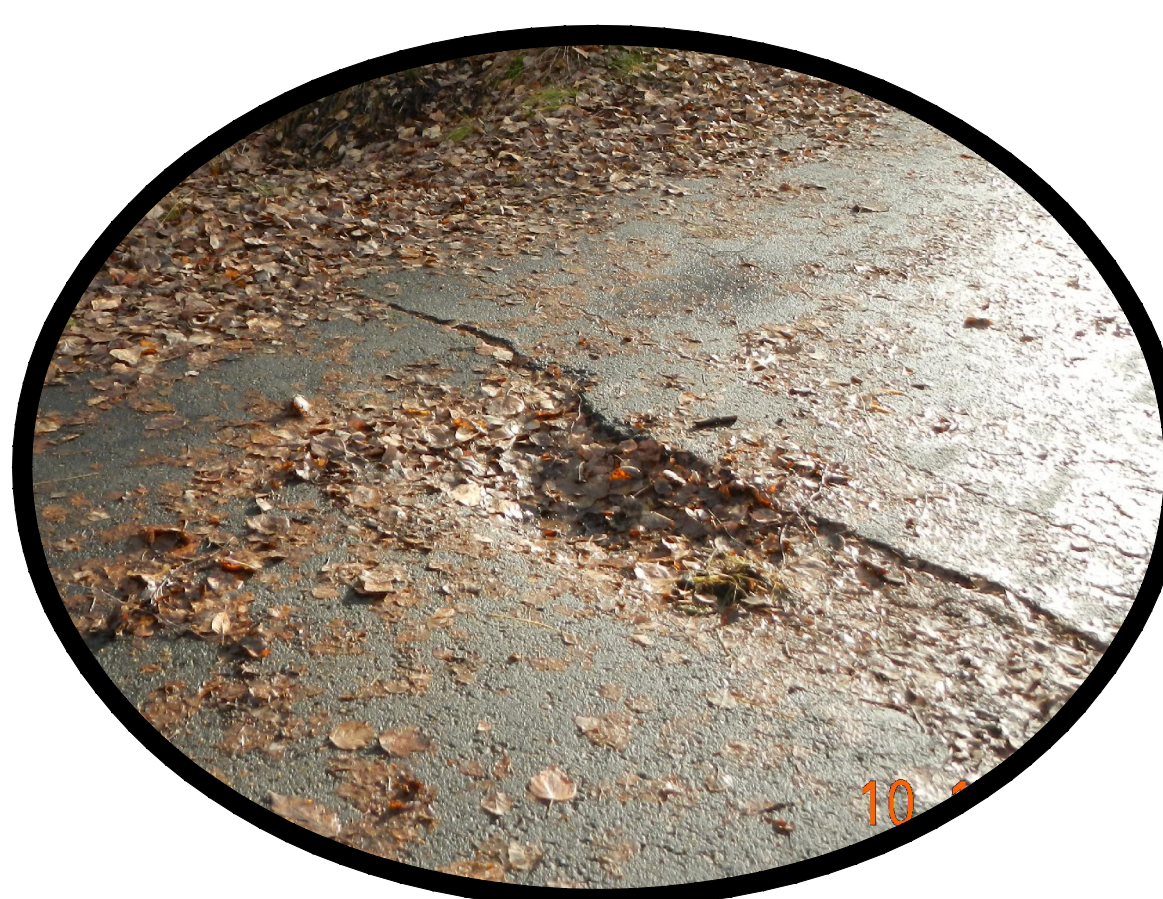
#### POTHoles & SINKHOLES:

Potholes form at fatigued paved surfaces. They are exacerbated during freeze-thaw cycles and grow rapidly during breakup. Sinkholes or depressions are caused by several issues but are most commonly caused by poor subgrade conditions and voids below the surface. Voids can occur due to washout, utility lines and tree root/stump deterioration. Both hazards are easily covered with leaves during the fall and are often unavoidable.

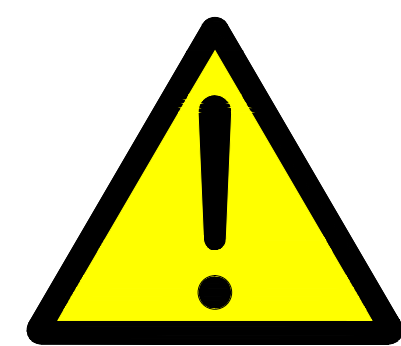
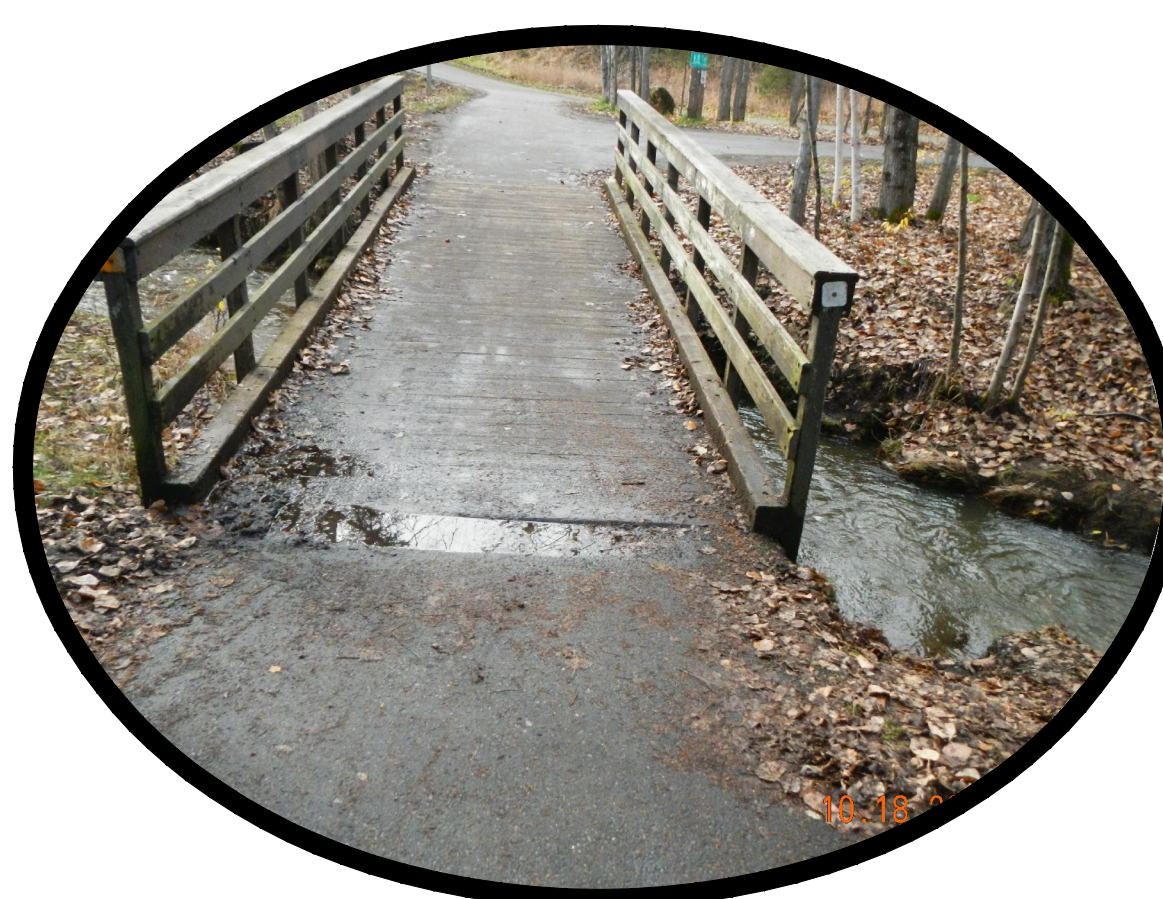
#### TRANSITIONS:

Transitions at bridges or sidewalks sometimes experience differential movement throughout a climatic cycle do to the properties of different materials. Transitions can cause trip hazards and can cause wheeled equipment such as strollers and wheelchairs to come to abrupt stops.

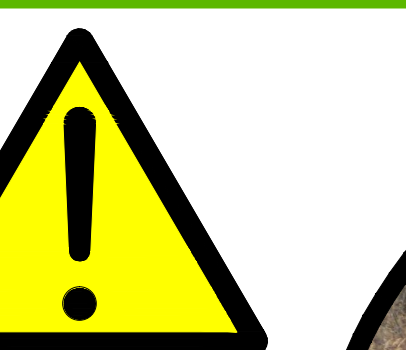
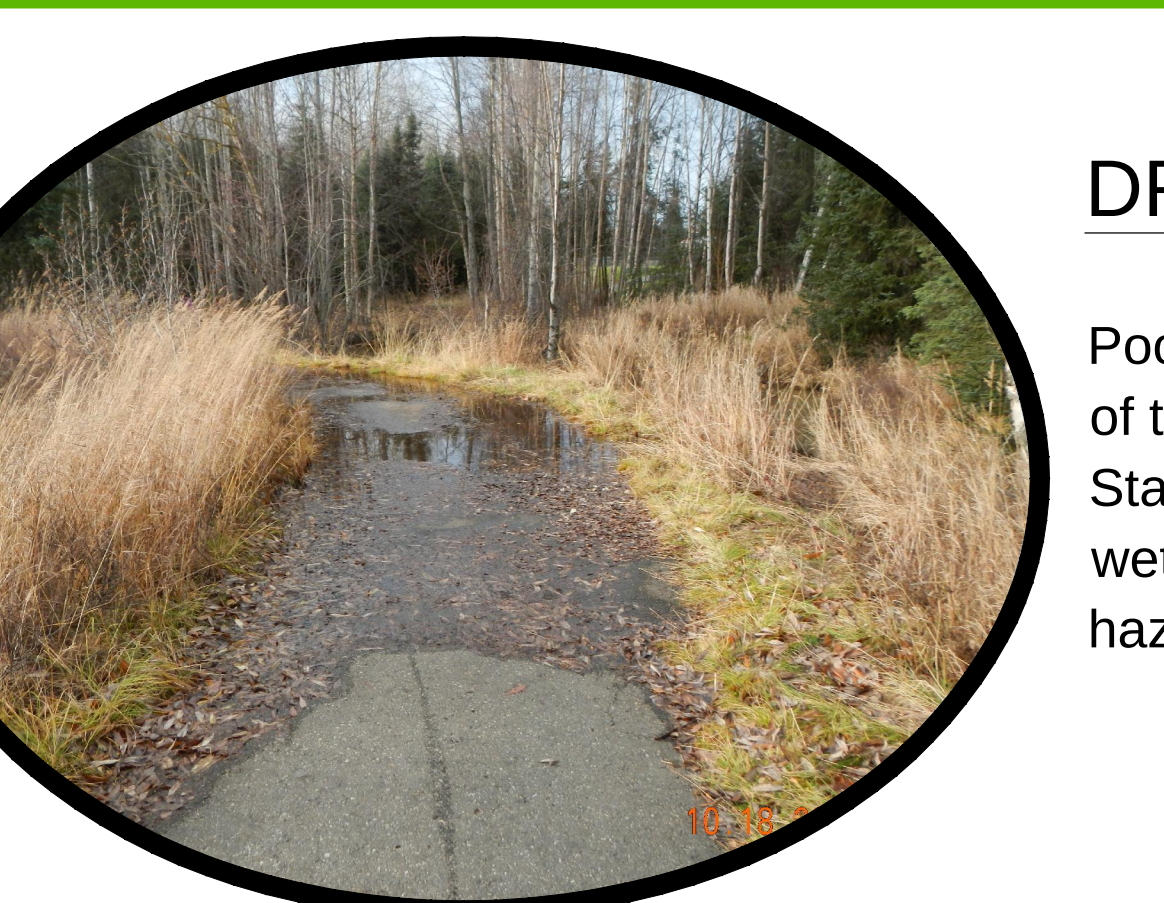
#### DRAINAGE:

Poor subsurface and surface drainage can be attributed to many of the failures and hazards encountered along the trail system. Standing water on the paved surface areas can be slippery in wet and frozen conditions. It can collect debris and hide other hazards such as potholes and sinkholes.

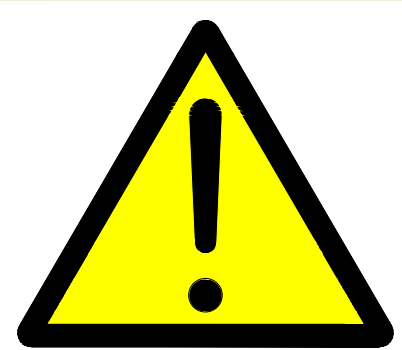
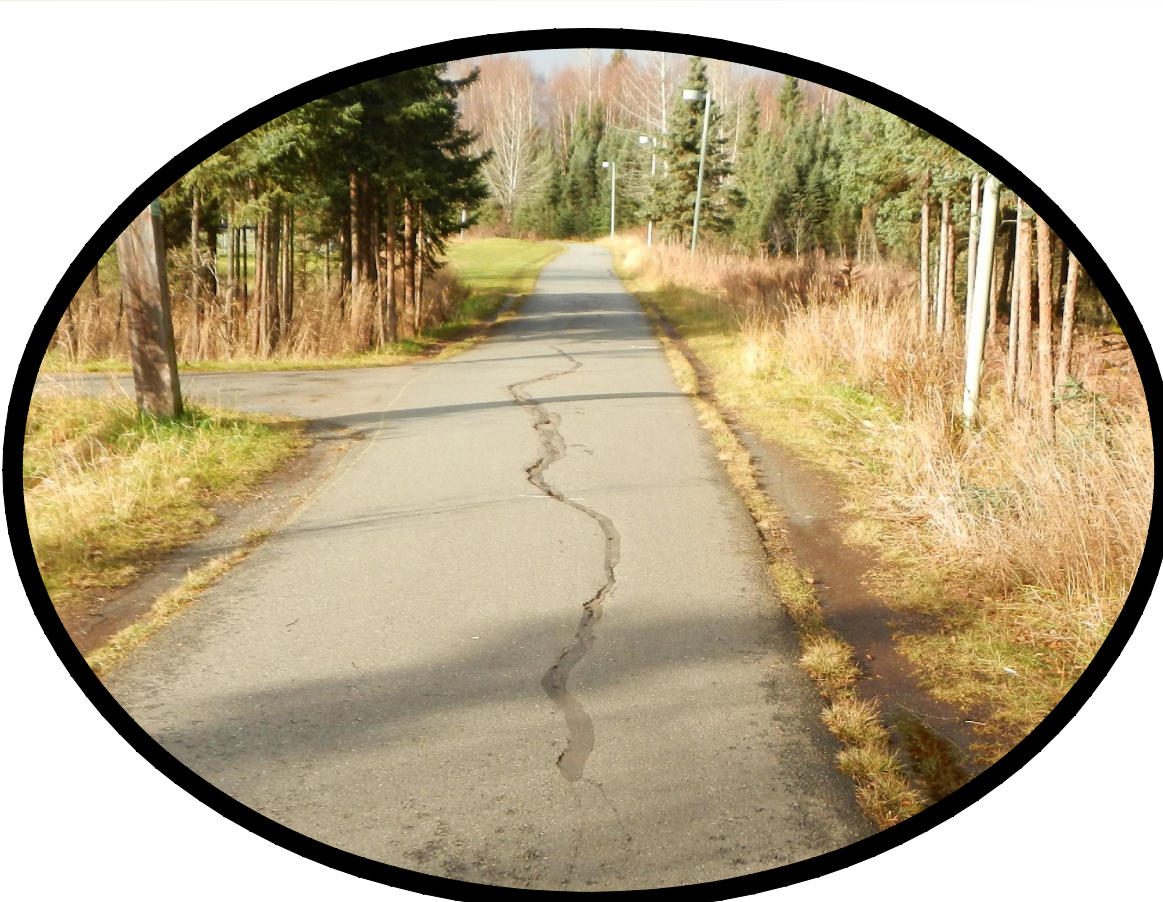
#### CRACKS:

There are several types of pavement cracks and reasons causing them. A few include; yielding subgrade soils; poorly constructed paving joints; temperature cycles; poor drainage; frost heaves; vegetation; thickness and pavement mix. Cracks, if not maintained, allow for water penetration into the underlying soils and can cause excessive movement in the trail surface. Cracks can be temporarily repaired and requires ongoing maintenance.
