# **2014 Dry Weather Screening Report**

## **APDES Permit No. AKS-052558**

**MUNICIPALITY OF ANCHORAGE**  
**WATERSHED MANAGEMENT SERVICES**

November 2014

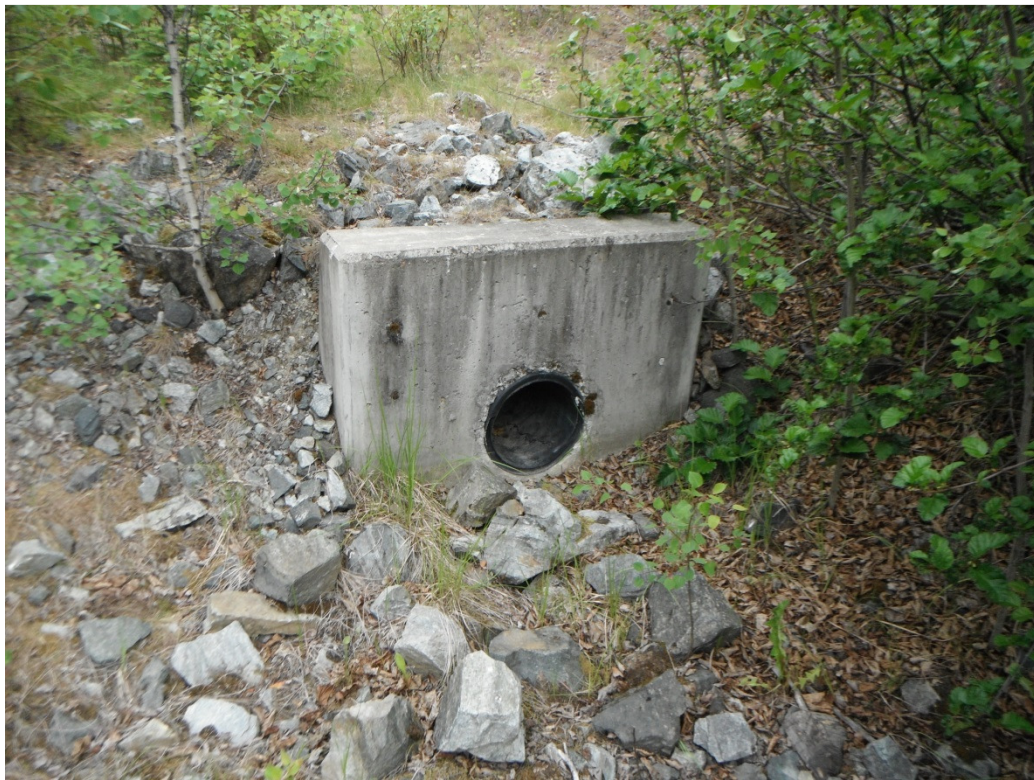
Eagle River **541-1**: East of Mountain Point Circle. Outfall was dry at time of sampling.

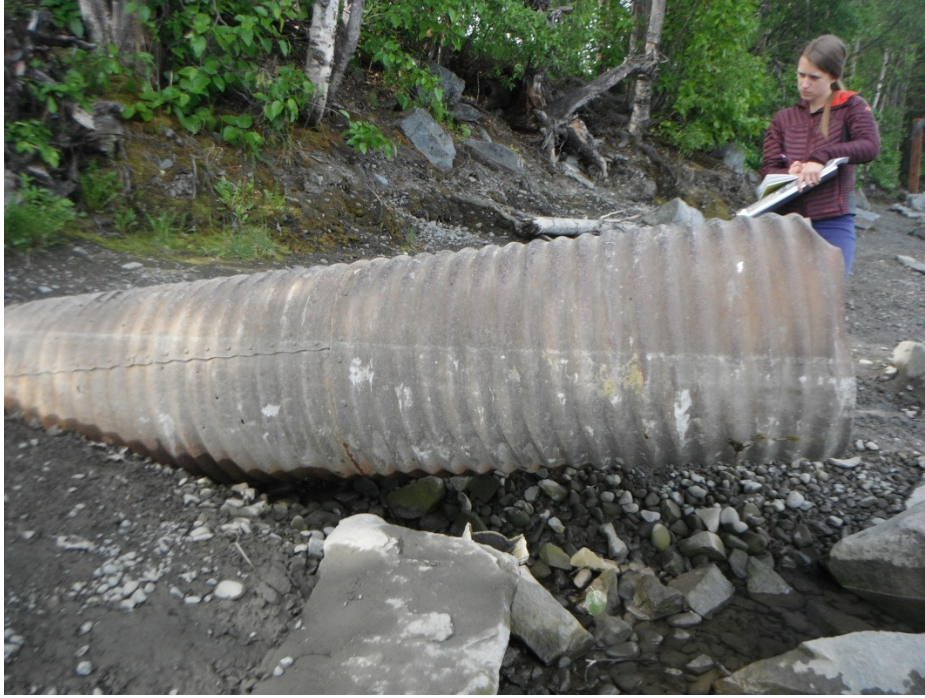
| Watershed | Outfall Number | Type of Issue | Notes |
|---|---|---|---|
| Ship Creek | 119-1 | Damaged | The end-of-pipe is angled upwards. The pipe has rusted through the bottom about three feet from the end of pipe. |

119-1: poor condition. Jacked up significantly,  
rust holes 6 ft in from end of pipe.  
Water flowing from holes in pipe

Ship Creek **119-1**: Jacked up and rusted out.

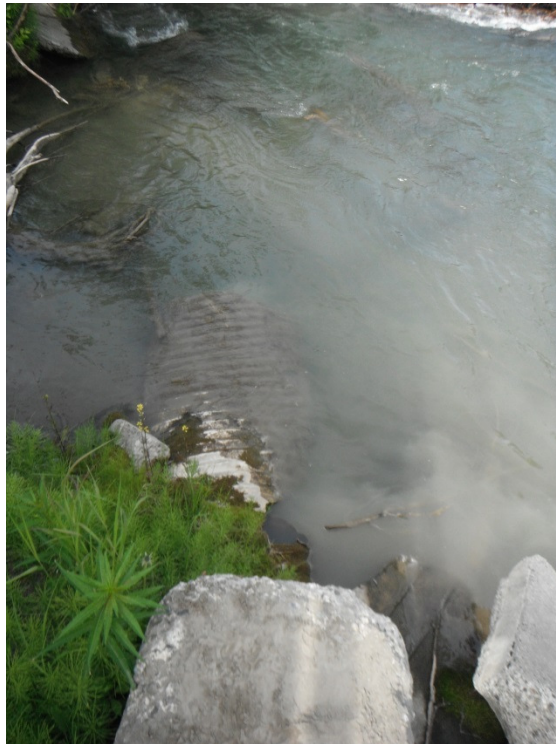
| Watershed | Outfall Number | Type of Issue | Notes |
|---|---|---|---|
| Ship Creek | 189-1 | Submerged,<br>Damaged | A break in the pipe exists about 4 feet from the end-of-pipe. It is submerged, but visual inspection determined that it was flowing. |

Ship Creek **189-1**: Submerged outfall

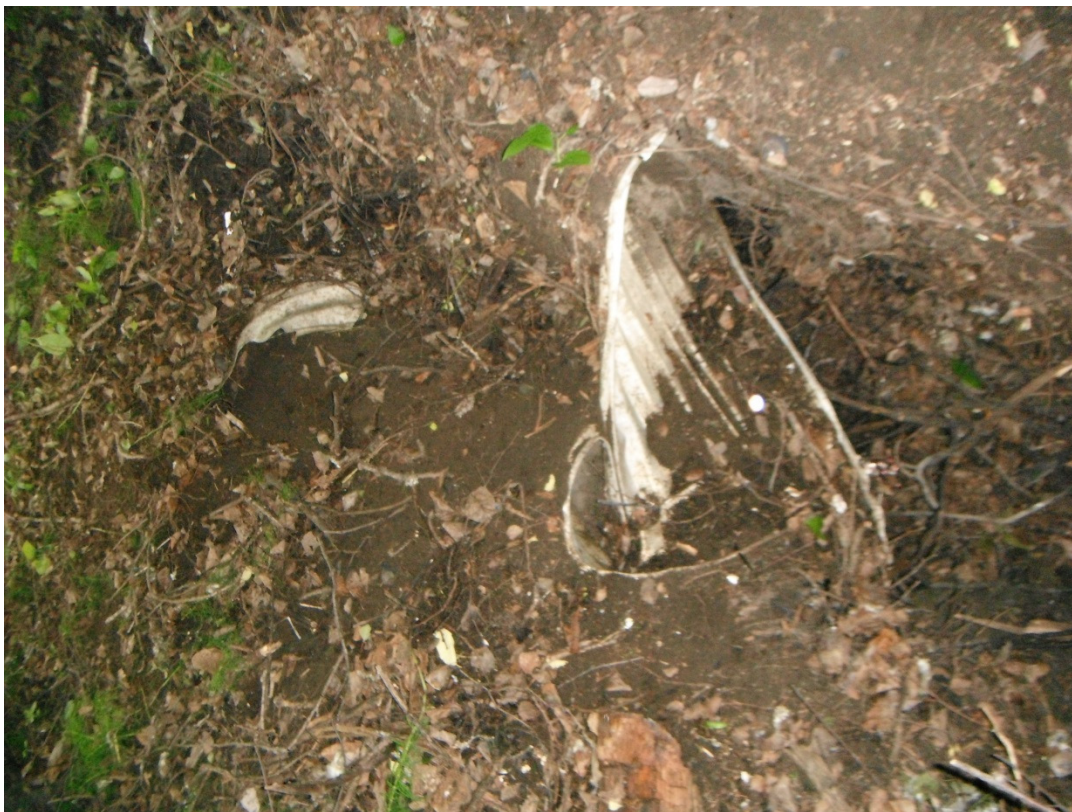
| <b>Watershed</b> | <b>Outfall Code</b> | <b>Latitude</b> | <b>Longitude</b> | <b>Location Description and Notes</b> |
|---|---|---|---|--|
| Fish Creek | 584-1 | 61.18545 | -149.93403 | Right bank opposite of park on Turnagain Blvd. Under a lot of debris and end of pipe clogged with dirt. Flow coming out from under rusted portion of pipe. |

| Watershed | Outfall Number | Type of Issue | Notes |
|---|---|---|---|
| Fish Creek | 584-1 | Clogged, Damaged | The field team removed a lot of debris, but discovered the end of pipe was crushed and clogged with dirt. Water was trickling out from a break in the pipe. |

Fish Creek **584-1**: After clearing debris

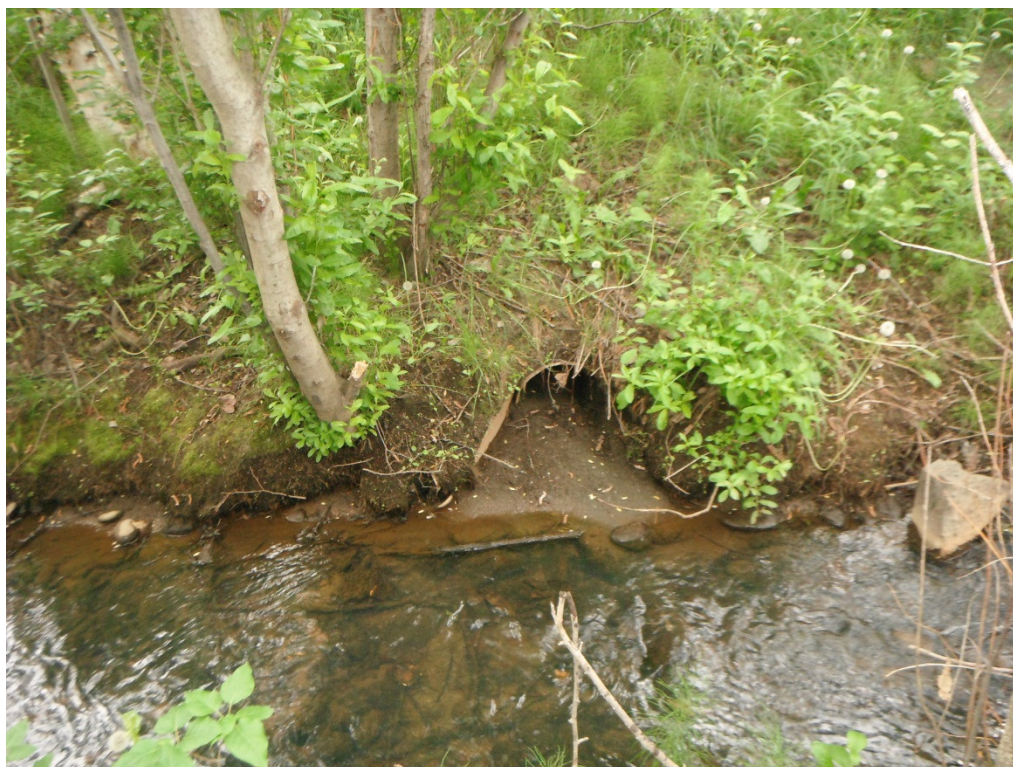
Fish Creek **1277-59**: Clogged with sediment

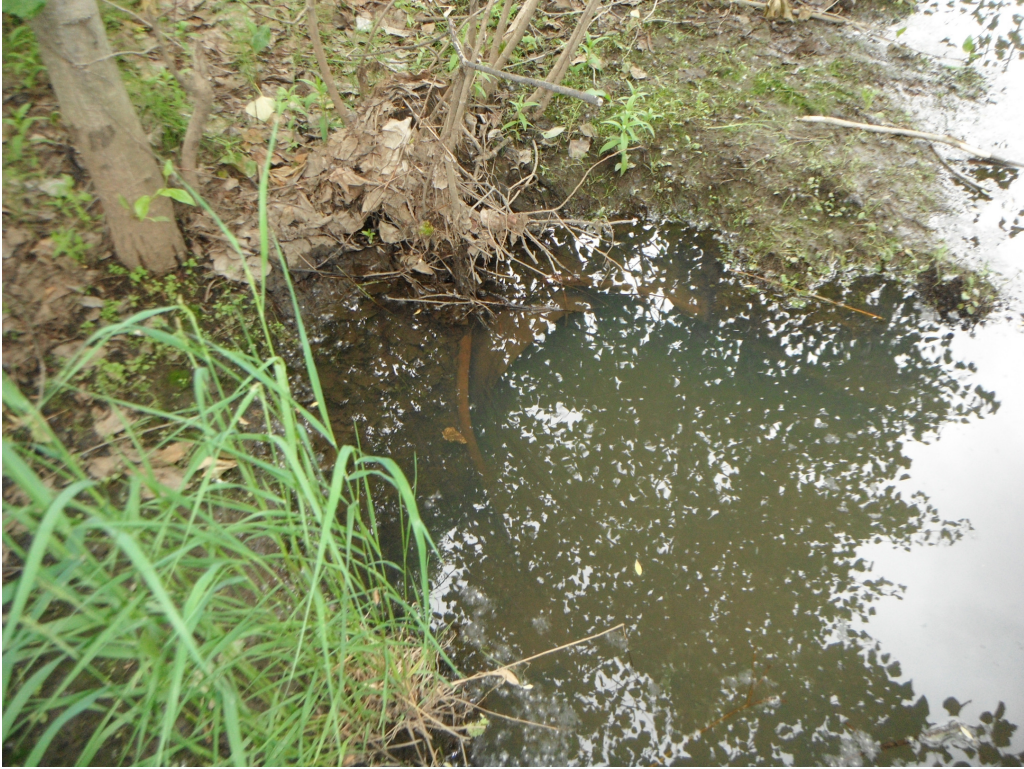
Fish Creek **686-1**: Completely submerged

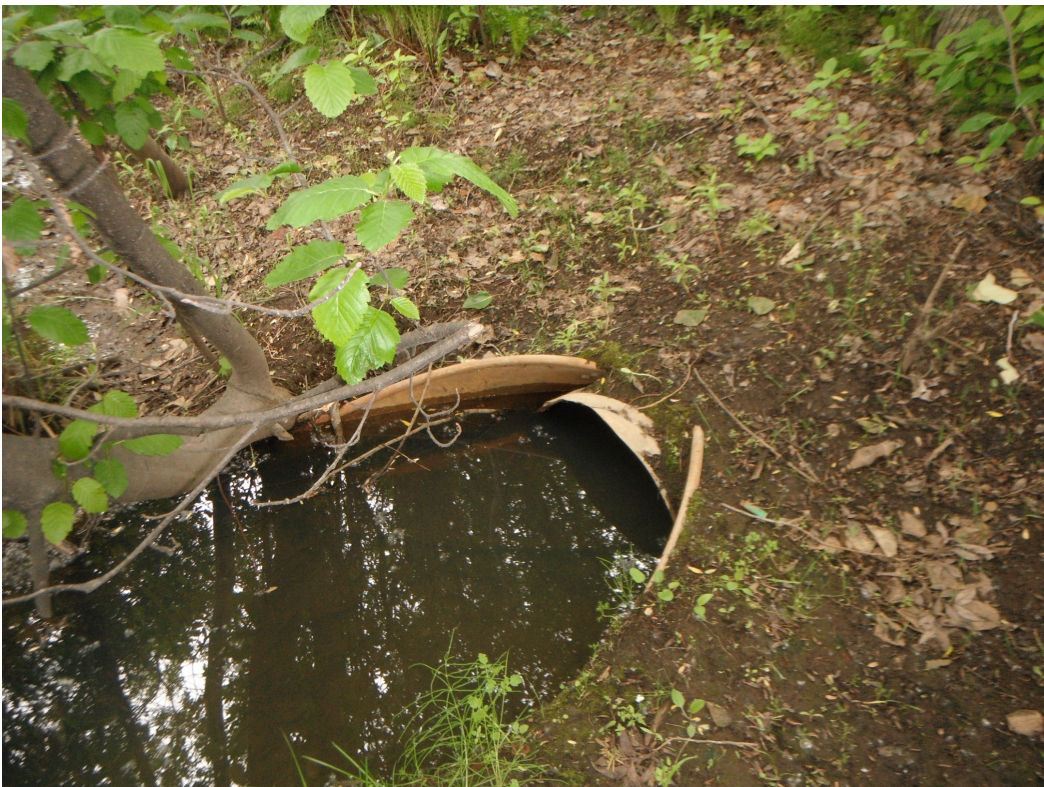
| Watershed | Outfall Number | Type of Issue | Notes |
|---|---|---|---|
| Fish Creek | 391-1 | Damaged | End-of-pipe damaged. Partially submerged |

391-1: Standing water. Overground pipe 2 ft to the right coming from parking lot. End of pipe damaged

Fish Creek **391-1**: End of pipe damaged and submerged

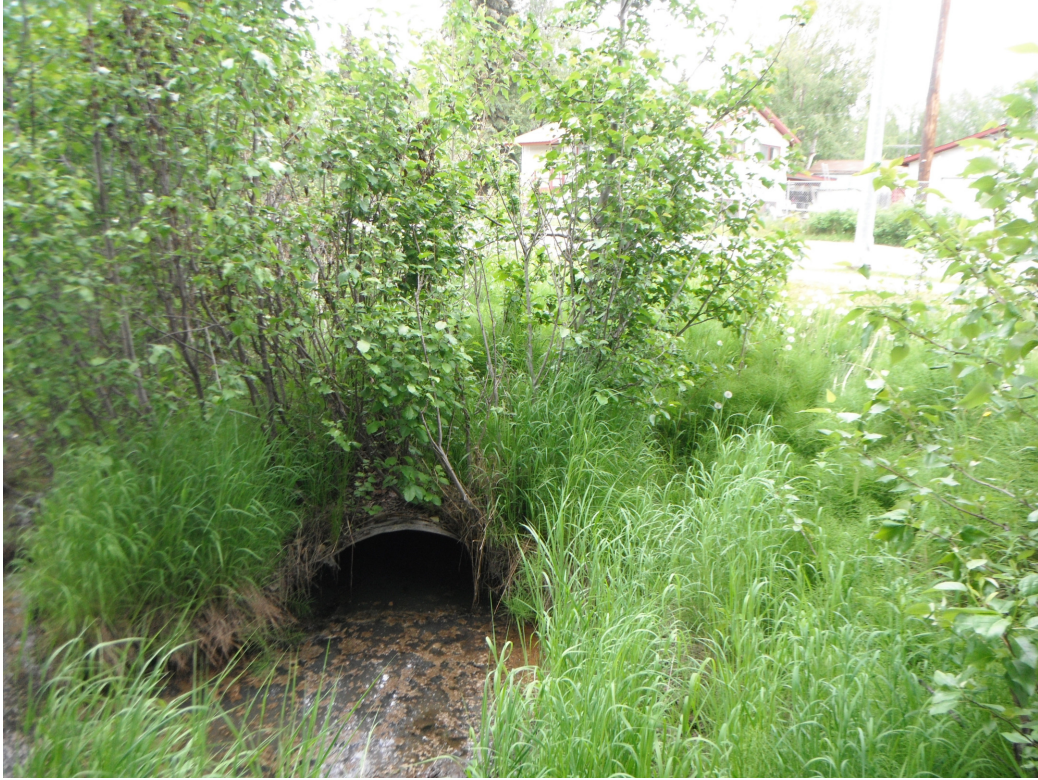
Fish Creek **480-1**: Outfall potentially moved during construction without HGDB update

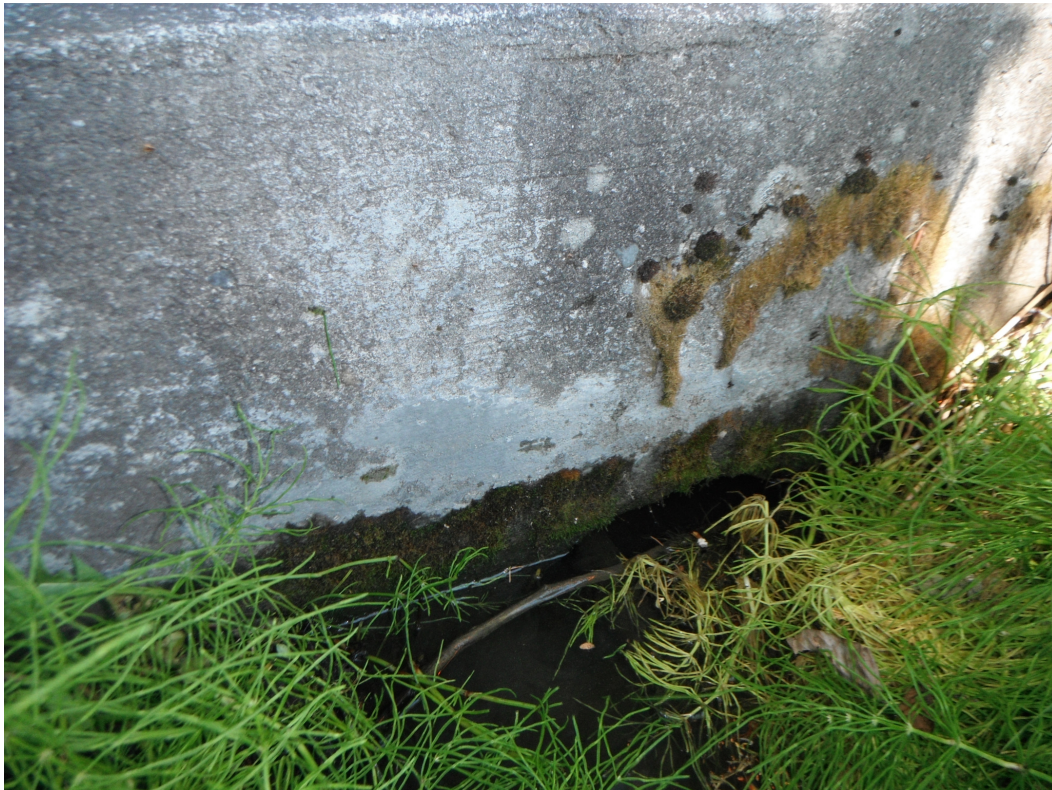
Campbell Creek **642-1**: Almost completely submerged

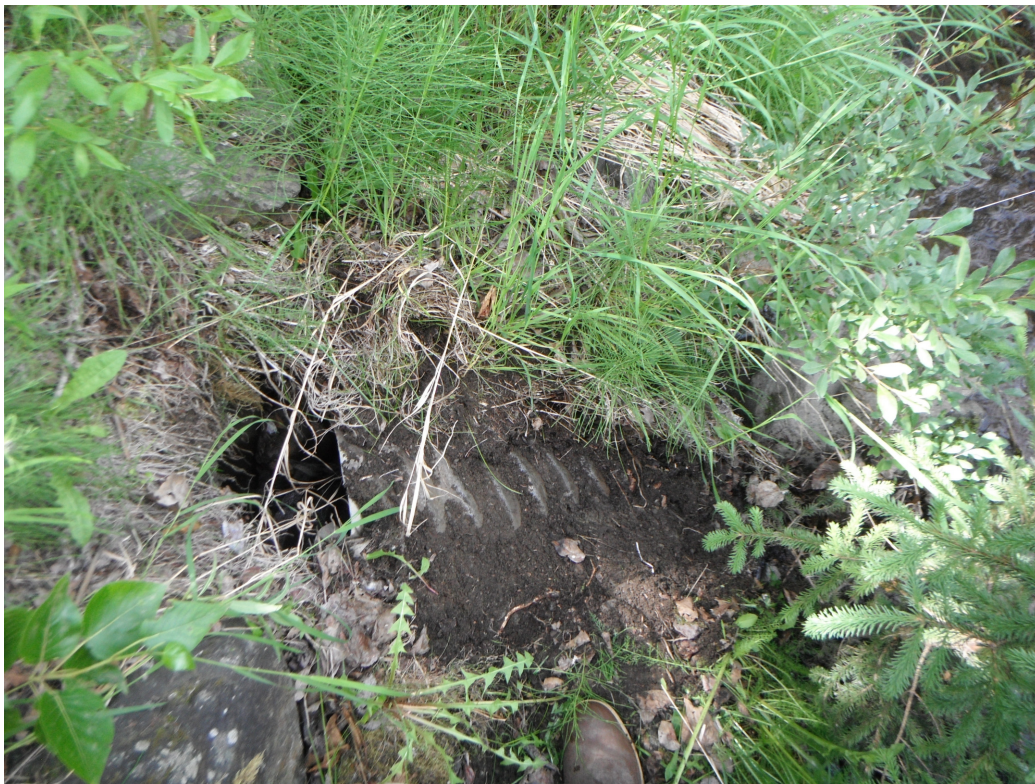
| Watershed | Outfall Number | Type of Issue | Notes |
|---|---|---|---|
| Campbell Creek | 447-64 | Damaged | End-of-pipe broken and bent over. |

447-64: Flowing well but EOP broken? bent over; unable to access

Campbell Creek **447-64**: Broken and bent. Note Creek to right, outfall flowing, but is inaccessible
