# MOA and ADOT&PF 2015 Low Impact Development Project Performance Monitoring Report

The Municipality of Anchorage

*January 2016*

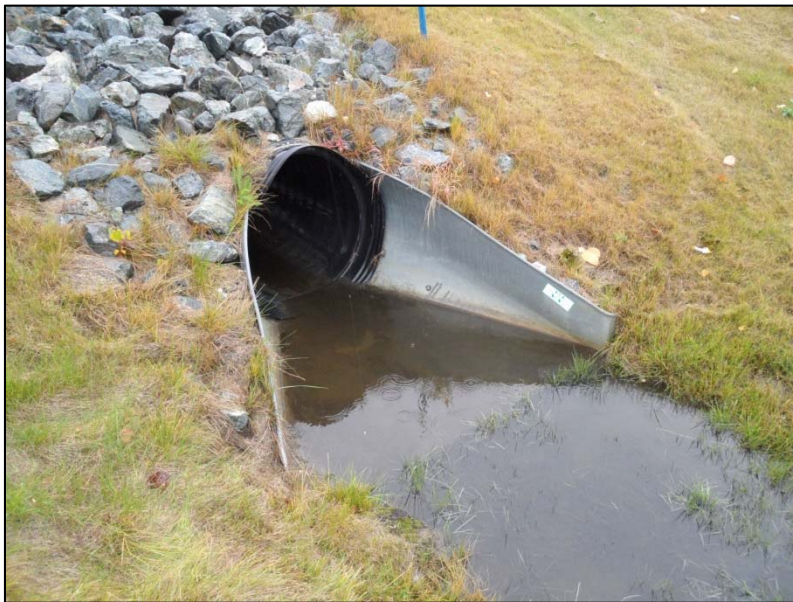
**Figure 9: Bioswale Outlet**

During the site observations on September 29, the swale was observed to be holding significantly more water than previous site visits. The water was flowing more rapidly, though still fairly slowly, toward the outlet. The water was observed to be more sediment-laden than in previous site visits, as evident by the water color. The swale outlet was flowing steadily. Downstream of the outlet, water was flowing into Campbell Creek, though it was bypassing the intended flow route and entering the creek by flowing under the embankment riprap. This is not expected to be problematic and did not appear to be causing erosion issues.

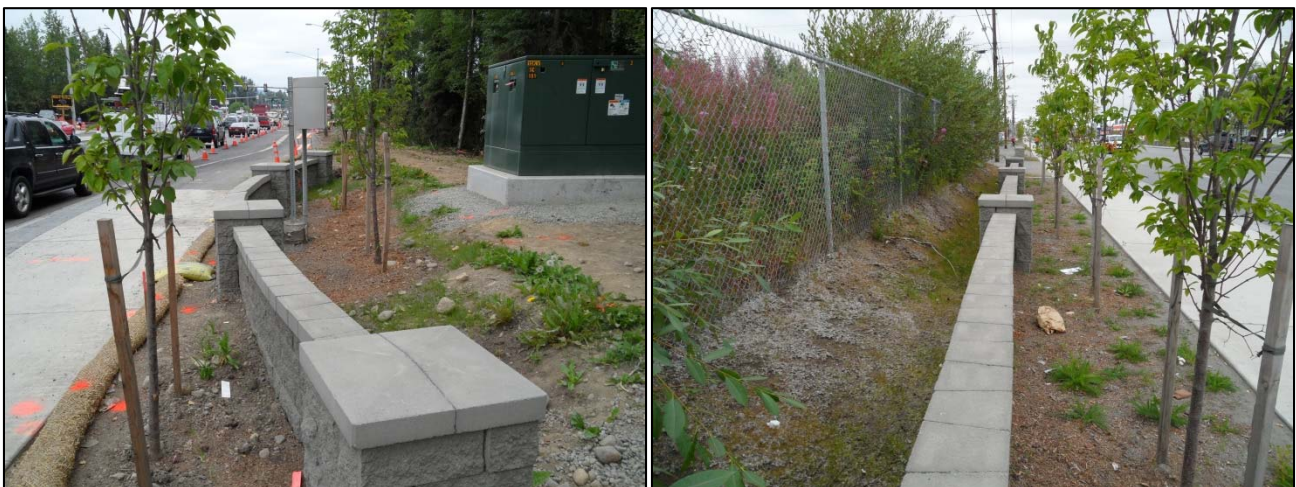
**Figure 11: 2013 Landscape Areas**

This project was included in the MOA 2013 LID monitoring program, and was generally found to be moderately successful at reducing peak flows from smaller rainfall events. In 2013, the vegetation was in need of maintenance, and topsoil and mulch in the area were subject to erosion issues. Performance was found to be reduced by the inclusion of impervious landscape walls, which added additional runoff and in some cases, blocked flow from adjacent impervious areas from entering the landscape beds.

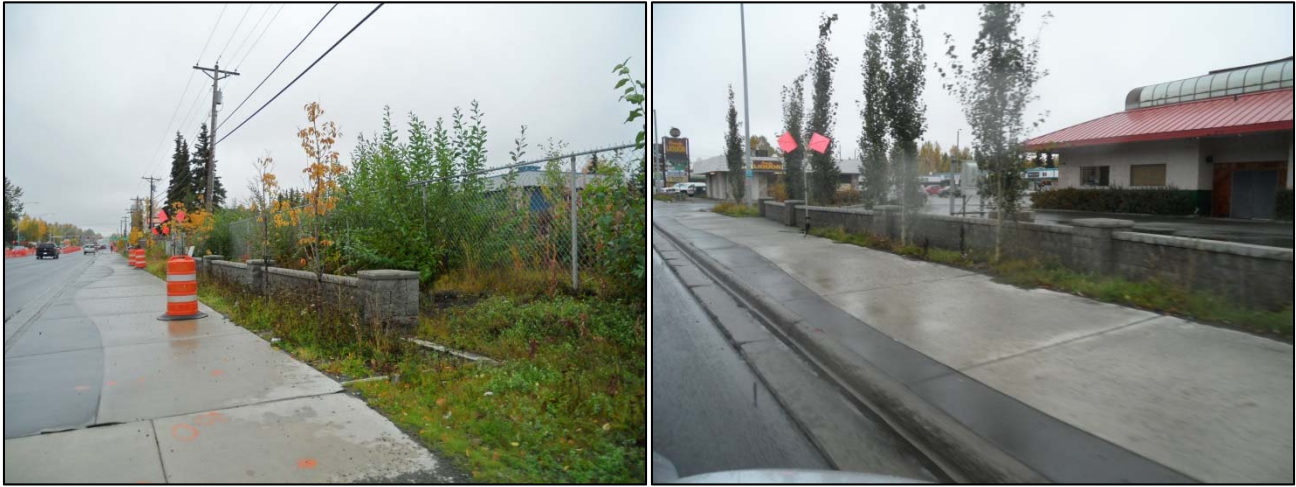
Figure 12: 2015 Landscape Areas

This site was visually inspected during the September 12 storm event. Inspection was not repeated because AWR found that only limited performance data of the landscaped areas could be obtained through visual inspection. Generally, the facility appeared to be performing the same or better than it was in 2013. The vegetated areas were largely unkempt, and some of the planted vegetation appeared to be missing. However, the planted areas were relatively well-vegetated with grasses and other “weeds.” While this is not aesthetically ideal, it is expected to have improved stormwater treatment performance by increasing transpiration and reducing runoff. A comparison of vegetation from 2013 to today is shown in Figures 11 and 12 below. Decorative walls were still in place and continue to block flow paths and increase runoff.

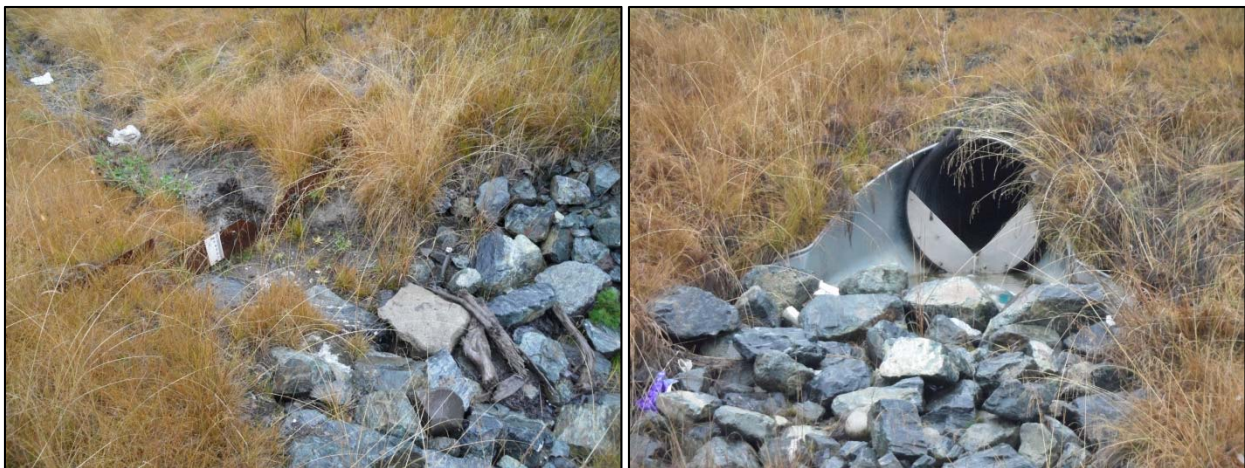
**Figure 14: Infiltration Basin Outlet (left) and Inlet (right)**

During the September 12 site visit, water was flowing into the facility via the culvert inlet, and the basin was storing a small amount of water on the basin floor. The outlet was not flowing, indicating that all inflow was being either infiltrated or stored. Similarly, on the September 28 site visit, water was flowing into the facility, but the outlet was not flowing. The basin was holding significantly more water than was previously observed. Standing water depths were approximately 13 to 15 inches. Generally, this indicates that the facility was still infiltrating and storing all of the basin inflow. The September 12 event was generally close to the rainfall event the facility was designed for. However, the rainfall that occurred from September 26 to September 28 was approximately 1.41 inches (based on ANC date), which exceeds the design event in both magnitude and duration.

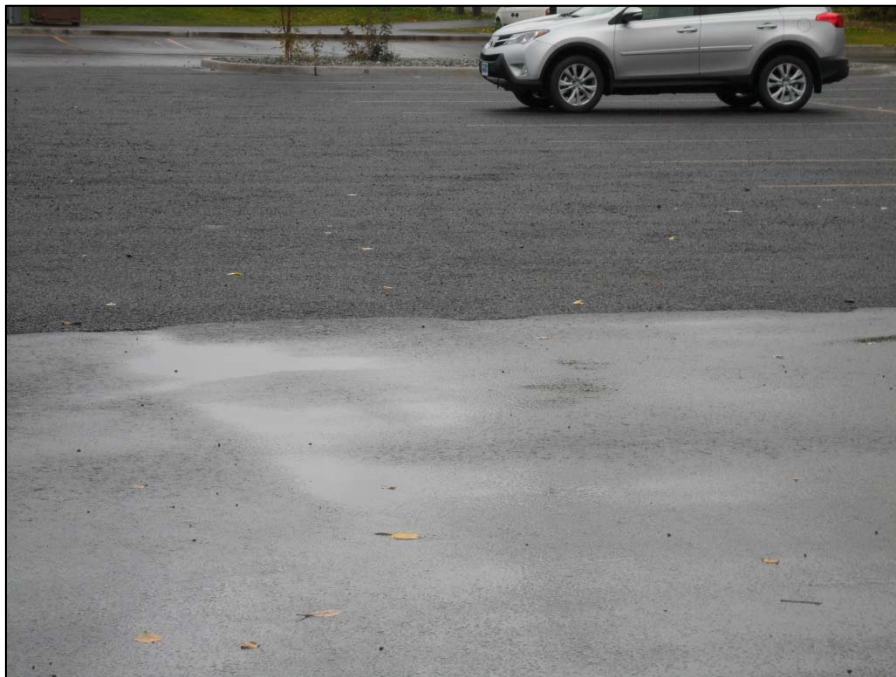
**Figure 20: Asphalt Interface During Rain**

clogging of the asphalt pores. The interface between the porous asphalt and the traditional asphalt on the north side of the parking lot was showing mild ponding, and some heaving of the parking was visible at the asphalt interface on the west side. (See Figure 20.) The most notable concern observed with the porous asphalt was surface raveling, likely caused by vehicle turning traffic. The parking lot was scattered with small rocks from surface raveling of the porous asphalt. Because the parking lot does not appear to be swept regularly, the rocks are being ground into the asphalt, compounding the raveling problem. This is shown in Figures 21 and 22.

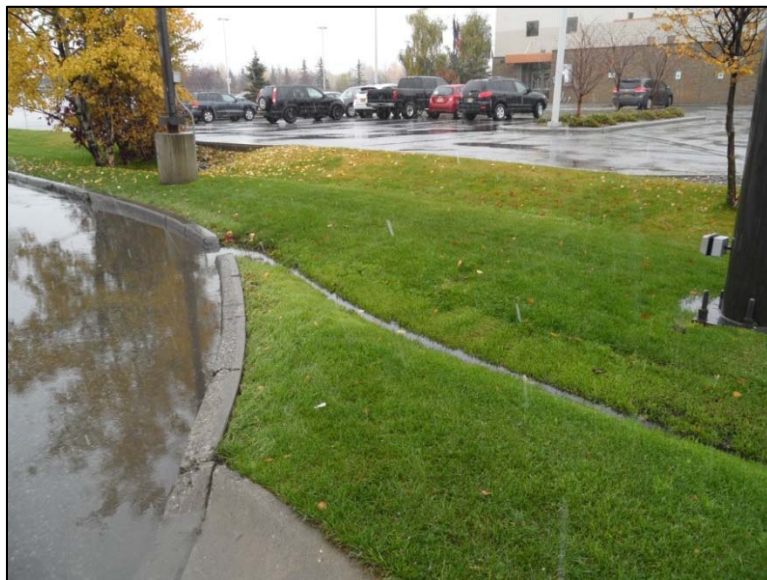
**Figure 38: Ponding and Swale at Mc Donald's Drive Through**

Notable ponding on impervious surfaces was observed in one location, at the south end of the Mc Donald's drive through. In this area, runoff is directed to a small swale and a culvert that passes under a pedestrian walkway. The small swale connects to the larger vegetated swale on the west side of the facility, but was generally not graded well to provide positive drainage. Ponding in the drive-through area is required in order for water to obtain enough head elevation to flow through the culvert. This could be easily fixed by lowering the elevation of the small swale and the pathway culvert. As it is, the ponding water did not appear to be causing adverse impacts. This area is illustrated in Figure 38.

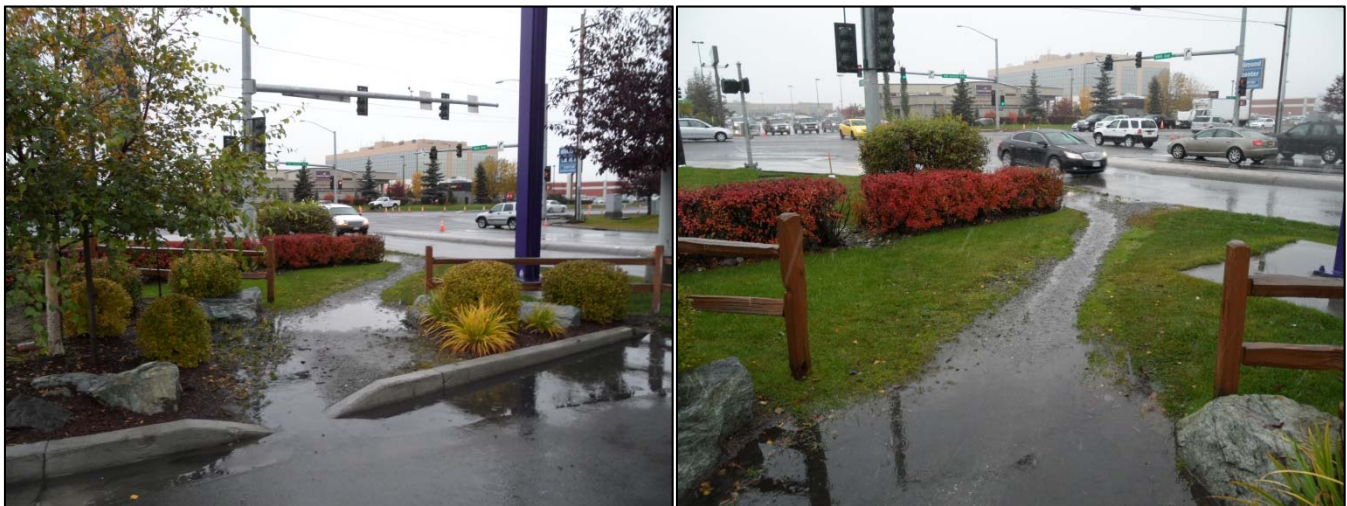
**Figure 39: Pedestrian Pathway Drainage**

The effectiveness of the landscaping to treat and store stormwater was observed to be reduced in one location by what appears to be an unauthorized pedestrian pathway located near the intersection of the OSH and 88<sup>th</sup> Ave. This pathway cuts through the landscaping and through a parking lot curb cut. During higher rain events, water flowing into the curb cut tends to flow down the pathway toward the intersection limiting the quantity of water that flows into the adjacent landscape areas. It appears that someone tried to correct this issue by creating a small depression in the pathway, which slows the flow of water and allows more water to enter the surrounding landscape. This issue could also be fixed by filling in the pathway and extending the decorative fencing to block pedestrian access through the landscaping. The pathway area is illustrated in Figure 39.

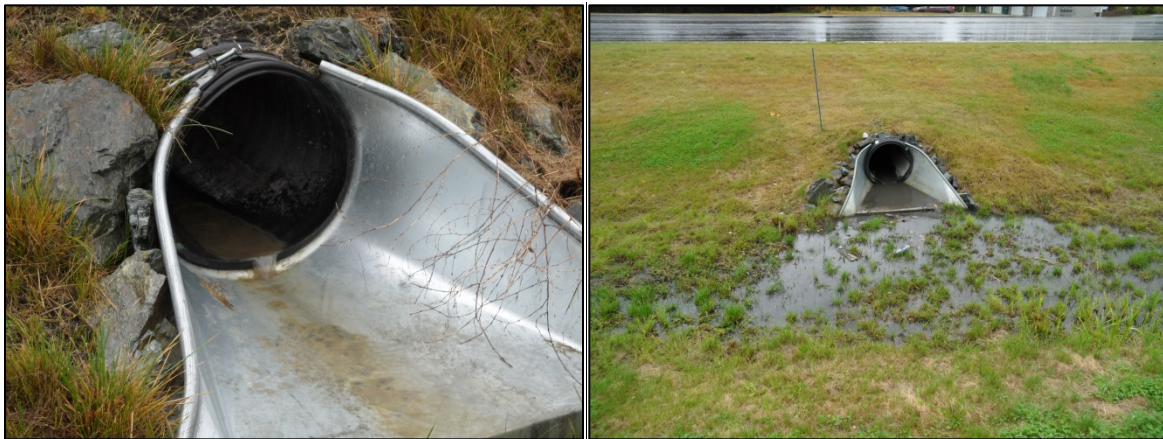
Observations: Water was steadily flowing into the bioswale from 4 of the 5 storm drains that outfall to the swale. At the far west storm drain outfall, vegetation was partially blocking the outfall, causing ponding and back of water in the storm drain pipe. Did not appear to be a problem at this flow rate. There was standing water in the swale that was trickling slowly toward the swale outlet on the east side. Water was flowing slowly into the bioswale outlet pipe. The bioswale vegetation looks good. Overall the system is looks to be performing very well. Inflowing water is slowed down, ponding occurs, and water moves slowly through the vegetation to the outlet.

*Inflow to bioswale and ponding at storm drain inflow pipe.*

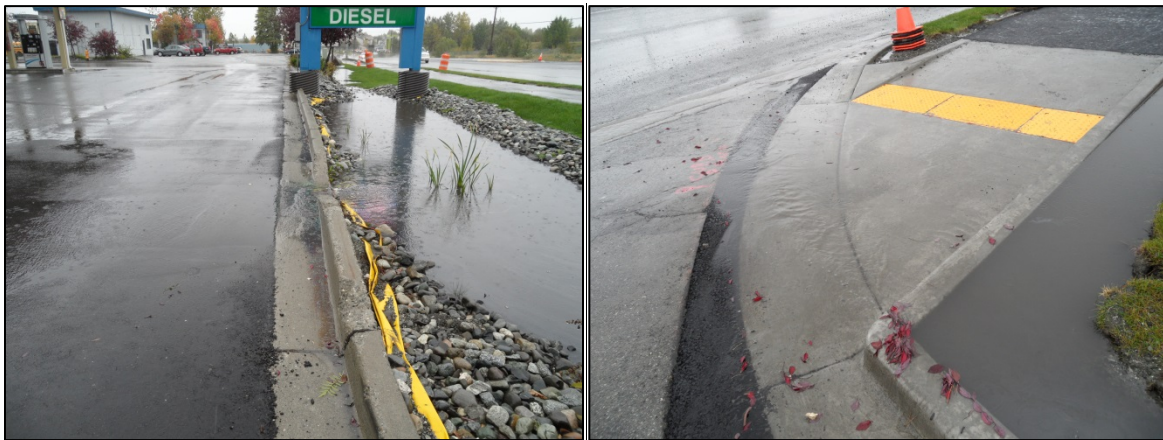
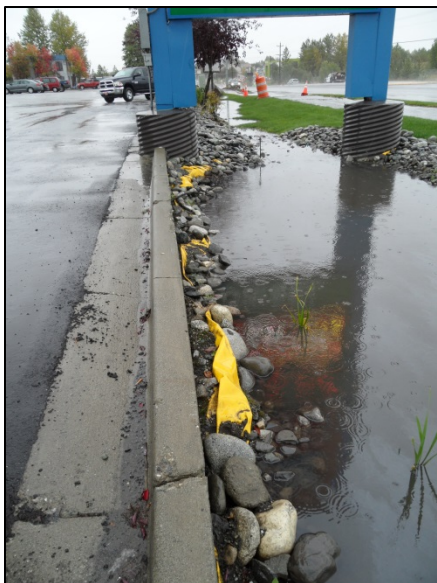
*Above left: Water flowing into the facility via a curb cut.  
Above right: Overflow at the downstream end (north)  
Left: Facility Overview. Below: Parking lot*

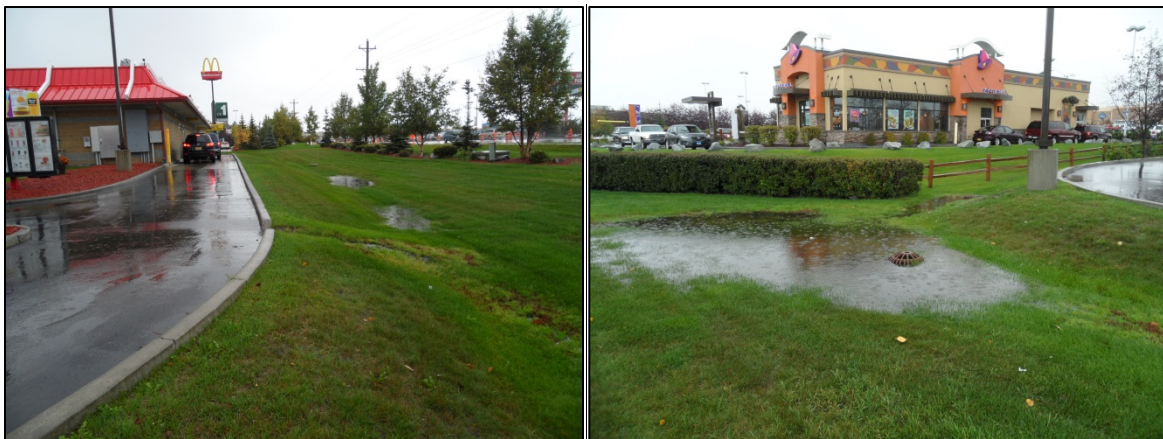
*Left: Vegetated Swale. Right: overflow beehive. (It was not clear why the beehive isn't flowing. Another storm drain manhole with a top grate is located near this beehive.)*

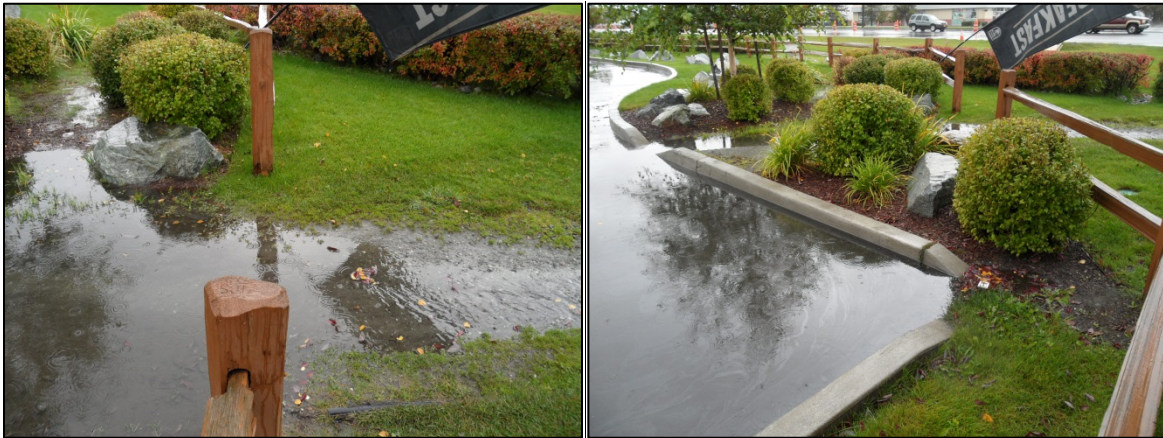
Most of the system appears to be working very well. On the north side of Taco Bell, a considerable amount of water is bypassing the system via a man-made foot path that has created a depression. On the south side of MacDonald's, localized ponding is occurring because one of the parking lot outlets is not flowing well. The facility is also receiving some water from the property to the south, though it does not appear to be designed to do so.

*Left and Right: Water bypassing vegetation via footpath.*

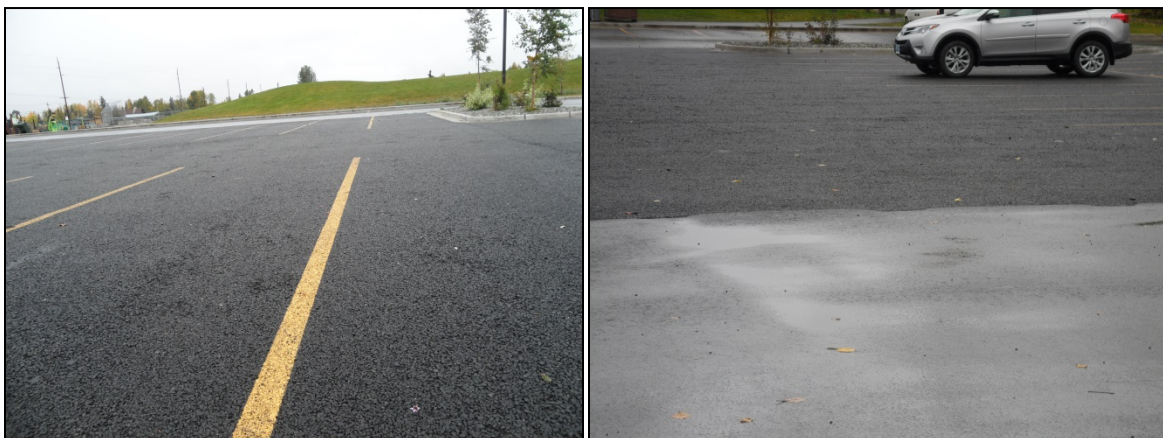
*Left: Surface raveling. Right: Interface heaving*

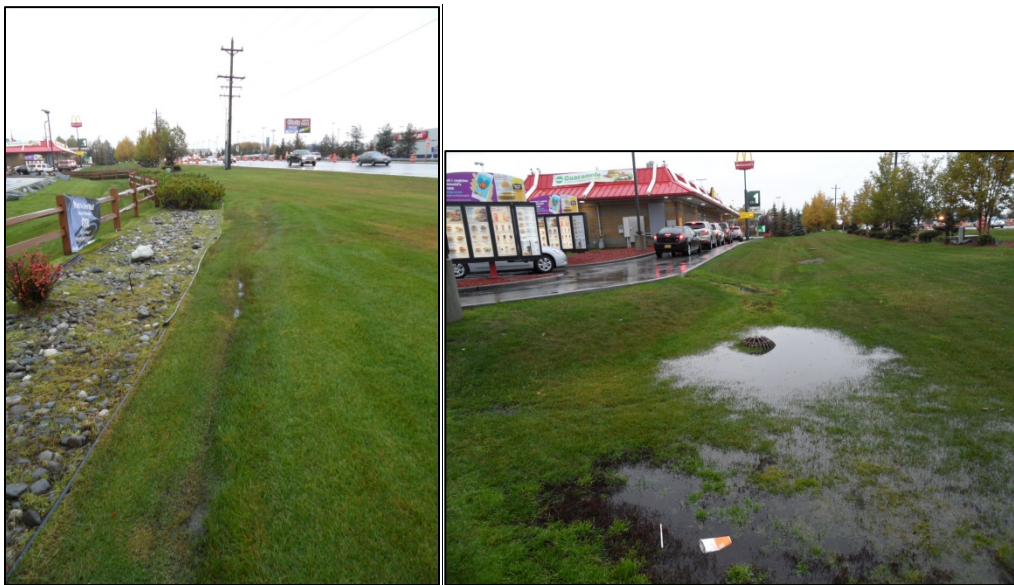
*Left: Vegetated Swale, standing water visible. Right: overflow beehive that is not flowing.*

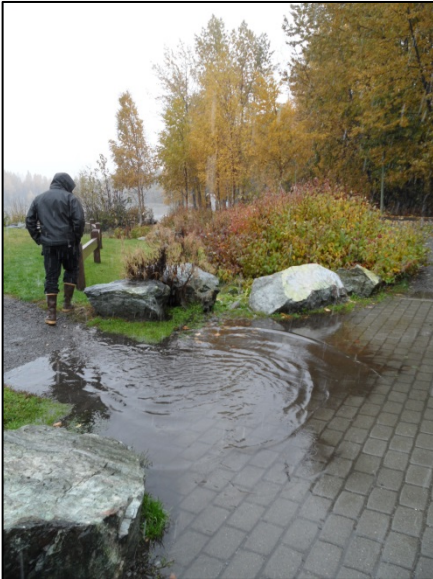
Observations: Heavy concentrated flow as observed flowing from the parking lot and into the rain garden. Surface ponding in the upper half of the rain garden was observed to be approx. 2 to 4 inches deep. Significant ponding was observed at the rain garden inlet. The ponding appeared to be from the thick vegetated mat on the rain garden surface, not from water coming to the surface from the rain garden layers. No ponding was visible at the lower end of the rain garden. The underdrain pipe was flowing about half full with a steady stream of water flowing into Taku Lake.

*Ponding at the rain garden inlet*

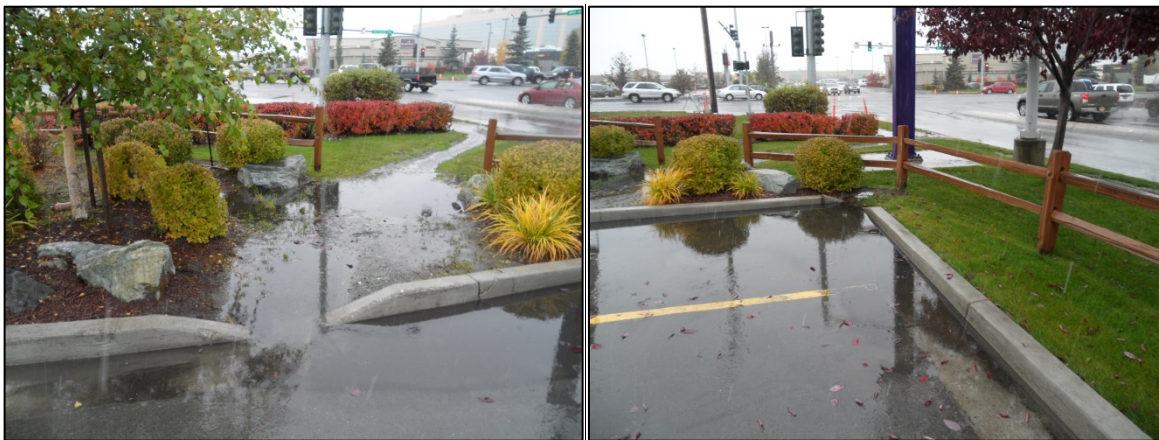
- Lots of sheet flow and concentrated flow from the parking lots to the vegetation areas.
- Significant amounts of water were flowing away from the site via the footpath.
- The two primary beehive inlets were actively flowing. The central beehive was not flowing, but significant ponding (approximately 8-inches deep) was observed and the area was overflowing to the secondary storm drain inlet nearby. (to the north).
- The culvert at the McDonald's drive-through was flowing and notable ponding of the drive-through asphalt surface was observed.

*Taco Bell Parking Lot – North Side. Foot path overflowing.*

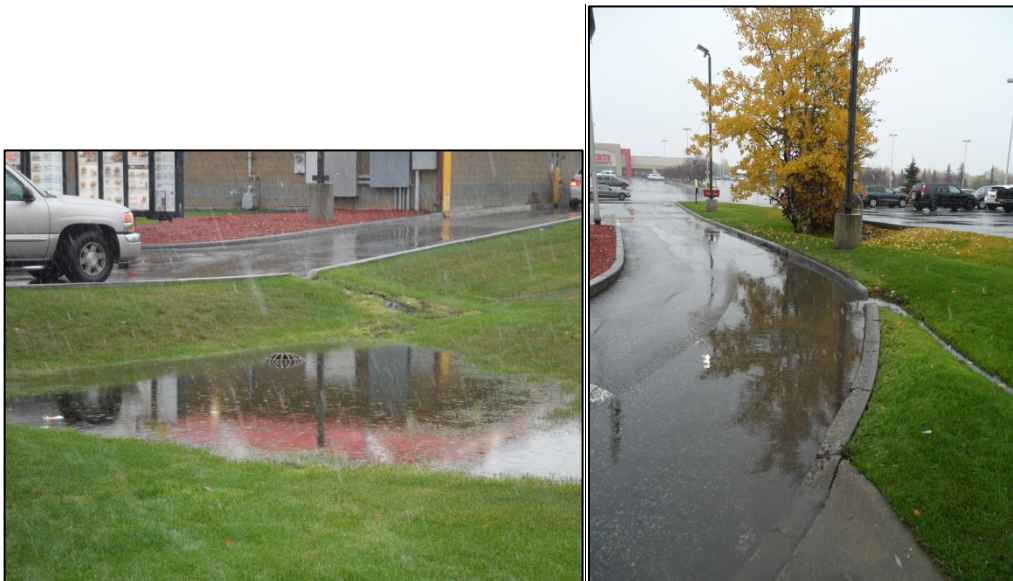
*Left: overflow beehive that is not flowing. Right: Ponding and outflow of McDonald's Drive through*

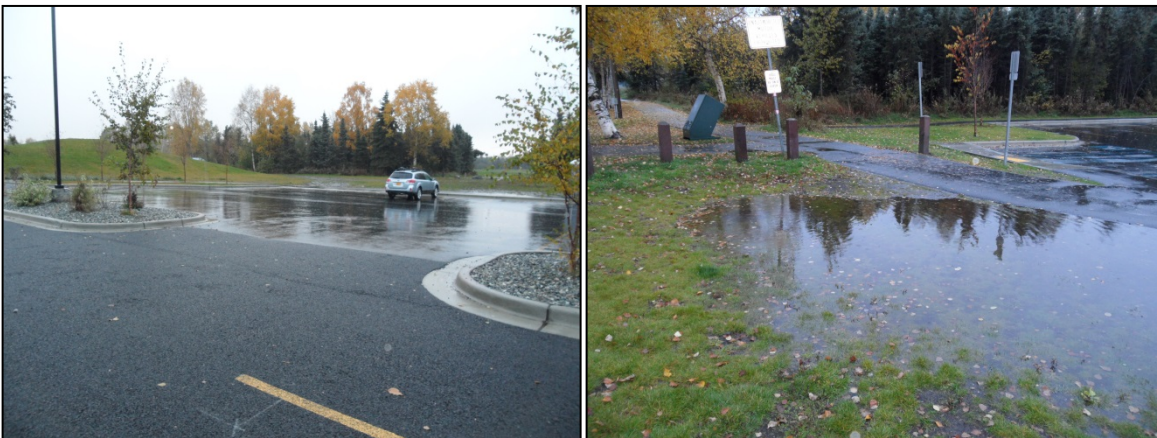
*Left: East asphalt interface. Right: Ponding east of the parking lot.*

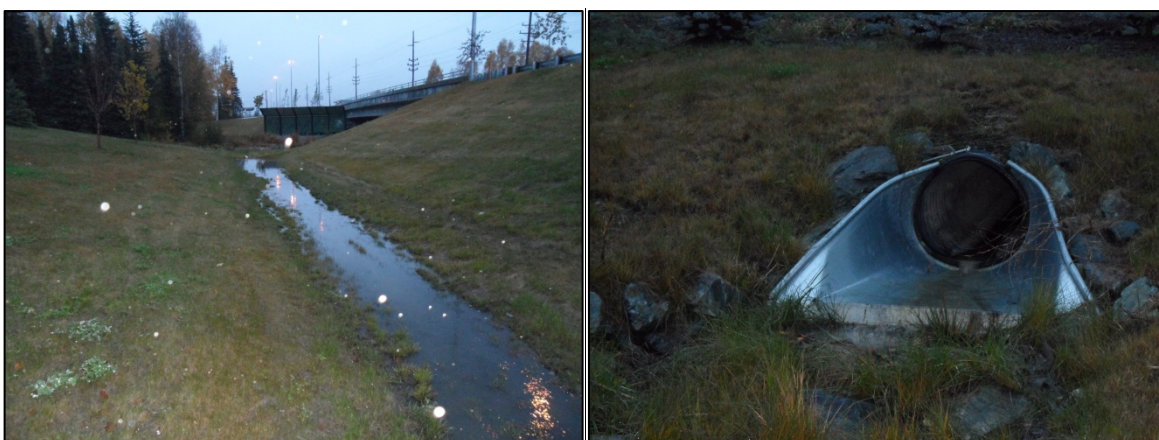
*Left: Bioswale flow path to Campbell Creek. Right: Muddy water inflow.*
