Snow Disposal Site Monitoring 2017 Data Report - Draft

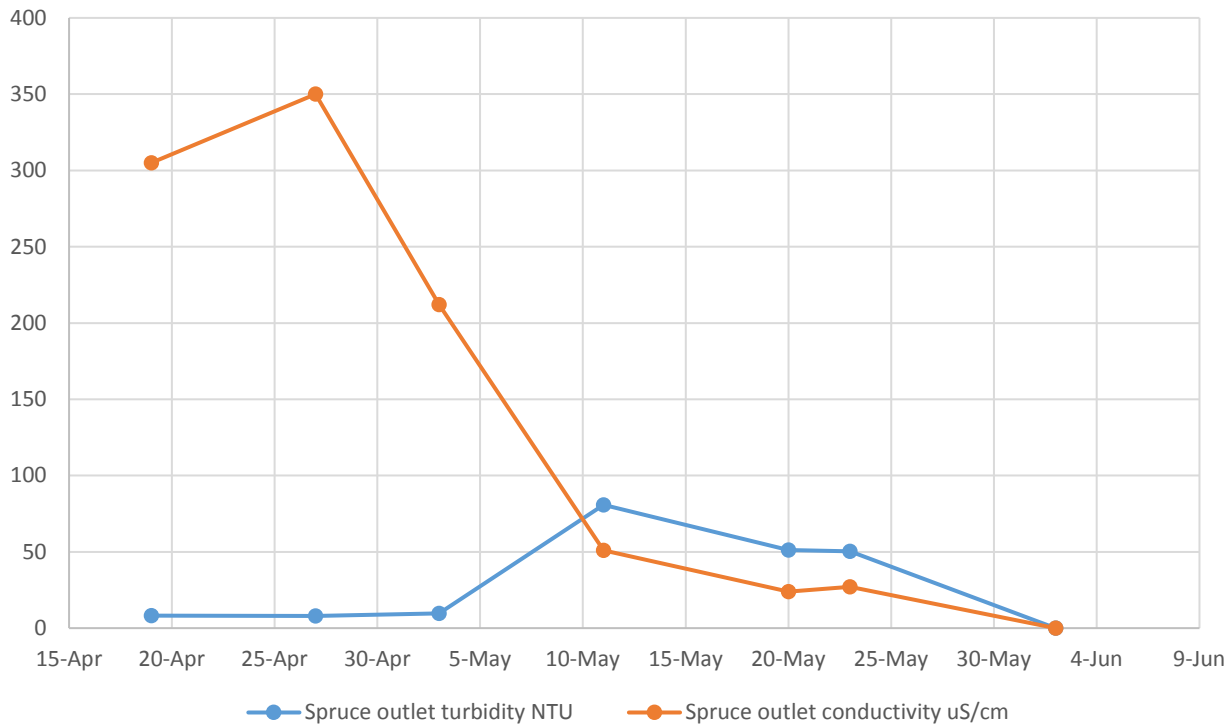
Spruce Street Outlet Snow Melt Trend

Site sampling began April 19, 2017 once snow melt was under way and moisture was readily visible in the snow pack. At the Spruce Street snow site melt conductivity – the surrogate for chloride - was rising. Conductivity peaked in the outlet on April 27th and in the wetland on May 11 and then declined steadily. It was monitored until flow stopped at the outfall. Conductivity numbers ranged from 27 to 350 microSiemens/centimeter (uS/cm) at the outfall and 31 to 126 uS/cm in the wetland.

Turbidity at Spruce Street was not rising at the start of the sampling period. It peaked on May 11th and then steadily declined. The turbidity values ranges from 8.2 to 81 Nephelometric Turbidity Units (NTU) at the outfall and 1.0 to 4.2 in the wetland.

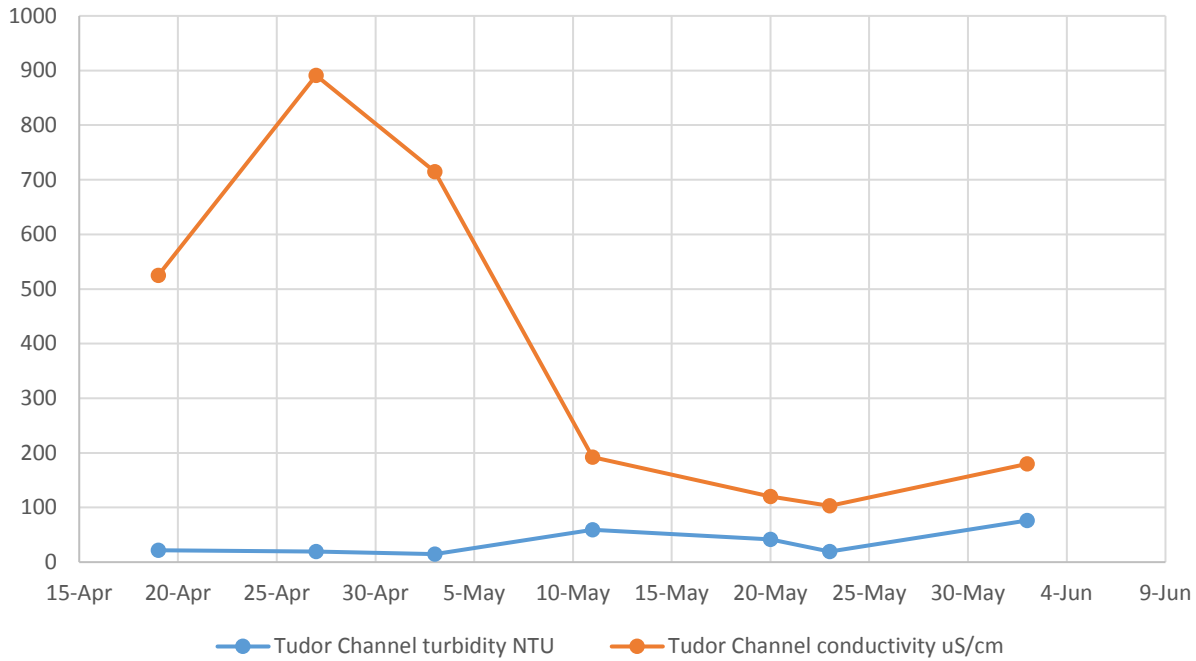
Tudor Channel Snow Melt Trend

At Tudor snow site melting was farther along. Conductivity in the channel was rising when sampling started, and it peaked shortly thereafter on April 27th. Conductivity in the pond had already peaked and was steadily declining. Conductivity values ranged from 103 to 891 uS/cm in the channel and 118 to 1451 uS/cm in the pond. Starting earlier at the Tudor site to collect samples is planned for the next sampling event.

Turbidity at Tudor was still low and rising. The channel was still rising slightly at the end of the sampling period, and the range was 14 to 60. Another week or two of sampling would have helped to demonstrate the full turbidity range – this will be taken into account for the next sampling event.
