MOA and DOT&PF 2018 Green Infrastructure and Low Impact Development Project Performance Monitoring Report

The Municipality of Anchorage

February 2019

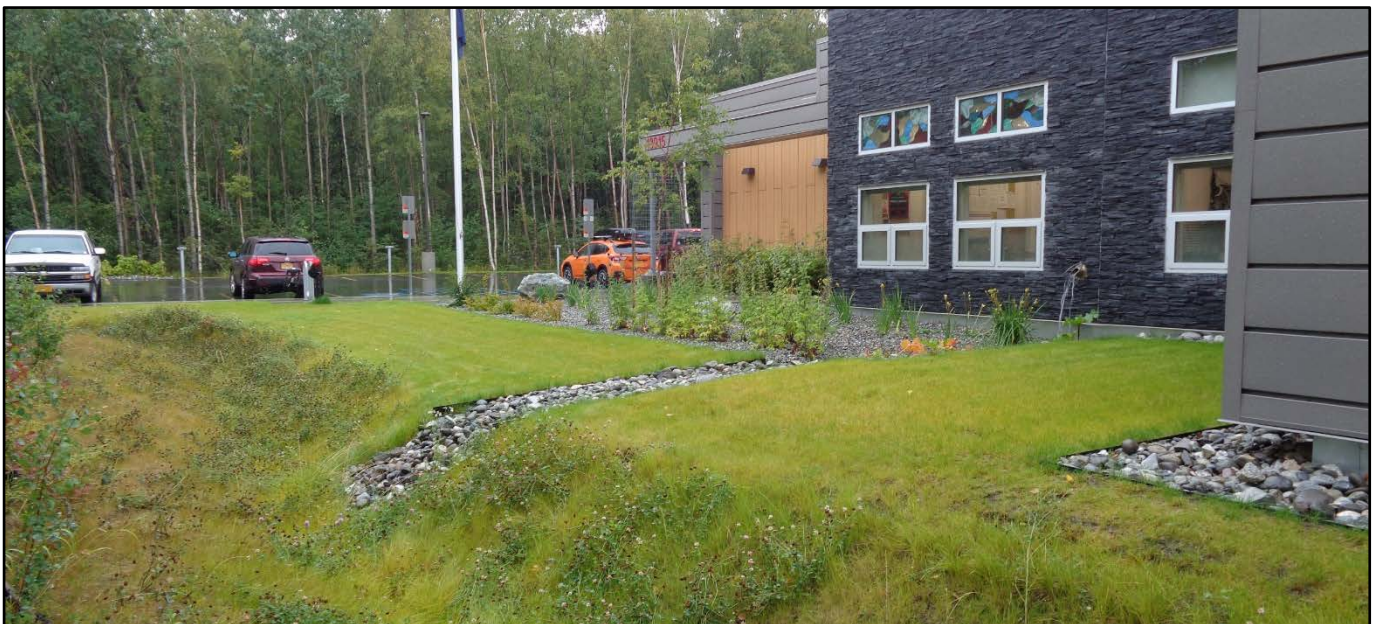
Figure 9: Vegetated Swale during the August 21 Site Visit

Vegetated Swale and Landscaped Detention Area. During the August 21 site visit, it was actively raining. Water was flowing from the fire station roof structure and from the rear parking lot into the vegetated swale. Only a small amount of water was observed in the vegetated swale, indicating that some of the inflow was successfully infiltrating. The vegetation in the swale was mature and healthy, and was keeping water movement through the swale at a slow velocity to provide opportunity for infiltration and evapotranspiration.

- The vegetation in the vegetated swale is both functional and aesthetic, and is expected to be relatively low maintenance. Use of these types of plants is recommended in similar locations, where appropriate.

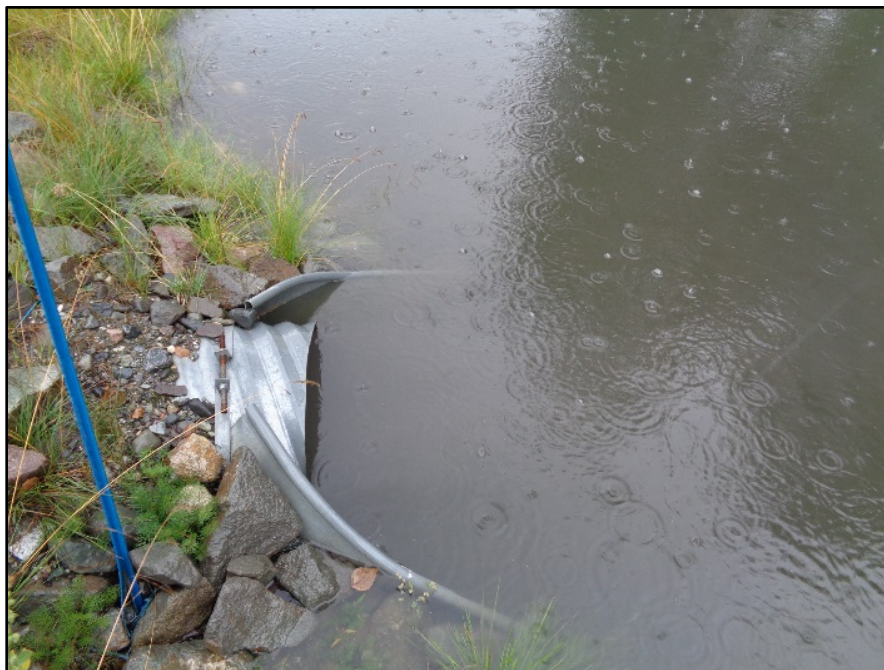
Figure 18: Infiltration Pond #1 Inlet, August 21, 2018

During the August 21 site visit, it was actively raining, and water was flowing into the ponds via inlet culverts that were partially submerged. It was partly cloudy during the October 16 visit, with no active precipitation. Pond depths for both visits are shown in Table 4. There was no overflow observed from any of the three infiltration ponds during either of the site visits.

It was observed during both site visits that vegetation surrounding Infiltration Ponds #1 and #5 had grown into tall grasses, but the grass around Pond #4 was fairly short. Figure 18 and Figure 19 show inlet culverts for each of the three ponds.

Both ponds have similar features, but the longer grasses in Pond #1 and Pond #5 are expected to improve overall pond performance. Longer grasses provide more opportunity for evapotranspiration, and the root structures help keep the pond floors open to infiltration. Allowing grasses to grow also reduces pond maintenance.

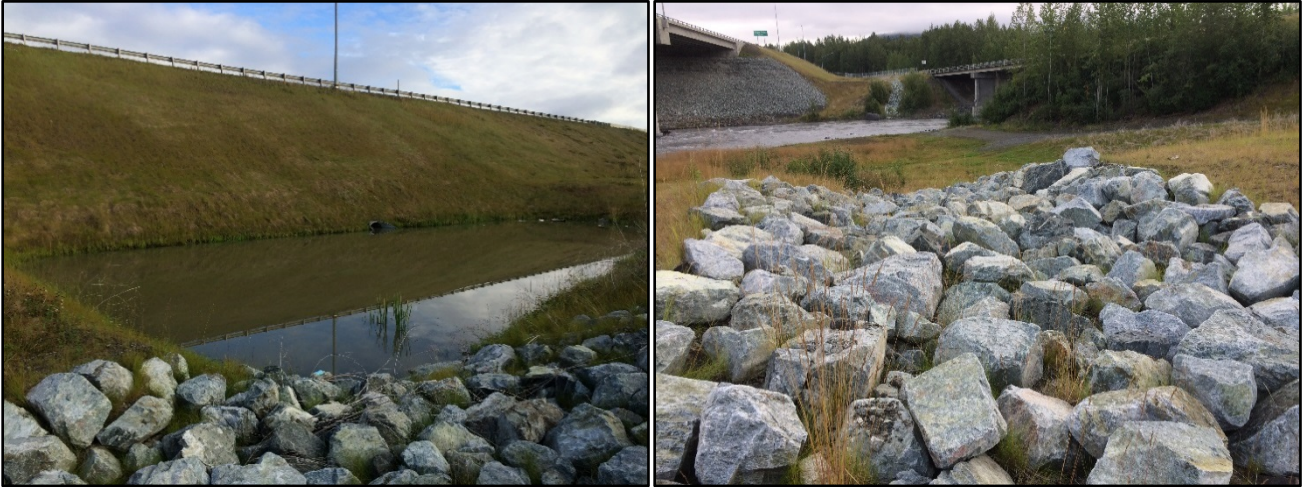
Figure 31: North Detention Pond (left) and Spillway Outfall from South Detention Pond (right), August 8, 2018

Three site visits were completed on August 8, August 21, and October 16, 2018. At the time of the August 8 site visit, it had rained earlier that morning but was no longer raining. There was standing water in the north pond and the culvert inlet was observed to be about two-thirds submerged, correlating to an approximate pond depth of 3.2 feet. There was no outflow from the pond. The south pond had no standing water, but the bottom of the pond was wet. There was no inflow or outflow from the south pond. Tall grasses between the rocks of the riprap-lined spillway were standing vertical, indicating that the spillway had not recently seen overflow. Photos from the site visit are shown in Figure 31.

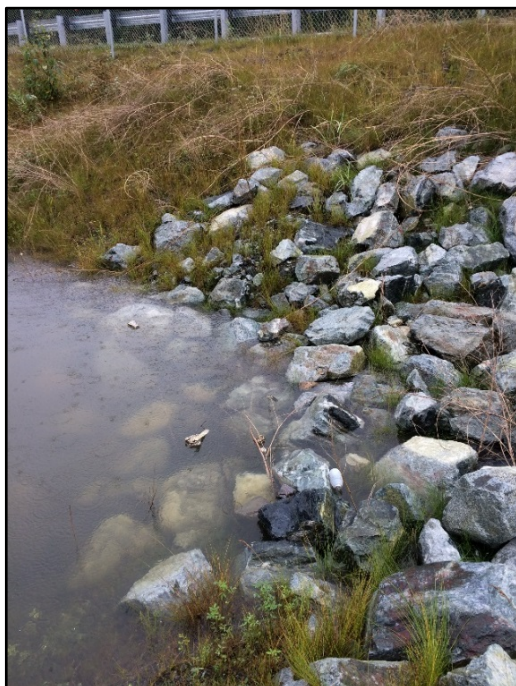
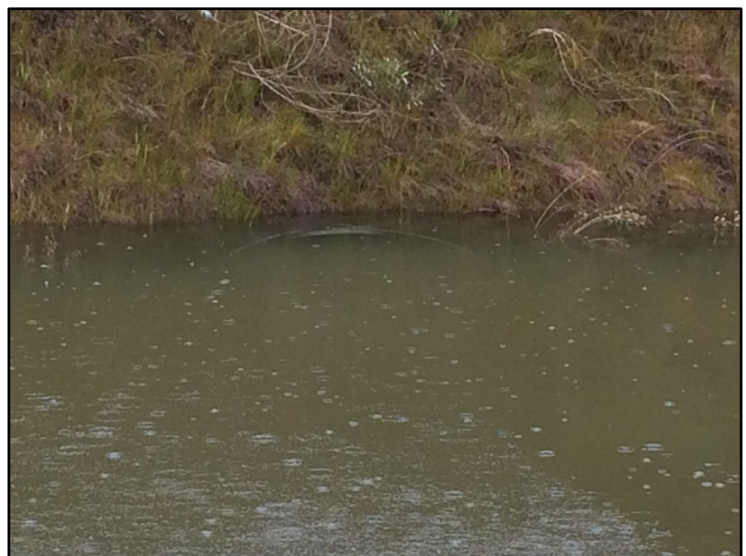
Figure 32: Outflow (left) and Submerged Inlet Culvert (right) – North Pond, August 21, 2018

It was actively raining at the time of the August 21 site visit. Water was flowing into the north pond via the submerged inlet culvert and direct runoff from VFW Road. Outflow from the north detention pond was observed in the overflow spillway to Eagle River. Figure 32 shows the submerged pond inlet and water leaving the pond via the spillway. The south detention pond had approximately one foot of standing water, but no visible inflow was observed. Saturated soils above the water surface were observed, along with a visible difference in vegetation based on elevation. It was estimated that there was a high water elevation earlier in the day of approximately five to six feet above the water surface elevation at the time of the site visit. There was no evidence of current or prior outflow from the south detention pond. Figure 33 shows the standing water in the south pond during the site visit. Long grasses and other vegetation lined the slopes of both ponds.

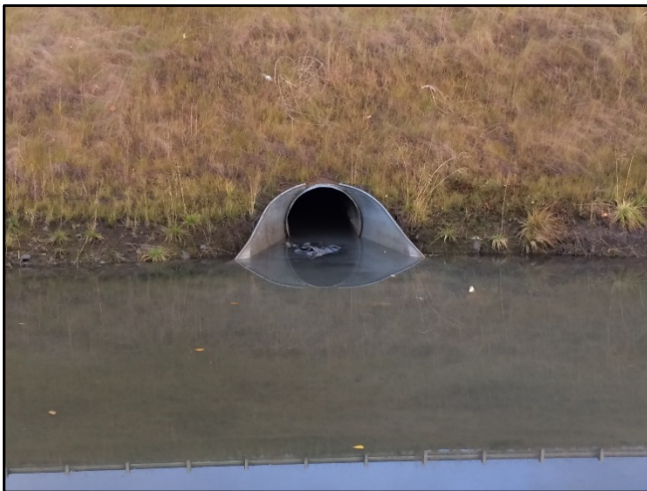
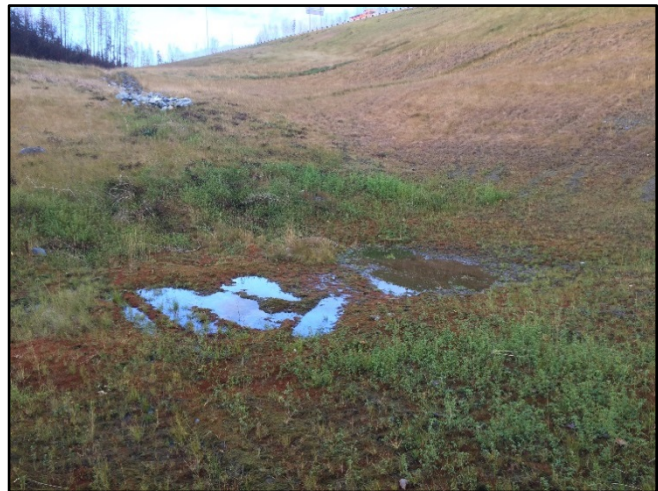
Figure 34: North Pond Inlet (left) and Standing Water in South Pond, October 16, 2018

The ponds were observed again on October 16. It had rained overnight but skies were partly cloudy and there was no precipitation at the time of the site visit. Standing water was observed in the north pond, with an estimated depth of approximately 1.5 feet. Water was flowing into the north pond via the inlet culvert and there was no outflow. The south pond had discontinuous standing water, estimated at a maximum depth of three to four inches. The south detention pond had no inflow or outflow. Figure 34 shows the north pond's inlet and standing water in south pond during this site visit.

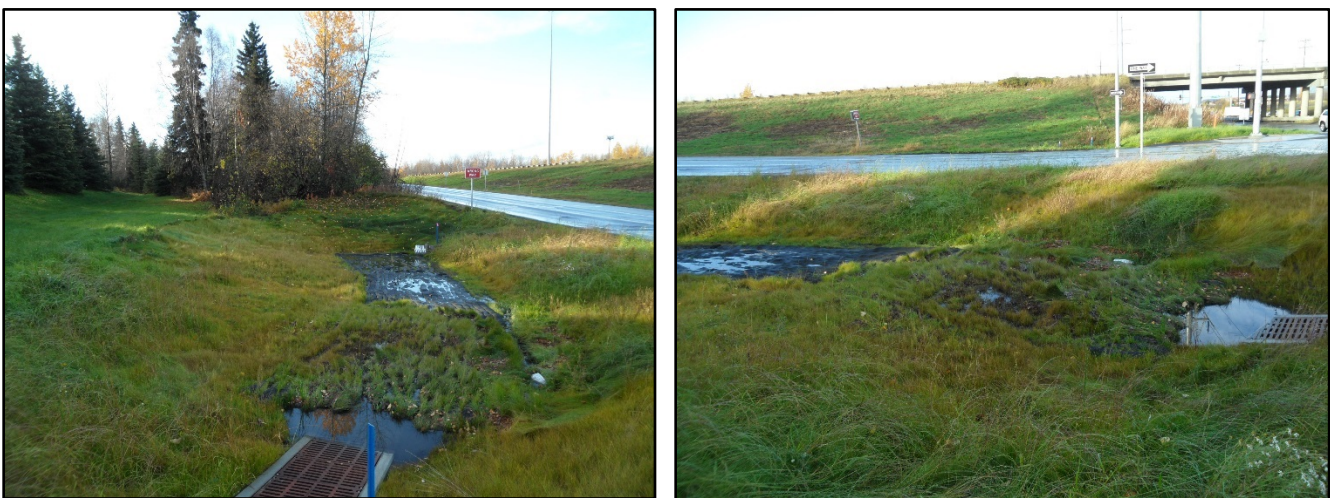
Figure 42: O'Malley Road Bioswale, October 16, 2018

The bioswale was also observed on October 16. There was no active precipitation at the time of the site visit, but the ground was wet. The bioswale was mostly empty, with some standing water near the inlet structure. As observed during the August site visit, there was limited vegetation in the swale's flow area. The bioswale during the October site visit is shown in Figure 42.

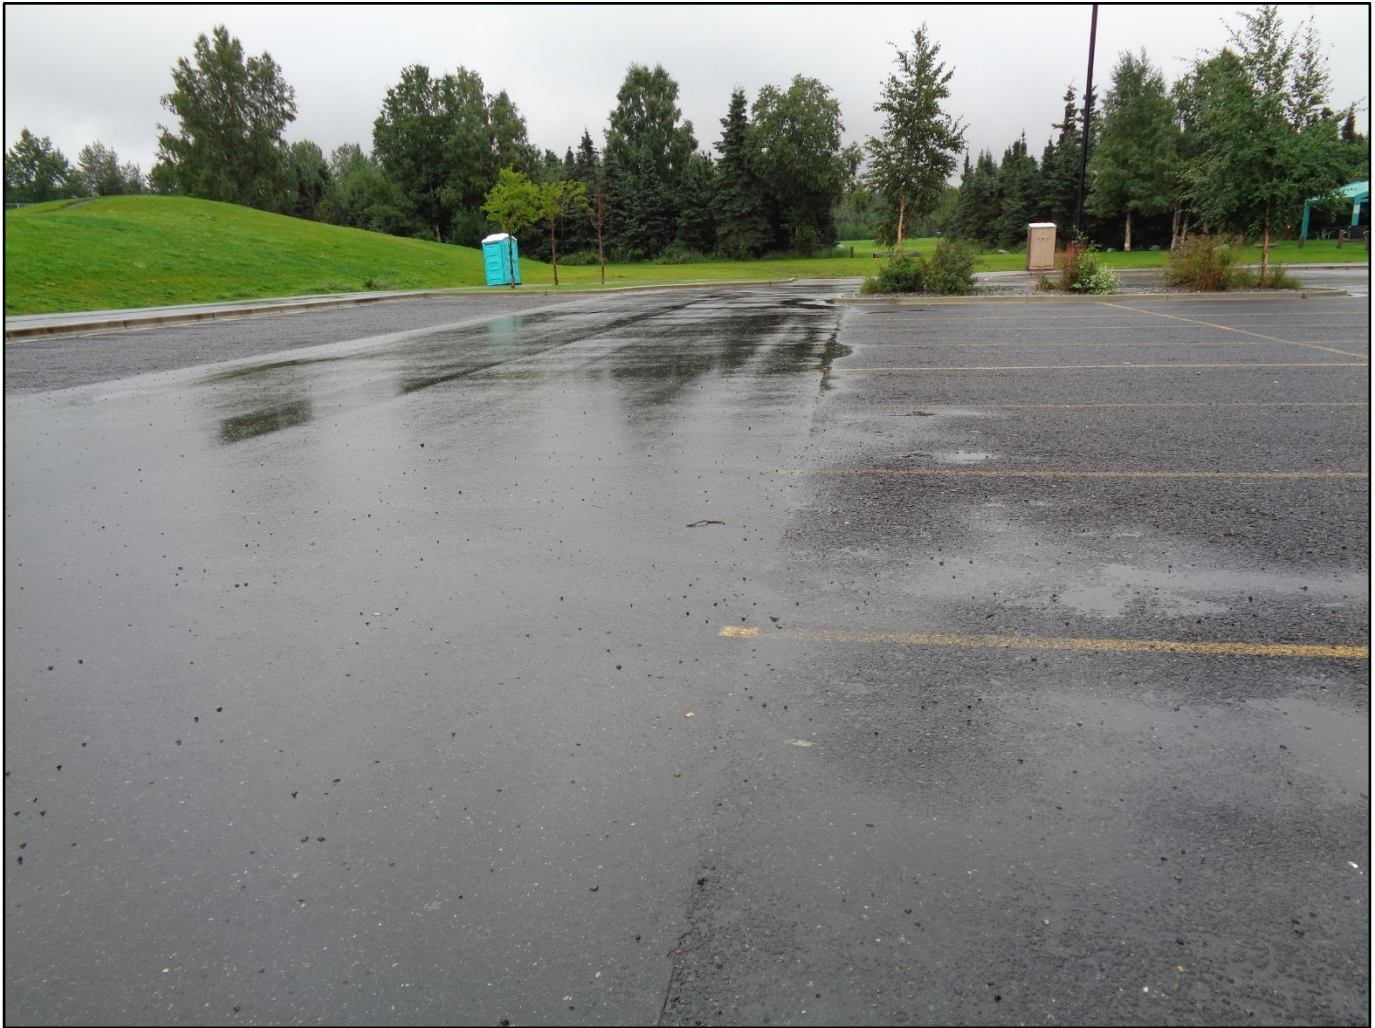
Figure 55: Porous/Traditional Asphalt Interface – August 21 Site Visit

The August 21 site visit occurred about 5:30 pm. It was actively raining at this time, and the site visit occurred near the end of a storm event that generated 0.72 inches of rain in a 24-hour period and over an inch of rain in a 48-hour period. (This event is described in Section 4.2 of this report.) All three sections of porous asphalt were observed to be draining well. Surface ponding was only noted at the edges of the porous asphalt, where runoff from the traditional asphalt was flowing onto the porous asphalt.

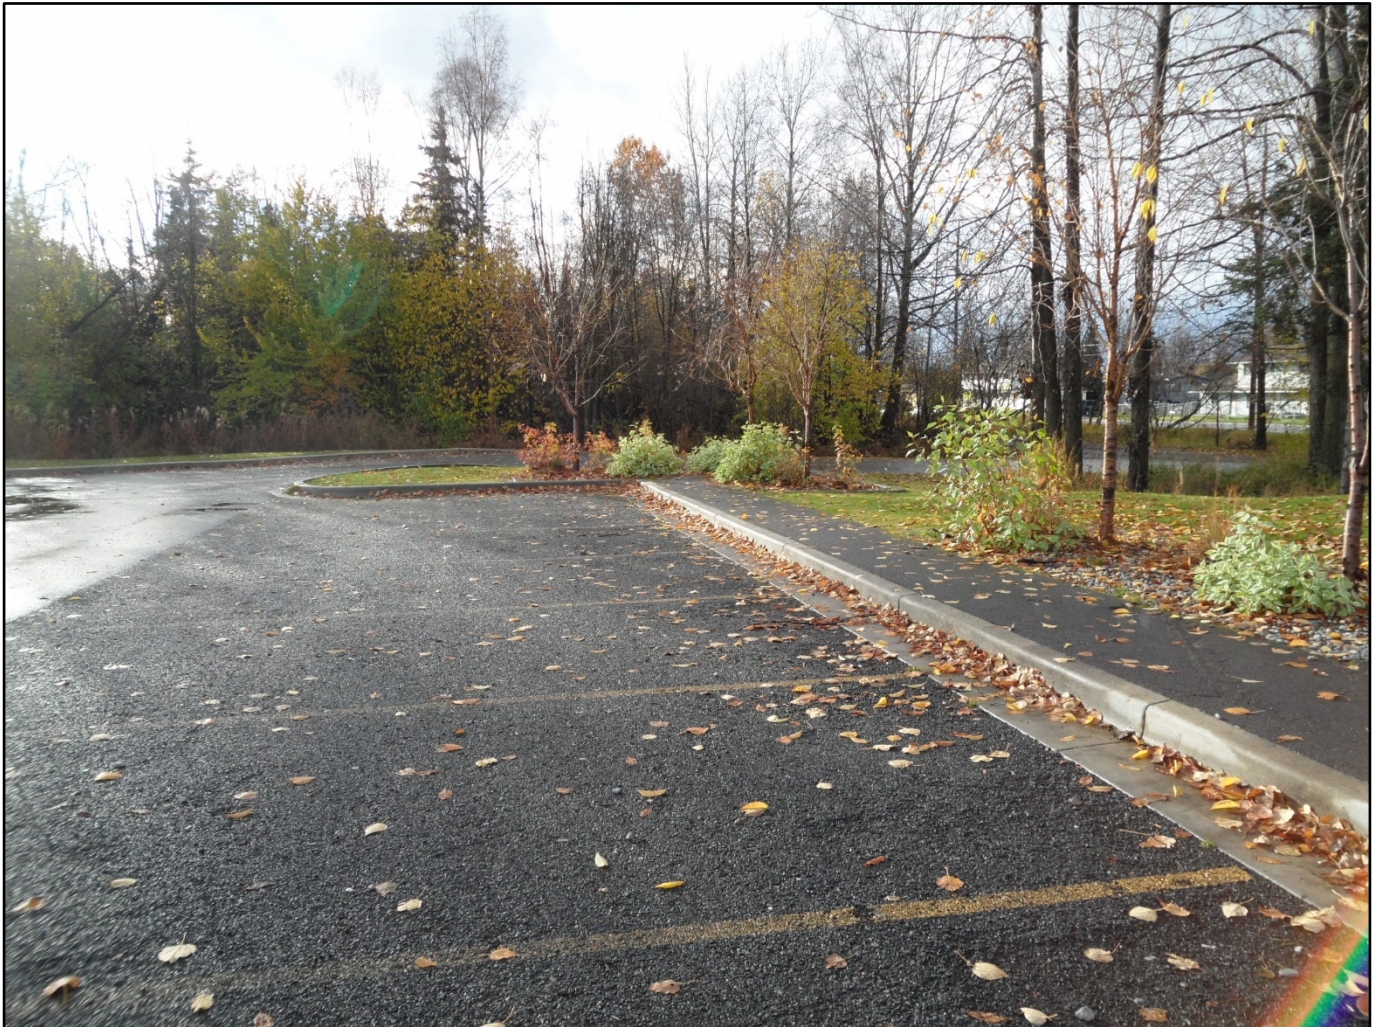
Figure 56: RJSP West Section of Porous Asphalt – October 16 Site Visit

Previous monitoring reports have noted surface raveling of the porous asphalt. This continues to be a concern, but did not appear to be notably worse than previous observations. There did not appear to be signs of new asphalt wear or damage, such as rutting or depressions. Damage mentioned in previous reports, such as rutting on the parking lot's west side, was still present but did not appear to be worsened. Light debris and small rocks from the surface raveling were observed on the asphalt surface.

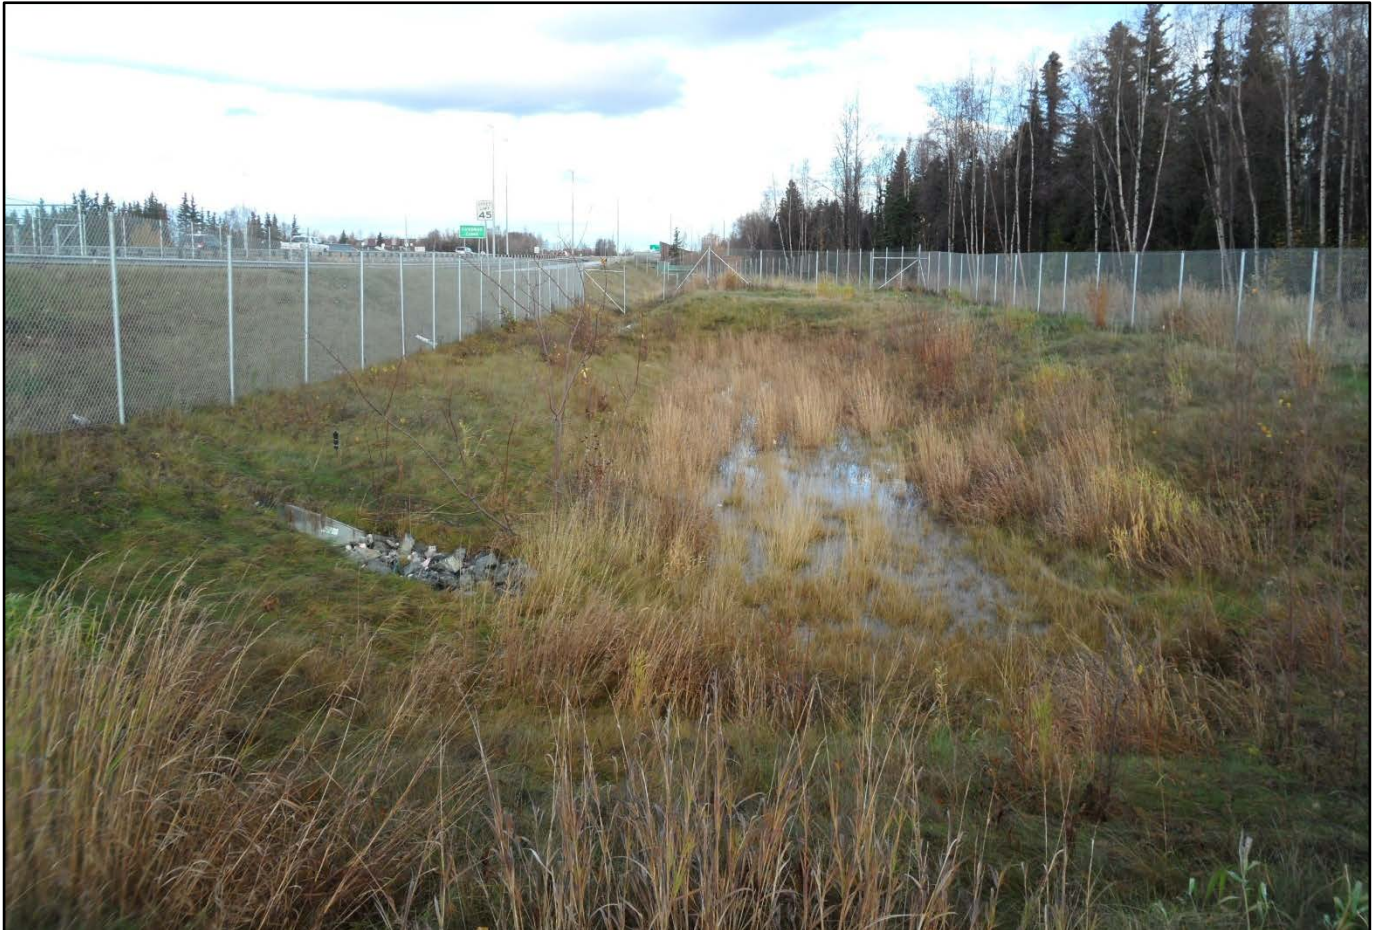
Figure 66: NSH Infiltration Basin – October 16 Site Visit

The October 16 site visit occurred at about 11:40 am, shortly after a rain event that had resulted in 0.52 inches of rain in 24 hour period and 0.82 inches of rain in a 48 hour period. It was not raining at the time of the site visit. The pond water level was notably lower than it had been in August, and neither the inlet nor the outlet were actively flowing. A photo of the pond from the October site visit is shown in Figure 66.
