2022 Dry Weather Screening Report

APDES Permit No. AKS052558

MUNICIPALITY OF ANCHORAGE

WATERSHED MANAGEMENT SERVICES

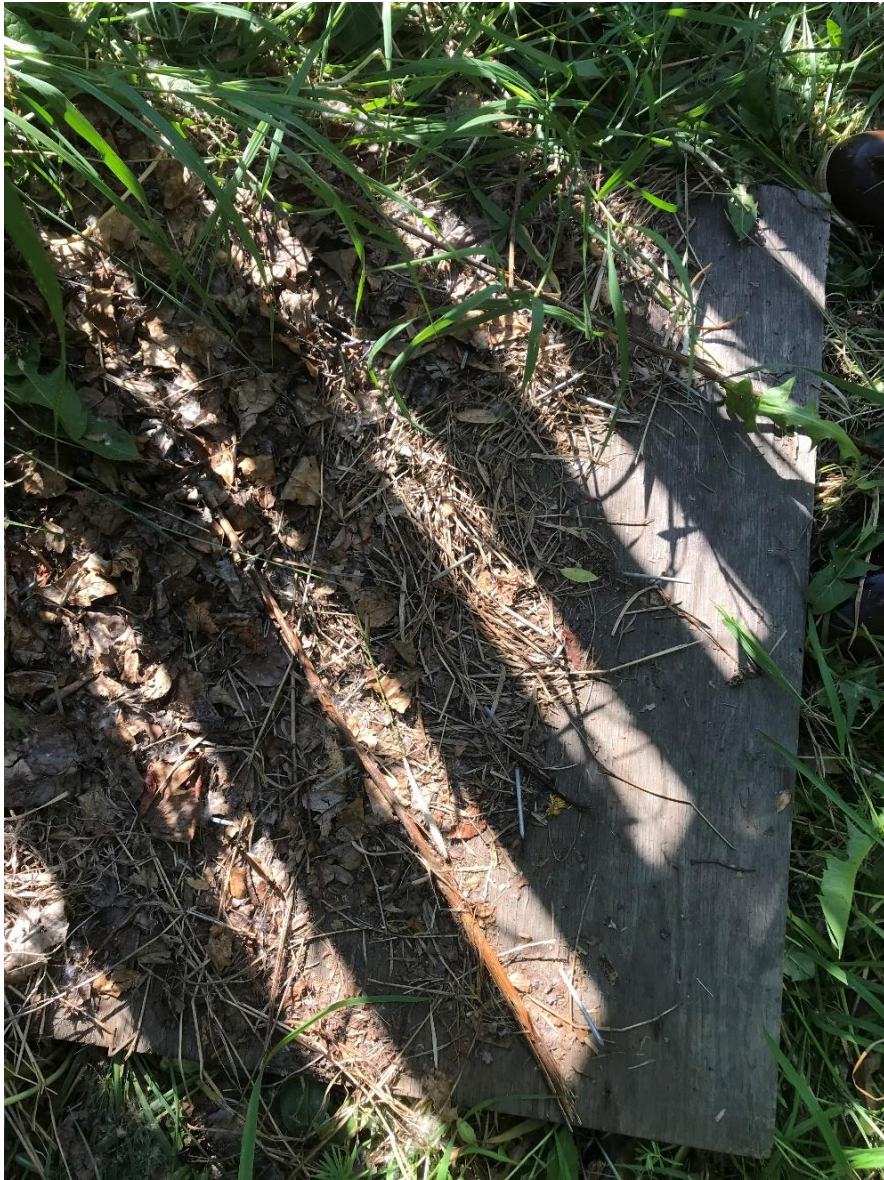
Fish Creek 1277-1. No Safe Access. June 22, 2022.
