SUBJECT: APDES Inspection of ANC Taxiway Z West Improvements, Authorization Number
AKR10H0AH

APDES INSPECTION REPORT

Name of Project: ANC Taxiway Z West Improvements

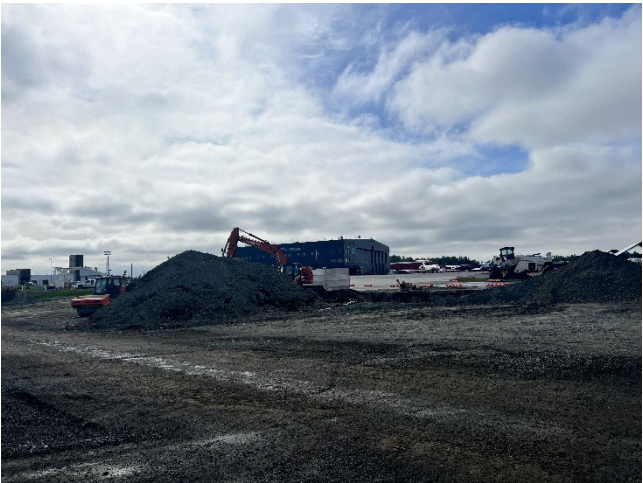
- No evidence of sedimentation or erosion was visible around the taxiway E intersection area that was actively being worked.
- Excavation was ongoing to repair a broken water line.

Excavation to repair a water line break began on Sunday 6/16	Excavating to extend taxiway Zulu to the East

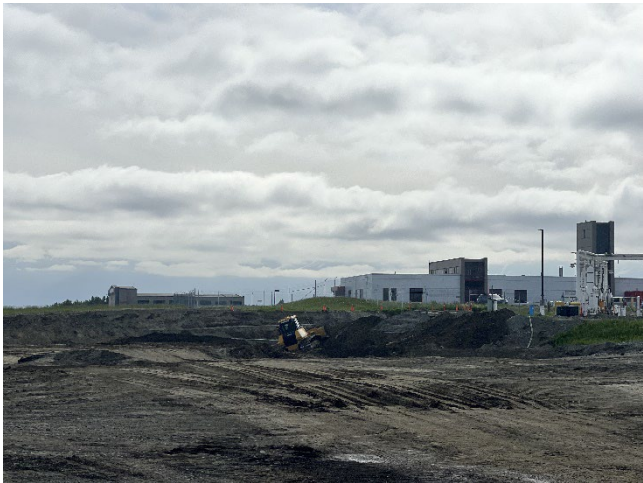
- Excavation to create a “stub” of what will be Taxiway Z to create additional space to allow jets to turn has begun.
- Several pieces of heavy equipment were stationary. No oil stains or other signs of leaks were observed beneath them.

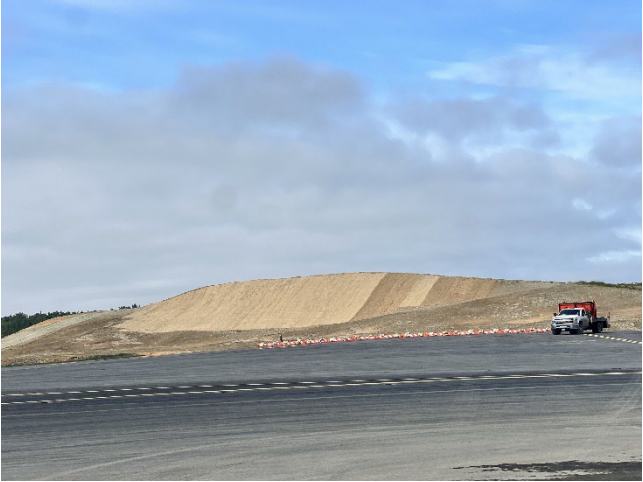
Slope stabilized with coconut mat RECP – will be excavated eventually	Articulated concrete TRM installation in drainage path of vegetated swale
Photo 31	Photo 32

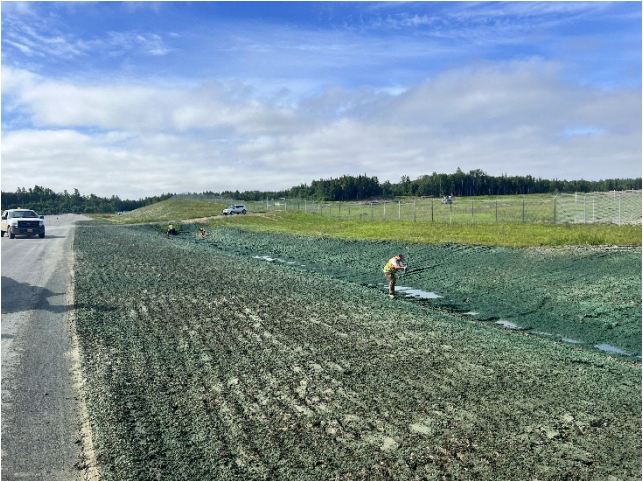
Trenching in swale that was hydroseeded 6/18/2024	Wattles as check dams in hydro mulched drainage area not yet at final grade

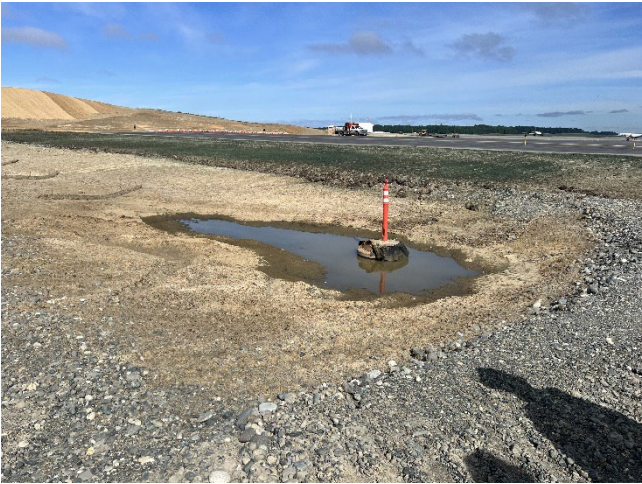
Manhole protected with filter fabric	Articulated concrete TRM in storage
Photo 35	Photo 36

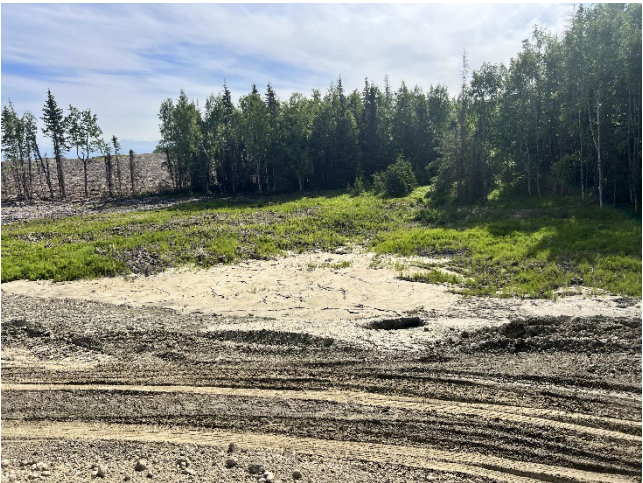
Some sediment migrated to low areas of the fill site, but did not appear to have discharged	Turbid water near fill site, as seen from access road

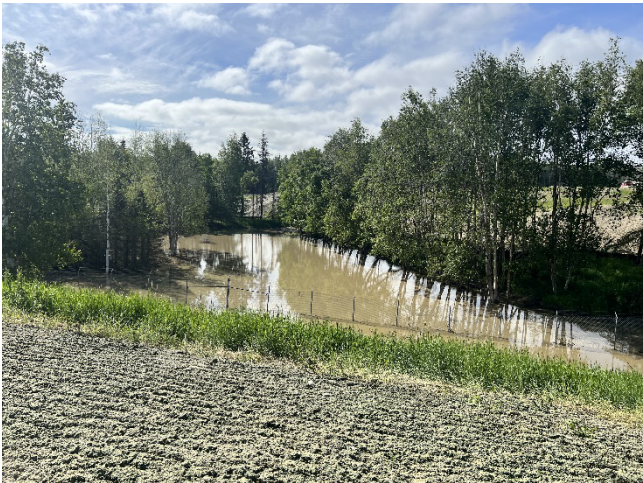
Turbid Water Near Soil Disposal Area (Fill Site)

- A depression near the fill site where excavated, uncontaminated soils are being disposed has filled with turbid water. This depression is bordered by vegetated buffer and silt fence perimeter control separates this area from disturbed areas of the site.

- The brush and trees bordering the waterfilled depression were standing upright, with no evidence of sediment on their leaves. If the vegetative buffer had been overwhelmed to allow sediment to migrate into the depression, the brush and trees would be expected to have retained some sediment.

- The silt fence appeared to be installed with appropriate tension and appeared to be well-maintained.
- Unvegetated area around the waterfilled depression was moderately sloped, stabilized with an opaque layer of hydro mulch, and showed no evidence of rilling or gullying.

- The waterfilled depression is at a relative low point. It did not appear to the inspector that it could discharge to adjacent areas in normal conditions.

- Representatives explained that they do not believe this water collected by means of surface runoff but may have been displaced groundwater resulting from the additional weight and mass of soils added to the adjacent fill site.

150.00269 W) is a quarter of a mile from the coordinates associated with Photo 40, of the waterfilled depression (61.1651208 N, 150.009163 W).
