APDES INSPECTION REPORT

APDES Discharge Number	Announced / Unannounced	Receiving Waters	Inspection Date
Number: AKR10H0JV AKR10H0JK	Announced	Turnagain Arm and Wetlands (unimpaired)	Date: 5/29/2025
Effective: 5/20/2024 5/22/2024			Entry Time: 10:00am
Expiration: 1/31/2026			Exit Time: 1:30pm

Name of Facility: Seward Highway MP75-90 Ph III

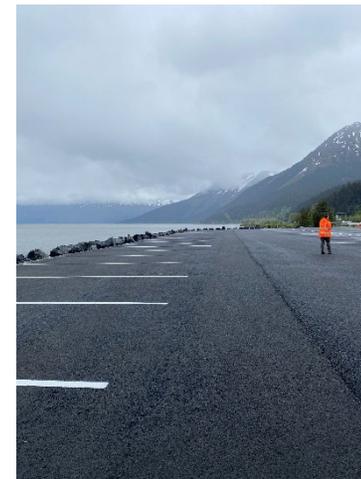
Photo 44

New Parking Lot

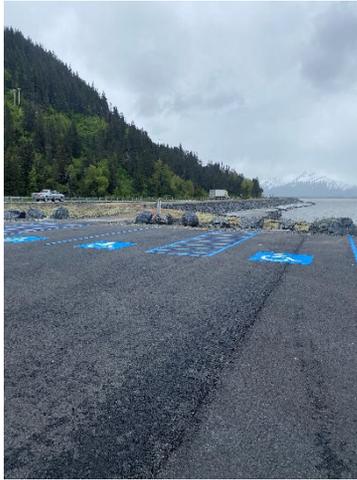
Photo 45

New Parking Lot

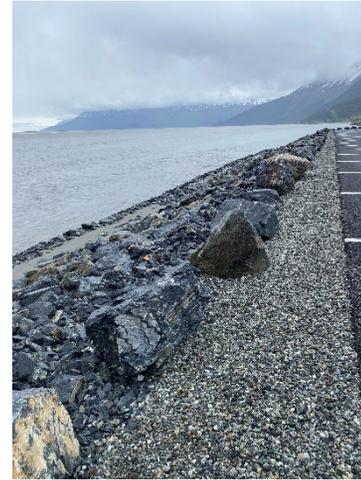
Photo 46

Rip Rap at New Parking Lot

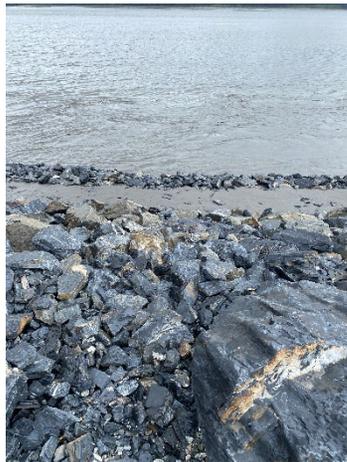
Photo 47

Rip Rap at New Parking Lot

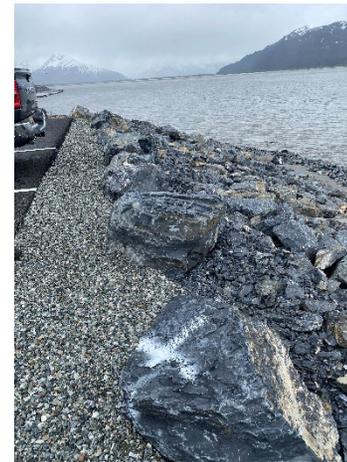
Photo 48

Rip Rap at New Parking Lot

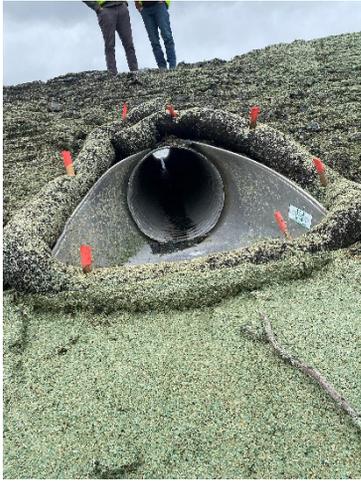
Photo 49

- The weather was windy, light rain, and 45 degrees Fahrenheit.
- The new parking lot has been paved and painted.
- All surrounding disturbed areas have been covered by hydroseed.
- There is no sign of the hydroseed taking root yet.
- Straw wattles at entrance to the culvert at the new parking lot are in functioning condition.
- The existing culvert is approximately 300 yards down the pedestrian path from the new lots and is in functioning condition.
- The pedestrian path runs along the Seward Highway to the next lot, which was completely as part of phase II of this project.
- The pedestrian path runs along the Seward Highway to the next lot and is adjacent to a wet land. There is a silt fence that runs along this section of the pedestrian path to minimize sediment transport into the wetland.
- The previous staging area is free of any stockpiles, construction materials, or equipment.

New Parking Lot Culvert (inlet)

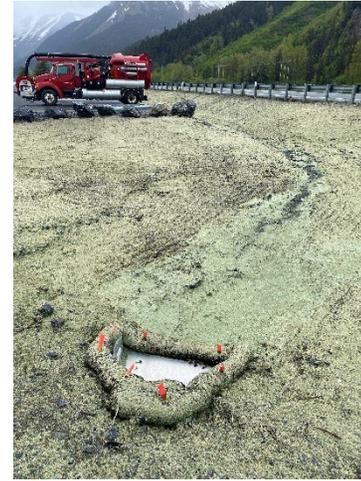
Photo 50

New Parking Lot Culvert (inlet)

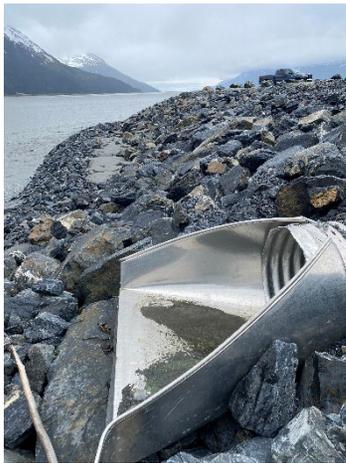
Photo 51

New Parking Lot Culvert (outlet)

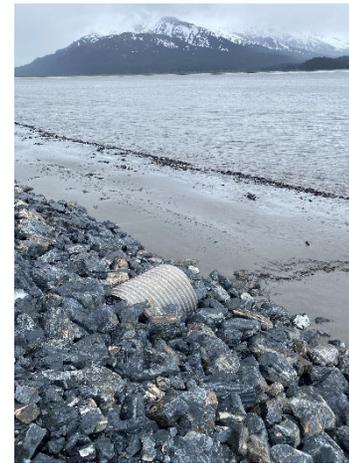
Photo 52

Existing Culvert at New Parking (outlet)

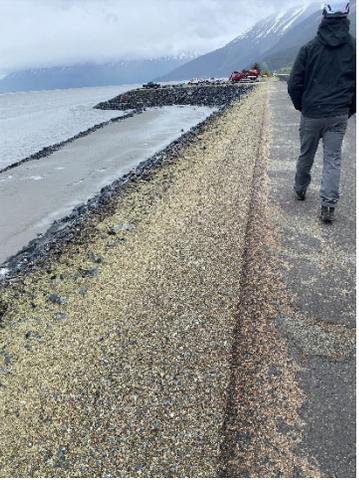
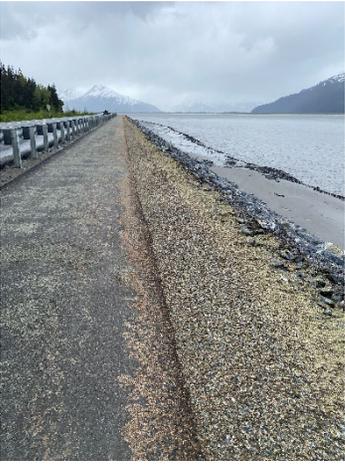
<p data-bbox="1325 846 1724 873">Hydroseed Along Pedestrian Path</p>
<p data-bbox="499 911 617 938">Photo 55</p>

<p data-bbox="359 1474 764 1502">Hydroseed Along Pedestrian Path</p>	<p data-bbox="1465 911 1583 938">Photo 56</p>

Final stabilization will be reached when hydroseed takes root and is able to hold sediment in place. BMPs should be inspected and maintained until this occurs. If the end date of the project needs to be extended past June 28th, 2025, please submit an NOI modification. Once final stabilization is reached, please submit a Notice of Termination (NOT) so terminate your permit coverage.

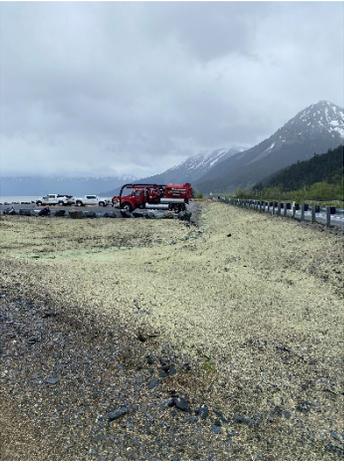
<p data-bbox="1339 1474 1709 1502">Hydroseed at New Parking Lot</p>

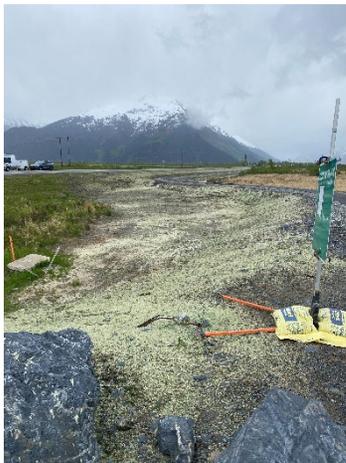
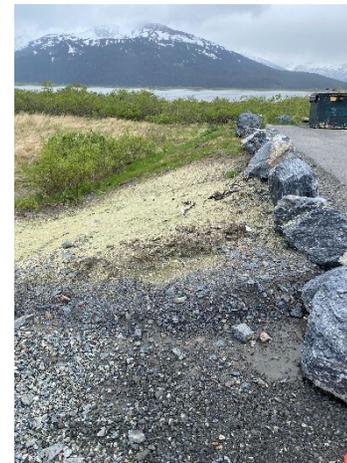
Hydroseed at Pedestrian Path Tie-in

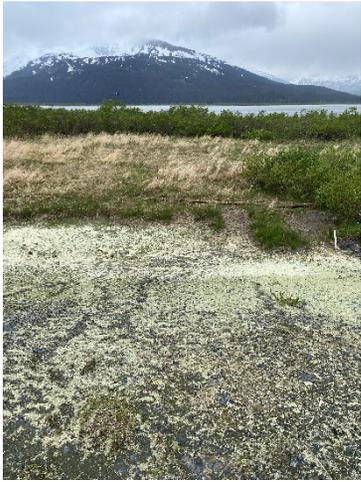
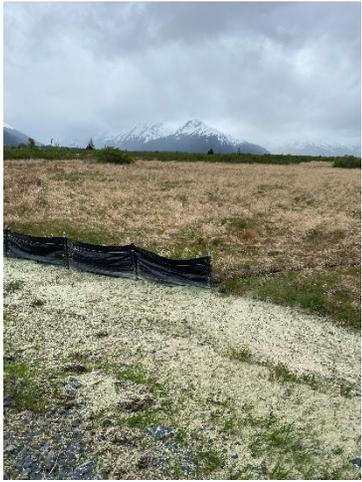
<p data-bbox="394 846 726 873">Straw Waddle (foreground)</p>	<p data-bbox="1178 846 1866 873">One end of silt fence that runs along the adjacent wetlands</p>
<p data-bbox="499 911 617 938">Photo 67</p>

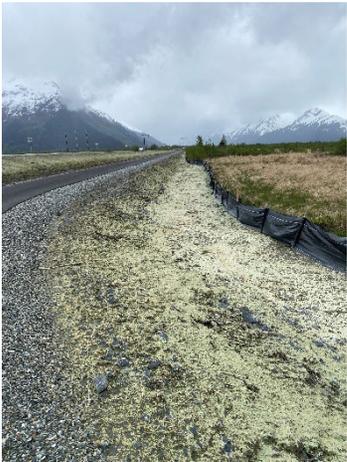
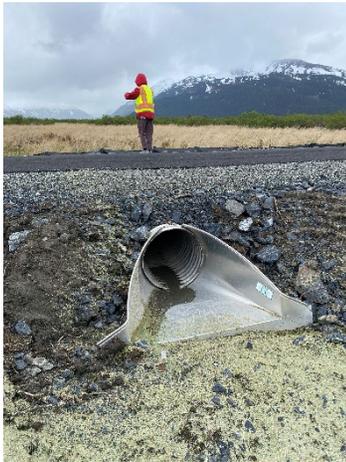
<p data-bbox="281 1476 837 1503">Silt fence that runs along the adjacent wetlands</p>	<p data-bbox="1310 1476 1734 1503">New Culvert at Phase II parking lot</p>

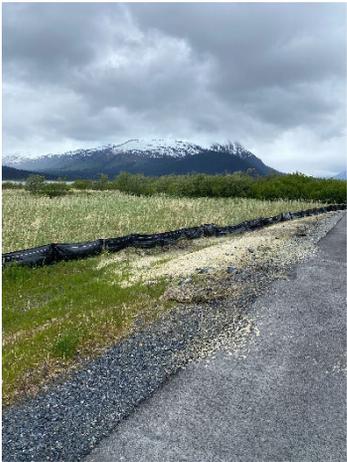
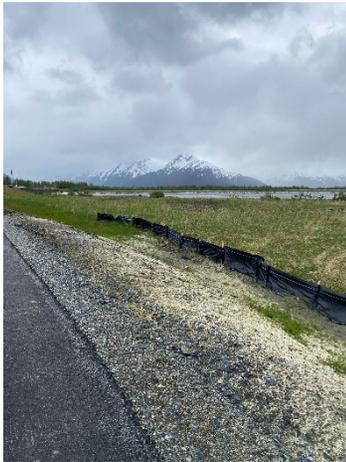
<p data-bbox="411 1474 709 1502">Silt fence and hydroseed</p>	<p data-bbox="1167 1474 1877 1502">Other end of silt fence that runs along the adjacent wetlands</p>

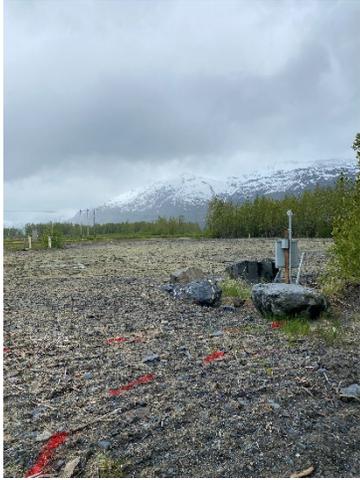
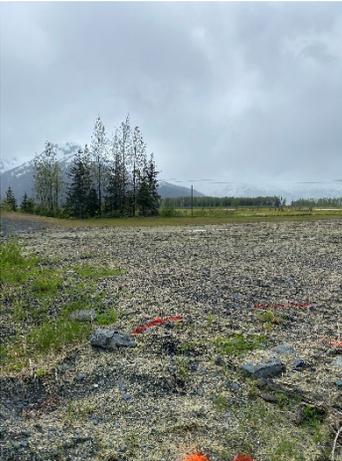
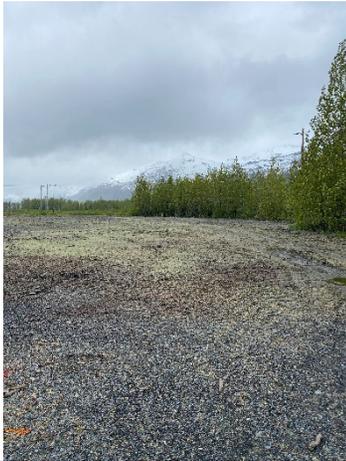
<p>Previous staging area</p>
<p>Photo 75</p>

<p>Previous staging area</p>	<p>Photo 76</p>

<p>Previous staging area</p>
