**Final Report**

# **State Farm Intersection Safety Studies**

*Date Prepared: July 2003*

*Authors: Gerry Forbes, President  
Geoffrey Ho, Senior Safety Specialist*

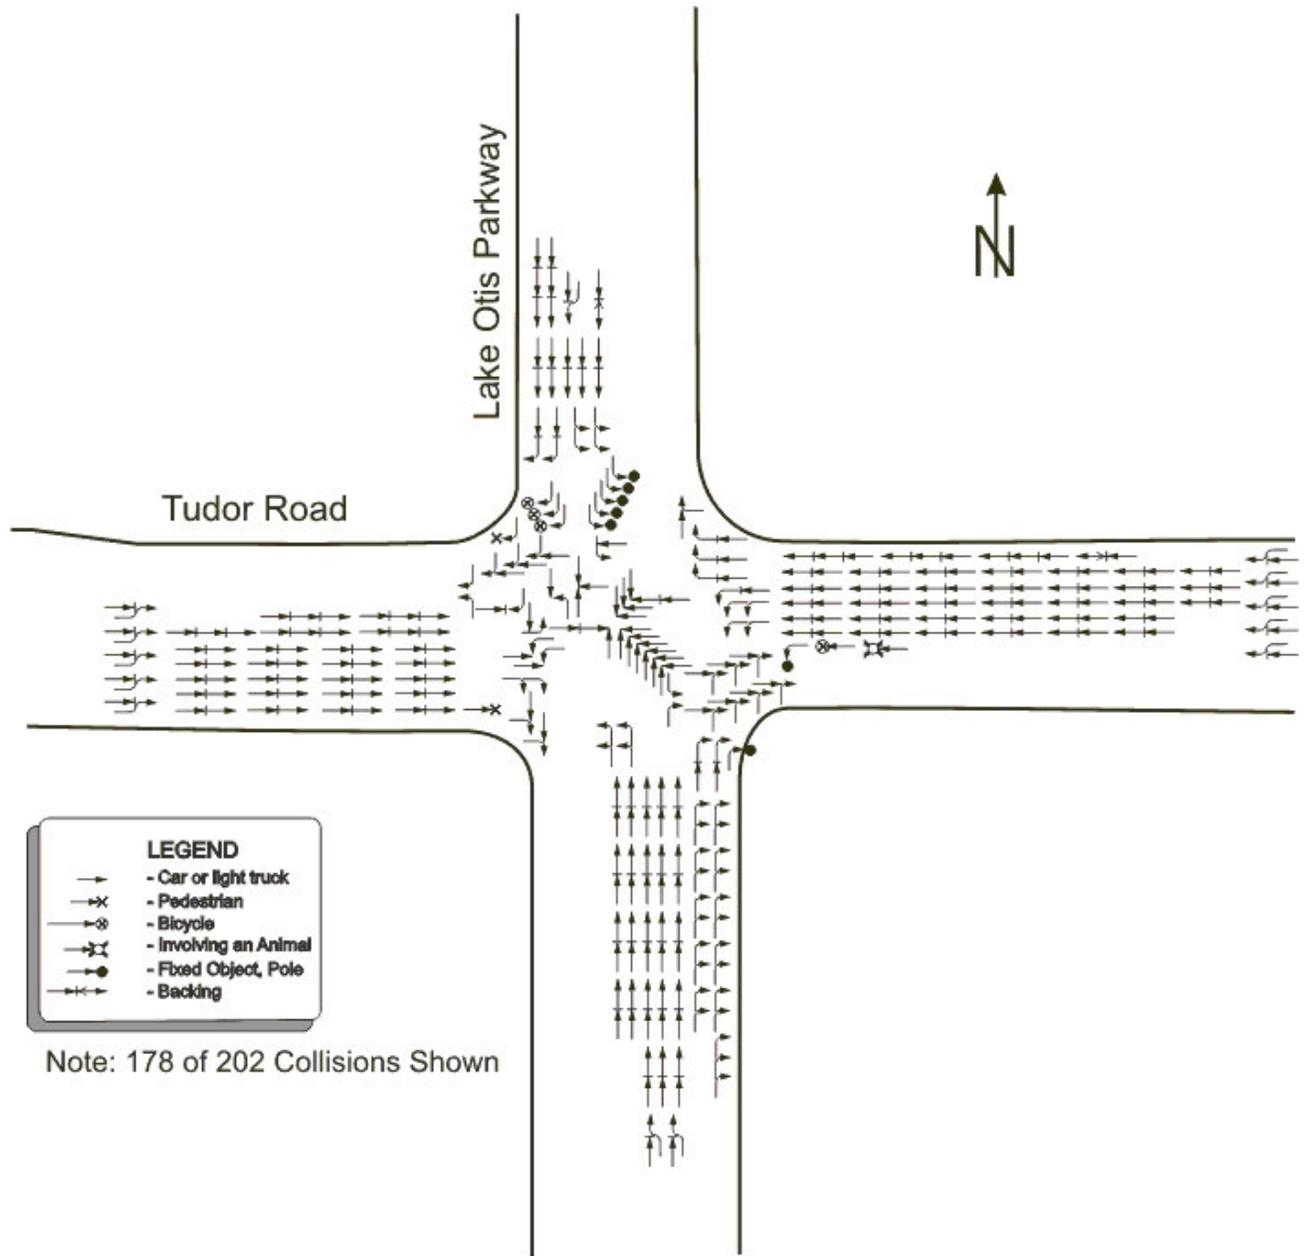
FIGURE 2.2: Collision Diagram for LOP at Tudor Road

The collision diagram for LOP at Tudor Road is shown in FIGURE 2.2. The aberrant collision characteristics were found to be:

The frequency of angle collisions is “as expected” for an Alaskan signalized intersection. However, angle collisions are the second most prominent collision type (39%), and are worthy of some consideration. A breakdown of the angle collisions indicates that:

- *49% of the angle collisions are between vehicles traveling in the same direction (sideswipes);*
- *41% of the angle collisions are between conflicting vehicles (usually right-turn vehicles); and*
- *4% of the angle collisions are between opposing vehicles (ex., left-turn with opposing through).*

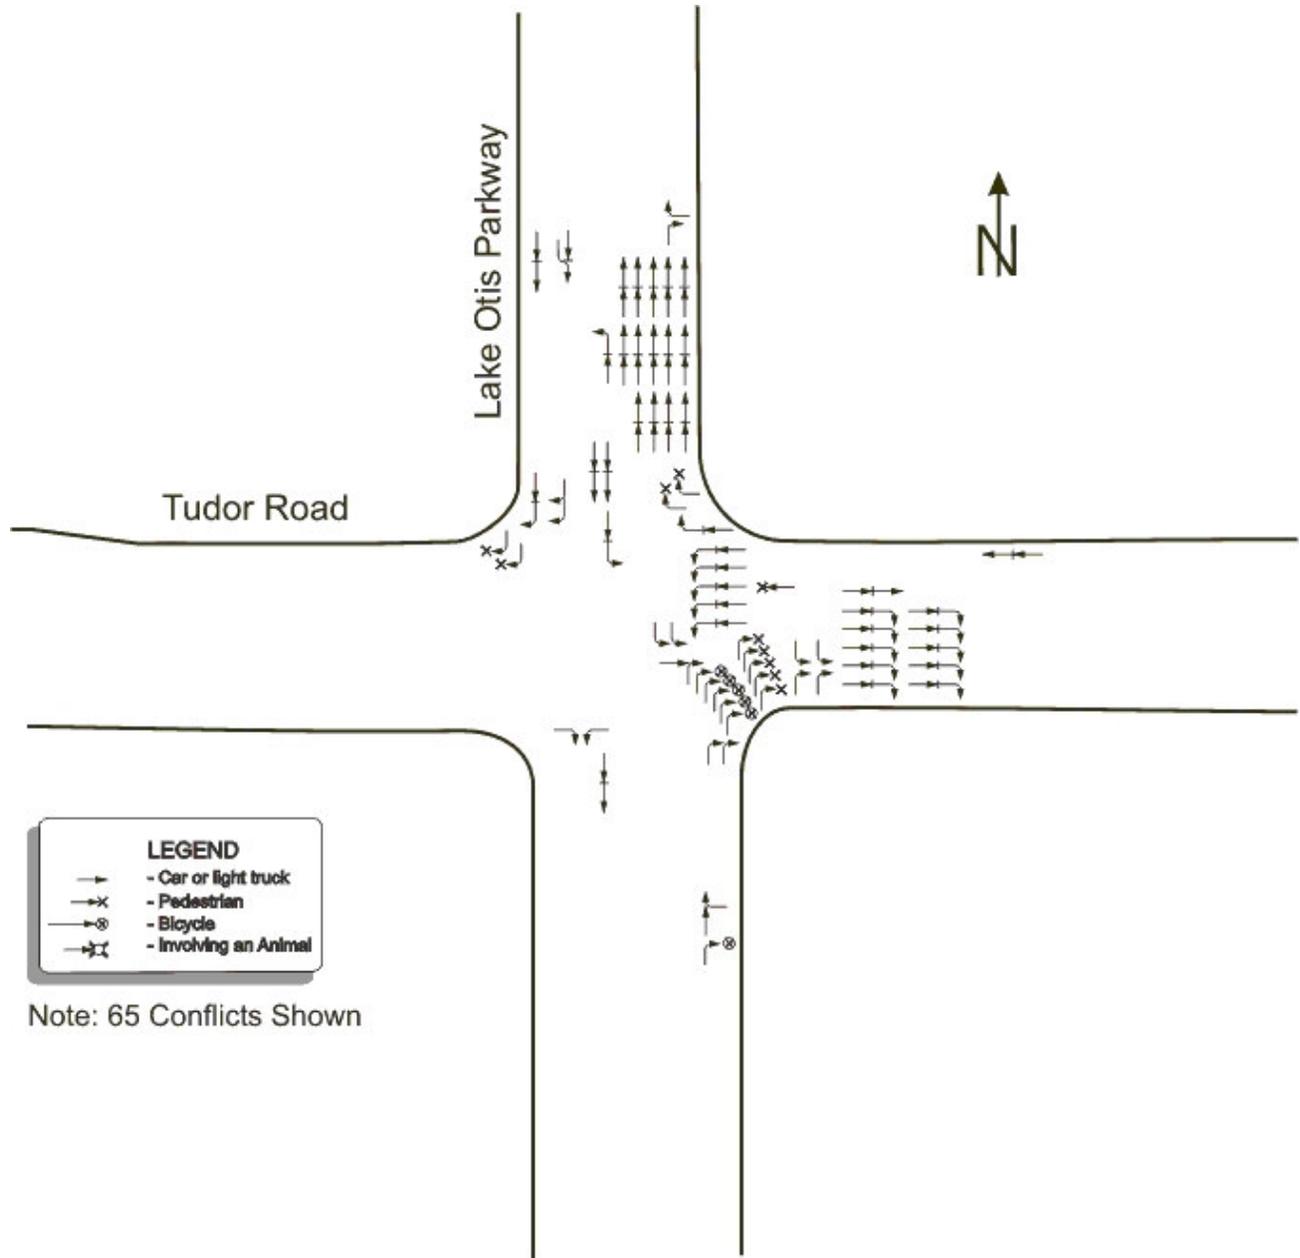
FIGURE 2.2: Traffic Conflict Diagram for LOP at Tudor Road

The spatial distribution of traffic conflicts is summarized in FIGURE 2.3. The results indicated that rear-end conflicts accounted for 58% of all observed conflicts. In addition, approximately 16% of the conflicts involved pedestrians or cyclists.

The majority of the rear-end conflicts were observed at the northbound and eastbound exit legs. The pedestrian and cyclist conflicts were mainly associated with the northbound right-turn movements on LOP.

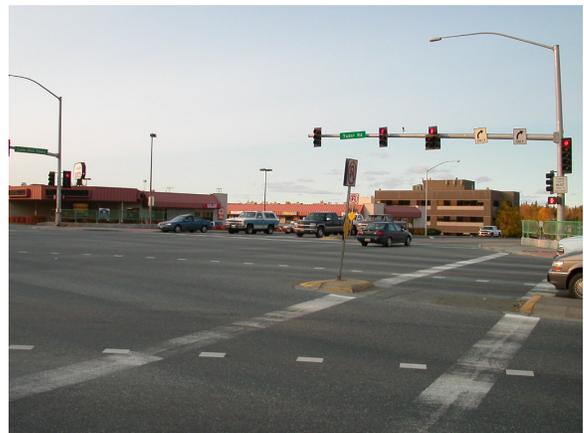
PHOTO 2.1: Sign Post at Westbound Approach

- *Location of Sign Post: The sign post located in the westbound approach median were observed to cause a number of conflicts.*
- *Vulnerable Road Users: Due to the long cycle length to accommodate the vehicular movements, vulnerable road users such as pedestrians and cyclists had to wait for an extended period to cross the intersection. This led to non-compliance and jaywalking, further increasing the collision risks for these road users.*

- *There are no signs providing upstream, advance warning of the dual turn lanes.*
- *It appears that the sign located on the westbound approach median may be impeding the southbound left-turn movement (please refer to PHOTO 2.1).*

- *Relocate the Keep Right sign and hazard marker on westbound approach to east of the crosswalk, and remove the median tip west of the crosswalk.*

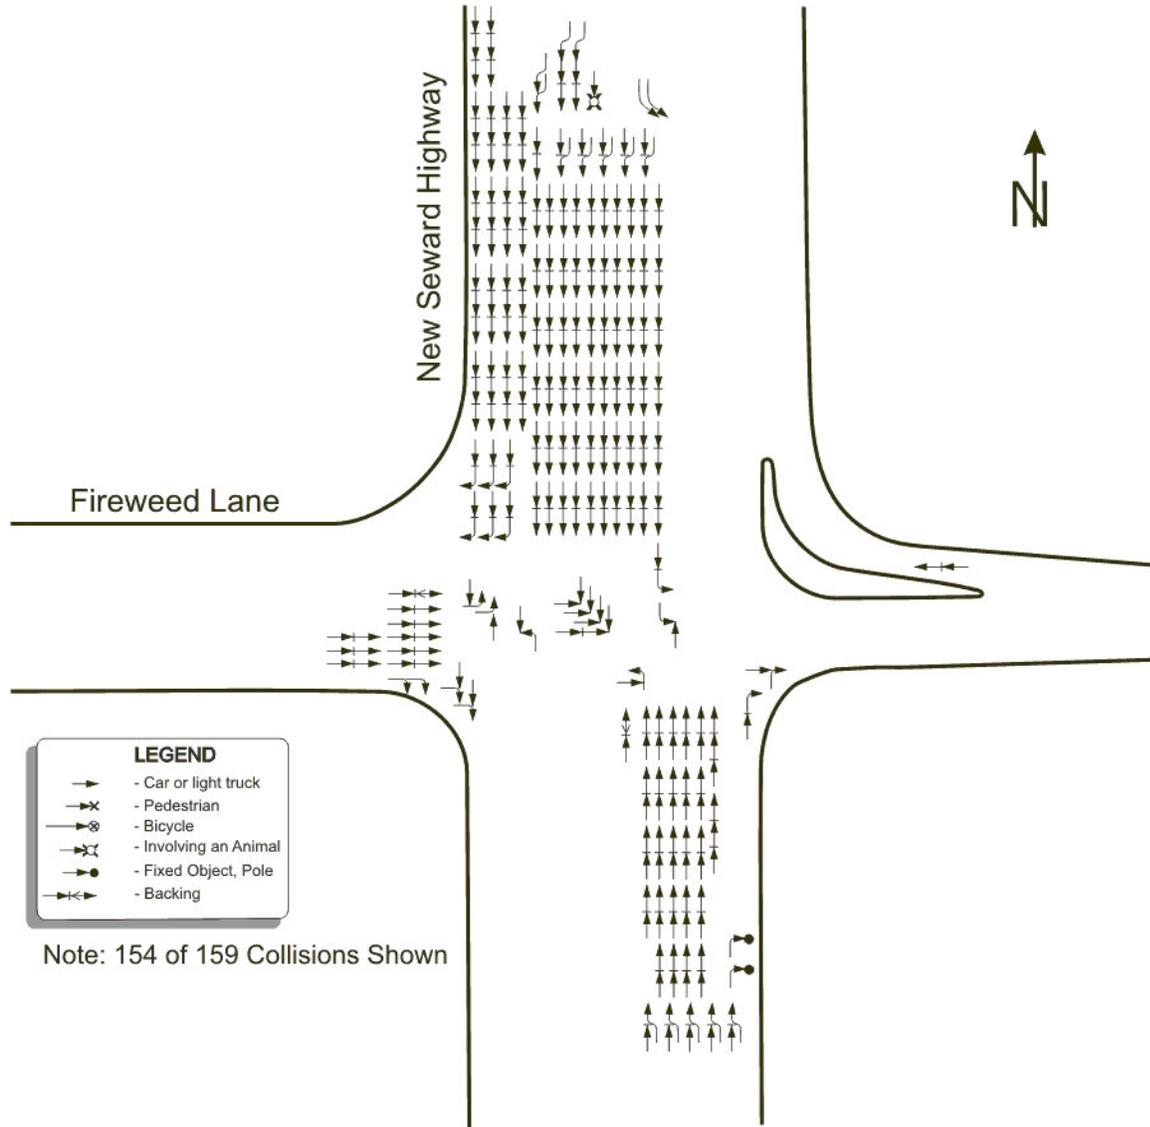
FIGURE 3.2: Collision Diagram for NSH at Fireweed Lane

The frequency of angle collisions is “as expected” for an Alaskan signalized intersection. However, angle collisions are the second most prominent collision type (20%), and are worthy of some consideration. A breakdown of the angle collisions indicates that:

- *The majority of the angle collisions involve northbound and southbound vehicles and are sideswipes between vehicles traveling in the same direction;*
- *For southbound travel the angle collisions are due to right-turns, lost control, or changing lanes; and*
- *For northbound travel the angle collisions have lane changes and improper overtaking as contributing factors.*

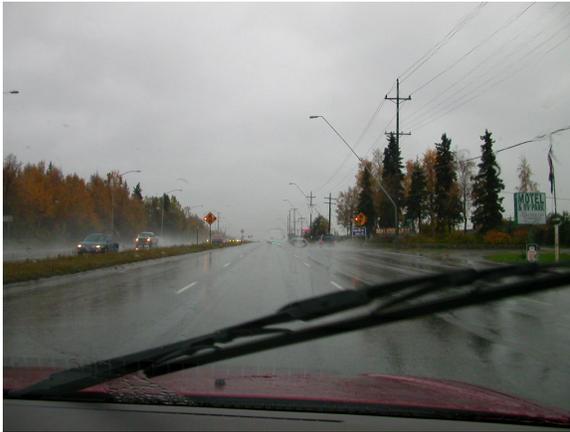
PHOTO 3.1: Southbound Signal Visibility

- The turning radius for the northbound right-turn appears to be tight for the operating speed on NSH, and may lead to rear-end incidents involving right-turn and through vehicles.
- The visibility of the traffic signals for the southbound approach appears to be limited due to the presence of a vertical crest curve (Please refer to PHOTO 3.1). This safety issue is

*further compounded by the high proportion of commercial vehicles that also limit the signal visibility for passenger vehicles.*

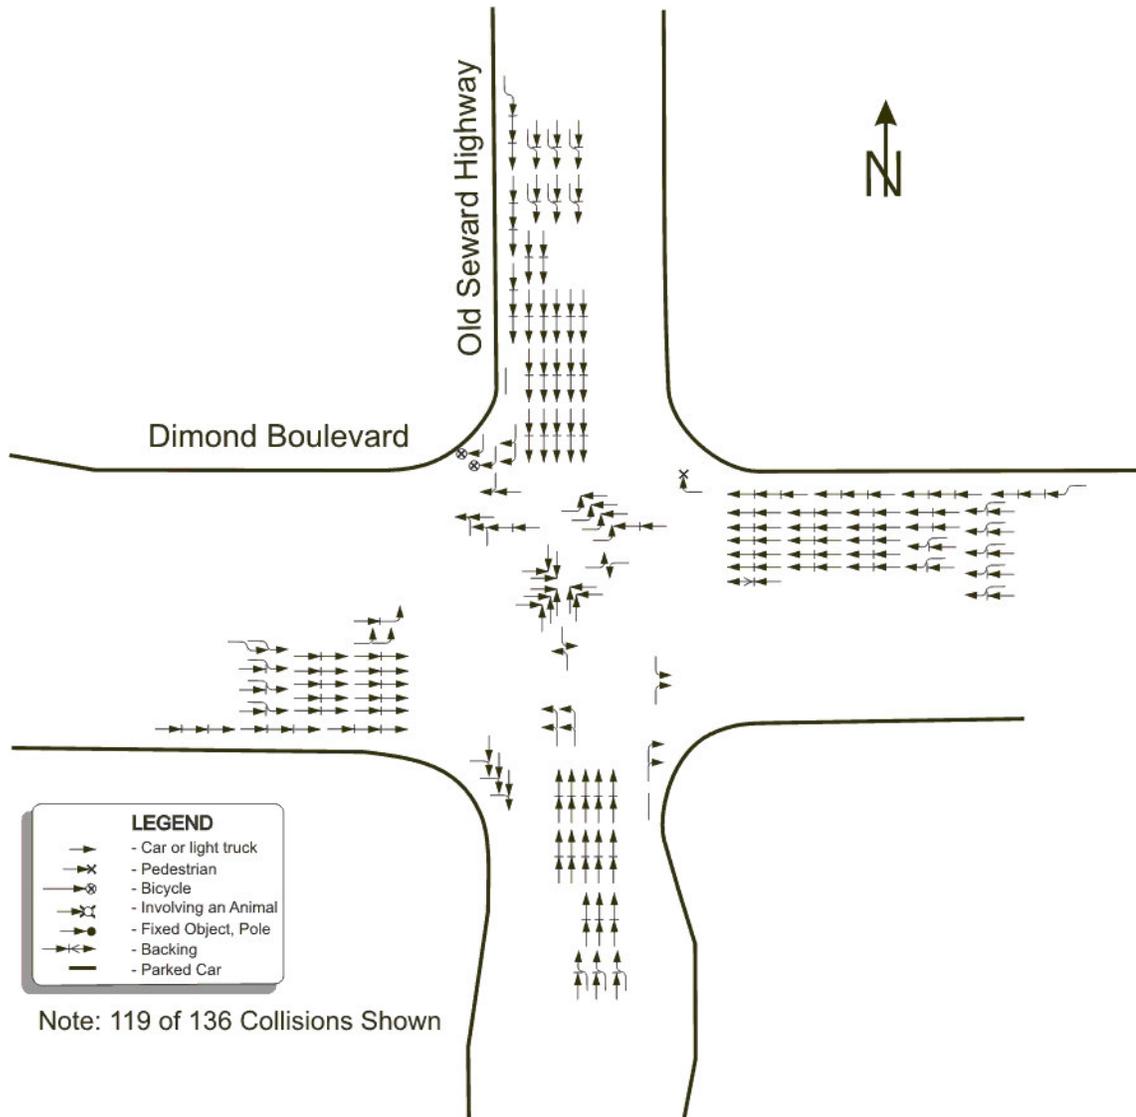
FIGURE 4.1: Collision Diagram for OSH at Dimond Boulevard

- *The rear-end collisions are fairly evenly distributed to all intersection approaches. However, the southbound direction which produces 16% of the entering volume, also produces 30% of the rear-end collisions.*

The frequency of angle collisions is “as expected” for an Alaskan signalized intersection. However, angle collisions are the second most prominent collision type (29%), and are worthy of some consideration. A breakdown of the angle collisions indicates that:

- At least 40% of the angle collisions were between vehicles moving in the same direction (i.e., sideswipe type collisions).
- The angle collisions are more prevalent in the dark; 38% of angle collisions occur in the dark, whereas 24% of all collisions occurred in the dark.

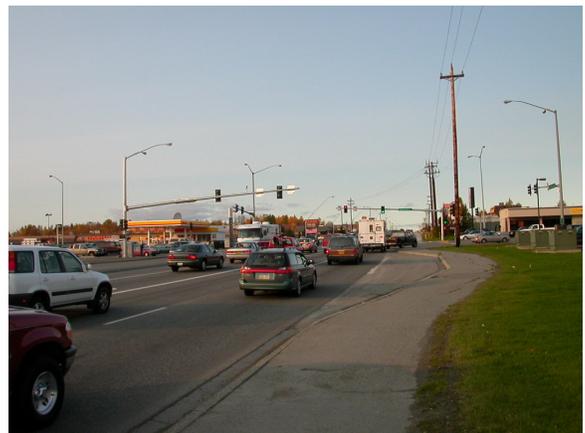
PHOTO 4.1: Northbound Approach

- *Currently an empty bus bay is provided at the northbound approach. It appears that some drivers may use the bus bay as a right-turn lane, particularly in the winter time when the pavement and the curb and gutter is covered by snow (please refer to PHOTO 4.1).*

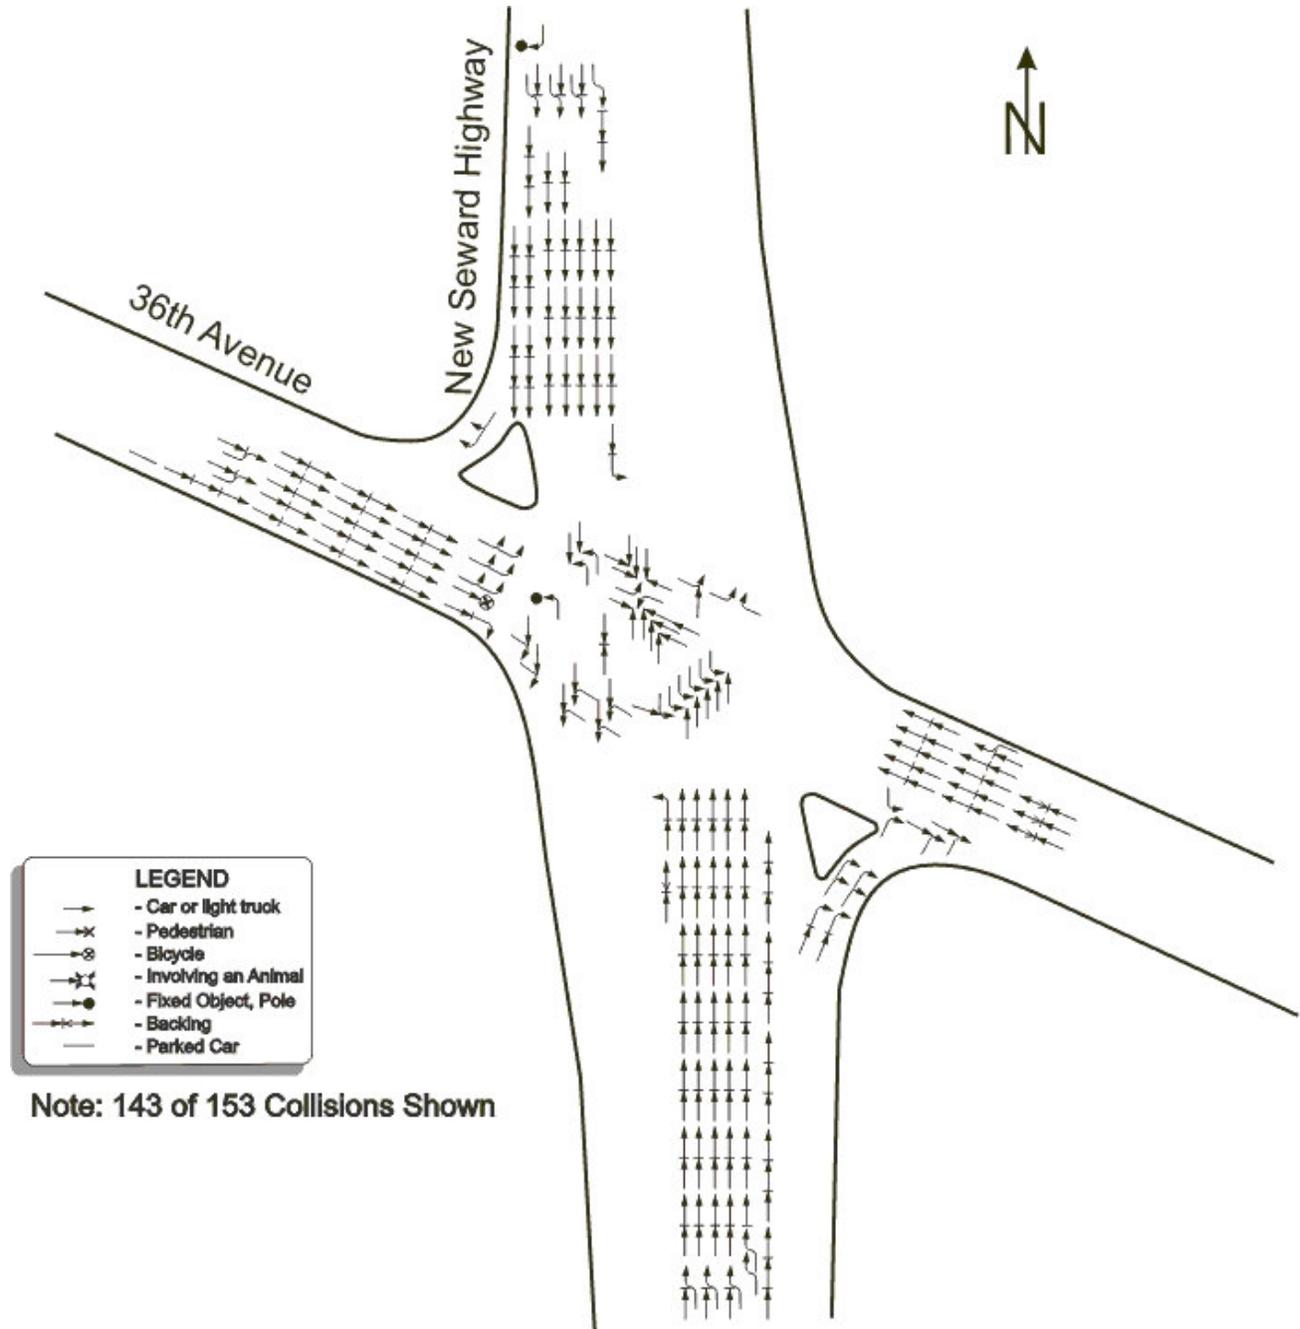
FIGURE 5.2: Collision Diagram for NSH at 36<sup>th</sup> Avenue

The frequency of angle collisions is “as expected” for an Alaskan signalized intersection. However, angle collisions are the second most prominent collision type (27%), and are worthy of some consideration. A breakdown of the angle collisions indicates that the majority of the angle collisions involve left-turning vehicles.

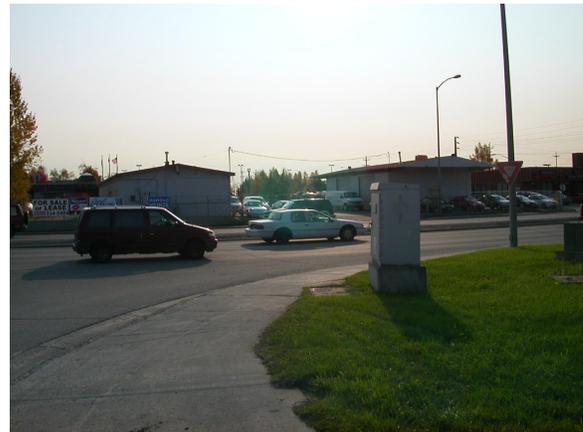
PHOTO 5.1: Yield Sign Placement

- *The Yield signs at the intersection appear to be worn out with little reflectivity. As well, the placement of the Yield signs may be less conspicuous to right-turn drivers (please refer to Photo 5.1). These safety issues may cause rear-end incidents involving right-turn vehicles along NSH.*

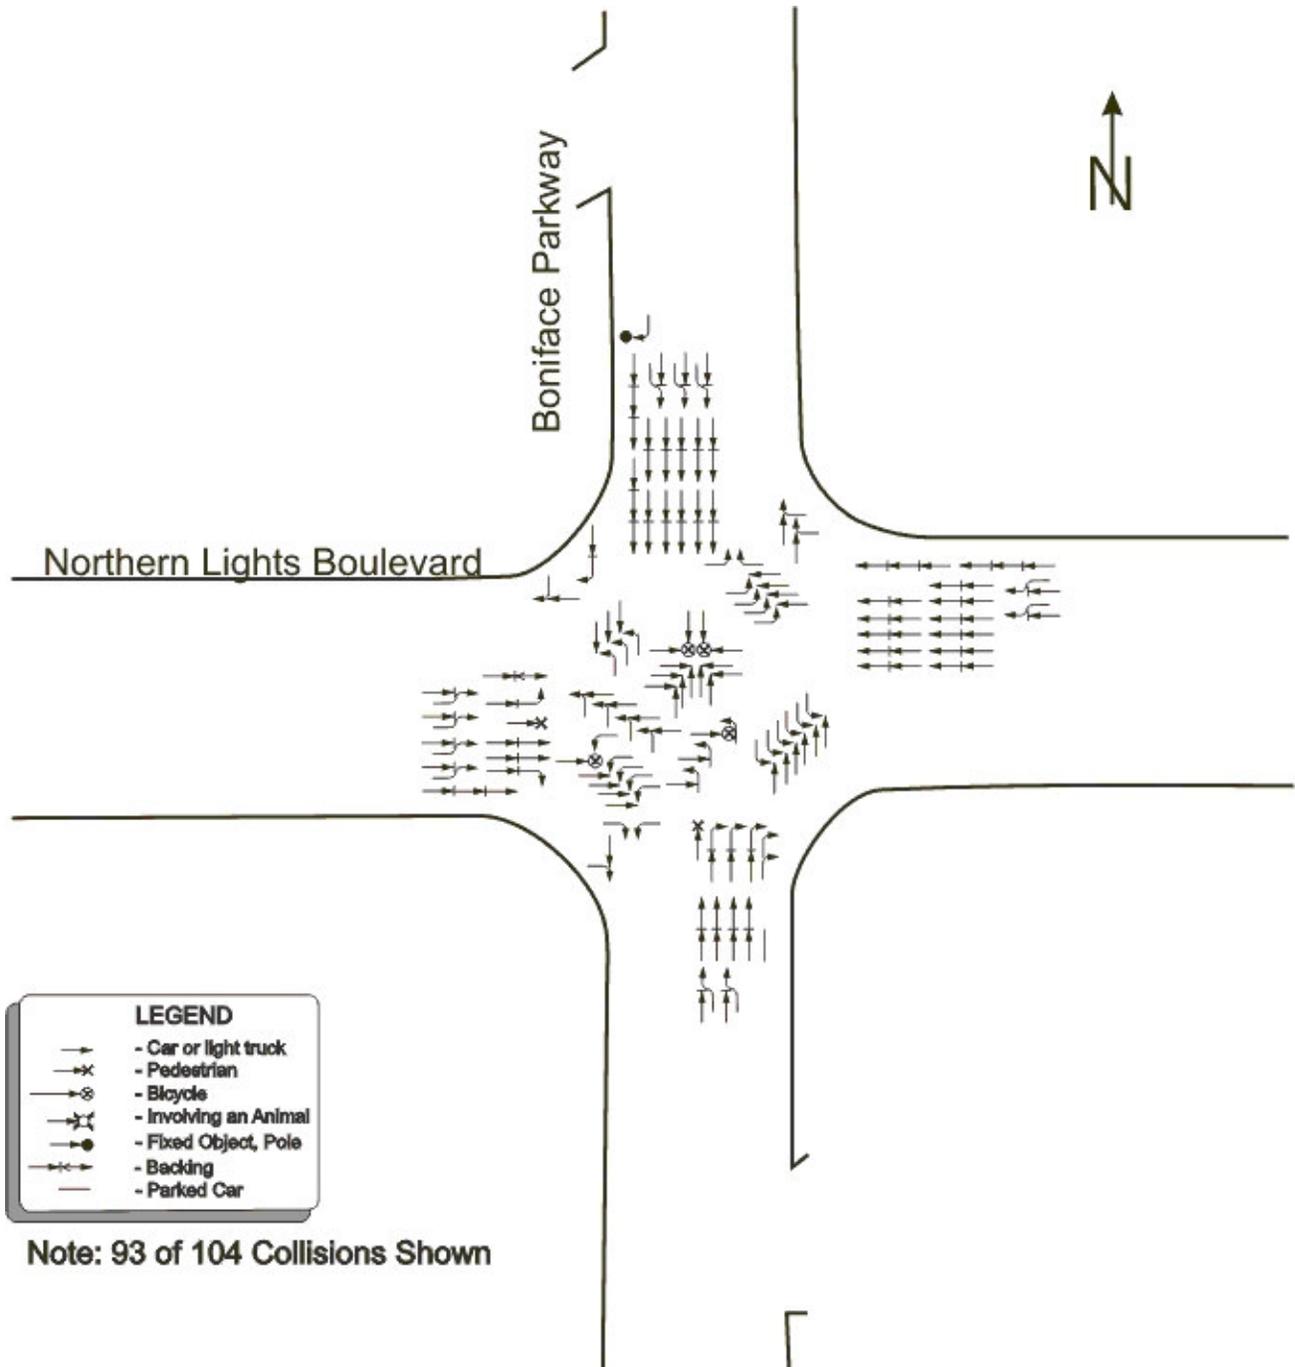
FIGURE 6.2: Collision Diagram for NLB at Boniface Parkway

The collision diagram for NLB at Boniface Parkway is shown in FIGURE 6.2. The aberrant collision characteristics were found to be:

- *The annual collision frequency appears to be increasing;*
- *Collisions occurring during darkness are over-represented;*
- *Angle collisions are the most frequent collisions and are over-represented at 52%;*
- *Rear-end collisions are the second most frequent collision type and are over-represented at 37%; and*
- *Cyclists collisions are over-represented although they constitute only five collisions over the three year study period.*

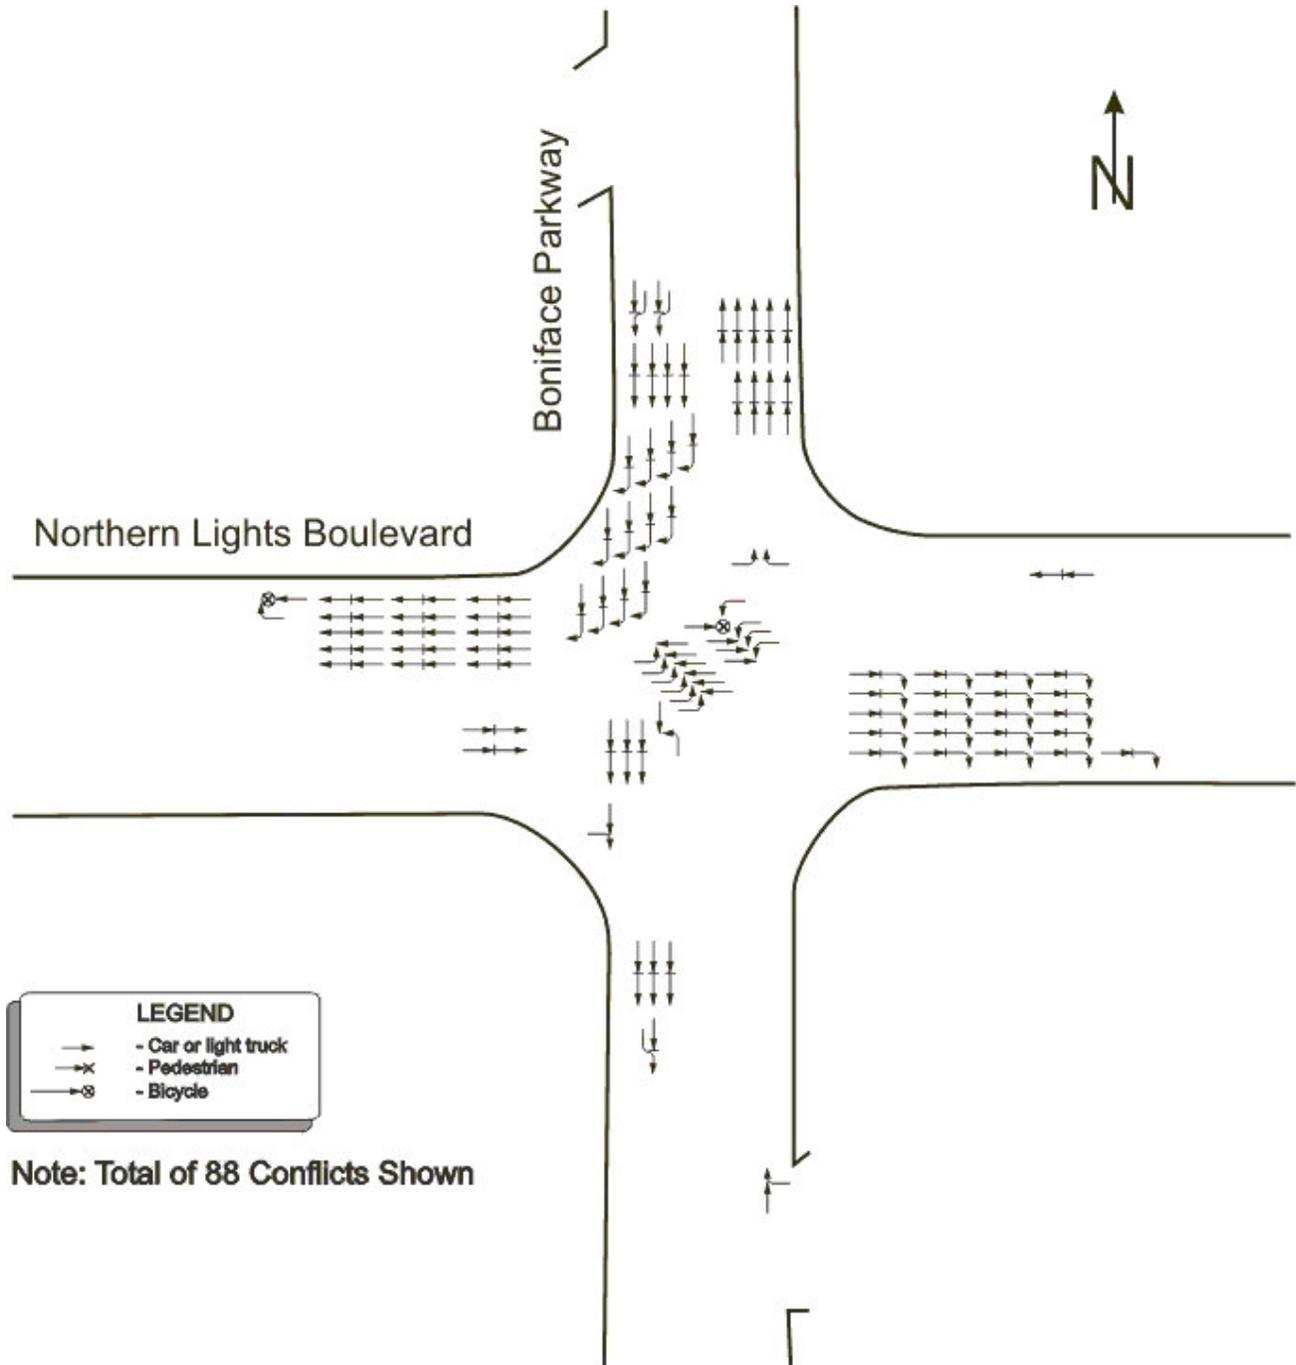
FIGURE 6.3: Traffic Conflict Diagram for NLB at Boniface Parkway

The overall average severity score of all the conflicts was found to be 3.3 and is considered high.

The spatial distribution of traffic conflicts is summarized in FIGURE 6.3. The results indicated that rear-end conflicts accounted for 80% of all observed conflicts, and 13% of the conflicts were found to be left-turn opposing conflicts. The majority of the rear-end conflicts were observed at the

southbound approach, and at the eastbound and westbound exit legs, and were mostly associated with the right-turn movements into driveways. The majority of the left-turn opposing conflicts

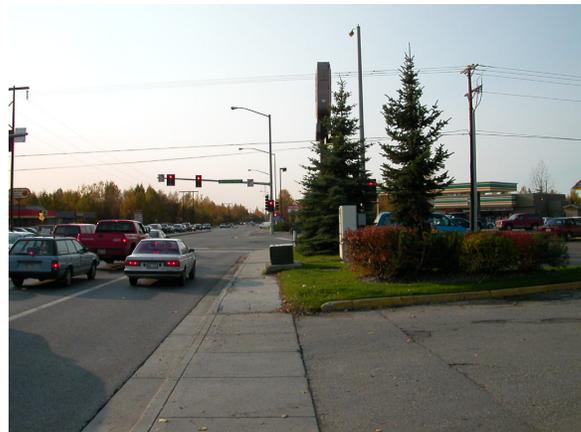
PHOTO 6.1: Obstructed Nearside Signals

All nearside right-hand-side signal displays are obstructed by landscaping, vegetation or commercial signs at the intersection, and the driveways located in close proximity to the intersection were observed to cause numerous conflicts involving right-turn vehicles.

- *Protected-permissive left-turn phasing is provided for all directions. Left-turn drivers were observed to accept inadequate gaps during the permissive phases causing left-turn opposing type conflicts.*
- *All nearside right-hand-side signal displays are obstructed by landscaping, vegetation or commercial signs at the intersection (please refer to Photo 6.1).*
- *A number of vehicles were observed to run the red light.*
- *The driveways located in close proximity to the intersection were observed to cause numerous conflicts involving right-turn vehicles.*
- *Southbound right-turn vehicles were often observed to be cutting through the gas station located at the northwest quadrant of the intersections. In addition, the lack of a curb and gutter along the west side of the southbound approach may create driver confusion due to the lack of delineation.*
