A. WNRC Case No. 2014-01, Chester Creek Watershed Plan Draft
for Review and Comment

Re: Chester Creek Watershed Plan (DRAFT)

Table of Contents

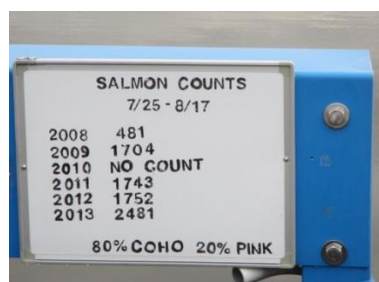
Figure 3.9. Salmon Counts by APU

³² These figures are taken from the sign posted by Alaska Pacific University at the counting area (the outflow of Westchester), and were confirmed by Dr. Rusty Myers, (personal communication, January 21, 2014). See Figure 3.9.

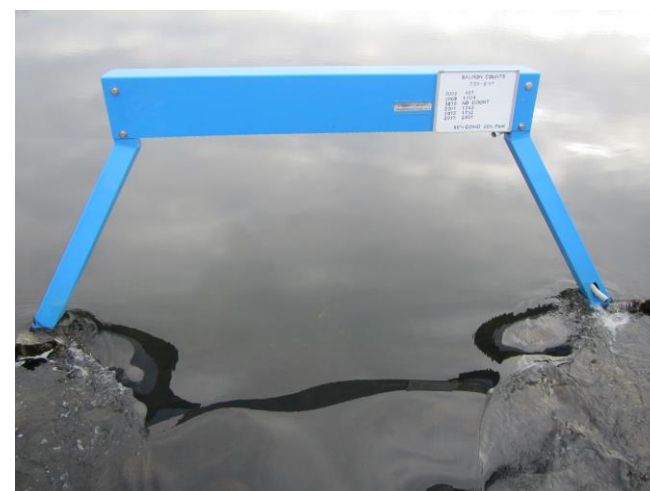
Figure 3.8. Outflow of Westchester Lagoon Where Fish Escapements Were counted by APU

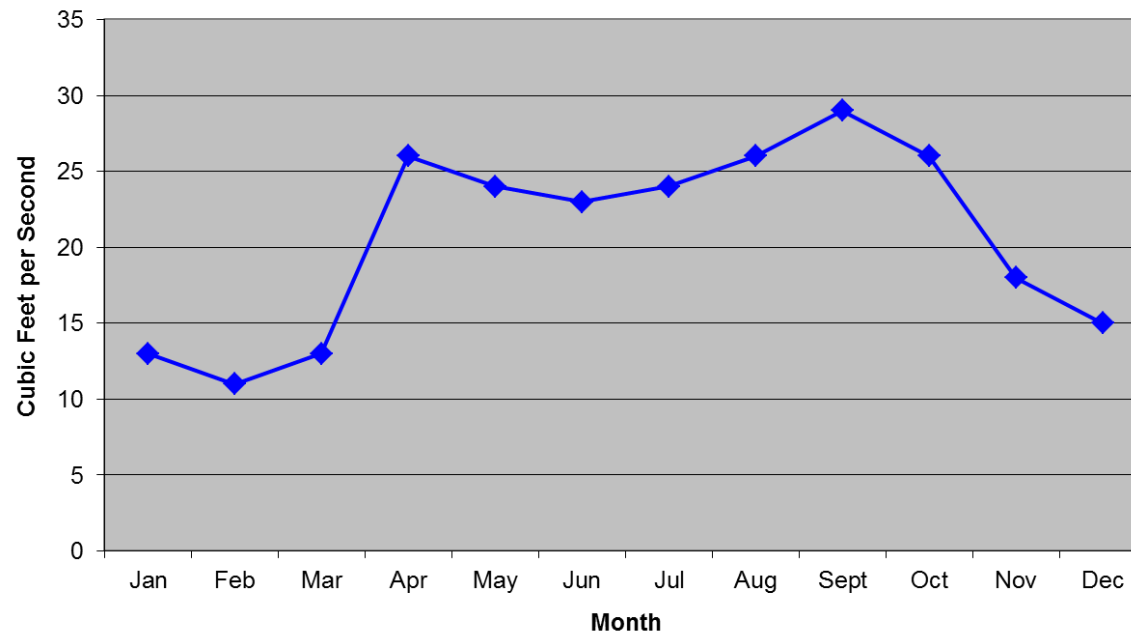
Figure 3.13. Mean Monthly Discharge of Chester Creek at the Arctic Blvd. Gage Station (USGS15275100), 1966 to 2012

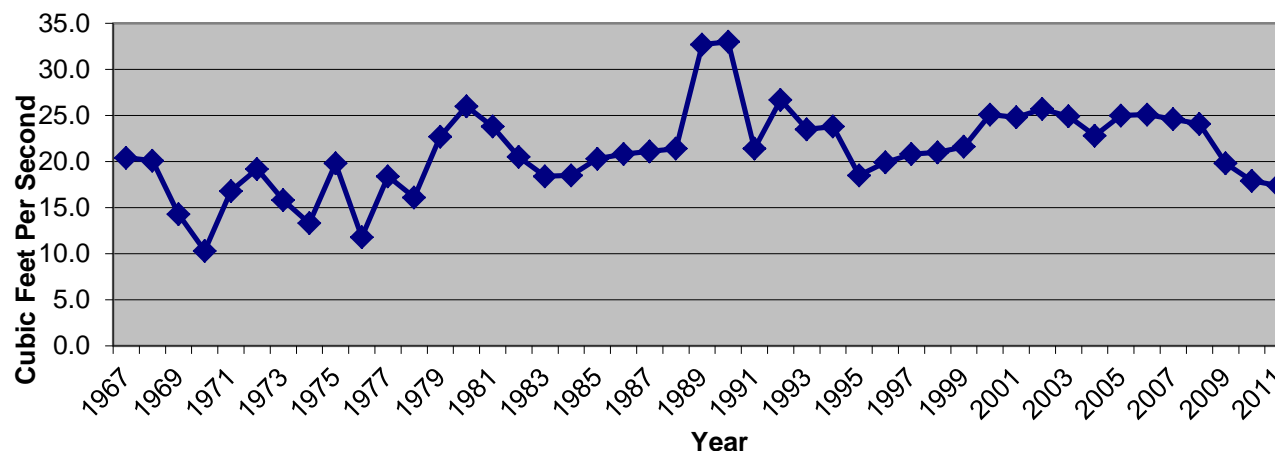
Figure 3. 14 graphs the USGS annual flow data for Chester Creek by year from 1967 to 2011⁴⁵, which shows high water in 1989 and 1990⁴⁶.

Figure 3.14. Mean Yearly Flow in Chester Creek at the Arctic Blvd. Gage Station, 1967 to 2011

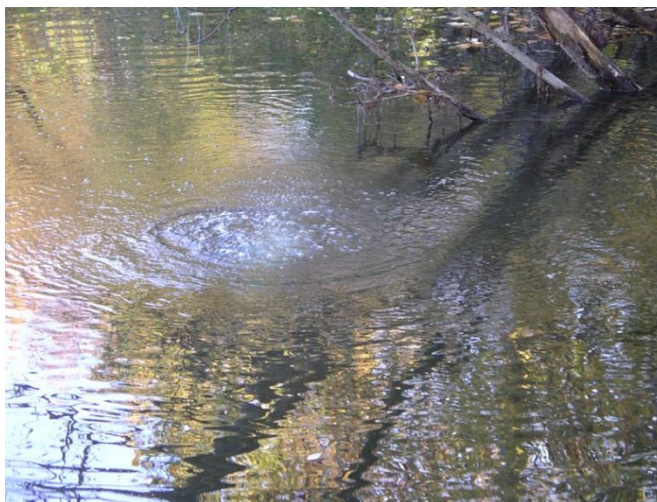
Fig 3.16 Discharged water from the Alaska Native Medical Center Outflow Bubbling into University Lake, (2010)⁵²

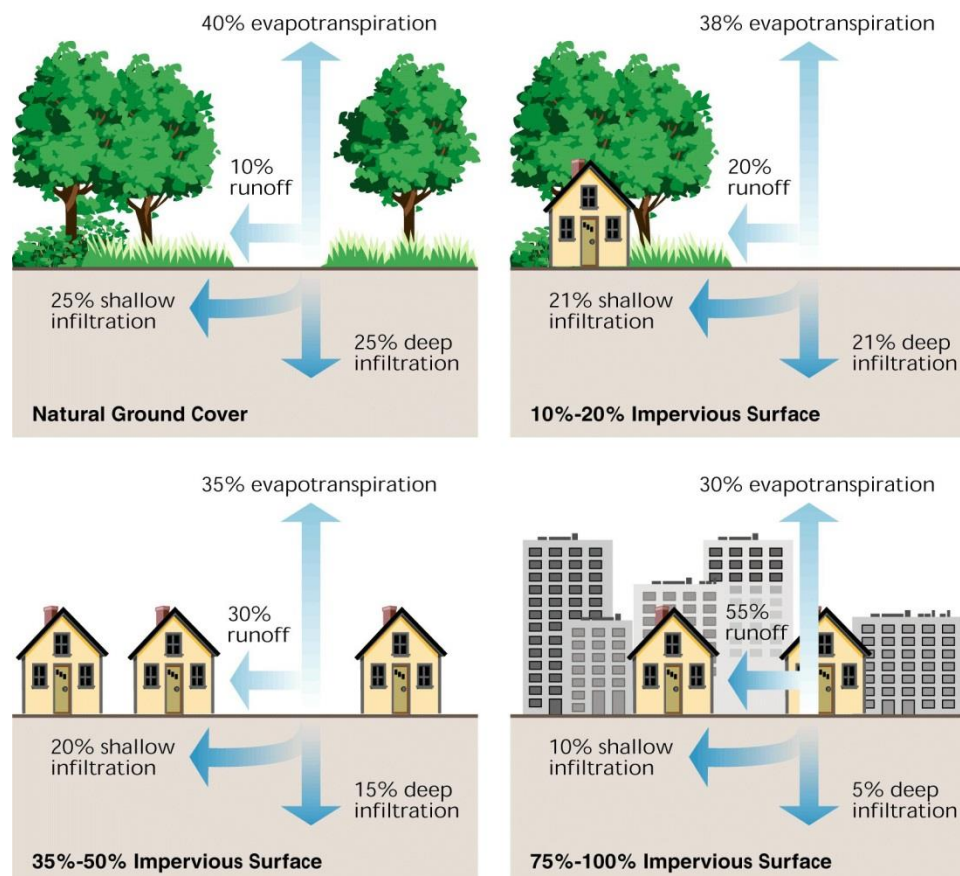
Figure 3.21. Illustration of the Effect of Increased Urbanization on Impervious Surfaces and Surface Runoff⁵⁹

As cities grow and watersheds are urbanized, much of the vegetation is replaced by impervious surfaces, which reduces the area where infiltration to groundwater can happen. Thus, an increase in stormwater runoff occurs—runoff that must be collected by extensive drainage systems that

combine curbs, storm sewers, and ditches that carry it directly to streams. Simply put, in a developed watershed, more water arrives into a stream considerably faster, resulting in a greater likelihood of frequent and more severe flooding that can carry increased levels of pollutants. As cities grow and more development occurs, the natural landscape is replaced by roads, buildings, housing developments, and parking lots (Figures 3.22 and 3.23).

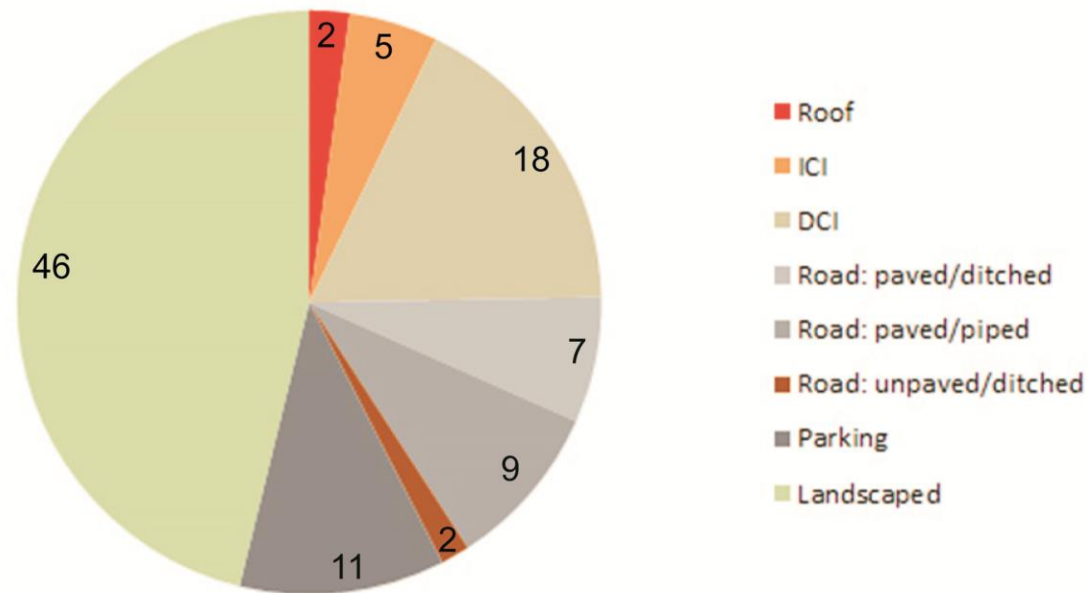
Figure 3.22. Percentage of Various Impervious Landcover Surfaces in Chester Creek Watershed⁶⁶

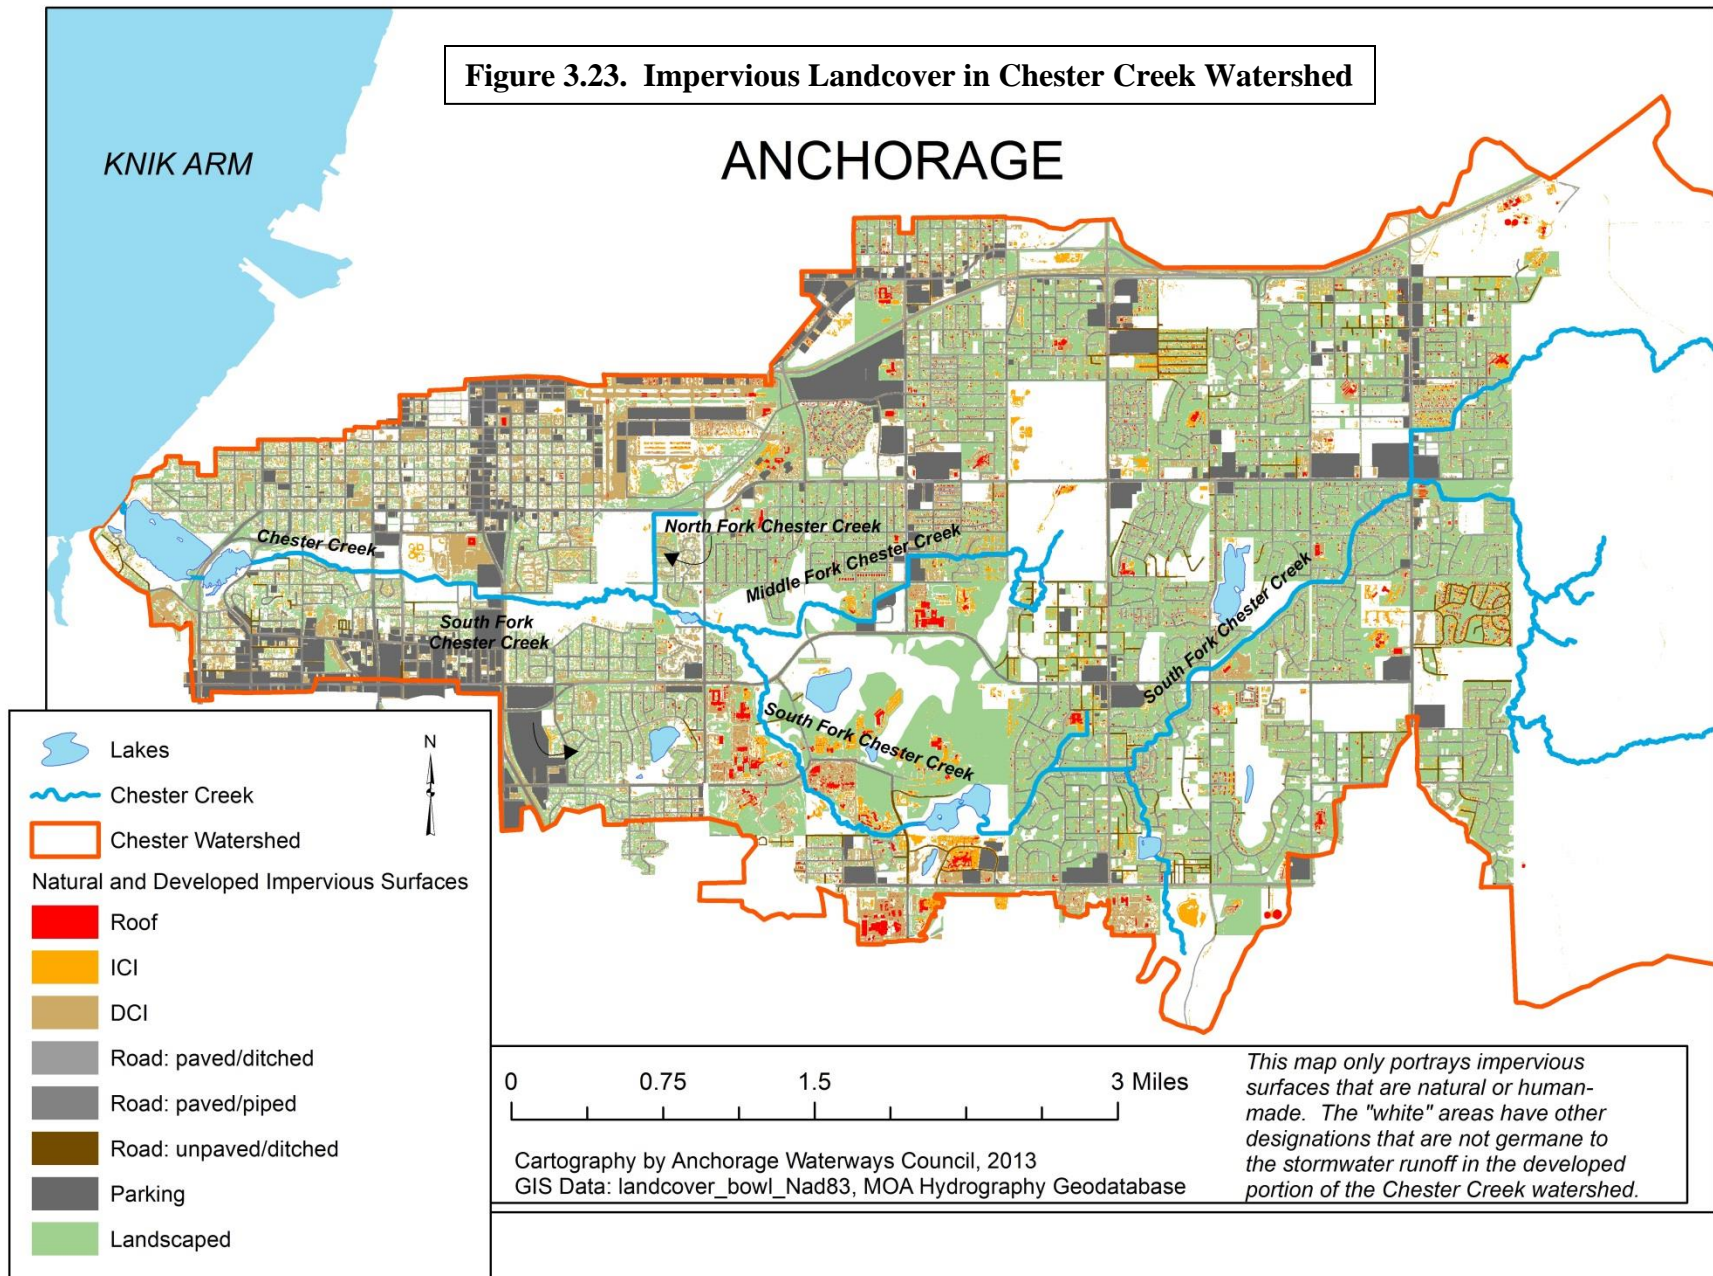
Figure 3.23. Impervious Landcover in Chester Creek Watershed

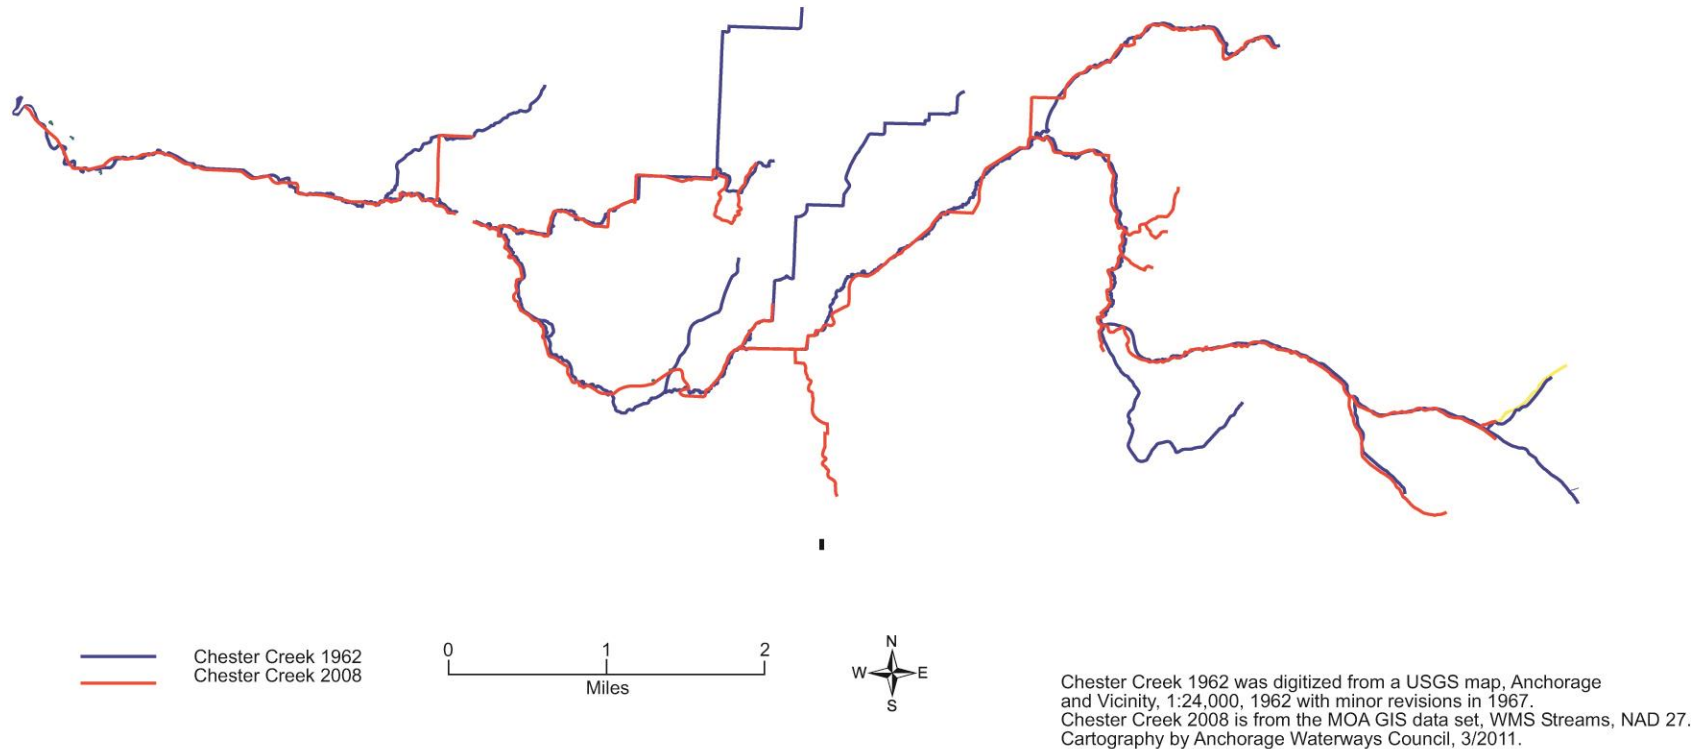
Originally, the creek had numerous small tributaries. To accommodate development, some of these tributaries were filled, and others were cut off and abandoned or combined into storm drain pipes. These changes confined Chester Creek to the three forks in which it flows today. In addition, wetland areas in and adjacent to the creek have been lost. As noted above, between 1950 and 1997, there was a net loss of over 2,800 acres of wetlands, and this has resulted in barely 1,000 acres remaining today. Besides loss, many of the wetlands in the watershed have also been modified.

Figure 3.27. Chester Creek 1962 and 2008 (B) (background removed)

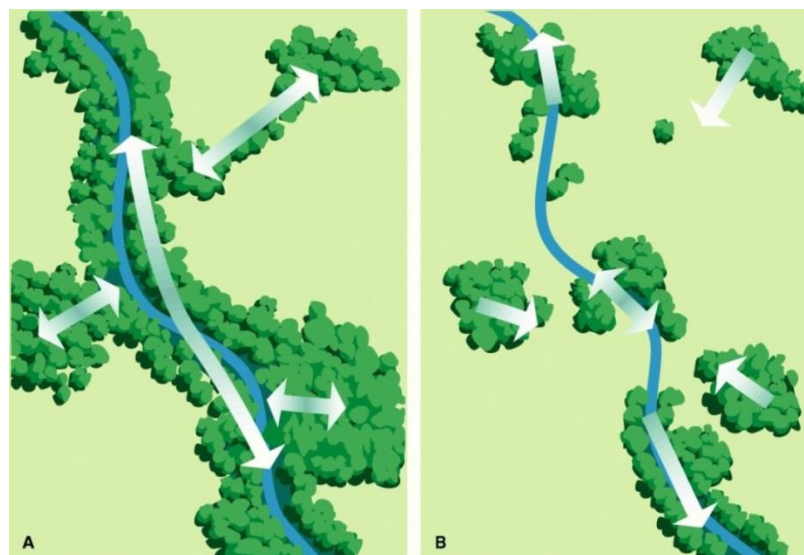
Figure 4.1. “A” shows a high degree of habitat connectivity and “B” is one of low connectivity which makes movement more perilous⁹²

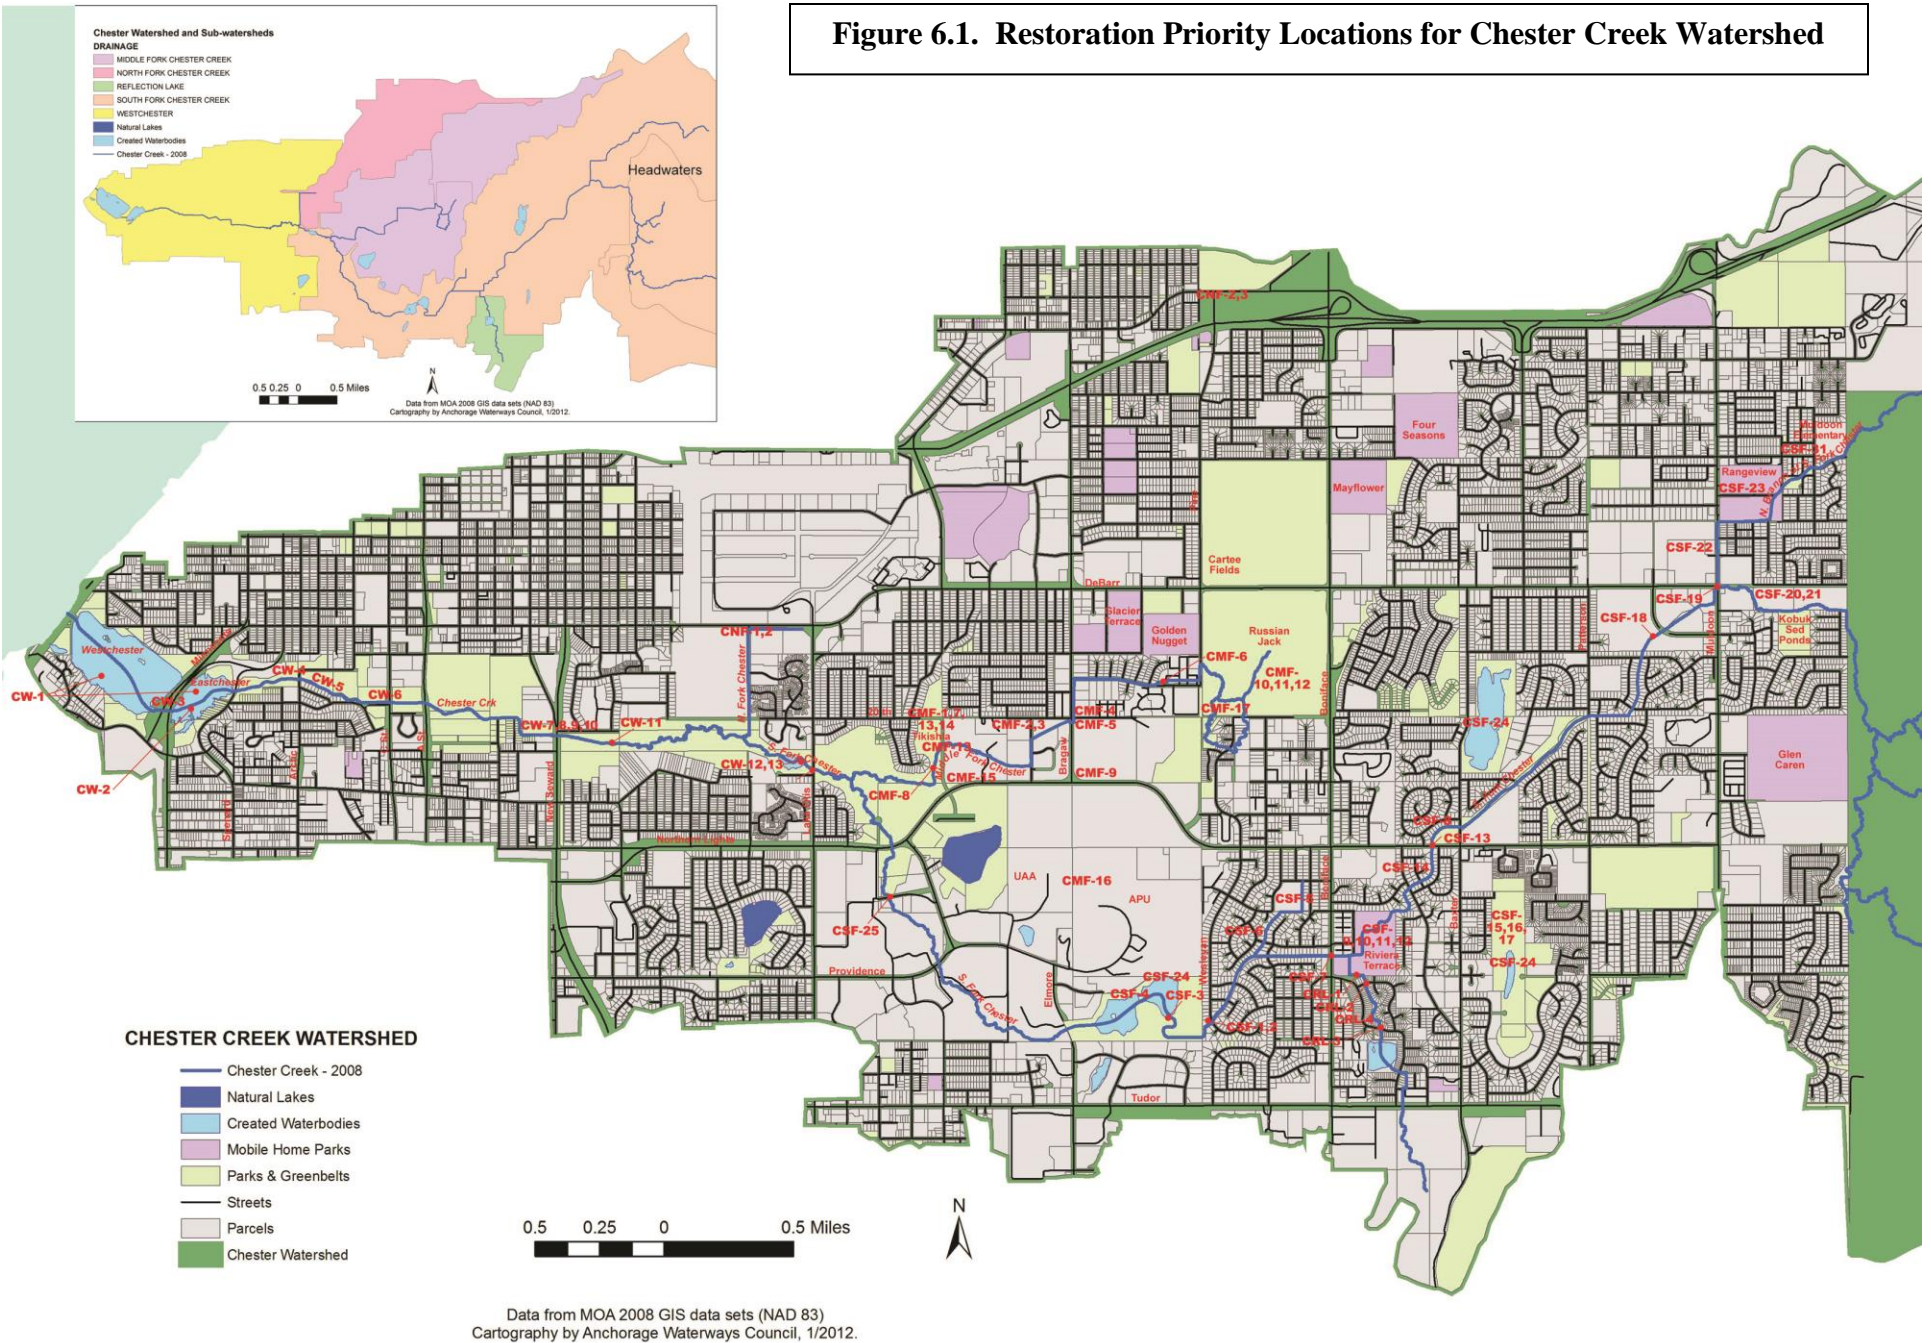
Figure 6.1. Restoration Priority Locations for Chester Creek Watershed

Table 6.1. Restoration Priorities Shown on Map
