# 1 INTRODUCTION

## 1.1 Project Objective

The vulnerability of Downtown Anchorage to seismically-induced ground failure, particularly in the 1964 Alaska Earthquake, is well documented. The downtown geologic hazard is mapped in Figure 1.1.

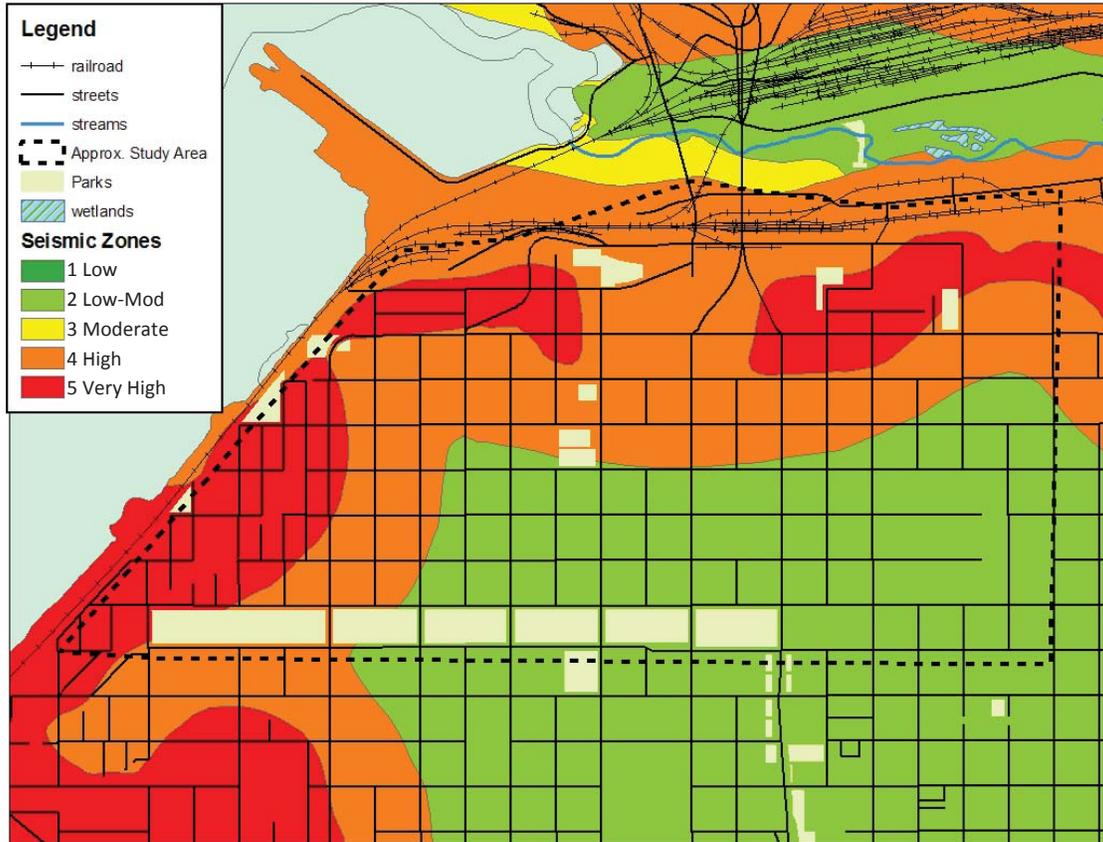
**Figure 1.1 Map of Downtown Anchorage Seismic Zones**

Ground failures in the 1964 Alaska Earthquake serve as a reminder of the geotechnical vulnerability of downtown Anchorage. The magnitude 9.2 subduction earthquake hit Alaska on Good Friday, March 27, 1964, the second largest recorded earthquake in history. Shaking lasted nearly five minutes. Ground failures, collapsing buildings, and a tsunami resulted in 131 deaths. In downtown Anchorage, the shaking resulted in the failure of the Bootlegger Cove Clay formation, causing both vertical and horizontal geotechnical displacements exceeding 10 feet. Large blocks of earth moved towards the water leaving grabens behind (Photos 1.1, 1.2, and 1.3) and pushing up a pressure ridge in front (Photo 1.4). Figure 1.2 shows a schematic of the movement. The areas with the most significant movement are mapped in Seismic Zone 5 (Figure 1.1).

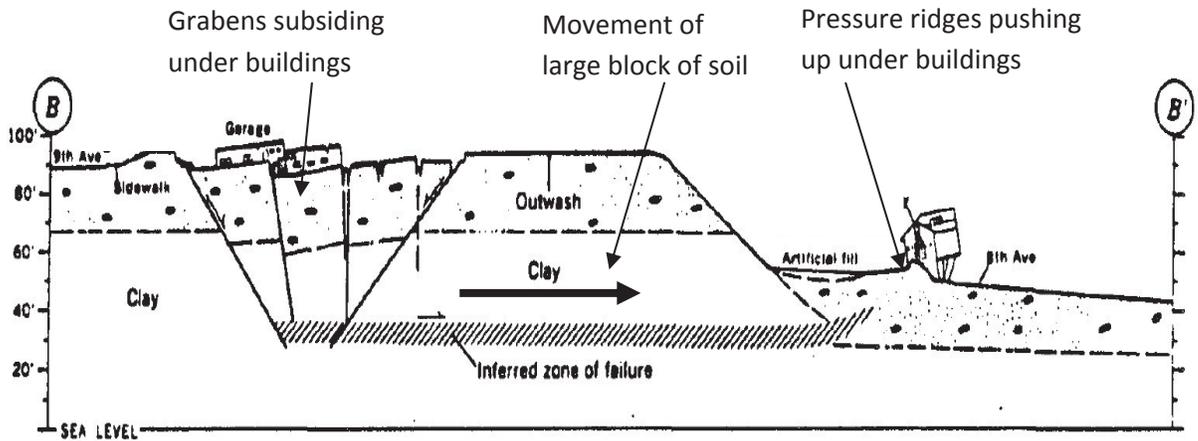
Figure 1.2 Cross section of soil strata in L Street slide area in 1964 Earthquake. (Moriwaki et al, 1985)

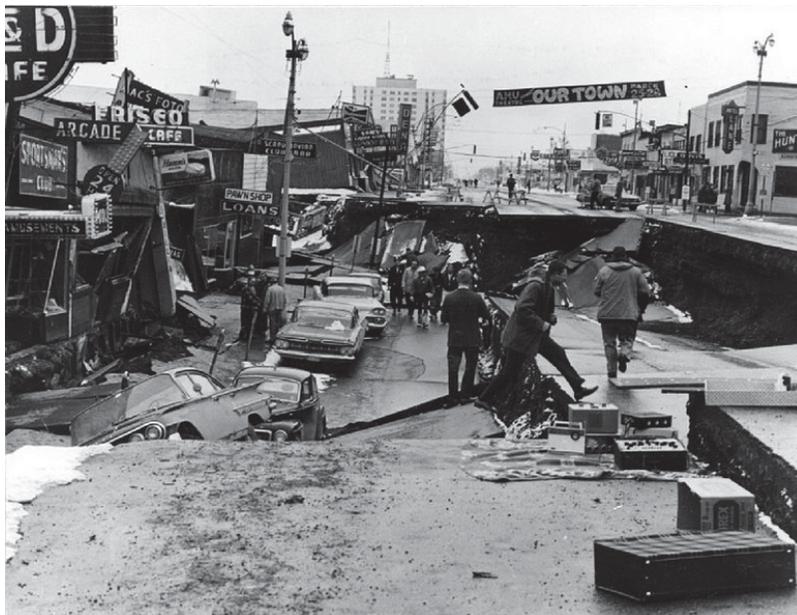
Photo 1.1 Collapse of Fourth Avenue near C Street, due to earthquake caused landslide. Before the earthquake, the sidewalk at left, which is in the graben, was at street level on the right. The graben subsided 11 feet in response to 14 feet of horizontal movement. Source USGS.

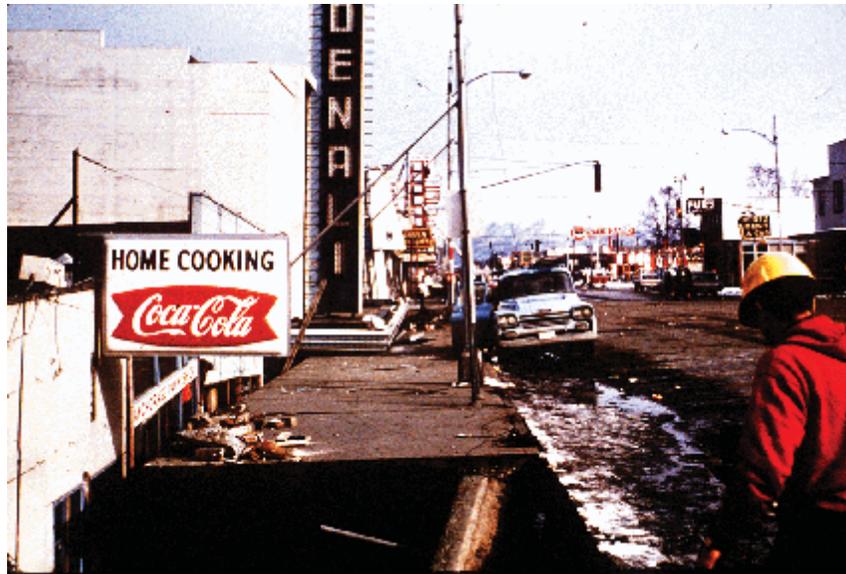
**Photo 1.2** The marquee of the Denali Theater, which was in the graben of the Fourth Avenue landslide in Anchorage, subsided until it came to rest on the sidewalk in front of the theater, which was on ground that was not involved in the landslide. Source USGS.

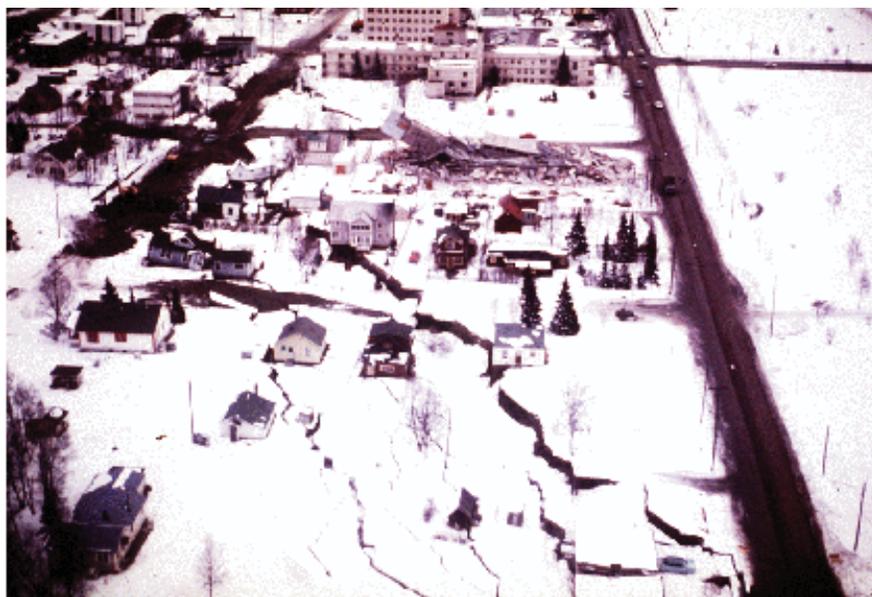
**Photo 1.3** A graben formed at the head of the L Street landslide in Anchorage during the earthquake. The slide block, which is virtually unbroken ground to the left of the graben, moved to the left. The subsidence trough sank 7 to 10 feet in response to 11 feet of horizontal movement of the slide block. The volume of the trough is theoretically equal to the volume of the void created at the head of the slide by movement of the slide block. A number of houses seen in this photograph were undercut or tilted by subsidence of the graben. Source USGS.

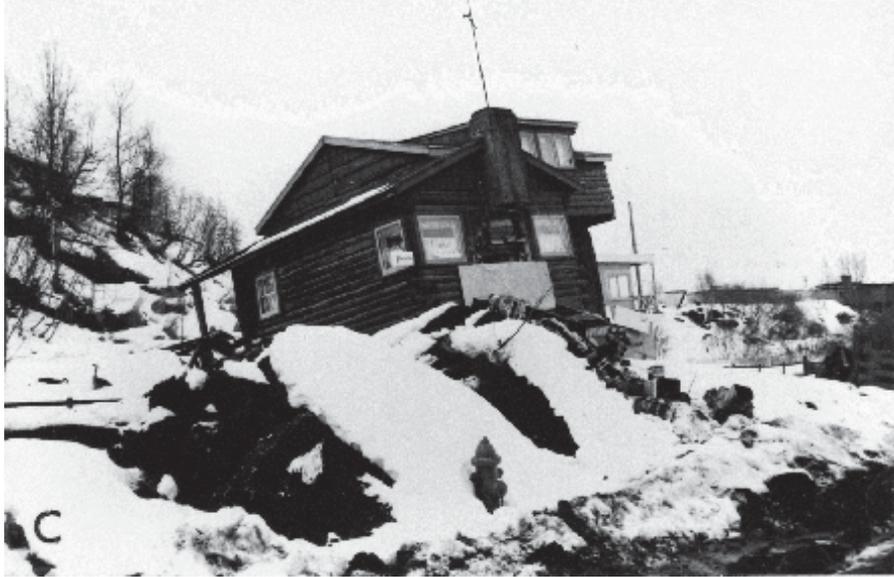
**Photo 1.4 House displaced by compressional ridge formed at toe of L Street landslide. Source USGS.**
