# Revised Geotechnical Report

## ANC FedEx Sorting Facility

Anchorage, Alaska

June 2023  
CRW Project Number 73138.00

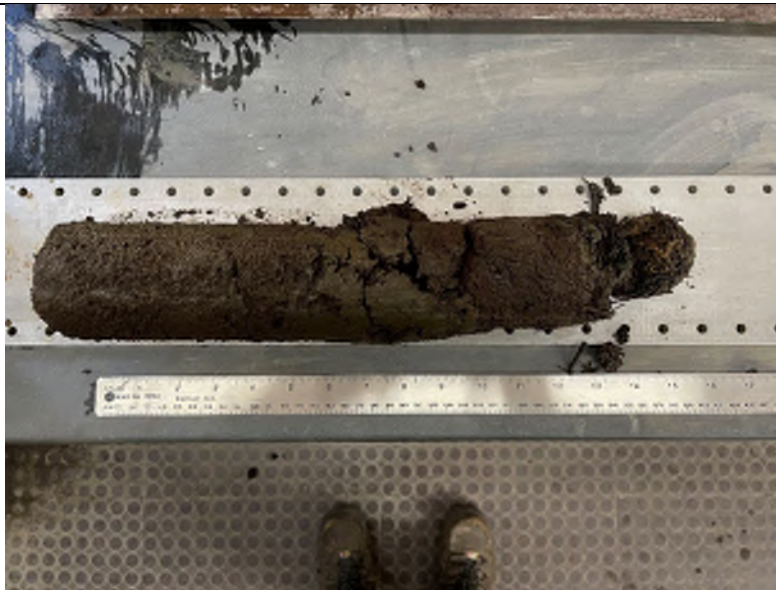
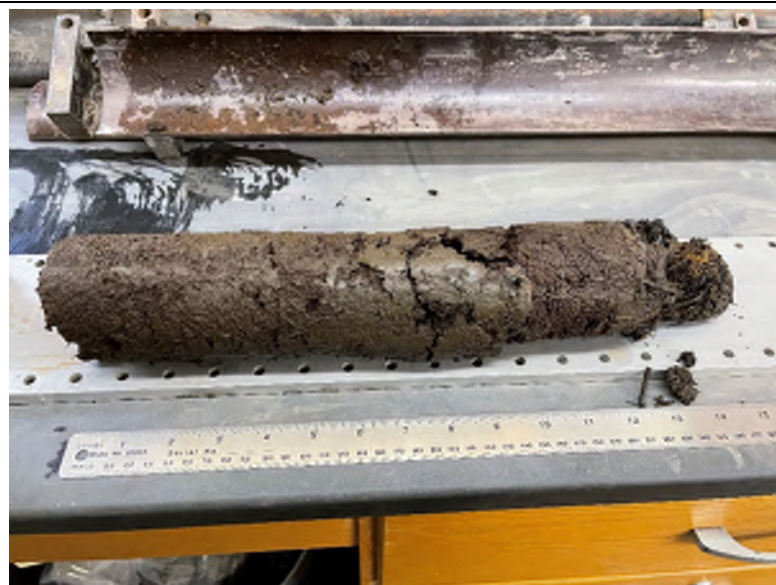
<b>Client:</b> CRW Engineering Group, LLC 3940 Arctic Blvd., Ste. 300 Anchorage, AK, 99503  <b>Project:</b> FedEx Bog  73138.00		
	<b>Date Received:</b>	March 21, 2022
	<b>Sample #:</b>	22-0250-S03 and S04
	<b>Material:</b>	BH-01 Sa2B

Sample after extraction

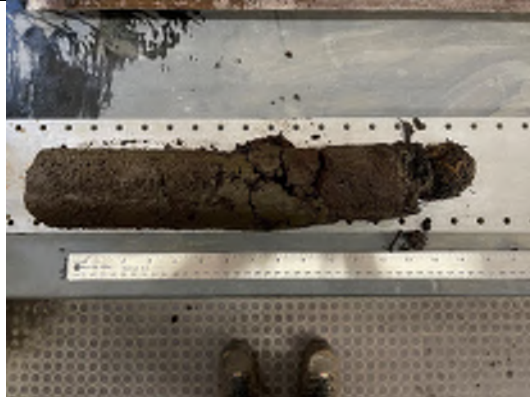
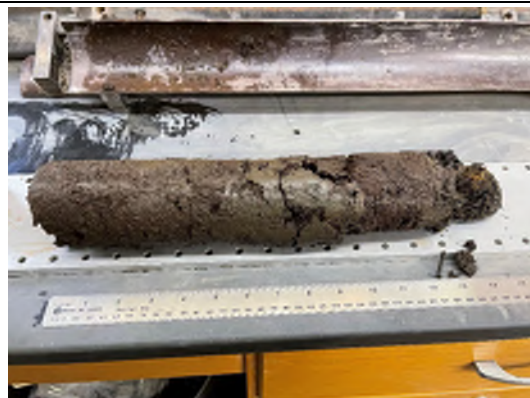
<b>Date Received:</b>	March 21, 2022
<b>Sample #:</b>	22-0250-S03 and S04
<b>Material:</b>	BH-01 Sa2B

Sample after extraction

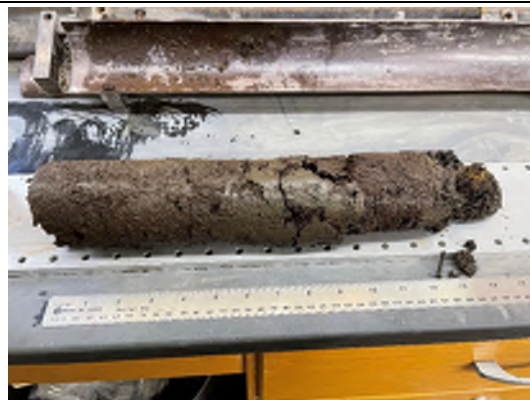
Sample after extraction

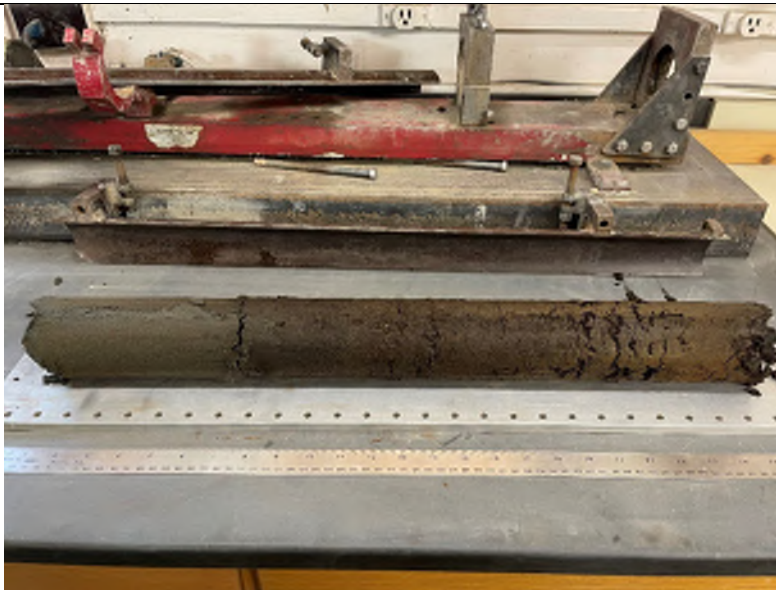
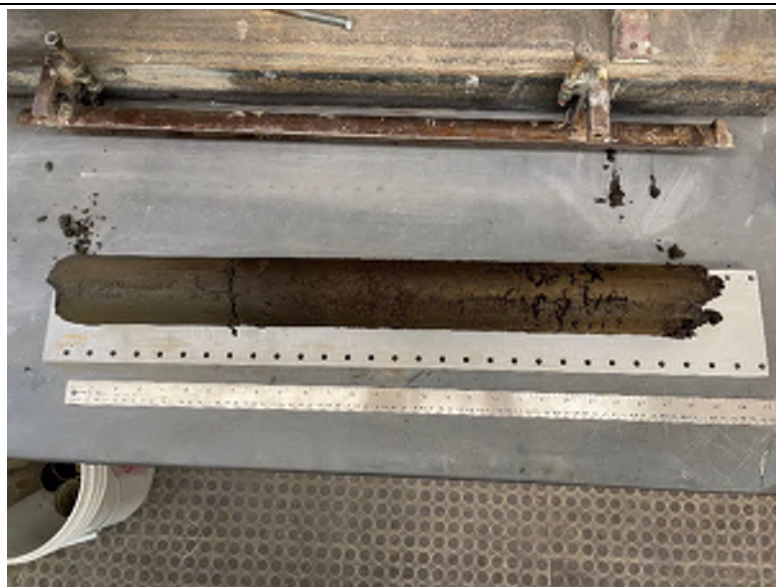
<b>Client:</b>	CRW Engineering Group, LLC 3940 Arctic Blvd., Ste. 300 Anchorage, AK, 99503	
<b>Project:</b>	FedEx Bog	
	73138.00	
		<b>Date Received:</b> March 21, 2022
		<b>Sample #:</b> 22-0258-S04 and S05
		<b>Material:</b> BH-05 Sa4

Sample after extraction

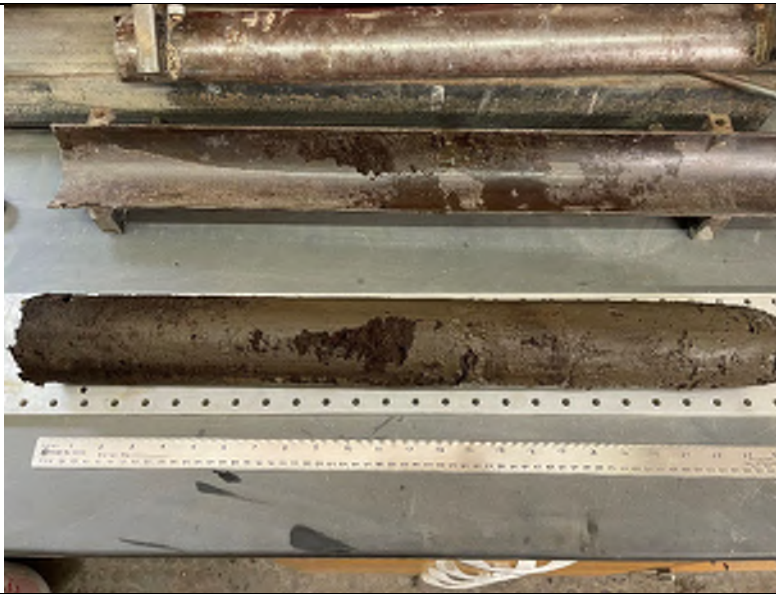
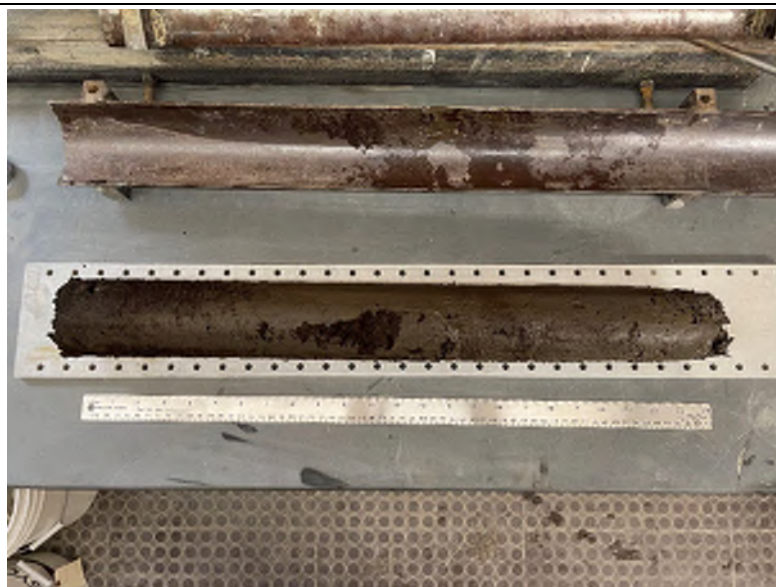
<b>Client:</b> CRW Engineering Group, LLC 3940 Arctic Blvd., Ste. 300 Anchorage, AK, 99503		
<b>Project:</b> FedEx Bog	<b>Date Received:</b>	March 21, 2022
73138.00	<b>Sample #:</b>	22-0261-S02
	<b>Material:</b>	BH-08 Sa2A

Sample after extraction

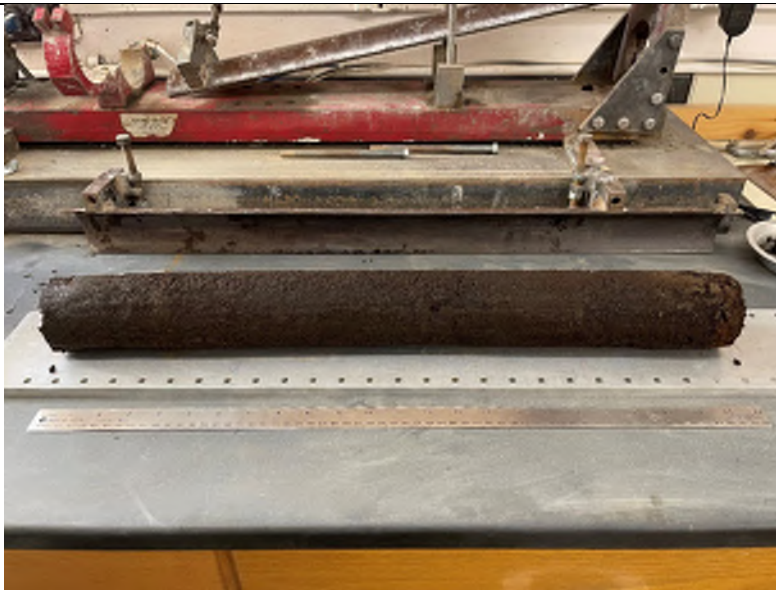
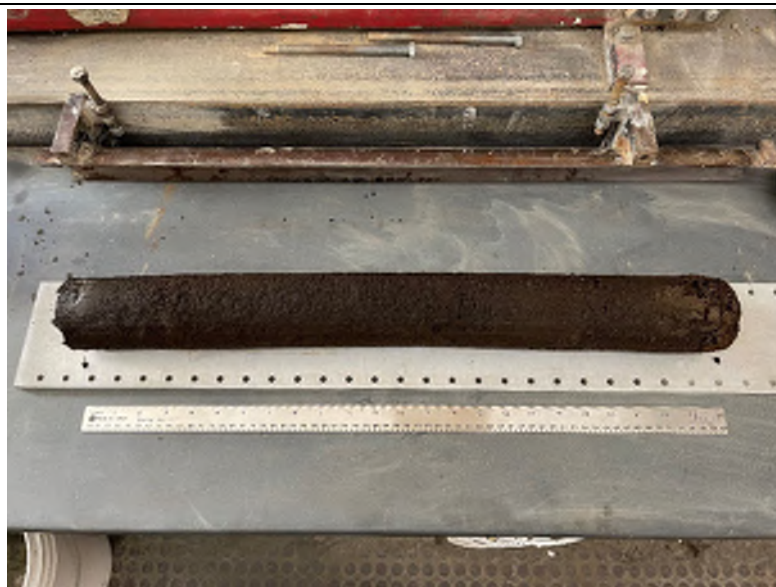
<b>Client:</b> CRW Engineering Group, LLC 3940 Arctic Blvd., Ste. 300 Anchorage, AK, 99503	
<b>Project:</b> FedEx Bog  73138.00	<b>Date Received:</b> March 21, 2022 <b>Sample #:</b> 22-0263-S02 <b>Material:</b> BH-10 Sa2

Sample after extraction

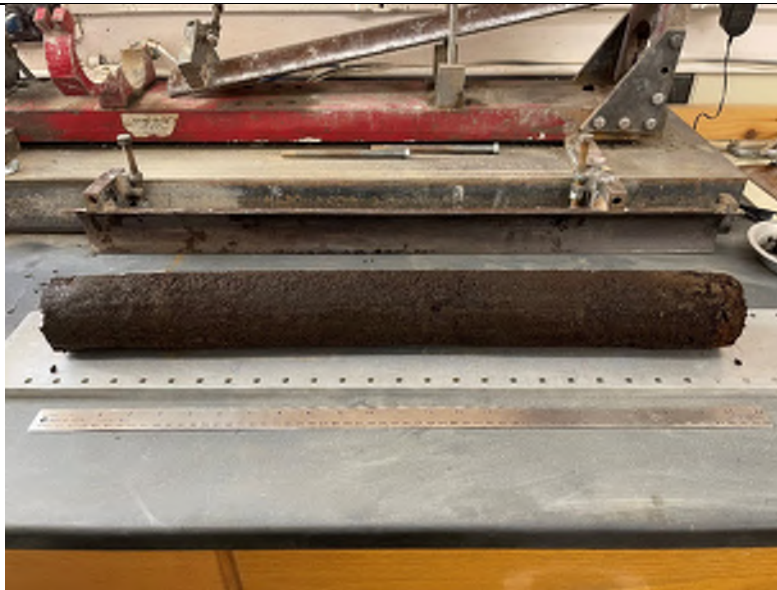
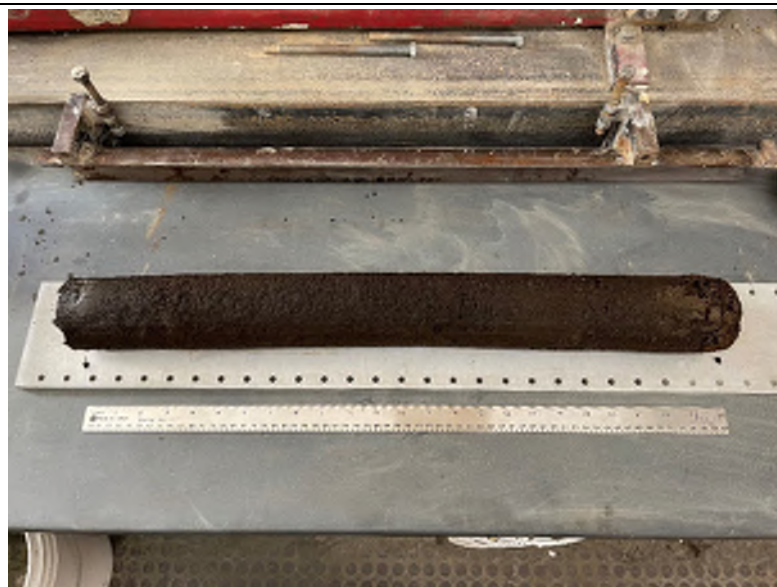
<b>Client:</b>	CRW Engineering Group, LLC 3940 Arctic Blvd., Ste. 300 Anchorage, AK, 99503	
<b>Project:</b>	FedEx Bog	
	73138.00	
		<b>Date Received:</b> March 21, 2022
		<b>Sample #:</b> 22-0263-S03
		<b>Material:</b> BH-10 Sa2

Sample after extraction

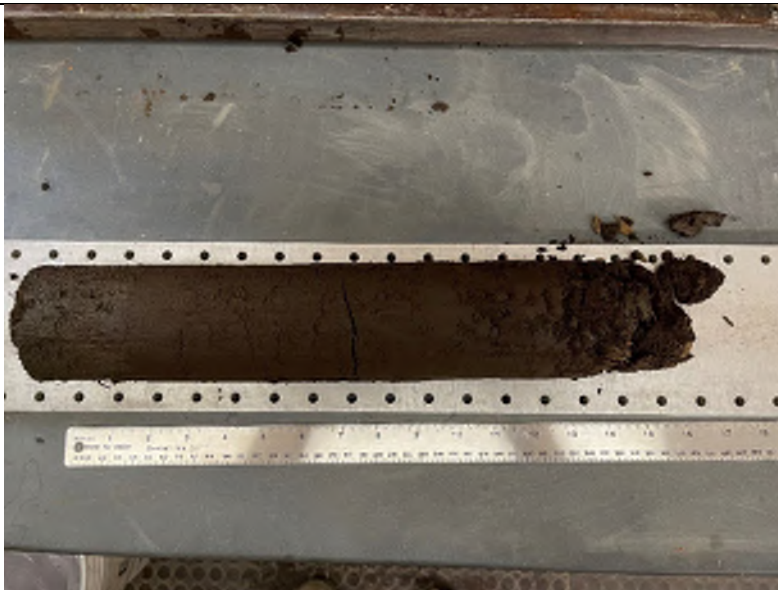
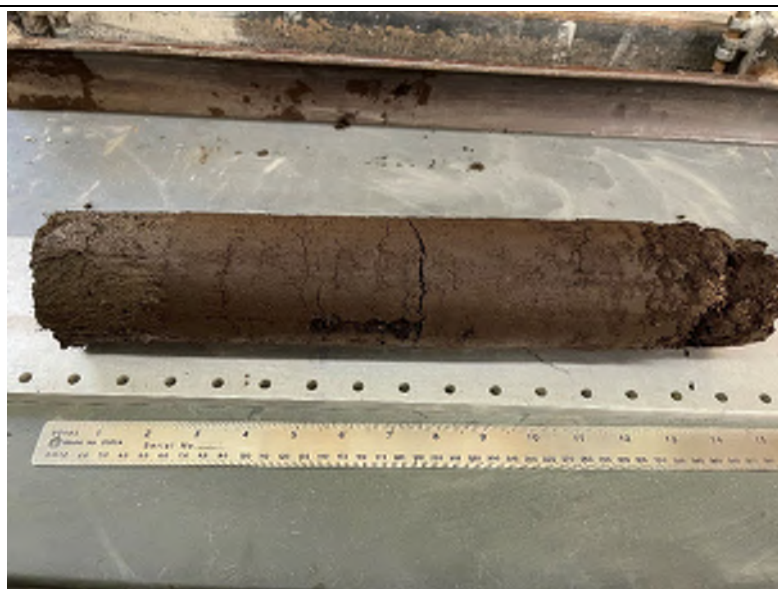
<b>Client:</b>	CRW Engineering Group, LLC 3940 Arctic Blvd., Ste. 300 Anchorage, AK, 99503	
<b>Project:</b>	FedEx Bog	
	73138.00	
		<b>Date Received:</b> March 21, 2022
		<b>Sample #:</b> 22-0265-S03
		<b>Material:</b> BH-12 Sa3A

Sample after extraction
