FAR NORTH BICENTENNIAL PARK

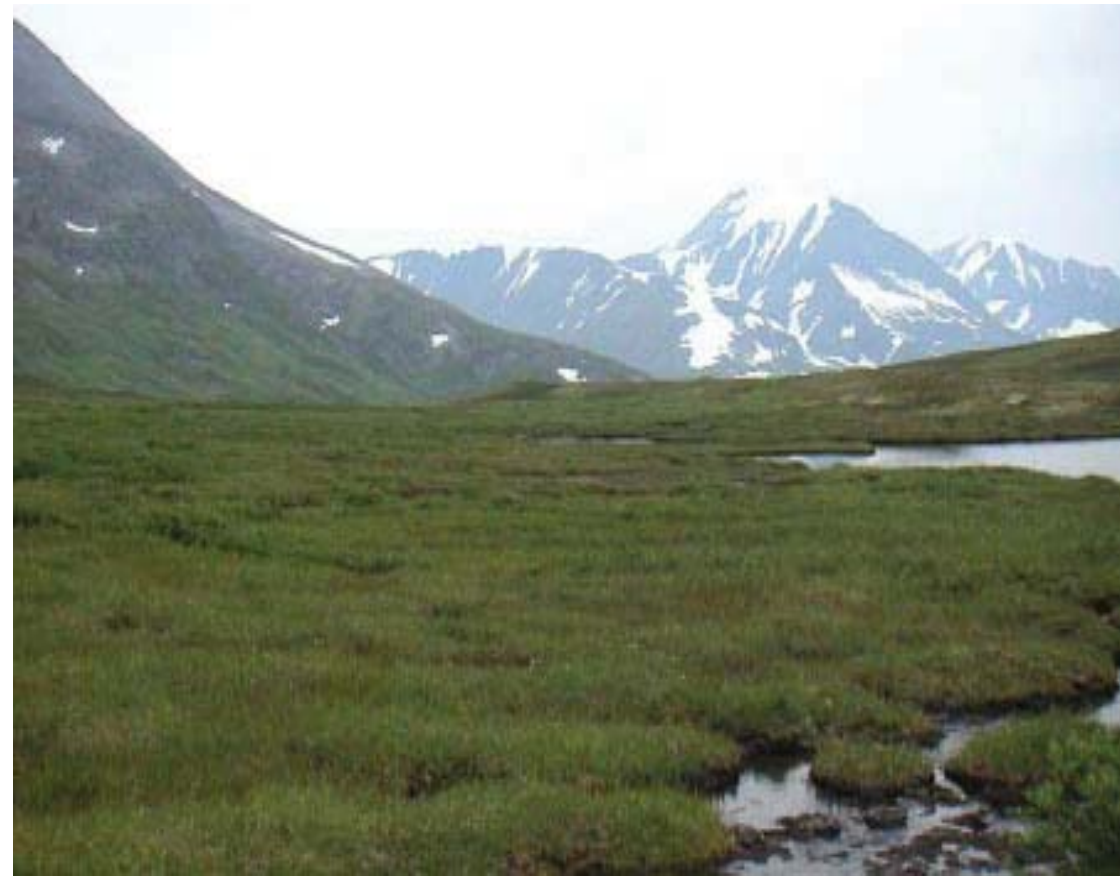
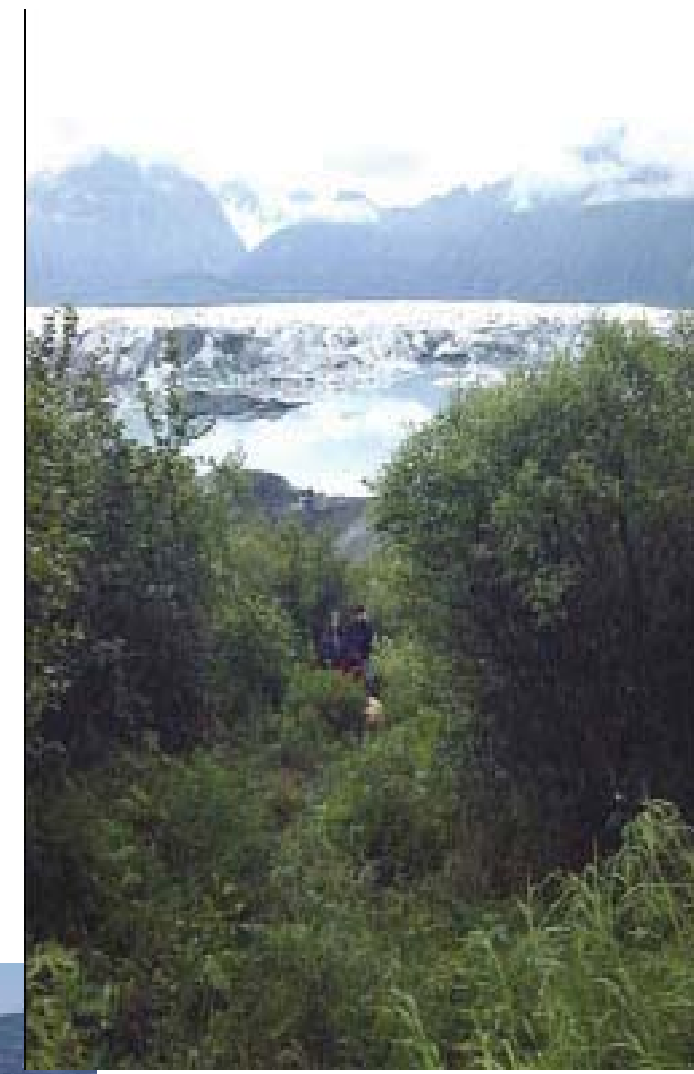
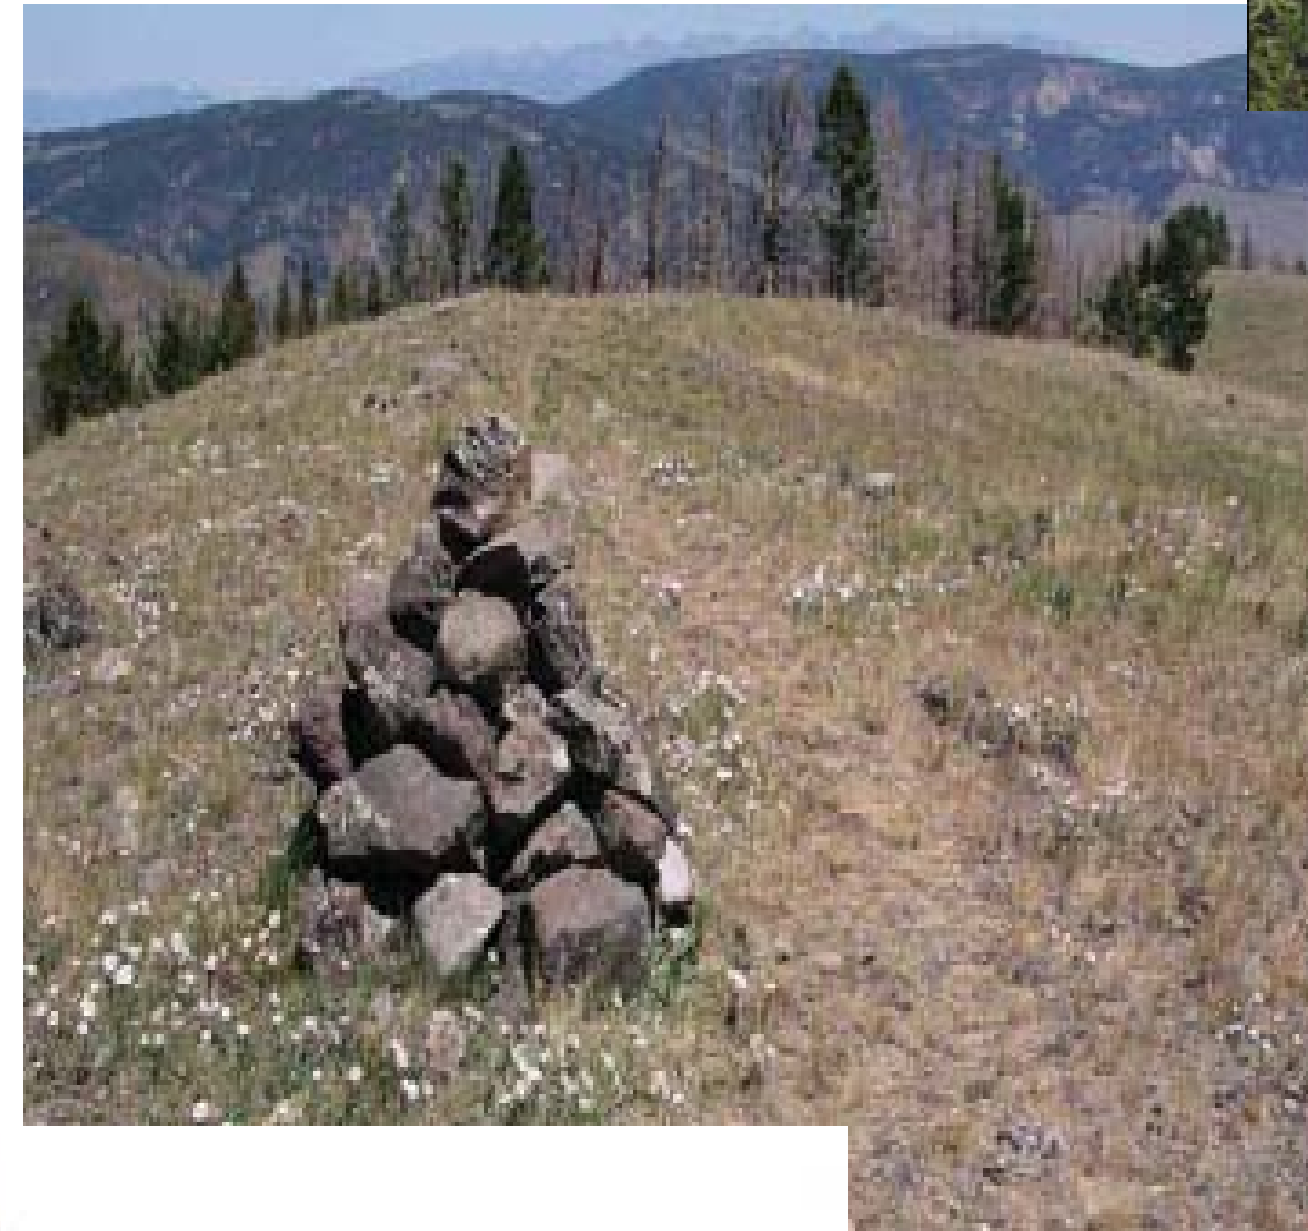
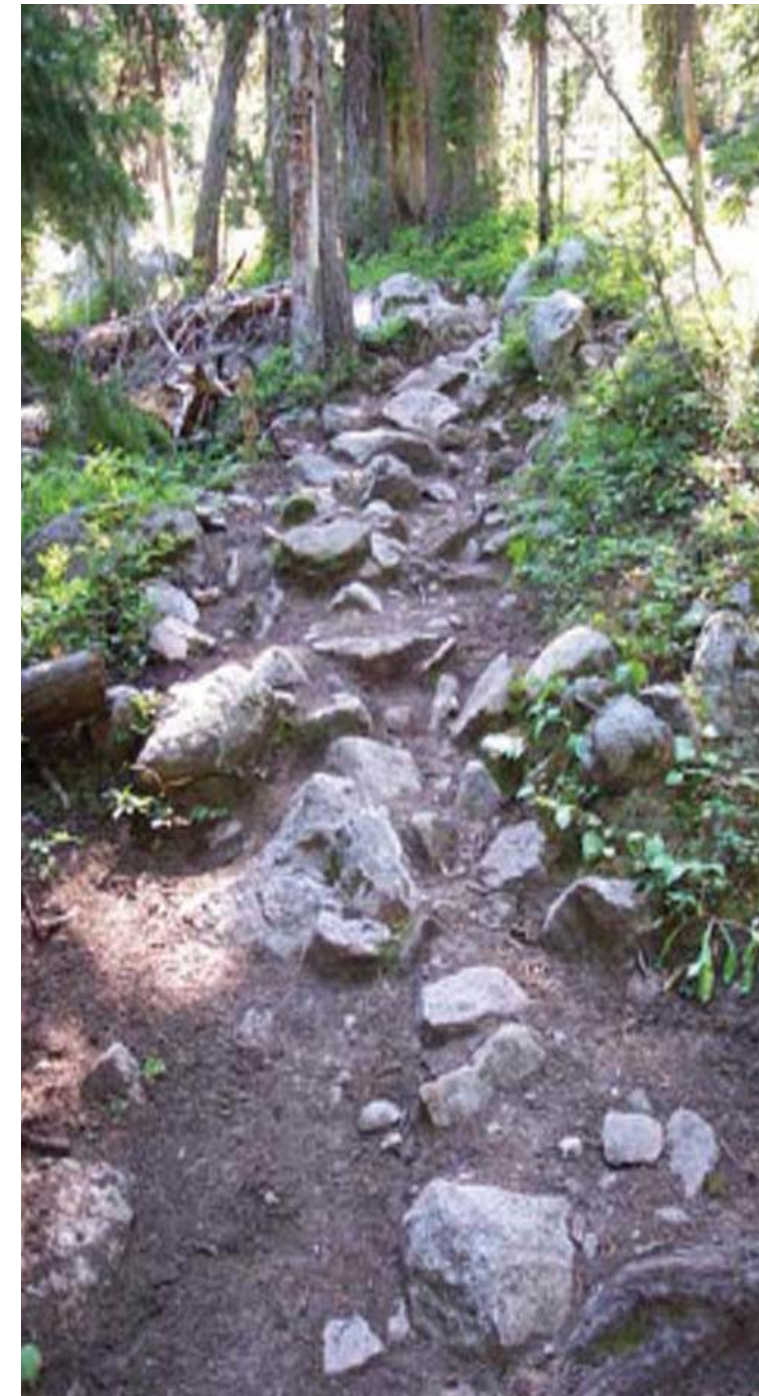
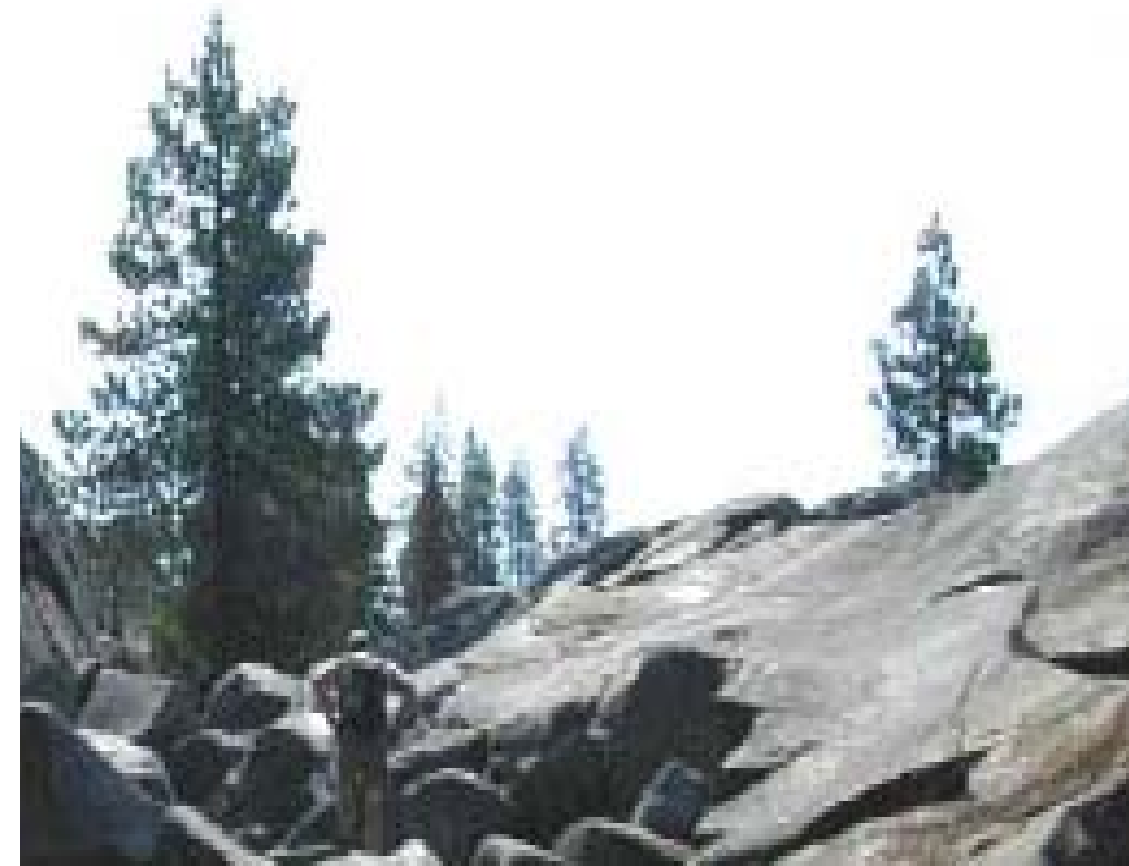
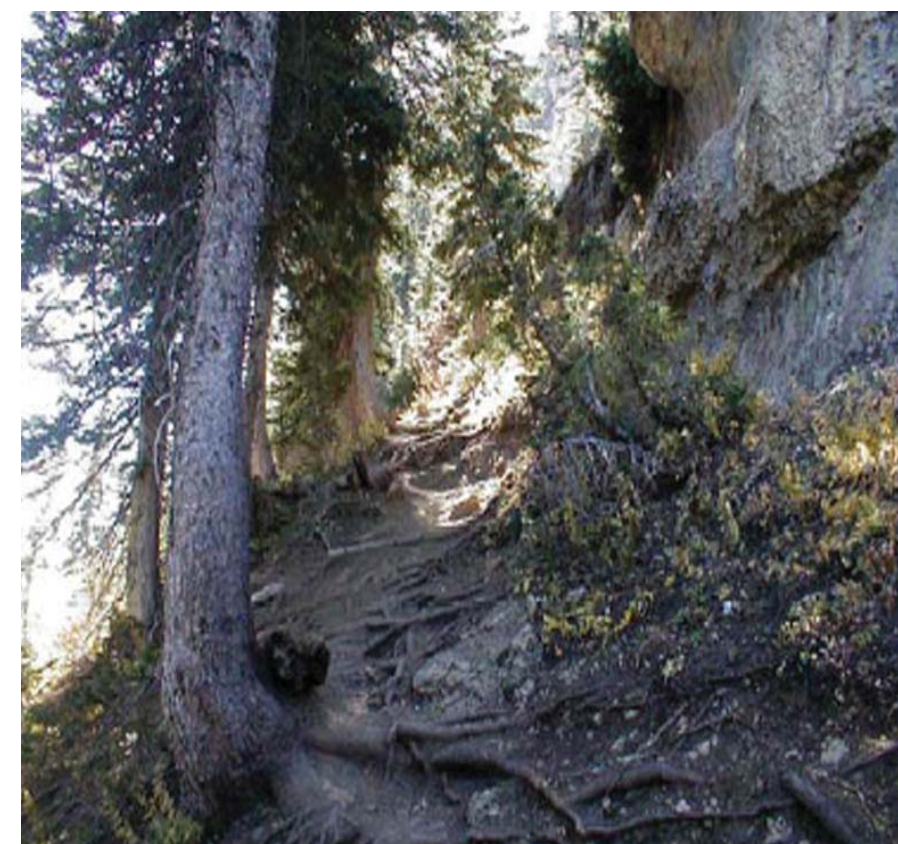
CLASS 1 FEATURES

- Tread intermittent and indistinct.
- Obstacles continuous.
- Constructed features minimal to non-existent.
- No destination signs present-limited to regulation, junction, and resource protection.

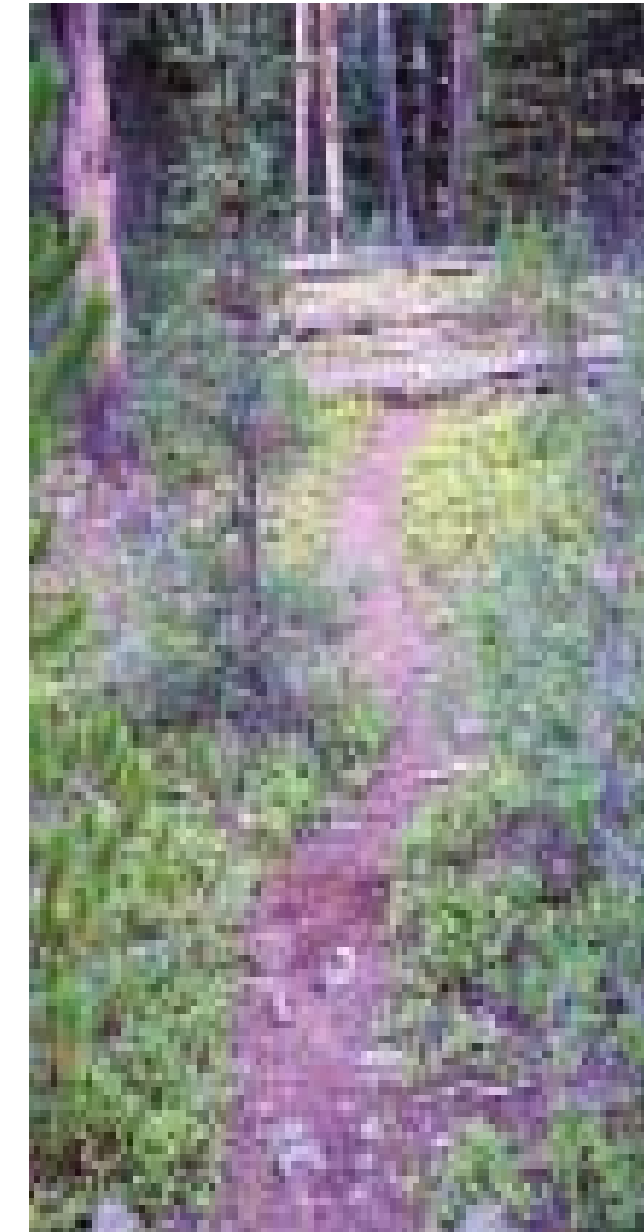
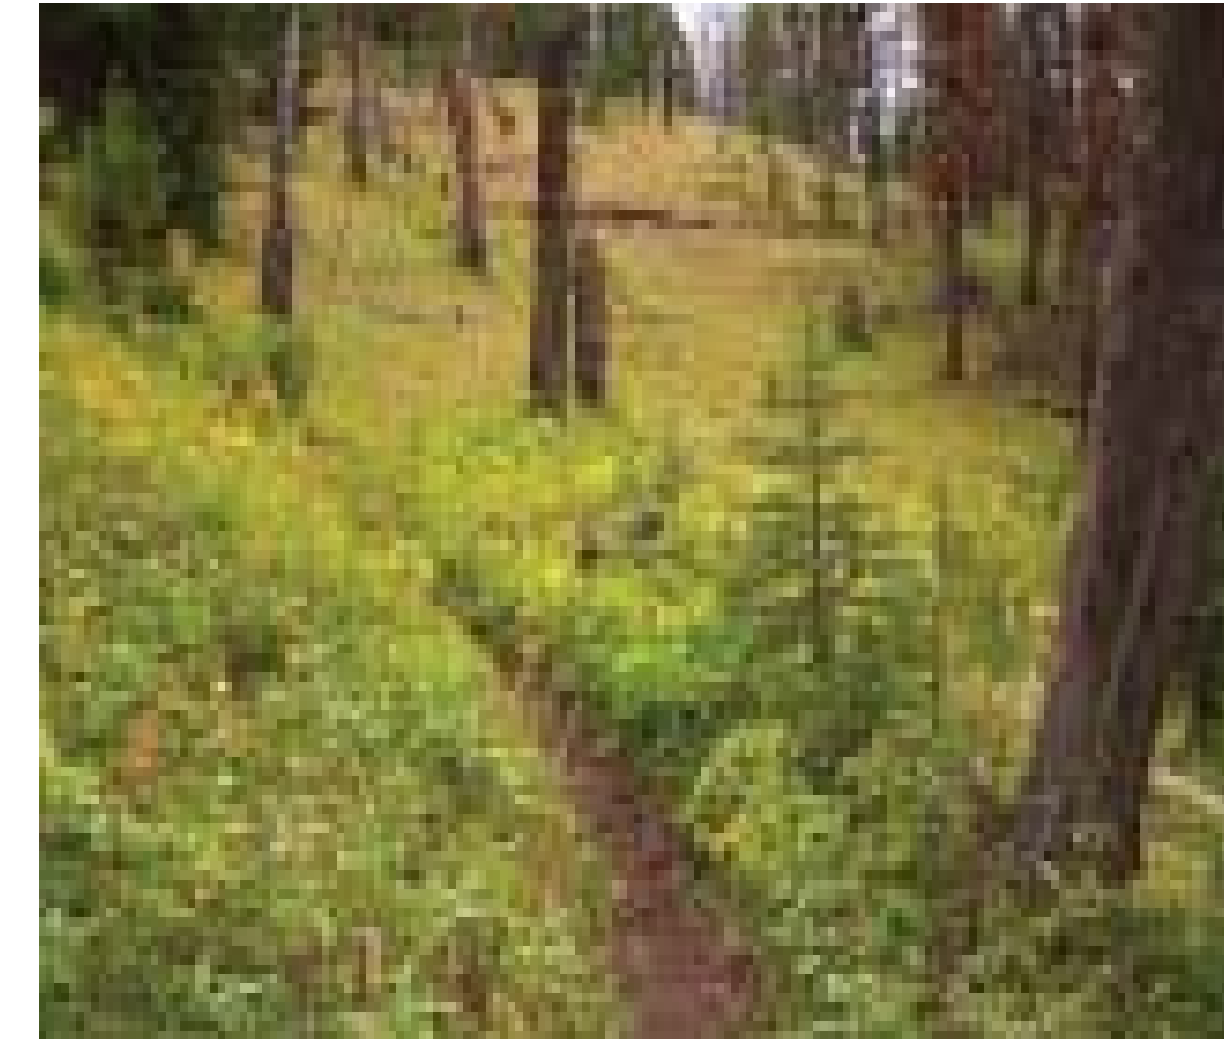
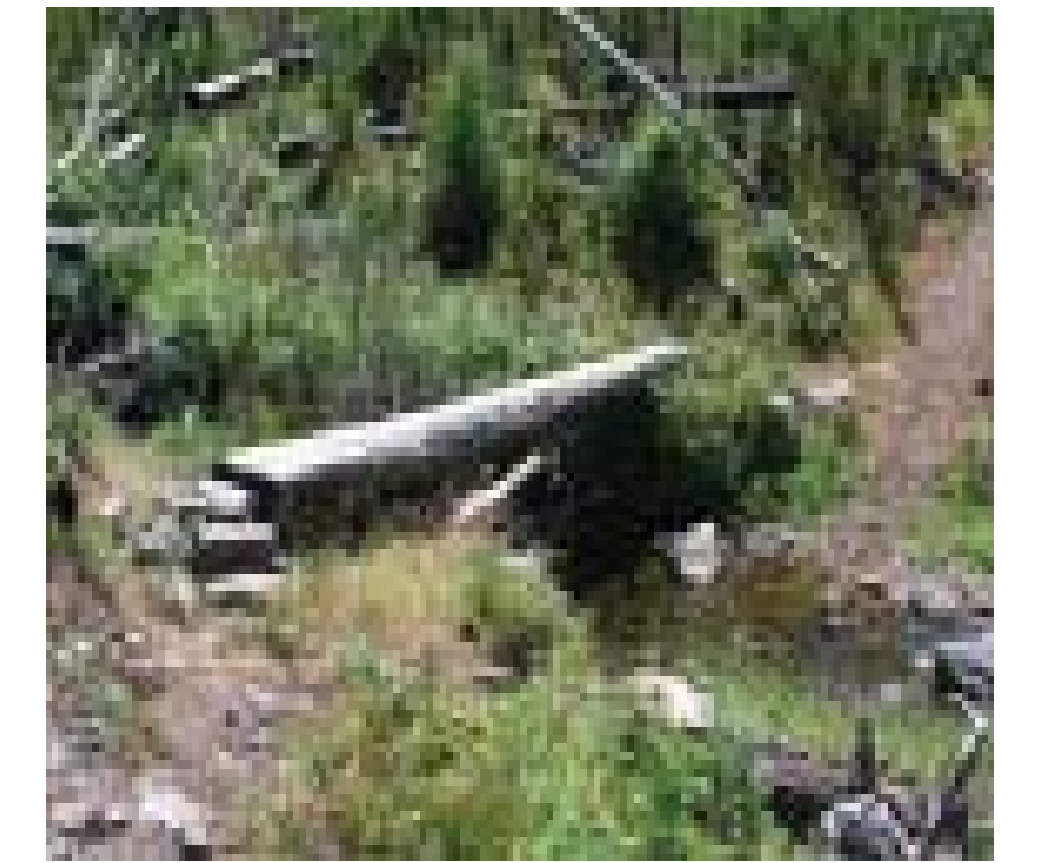
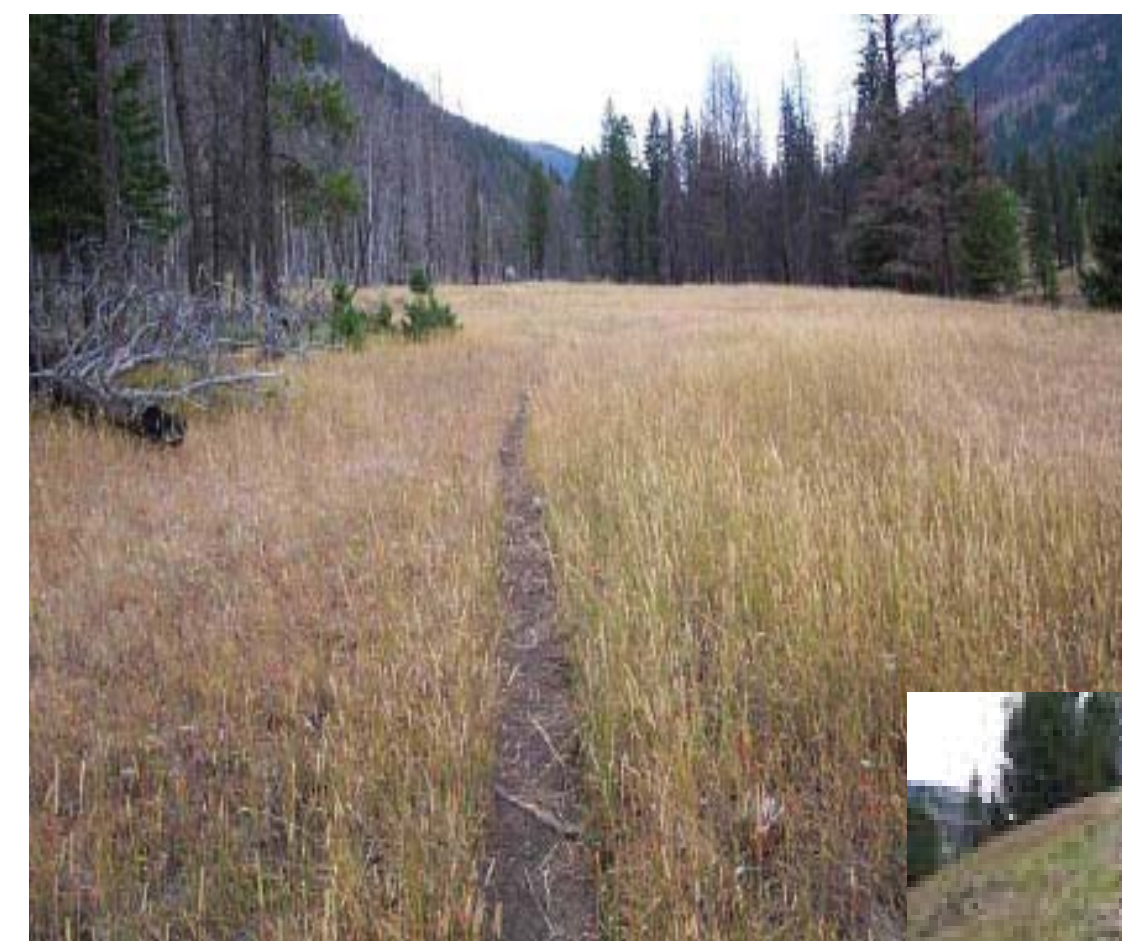
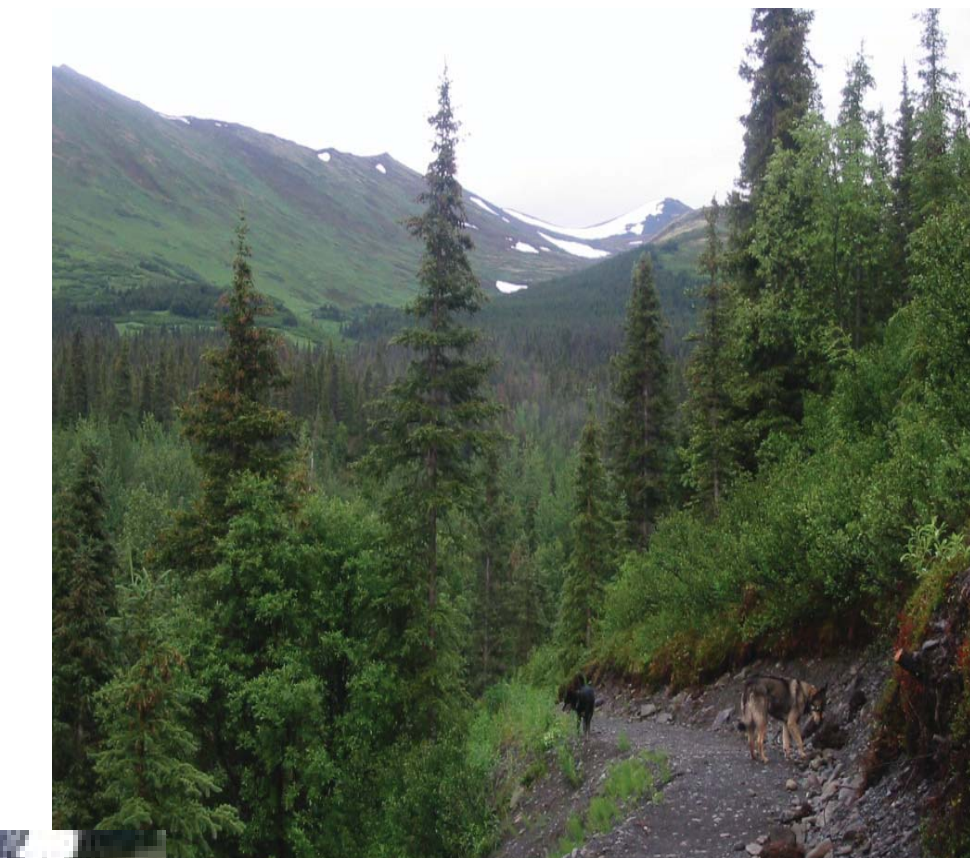
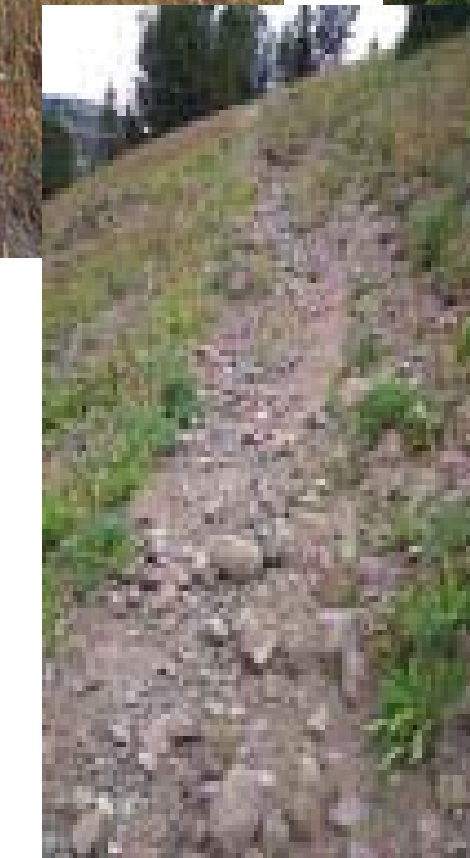
CLASS 2 FEATURES

- Tread discernible and continuous, but narrow and rough.
- Obstacles occasionally present.
- Structures are of limited size, scale and numbers.
- Minimal signage for basic direction, generally limited to regulation and resource protection.

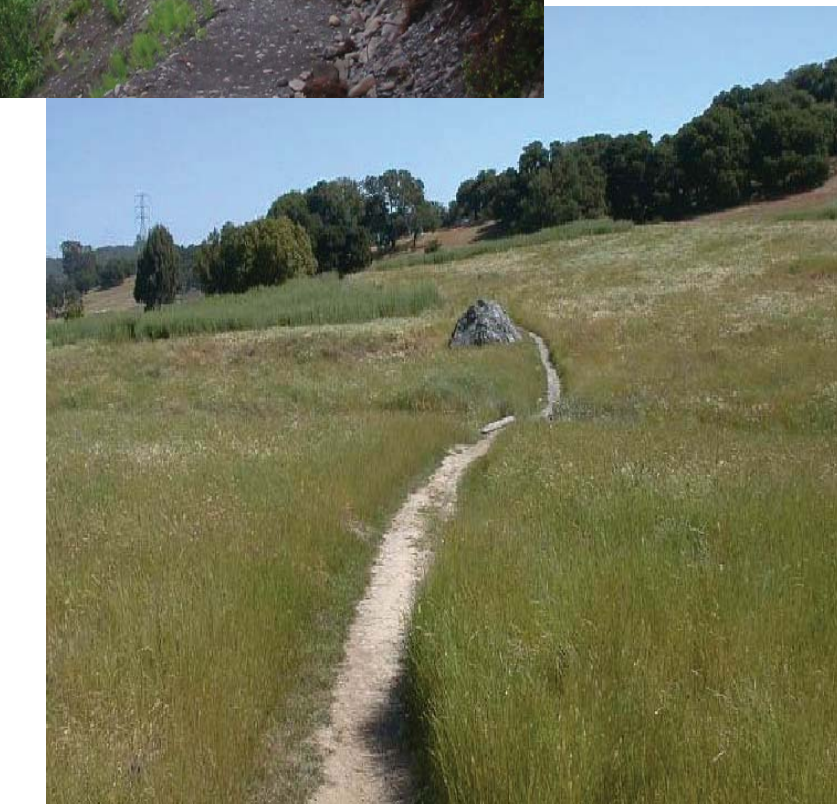
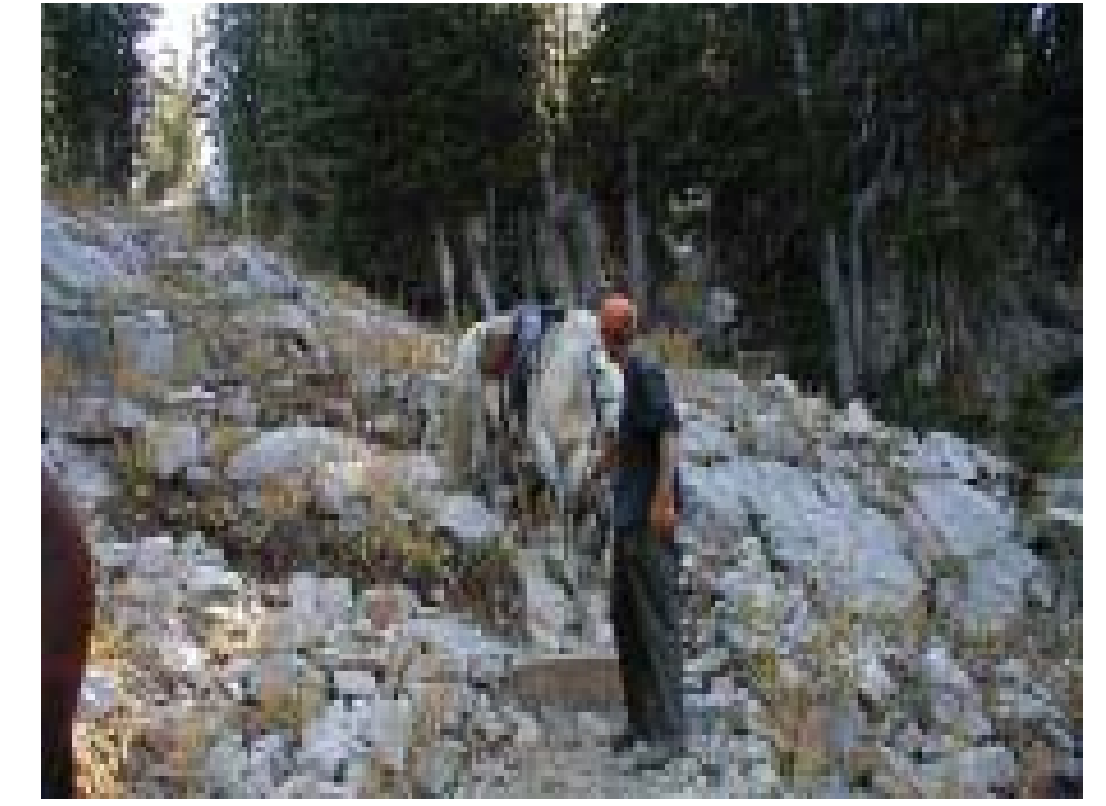
TRAIL CLASS 3

CLASS 3 FEATURES

- Tread obvious and continuous.
- Obstacles infrequent. Vegetation cleared outside of trailway.
- Trail structures (walls, steps, drainage, raised trail, boardwalk) may be common and substantial.
- Directional signs at trail junctions.

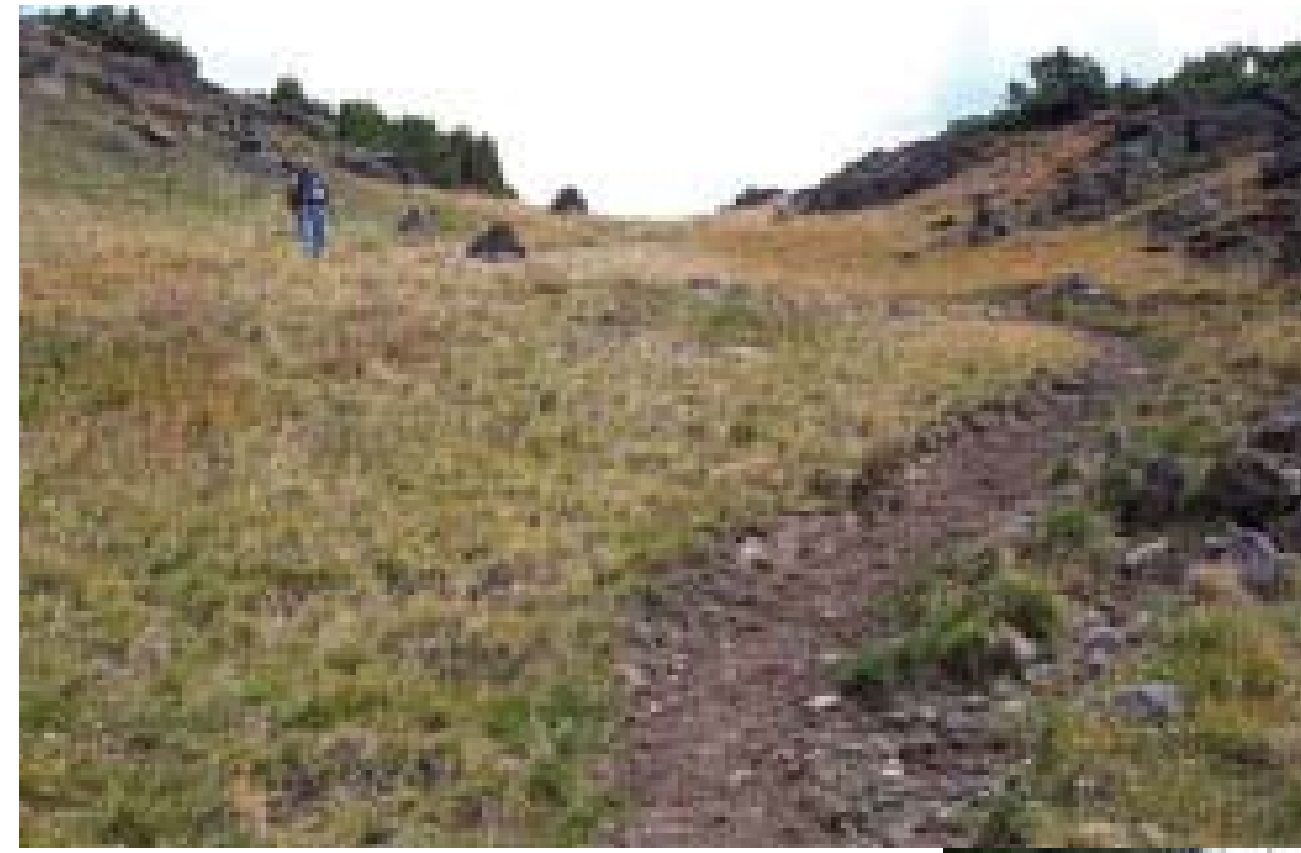
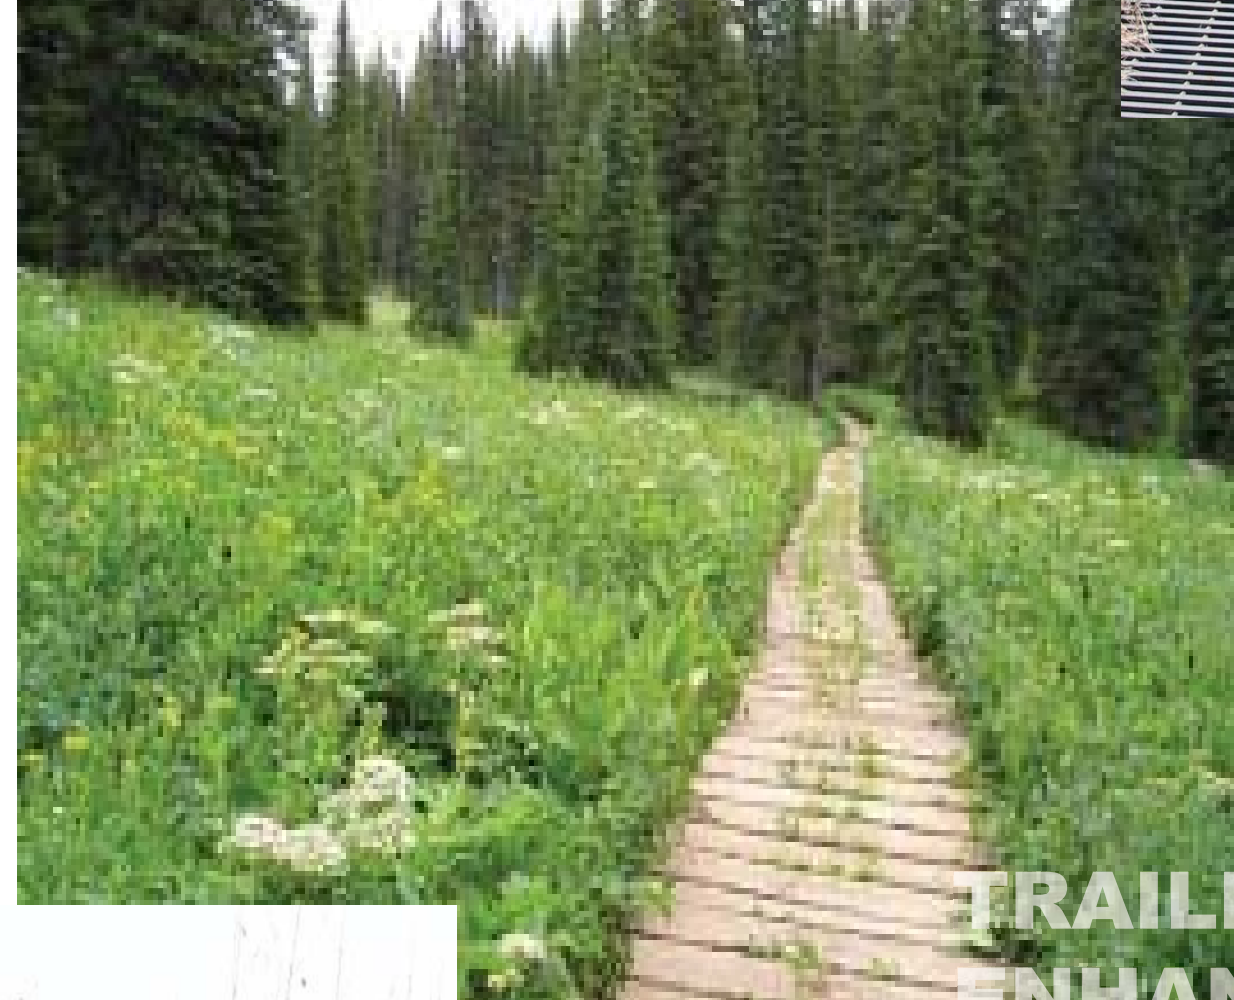
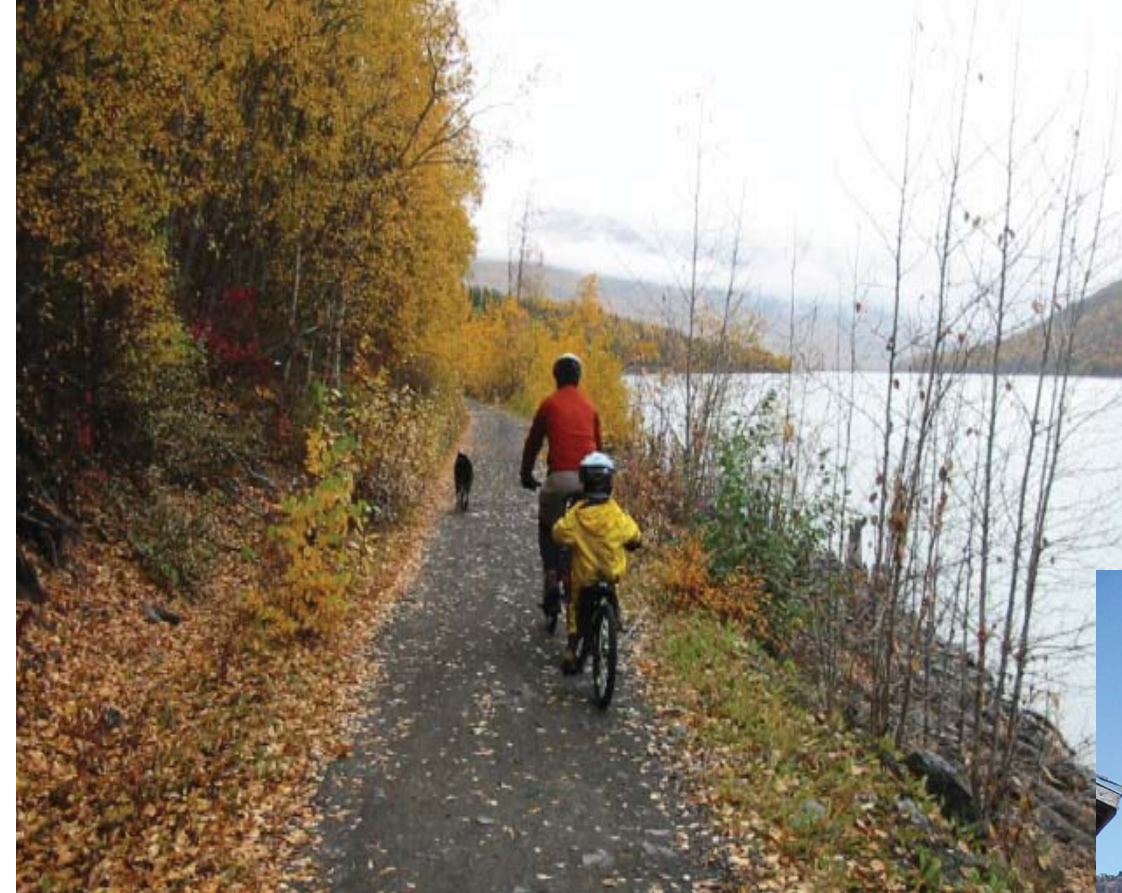
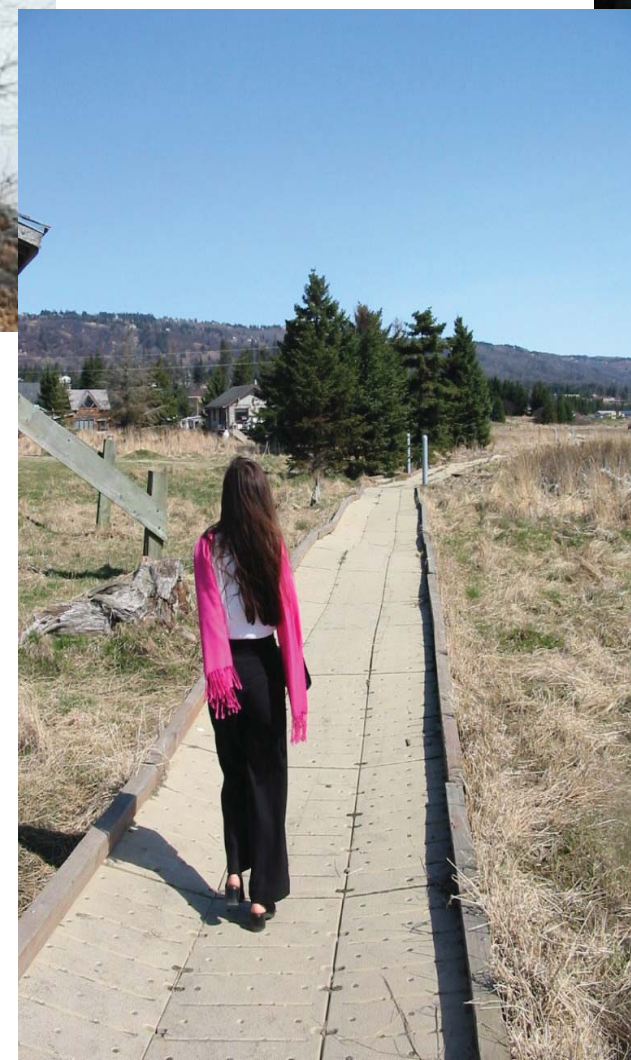
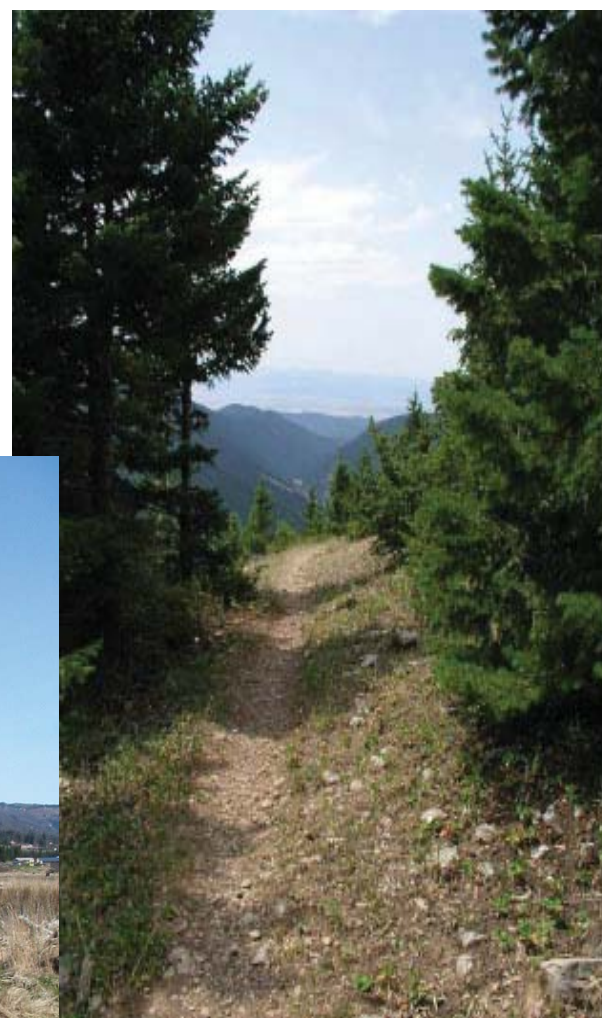
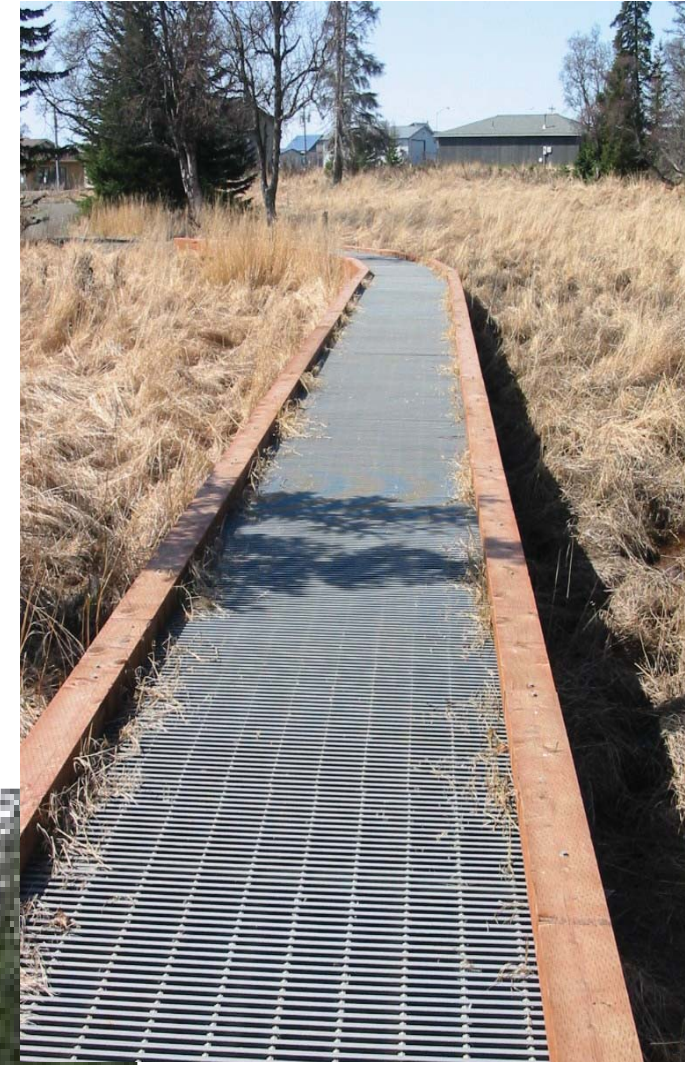
CLASS 4 FEATURES

- Tread is wide and relatively smooth with few irregularities.
- Few or no obstacles exist, grades typically less than 12%, vegetation cleared outside of trailway.
- Constructed features/structures are frequent and substantial. Substantial trail bridges are appropriate at water crossings.
- Wide variety of signs present-informational and possibly interpretive.
