FAR NORTH BICENTENNIAL PARK

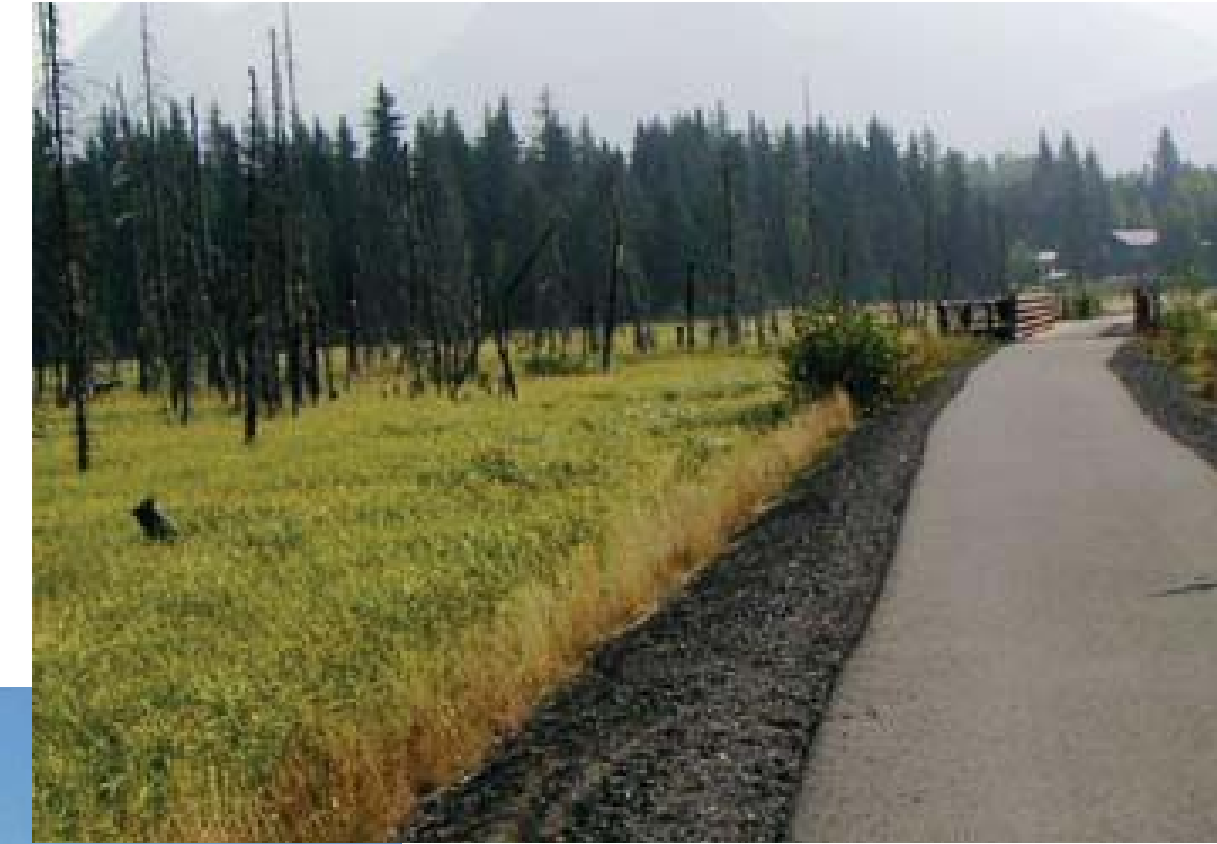
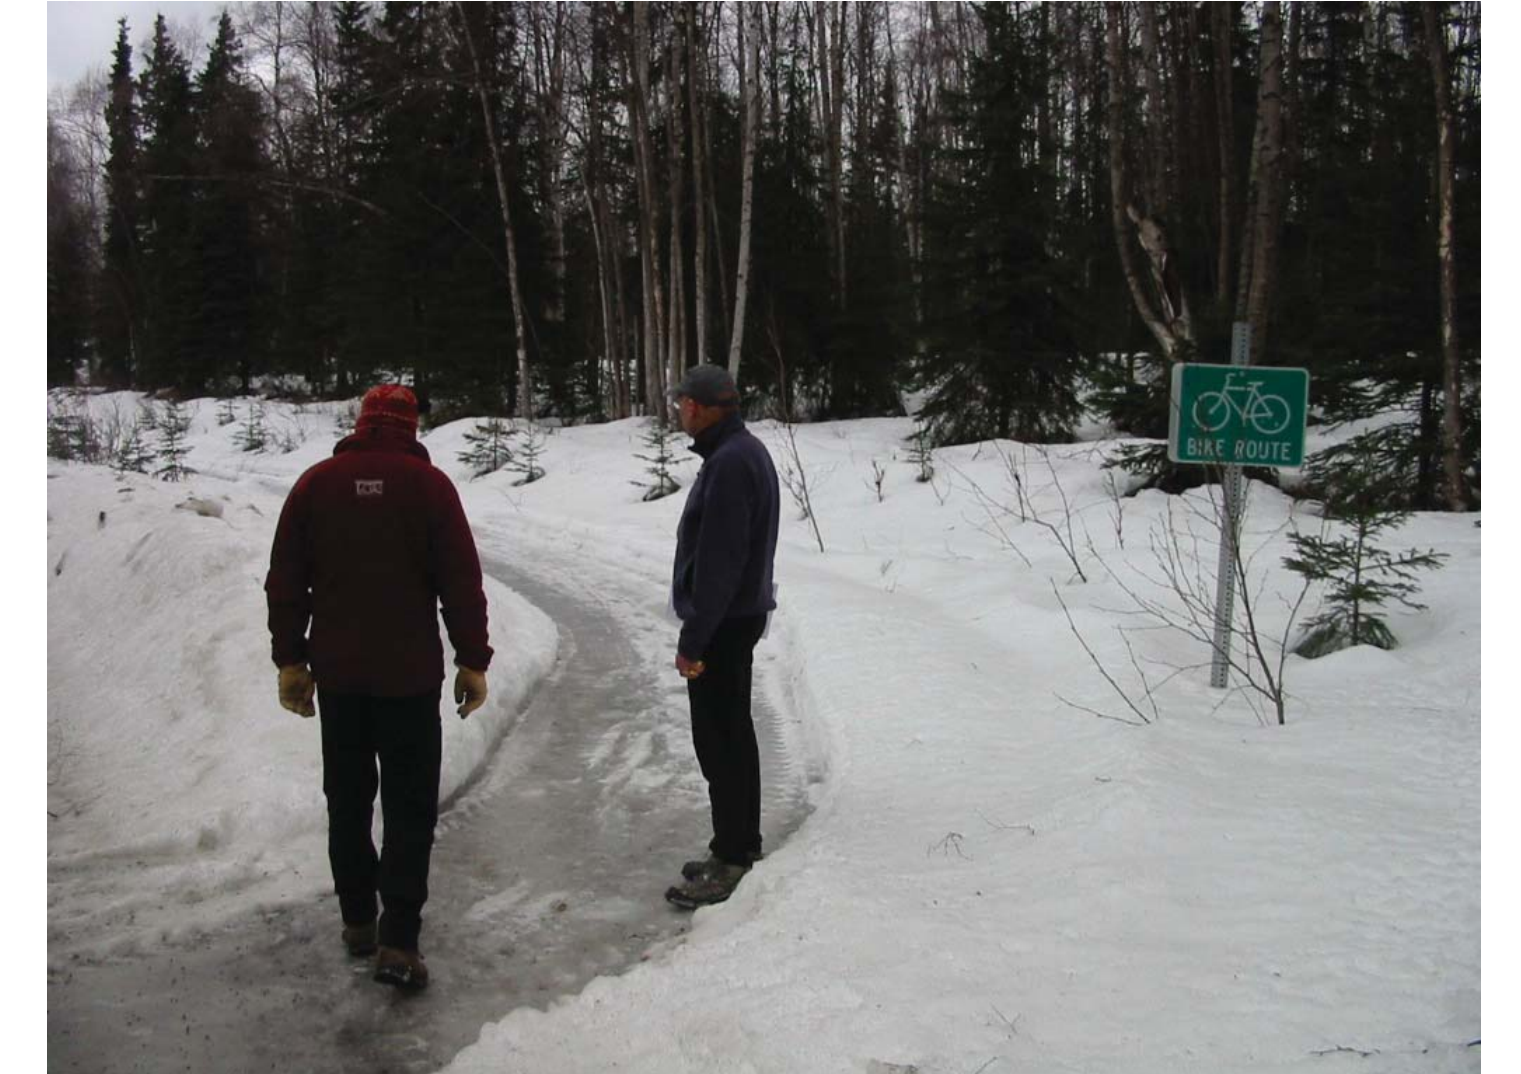
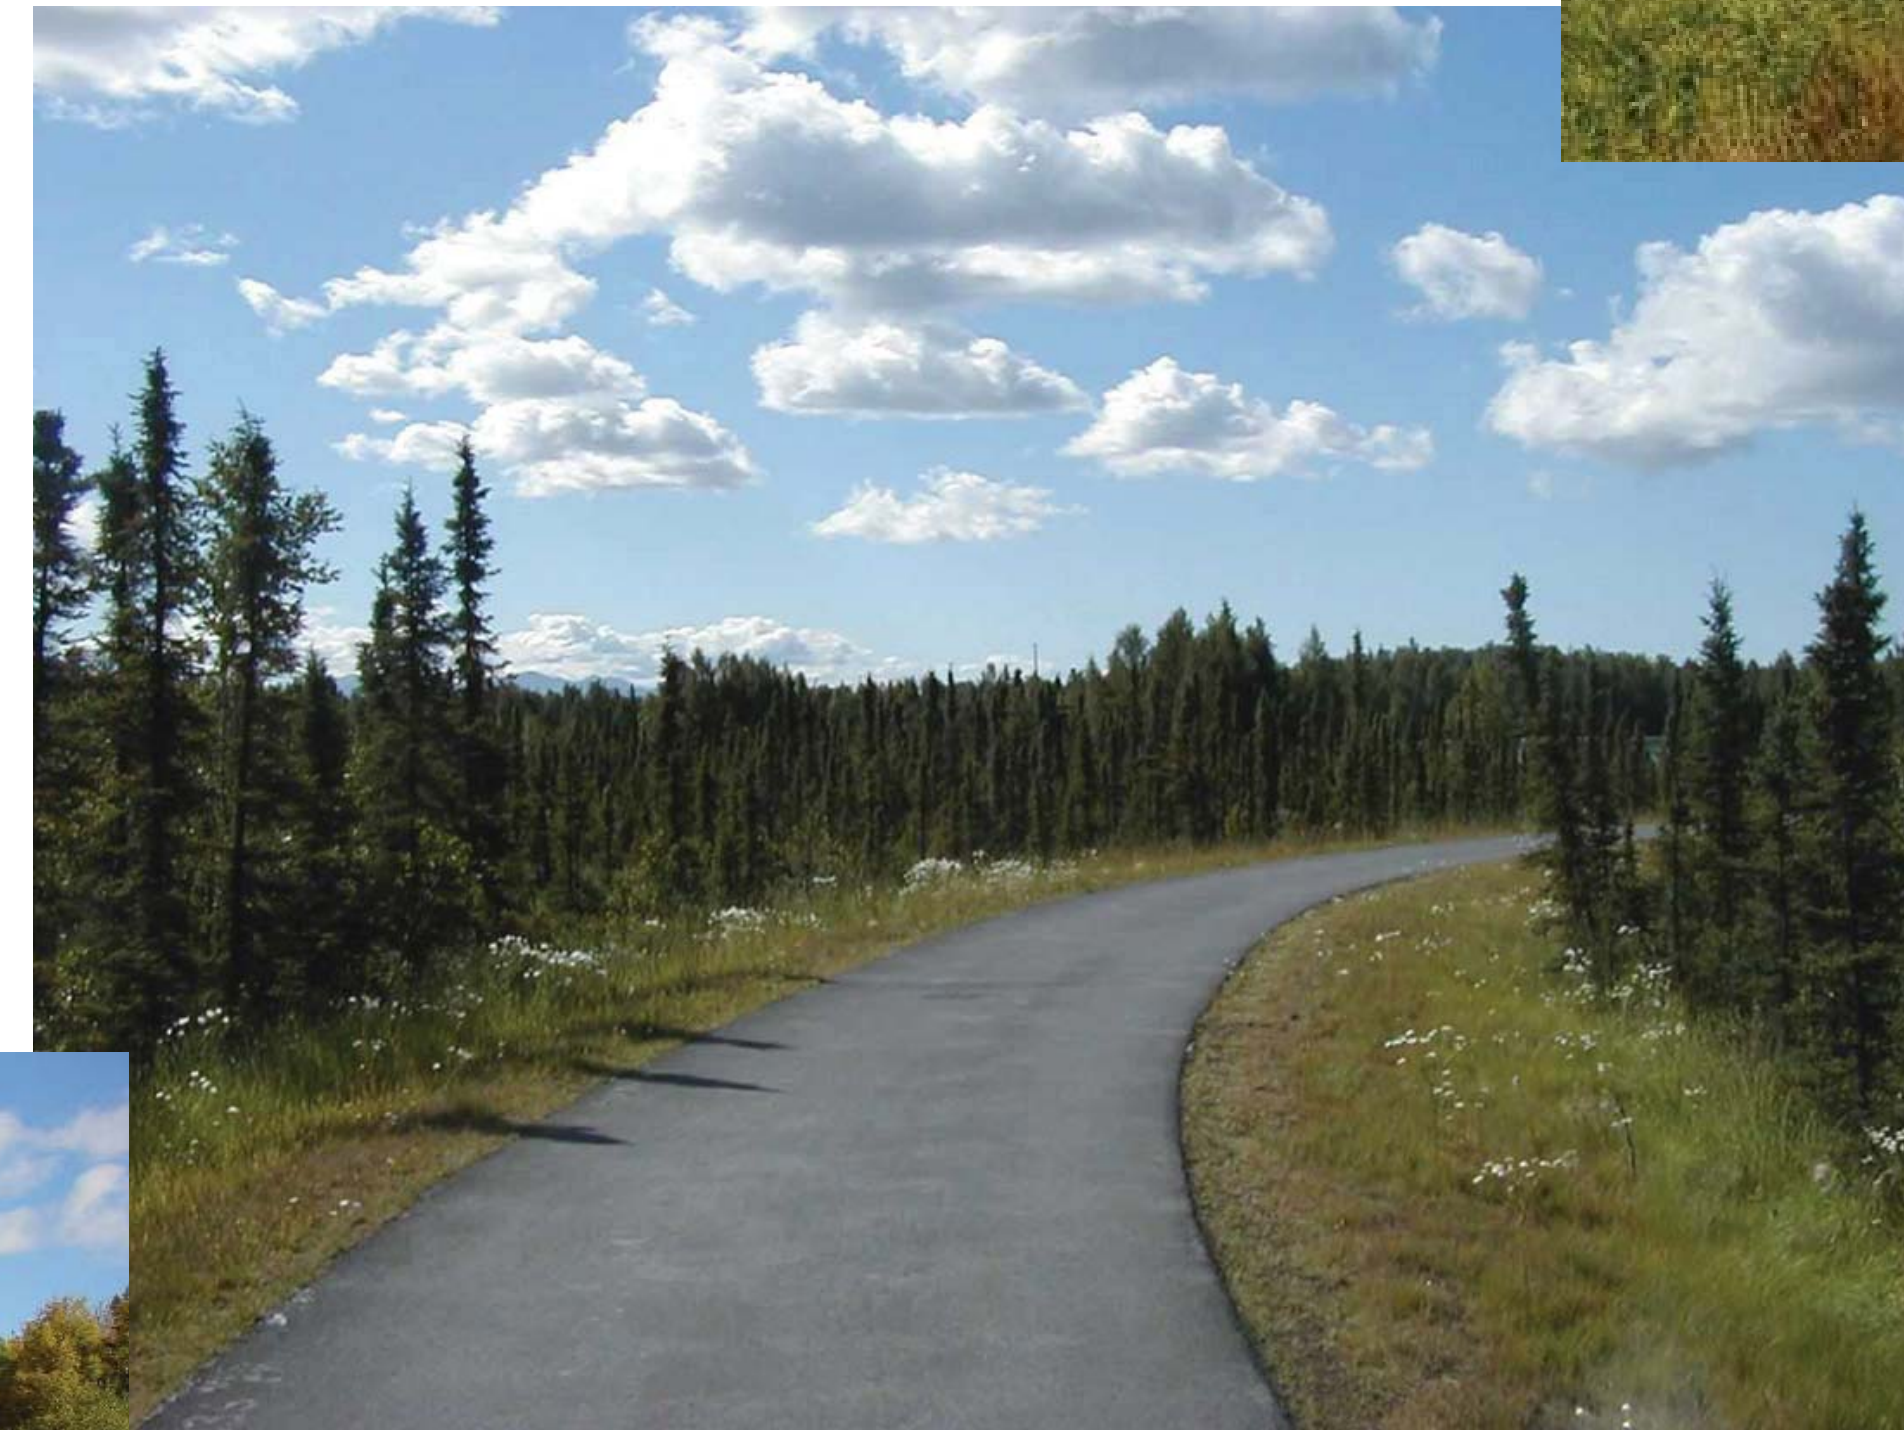
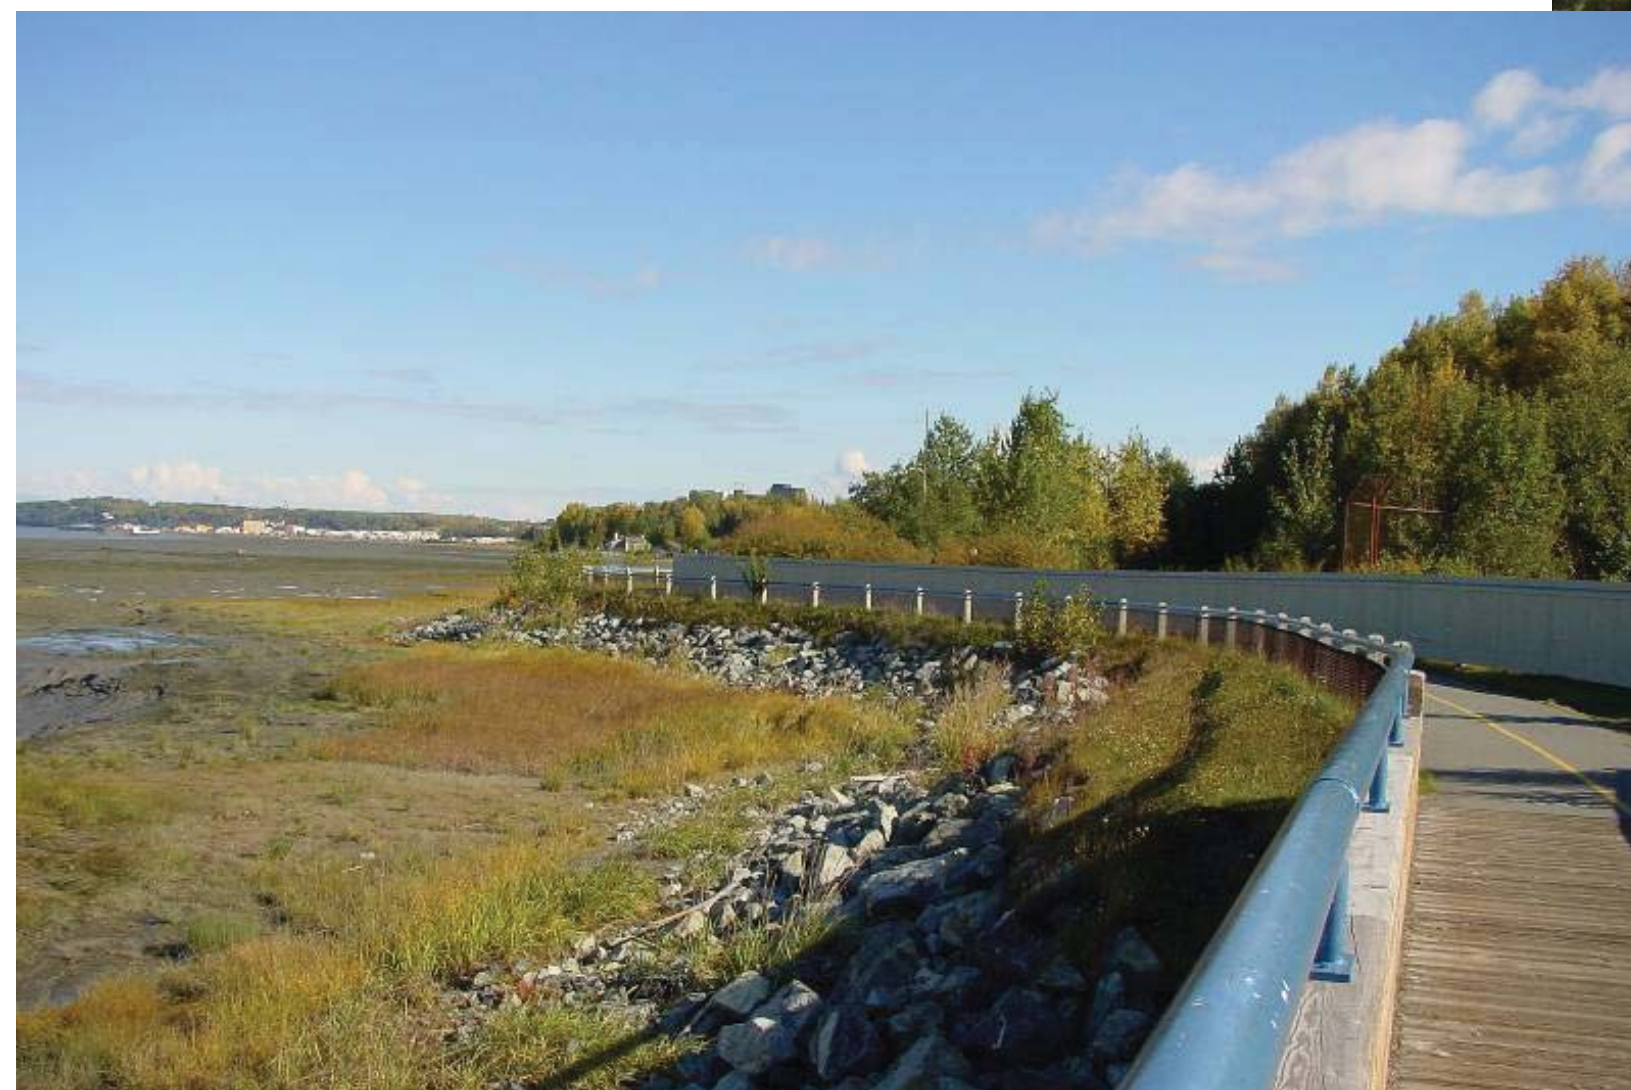
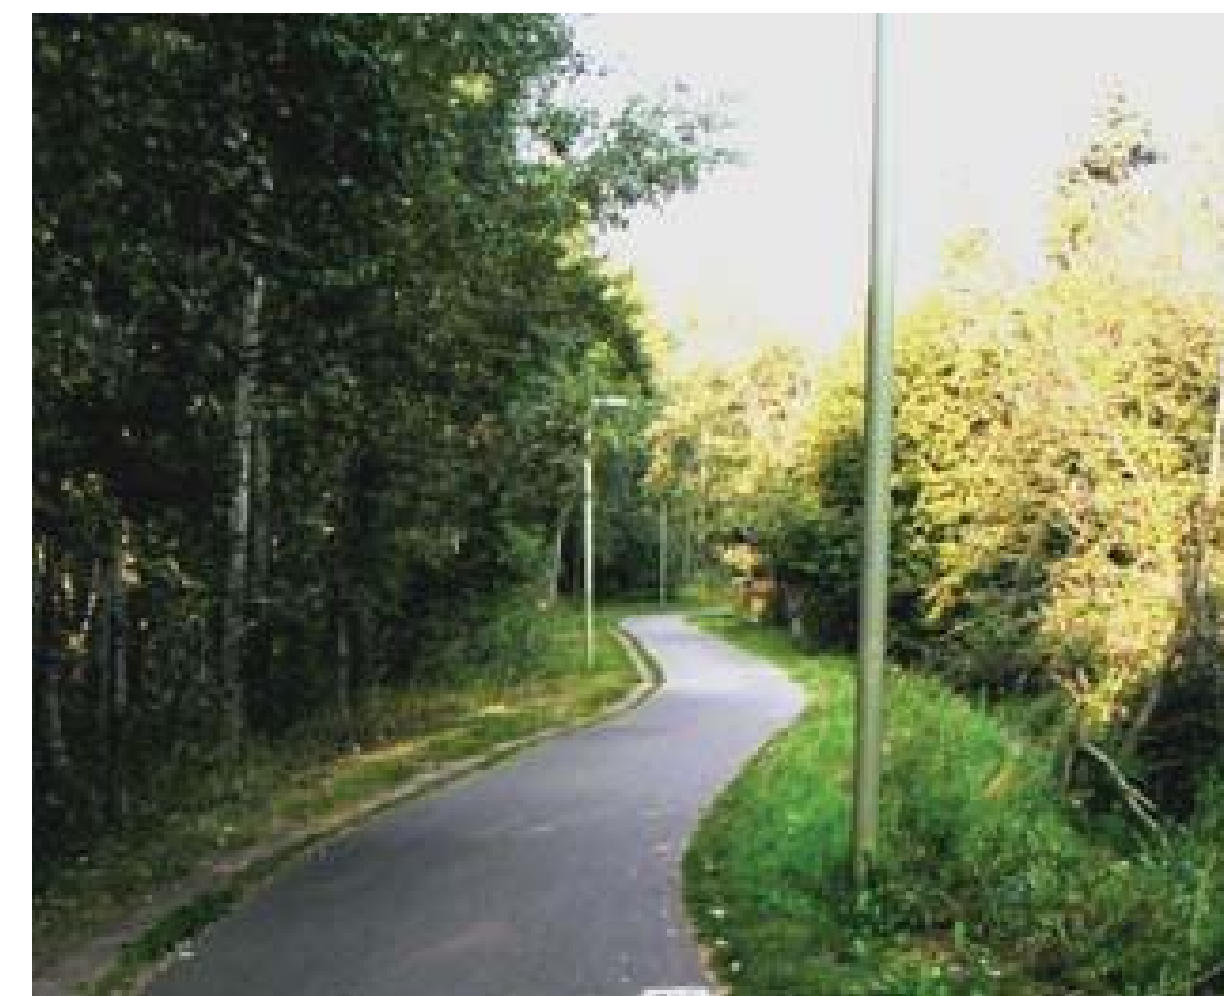
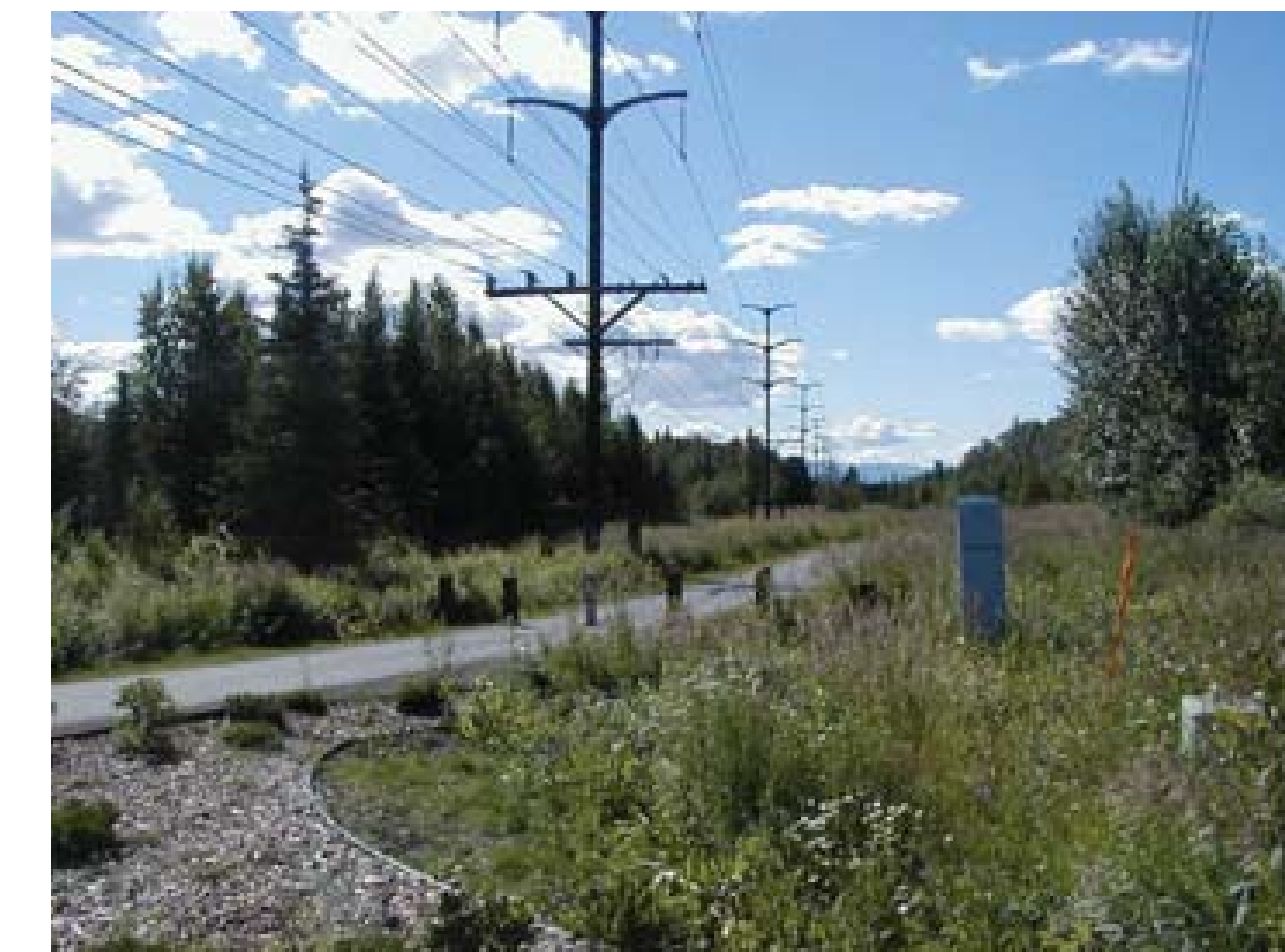
CLASS 5 FEATURES

- Tread of trail is commonly hardened with asphalt or other imported material.
- No obstacles, grades typically less than 8% for accessibility.
- Constructed features/structures are frequent or continuous - curbing, handrails, trailside amenities, and boardwalks.
- Wide variety of signage - informational and interpretive.
