Application for Administrative Site Plan Review

Land Reclamation Narrative for 92nd Ave & C Street

CROSS SECTIONS
C STREET & 92nd AVENUE

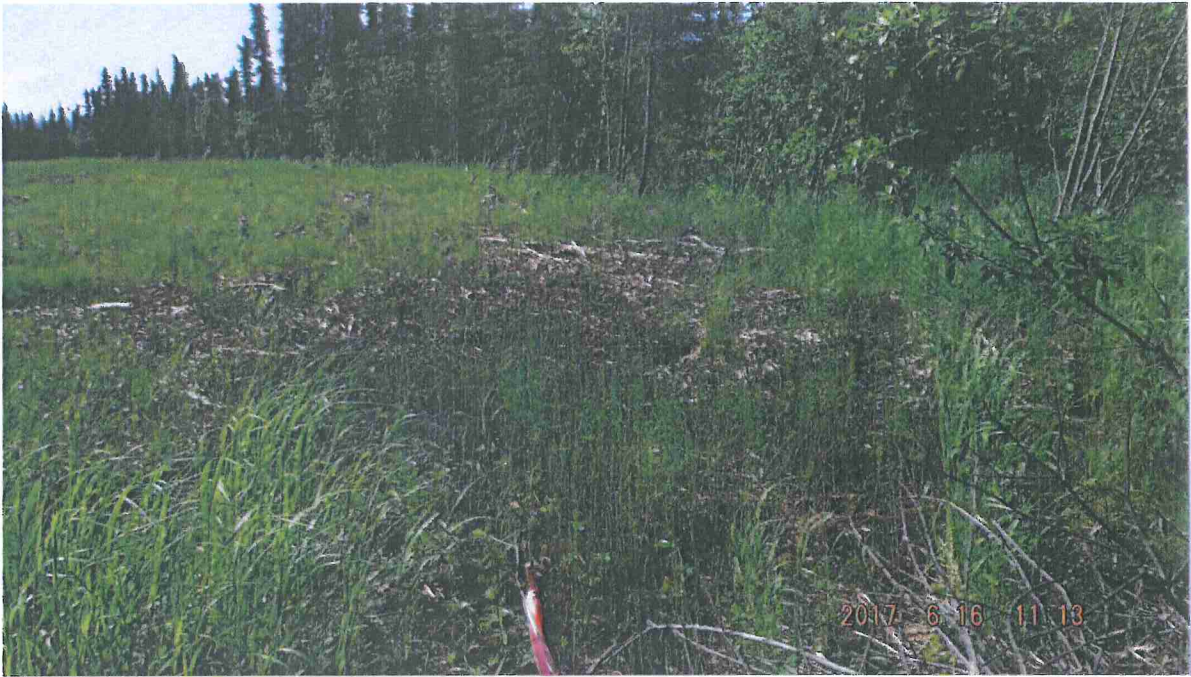
Cleared portion of site (left) and remaining forested portion (right). Surface water accumulation in foreground with water horsetail (*Equisetum fluviatile*; OBL).

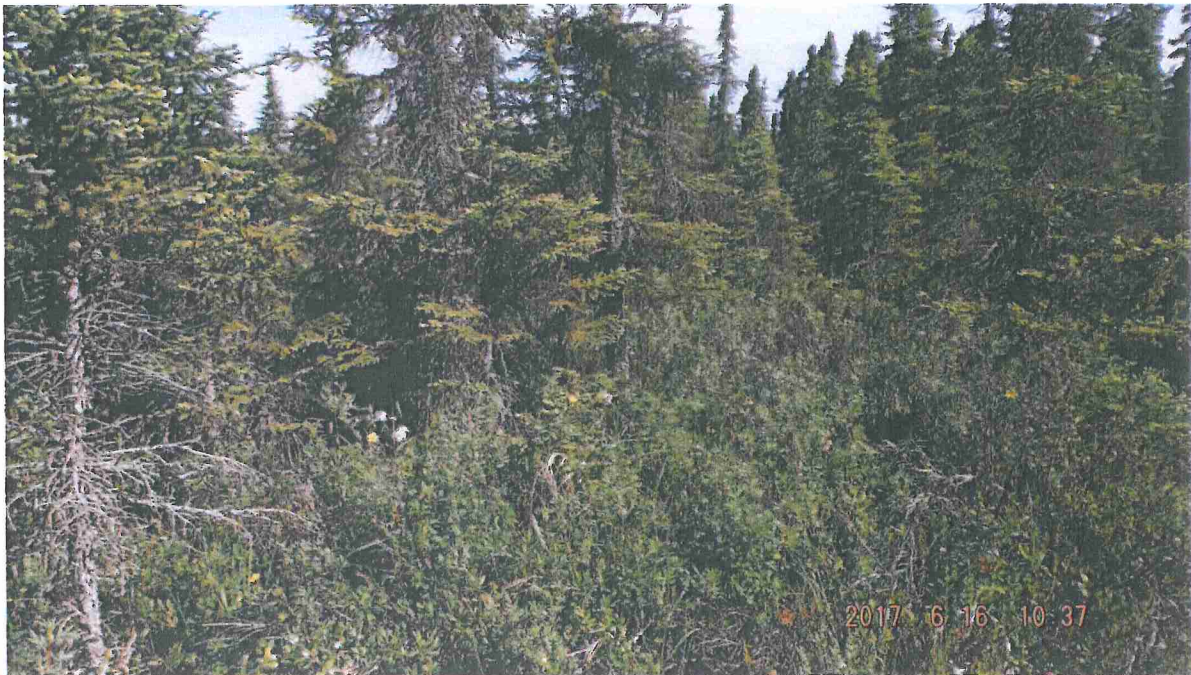
Forested and shrub-scrub wetland in the central and eastern portion of property (e.g., DP-5).

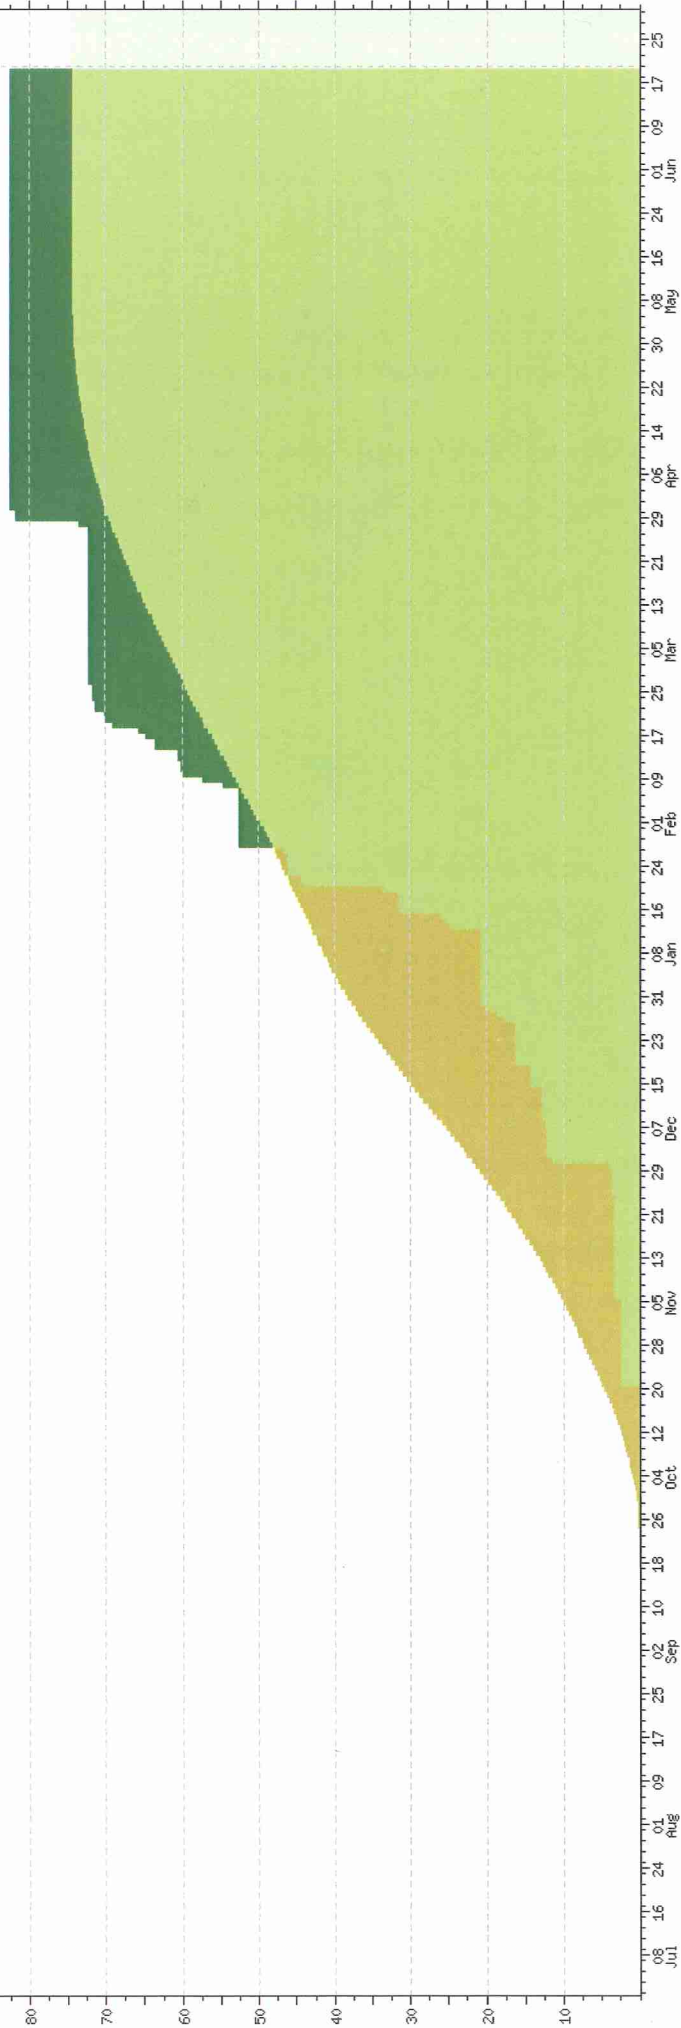
PANC 2016-2017 Cumulative Snow

Below Normal, Normal, Above Normal
