**PLANNING DEPARTMENT
CURRENT PLANNING DIVISION
ADMINISTRATIVE SITE PLAN REVIEW**

DATE	November 14, 2017
CASE NO:	2017-0122
APPLICANT:	Ridge Equipment, LLC
REPRESENTATIVE:	Brandon Marcott, Triad Engineering
REQUEST:	Administrative site plan review for a Land Reclamation Use in the I-2 (Heavy Industrial) District in accordance with AMC 21.05.060E.5
TITLE 21 CODE CITATION:	Title 21 – Land Use Planning, 21.05.060E.5
LOCATION:	On the west side of C Street and the south side of West 92 nd Avenue
COMMUNITY COUNCIL:	Bayshore-Klatt
TAX I.D. NUMBERS:	016-291-20
GRID:	SW2430

C STREET & 92nd AVENUE SECTION LOT 5 NW 1/4 SECTION 18, T12N, RSW GRADING PLAN

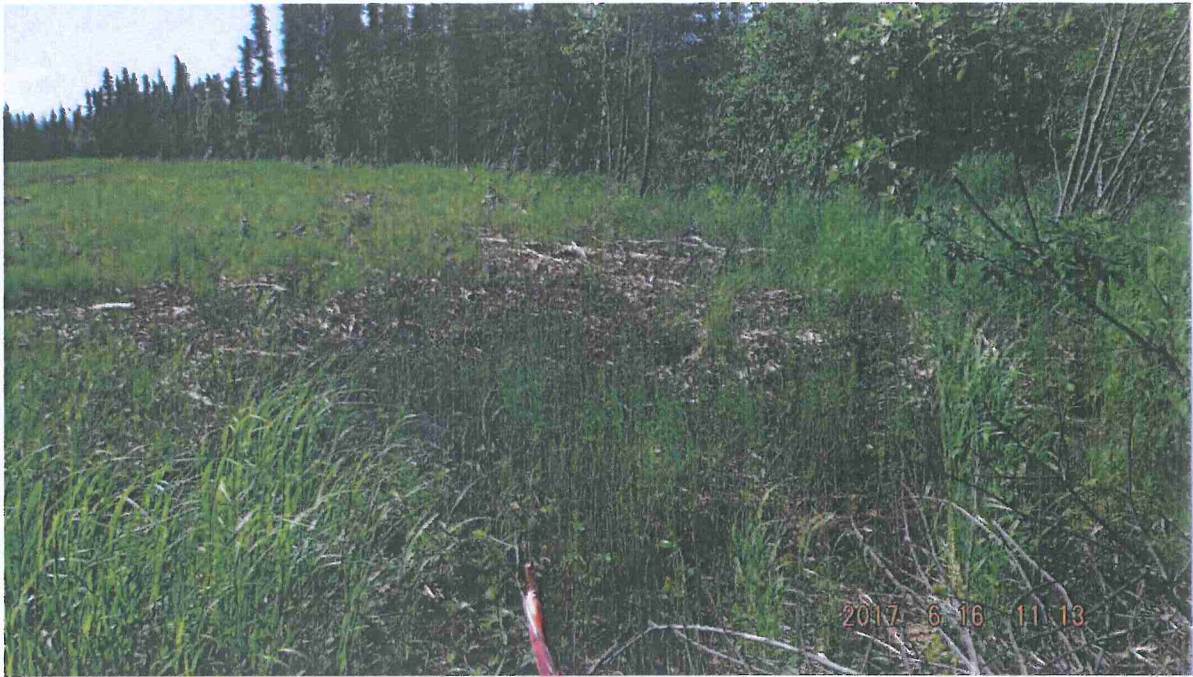
Cleared portion of site (left) and remaining forested portion (right). Surface water accumulation in foreground with water horsetail (*Equisetum fluviatile*; OBL).

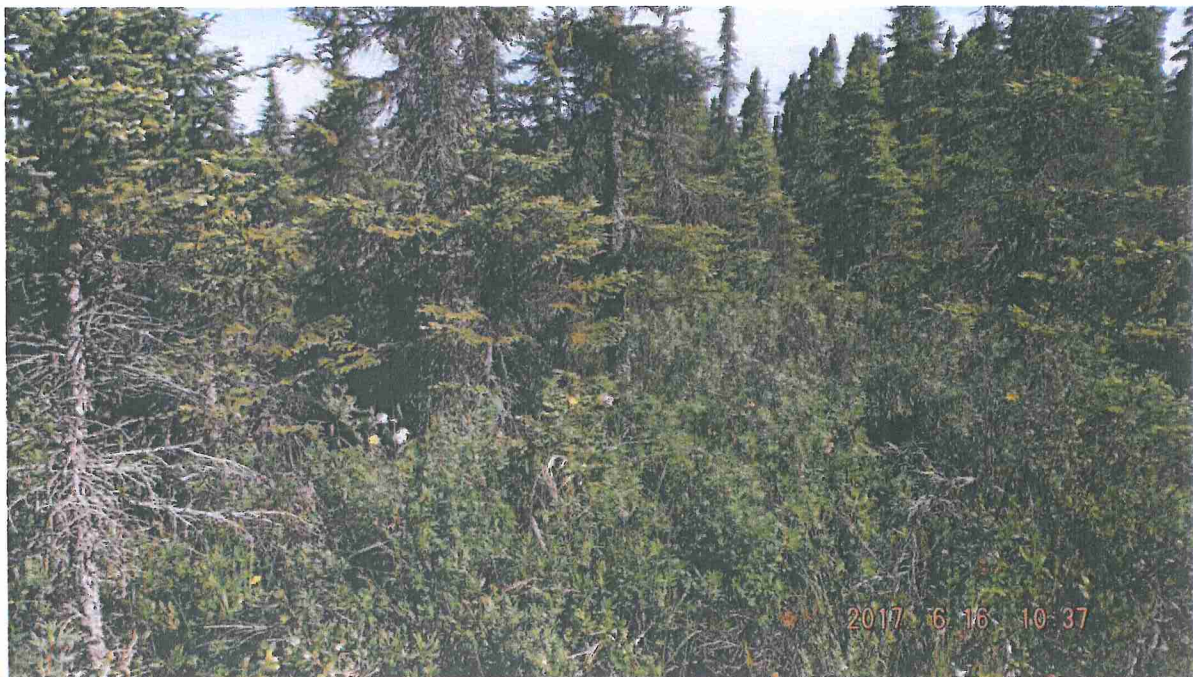
Forested and shrub-scrub wetland in the central and eastern portion of property (e.g., DP-5).

The wetlands on the property can be characterized generally as the NWI mapping indicates: the eastern portion of the property is open forest of paper birch and a mixture of white and black spruce trees, with saturated soil conditions (PFO1/4B); the central part consisting of a closed forest of black spruce trees and deciduous shrubs (PFO4/SS1B); and, the western part consisting of a dense thicket of low shrubs including sweet gale, swamp birch, shrubby cinquefoil, mixed with small and stunted black spruce saplings, along with scattered bluejoint grass and sedges, all in saturated and inundated, black, greasy, organic soil (PSS1/EM1B).

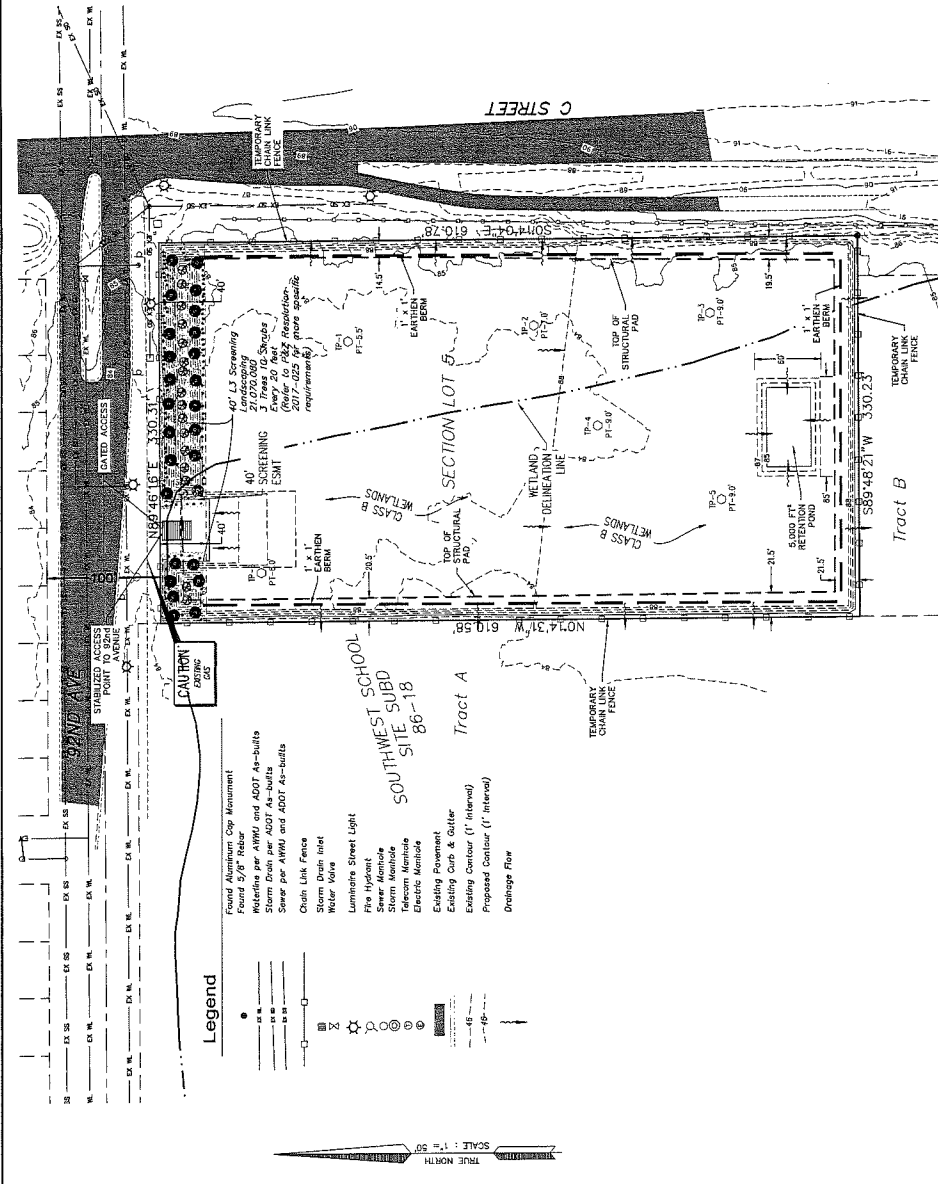
Notes:
 1. BASIS OF BEARINGS ARE THE FOUND MONUMENTS PER PLAN 2012-98.
 2. BASIS OF ELEVATION IS GAMB DATUM, 1972 NOS ADJUSTMENT.

SITE PLAN INFORMATION (AMC 21.05.080.E.5)

Drainage: Sheet C2 indicates drainage arrows to an onsite retention pond. Drainage will be directed away from the future building footprint.

Existing and proposed topographical contours (ten-foot contour): Sheet C1.0 in Appendix A shows one-foot contours.
