**SUBJECT:** Hearing on February 9<sup>th</sup>, 2015 - *Chester Creek Watershed Plan* Draft

# CHESTER CREEK WATERSHED PLAN

## DRAFT

Rev. 5, November 7, 2014

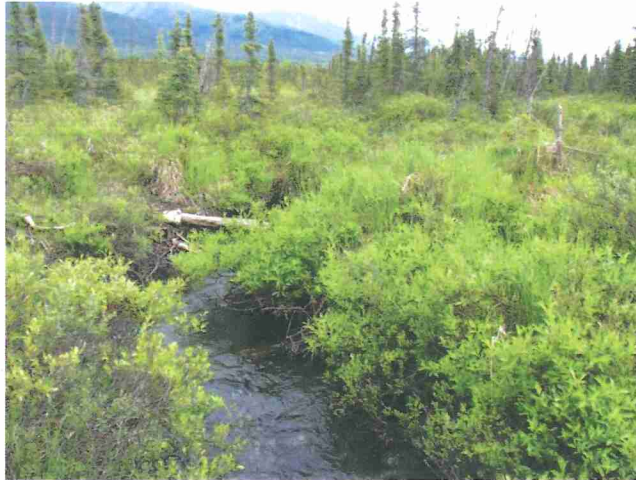
**Figure 3.1. South Fork Chester Creek Leaving JBER (Military Lands) (2011)**

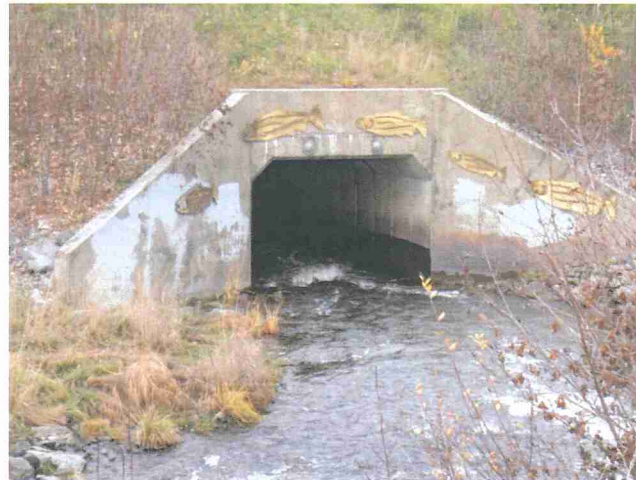
**Figure 3.2. Chester Creek Flowing out of Westchester Lagoon to Knik Arm (2013)**

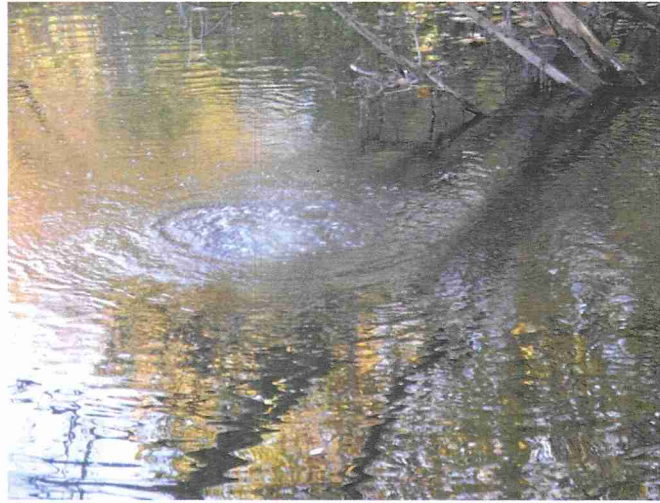
**Fig 3.16 Discharged water from the Alaska Native Medical Center Outflow Bubbling into University Lake, (2010)<sup>52</sup>**

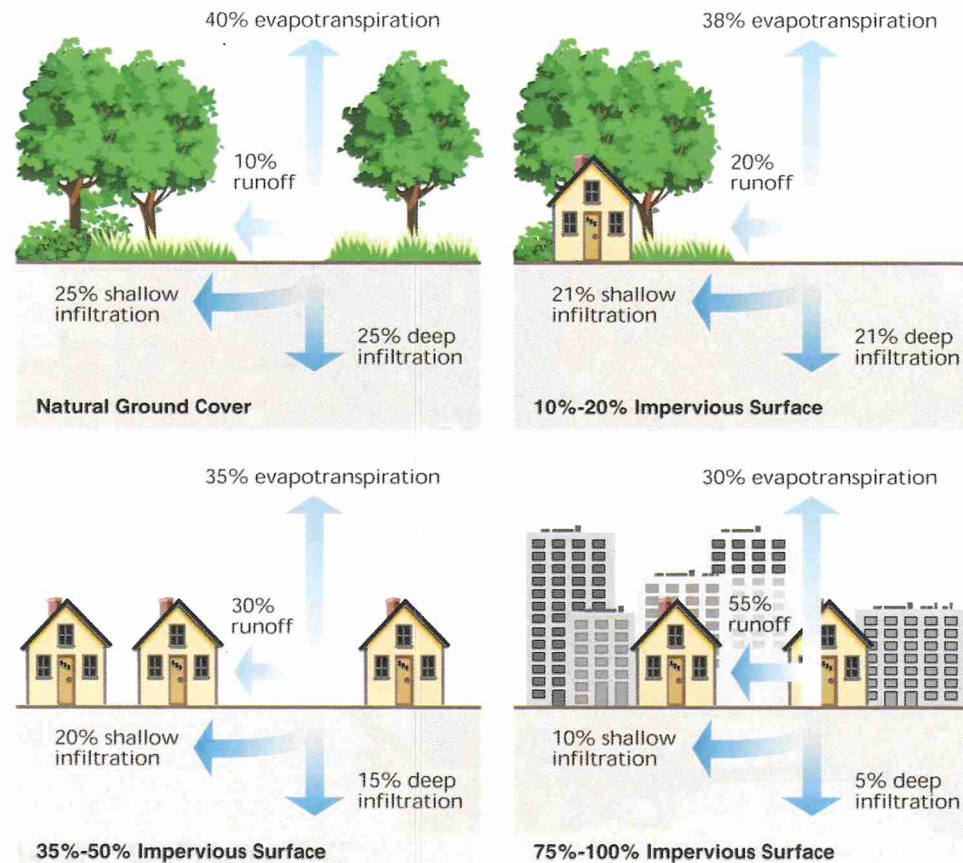
**Figure 3.21. Illustration of the Effect of Increased Urbanization on Impervious Surfaces and Surface Runoff<sup>59</sup>**

As cities grow and watersheds are urbanized, much of the vegetation is replaced by impervious surfaces, which reduces the area where infiltration to groundwater can happen. Thus, an increase in stormwater runoff occurs—runoff that must be collected by extensive drainage systems that

combine curbs, storm sewers, and ditches that carry it directly to streams. Simply put, in a developed watershed, more water arrives into a stream considerably faster, resulting in a greater likelihood of frequent and more severe flooding that can carry increased levels of pollutants. As cities grow and more development occurs, the natural landscape is replaced by roads, buildings, housing developments, and parking lots (Figures 3.22 and 3.23).

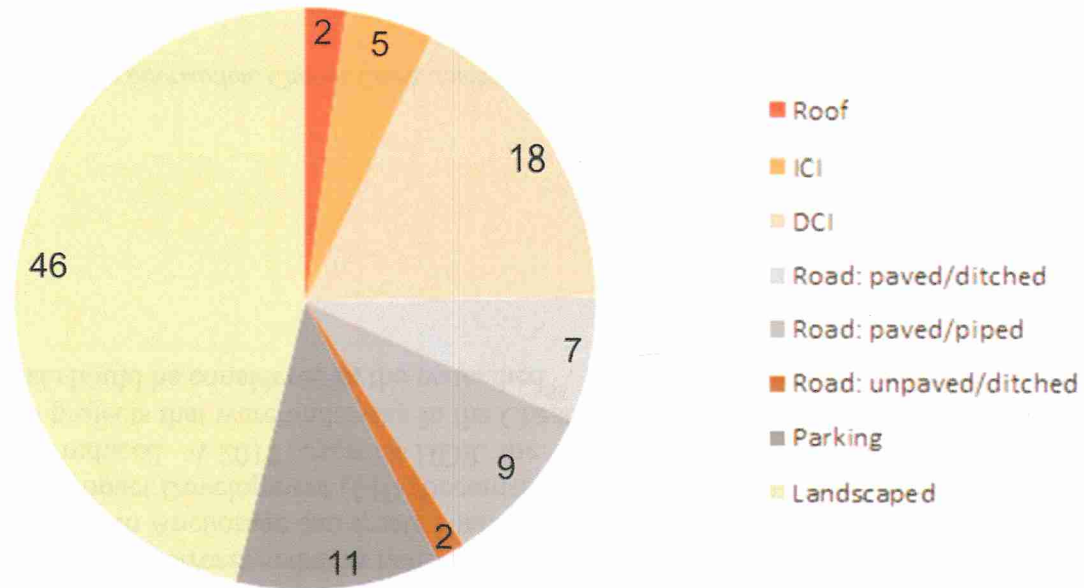
**Figure 3.22. Percentage of Various Impervious Landcover Surfaces in Chester Creek Watershed<sup>66</sup>**
