**Final Performance Report
October 1, 2017 through April 12, 2019**

**Municipality of Anchorage, AK
FY2017 EPA Brownfield Community-Wide Assessment Grants
for Hazardous and Petroleum Substances**

Cooperative Agreement: BF-01J39201

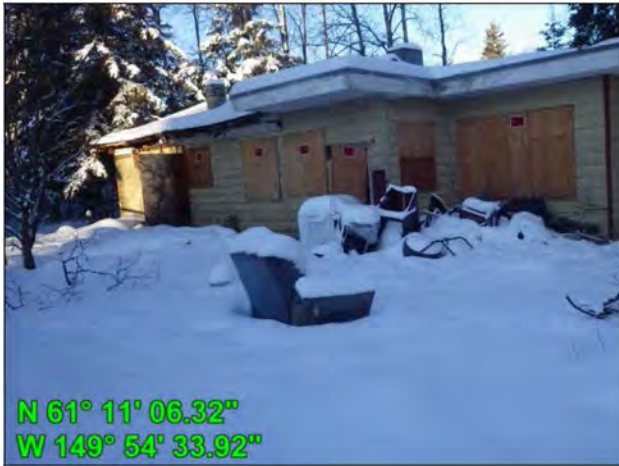
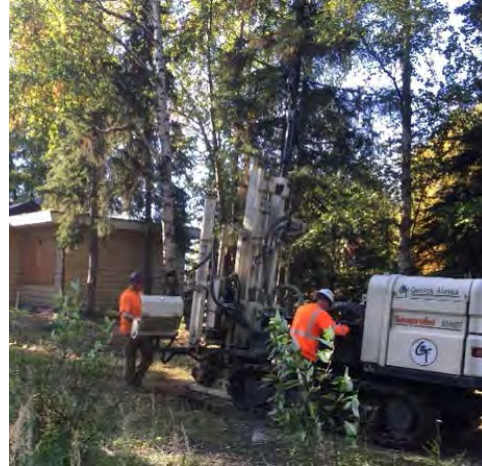
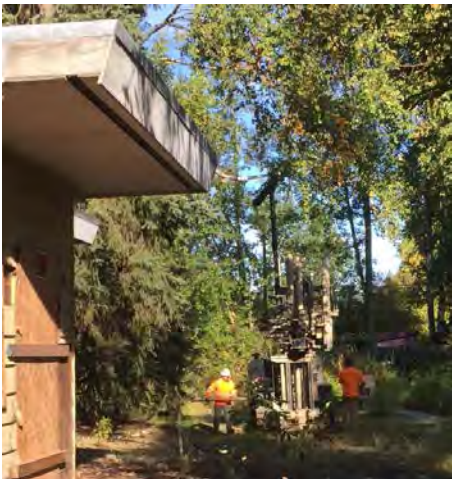
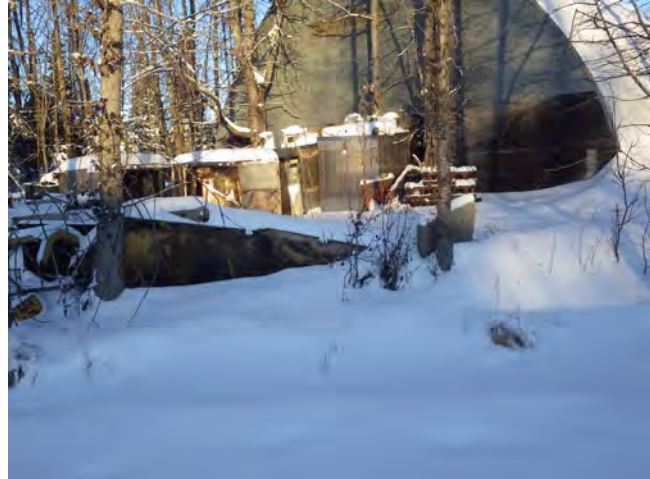
Site #1: 3901 Hayes St.

Background: The property consists of approximately 3.67 acres of land on an irregular-shaped parcel (Parcel No. 010-112-36-000; Tax Lot 107A) located in a mixed-use (residential, commercial, and light industrial) area. The property is generally flat with a boarded-up residential structure located on a rise in the southeastern corner of the property and Fish Creek, a channelized stream running south-southwest along the northwestern margin of the property.

The historical uses of the property included residential and commercial use as a construction equipment staging area. There were no environmental listings found for the site. However, the Phase I Environmental Site Assessment (ESA) conducted for the property identified the following recognized environmental conditions (RECs):

- Observed dumping at the property;
- Placement of fill material at the property; and
- A former Tesoro Olson Gas Service Station located on the northwest adjacent

Project Outcomes: Brownfield Community-Wide Assessment (CWA) Grant funding was used to complete a Phase I ESA, Phase II ESA and a Regulated Building Materials (RBM) survey to support the sale and redevelopment of the property. The Phase II ESA included advancing seven soil borings, the installation of five temporary monitoring wells and the construction of three soil vapor sampling points. The following contaminants were discovered at the property: arsenic (soil and groundwater), lead (groundwater), trichloroethane (soil), and diesel range organics (soil). There were no contaminants found in soil vapor.

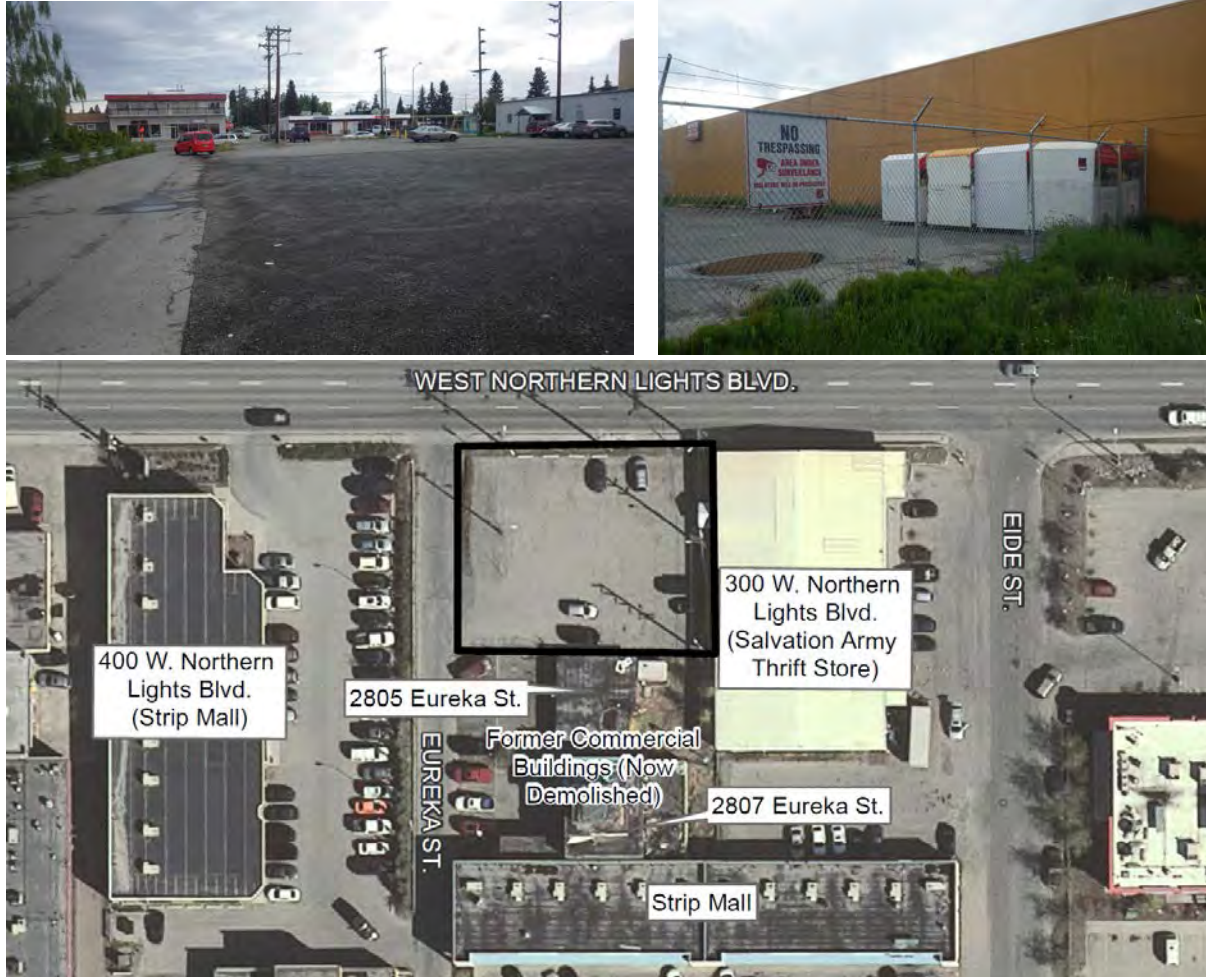
Site #2: Former Blueberry Substation

Background: The former Blueberry Substation property consists of approximately 0.27 acres of land on two contiguous and equally-sized, rectangular parcels (Parcel No. 009-035-45-000 and 009-035-46-000). The property is generally flat and is currently an asphalt-paved parking lot used by the Salvation Army thrift store located on the east adjacent property. The property is located in an area of mixed land use including vacant land, commercial and retail usage.

The property was formerly occupied by an electrical substation (Blueberry Substation) constructed in 1954 and operated by the Chugach Power Authority (CPA) until 1984 when it was transferred to the MOA Municipal Light and Power (MP&L) as part of a land swap settlement. According to MP&L, the electrical substation was decommissioned in 1997. No surface manifestations of the former use were visible during the site reconnaissance. A Phase I ESA was recommended to document historical uses of the property and adjacent properties in addition to identifying potential RECs associated with the property. The Phase I ESA identified the use of the property as an electrical

substation between 1954 and 1997 when it was reportedly decommissioned as a REC. Electrical substations typically utilize electrical transformers, capacitors, and other electrical equipment that contained dielectric fluids (oils). Based on the apparent age of the substation, the dielectric fluids may have contained polychlorinated biphenyls (PCBs), a class of hazardous material, as well as other oil-related semi volatile organic compounds (SVOCs).

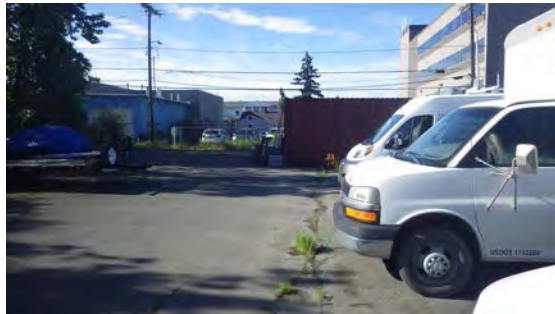
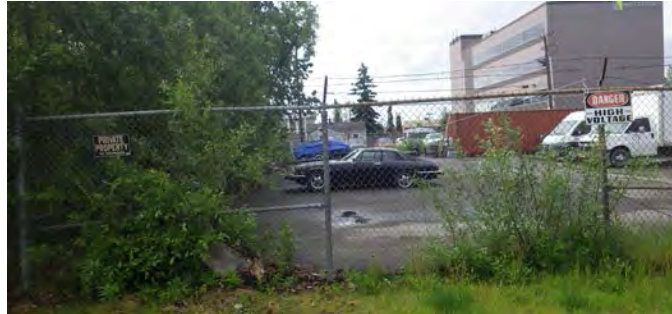
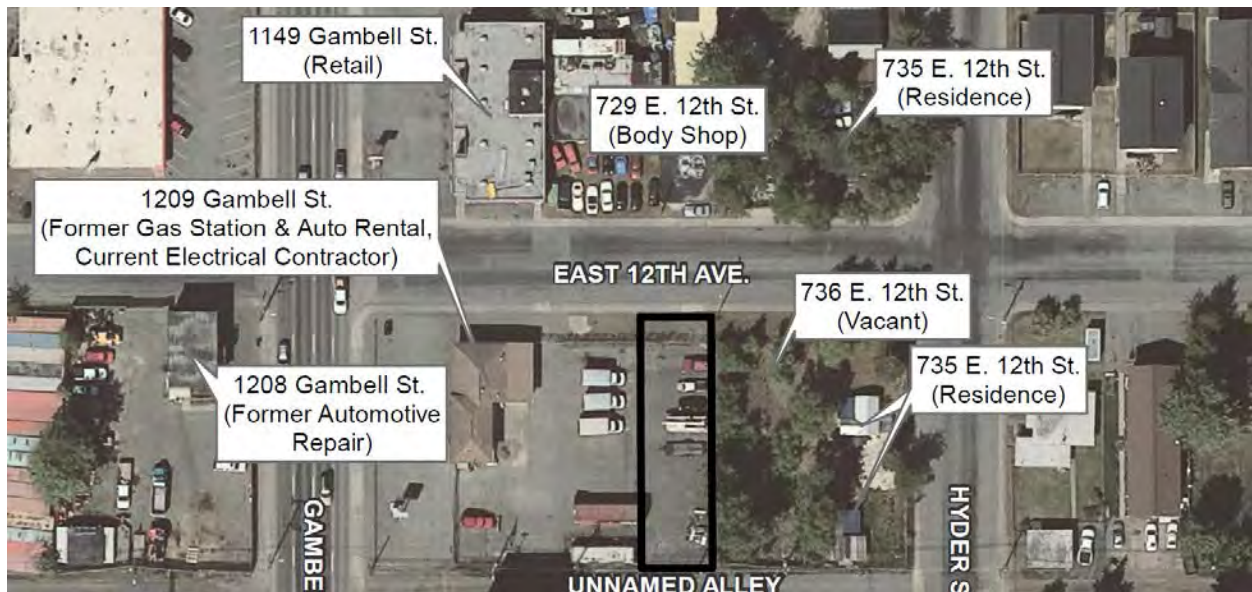
Site #3: Former Fairview Substation

Background: The former Fairview Substation property consists of an approximately 0.15 acres rectangular parcel of land (Parcel No. 002-131-41-000). The property is generally flat and is currently an asphalt-paved parking lot used for vehicle and material storage by Light'n Up, Inc., an electrical contractor located on the west adjacent property. The lot is fenced, with access through a locked gate on E. 12th Ave. The property is located in an area of mixed commercial and residential development. Immediately adjacent property uses are a mixture of undeveloped and commercial usage.

The property was formerly occupied by an electrical substation constructed in 1950 and operated by the Chugach Power Authority (CPA) until 1984 when it was transferred to the MOA Municipal Light and Power (MP&L). The electrical substation was decommissioned in 2007. No surface manifestations of former use as a substation are currently visible at the property. A Phase I ESA was recommended to document historical uses of the property and adjacent properties in addition to identifying potential RECs. The Phase I ESA identified the historical use of the property as an electrical substation for up to 57 years as a REC. The following RECs were identified for adjacent properties: the use of the west adjacent property as a retail gas station; 55-

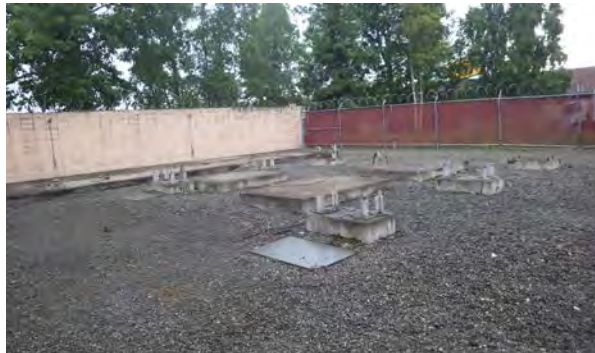
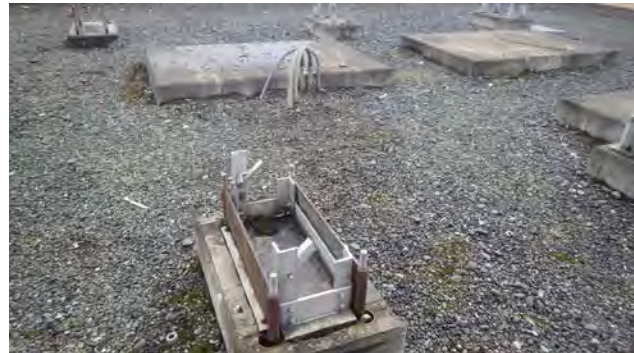
Site #4: Former Mountain View Substation

Background: The former Mountain View Substation consists of a single rectangular parcel totaling approximately 0.65 acres (Parcel No. 005-071-01-000) located in an area of commercial usage, with nearby residential areas. The perimeter of the property, excluding the right-of-way area on the western boundary contains grassy landscaped areas and several trees. An asphalt drive extends east from Bragaw Street onto the southeast corner of the Property and provides access to the former electrical substation. The former electrical substation was located within an area secured by a chain link fence and construction masonry unit wall. Although the electrical equipment for the former substation has been removed, several concrete pads that supported the former equipment are still present. The ground surface within the secured area is covered with gravel.

The electrical substation was constructed in 1962 and operated by the Chugach Power Authority (CPA) until it was transferred to the MOA Municipal Light and Power (MP&L) in 1984 and reportedly decommissioned in 1990. A 2011 aerial photograph shows that the electrical substation equipment was still present at the property. Discussions with MP&L indicate that decommissioning of an electrical substation may consist of de-energizing the equipment, draining the dielectric fluids and removing the equipment at a later date, as appears to have been the case for the property.

Project Outcomes: CWA Grant funding was used to complete a Phase I and Phase II ESA to support the sale and redevelopment of the property. The Phase II ESA results do not indicate any significant leaks or spills from electrical equipment. The presence of PCBs and PAHs were confirmed in a few soil samples, but at concentrations that are less than the ADEC cleanup levels. Thus, it was determined that no cleanup would be required.

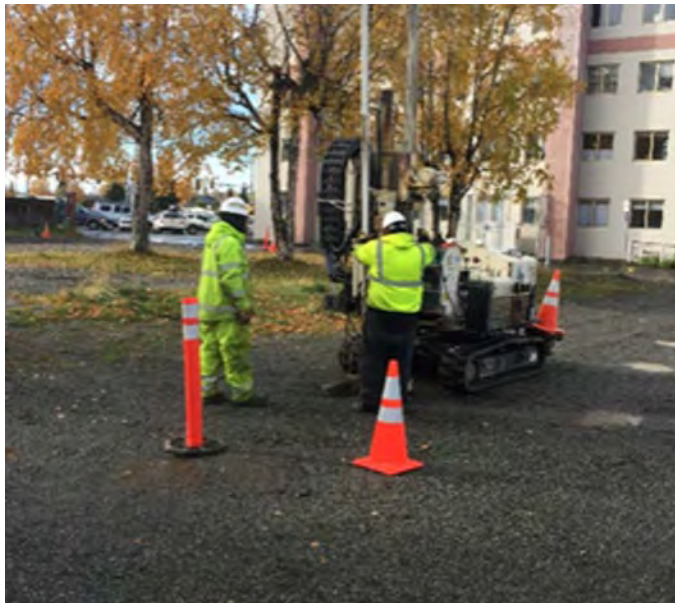
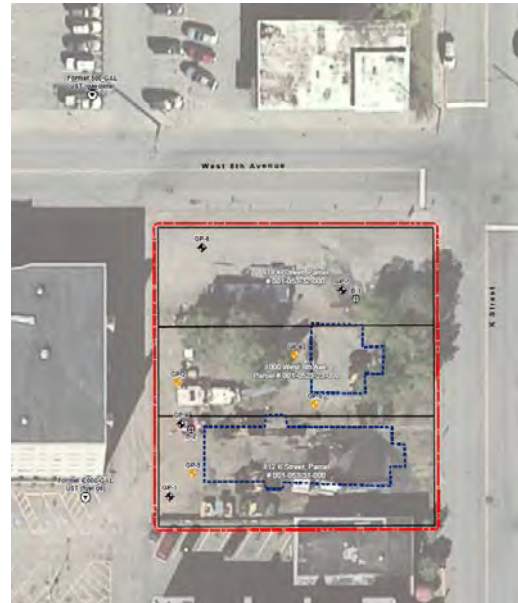
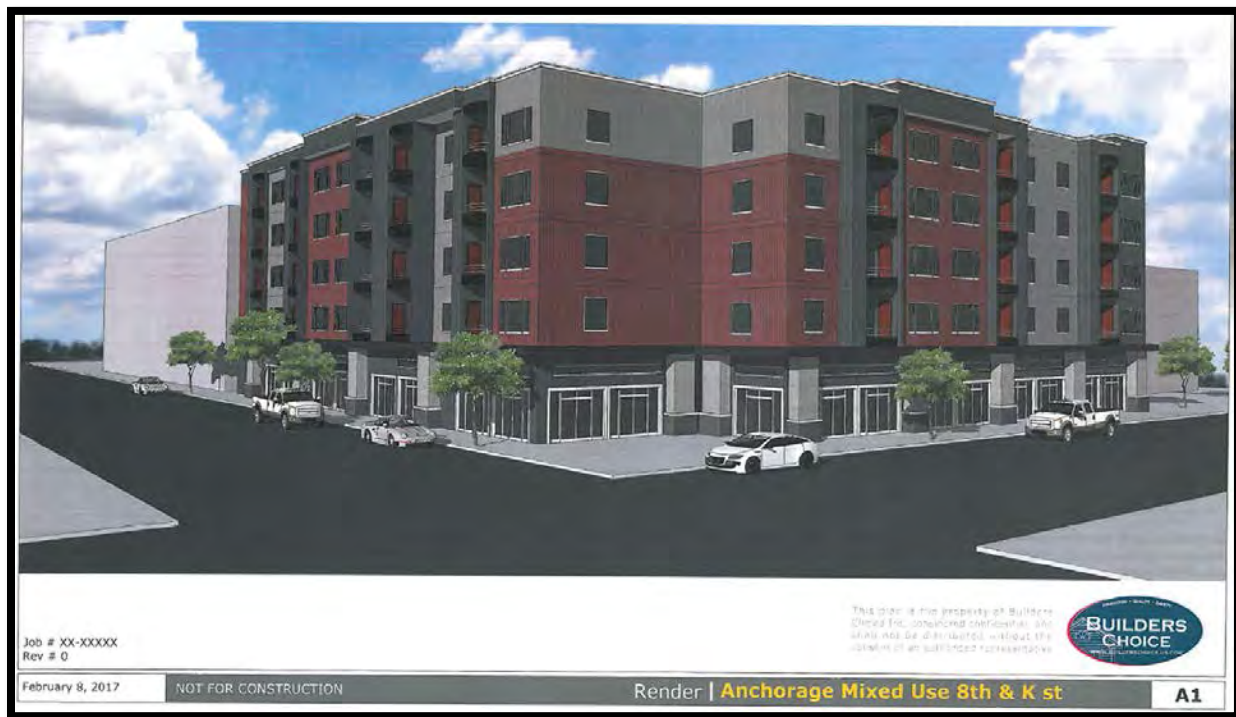
Site #5: Former Residential Site

Background: The property is approximately 0.48 acres in area and is located on the southwest corner of the intersection of West 8th Avenue and K Street. The property consists of three adjacent parcels (Parcel No. 001-053-23-000, 001-053-31-000, and 001-

053-32-000) owned by the Anchorage Community Development Authority (ACDA) since 2013. According to the 2018 Phase I ESA report for the property (Shannon and Wilson, 2018), the property was used for residential purposes from approximately 1950 to 2012 when the residential structures were demolished. Currently, the property is vacant and undeveloped.

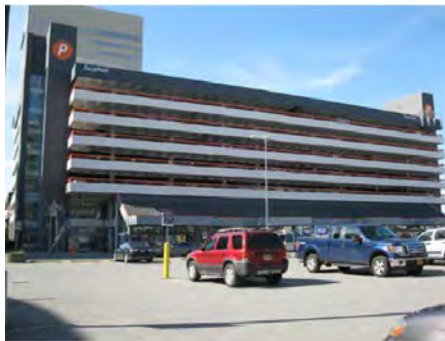
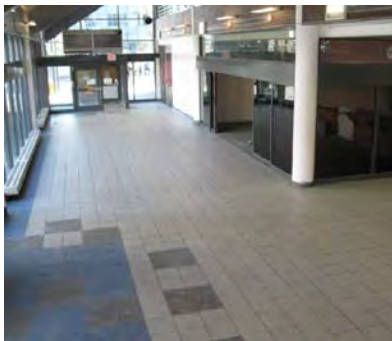
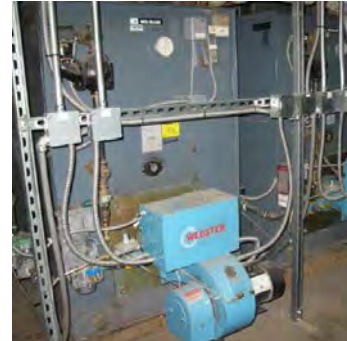
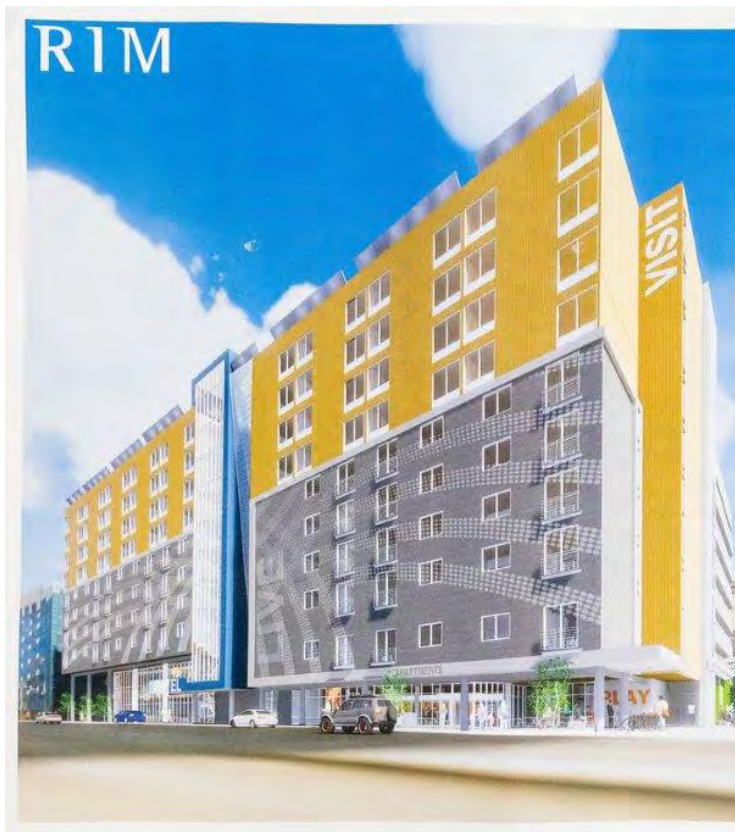
Site #6: Downtown Transit Center

Background: The property is approximately 2.06 acres in area and is located on the southwest corner of the intersection of West 6th Avenue and G Street. The Property consists of one parcel (Parcel No. 002-114-45-000) owned by the ACDA since 2013. The 6th and G Parking Facility, constructed in 1985, consists of a six-story parking garage with a two-story building section positioned along the north elevation of the structure that houses the Anchorage Downtown Transit Center (ADTC). The ADTC at the first level includes: office and operations related space for People Mover Public Transportation, ACDA; and security staff; suites that were previously leased for office space and food venues; public restrooms; a large open mall space; storage rooms; and mechanical

and electrical rooms. The second level of the ADTC is accessed by a main staircase, two exit stairwells, or by elevators that provide access to a mezzanine corridor leading to additional office suites.

A Phase I ESA completed by Shannon & Wilson in 2018 reported the potential presence of ACM, lead-based paint (LBP) and miscellaneous hazardous materials based on the building's construction date of 1985.

Therefore, EPA CWA funding was used to complete an RBM survey of the building. The survey found the following:

- ACM: According to record documents, the two existing Weil McLean hydronic boilers were installed in 1993 in conjunction with a partial replacement of the associated flue assemblies. The boilers and their flue assemblies are assumed to contain ACM within their internal construction.

- LBP: It was discovered that existing paint finishes were very common throughout the various interior spaces with little evidence of isolated paint coatings being used and no conditions were found to be suspect.

- Polychlorinated Biphenyls (PCBs): The inspection of ballasts contained within the example luminaires found in each case that the ballast(s) displayed the "No PCBs" marking on the ballast label.

- Universal Waste: Lamps, batteries, thermostats, and other materials can contain mercury, lead, and acid. These items were present and a recommendation made for them to be collected prior to demolition and to prevent inadvertent releases of hazardous materials.

- Radioactive Materials: Small amounts of radioactive materials can be found in smoke detectors and exit signs. These materials should be properly disposed prior to demolition.
