# CHAPTER 2.0 EXISTING CONDITIONS

# CHAPTER 2.1 GEOLOGY AND SOILS

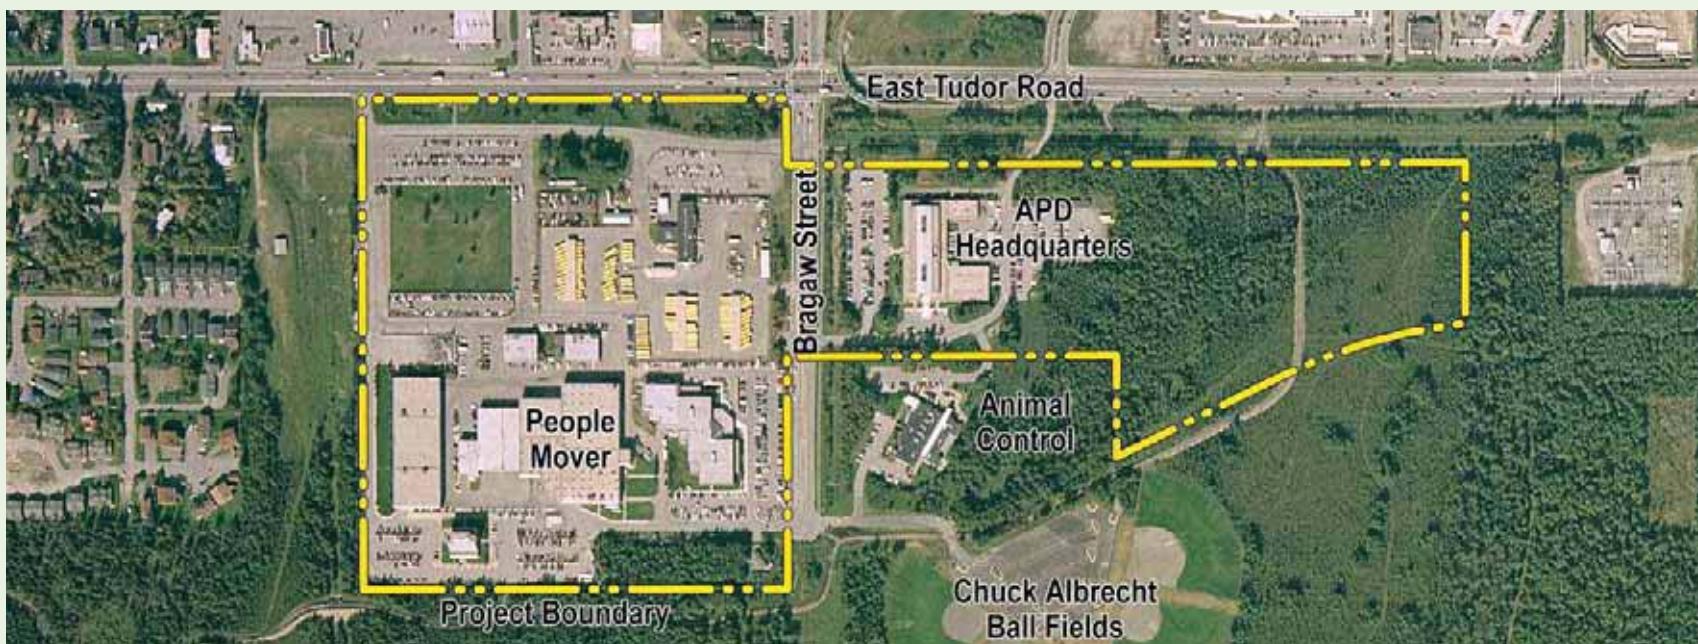
Figure 2: Original Site

The Visual Assessment document (May 2003) addressed the developed western portion of the site and only part of the master plan area east of Bragaw Street (Figure 2). In addition to documenting the existing natural resources and human environment of the area, it identified the significant site features for various areas. The positive visual attributes in the foreground areas included landscape buffers, wetlands, undeveloped forest, trails and educational signs along the trails. The positive visual attributes in the background included the forested areas to the south and the distant views of the mountains to the east.

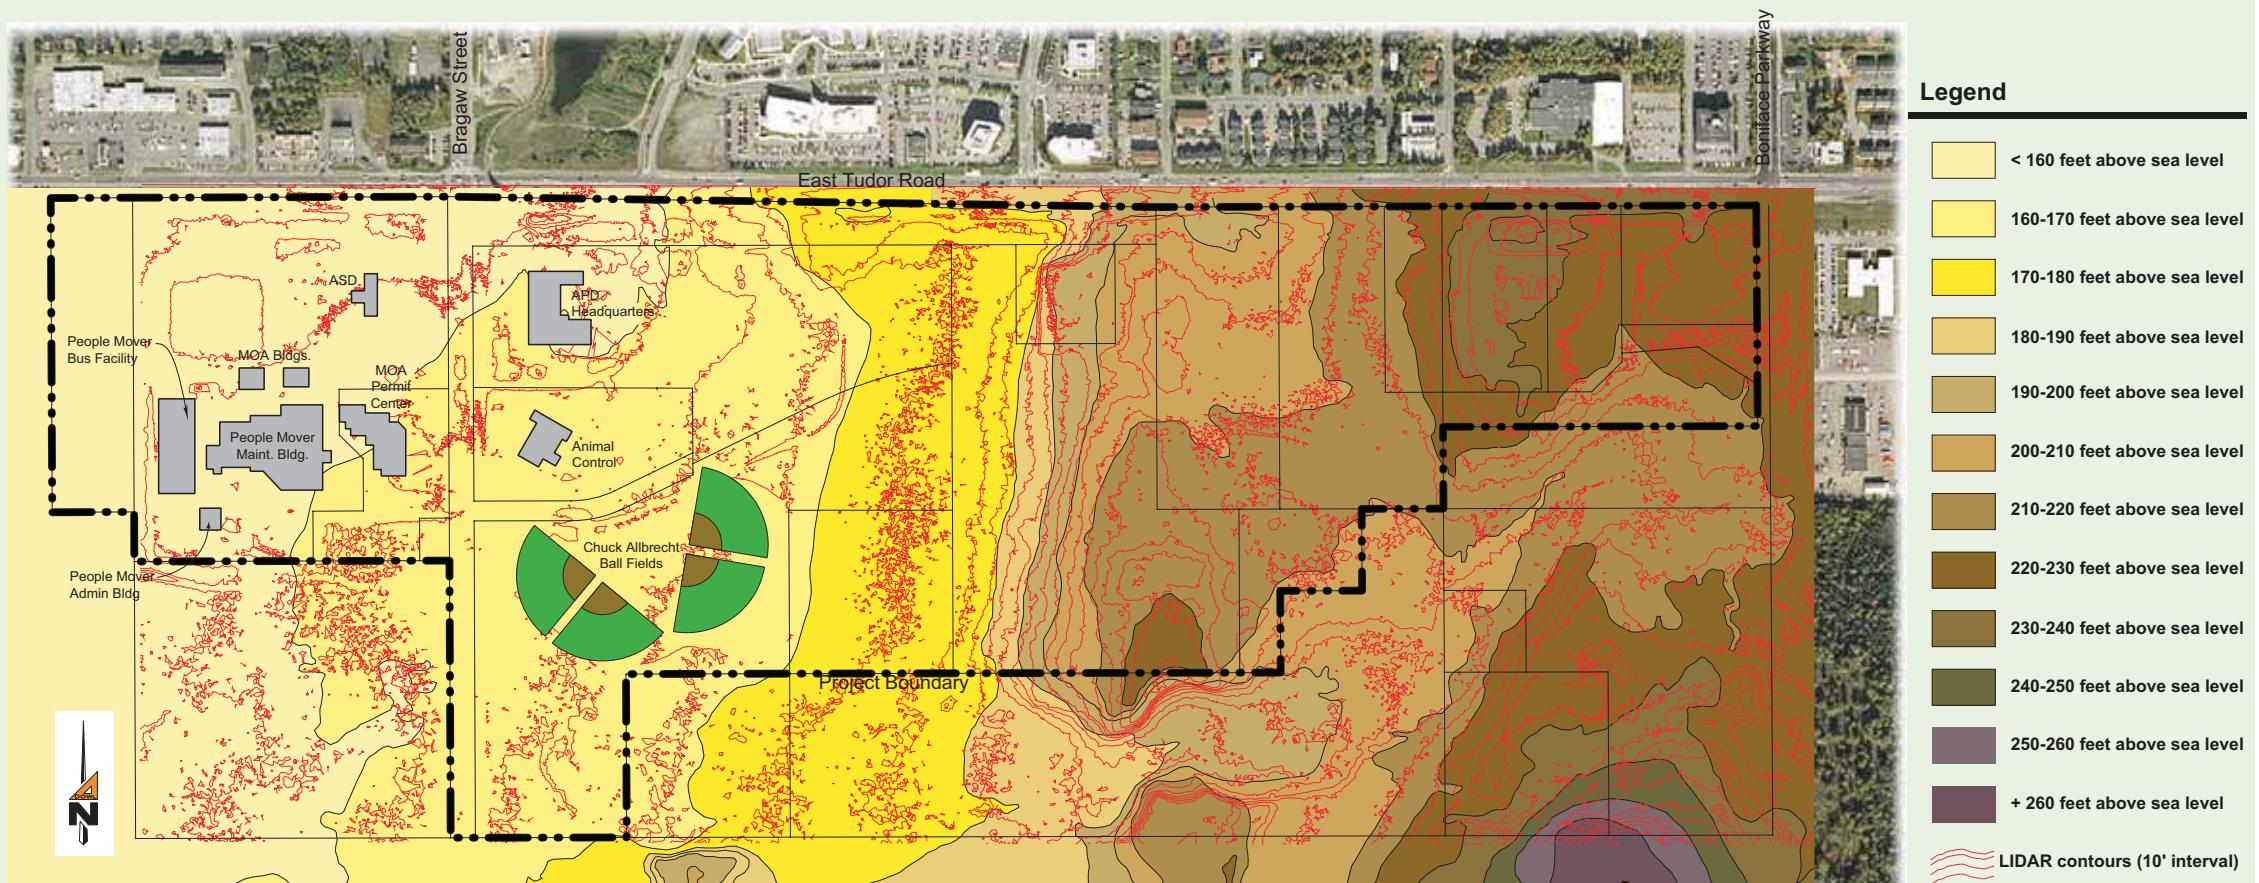
Figure 3: Expanded Site with Topography and LIDAR Data

The topography of this site is relatively flat. Traveling from the eastern end of the site to the western end, there is an 80-foot elevation change, and from the north to the south there is an elevation change from 0 to 30 feet (Figure 3). Just outside the project boundaries, the topography to the south and east begins to change rapidly. First dropping in elevation due to the presence of the north and south forks of Campbell Creek, the land then quickly rises into low foothills and then into the Chugach Mountains.

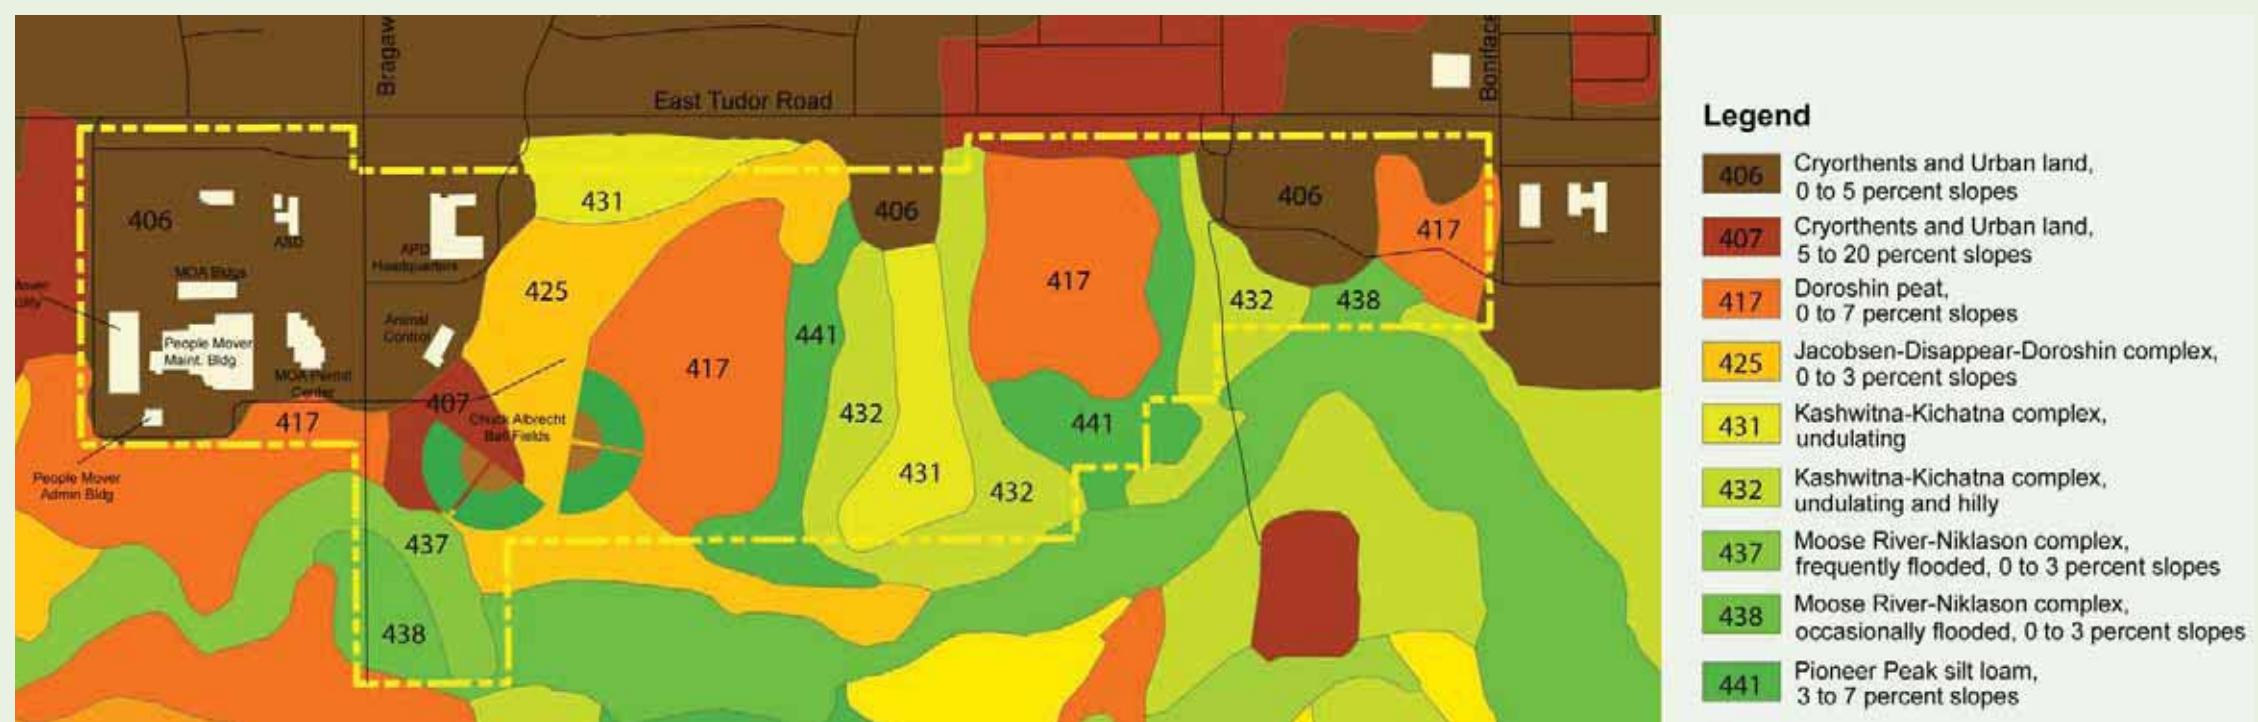
Figure 4: Soils Information

The project site contains nine different soil types (Figure 4). The soils range in character from Kashwitna-Kichatna complex, a soil generally well suited to land use and development, to Doroshin Peat, a soil type with a limited ability due to its high water table, organic material, and frost action, characteristics that result in significantly higher development costs. Table 2.1 lists the soil types found within the project site and their characteristics.

In terms of land use and future development possibilities, a significant portion of the site's soils have already been urbanized, particularly on the western side. The undeveloped area east of the existing APD headquarters is largely composed of soils that are severely wet and prone to frost action. Future development scenarios should recognize and consider this factor.

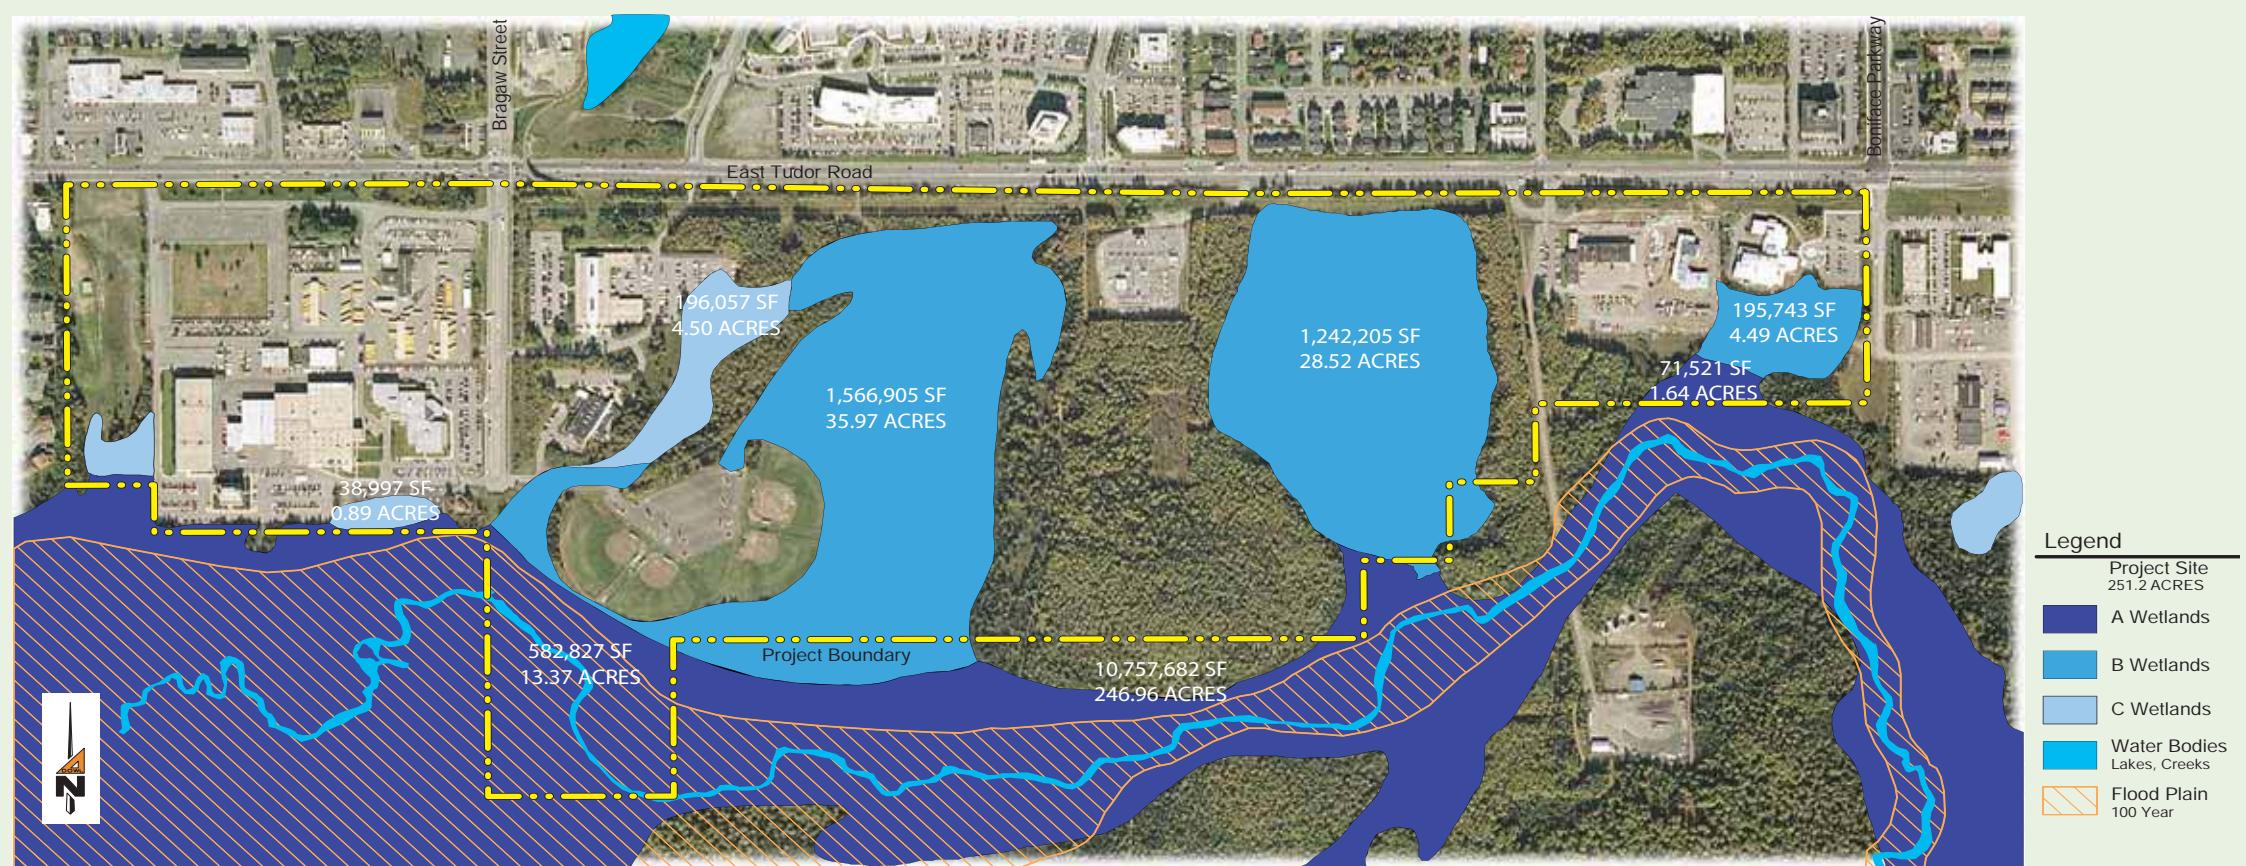
Figure 5: Hydrology and Wetlands

Although the master plan area contains no lakes or creeks, the north and south forks of Campbell Creek flow just to the south of the area, before converging about a half mile to the west. Both University Lake and Mosquito Lake lie about a mile to the north. Class A, B, and C wetlands exist on the project site (Figure 5). The Class A wetlands are located along the southern border of the project site, primarily along the Campbell Creek floodplain, southwest of the Chuck Albrecht Ball Fields, and south of the State of Alaska Food Safety and Health Laboratories.

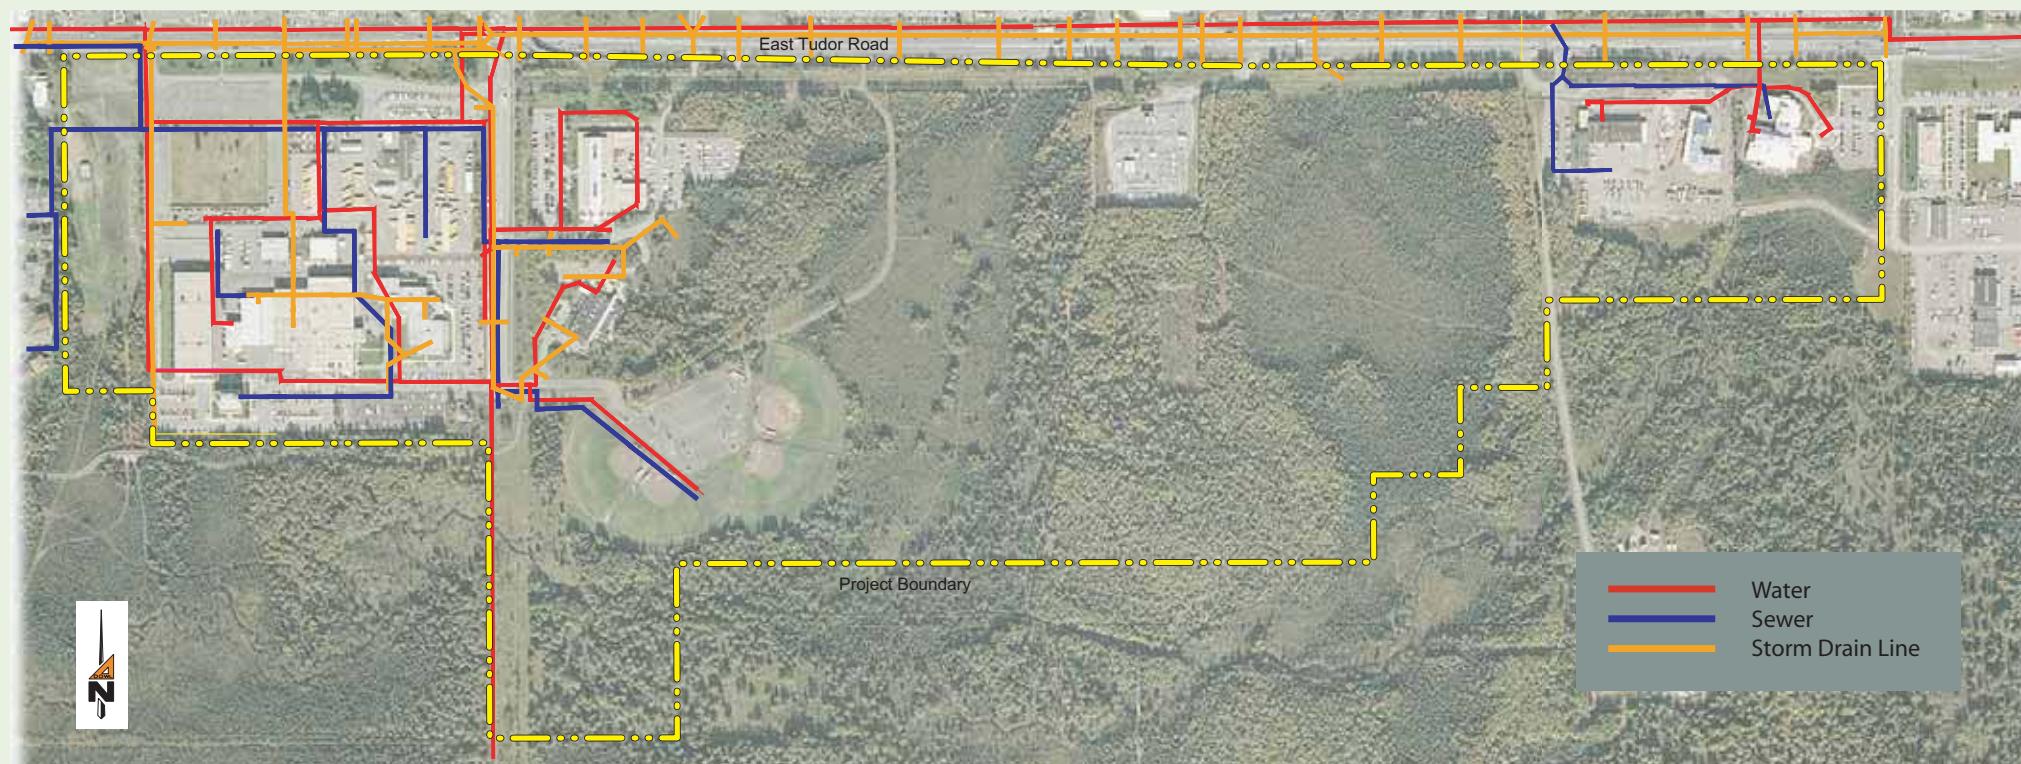
Figure 7: Existing Utilities

Sewer, water, gas, electrical, and telephone utilities currently exist within the developed areas of the master plan area (Figure 7). The undeveloped central portion of the master plan area is not currently served by any utilities. Sewer lines enter the master plan area from Tudor Road and serve all the existing buildings on the West side of Bragaw Street and the facilities at the east end of the area near Boniface Parkway. The sewer lines along Bragaw Street serve the limited development to the east of Bragaw Street (APD, Animal Control, and Chuck Albrecht Fields). Water is provided to the developed areas on the west end from Tudor Road and Bragaw Street. The facilities near Boniface Parkway are served from water lines in the Tudor Road corridor.

The main storm drain for the area runs along the Tudor Road corridor. Additional storm drain systems in the western portion of the master plan area include one along Bragaw Street, one that collects storm water from the developed area west of Bragaw Street, and one that collects storm water from APD and Animal Control. The storm drain system that serves APD and Animal Control connects into the storm drain on Bragaw Street. The storm drain on Bragaw Street and the storm drain system west of Bragaw Street connect into the main storm drain along Tudor Road (Figure 7).

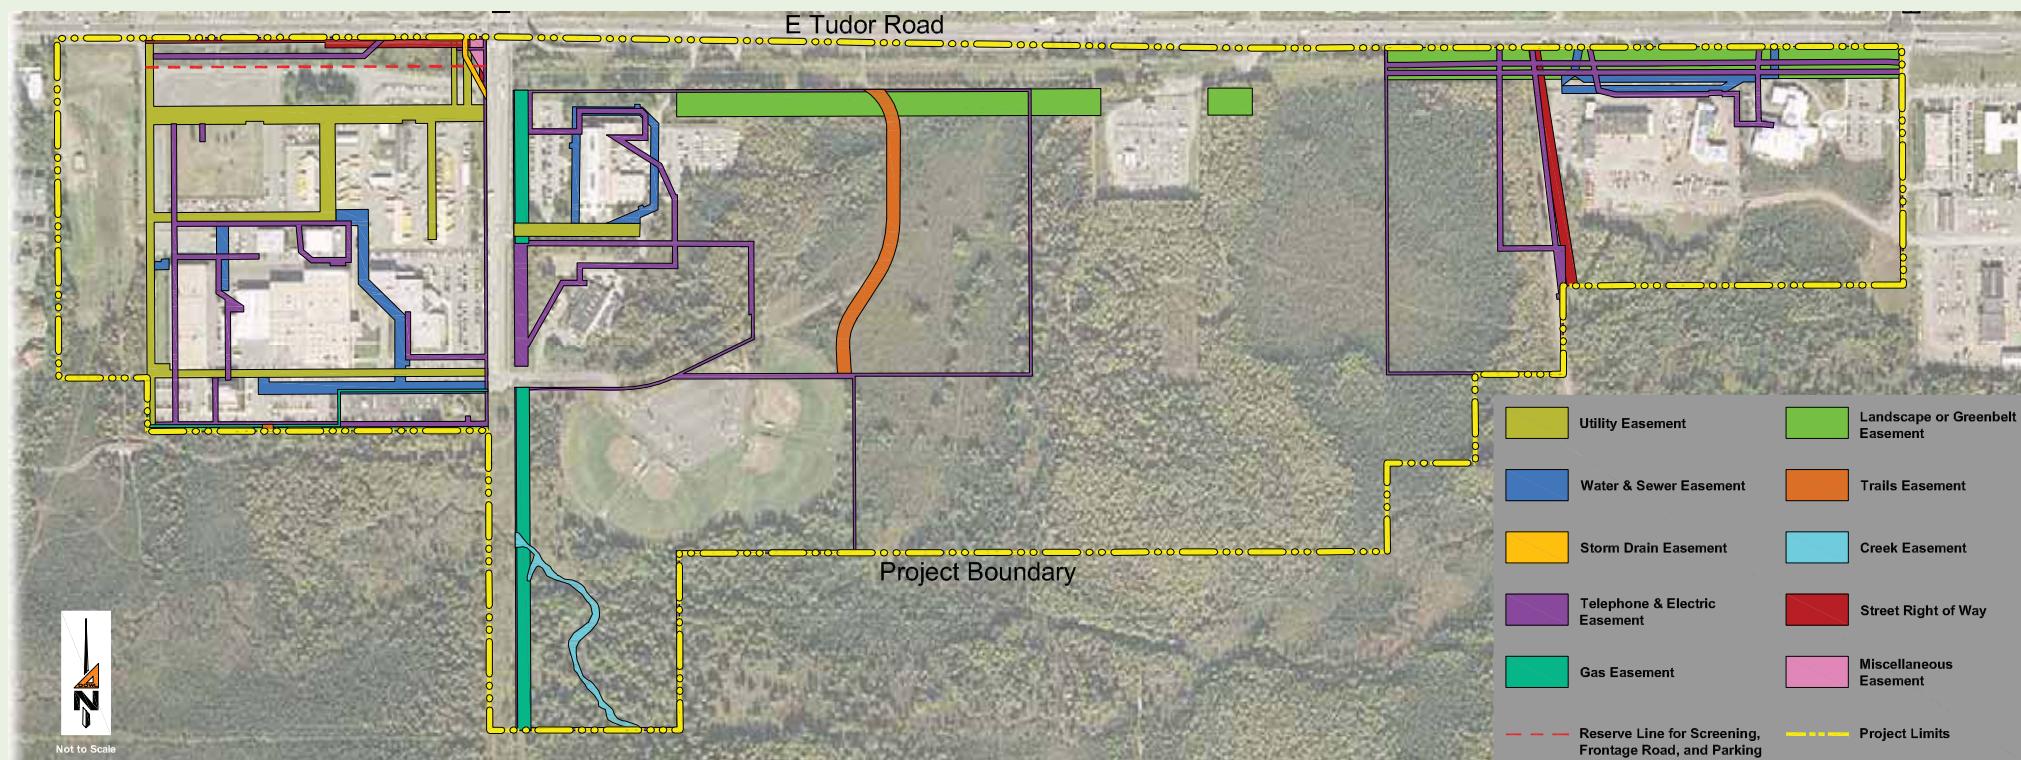
Figure 8: Existing Easements

Existing easements within the master plan area include: gas, water, electrical, telecommunication, general utility, fire hydrant, sanitary sewer, public use, storm drain, trail, buffer landscape, and greenbelt easements. Figure 8 illustrates the location, orientation, and extent of these easements.

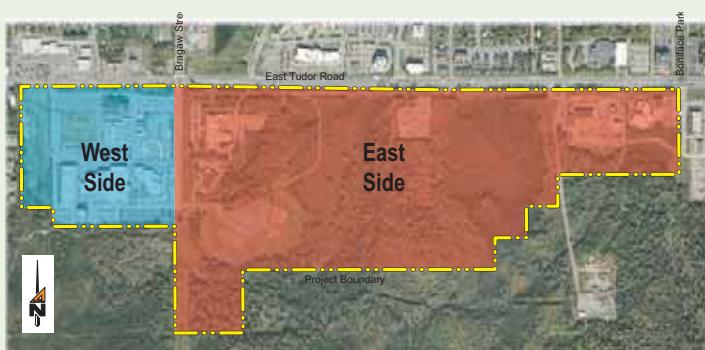
Figure 9: Access to East and West Side Areas

The master plan area consists of two parts with Bragaw Street as the dividing line. This analysis will look at the access and circulation for each part separately. For convenience, the master plan area west of Bragaw Street will be called the West Side, and the master plan area east of Bragaw Street will be called the East Side (Figure 9).

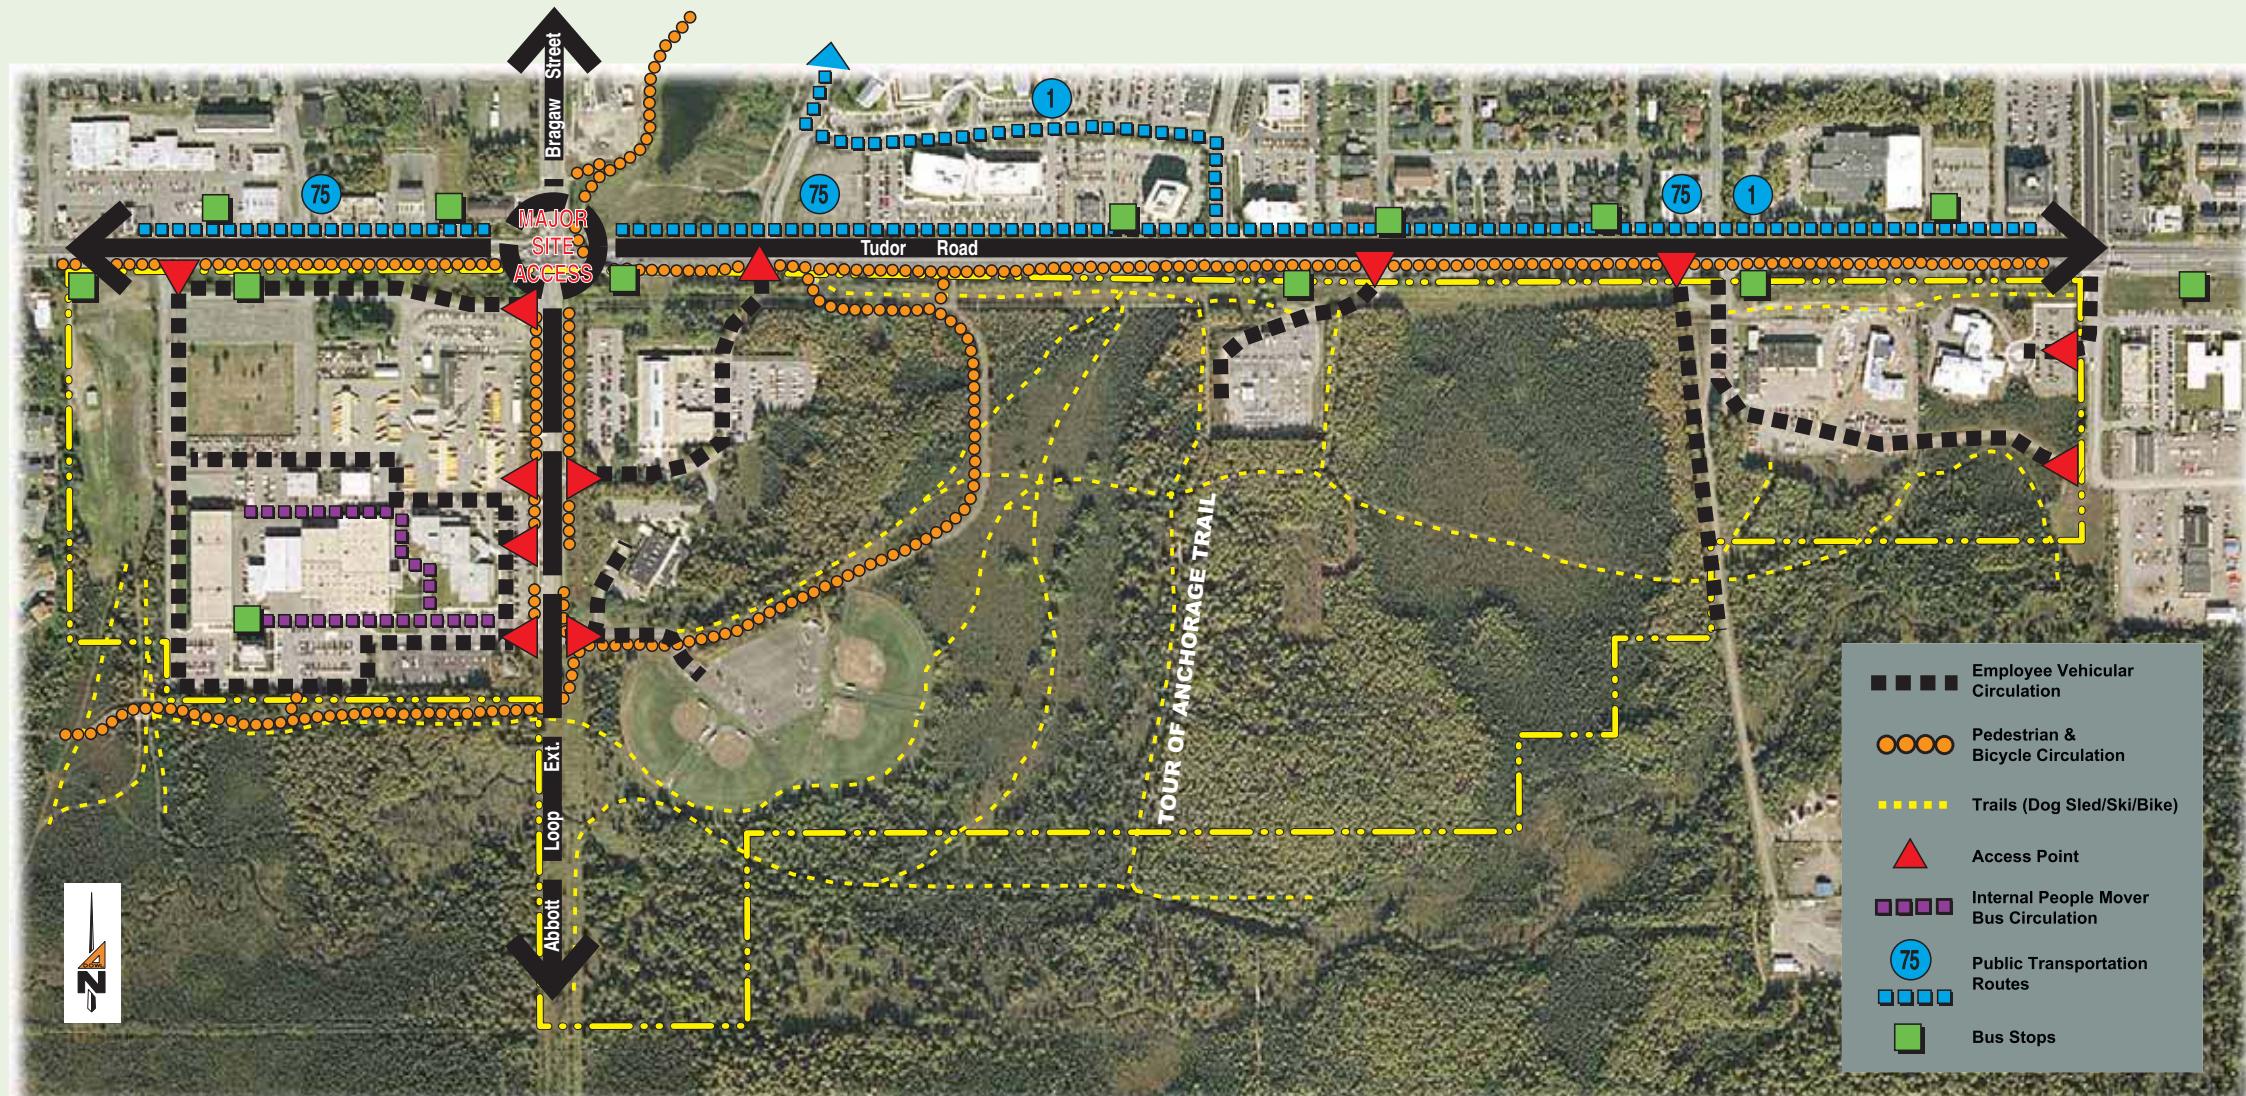
Figure 10: Existing Circulation

Eastbound traffic on Tudor Road can access the West Side through a right-turn-in/right-turn-out curb cut at the northwest corner of the parcel (Figure 10). Vehicles from all other areas must use the Tudor Road and Bragaw Street signalized intersection for access to Bragaw Street and then into the site. The Tudor Road and Bragaw Street intersection operates at level of service (LOS) E during peak hours. The DOT&PF recently completed a project to expand an eastbound/southbound turn lane to help with traffic flow at this intersection. The adopted LRTP justifies the need to reduce the traffic congestion at the Tudor Road and Bragaw Street intersection with the extension of 48<sup>th</sup> Avenue from Bragaw Street to Boniface Parkway.
