Application for Wetland Permit
Laurel Acres Subdivision Block 9, Lot 1

Laurel Acres Block 9, Lot 1 Wetland Permit Narrative

Wetland Delineation Investigation
Lot 1, Block 9 Laurel Acres Subdivision, Anchorage, AK—
July 3, 2025

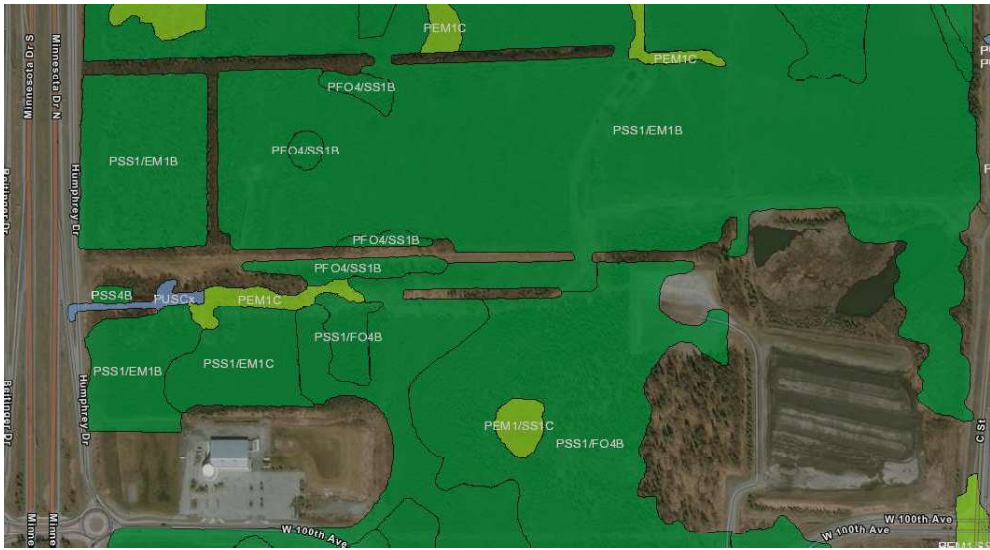
NWI:

Since we discussed it, here are snapshots of the NWI vs MOA mapper. NWI is by no means 100% accurate but I believe it matches real world conditions along the pipe stream "cooridor" better than the MOA wetlands mapper.

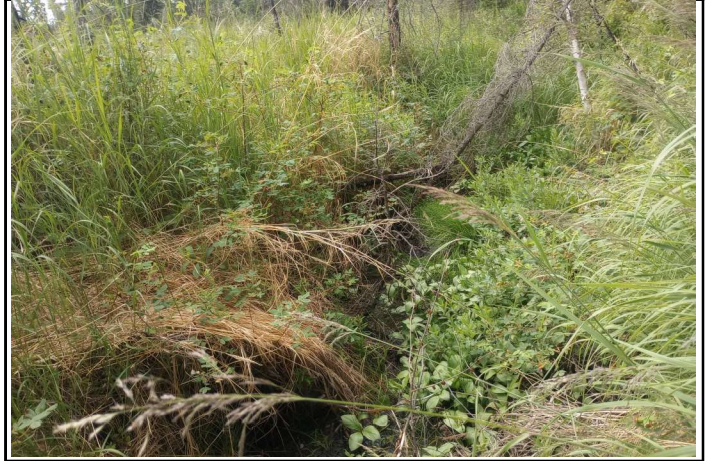
Typical view of constructed ditch oriented (east-west) located southwest of the subject property at 61.135365, -149.89882.

3TA observed previous disturbance to vegetation and soil on all sides of the subject property just beyond the property boundaries. In the 1970s, a trench for the purpose of draining wetlands was constructed just beyond the southern property boundary. In the 1980s the vegetation appears to have been cleared just beyond the eastern property boundary for an unknown purpose. In the 1990s the area beyond the western

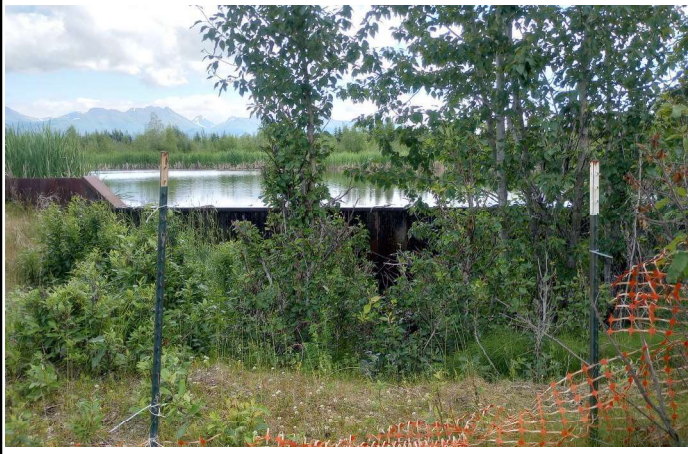
View of the sheet pile dam and man-made wetlands located approximately 800ft southeast of the subject property. View is to the southeast.

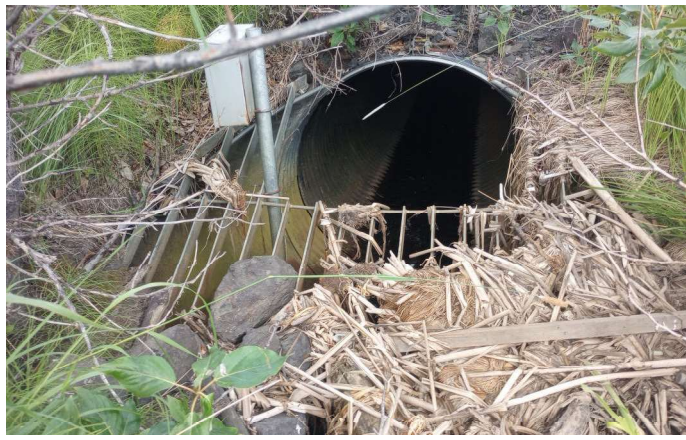
View of the pipe stream inlet at 61.133624, -149.891645. Sheet pile dam is behind photographer.

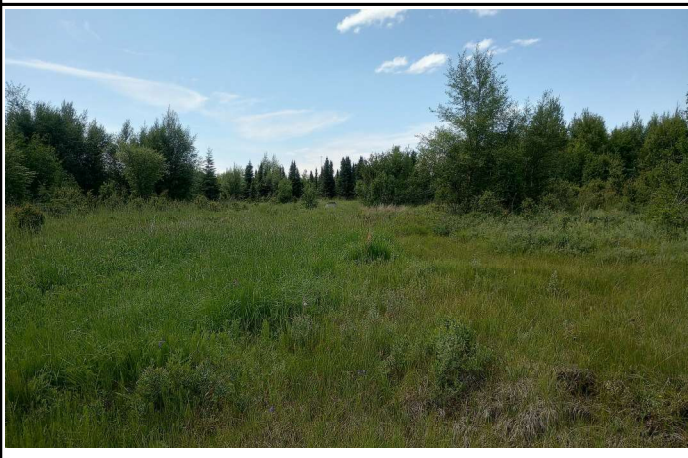
Photo of the previously disturbed pipe stream route taken from 61.133882, -149.892833. Access manhole is visible at center. View is to the west.

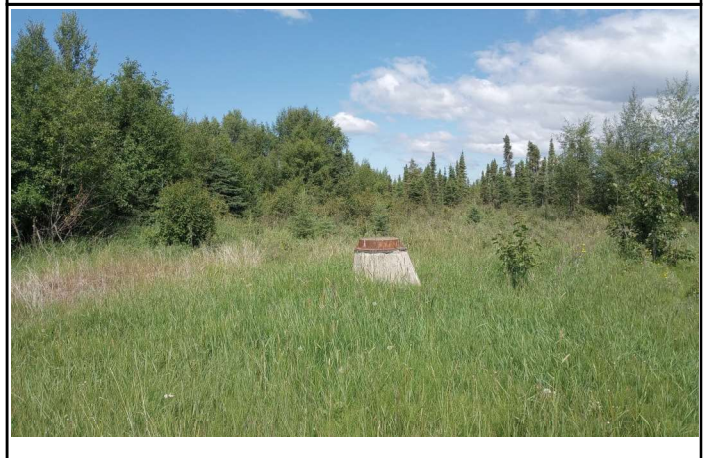
Photo of the previously disturbed pipe stream route taken from 61.133639, -149.895271. Access manhole is visible at center. View is to the north.

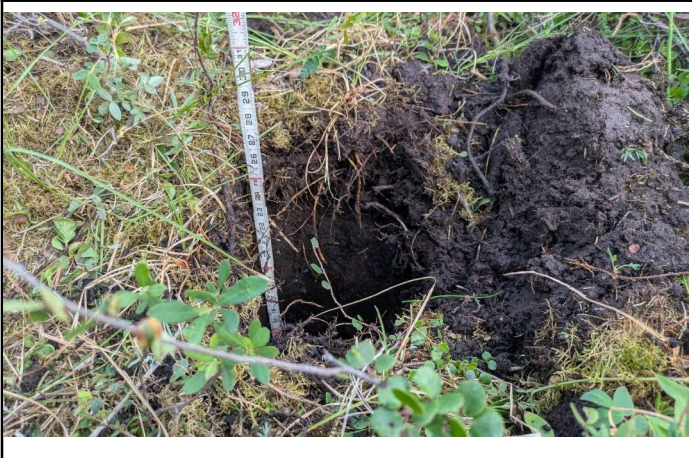
SP1 test pit.

Profile Description: (Describe to the depth needed to document the indicator or confirm the absence of indicators.)								
Depth (inches)	Matrix		Redox Features				Texture	Remarks
	Color (moist)	%	Color (moist)	%	Type ¹	Loc ²		
0 - 27							Mucky Peat	
-								
-								
-								
-								
-								
-								
-

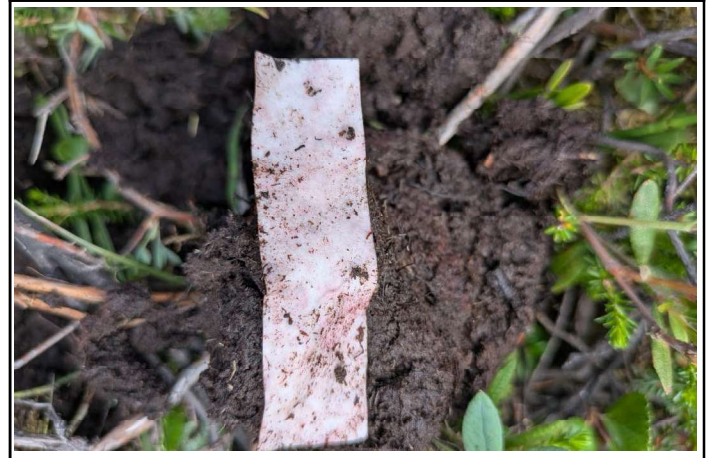
SP1—presence of 'C4—Reduced Iron' using dipyrldyl paper

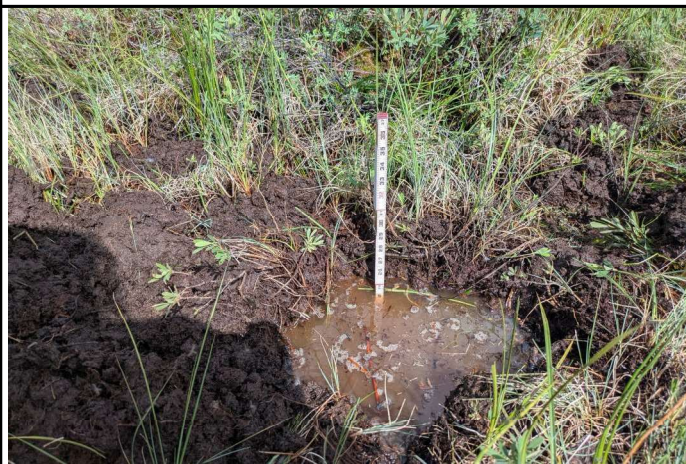
SP2 test pit.

Profile Description: (Describe to the depth needed to document the indicator or confirm the absence of indicators.)								
Depth (inches)	Matrix		Redox Features				Texture	Remarks
	Color (moist)	%	Color (moist)	%	Type ¹	Loc ²		
0 - 30							Peat	
-								
-								
-								
-								
-								
-								
-

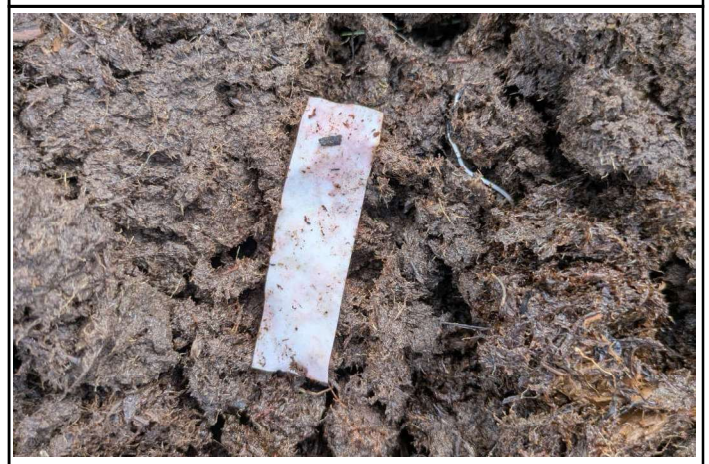
SP2—presence of 'C4—Reduced Iron' using dipyrldyl paper
