Application for Wetland Permit
Laurel Acres Subdivision Block 9, Lot 1

Laurel Acres Block 9, Lot 1

Wetland Permit Narrative

Wetland Delineation Investigation
Lot 1, Block 9 Laurel Acres Subdivision, Anchorage, AK—
July 3, 2025

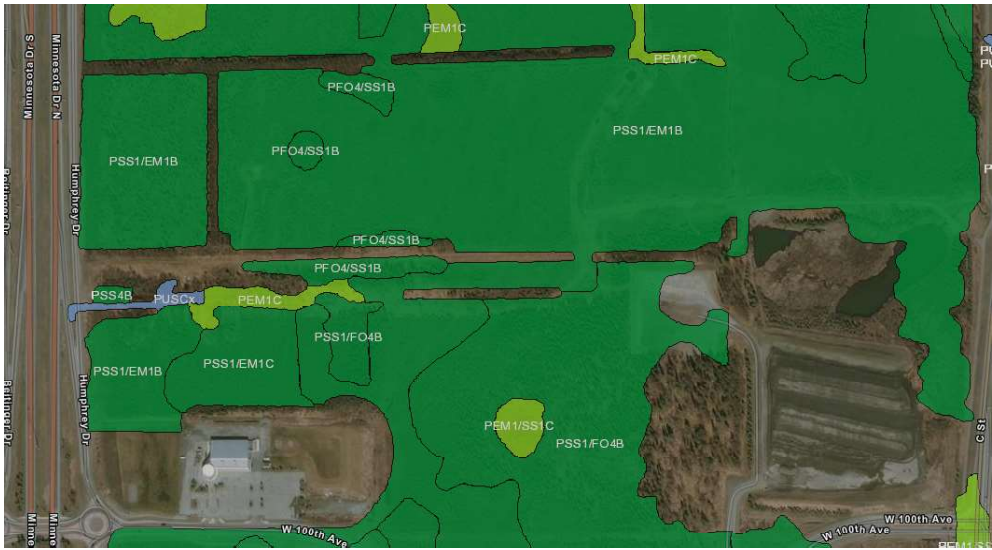
NWI:

Since we discussed it, here are snapshots of the NWI vs MOA mapper. NWI is by no means 100% accurate but I believe it matches real world conditions along the pipe stream "cooridor" better than the MOA wetlands mapper.

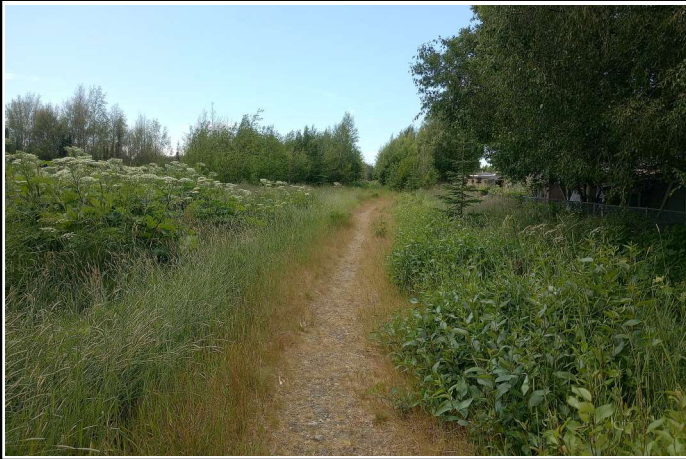
Overgrown access road just north of northern property line at 61.137457, -149.892396. View is to the west.

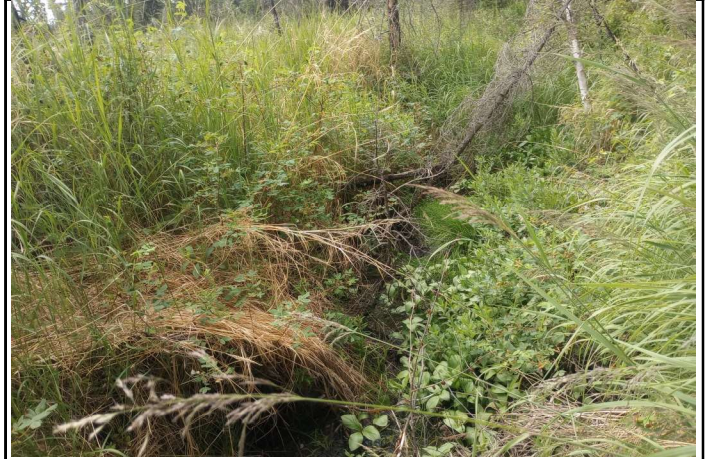
Typical view of constructed ditch oriented (east-west) located southwest of the subject property at 61.135365, -149.89882.

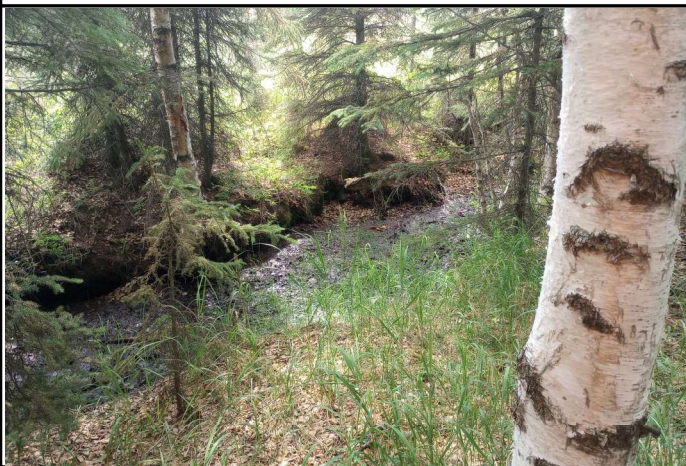
Typical view of constructed ditch oriented (east-west) located southwest of the subject property at 61.135417, -149.897131.

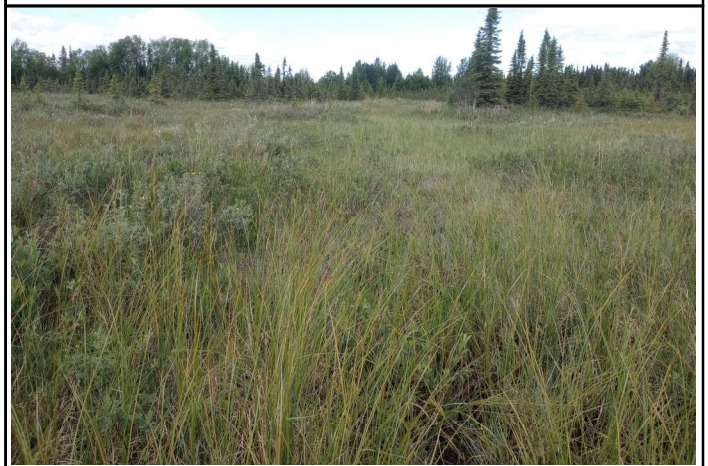
Typical view of previously disturbed area oriented (north-south) located southeast of the subject property at 61.135026, -149.892131. View is to the north.

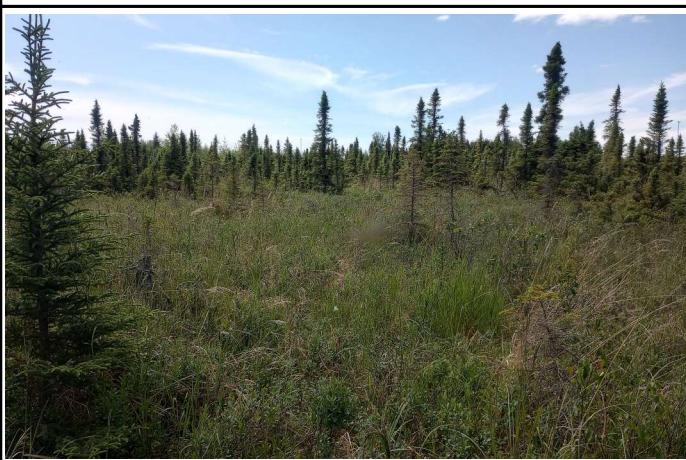
Typical view of wetland located due west of property at 61.135675, -149.895179. View is to the north.

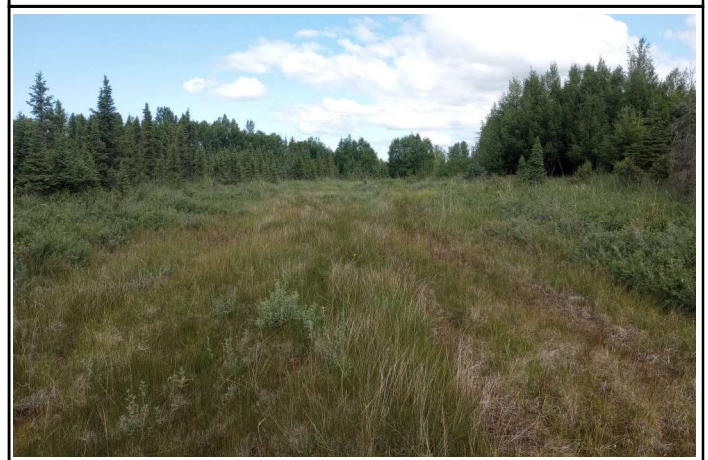
Typical view of previously disturbed area oriented (north-south) located southwest of the subject property at 61.134574, -149.895310. View is to the northeast.

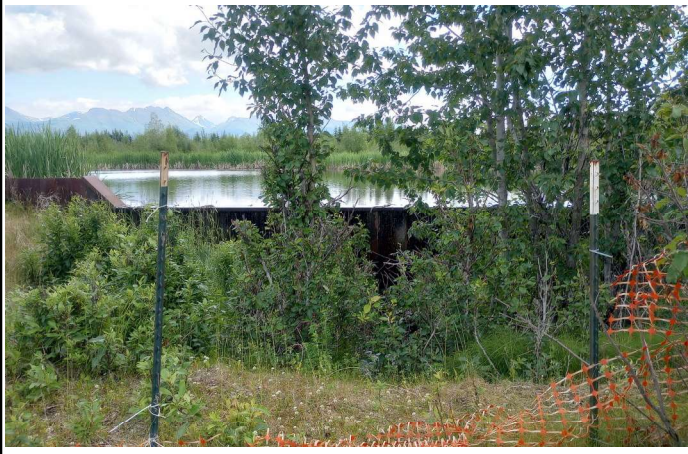
View of the sheet pile dam and man-made wetlands located approximately 800ft southeast of the subject property. View is to the southeast.

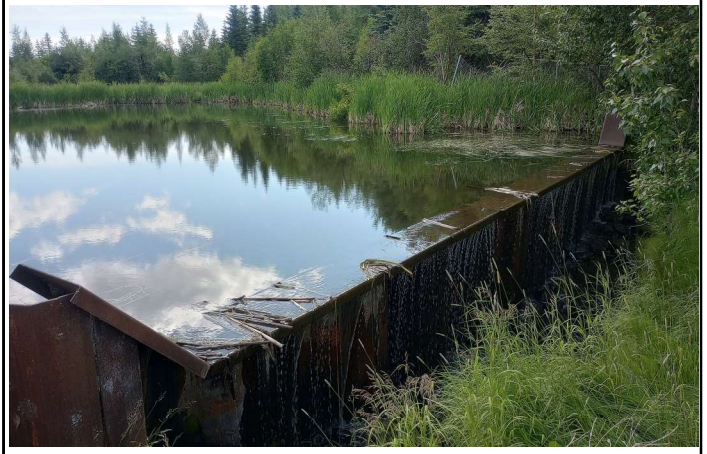
Sheet pile dam and man-made wetlands at 61.133653, -149.891577. View is to the south.

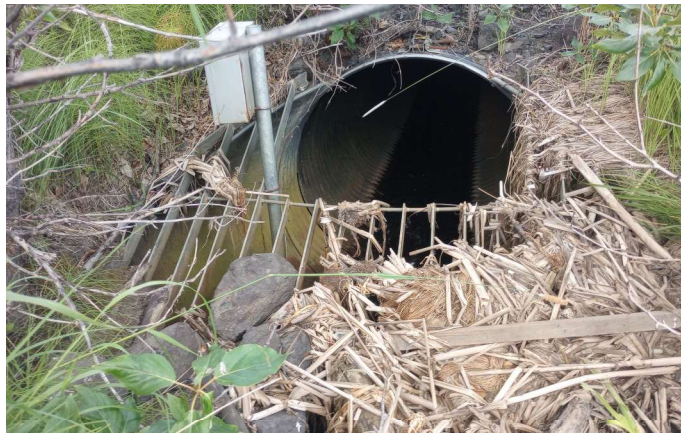
View of the pipe stream inlet at 61.133624, -149.891645. Sheet pile dam is behind photographer.

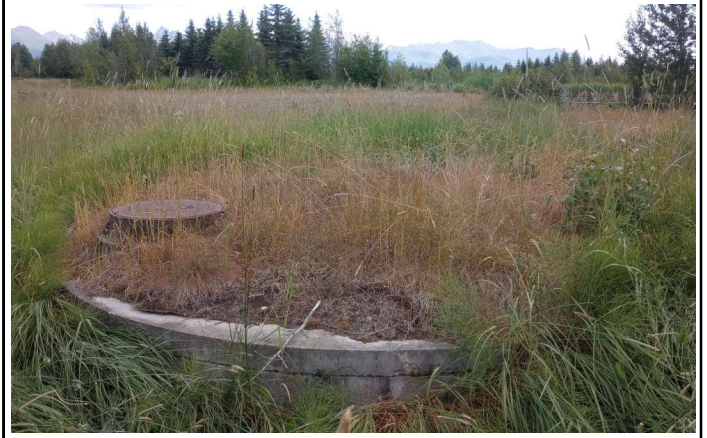
Picture of a utility vault located approximately 100ft northwest of sheet pile dam at 61.133882, -149.891931. View is to the east.

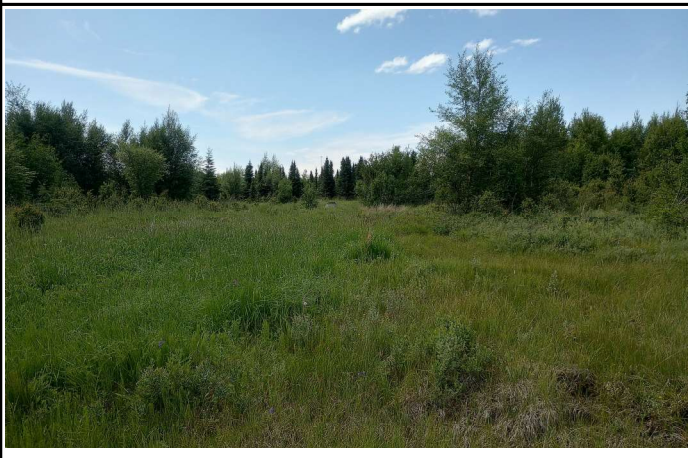
Photo of the previously disturbed pipe stream route taken from 61.133882, -149.892833. Access manhole is visible at center. View is to the west.

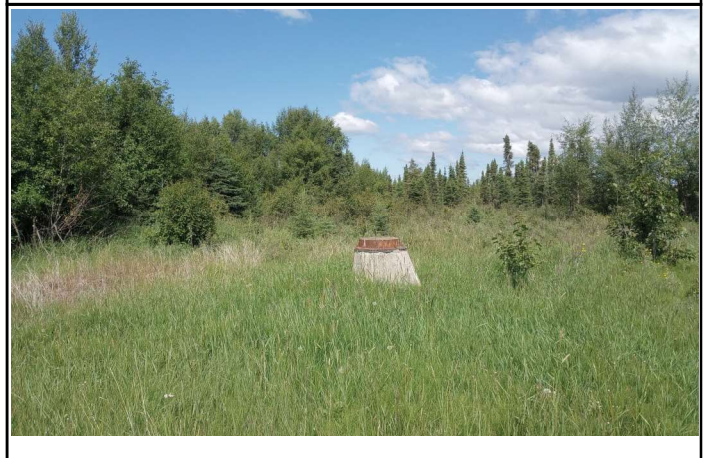
Photo of the previously disturbed pipe stream route taken from 61.133639, -149.895271. Access manhole is visible at center. View is to the north.

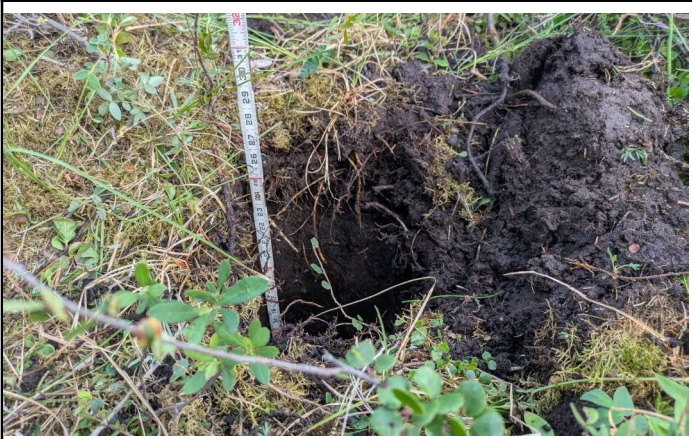
SP1 test pit.

Profile Description: (Describe to the depth needed to document the indicator or confirm the absence of indicators.)								
Depth (inches)	Matrix		Redox Features				Texture	Remarks
	Color (moist)	%	Color (moist)	%	Type ¹	Loc ²		
0 - 27							Mucky Peat	
-								
-								
-								
-								
-								
-								
-

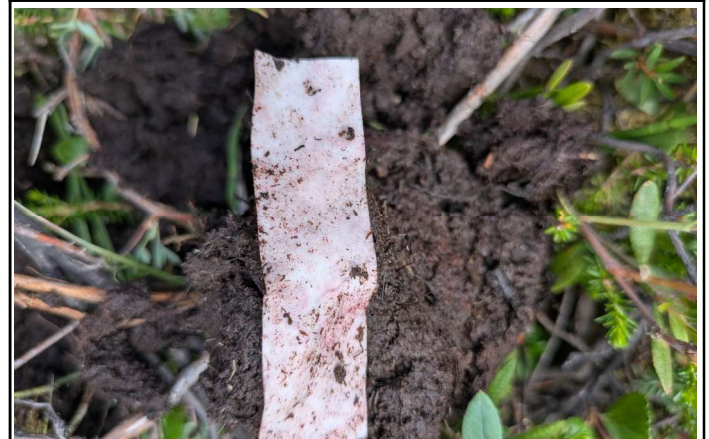
SP1—presence of 'C4—Reduced Iron' using dipyrldyl paper

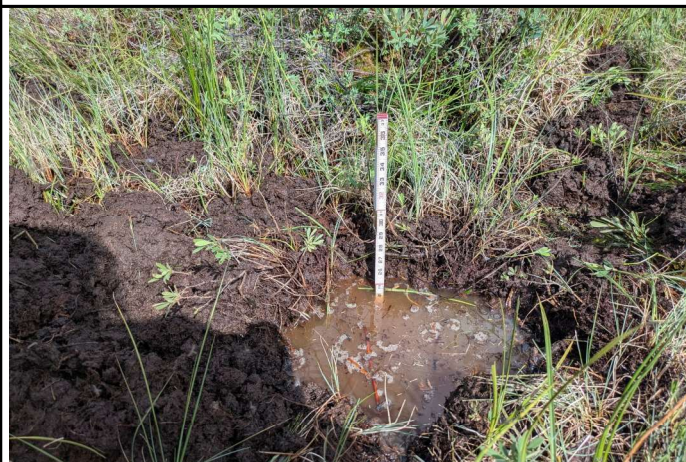
SP2 test pit.

Profile Description: (Describe to the depth needed to document the indicator or confirm the absence of indicators.)								
Depth (inches)	Matrix		Redox Features				Texture	Remarks
	Color (moist)	%	Color (moist)	%	Type ¹	Loc ²		
0 - 30							Peat	
-								
-								
-								
-								
-								
-								
-

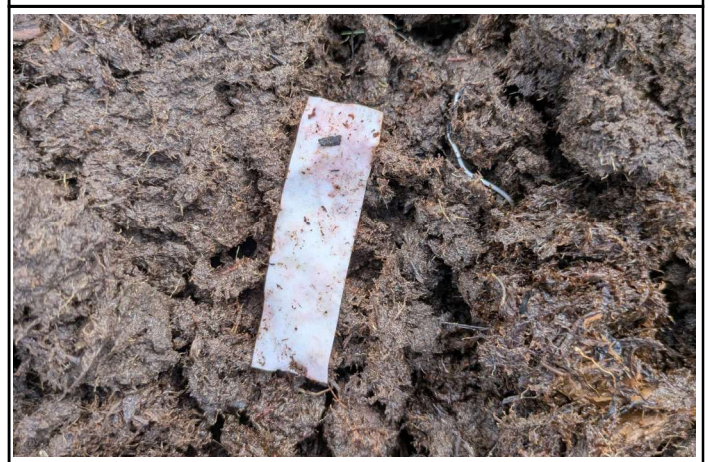
SP2—presence of 'C4—Reduced Iron' using dipyrldyl paper
