# **Potassium Acetate Deicer Impacts at Anchorage, Alaska: Data Report**

DOCUMENT NO: APr98003

MUNICIPALITY OF ANCHORAGE  
WATERSHED MANAGEMENT PROGRAM

March, 1999

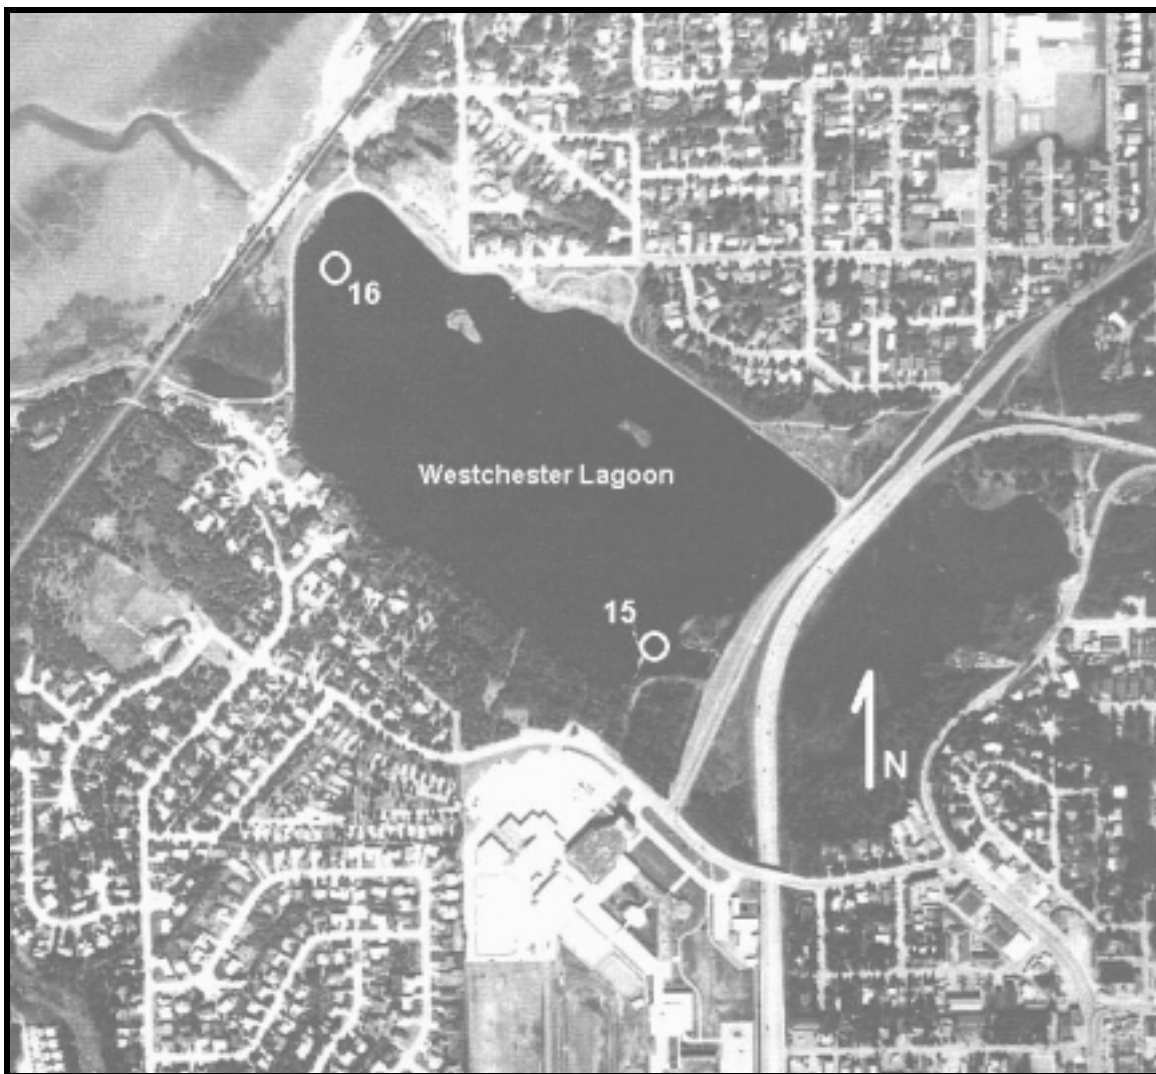
**Figure 5**

○ 1996 Water Quality Sampling Sites

**Sampling Stations**  
**Westchester Lagoon**

University Lake (UL-01, 02) and Westchester Lagoon (WC-01, 02), in the Chester Creek drainage, were sampled to characterize water quality before, during, and after any potential influx of potassium acetate. In University Lake the sites were in each of the two bays (Figure 4). In Westchester Lagoon both sample sites were in the large bay, one site in the old stream channel and one site in a shallower area (Figure 5). All samples were two-meter composite grab samples.

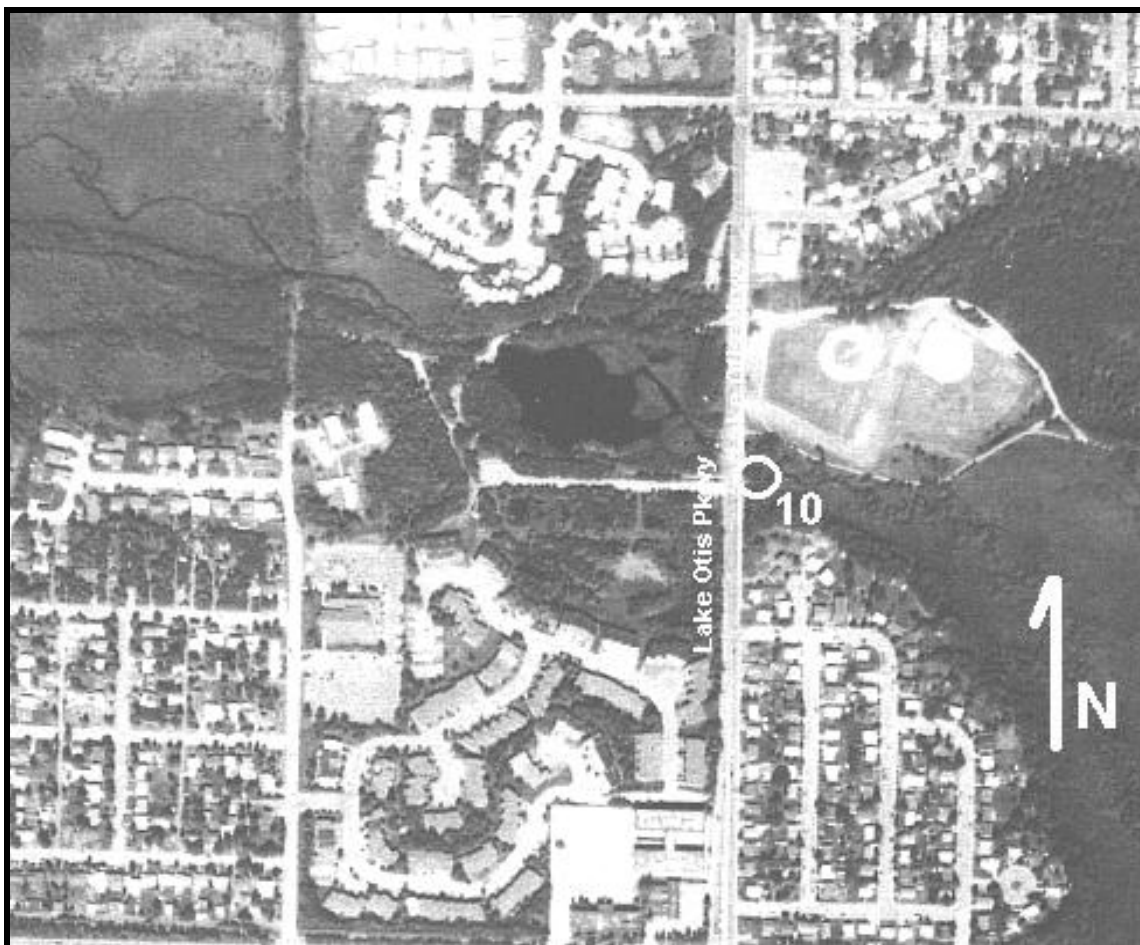
**Figure 6**

○ 1996 Water Quality Sampling Sites

**Sampling Stations**  
**Chester Creek (CC-02)**

Chester Creek (Figures 3, 4 and 6) will be sampled (grab) at 3 sites. The first site (CC-1) was located approximately 50 feet upstream from the University Lake inlet footbridge. This site was used for the CBOD<sub>5</sub> decay rate determination and for water quality characterization. The second site (CC-2) is approximately 50 feet upstream from the Lake Otis Parkway culverts and the third site (CC-3) is at the Aurora Street foot bridge. Both the second and third sites were for water quality characterization. Water samples from a fourth Chester Creek site (CC-Upper) and one Campbell Creek (Cam-1) site were used as background water quality sites because of the reduced possibility of deicer contamination at the site (Figure 7 & 8).

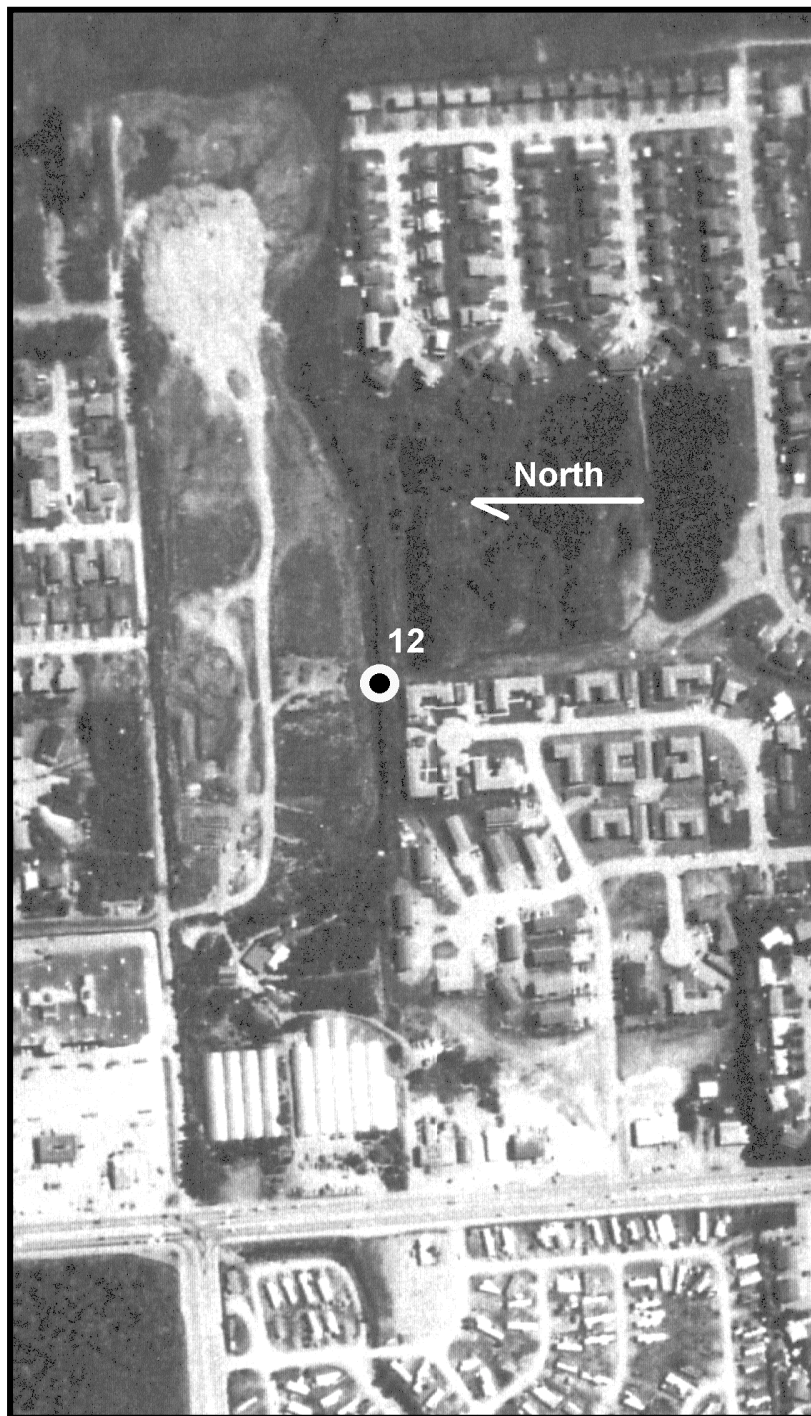
**Figure 7**

○ 1996 Water Quality Sampling Sites

**Sampling Stations** Chester Creek (CC-Upper)

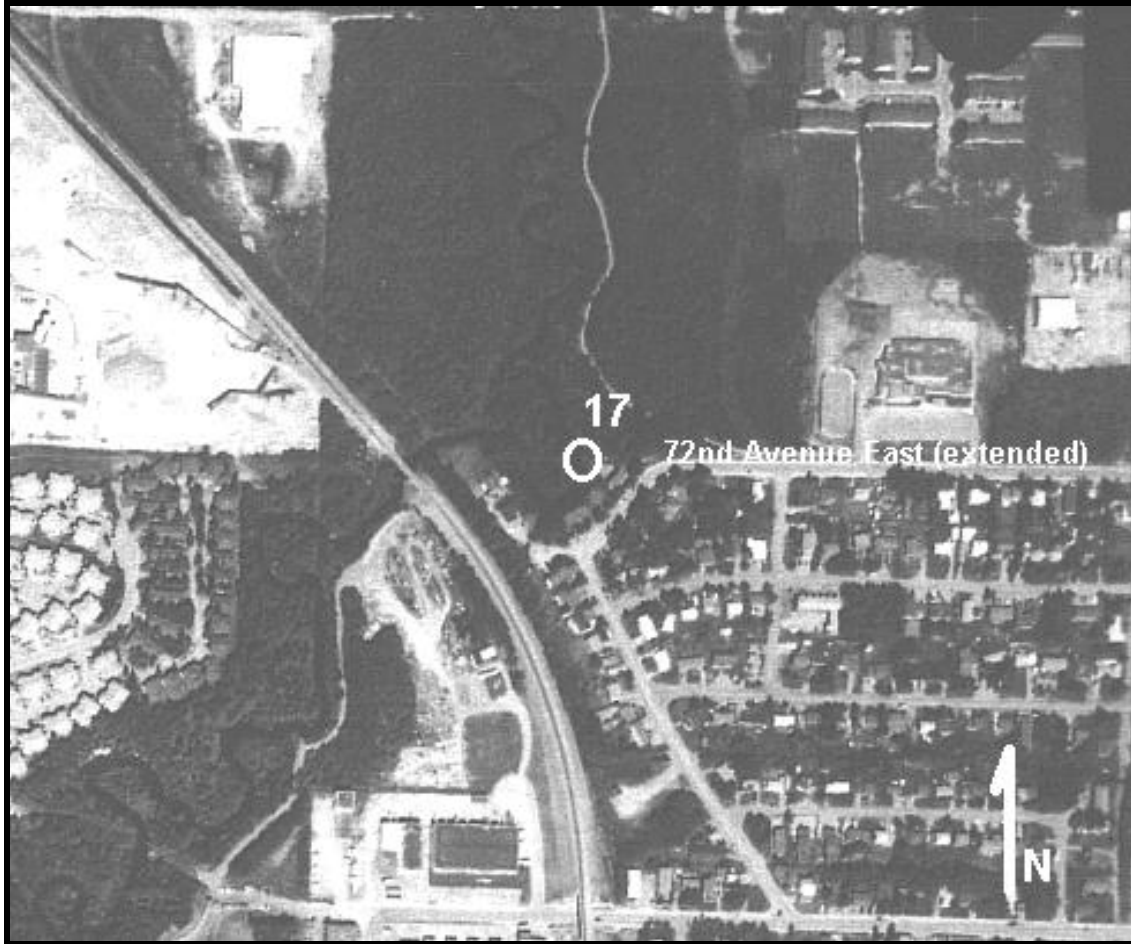
**Figure 8**

○ 1996 Water Quality Sampling Sites
