# Memorandum

**Date:** December 16, 2016  
**To:** Kyle Kelly, MOA Girdwood Service Area Manager  
**Through:** D. Michael Rabe, PE - CRW Engineering Group, LLC  
**From:** Rebecca Campbell, PE, PTOE - CRW Engineering Group, LLC  
**Project:** Girdwood Cemetery  
**Project No:** CRW#10131.07  
**Subject:** Girdwood Cemetery Feasibility Study  
Tract D, Girdwood Elementary Subdivision

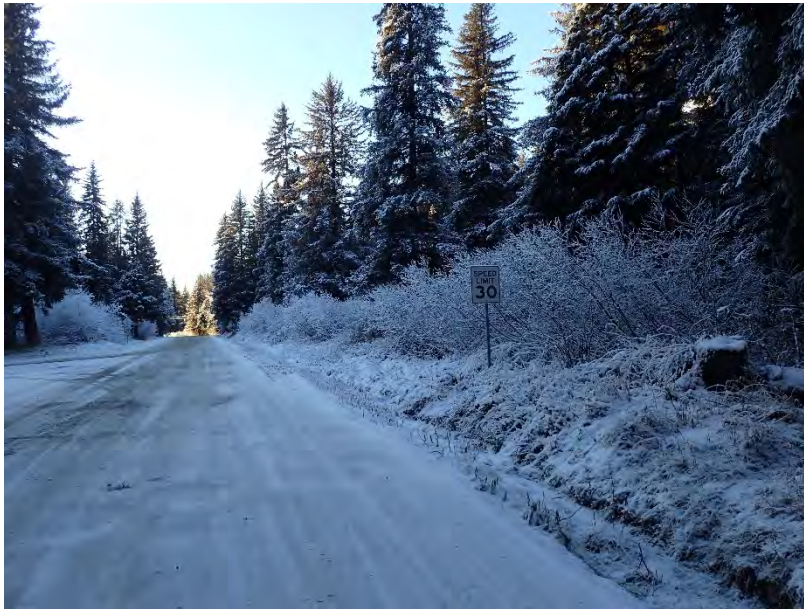
Photo 2 – Crow Creek Road at Project Site –Facing South

Slopes within the project area average 5% to 10% based upon LIDAR imagery, posing few challenges to development. The project area increases in slope as it moves from east to west and south to north into the Chugach Mountains, with slopes of up to 20% at the property edge. The property slopes towards Crow Creek Road and drainage is conveyed overland southwest across the site to California Creek and to the road ditch system on Crow Creek Road. There is no existing storm drain on the project site or along Crow Creek Road. There have been reports of flooding on the site.

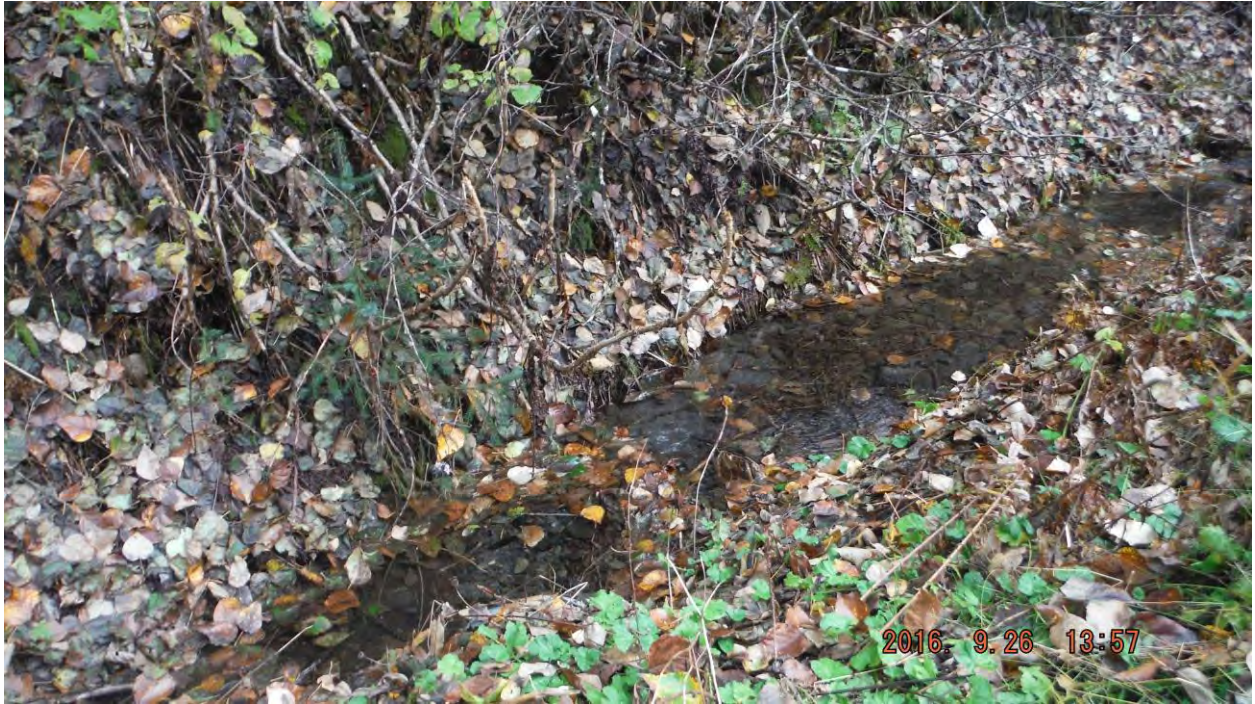
**Stream #4 (near west property line)**

Stream #4 is a small tributary of California Creek that flows along the trail pathway in the southwest part of the property. The stream flows beneath the trail path via a culvert. A small fish was observed, possibly a dolly varden, but given the connection with California Creek salmon are potentially present in this stream.

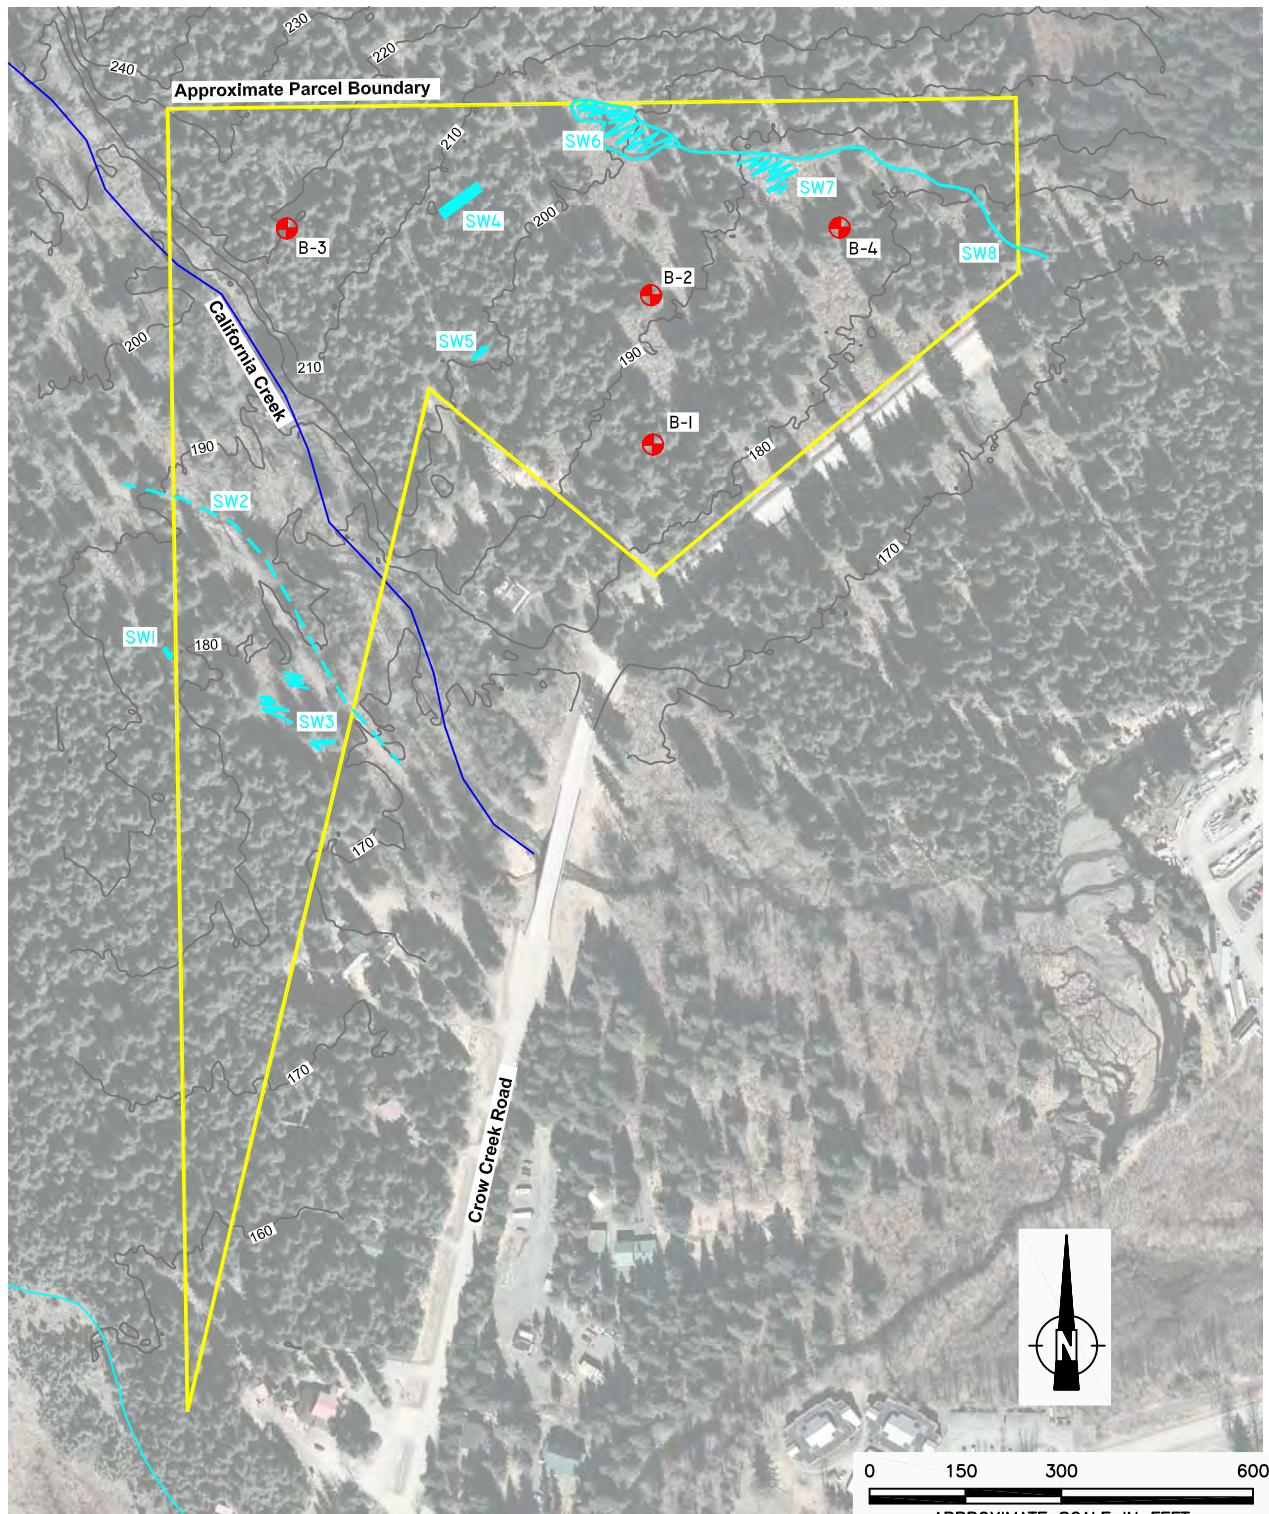
Drawing adapted from base map provided by CRW Engineering Group, LLC. Contour interval is 10 feet.

See Site Plan presented in Figure 2 for Surface Water Feature locations.

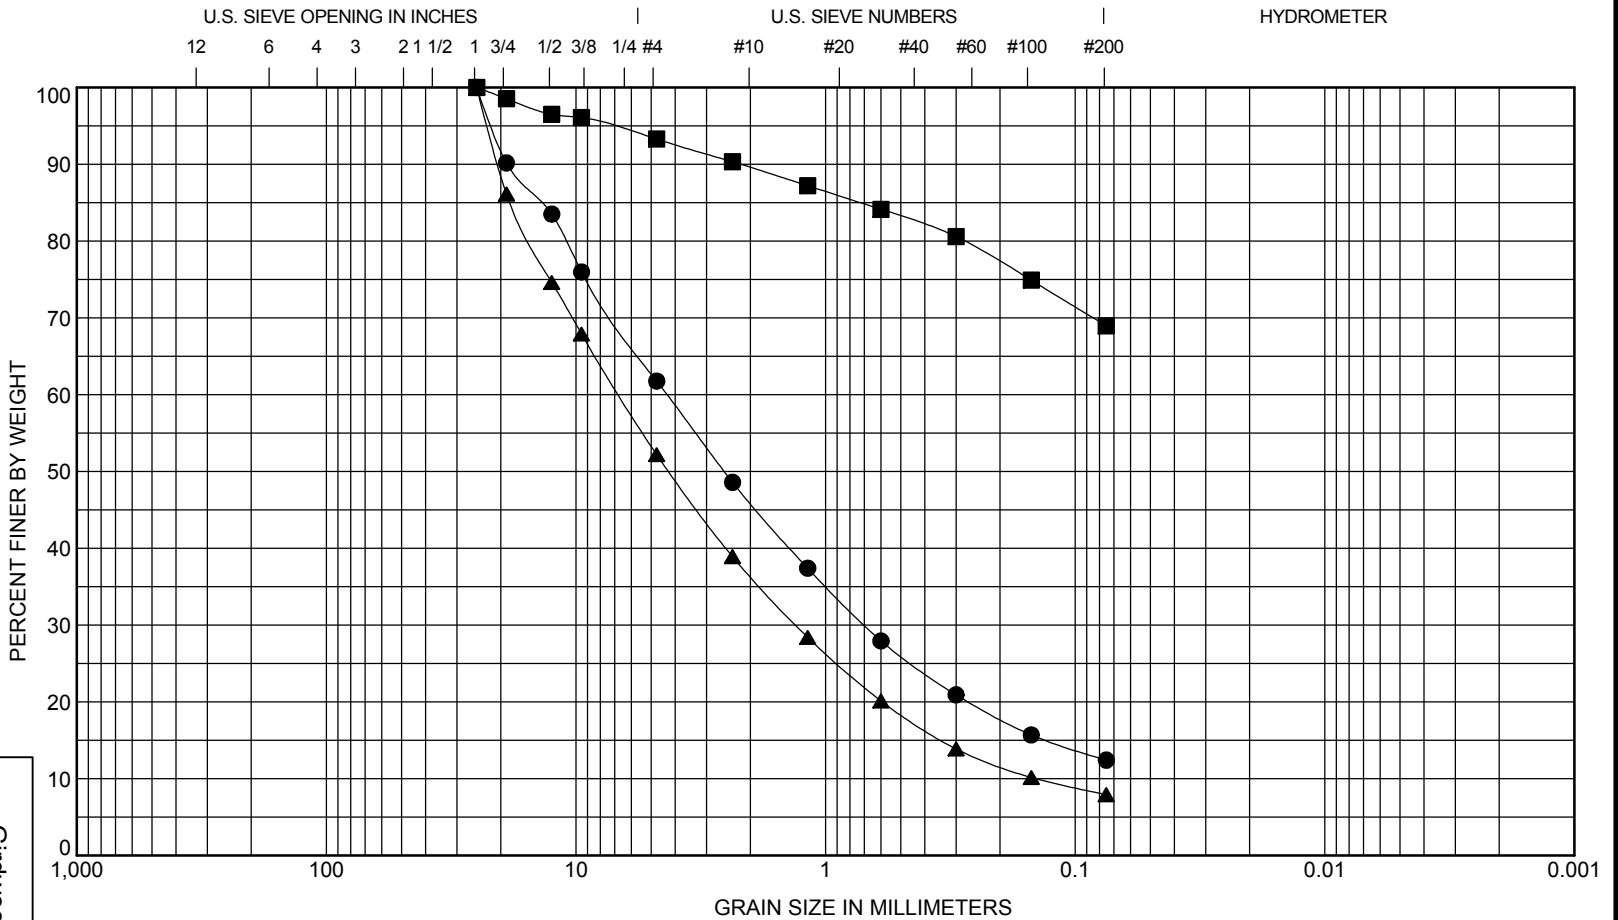
Sample	Depth, Ft	Classification					LL	PL	PI	Cc	Cu
● B-1 S3	5.0 - 6.5	Well-Graded Sand with Silt and Gravel (SW-SM)								2.5	96.0
■ B-1 S6	15.0 - 16.5	Silt with Sand (ML)									
▲ B-2 S2	2.5 - 4.0	Well-Graded Gravel with Silt and Sand (GW-GM)								1.8	46.9
Sample	Depth, Ft	D100	D60	D30	D10	%Gravel	%Sand	%Silt	%Clay		
● B-1 S3	5.0 - 6.5	25	4.32	0.7	0.14	38	49	12			
■ B-1 S6	15.0 - 16.5	25	6.7	1.31	0.14	7	24	69			
▲ B-2 S2	2.5 - 4.0	25	6.7	1.31	0.14	48	44	8

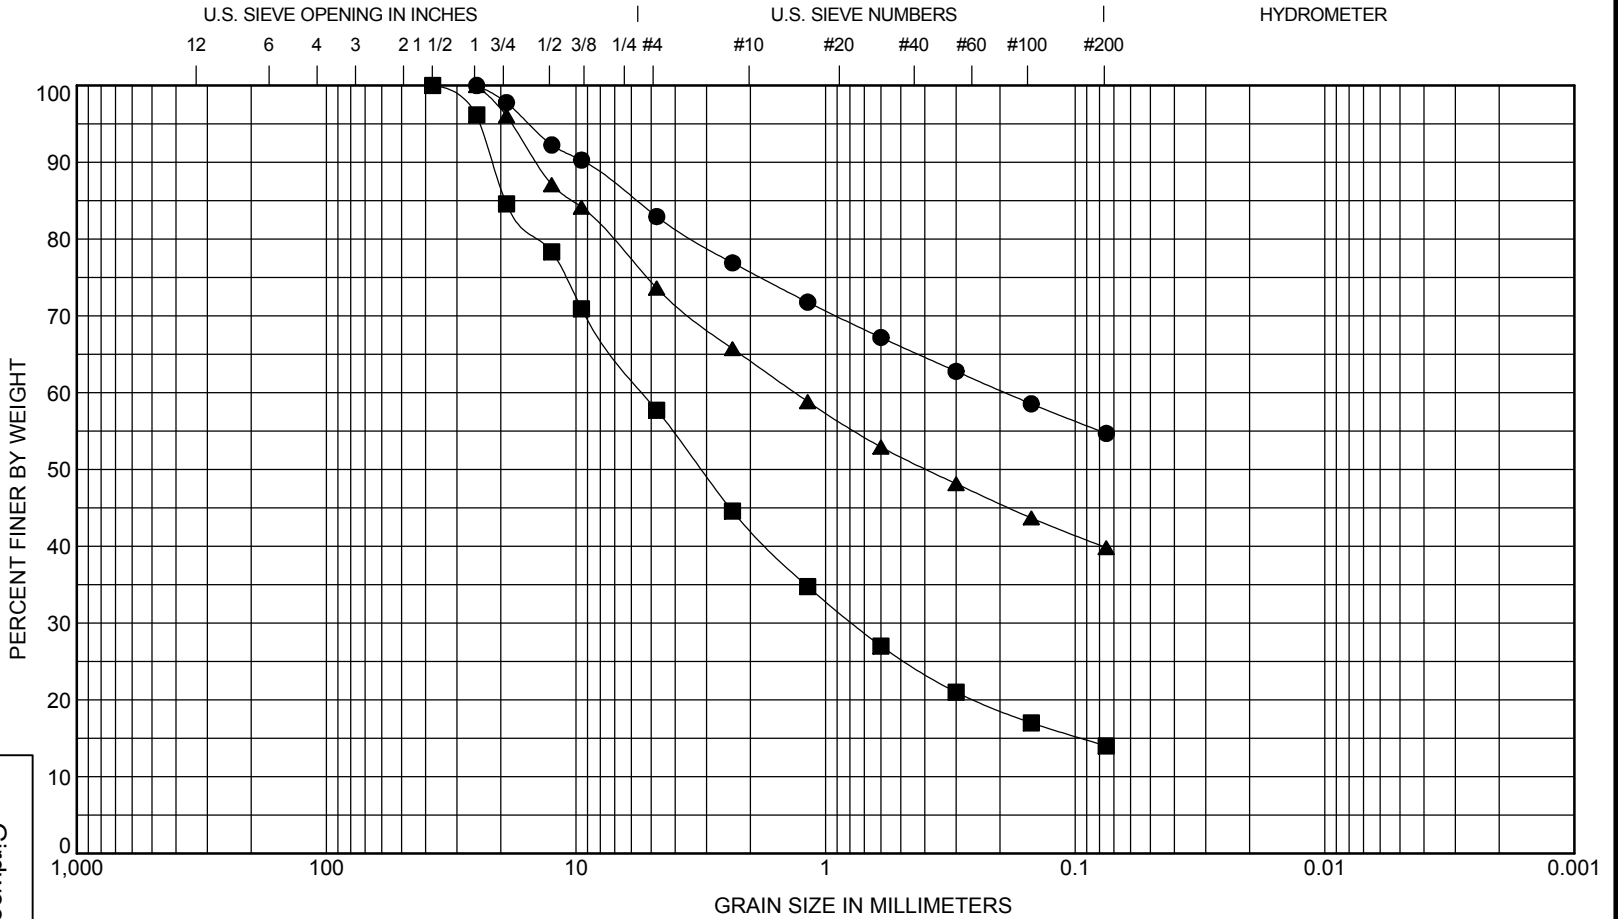
**FIG. 9**  
Sheet 2 of 3

Sample	Depth, Ft	Classification					LL	PL	PI	Cc	Cu
● B-2 S4	7.5 - 9.0	Silt with Sand and Gravel (ML)									
■ B-3 S3	5.0 - 6.5	Silty Sand with Gravel (SM)									
▲ B-3 S7	20.0 - 21.5	Silty Sand with Gravel (SM)									
Sample	Depth, Ft	D100	D60	D30	D10	%Gravel	%Sand	%Silt	%Clay		
● B-2 S4	7.5 - 9.0	25	0.19	0.78		17	28	55			
■ B-3 S3	5.0 - 6.5	37.5	5.35			42	44	14			
▲ B-3 S7	20.0 - 21.5	25	1.33			26	34	40

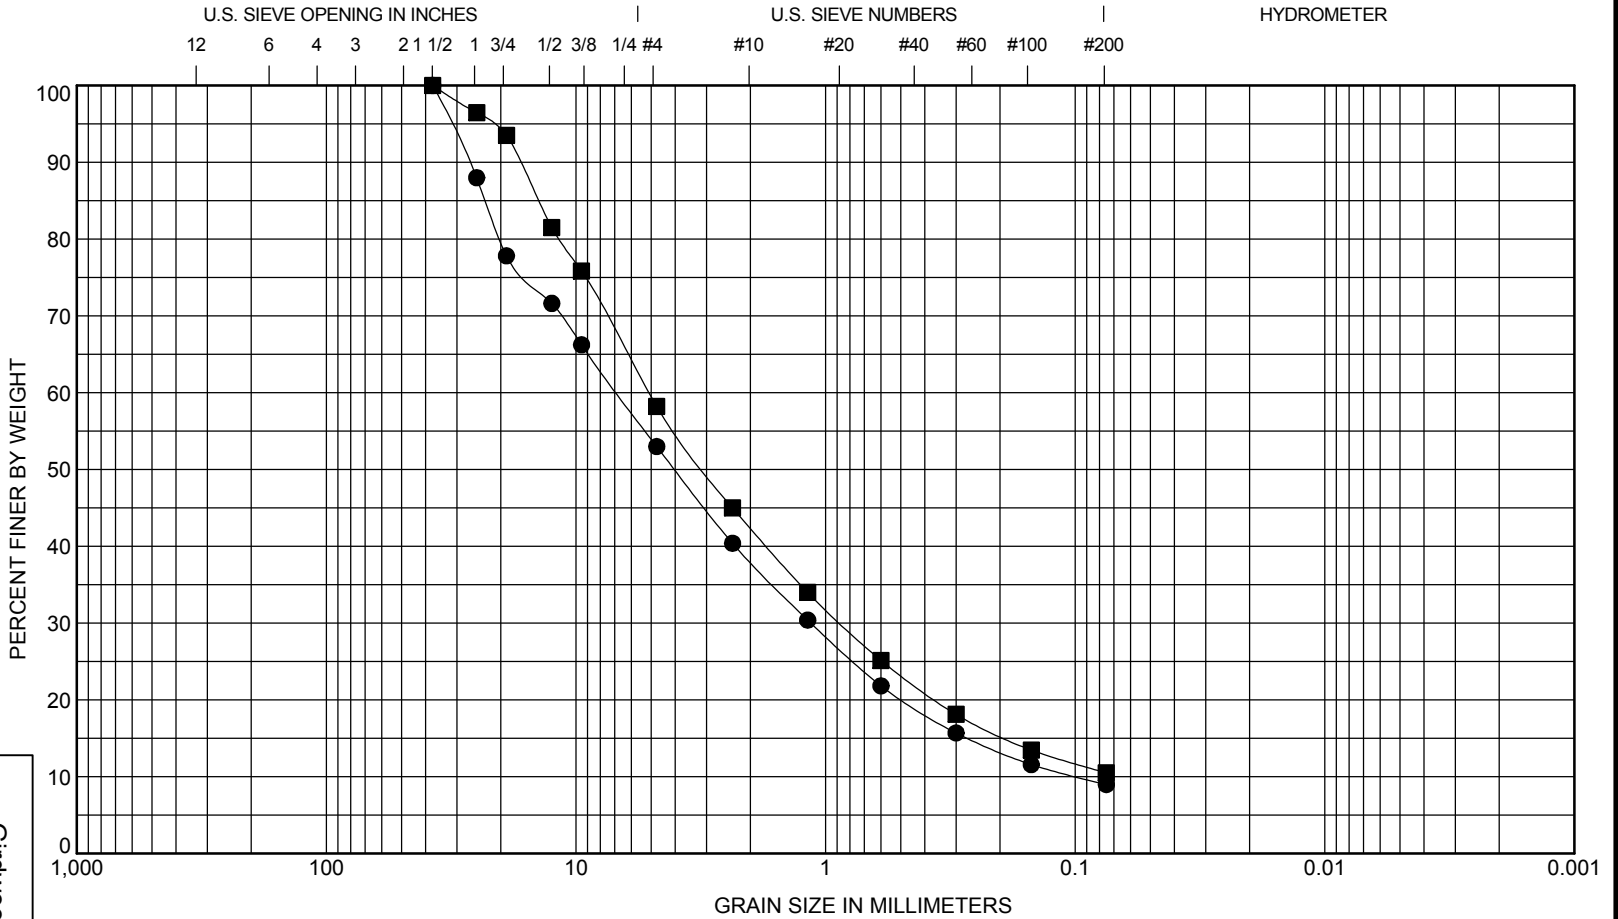
Sample	Depth, Ft	Classification					LL	PL	PI	Cc	Cu
● B-4 S2	2.5 - 4.0	<b>Well-Graded Gravel with Silt and Sand (GW-GM)</b>								1.9	69.6
■ B-4 S3	5.0 - 6.5	<b>Well-Graded Sand with Silt and Gravel (SW-SM)</b>								2.2	76.5
