MOA and ADOT&PF 2014 Low Impact Development Project Performance Monitoring Report

Prepared for:

The Municipality of Anchorage

January 2015

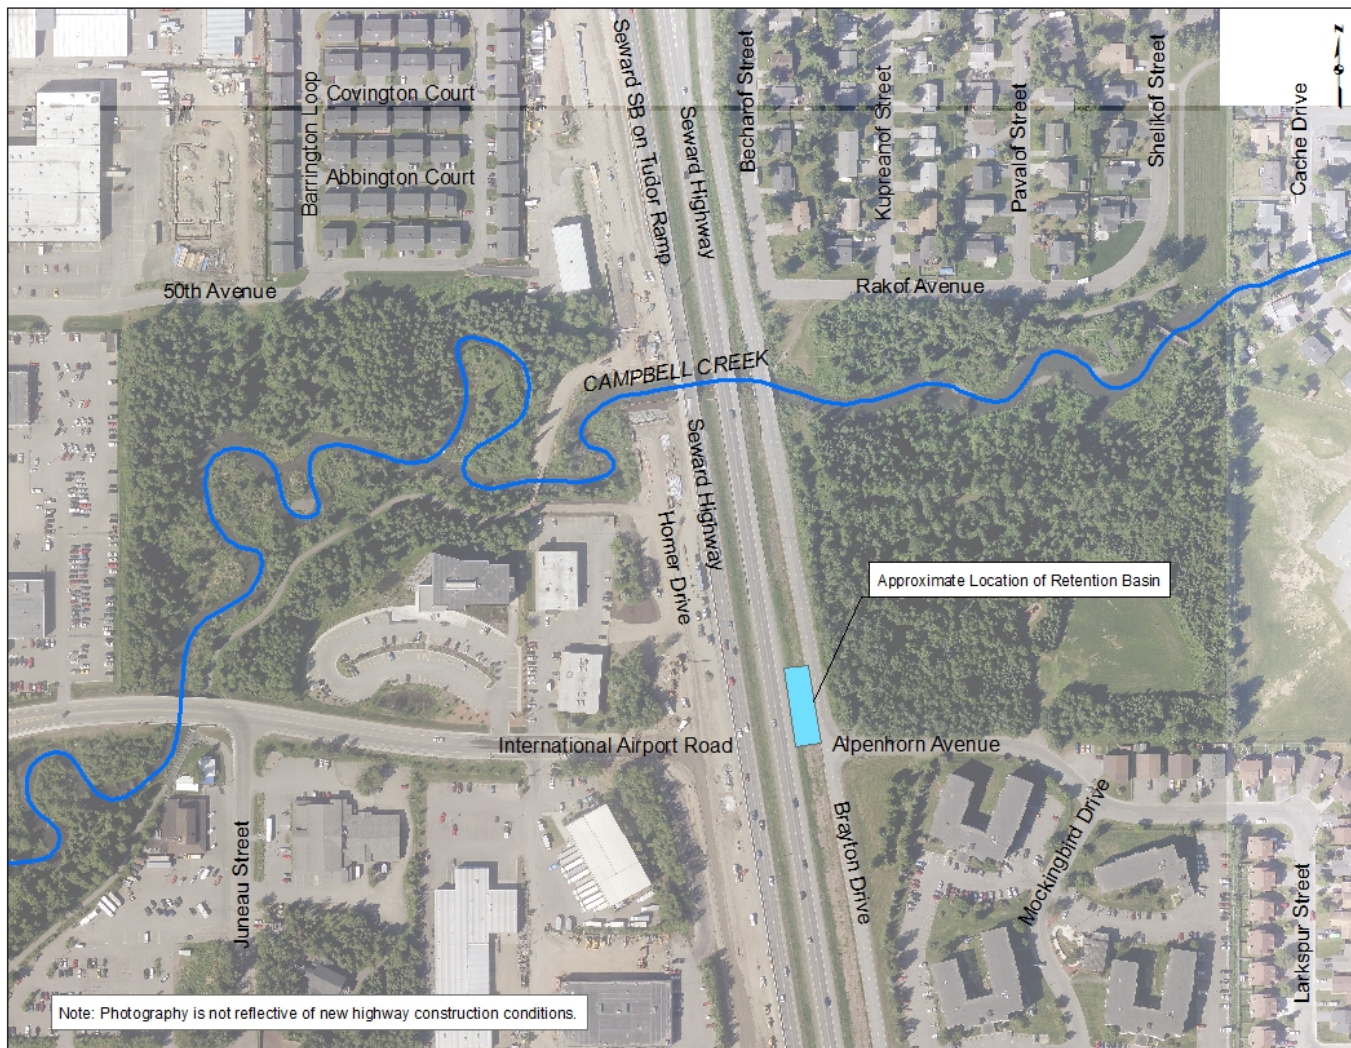
Figure 5: NSH Site Overview

If LID had not been incorporated into this project, surface runoff from Basin 4 would discharge directly to Campbell Creek. However, as an LID pilot project, surface runoff from Basin 4 is routed via a series of pipes and vegetated ditches to an infiltration pond located near the intersection of Brayton Drive and Alpenhorn Ave. The infiltration pond is designed to capture and infiltrate the runoff generated from the water quality event. Larger events are designed to overflow from the pond to a vegetated ditch that discharges to Campbell Creek. Figure 5 below shows an overview of the retention basin area, and Exhibits 1 and 2 in Appendix C show the retention basin design layout and the associated drainage area.

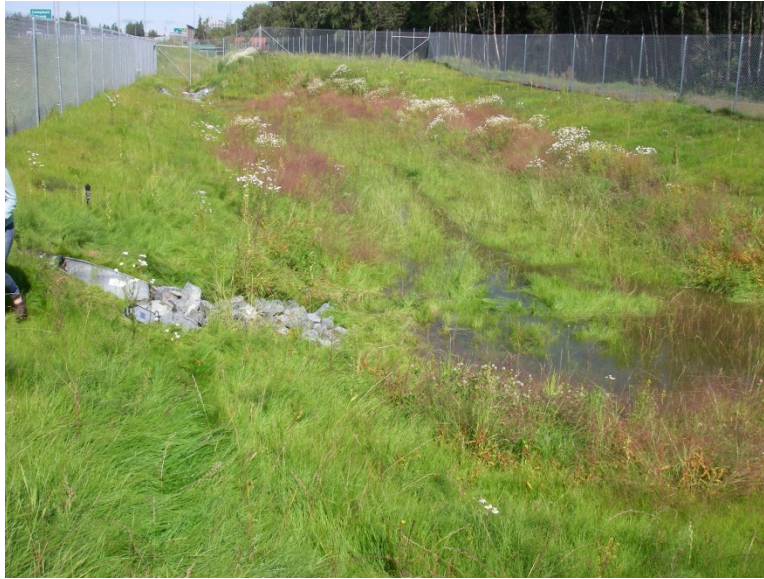
Figure 6: NSH Retention Basin

The NSH retention basin is approximately 150 feet long and 45 feet wide, with gentle side slopes and an approximate average depth of two feet. (See Figure 6 below.) The basin is vegetated with grasses, and riprap is present near the inlet and outlet. The basin inlet is a 24-inch diameter culvert on the southwest side of the basin, and the outlet is a small earthen berm on the north side. The outlet berm is overtopped when the basin exceeds capacity.

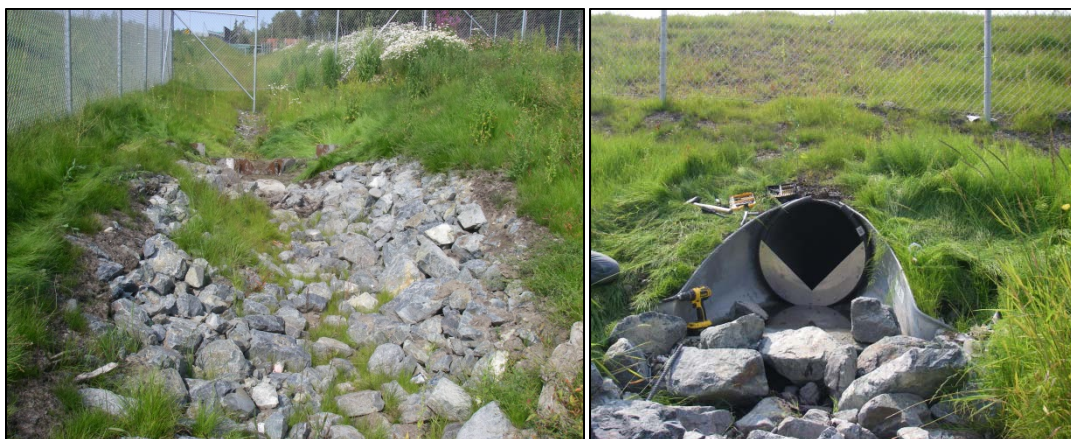
Figure 7: Retention Basin Outlet (left) and Inlet (right)

In order to monitor the performance of the retention basin, HDR installed monitoring equipment to record data from July 21 through October 17 of 2014. The monitoring equipment included a v-notch weir and a pressure transducer located at both the inlet and the outlet. See Figure 7 below. The pressure transducers were set at a known depth below the weir notch and were calibrated to record the depth of water flowing over the notch. By recording the basin's inflow and outflow, the impact of the retention basin can be measured and compared to a theoretical case of the project constructed with no LID. For the theoretical case of no LID, it was assumed that all water entering the retention basin would continue to Campbell Creek. In reality, a small amount of infiltration may take place in the vegetated ditch in this scenario, but that amount is difficult to quantify in a theoretical situation with the available project information.

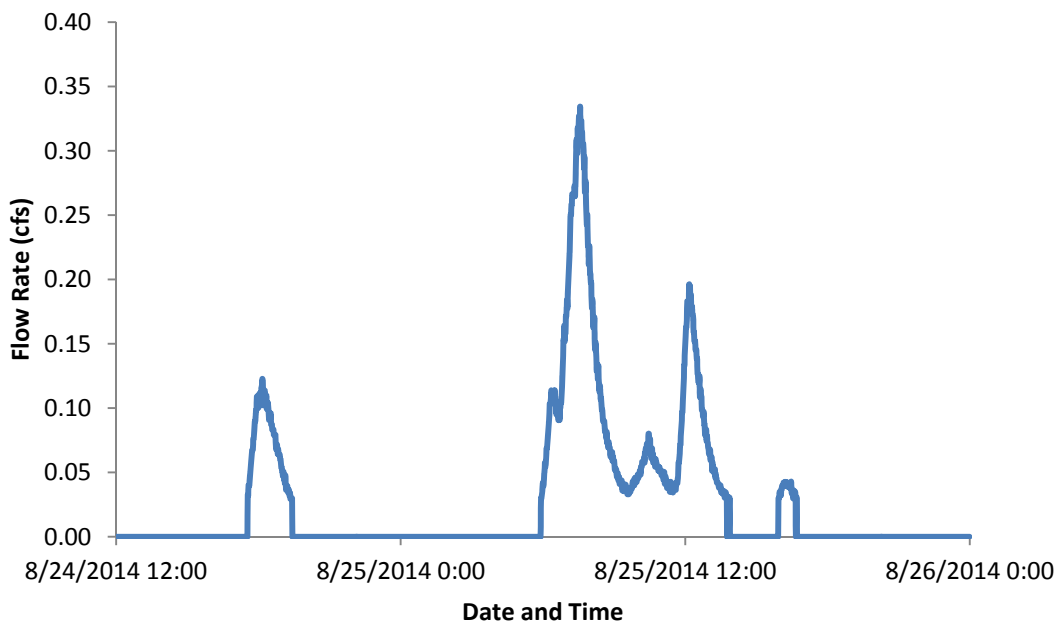
Figure 11: Event 2 August 24-25 NSH Basin Inflow Hydrograph (No outflow)

Analysis of the data showed that the retention basin did not produce an outflow hydrograph for Events 2 and 3. In both cases, the entire event was captured by the basin. Inflow hydrographs for these events are shown in Figures 11 and 12. Supporting data is including in Appendix D.

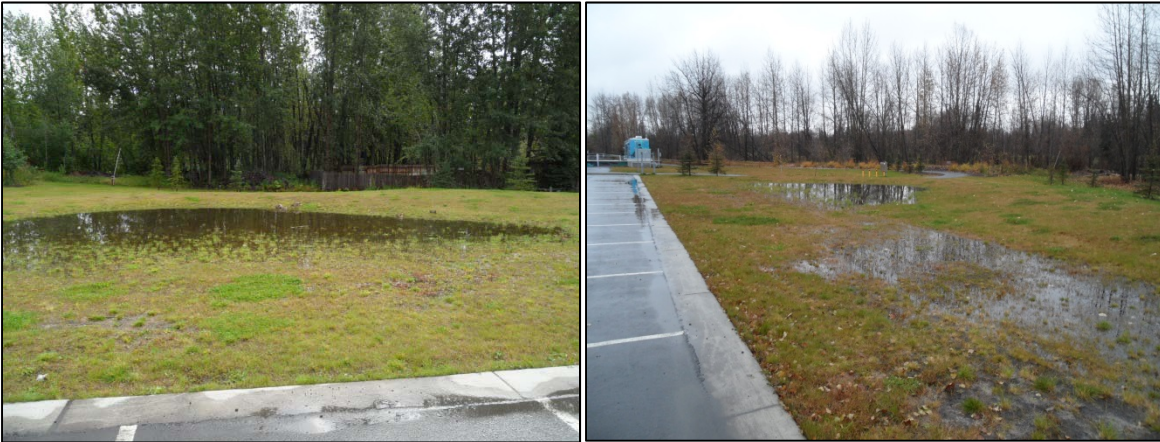
Figure 16: Hatchery West Rain Garden

The parking lot of the Ship Creek Hatchery was reconstructed as part of the project that converted the old site into a hatchery in 2011. The hatchery is located immediately adjacent to Ship Creek, which is listed as an impaired water body in the MOA/ADOT&PF APDES permit. The entire site design is centered around minimizing direct stormwater runoff to Ship Creek. The topography of the site's green areas are contoured to capture water, and flat curbs are used in lieu of traditional curbs around parking lot landscape features to allow stormwater from pavement to flow into the landscaping. The site includes two rain gardens, which are the focus of this monitoring and reporting discussion. The two rain gardens are shown in Figures 16 and 17.

The project's two rain gardens collect runoff from the hatchery's large parking lot, a total of approximately 18,850 square feet. Approximately 10,600 square feet of the parking lot drains to the western rain garden, which has a design storage capacity of 3,100 cubic feet, and approximately 8,250 square feet drains to the eastern rain garden, which has a design storage capacity of 3,200 cubic feet. The slope of the parking area is roughly 2%, and stormwater runoff enters both rain gardens as sheet flow from the adjacent asphalt. The rain gardens are designed to accept and infiltrate small, frequent storm events and bypass larger events. Water that enters the rain gardens but is not infiltrated is allowed to overflow the earthen sides of the gardens toward the south. Overflow water is directed to Ship Creek via overland flow. Both rain gardens are fully vegetated with grass-like vegetation. The rain garden sizes and drainage basins are shown in Exhibit 3 in Appendix C. The overall layout of the hatchery site is presented in Figure 18 below.

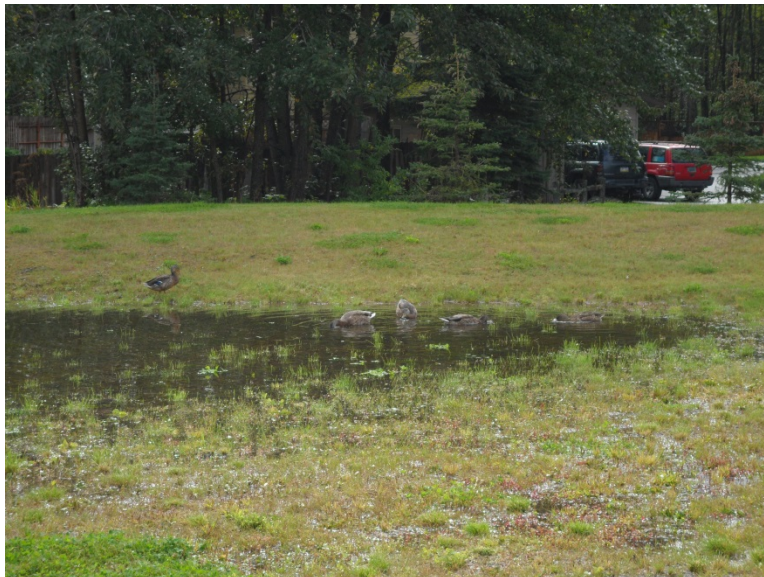
Figure 21: Geese on Hatchery West Rain Garden

The hatchery rain gardens are also unique in that they are designed to utilize the site's topography and green space, and actually function more like landscaped depressions or "ponds" than traditional rain gardens. By adding these unique design features, the rain gardens provide not only stormwater benefits, but aesthetic benefits and even wildlife habitat. Figure 21 below shows geese observed on the west pond during a monitoring visit.

This type of site design and the use of site contouring to create rain gardens or shallow basins for stormwater management is an excellent use of LID application in Anchorage. This type of site design is recommended wherever adequate space is available. If a receiving system is not immediately adjacent to the site, as it is in this case, this type of design could include overflow field inlets that connect to piped systems or overflow could be directed to conveyance ditches.

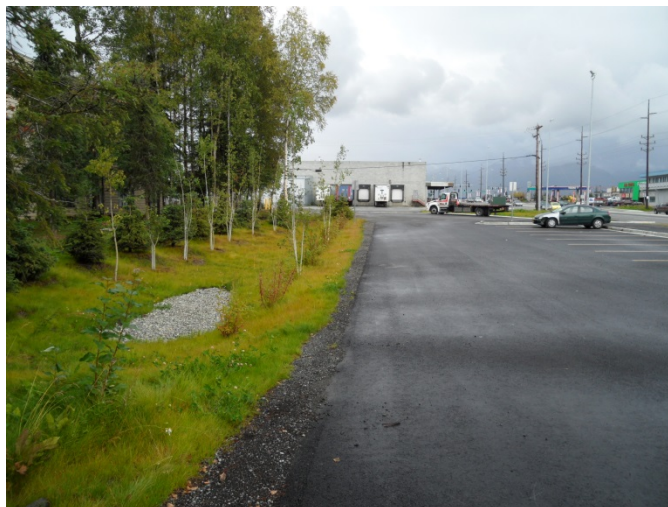
Figure 22: West Dowling Rain Garden and Parking Lot

The parking lot rain garden is designed to intercept parking lot runoff instead of allowing it to flow directly to nearby Campbell Creek. The rain garden accepts runoff from both the parking lot and a portion of the access drive for a total of approximately 8,600 square feet of impervious surface with gentle slopes generally less than two percent. The rain garden is located on the north side of the parking lot. Water enters the rain garden via sheet flow from the parking lot. Water that enters the rain garden but is not infiltrated is allowed to overflow the earthen sides of the gardens toward the west. Overflow water is directed to Campbell Creek via overland flow and natural swales. The rain garden is approximately 84 feet long with a width that varies from 0 to 20 feet as the rain garden shape tapers toward the east. The design storage volume is 375 cubic feet. The rain garden size and drainage basin are shown in Exhibit 4 in Appendix C. The parking lot and rain garden shown in the figure below.

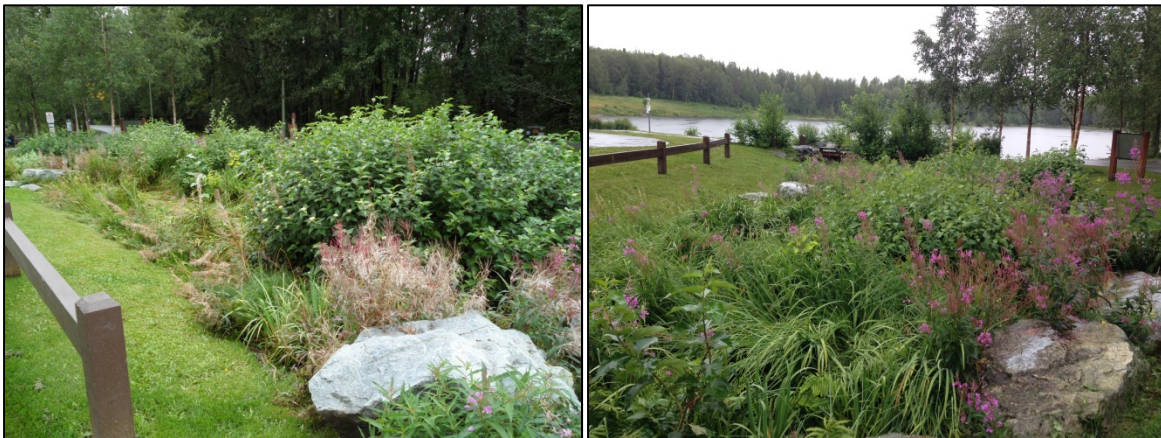
Figure 25: Taku Lake Rain Garden

The vegetation in the rain garden was somewhat overgrown with grasses, small trees, and other plants that have taken root there. Although this is not visually appealing, it is expected to enhance hydrologic performance by providing increased evapotranspiration and deeper roots for improved infiltration. Figure 25 below provides updated pictures of the rain garden. Additional photos are included in the site visit reports in Appendix F.

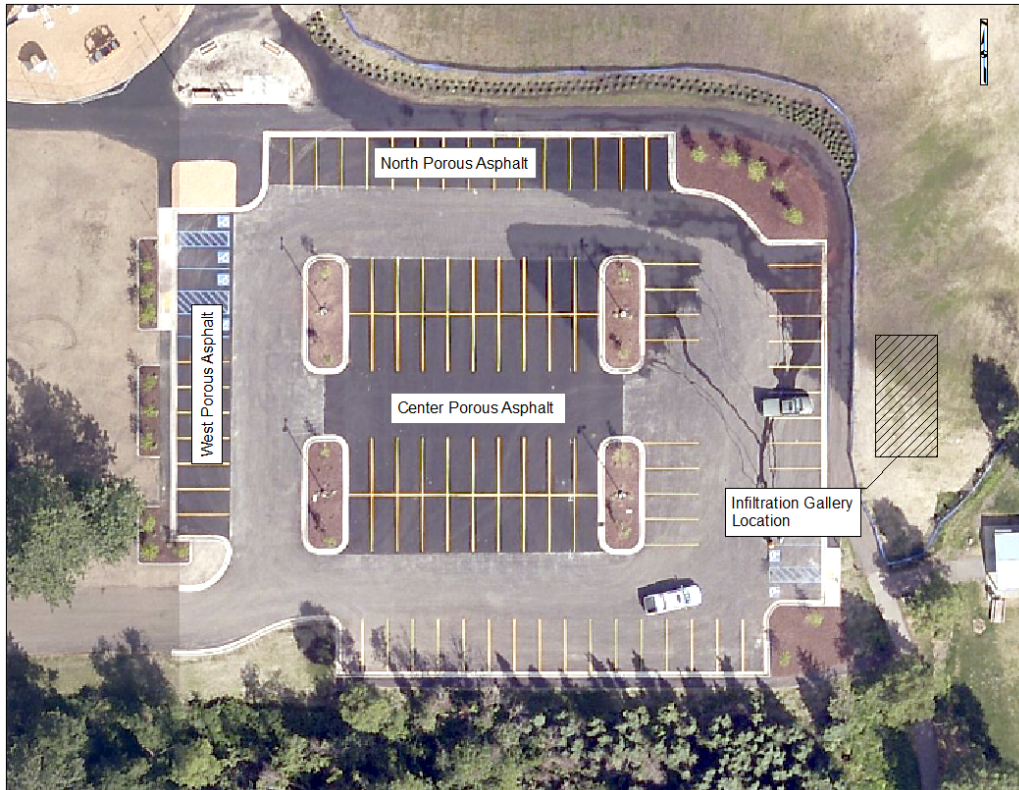
Figure 26: RJSP Parking Lot Layout

The RJSP parking lot is located at 821 Pine Street in Anchorage, which is south of 6th Avenue, and north of Debarr Road. The parking was retrofitted in 2012-2013 to provide improved parking and safer pedestrian facilities for park users. The project was a joint effort between WMS and the MOA Parks and Recreation Department (Parks). The RJSP parking lot is used in the summer months for access to the softball fields located north and south of the parking lot and the soccer fields to the east. It is also used year-round for access to the park's popular trail system. The parking lot LID features include porous asphalt and an underground infiltration gallery. Additional information and technical descriptions of the LID features are presented in the *MOA 2013 Low Impact Development Project Performance Monitoring Report*. An overview of the RJSP site is shown in Figure 26 below.

The new parking lot and surrounding sidewalks are approximately 44,400 square feet. The parking lot is a combination of traditional asphalt pavement and porous asphalt pavement. There are three sections of porous asphalt totaling 14,288 square feet or approximately 32 percent of the parking lot area (see Figure 26 above). The project designers worked with Parks maintenance personnel to determine the ideal placement of the porous asphalt for improved long-term performance of the asphalt. If porous asphalt is regularly snowplowed and then sanded for traction, it requires vacuum sweeping to prevent the fine sand particles from clogging the voids in the asphalt (the plowing itself is not expected to be problematic for porous asphalt, but plowing and sanding is usually performed in conjunction.) Parks' ability to maintain the asphalt is limited to their existing maintenance equipment, and the porous asphalt is not able to be vacuum swept. For this reason, project designers located the asphalt in portions of the parking lot that will not be opened for winter use, and therefore will not be sanded.

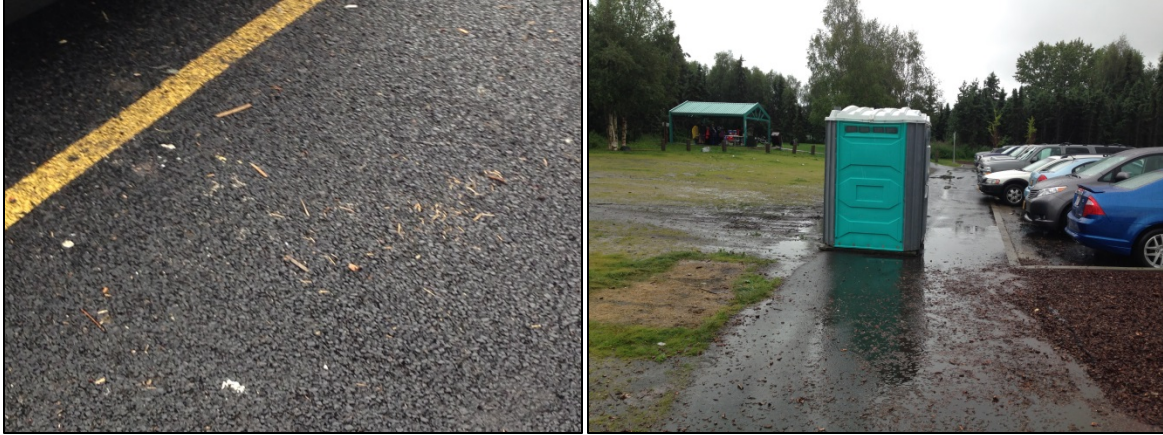
Mulch on the porous asphalt and spilling over from the landscaped areas.

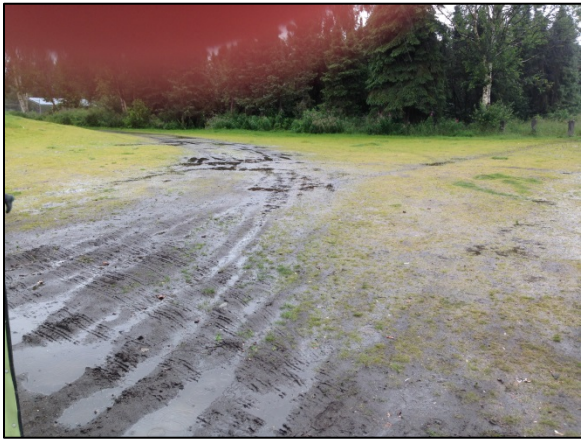
Water upstream of the infiltration gallery, flowing into the parking lot.

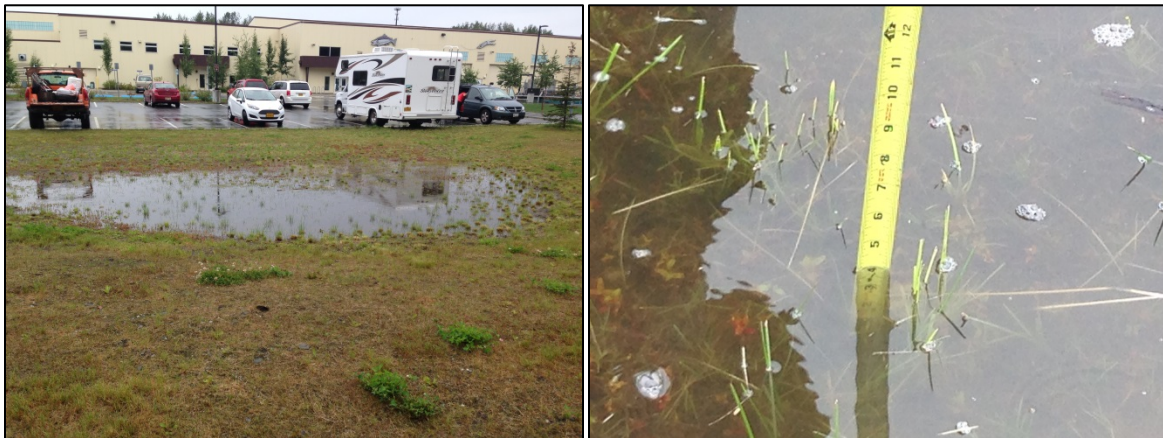
West Rain Garden

The rain gardens can generally be described as grassy depressions that collect and percolate stormwater into the ground. There are three depressed areas used for this purpose. The depressions are collecting runoff from a notably sized parking lot and possibly from the building itself. Two of the depressions on the west side of the parking lot had standing water. In the west most pond, the water was measured to be approximately 4 inches deep.

Generally, the parking lot appears to be well designed from the stormwater standpoint. Water is directed to the grassy areas, and to a small landscaped area, via the asphalt slope and flat, concrete curbs at the edges, instead of raised ones.

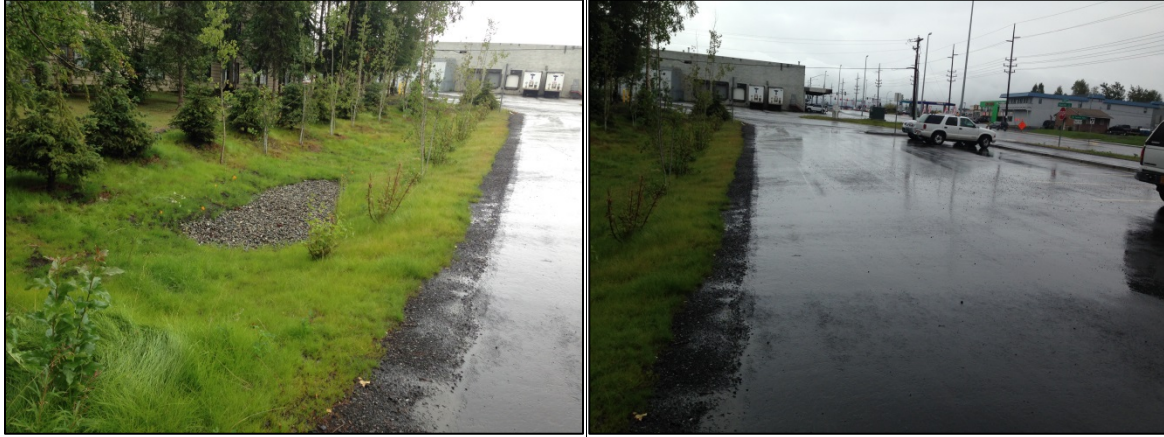
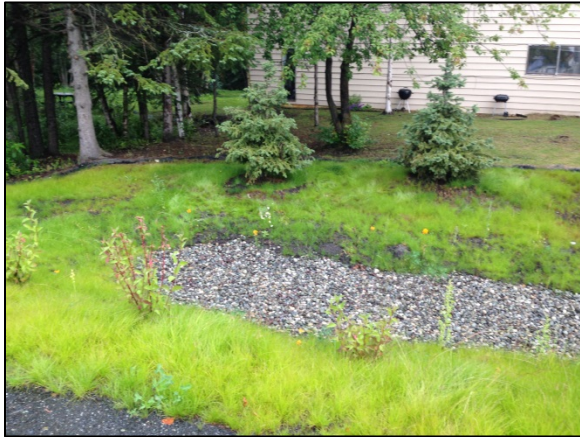
Water from the area parking lot is flowing to the rain garden. The bottom of the rain garden area is rocky. Vegetation has grown in around the rock and on the side slopes of the facility. No standing water was observed in the rain garden. The parking lot and access drive are in need of sweeping.

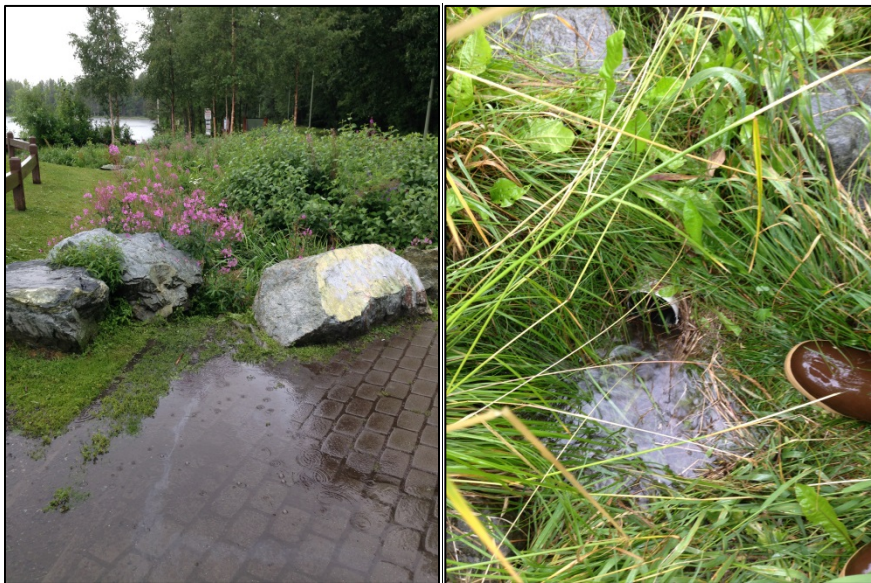
Large amounts of water from the parking lot and the access drive were flowing (via channel flow) into the rain garden. Oil sheen on the inflow water was observed. The rain garden vegetation was full and healthy. The bottom of the rain garden was not visible. The outlet pipe was actively flowing. An exact depth of flow was difficult to determine due to ponding in the vegetation at the outlet, but was estimated to be approximately one inch deep.

Water entering rain garden (Left) and rain garden outlet pipe (right)

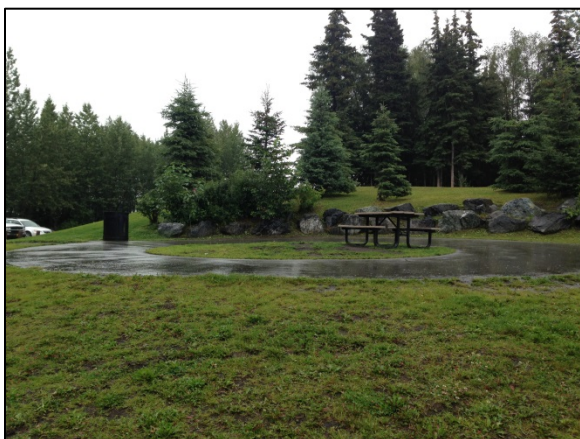
Runoff from adjacent walkway

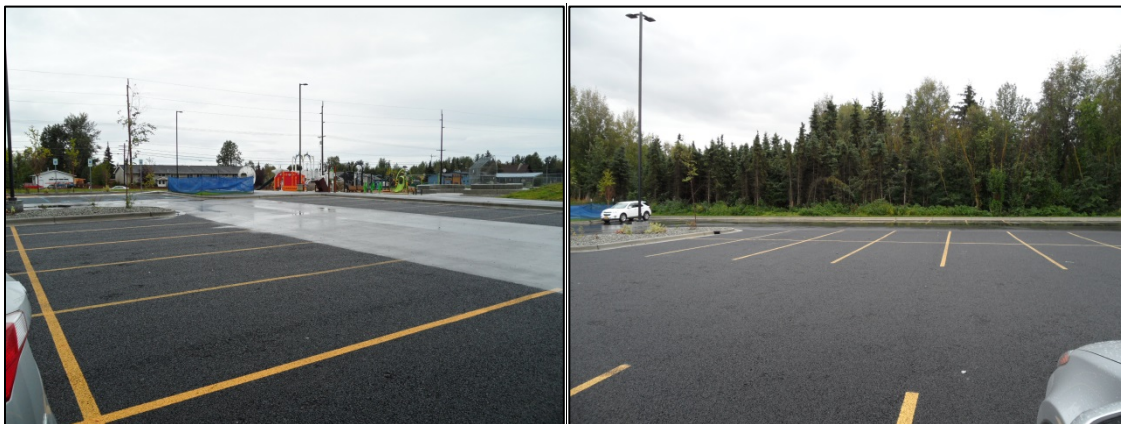
Parking lot overviews

Each of the inspection ports in the infiltration gallery were checked; standing water was not observed in any of the ports. A Kleenex and a tree branch were observed inside the port with the broken cap.

The water levels in each of the porous asphalt monitoring wells was checked. The monitoring wells in the central and western sections of porous asphalt had a very small amount of standing water in the bottom of the well, approximately one inch or less. The monitoring well on the northern section of porous asphalt was observed to have 40 inches of standing water. Most of the putty/grease like substance in the top of the western well was removed so that the well cap could be opened.

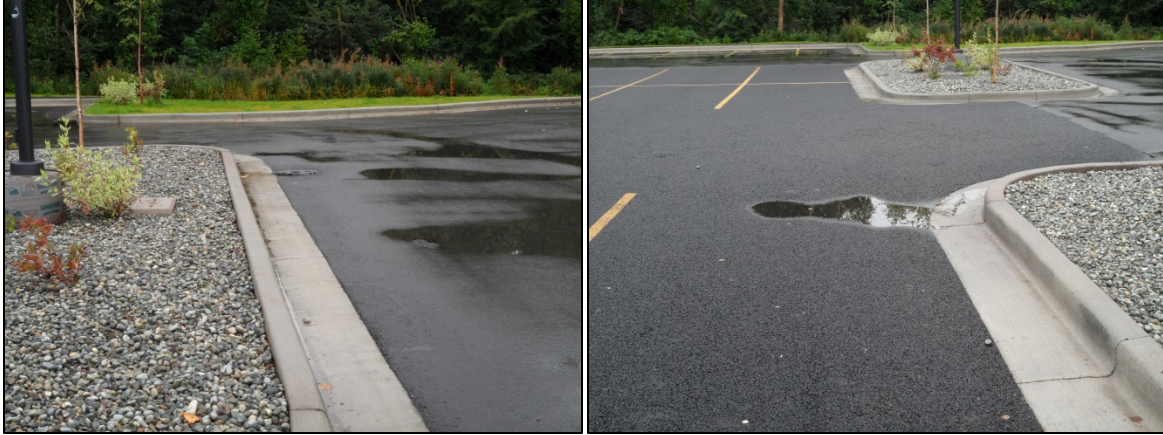
Left: New rock mulch. Right: ponding on the porous asphalt surface

The rock mulch has prevented the problem from worsening, and the sweeping appears to have improved the asphalt performance. Surface ponding was observed at only one location, adjacent to a landscape planter, during subsequent site visits. The impacted portion of the porous asphalt is small, and does not appear to be impacting the performance of the parking lot as a whole. The condition could potentially be remedied by vacuum sweeping the parking lot, if funding and appropriate equipment were available.

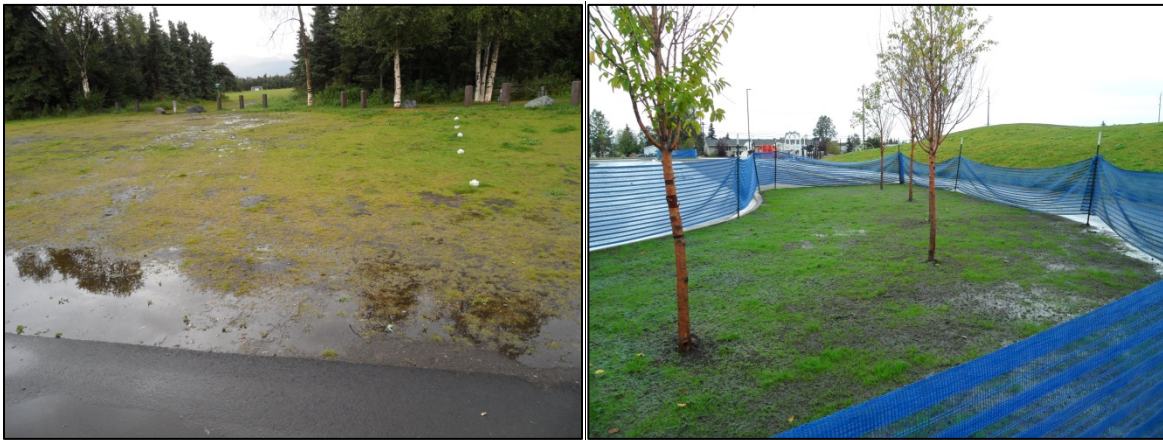
Left: Runoff from the area to the east of the parking lot. Right: Seeded area that replaced the mulch.

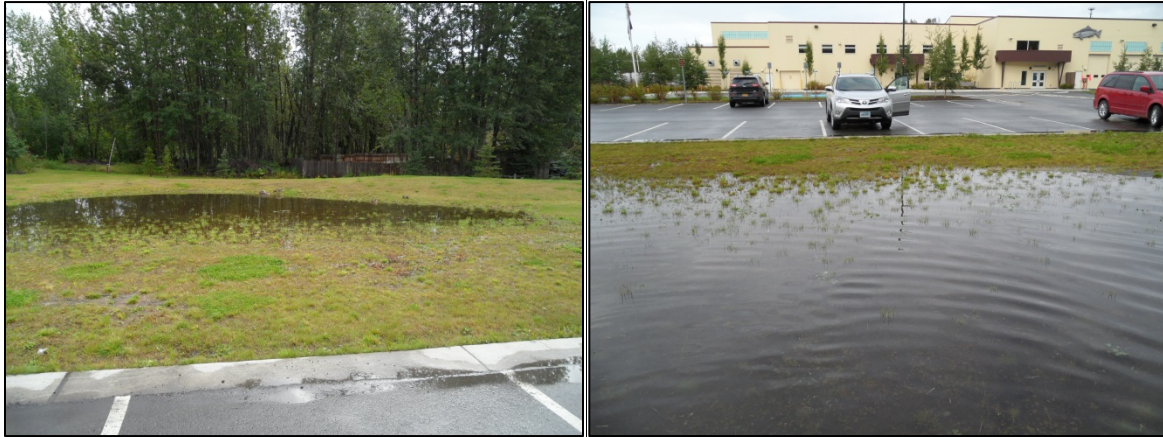
West rain garden

Observations: Ponded water was observed in both of the rain gardens/grassy depressions. Both locations had ducks in the water. Overflow from the depressions was not observed. The standing water in the western garden, closest to Reeve Blvd was 5 inches in the deepest observed location. In the eastern garden, standing water was 9 inches in the deepest observed location.

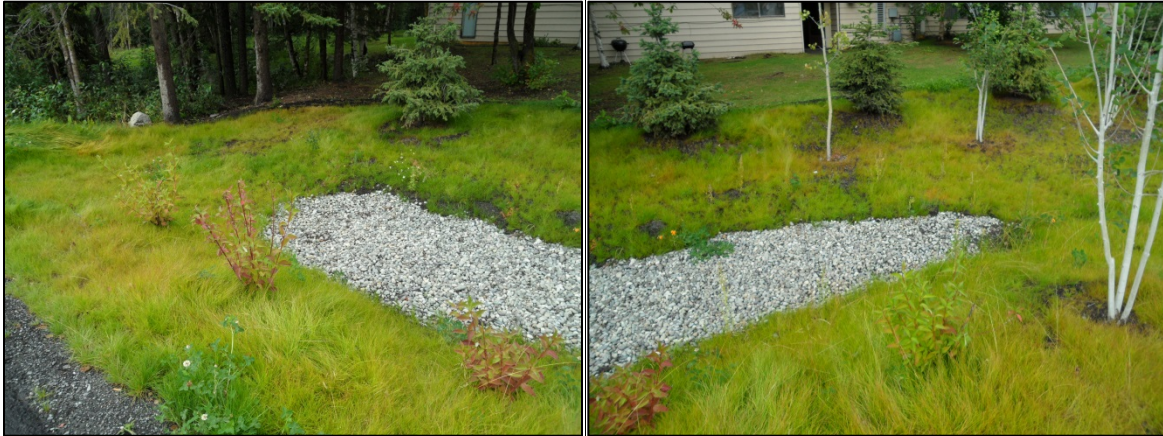
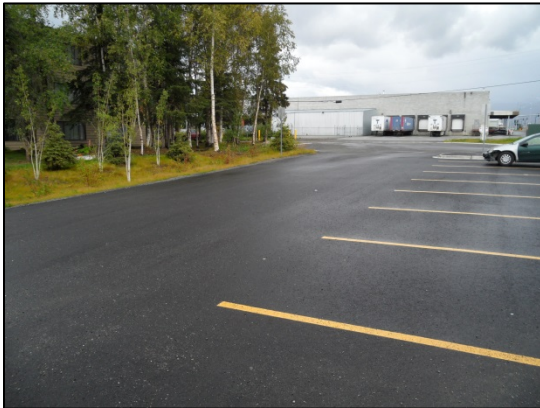
Rain Garden (above) and Parking Lot (below)

Observations: The rain had stopped and water was not actively flowing into the rain garden at the time of this site visit. No standing water was observed in the rain garden, and the vegetation looks stable.

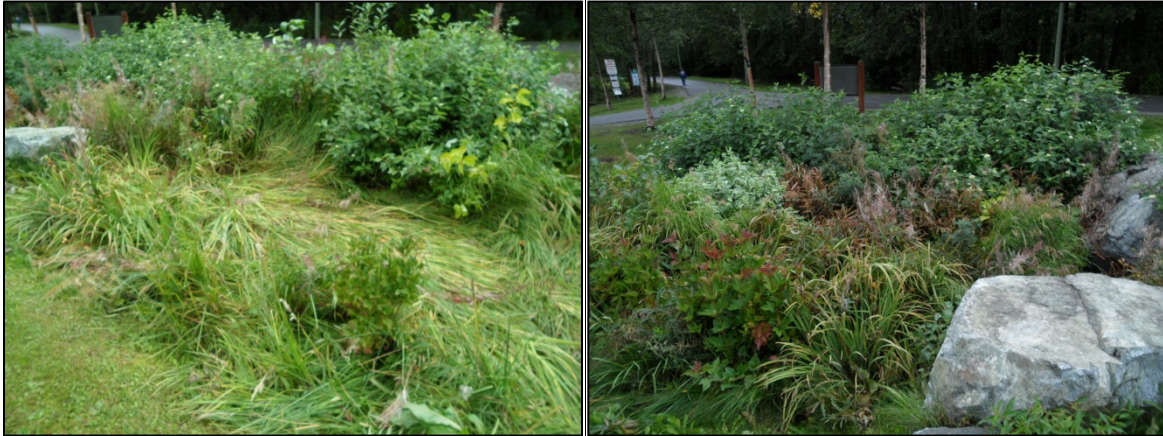
Rain garden

Standing or ponded water was not observed in the rain garden or at the garden outlet. The outlet pipe was not flowing. Vegetation in the rain garden appeared to be overgrown.

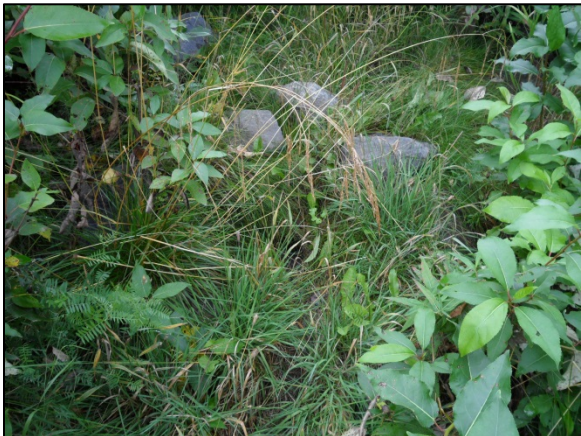
Outlet pipe with no flow

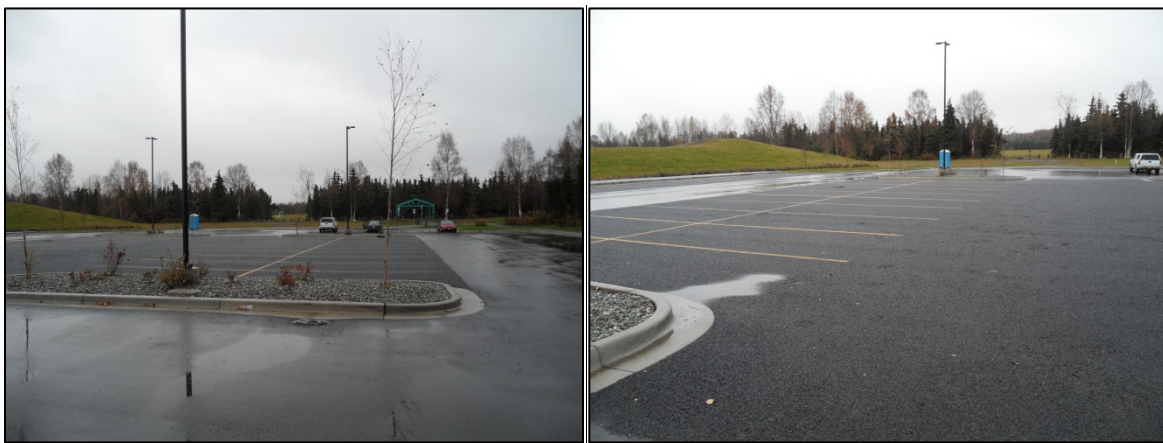
- North MW: Water was observed to be 40 inches from the top of the casing, and the total well depth from TOC is 81 inches. (41 inches of standing water.)
- West MW: 4 inches of standing water
- Central MW: 6 inches of standing water

Left: Parking lot overview. Right: ponding on the porous asphalt

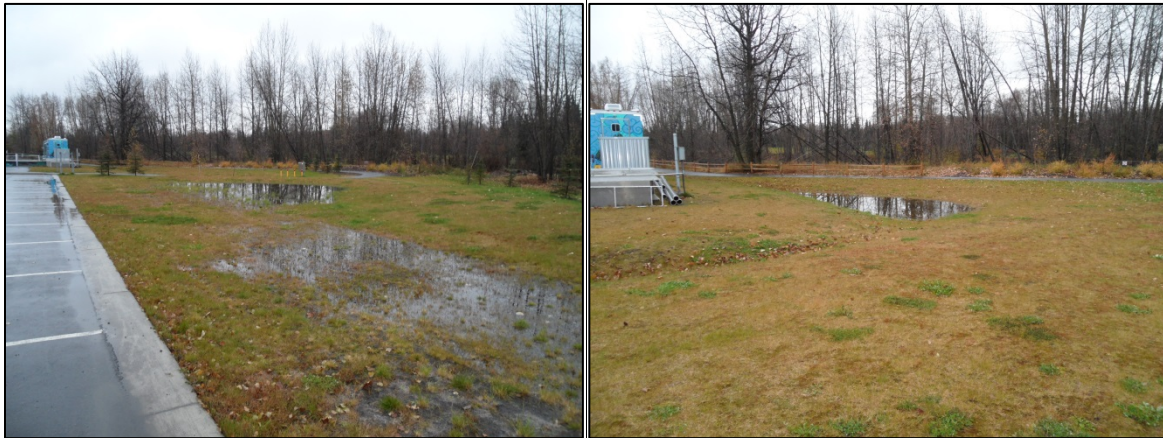
Ponded water was observed in both of the rain gardens/grassy depressions. Overflow from the depressions/rain gardens was not observed. The standing water in the western garden, closest to Reeve Blvd was 6 inches in the deepest observed location. In the eastern garden, standing water was 10 inches in the deepest observed location.

Left: West rain garden. Right: East rain garden

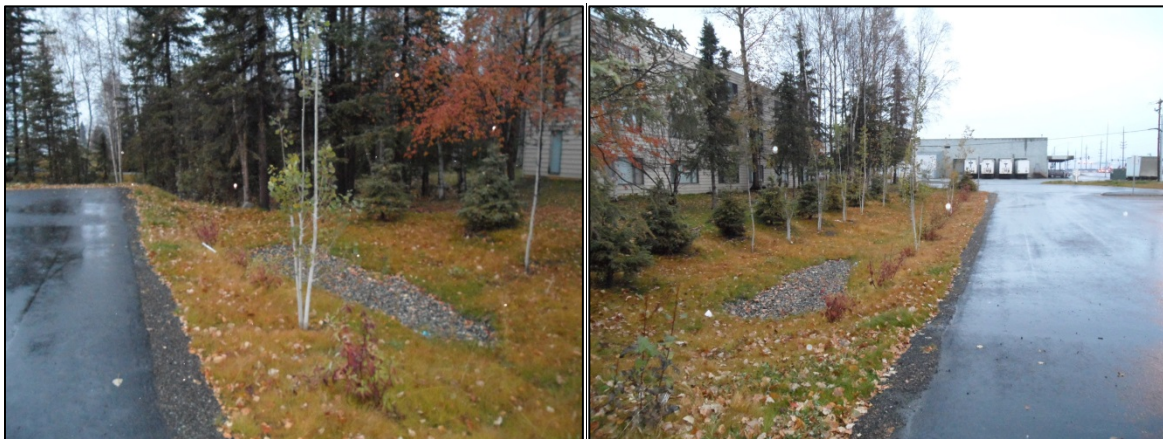
Rain garden and parking lot

Observations: The rain had slowed to a slight drizzle. No standing water was observed in the rain garden, and the vegetation looks stable.

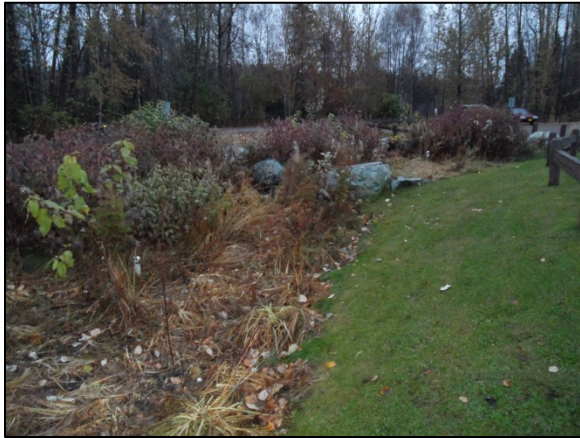
Rain garden

Observations: Light rain was falling. Standing or ponded water was not observed in the rain garden or at the garden outlet. The outlet pipe was not flowing.

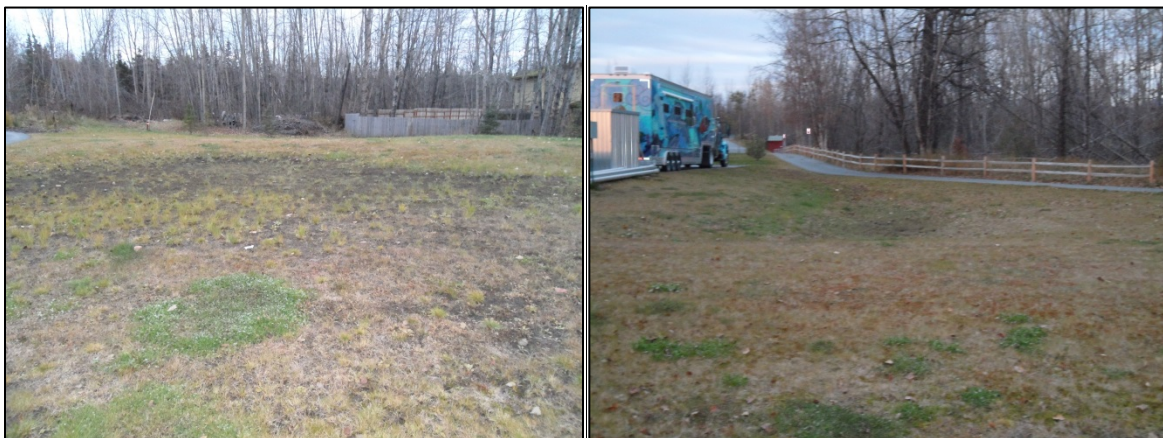
Observations: Both rain gardens had no standing water. The rain gardens' bottom surfaces were soft and slightly muddy, but no standing water was observed.

Left: West rain garden. Right: East rain garden
