# **2020 Dry Weather Screening Report**

## **APDES Permit No. AKS052558**

### **MUNICIPALITY OF ANCHORAGE**

Prepared for: Municipality of Anchorage  
Project Management and Engineering Department  
Watershed Management Services

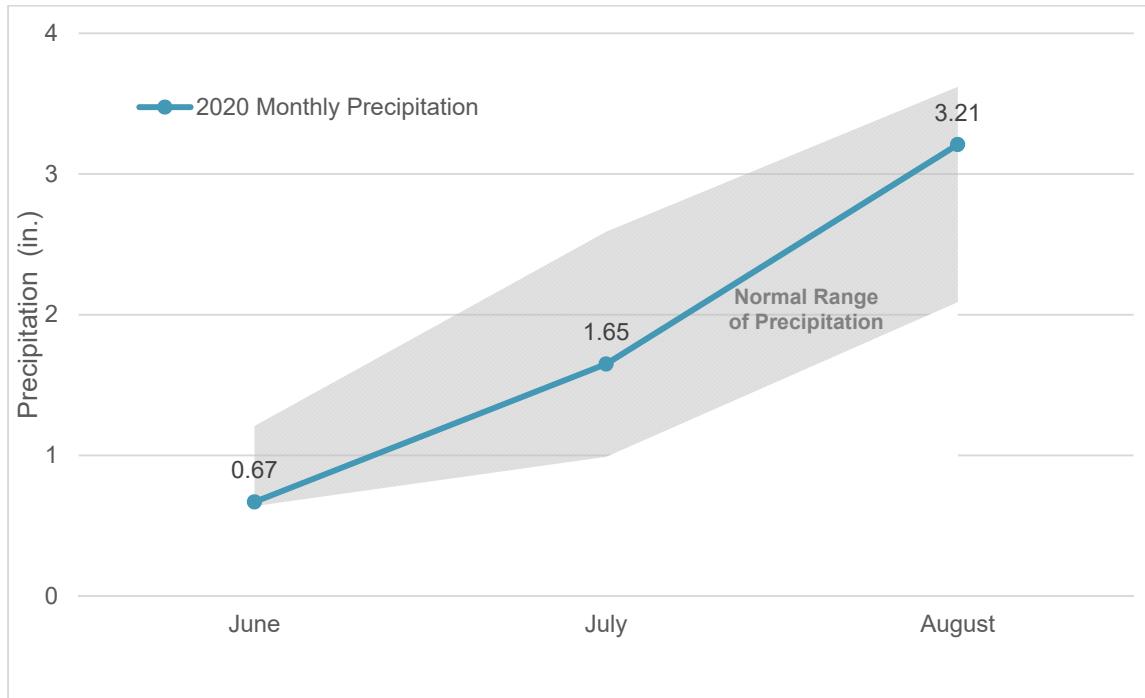
**Figure 1. Monthly Precipitation in Anchorage, Summer 2020**

Notes: 2020 monthly precipitation data recorded at Ted Stevens International Airport. Source: NWS 2020b. Normal range of precipitation shown is the range between the 25<sup>th</sup> and 75<sup>th</sup> percentiles of monthly precipitation averages recorded at the Ted Stevens International Airport for the 30 year period from 1981 to 2010. Source: NOAA 2016.

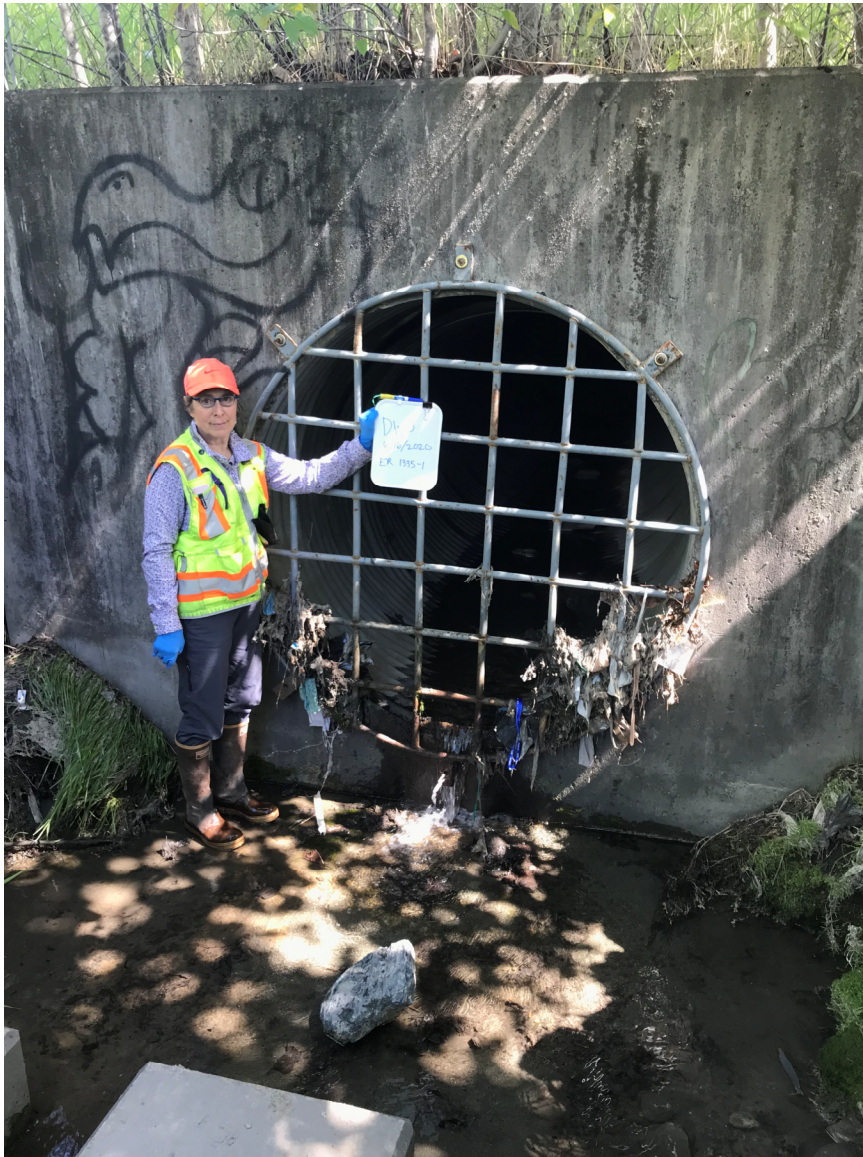
Eagle River 1335-1. June 16, 2020.

Outfall Code	Latitude	Longitude	Location Description and Condition Notes
<b>Eagle River</b>			
<b><i>Eagle River Mainstream</i></b>			
1335-1	61.29962	-149.54226	North bank, at pedestrian tunnel below Eagle River Loop Rd. Outfall in concrete headwall, discharges to flow path constructed with rock gabions. Outfall and flow path in good condition. Urban debris within grate
303-1	61.29799	-149.53482	North bank, outfall is along trail south of Little Cape Cir. EOP is located at terminus of mapped closed conveyances and flow path conveys discharge to west (not to south as mapped in HGDB). Outfall in good condition with high flow that cascades down rocks into flow path.
<b><i>Meadow Creek</i></b>			
646-71	61.31722	-149.55441	South bank, west of Chain of Rock St. Outfall is approximately 150 feet farther downstream than shown on HGDB and is in good condition. Outfall flows directly into creek and is perched above creek's normal water elevation.

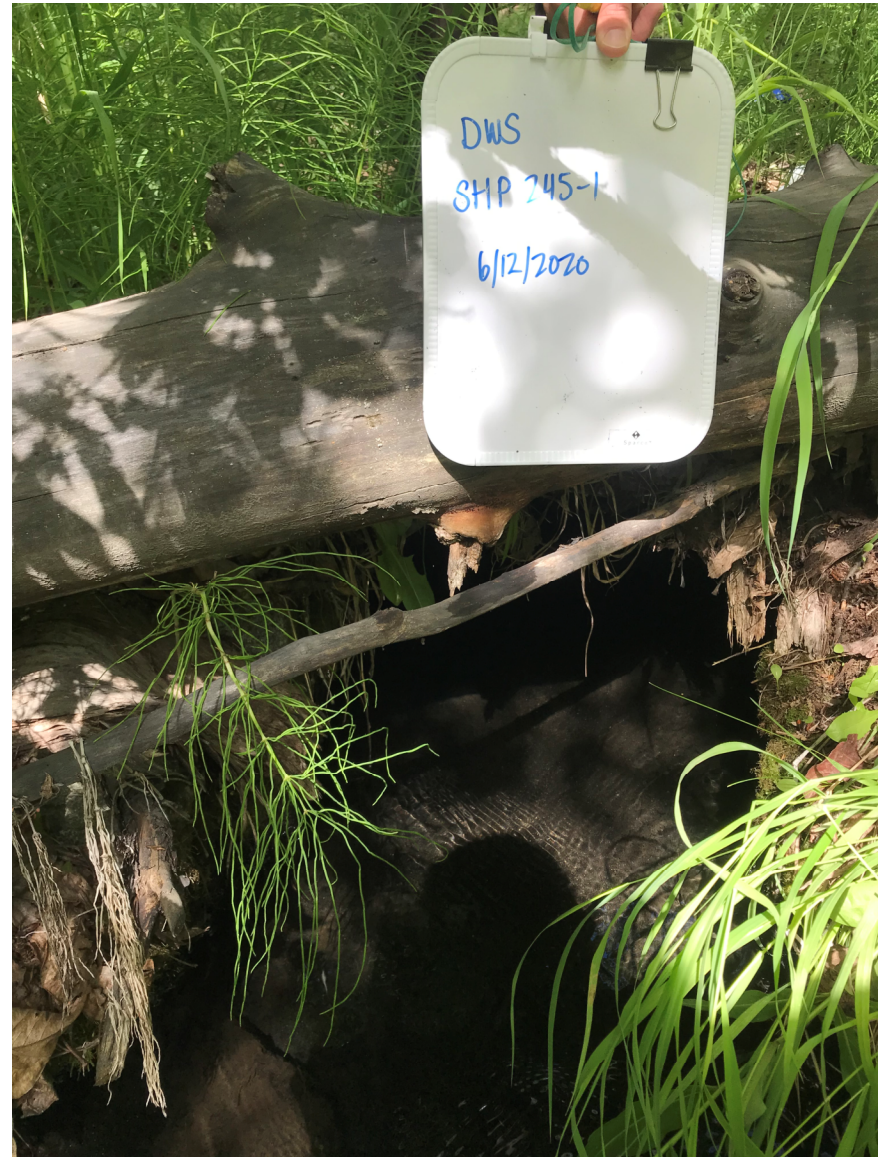
Ship Creek 245-1. June 12, 2020.

Outfall Code	Latitude	Longitude	Location Description and Condition Notes
245-1	61.22775	-149.83301	North bank at Yakutat St. EOP has an overhang and is covered in vegetation and woody debris. Some sand in pipe and flow path but otherwise good condition.

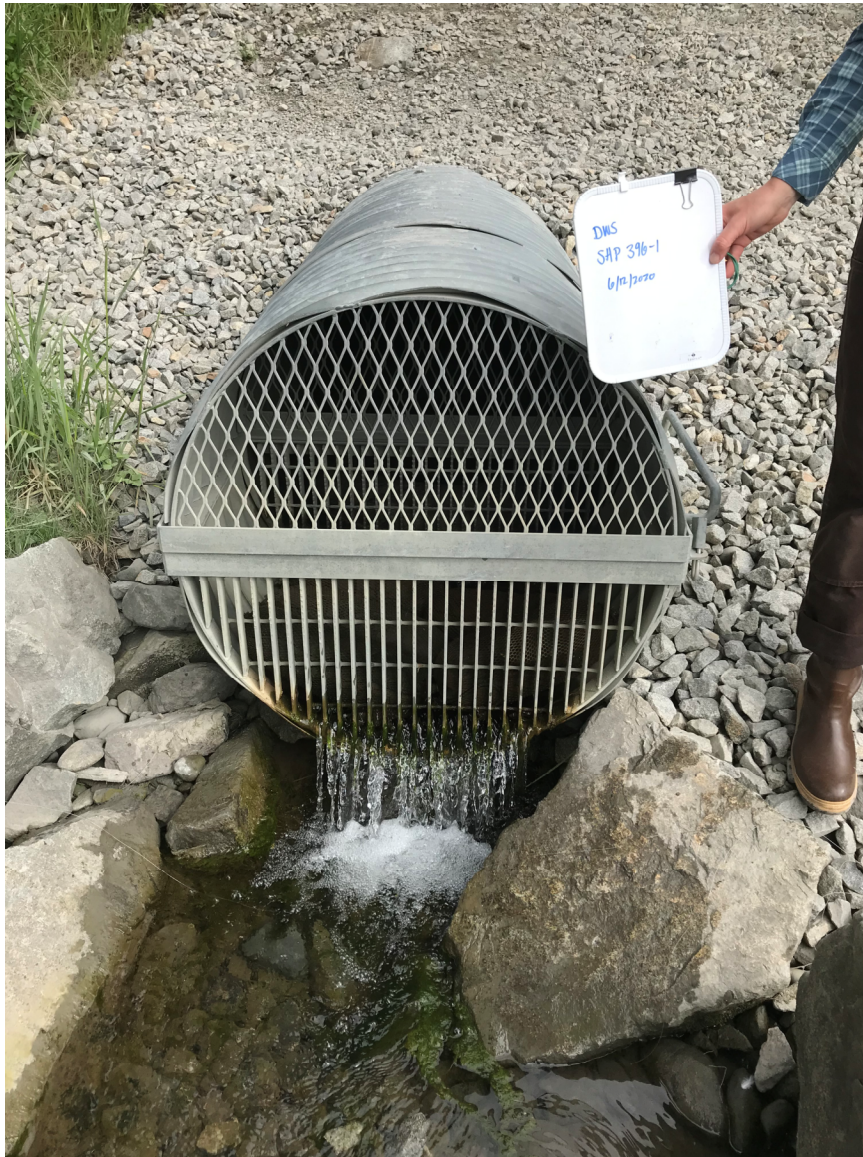
Ship Creek 396-1. June 12, 2020.

In response to the exceedances at outfall 396-1, MOA WMS performed two follow-up visits on August 7 and October 8 to determine whether the bacteria detected during sampling were due to an illicit discharge. The investigations, conducted during dry weather periods, looked at the drainage area to the outfall and collected samples from three locations where flows were observed. On October 8 the fecal coliform level at outfall 396-1 was 30 colonies/100mL, below the program threshold. Fecal coliform was not detected at the other two sample locations. Investigators believed the earlier exceedances were likely due to bacterial growth on sandbags behind the outfall grate, which were placed in the storm sewer as a sediment control measure. The sandbags will be removed and the outfall will be resampled under the 2021 DWS program. The follow-up report is included in Appendix F.

Based on the results of the sampling and drainage area investigations, WMS believes the flows were caused by ground water infiltration to the storm sewer, and the bacteria levels observed during the summer of 2020 were caused by bacteria growth in a sediment control system (sandbags placed inside the grated culvert). As a result, maintenance crews will be asked to remove or replace the sandbags and we will resample the outfall next season (2021) as part of dry weather screening activities.
