2023 Dry Weather Screening Report APDES Permit No. AKS052558

MUNICIPALITY OF ANCHORAGE

WATERSHED MANAGEMENT SERVICES

Prepared by: HDR Engineering, Inc.

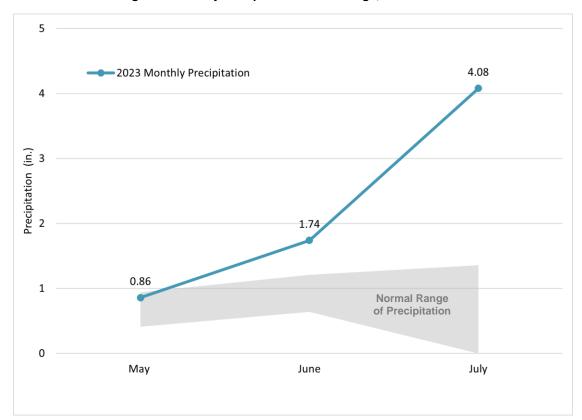
Figure 1. Monthly Precipitation in Anchorage, Summer 2023

The MS4 permit stipulates that dry weather screening should be conducted between June 1 and August 30 of each year, following at least 48 hours of dry weather after any storm event that created runoff in the MS4.³ Precipitation in the Anchorage area was within the normal range in May 2023. In June 2023, precipitation increased and was above normal while in July 2023 precipitation increased significantly and was higher than normal (Figure 1).

Notes: 2023 monthly precipitation data recorded at Ted Stevens International Airport. Source: NWS 2023b. Normal range of precipitation shown is the range between the 25th and 75th percentiles of monthly precipitation averages recorded at the Ted Stevens International Airport for the 30-year period from 1991 to 2010. Source: NOAA 2021.

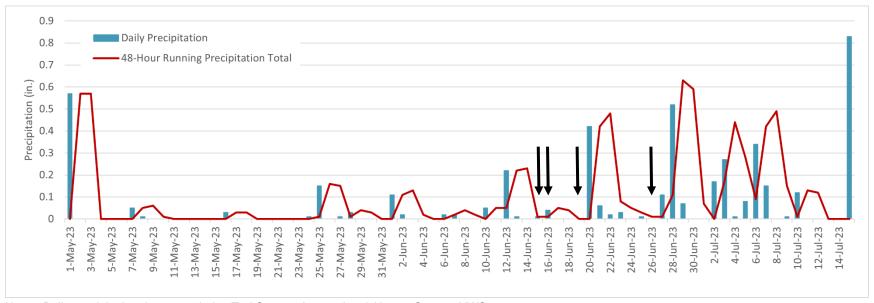
Figure 2. Daily Precipitation in Anchorage, Summer 2023

HDR conducted monitoring on four days in June, consulting recent precipitation recorded by the National Weather Service at the Ted Stevens Anchorage International Airport to determine appropriate monitoring timing, when necessary (NWS 2023a). Precipitation for the entire month of June was higher than normal, and continued to increase throughout July. All sampling occurred prior to the drastic increase in precipitation in July. Figure 2 shows the daily precipitation and 48 hour running total precipitation for summer 2023. The dates when sampling occurred are indicated by the black arrows.

Notes: Daily precipitation data recorded at Ted Stevens International Airport. Source: NWS 2023c. Black arrows indicate monitoring dates.

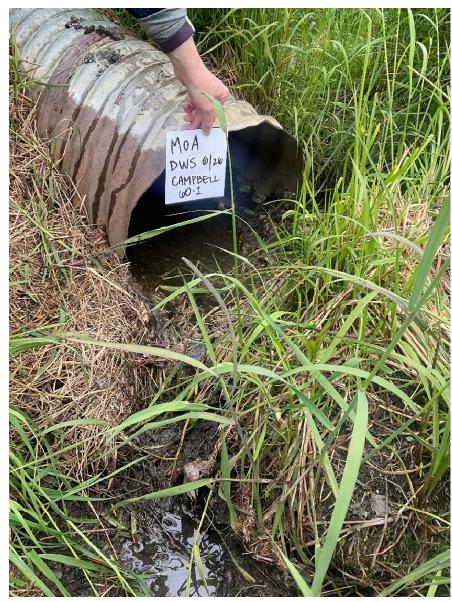
Campbell Creek 60-1. June 26, 2023.

Outfall Code	Latitude	Longitude	Prioritization Score	Location Description	Condition	Water flowing?
Campbell Creek						
60-1	-149.943724	61.123502	4	Accessible from Perenosa Bay Dr.	Fair condition. CMP. Bottom of outfall corroded. Two inches of sediment buildup within pipe.	No
74-2	-149.827785	61.151898	2	Accessible from Delridge Cir.	Could not locate EOP. Seepage found.	No
111-2	-149.881	61.15554	14	Accessible from Foxridge Cir.	Good condition. Smooth walled HDPE pipe. One inch of water in EOP.	Yes
175-1	-149.898	61.10652	10	Accessible from Botanical Heights Cir.	CMP with a grate and collar. Horsetails growing in the collar.	Yes
285-1	-149.828	61.15195	4	Accessible from Lore Rd.	Poor condition. Outfall made of plastic. Orange-brown precipitate present in outfall.	Yes
285-19	-149.822581	61.151868	NA	Along Lore Rd. Could not locate outfall.	-	-
285-15	-149.82614	61.151882	N/A	Accessible from Lore Rd.	HDPE pipe with a collar. Outfall backwatered with green algae present.	Yes

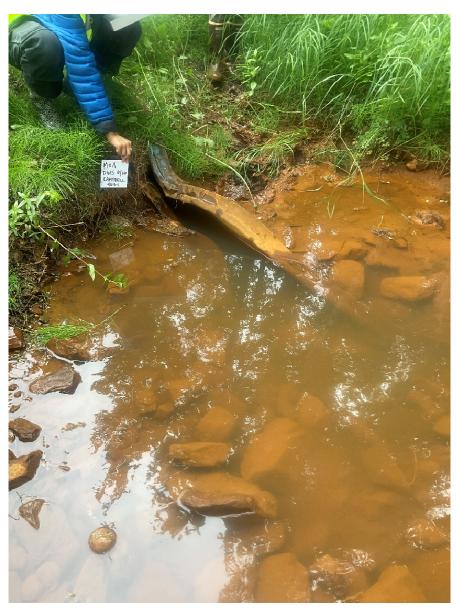
Campbell Creek 463-1. June 26, 2023.

463-1	-149.94	61.12436	14	Accessible from Ensign Dr.	Poor condition. Collar collapsed on itself. Outfall backwatered. Heavy presence of orange precipitate.	Yes
475-1	-149.858	61.14846	13	Accessible from 80 th Ave.	Poor condition. Outfall surrounded by vegetation. EOP embedded within vegetation.	Yes
485-98	-149.857	61.173	13	Accessible from Brayton Dr. and Alpenhorn.	Good condition. CMP. Orange- brown precipitate present in downstream channel.	Yes

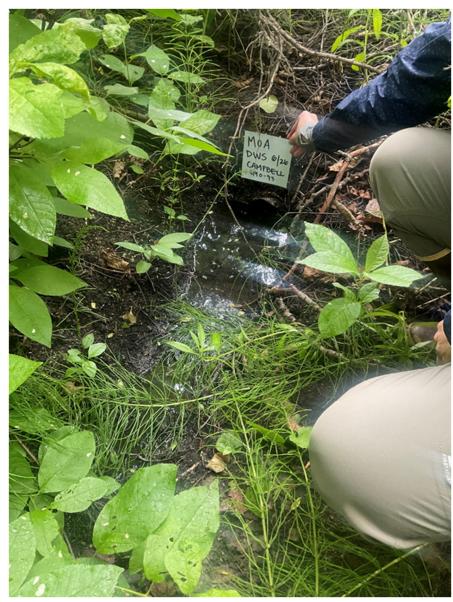
Campbell Creek 490-93. June 26, 2023.

Outfall Code	Latitude	Longitude	Prioritization Score	Location Description	Condition	Water flowing?
490-93	-149.941054	61.12288	N/A	Accessible from Sleeping Lady Ln. Fair condition. Outfall backwatered and approximately 90% submerged.		Yes
490-95	-149.941	61.12219	10	Accessible from Marathon Cir.	Good condition. Smooth walled HDPE pipe with a collar.	Yes
529-1	-149.96438	61.137788	4	Accessible from side road adjacent to Dimond Rd.	Fair condition. CMP with a metal collar. Top of outfall damaged.	No
548-1	-149.906594	61.141737	14	Near intersection of Minnesota Dr. and Diamond Blvd.	Could not locate EOP. DS cross culvert seen but not investigated.	No
608-39	-149.74	61.18172	10	Accessible from Scenic View Dr.	Good condition. Smooth walled HDPE pipe.	Yes
675-1	-149.864	61.15366	12	Accessible from E 74 th Ave.	Good condition. CMP with a metal collar. Outfall is slip lined with smooth walled HDPE pipe.	Yes

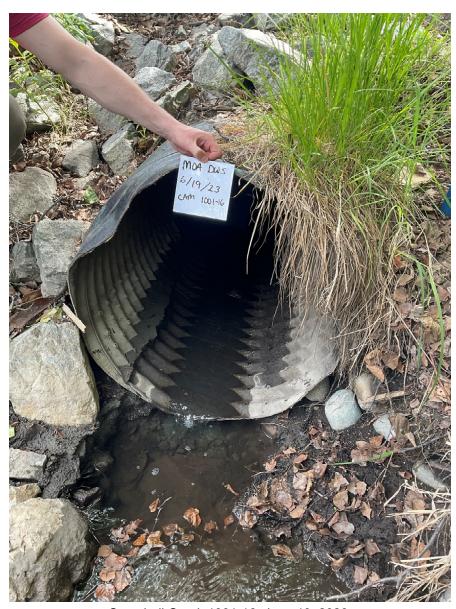
Campbell Creek 1001-16. June 19, 2023.

1001-16	-149.853	61.14748	13	Accessible from Sandlewood Pl.	Fair condition. Plastic pipe. Damage observed on the top of the outfall and uniform holes line the sides.	Yes
1339-38	-149.948	61.15468	10	Along Caravelle Dr. Could not access due to private property.	-	-
1493-1	-149.982	61.13541	13	South of Diamond Blvd. and Sand Lake roundabout.	Could not locate EOP, assumed to be under riprap. Flow seen under riprap.	Yes
1494-1	-149.983	61.15352	10	Located off of Cobbler Dr. and Katahdin Dr.	Could not locate EOP.	-
1495-1	-149.966133	61.137828	7	Accessible from road adjacent to Dimond Blvd. Located underneath a bush.	Fair condition. Smooth walled HDPE pipe.	No
Chester Creek

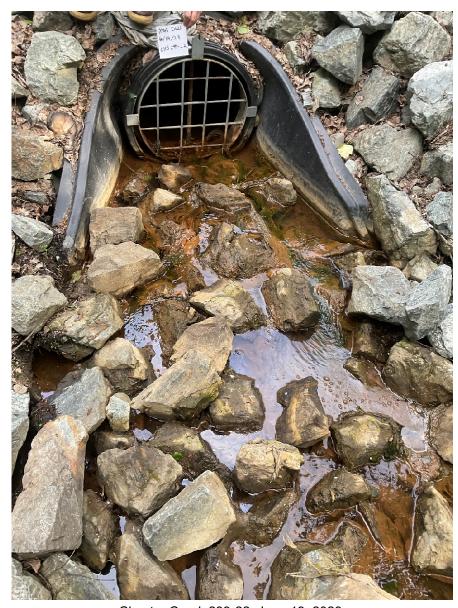
Chester Creek 299-22. June 19, 2023.

Outfall Code	Latitude	Longitude	Prioritization Score	Location Description	Condition	Water flowing?
299-22	-149.874	61.20258	15	Accessible from Eagle St. Good condition. Smooth walled HDPE pipe with a grate and plastic collar.		Yes
484-1	-149.869	61.20158	15	Accessible from residential road off of E 21st Ave.	Good condition. CMP. There is damage to the top of the outfall.	No
547-1	-149.760504	61.205239	7	Accessible from Cheney Lake Park.	Fair condition. CMP with grate and collar. The grate is partially blocked with debris.	No
553-1	-149.744	61.20274	13	Accessible from 20 th Ave. Outfall on eastern side of stream.	Good condition. CMP and accompanied by a rectangular weir.	Yes
554-2	-149.78177	61.193206	16	Accessible from E 30 th Ave.	Constructed of concrete. Outfall partially buried.	Yes
568-1	-149.825	61.21847	11	Accessible off of Mountain View Dr.	Good condition. Smooth walled HDPE pipe. CMP open flume directs flow down the steep embankment.	Yes

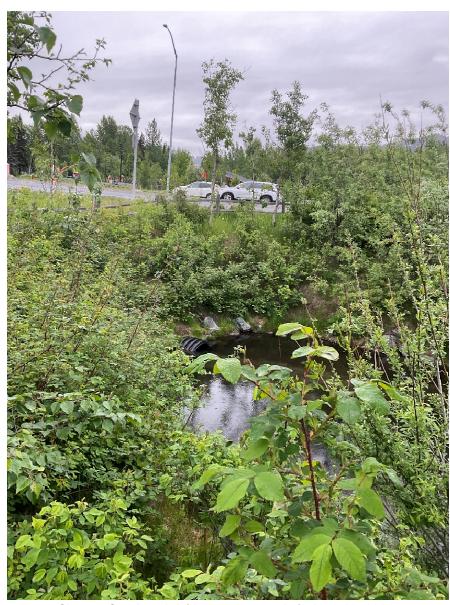
Chester Creek 574-1 (downstream outlet). June 16, 2023.

574-1	-149.734	61.21253	6	North of intersection of Muldoon Rd. and Creekside Center Dr. Point located in middle of road.	Could not locate. Closest downstream connection is corouted with stream and was not investigated.	-
Fish Creek						
388-197	-149.928	61.17865	21	Accessible from Northwood Dr.	Good condition. Rust in collar.	No

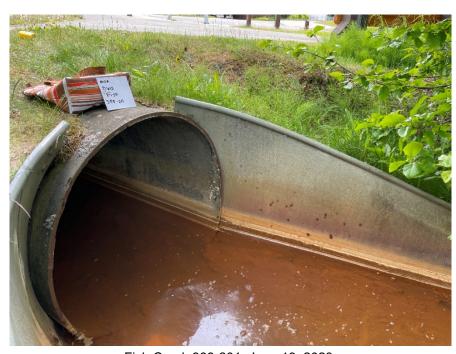
Fish Creek 388-201. June 19, 2023.

Outfall Code	Latitude	Longitude	Prioritization Score	Location Description	Condition	Water flowing?
388-201	-149.928	61.17831	21	Accessible from W 47 th Ave. in Northwood Park.	Good condition. Iron deposits around outfall. Collar exhibiting rust.	Yes
555-1	-149.965	61.16101	7	Accessible from the end of Delong Landing Cir.	Good condition. HDPE pipe. Vegetation growing around outfall.	No
573-156	-149.842419	61.183626	15	Tried to access from South Salem Dr. and from the southeast. Could not access due to private property or bog.	-	-
Furrow Creek						
5-1	-149.883	61.10603	9	Accessible from pedestrian trail in Johns Park.	Fair condition. CMP with a collar.	Yes
34-26	-149.861	61.1012	14	Accessible from Oceanview Dr.	Good condition. CMP.	No
34-54	-149.860333	61.10008	14	Located off of Oceanview Dr.	Could not locate EOP. Seepage found.	No
407-2	-149.838742	61.1051	10	Located off of Loren Cir. Could not access due to private property.	-	-
