Prepared For:
The Municipality of Anchorage
Watershed Management Services

Campbell Creek Watershed Plan

The Municipality of Anchorage
Watershed Management Services
4700 Elmore Road
Anchorage, Alaska 99507

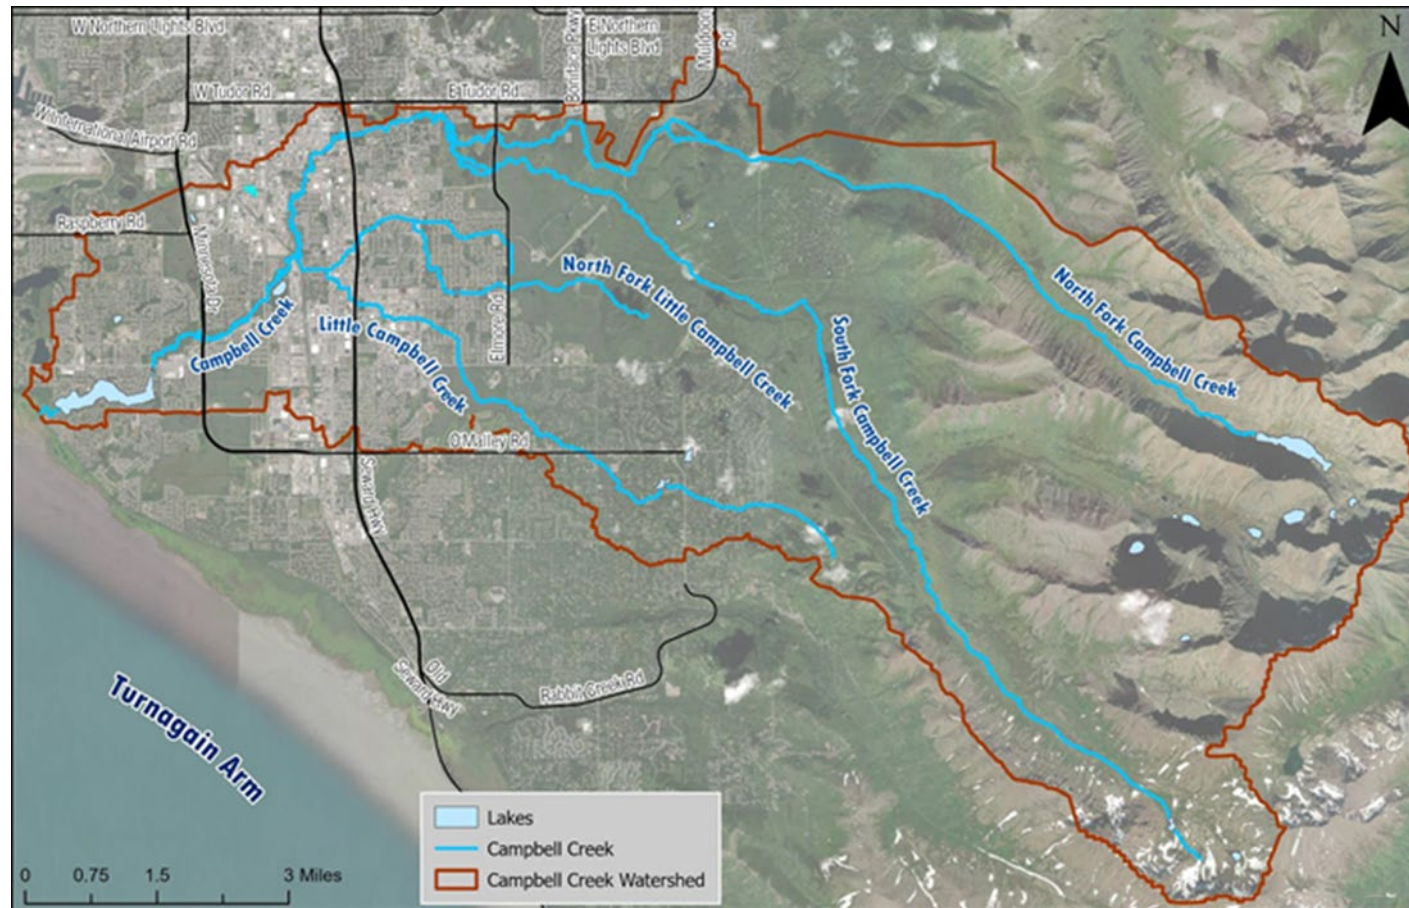
Figure 1: Campbell Creek Watershed

The Campbell Creek Watershed extends approximately 16 miles from the Chugach Mountains to the creek's mouth on Turnagain Arm, just downstream of Campbell Lake. The watershed location is provided in Figure 1.

The Campbell Creek Watershed is approximately 69 square miles and includes several tributaries (shown in Figure 1). The watershed encompasses a diverse range of land uses. Approximately 70% of the watershed area consists of undeveloped land, open spaces, and parks, offering a variety of opportunities for outdoor recreation. The urbanized portions of the watershed are home to many residents, businesses, schools, recreation areas, and an airstrip. As of the 2020 Census, the Campbell Creek Watershed has 83,543 residents, accounting for approximately 29% of Anchorage's total population. Unfortunately, the Campbell Creek Watershed also has areas of concern for the natural environment that limit recreational and economic opportunities and impair its aesthetic qualities. These issues include water quality degradation and development along the creek-side or riparian habitat.

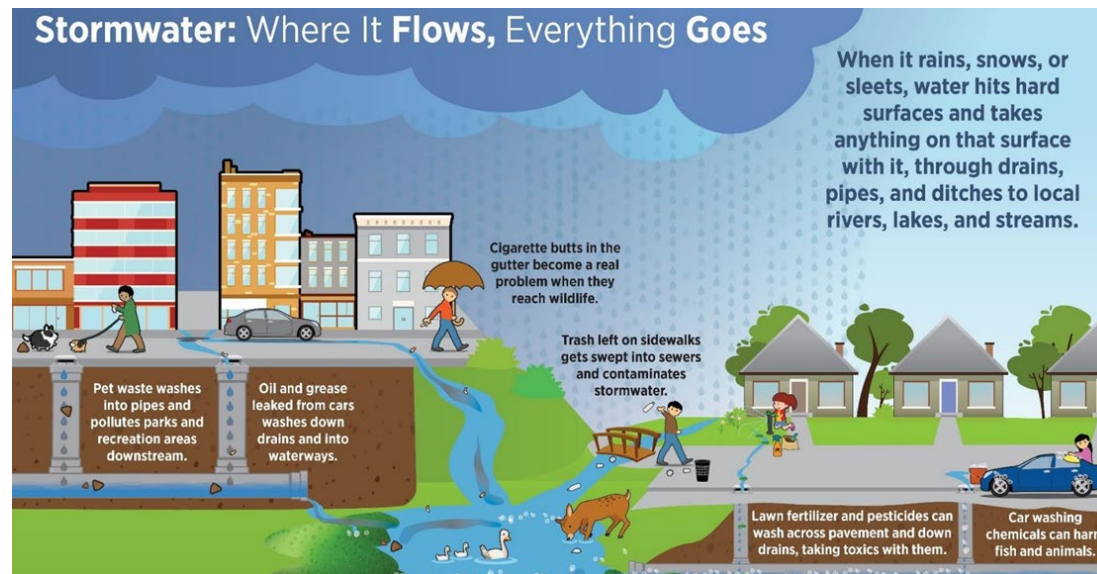
Figure 7: Urban Stormwater Runoff (US EPA)

Urbanization affects not only the quantity of stormwater runoff but also its quality. Development increases both the concentration and the pollutants carried by runoff. As stormwater runoff flows over rooftops, lawns, roadways, and other surfaces, it picks up and transports contaminants and pollutants to water bodies. Losing the original topsoil and vegetation removes a valuable filtering mechanism for stormwater

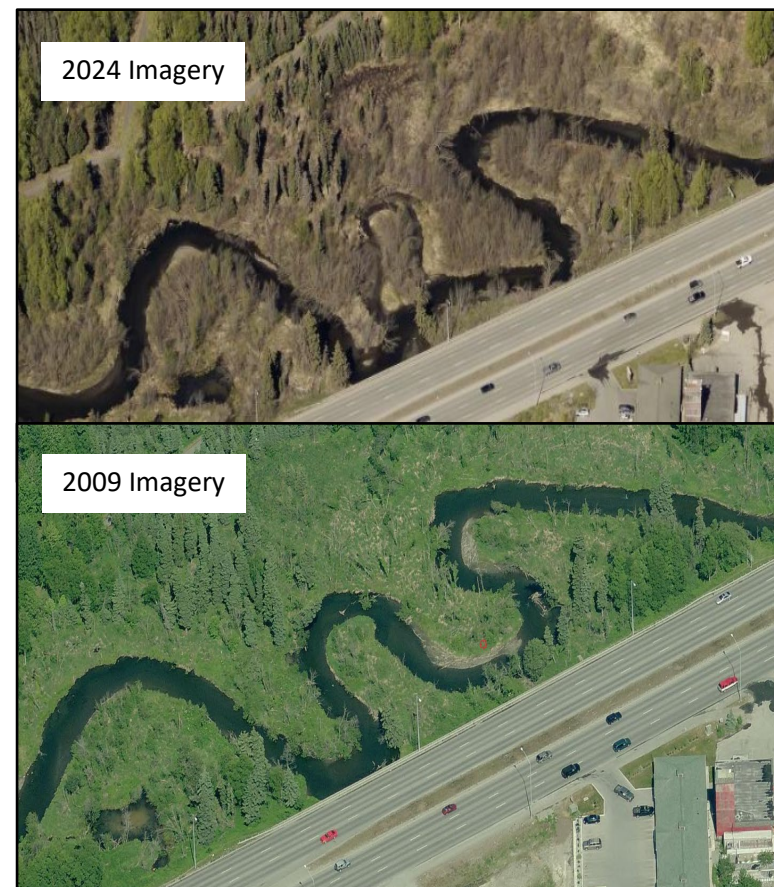
Figure 9: Oxbow in Campbell Creek northeast of Minnesota Dr. & W Dimond Blvd.

In an undeveloped state, stream channels are bordered by natural vegetation and can meander or straighten across their floodplain. An example of this is an oxbow shown in Figure 9, located northeast of Minnesota Drive and W. Dimond Boulevard. Natural channels can include a diversity of depths and configurations. As a city becomes more developed, natural channels are often modified (moved, straightened, piped, dammed, etc.) to accommodate more room for development. It's essential to understand the impact of channel modification on an ecosystem and future infrastructure planning.
