Phase 2 Environmental Assessment of the Government Hill Wireless Station

December 11, 1997

**PHASE 2 ENVIRONMENTAL SITE ASSESSMENT
GOVERNMENT HILL WIRELESS STATION
132/140 EAST MANOR AVENUE
ANCHORAGE, ALASKA**

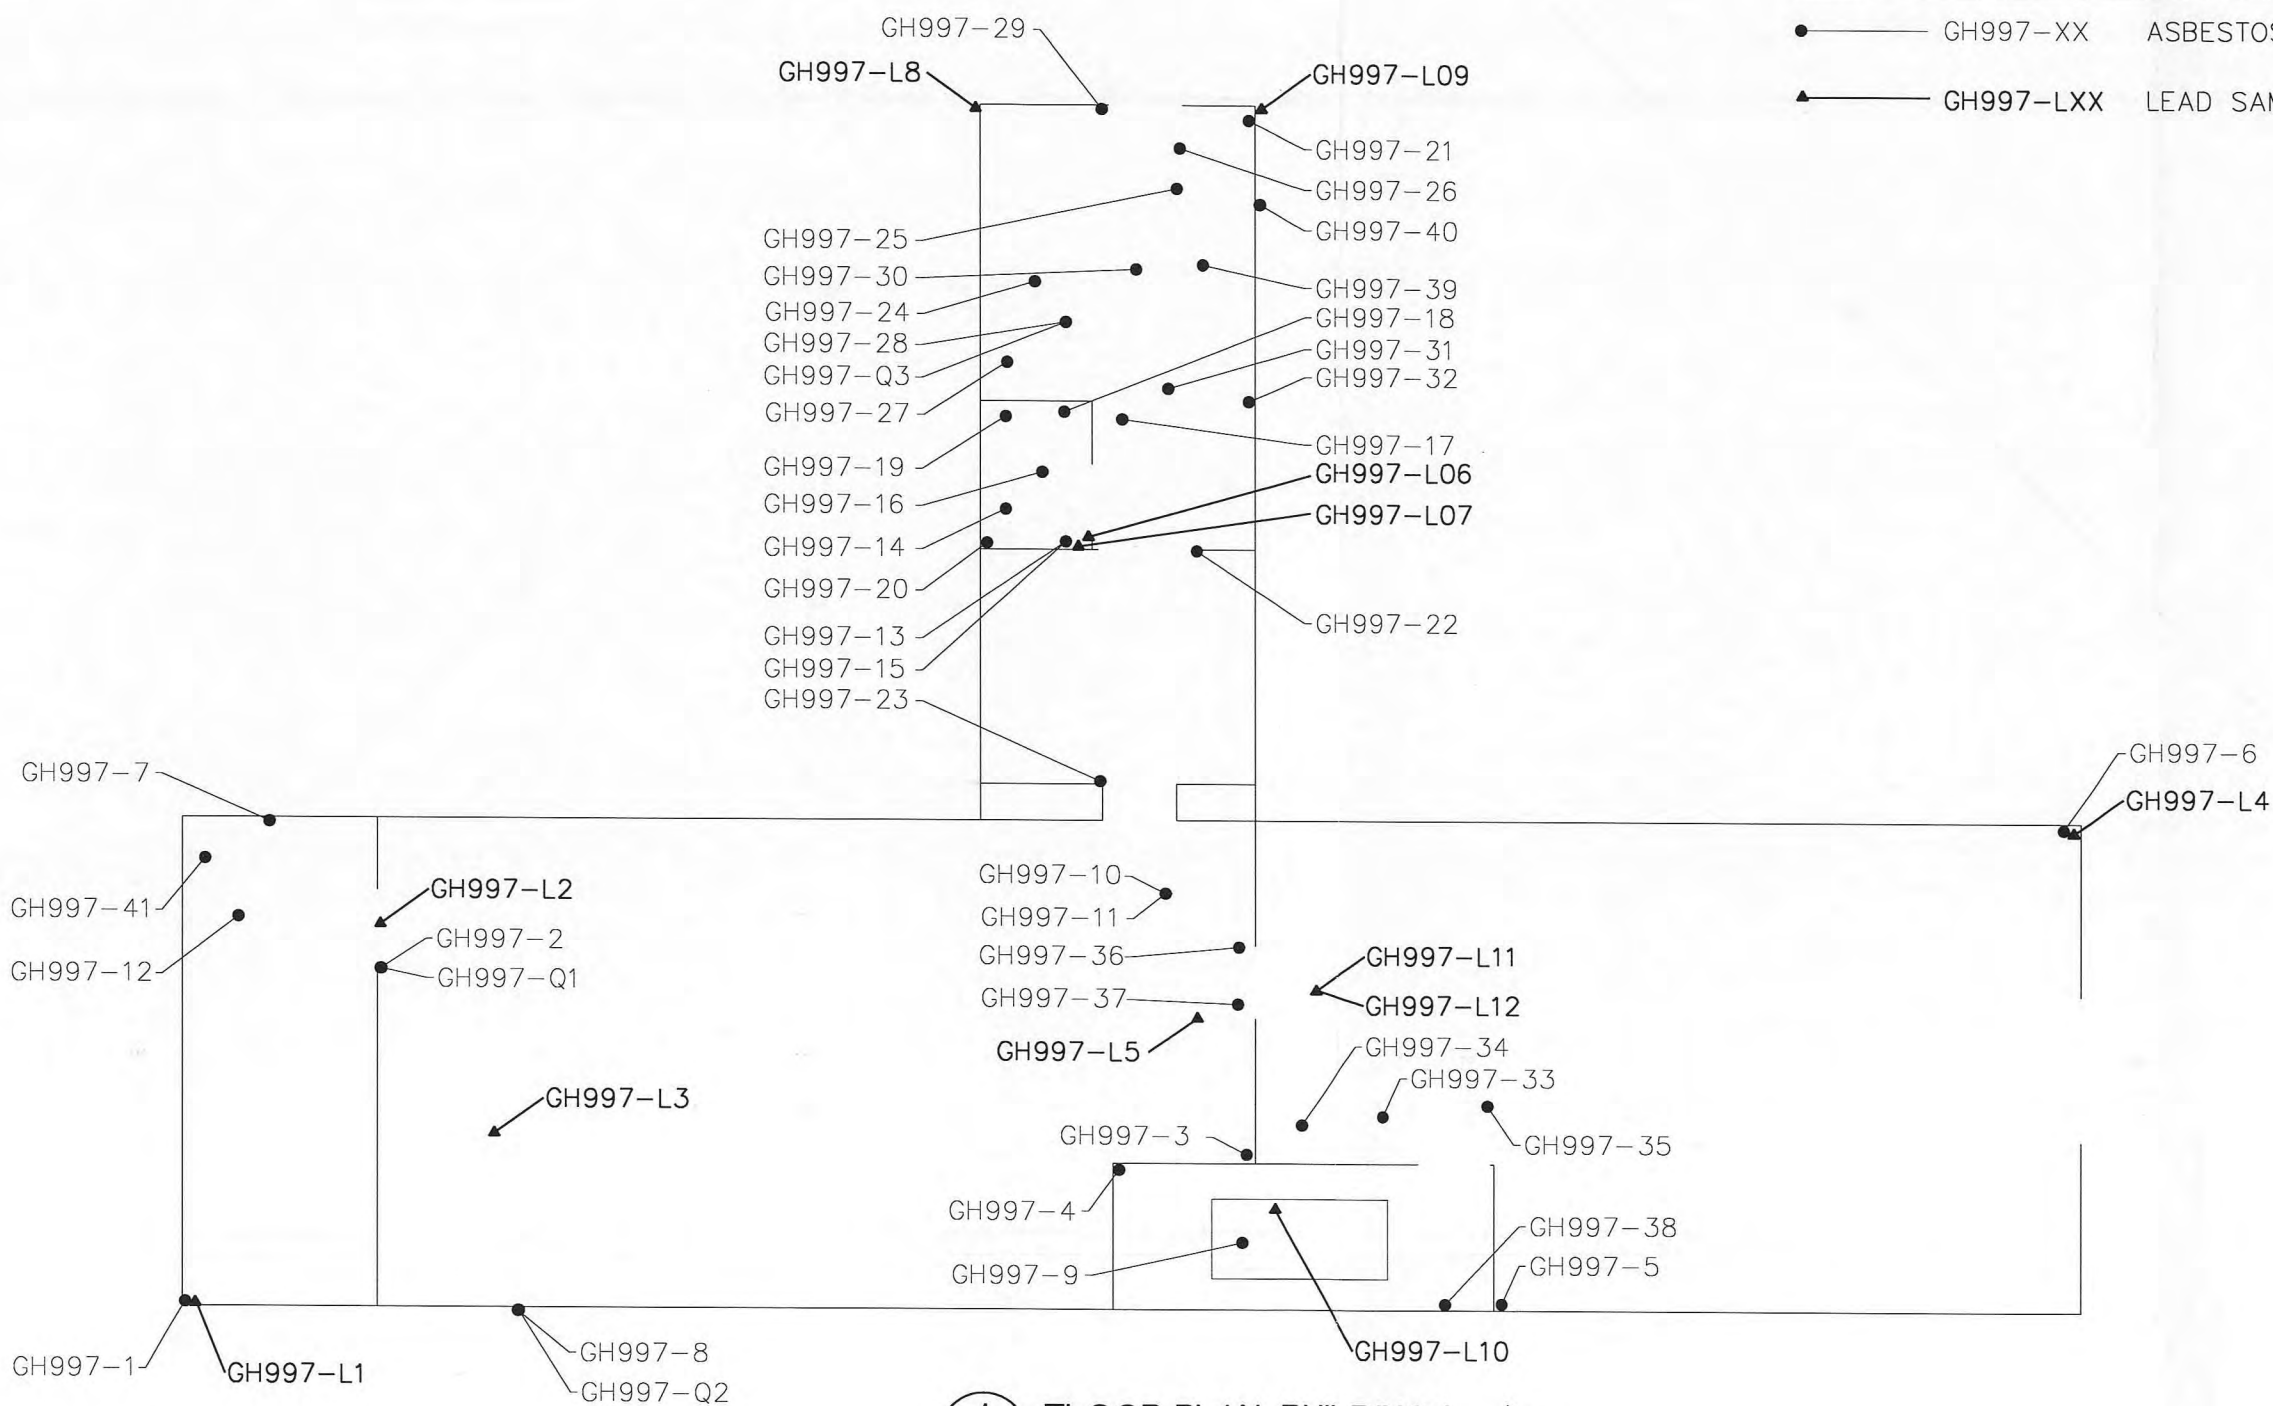
1 FLOOR PLAN, BUILDING 1
1/8"=1'0"

The following non-friable asbestos-containing materials were found in Building #1: Red 12"x12" floor tile, cement asbestos board, wire insulation, sheet vinyl flooring, and roofing materials. The friable ACM found in Building 1 included pipe insulation in the crawl space of the west wing, furnace gaskets and furnace refractory insulation.

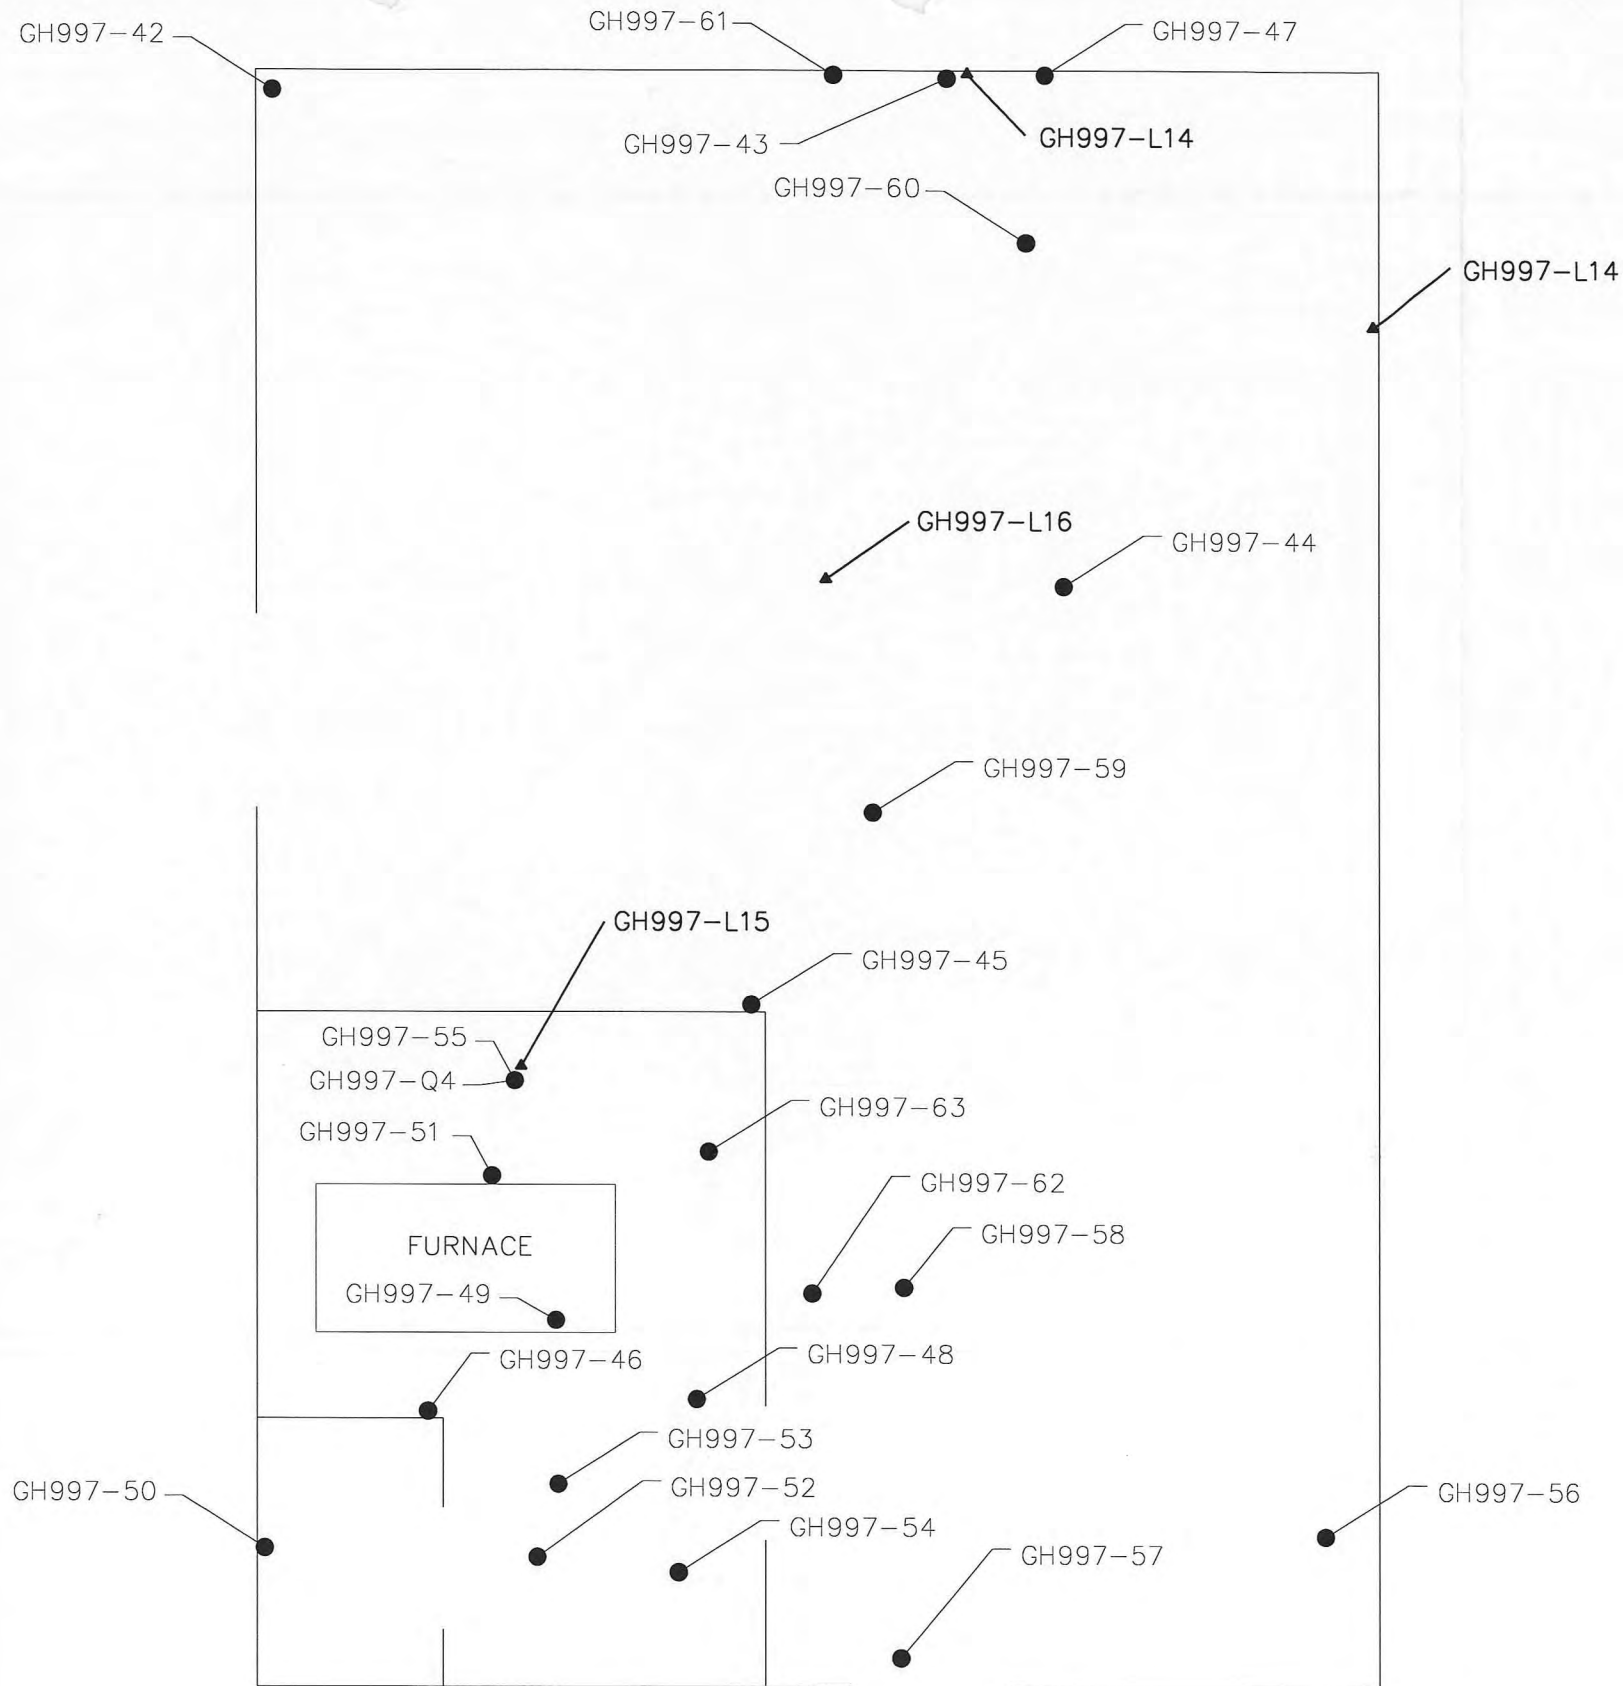
1 FLOOR PLAN, BUILDING 2
B2 1 1/4"=1' 0"

The following non-friable asbestos-containing materials were found in Building #2: Joint compound of gypsum wall board walls and ceilings, dark brown 9"x9" floor tile, cement asbestos

board, and roofing materials. The friable ACM found in Building 2 included pipe insulation in the crawl space, furnace gaskets, furnace refractory insulation and loose asbestos paper in the attic.

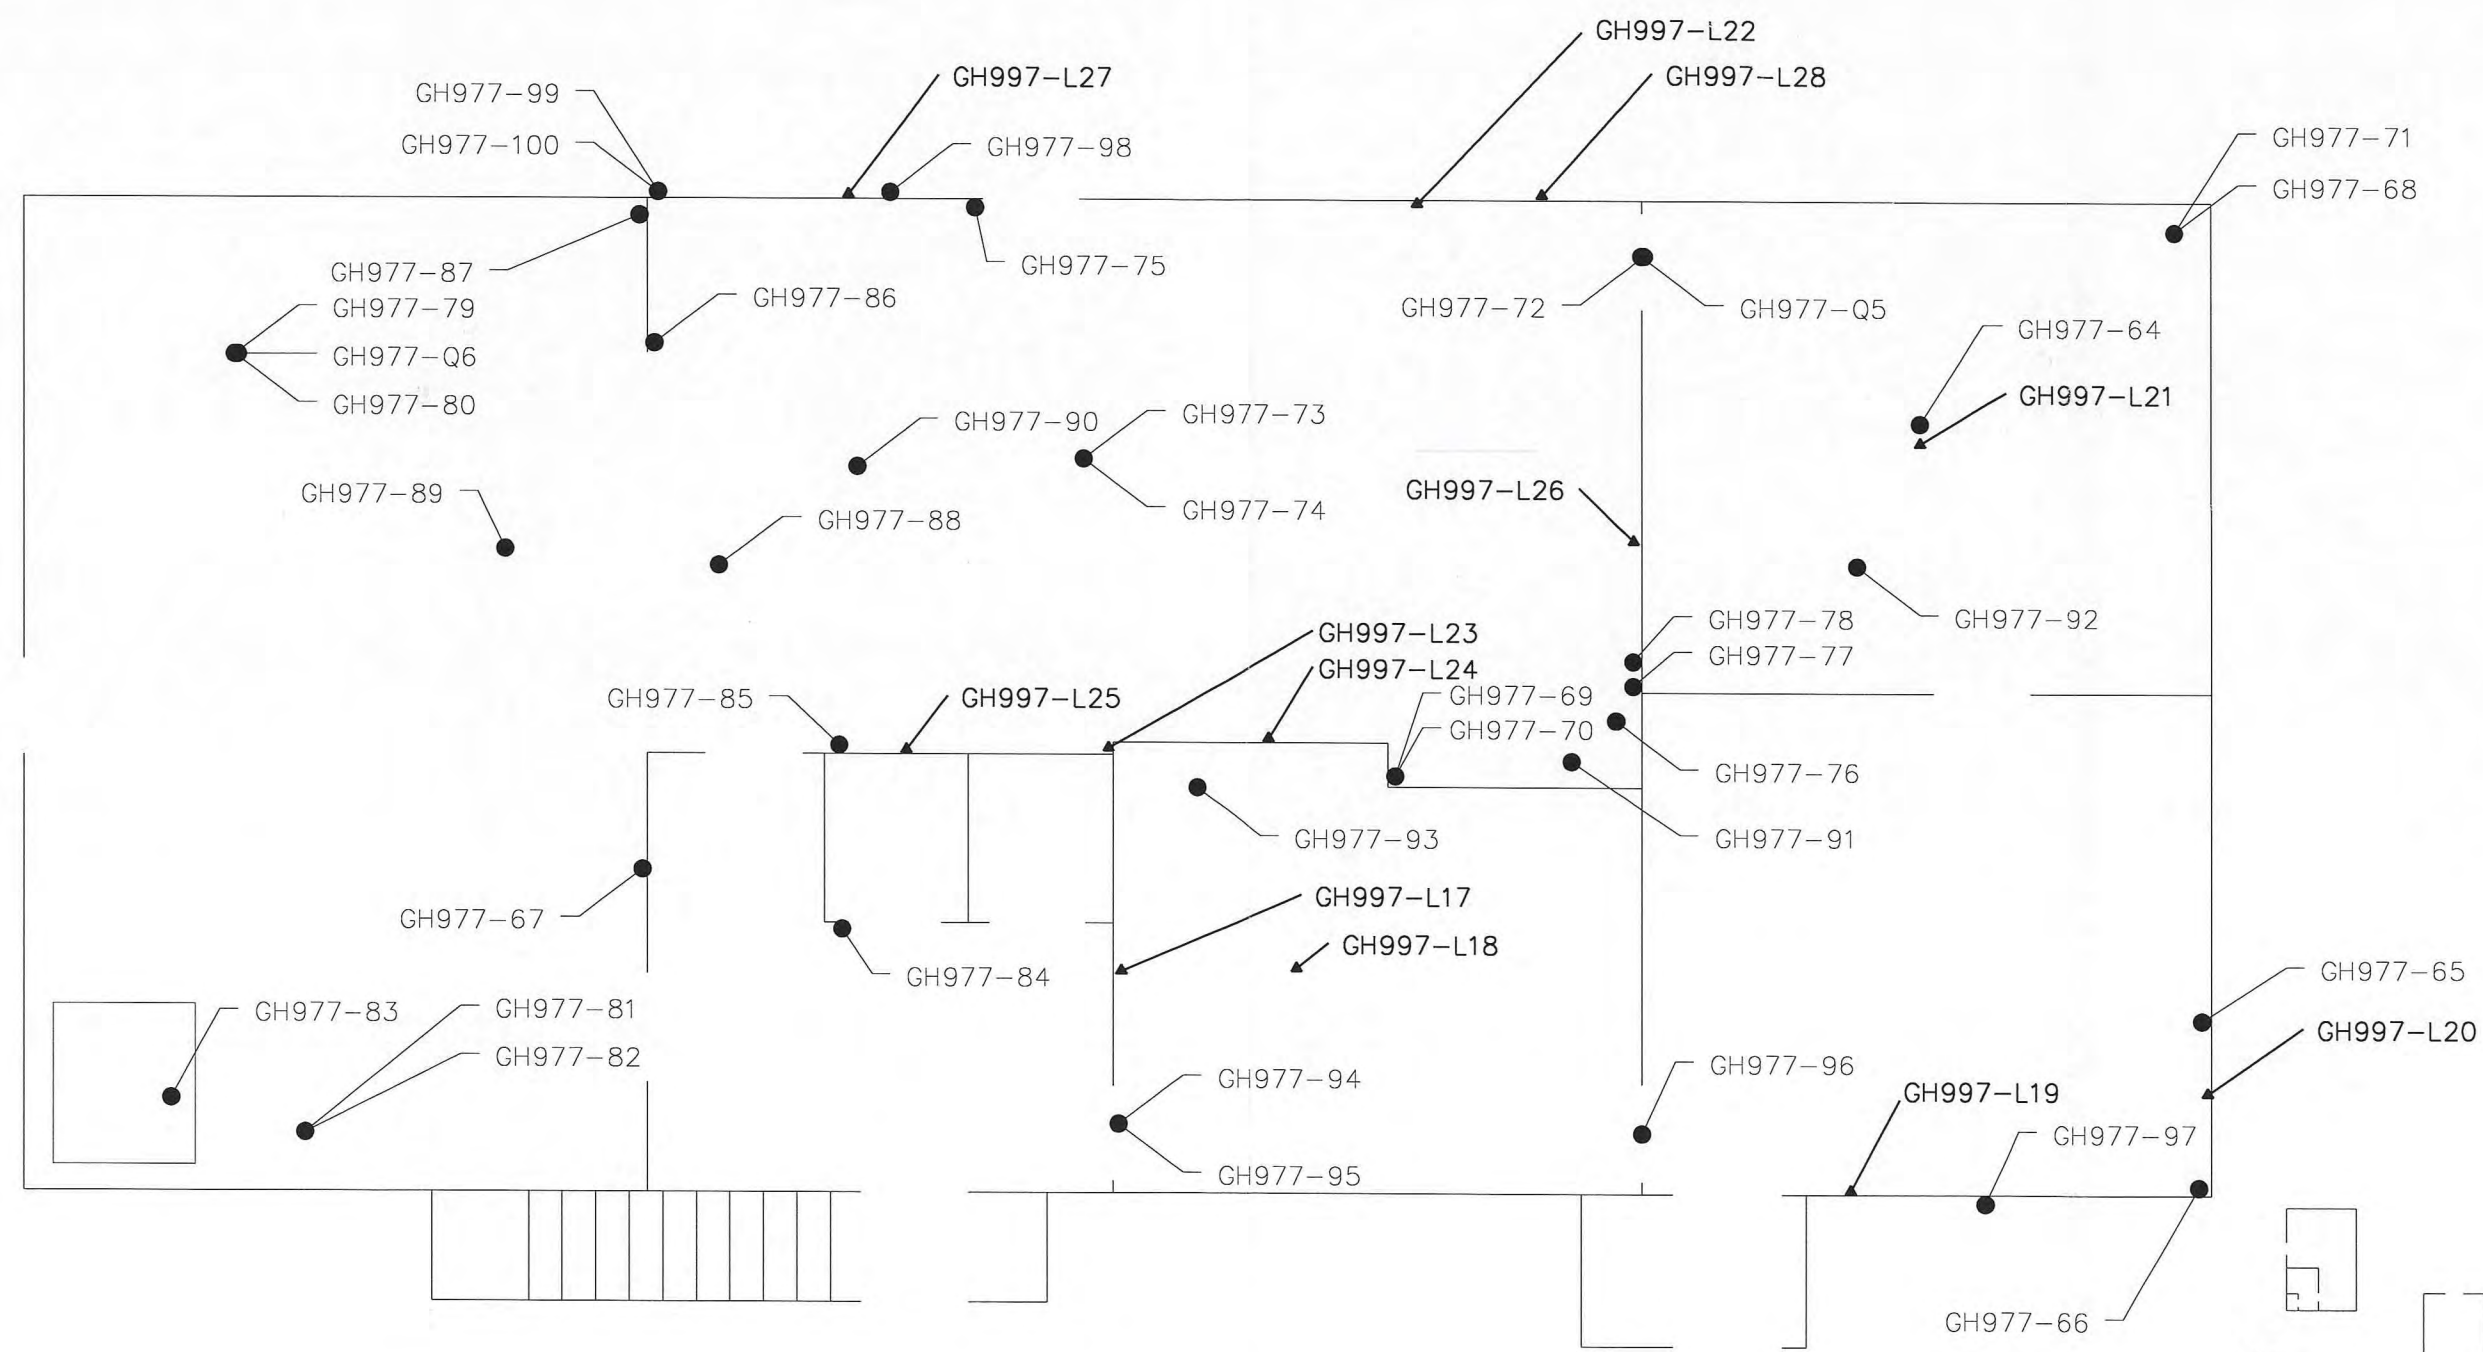
1 FLOOR PLAN, BUILDING 3
 3A 1 3/16"=1'0"

The following non-friable asbestos-containing materials were found in Building #3: Joint compound of cellulose board walls and ceilings in north addition, joint compound of gypsum wall board walls and ceilings in south addition, cement asbestos board, and roofing materials. The friable ACM found in Building 3 included furnace and boiler gaskets, furnace and boiler refractory insulation, and pipe insulation in the basement and crawl space.
