Appendix B: Photographs

Documentation of Present Appearance

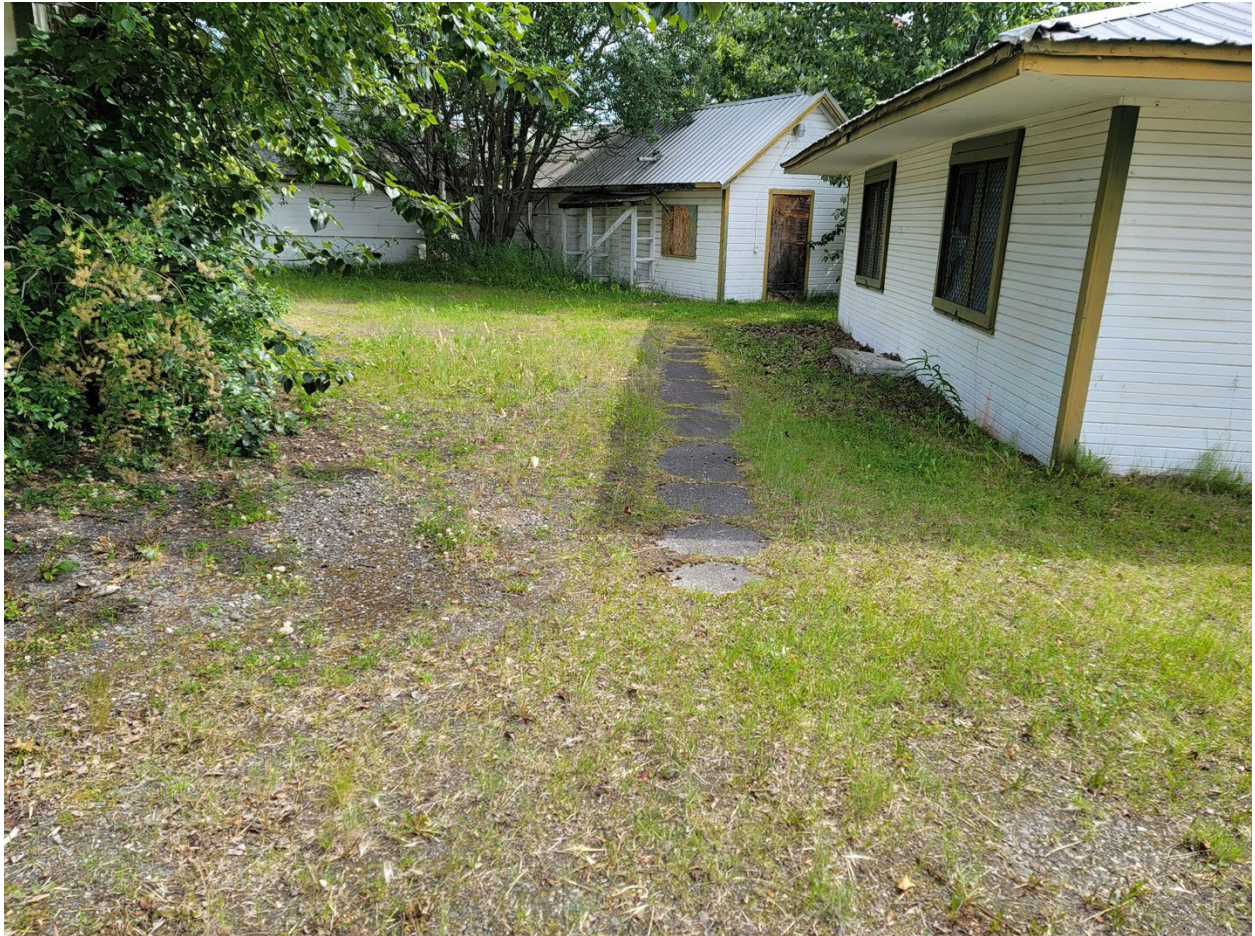
Figure B10. Building C, view to the southeast. The photograph shows the dense overgrowth of vegetation that surrounds and obscures the building (©TNSDS 2023).

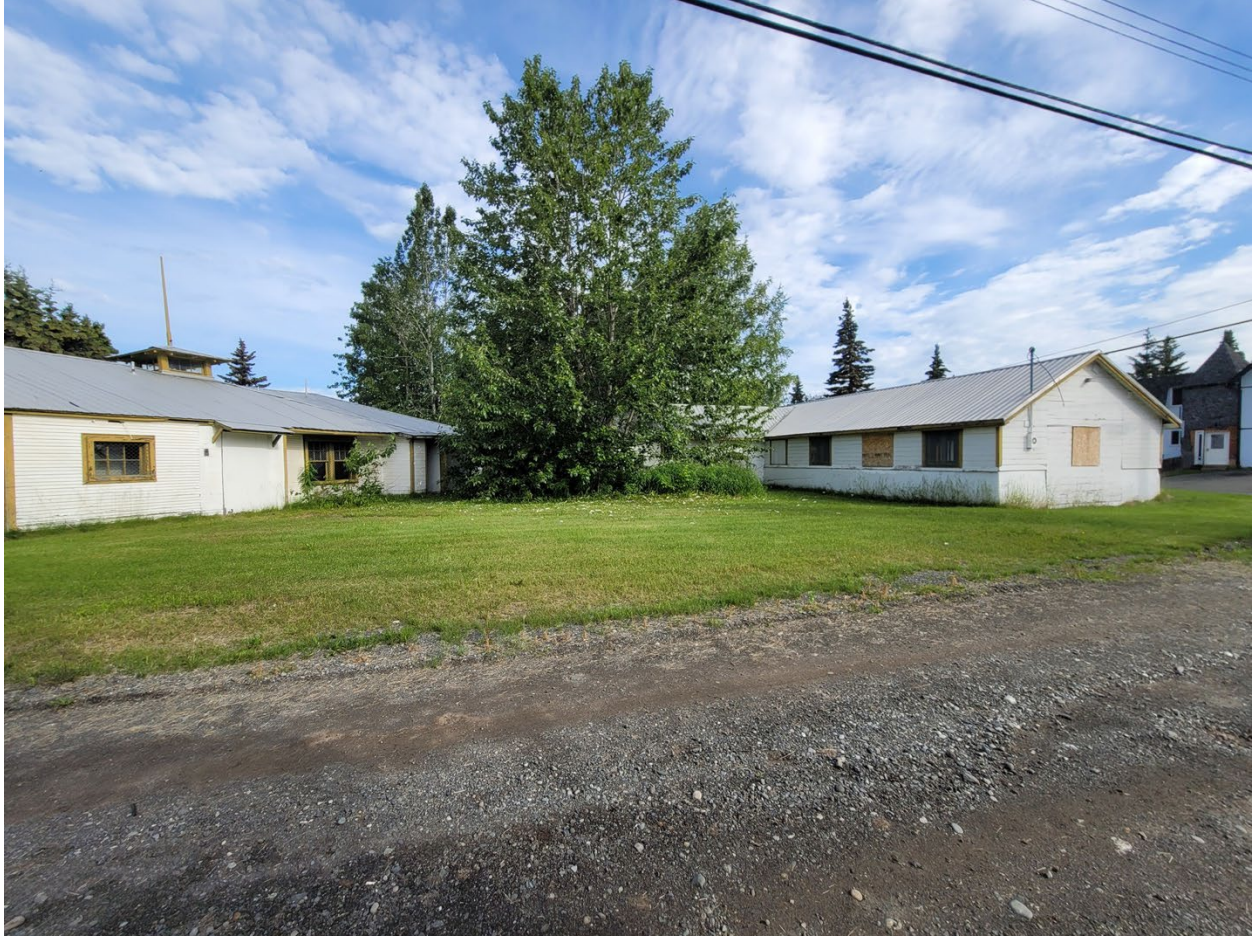
Figure B12. Northwest façade of the long axis of Building B. The photograph shows the remains of the paved driveway and curbs that once made up a driveway into the vehicle bay of Building B (©TNSDS 2023).

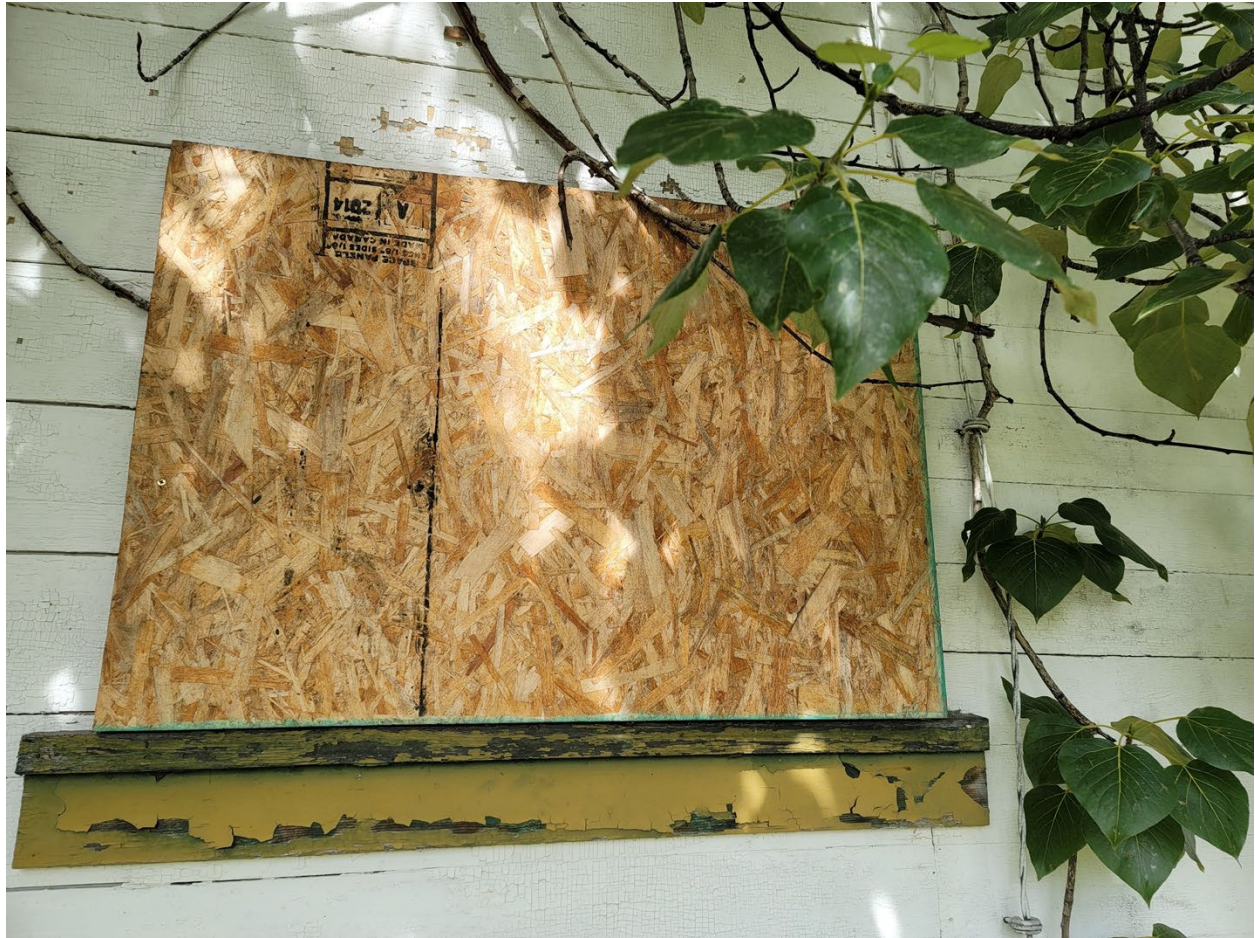
Figure B36. Detail photograph of the door in the southwest facade of the addition of Building B. The photograph shows the significant deterioration of the door material (©TNSDS 2023).

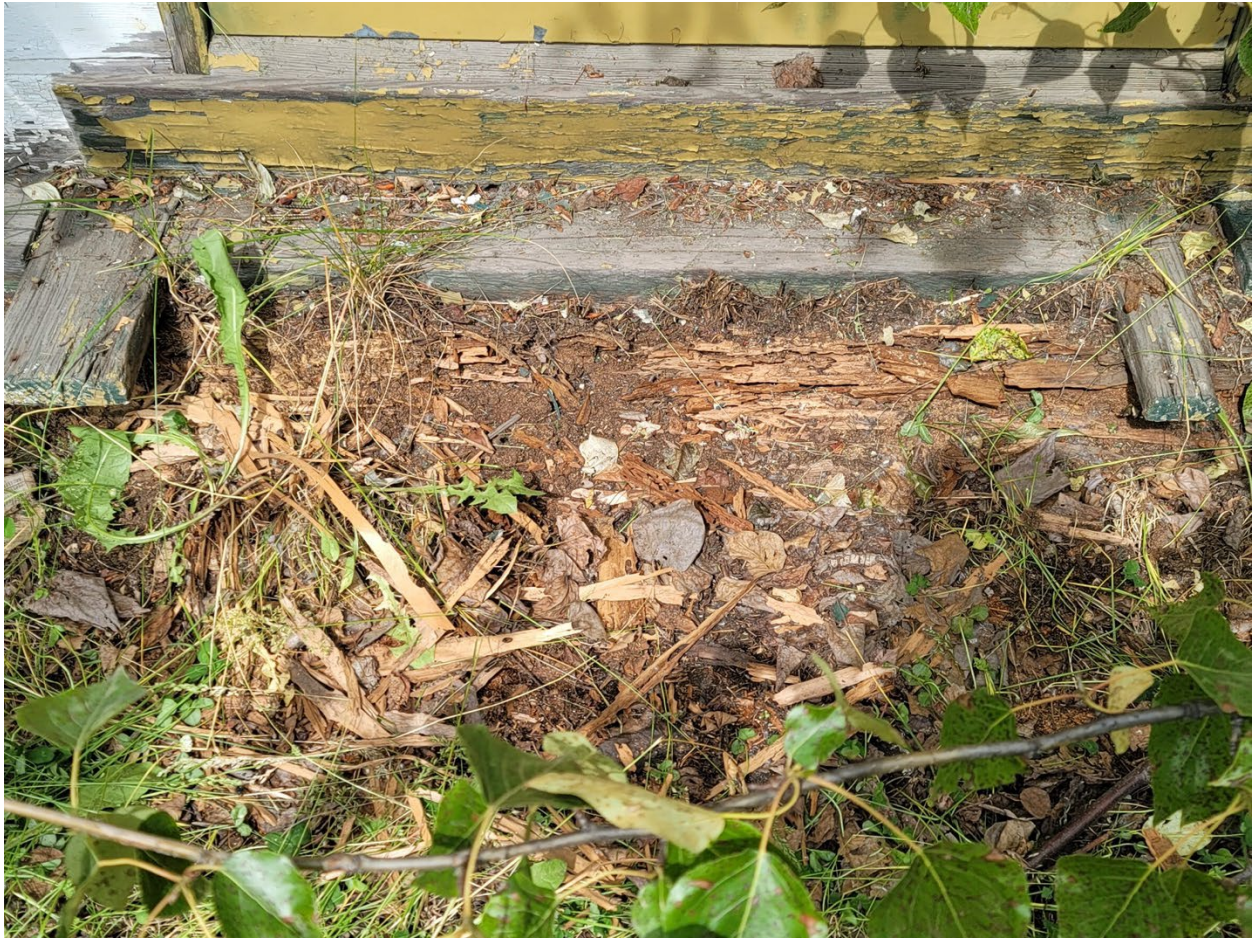
Figure B43. Detail photograph showing the deteriorated, wood framed porch or stoop located in front of the entrance in the northwest façade of the long axis of Building B (©TNSDS 2023).

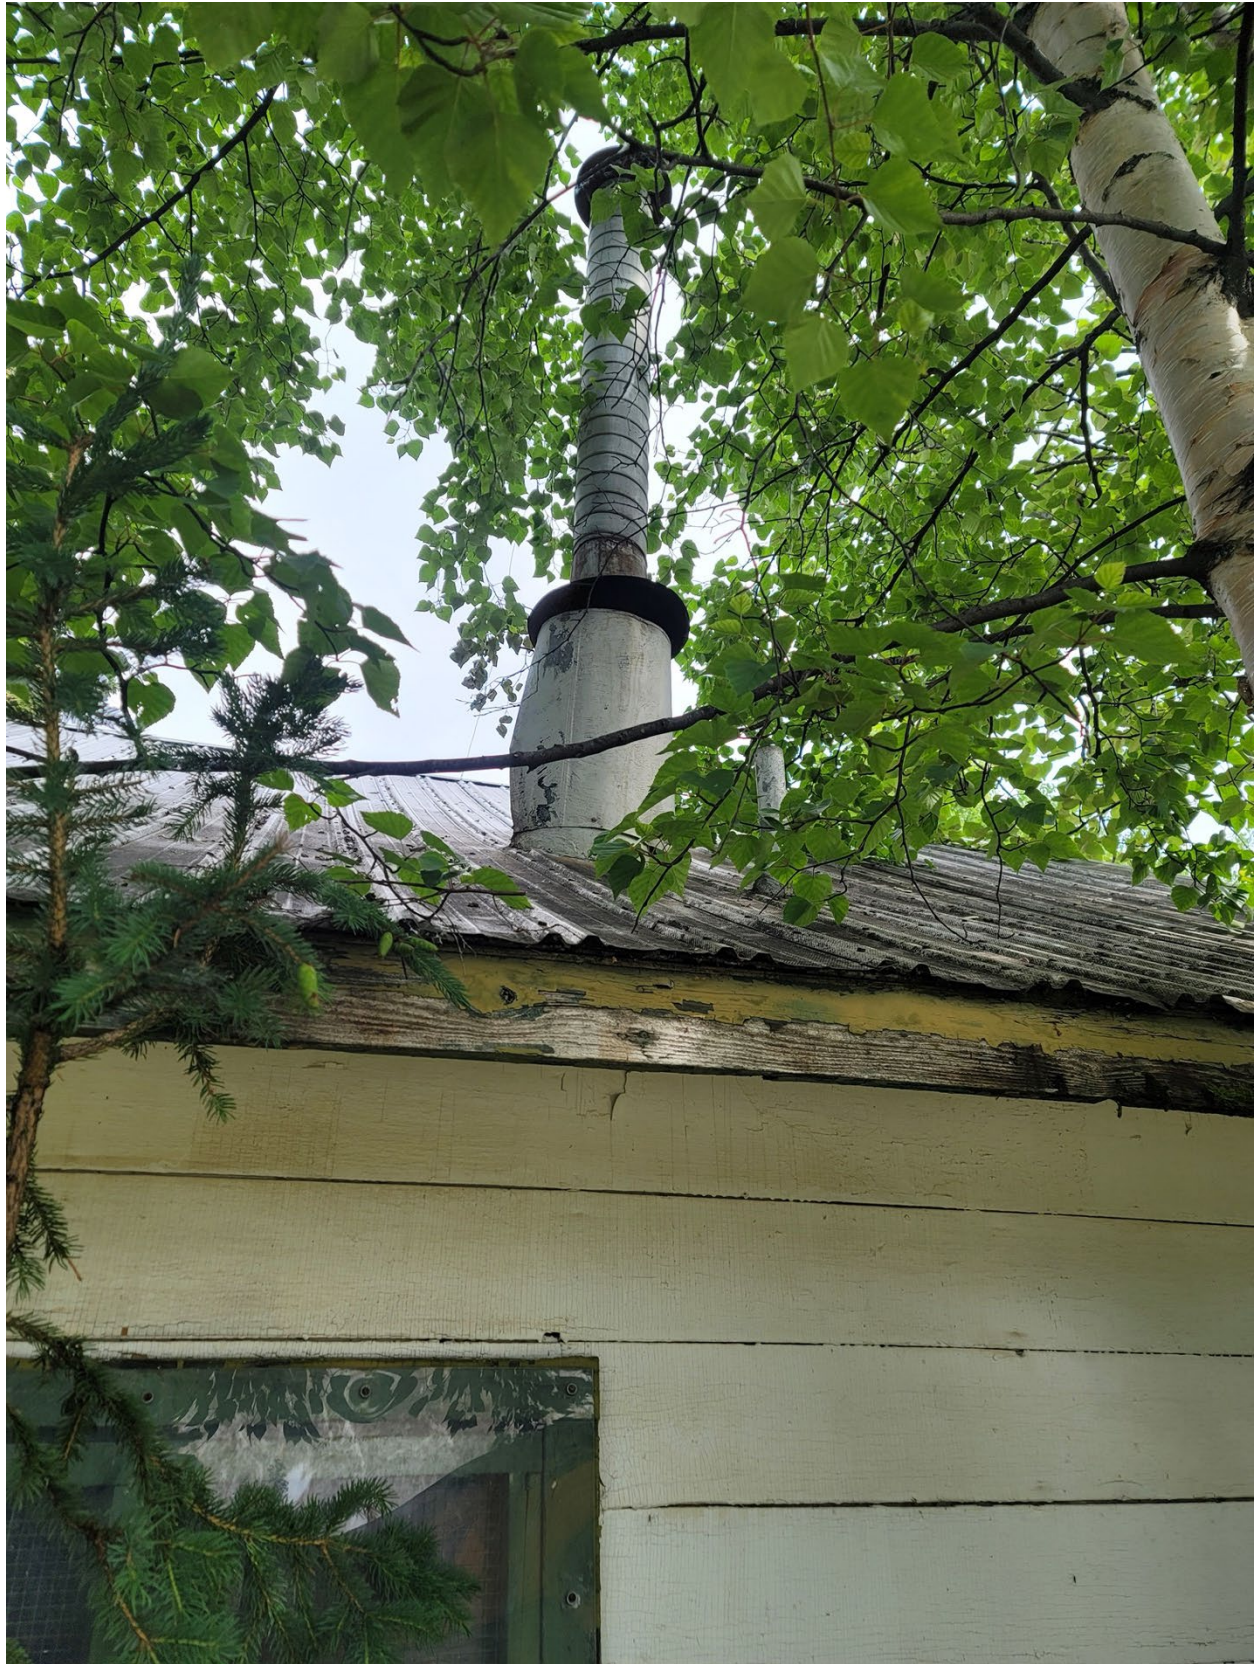
Figure B47. Detail photograph of the collapsed chimney on Building B (©TNSDS 2023).

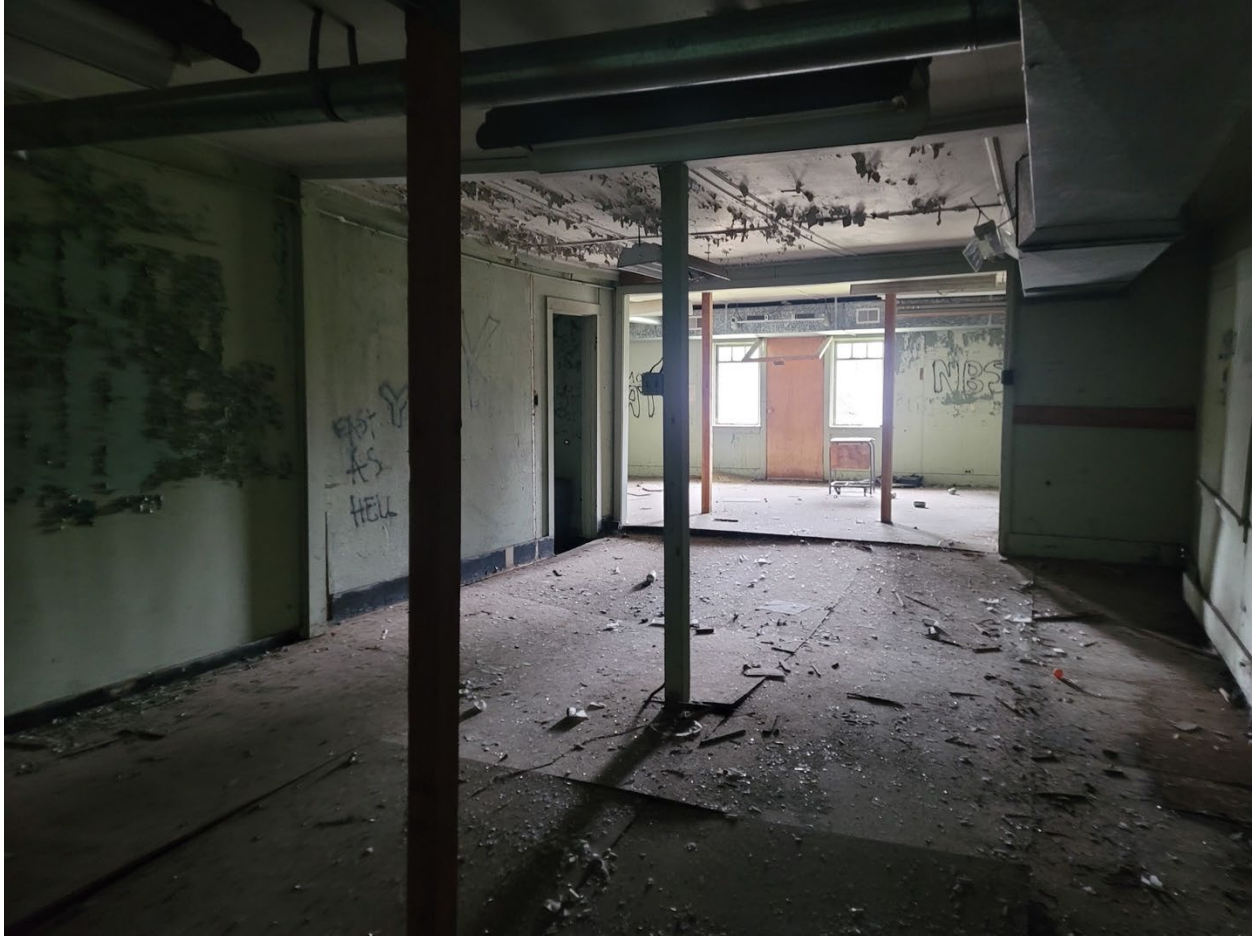
Figure B51. Interior of the northernmost rooms in Building A. The photograph shows the holes and cracks in the flooring and wall finishes (©TNSDS 2023).
