# EERI Earthquake Reconnaissance Report: M7.1 Anchorage Earthquake on November 30, 2018

Wael M. Hassan, John Thornley, Janise Rodgers, and Christopher Motter

July 2021

*A product of the EERI Learning from Earthquakes Program*

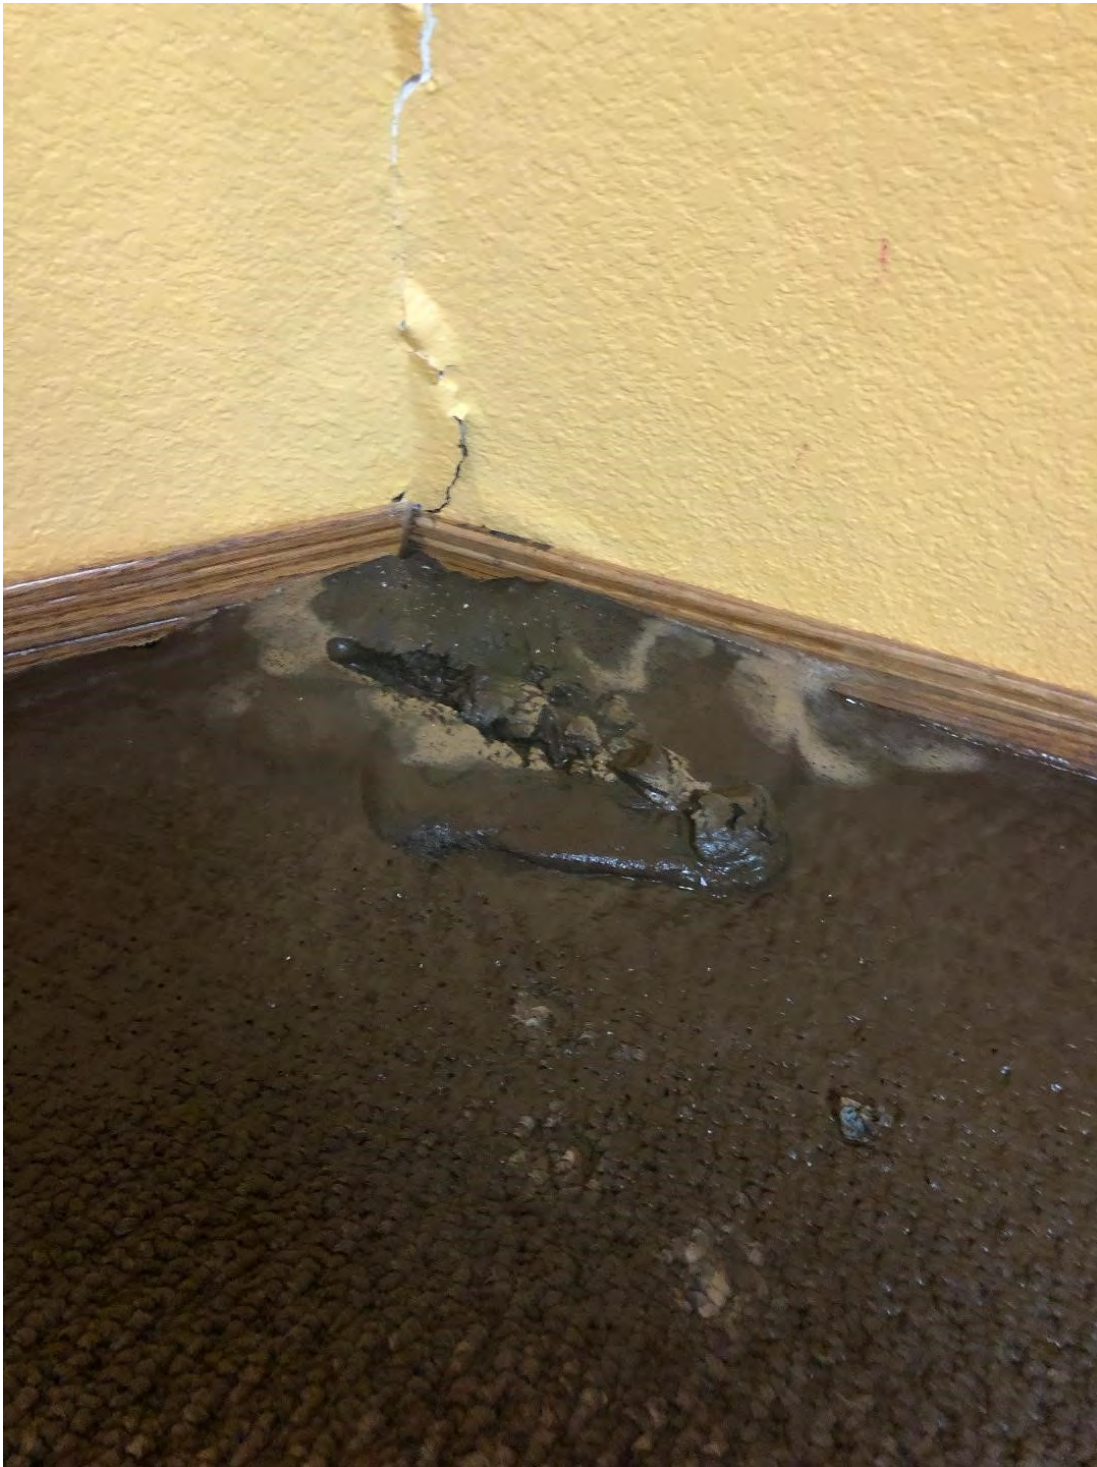
Crawl spaces below the ground level floor of residential structures are common within Southcentral Alaska. In areas affected by liquefaction, numerous homeowners found fine sand had filled portions of crawl spaces (Figure 3.1). In other homes where basement floors consisted of a concrete slab on grade construction, fine sand was found to have come through the joints (Figure 3.2) at the edge of the floor slab, and obvious settlement of the concrete slab was observed (Figure 3.3). Settlement of shallow foundations was also observed, and door and window openings were askew. Utility services, especially for gravity-fed sewer lines, were also impacted, and repairs were required to reestablish proper flow direction (Figure 3.4).

*Figure 3.2. Slab on grade liquefaction ejecta (photo: Howard Weston).*

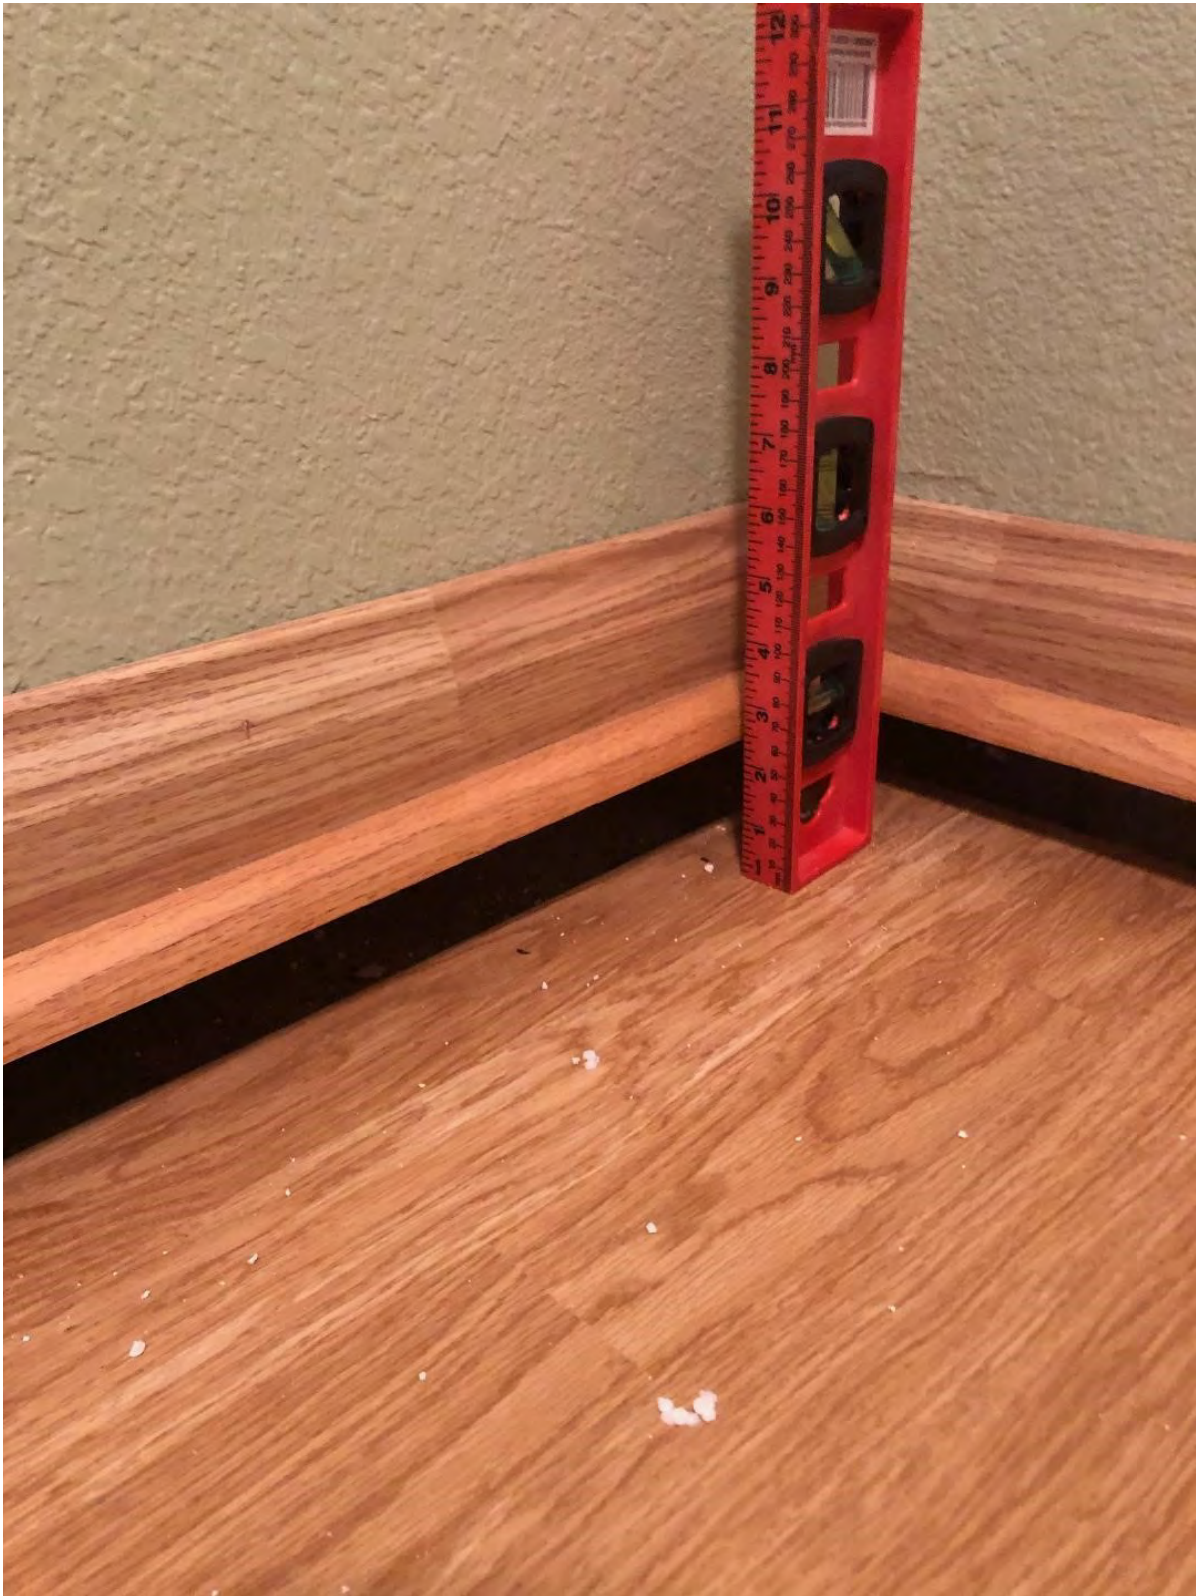
Figure 3.3. Slab on grade liquefaction-induced settlement of 6 cm (photo: Howard Weston).

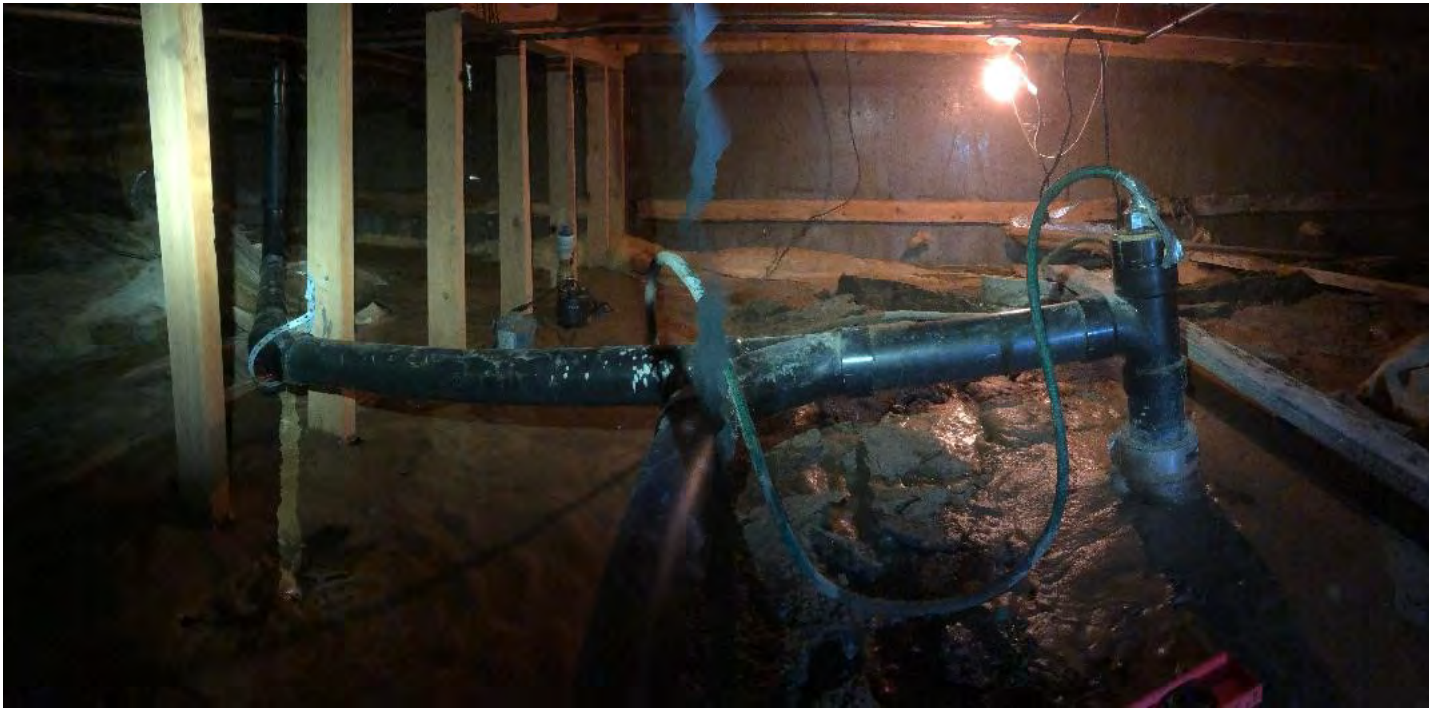
Figure 3.4. Displaced residential sewer service (photo: Howard Weston).

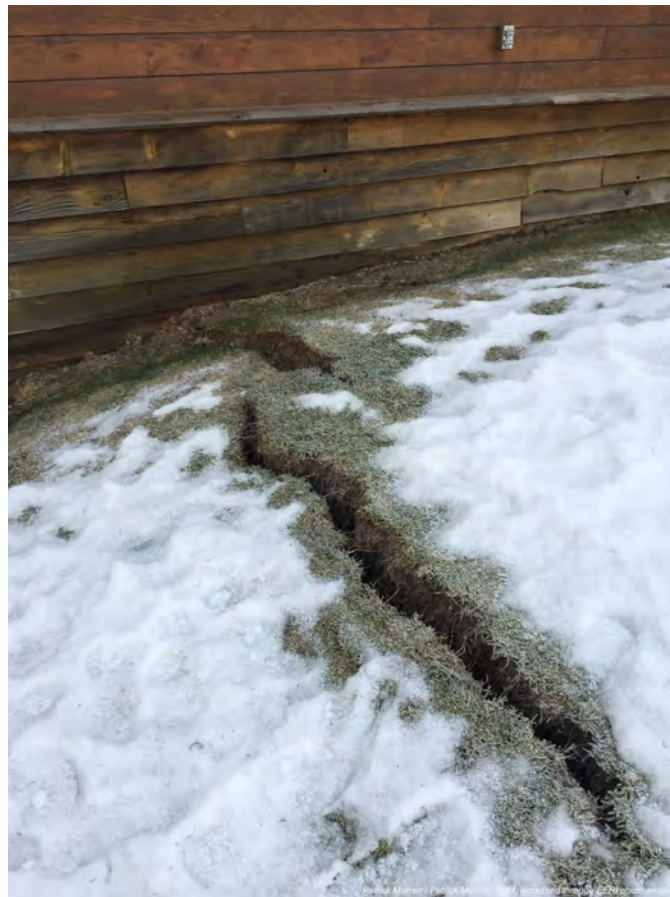
During the days following the earthquake, numerous groups in the field, as part of several reconnaissance teams observed failures that appeared to be due, in part, to anthropogenic fill soils below structures (Franke and Koehler, 2019; EERI Clearinghouse). Differential subsidence of fills caused impacts to numerous structures, including residential buildings (Figure 3.7). There were observations of fill slopes becoming unstable above other residential structures, causing red tagging of homes because of potential slope failures. As the aftershocks continued in the days and weeks after the main event, numerous building owners were concerned about the safety of these structures and the poor fill materials.

Figure 3.7. Anthropogenic fill failure (photo: EERI Clearinghouse).

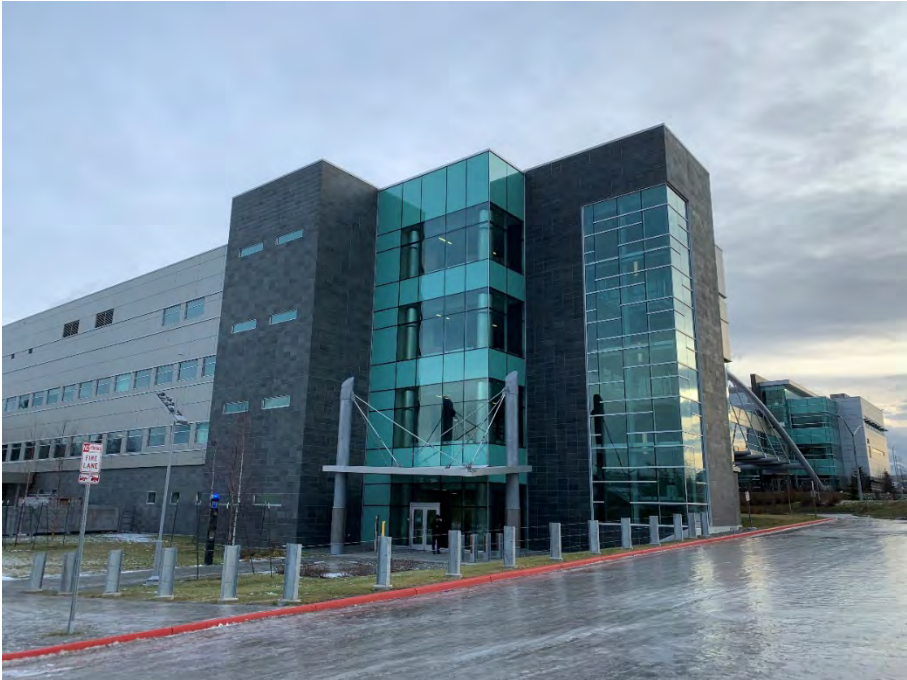
Figure 4.5. (a) Engineering and Industry Building (EIB), University of Alaska, Anchorage (UAA) (photo: Wael Hassan) and its (b) response spectra and (c) recorded floor acceleration (source: Utpal Dutta, University of Alaska, Anchorage, pers. comm., 2019).

The EIB, a 2015 four-story steel moment-frame building at UAA campus (Figure 4.62) experienced only light cosmetic cracking in the sheetrock, especially at the stairwell, and breaking of one large glass cabinet (Figure 4.5). The building is instrumented on all four levels, along with a free-field site array outside the building. The maximum recorded PGA at the ground-floor level was 0.21g, and the roof acceleration was 0.58g. The recorded spectra at the building were lower than the DBE spectra at the building fundamental period (0.80 seconds), which explains the negligible damage.

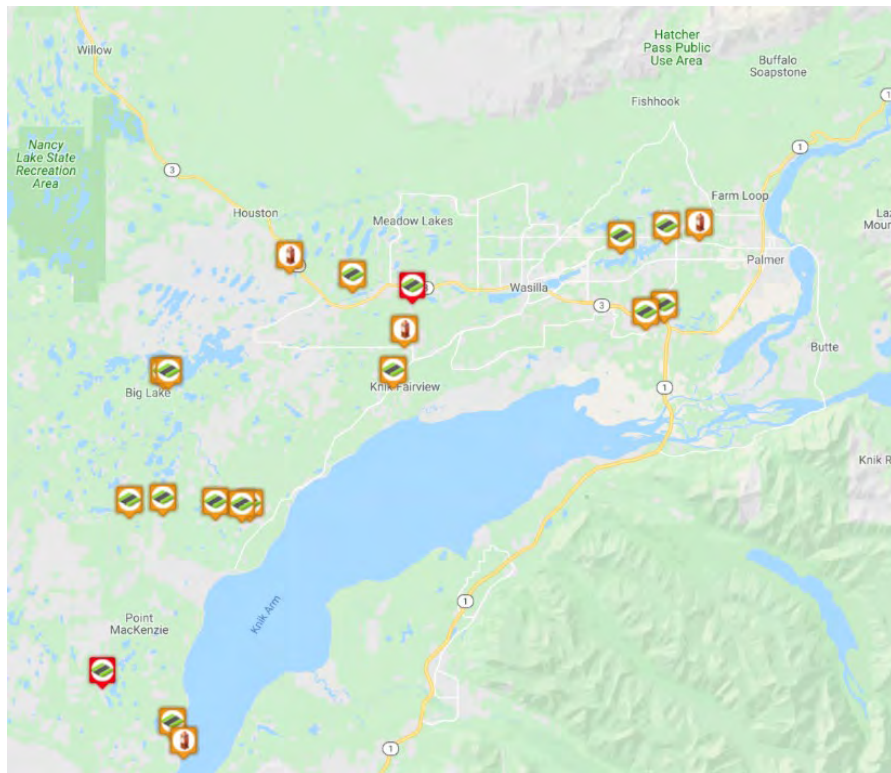
Figure 4.10. Mat-Su Borough: residential buildings with major structural damage/collapse (source: Mat-Su Borough Records).

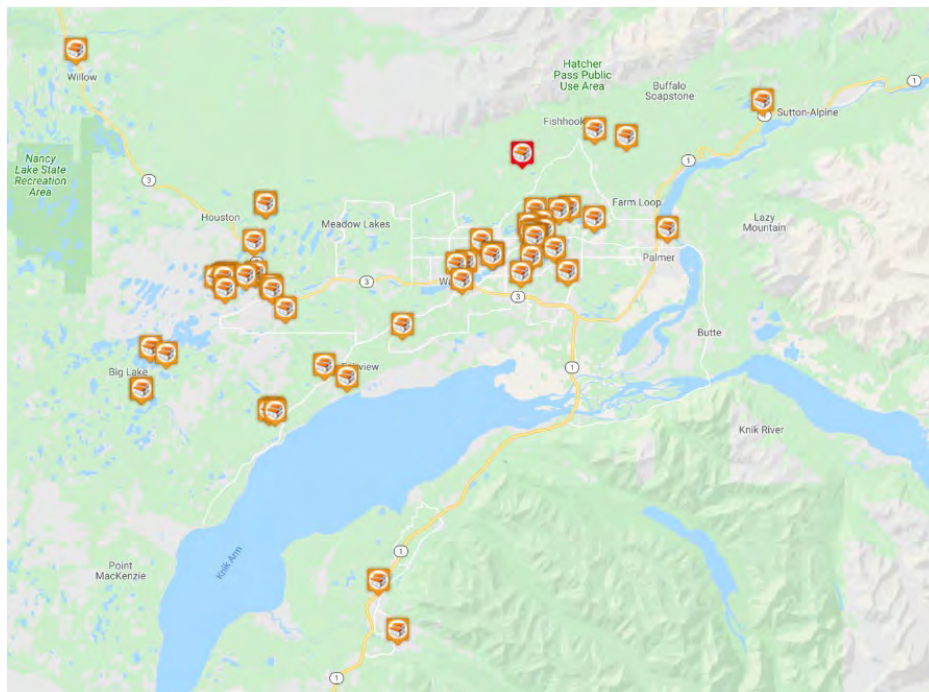
Figure 4.11. Mat-Su Borough: public buildings and infrastructures with major structural damage/collapse (source: Mat-Su Borough Records).

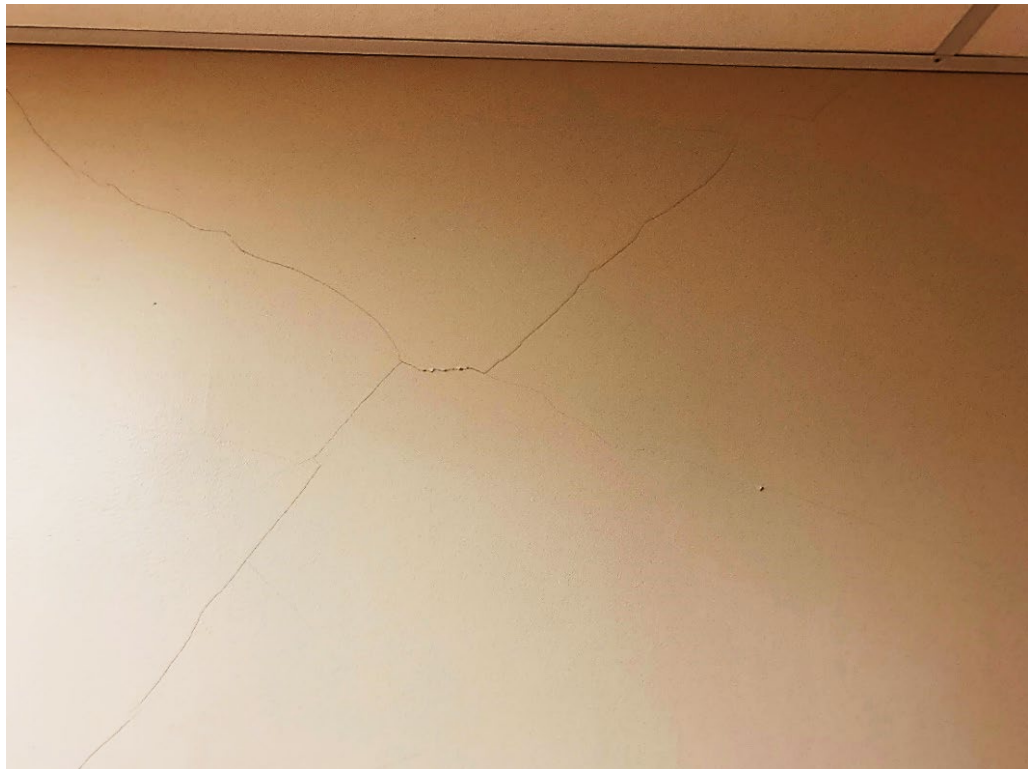
The most common observed structural damage was shear cracking in structural walls, flexural and shear cracking in some girders, flexural and splitting cracking in columns, slab-on-grade cracking, and flexural cracking in topping slabs in composite construction. In particular, diagonal and cross shear cracks in concrete shear walls, especially in older construction, were observed in several buildings, including schools, hospitals, and office buildings. In some of these buildings, structural review found these walls to be under-designed. Figures 4.13 and 4.14 show concrete shear wall extensive shear cracking in a hospital and a school buildings in Anchorage and Mat-Su, respectively. Vertical cracks and diagonal cracks in concrete walls around openings were also observed. The hospital building shear wall cracks in Figure 4.14 were concentrated in the core wall over the first two stories on both faces of each individual wall of the building core wall.

*Figure 4.13. Concrete core wall with cross shear cracks in a multistory Anchorage building (photos: Wael Hassan).*

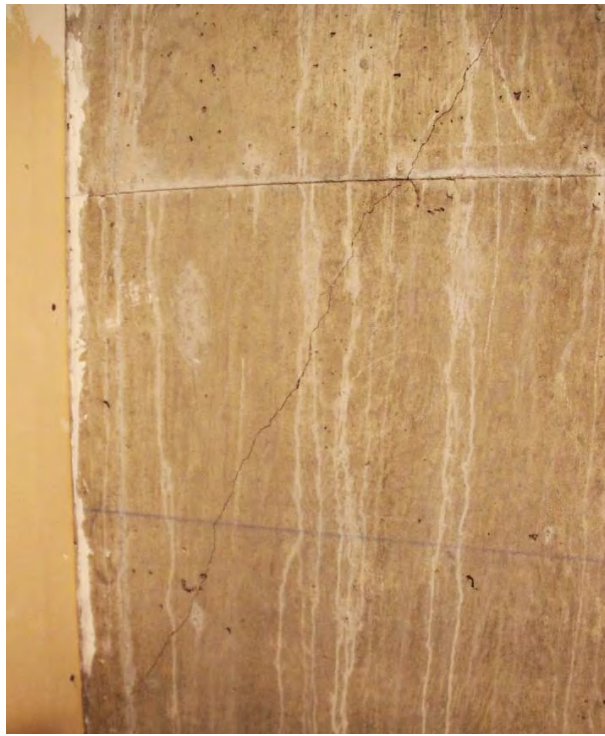
Figure 4.14. (a) Concrete shear wall with diagonal cracks (photo: Chris Motter), (b) shear wall diagonal crack at a parking structure (photo: Wael Hassan), (c) concrete-parapet cracking (photo: Wael Hassan), (d) concrete composite slab with flexural cracking (photo: Janise Rodgers), and (e) cast-in-place slab with flexural cracks (photo: Colin Maynard<sup>8</sup>).

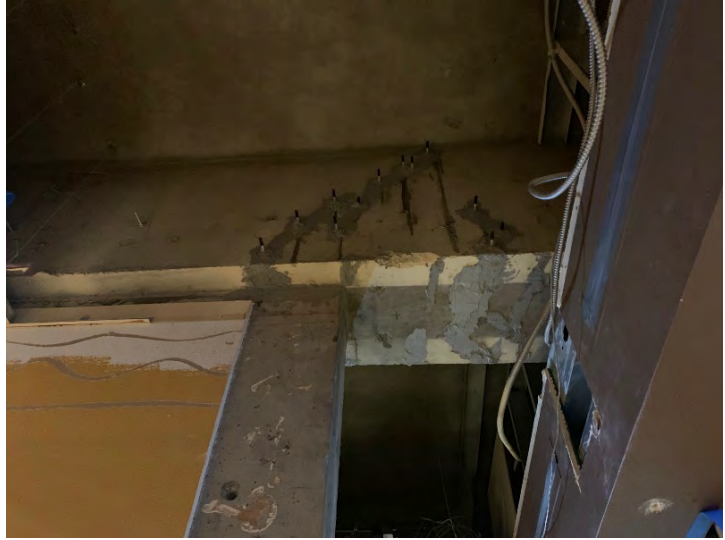
Concrete girder shear and flexural cracks appeared on a few occasions. The case of the Westmark Hotel in Anchorage is of particular interest. The building is a 14-story CMU and concrete-frame hotel building built in 1970 (Figure 4.15). Minor hairline shear cracks, 1/32 of an inch wide, appeared in three transfer concrete girders in the first floor supporting the 14 floors above because of the November 30 earthquake, and the building was yellow-tagged (Figure 4.15). The large number of strong aftershocks has exacerbated the structural damage in many buildings, including the Westmark Hotel, in

Figure 4.15. (a) Westmark Hotel (photo: Wael Hassan), (b) transfer-girder shear cracking repair (photo: Wael Hassan), (c) transfer-girder initial state (photo: PDC Engineers), and (d) aftershock shear crack (photo: PDC Engineers).

which these concrete girder shear cracks kept widening to about 5/32 of an inch, warranting immediate retrofitting. Concrete jackets were provided to girders, supporting columns, and foundations. The hotel was closed to undergo structural retrofitting for 5 months following the earthquake.

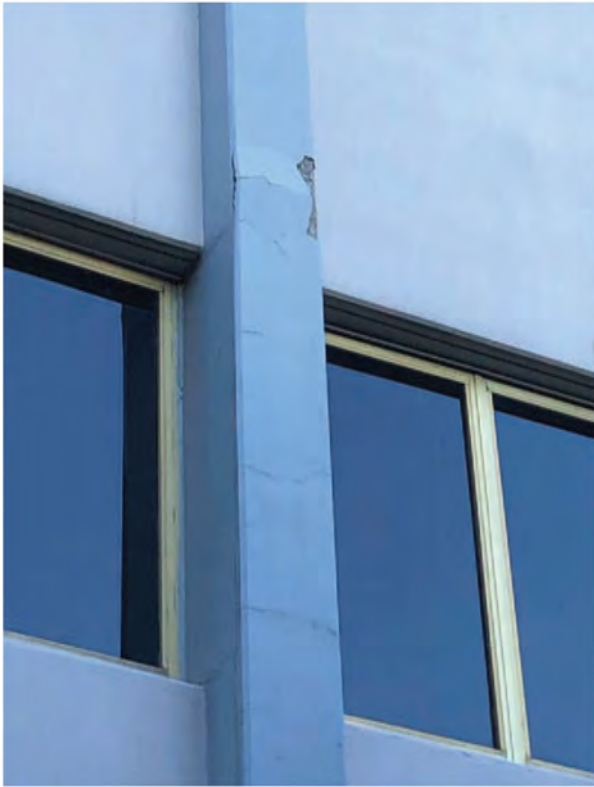
Figure 4.17. Concrete-column damage: (a) flexural cracks (photo: Patrick Murray) and (b–d) splitting cracks (photos: Joint Base Elmendorf-Richardson (JBER)).<sup>10</sup>

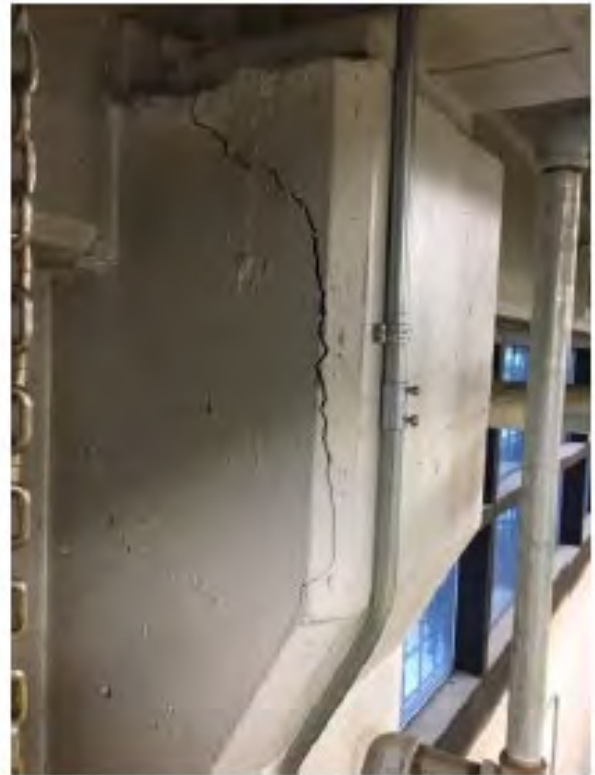
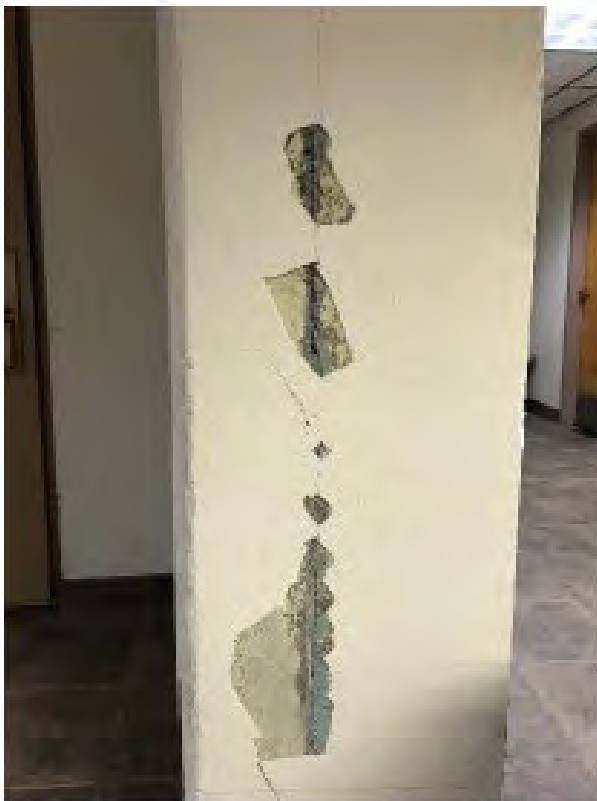
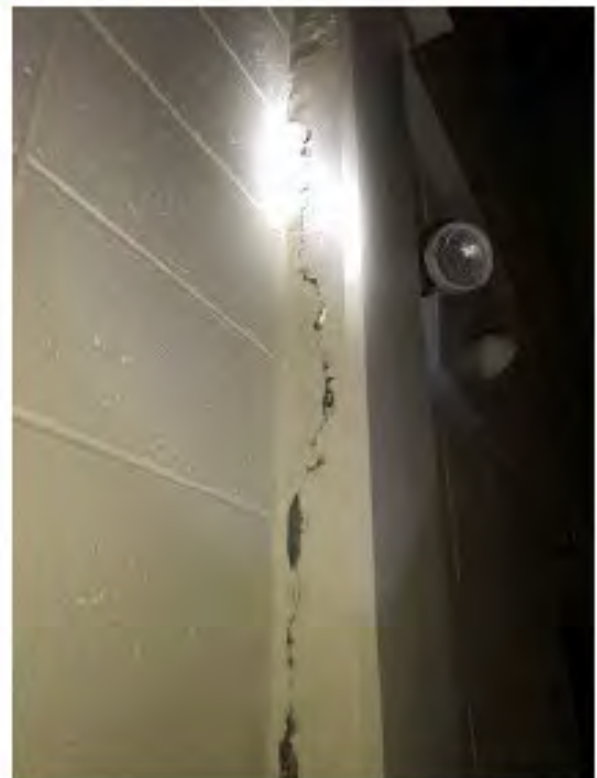
Vertical-column splitting cracks in moment-resisting concrete frames were observed in a few cases. The Frontier Building in Anchorage is worth mentioning. The 14-story 1981 moment-resisting-frame concrete building experienced hairline to minor overstressing concrete cover splitting cracks in many of the circular exterior and corner columns at stories three, four, and five (Figure 4.16). The crack length ranged from 3 inches to 20 inches, while the crack width was about 1/32 to 1/16 of an inch. The estimated fundamental period of the building (Çelebi, 2020<sup>9</sup>) is 2.2 seconds. The building experienced a relatively low PGA of 0.193g; however, the shaking was strong, perhaps because of its relatively higher stiffness as a concrete-frame building. A few other examples for concrete column–overloading splitting and flexural cracks are depicted in Figure 4.17.

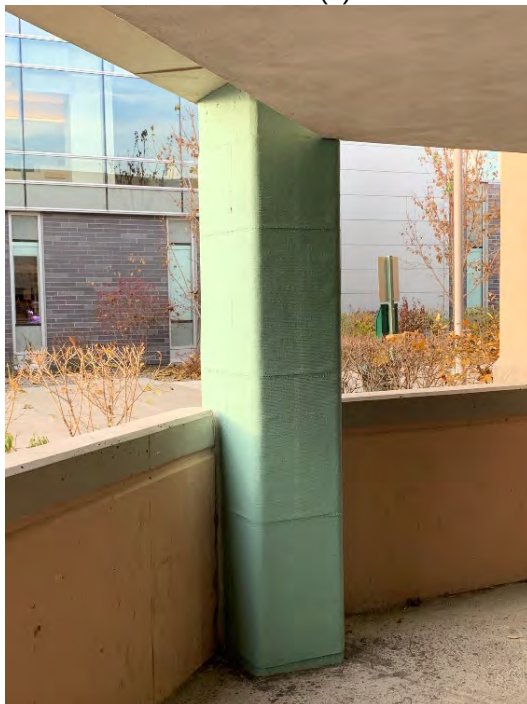
Fiber-reinforced polymer (FRP)-retrofitted concrete buildings performed satisfactorily during the earthquake, with only minor flexural cracks in unstrengthened columns and minor cracking in shear walls, with no sign of FRP debonding

**Figure 4.18.** (a) PAMC Parking Structure 1 with building retrofitting via (b) FRP wrapping. (c) No signs of debonding were observed following the earthquake. The retrofitting project included (d) separating the concrete parapet from the column with elastic material to avoid a short-captive-column condition (photos: Wael Hassan).

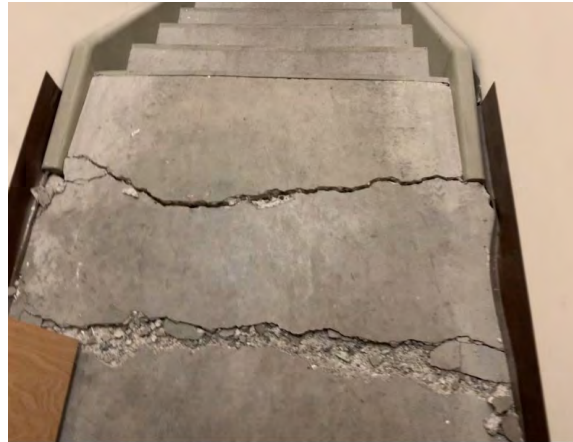
Minor cracking was observed in precast concrete buildings, especially as splitting and minor crushing at connections (Figure 4.19e,f). Concrete stairwell separation and splitting cracks and corner concrete crushing were observed in some cases (Figure 4.19a). In limited cases, multistory-tall concrete columns that were unsupported laterally underwent large inelastic deformations, rendering the columns unstable under large permanent residual drift.<sup>12</sup>

Figure 4.19. (a) Concrete stair crushing and cracking, (b) column shear flexural cracking and concrete-girder spalling, (c) column flexural cracks, (d) retaining/bearing-wall vertical cracks (photos a-d: Wael Hassan), (e) precast-girder splitting cracks, and (f) precast-wall minor crushing (photos e-f: Colin Maynard<sup>13</sup>).

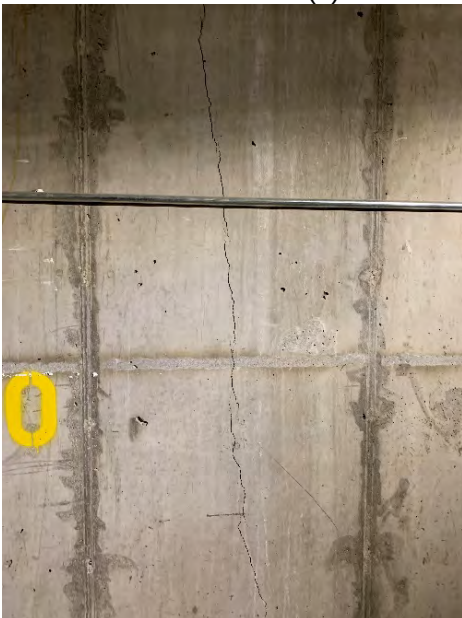
(d)

Minor vertical and diagonal cracking in concrete retaining walls was observed in many buildings, even in new construction (Figure 4.19d). This was especially evident in retaining foundation walls supporting vertical loads from multistory frame buildings, in the case of ground slope/grades where the retaining wall extends above ground for up to one story in height. Seismic joints performed satisfactorily as per the design's intent, causing minor aesthetic damage but preventing major structural damage. In several warehouses, the roof diaphragm separated from the concrete tilt-up walls. In a swimming pool in Palmer, minor shear cracks occurred throughout the walls<sup>23</sup>.

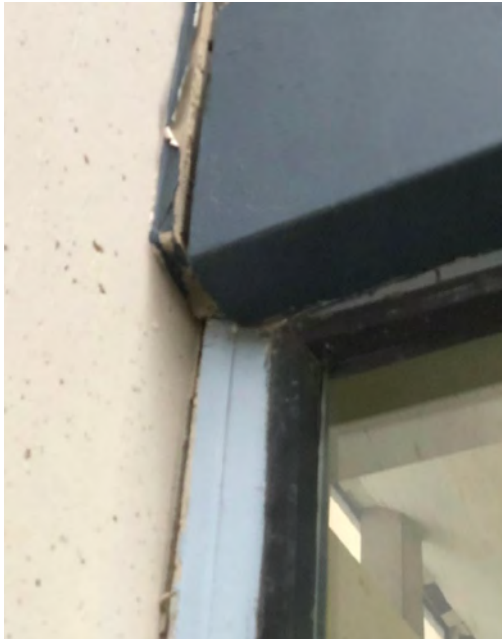
*Figure 4.19. (a) concrete beam displacement at connection to wall; (b) concrete spalling due to failure at beam to wall connection, likely a precast beam. (photos: Reid Middleton, ASD)*

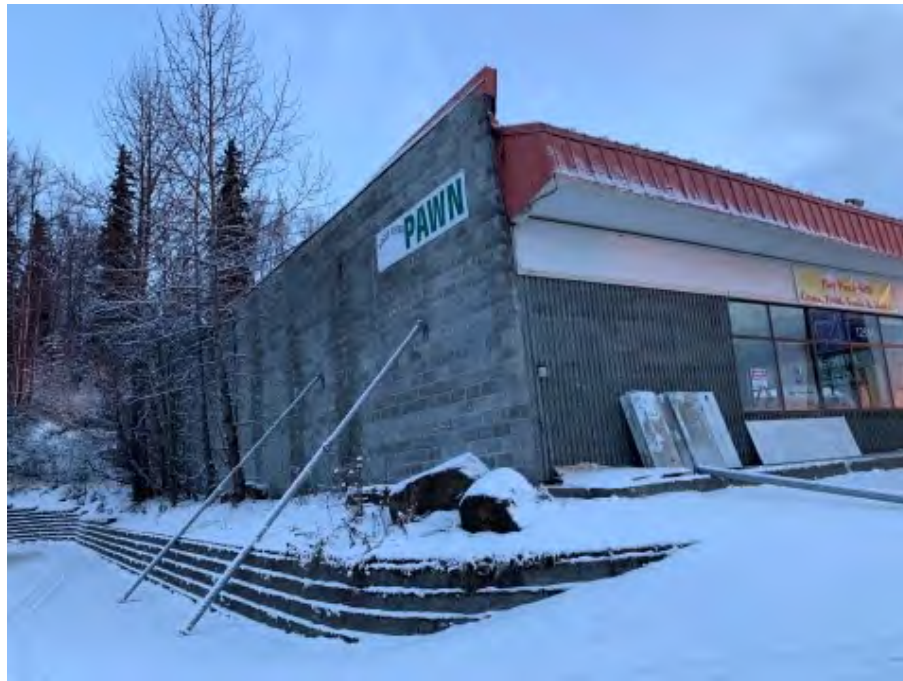
*Figure 4.21.a. CMU wall-wall and wall-floor connection failure and out-of-plane deformation of a CMU wall, leading to incipient collapse (photo: Wael Hassan).*

To present an example of CMU wall-wall and wall-floor connection failure, severe damage was observed to a masonry pawn shop building in Eagle River (Figure 4.21). The building appeared to be near to collapse. The building appeared to have timber-frame roofing that connected to masonry load-bearing walls. The walls had moved out of plane, pulling away from the roof, and were braced with strong-backs, as shown in Figure 4.21. Parapet damage was observed in the form of out-of-plane cracking at the base of the parapet, which led to residual deformation. Within the building, severe damage was observed to suspended ceilings, which were near to collapse. Bracing was being used vertically inside of the building to support the roof. The pawn shop owners were in the process of removing the merchandise and closing the business. The pawn shop owners indicated that they were renting for \$4,200 per month and expected that the building owner would repair and try to re-lease. The building was irreparable, was eventually demolished, and is being rebuilt at the time of this report. On a few occasions, especially in Eagle River, damage warranted demolishing the building.

The most common CMU damage patterns observed were connection failure between the CMU wall and floor system (Figures 4.21, 4.22b,c, and 4.23), floor joist/beam unseating off CMU walls (Figure 4.25), and CMU wall-wall connection failure (Figures 4.22a and 4.24). Many examples of such damage patterns across both the Anchorage and Mat-Su Boroughs indicate the special vulnerability of CMU connections in the region. Some of the buildings that experienced this kind of damage were built after 1985 (and even the 1990s) presuming that seismic details were in effect at the time of construction. Several root causes might have led to CMU wall-floor and wall-wall connection seismic vulnerability, including poor design and detailing deviating from codes, poor construction of the connection details (both causes were evident in multiple buildings, including schools as indicated in Chapter 6 of this report), the absence of positive steel, or the absence of seismic details altogether. Many of the CMU walls with this type of damage warranted immediate red tagging of the building because of significant instability concerns about floor collapse and out-of-plane deformation of the wall, especially with a large number of significant aftershocks. Lateral restraining supports (steel or wooden props) were installed (Figure 4.21) in most cases.

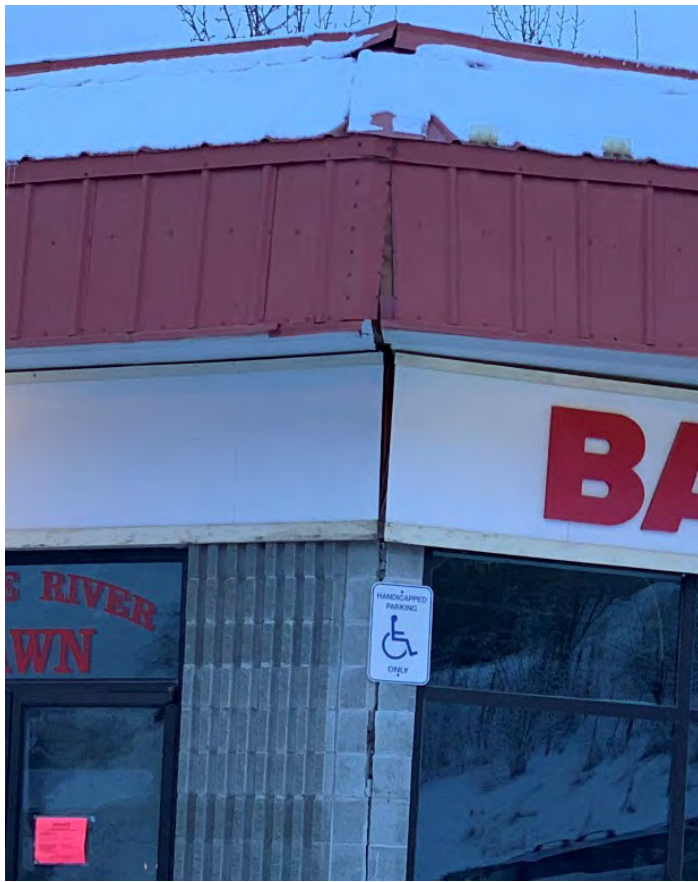
Figure 4.21.b. (a) CMU wall-wall failure, (b) wall-floor connection failure (photos: Wael Hassan), and (c) parapet damage (photo: Chris Motter).

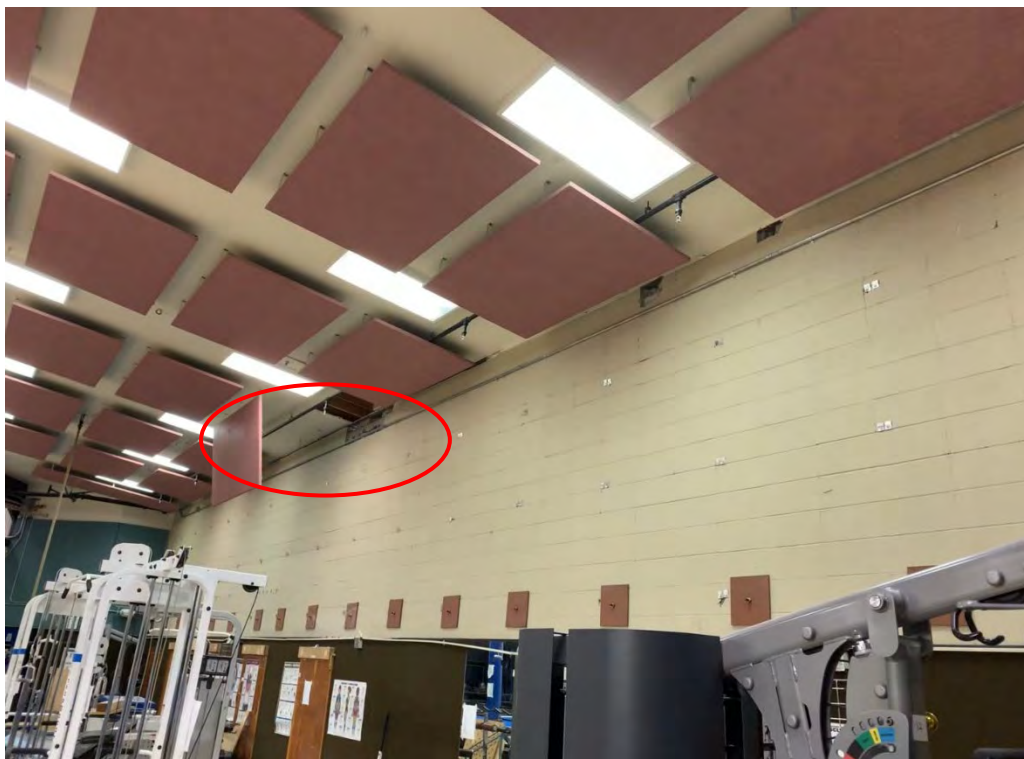
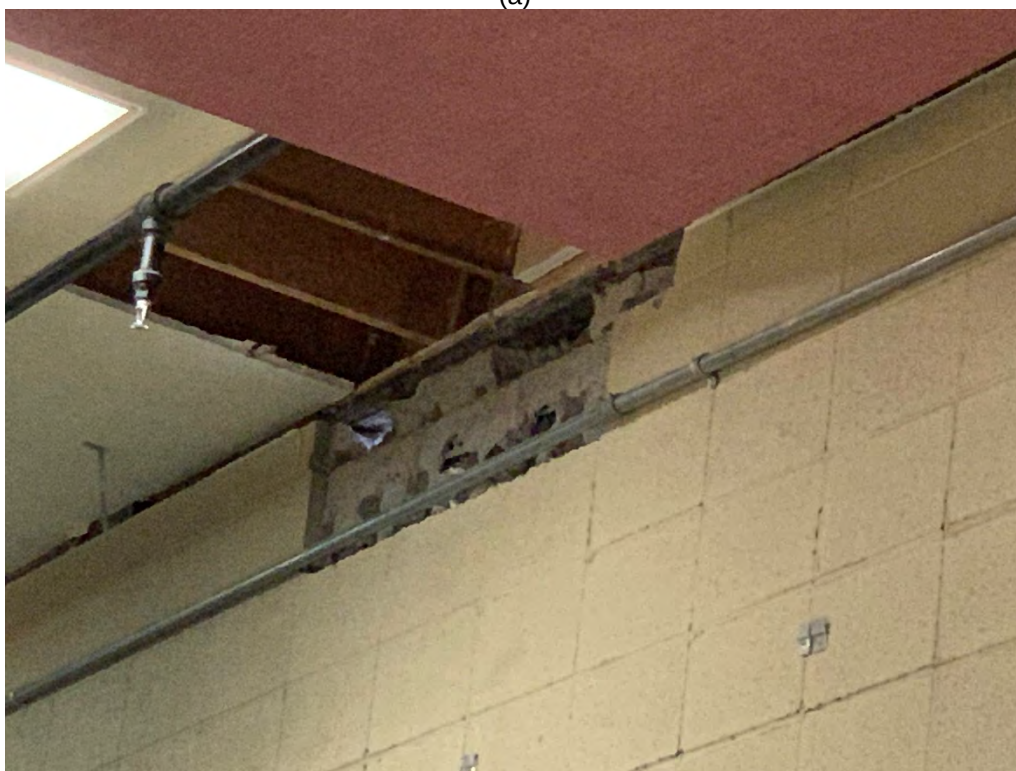
Figure 4.22. An example of CMU wall-floor connection failure with absence of seismic reinforcement. The circled portion in (a) is shown with further detail in (b) (photos: Wael Hassan).

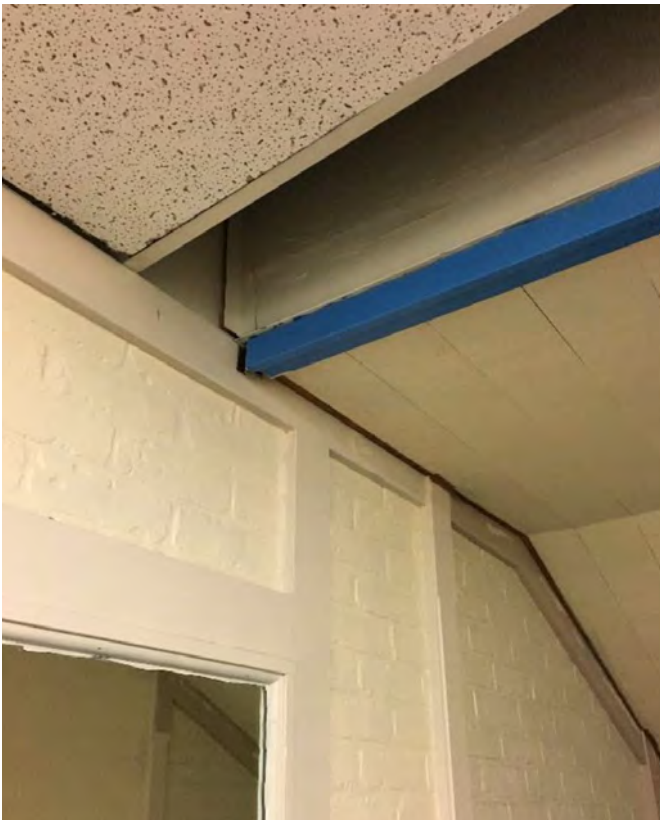
Figure 4.23. (a) Interior CMU wall detachment from floor framing and (b) exterior CMU wall detachment from floor framing and roof partial collapse (photos: PND Engineers).

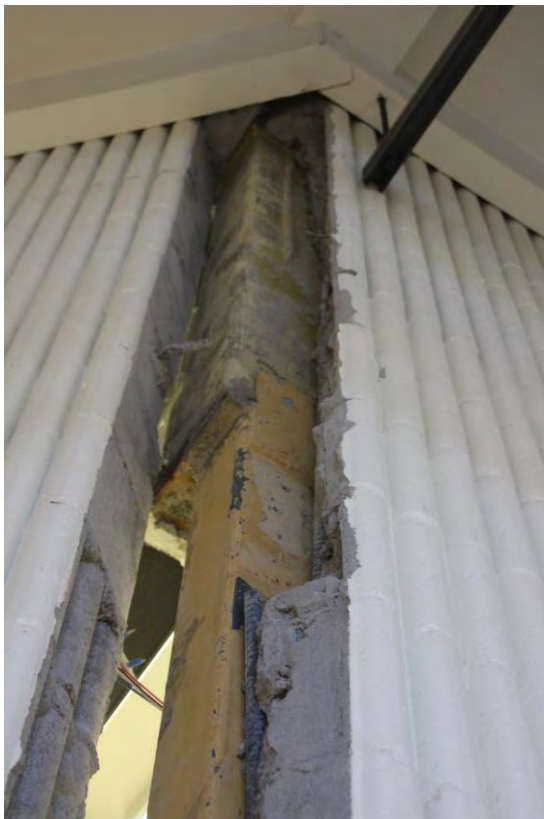
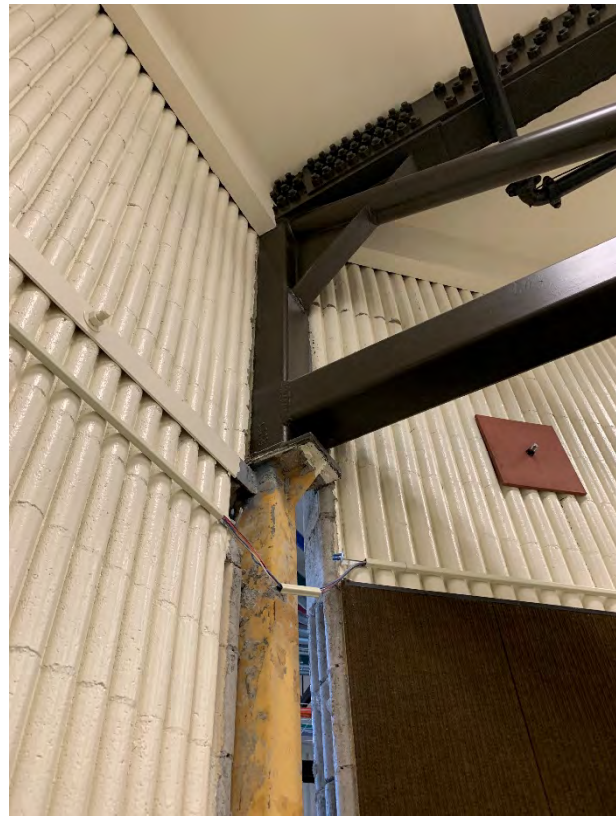
Figure 4.24. Examples of CMU wall-wall connection failures (a, b) at steel columns (photos: Wael Hassan) and (c) with no column (photo: JBER29).

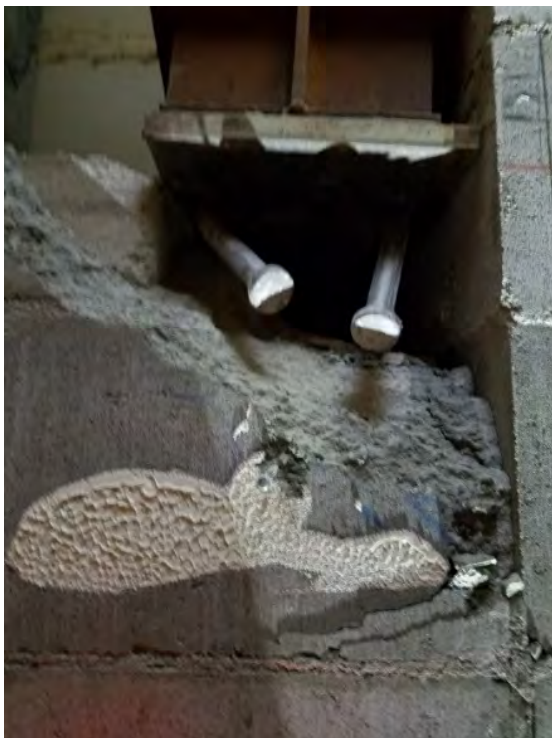
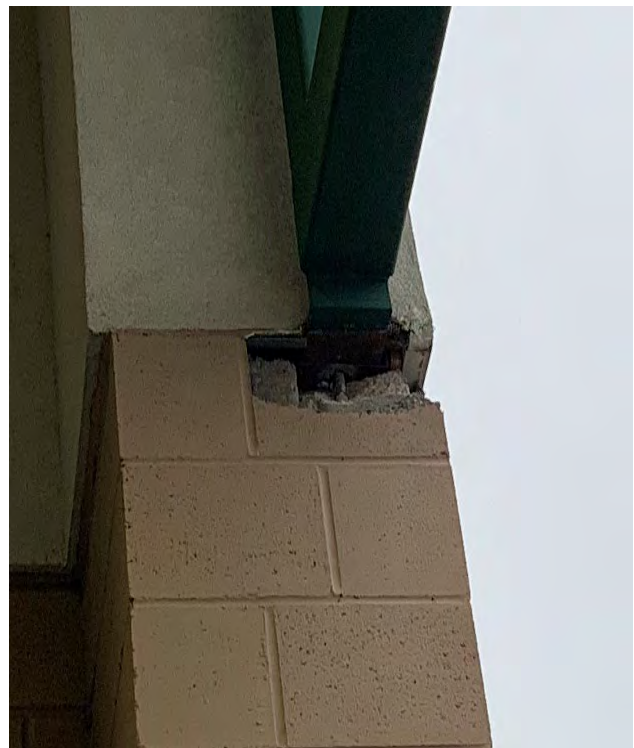
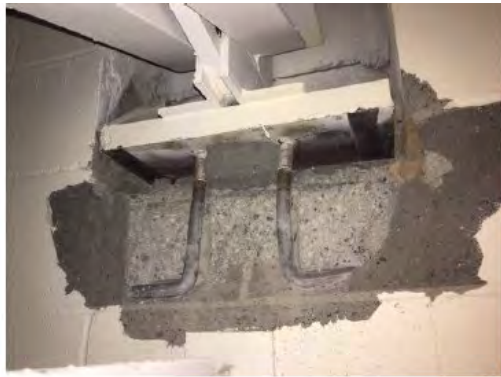
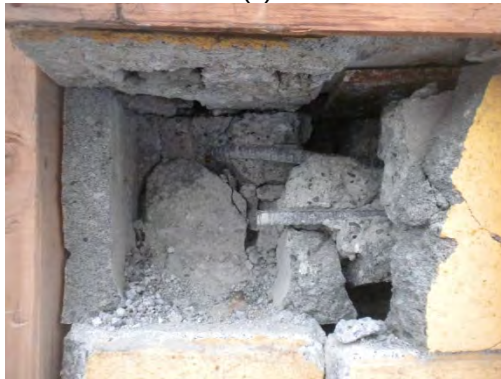
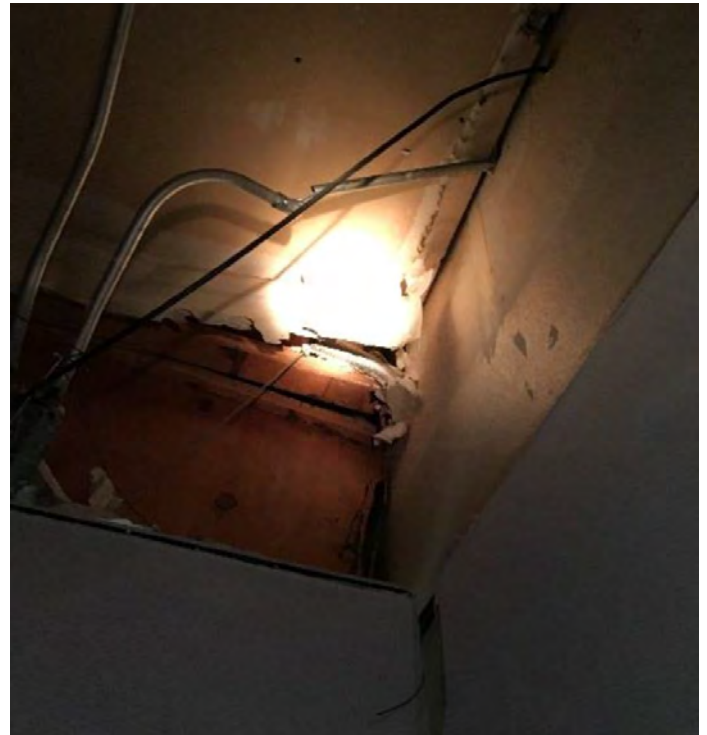
*Figure 4.25. Examples of CMU wall-beam connection failures: (a) steel beam–CMU wall connection failure at Mat-Su School (photo: Bill Noyan), (b) CMU wall connection failure at an Anchorage retail building (photo: Wael Hassan), (c) steel beam–CMU wall connection damage (photo: JBER<sup>29</sup>), (d) lack of seismic anchorage steel length and hook (photo: Colin Maynard<sup>41</sup>), and (e) steel joist off-seating to CMU wall (photo: PND Engineers).*

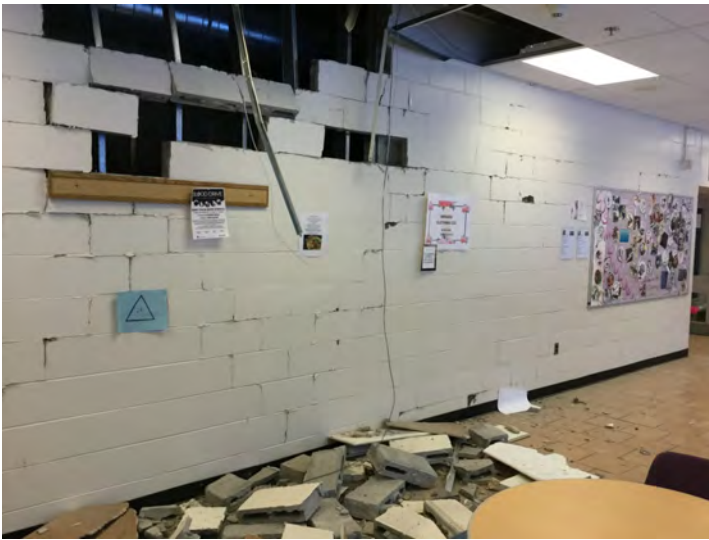
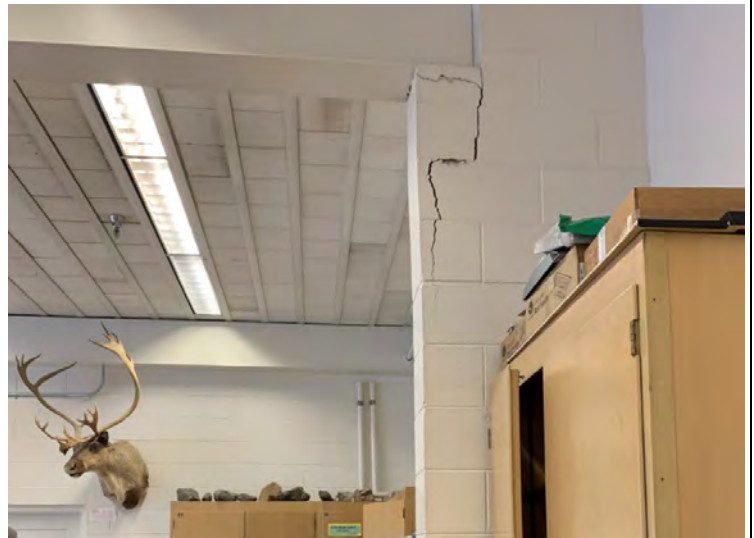
Another common damage pattern in CMU walls was the stepped- or “stair”-type diagonal cracking that in many cases caused partial failure of the wall (Figures 4.26, 4.27, and 4.28). The diagonal crack length ranged from a few CMU-unit lengths to covering the entire wall panel. Crack width ranged from hairline to severe cracking (2 inches wide). In some cases, vertical CMU wall cracks were the main damage (Figure 4.29). A common damage theme was masonry units crushing at the wall base, corners, and connections (Figure 4.30). Lack of seismic details at the connection between two orthogonal walls led to detachment and separation cracks between walls (Figure 4.24). Similarly, lack of reinforcement between CMU walls and columns led to detachment cracks at their interface (Figure 4.24). Vertical splitting, severe spalling, and crushing were observed in some CMU piers (Figures 4.28 and 4.29). Damage in lintels/headers was also observed. The lack of connection between the steel framing and the CMU wall led to deformation compatibility issues and damage at the wall-frame interface (Figure 4.31).

Figure 4.26. (a) Heavy CMU wall damage at King Tech High School and (b) steel beam–CMU wall connection failure in Central Middle School (photos: Anchorage School District).
