# EERI Earthquake Reconnaissance Report: M7.1 Anchorage Earthquake on November 30, 2018

Wael M. Hassan, John Thornley, Janise Rodgers, and Christopher Motter

July 2021

*A product of the EERI Learning from Earthquakes Program*

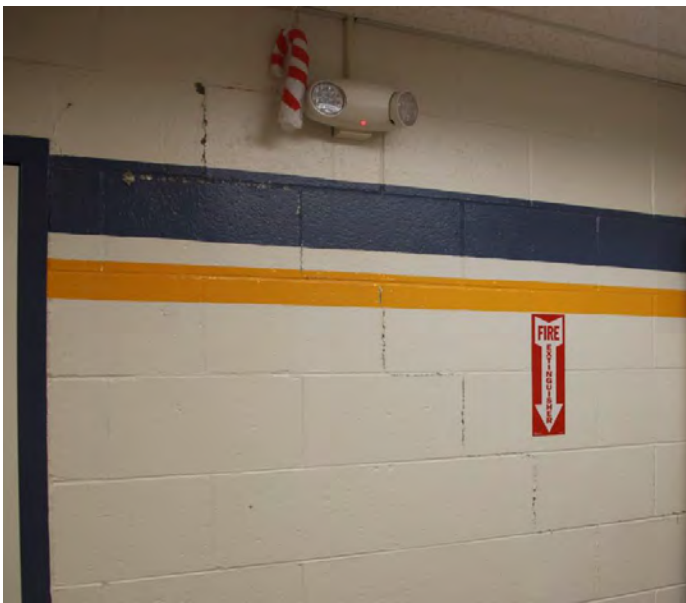
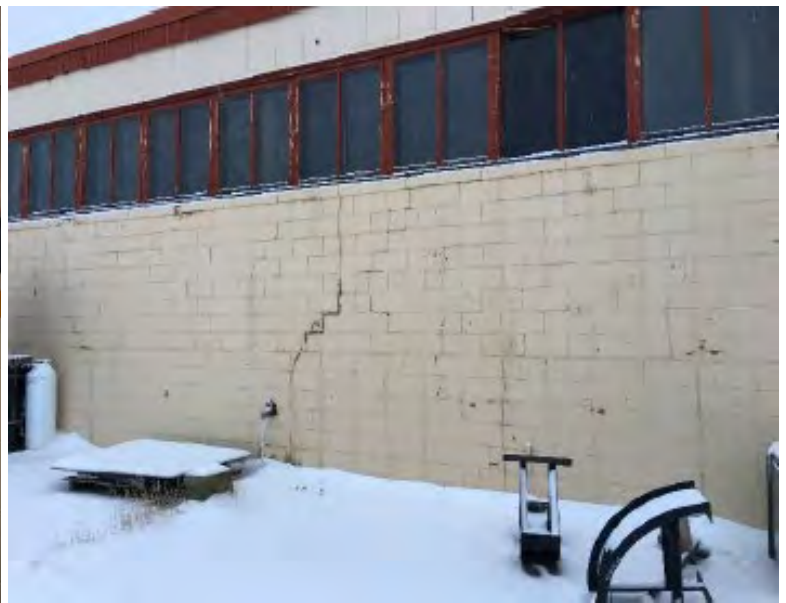
Another common damage pattern in CMU walls was the stepped- or “stair”-type diagonal cracking that in many cases caused partial failure of the wall (Figures 4.26, 4.27, and 4.28). The diagonal crack length ranged from a few CMU-unit lengths to covering the entire wall panel. Crack width ranged from hairline to severe cracking (2 inches wide). In some cases, vertical CMU wall cracks were the main damage (Figure 4.29). A common damage theme was masonry units crushing at the wall base, corners, and connections (Figure 4.30). Lack of seismic details at the connection between two orthogonal walls led to detachment and separation cracks between walls (Figure 4.24). Similarly, lack of reinforcement between CMU walls and columns led to detachment cracks at their interface (Figure 4.24). Vertical splitting, severe spalling, and crushing were observed in some CMU piers (Figures 4.28 and 4.29). Damage in lintels/headers was also observed. The lack of connection between the steel framing and the CMU wall led to deformation compatibility issues and damage at the wall-frame interface (Figure 4.31).

Figure 4.27. CMU wall stepped cracking (photos: (a) Chris Motter and (b) JBER).

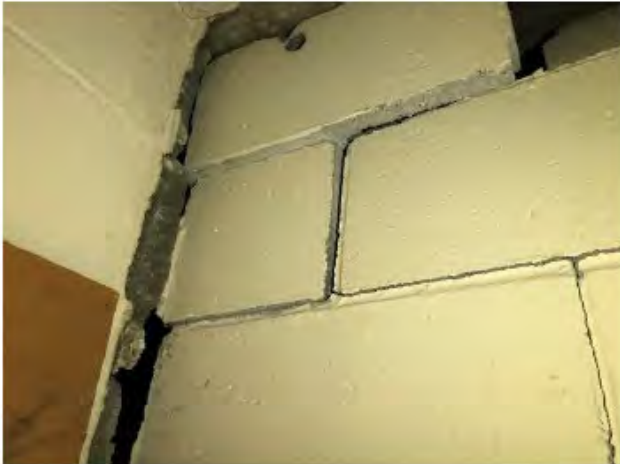
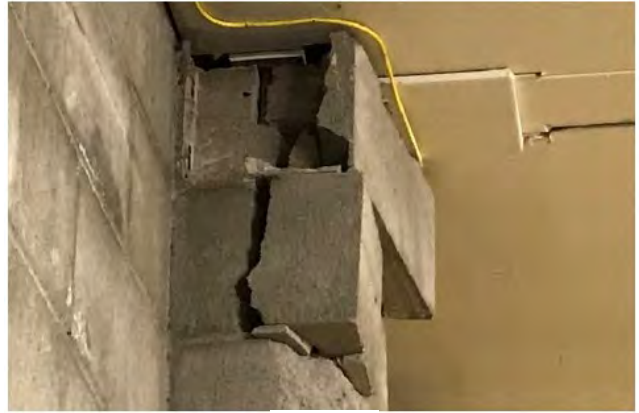
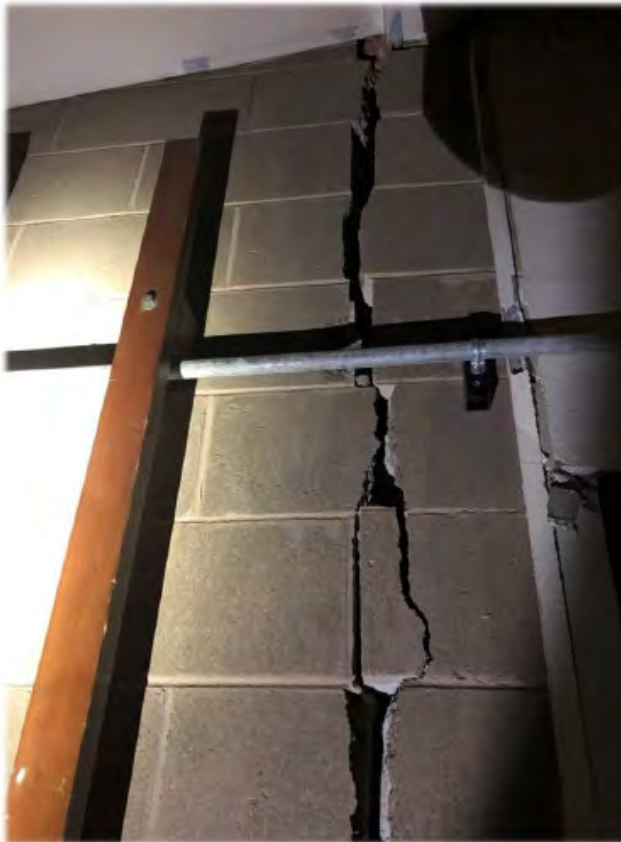
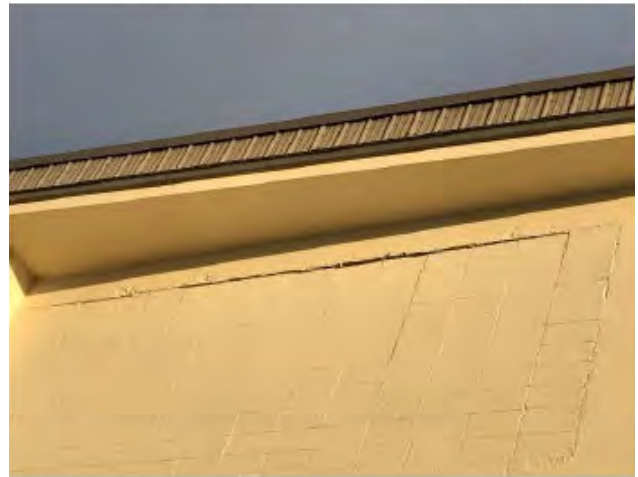
Figure 4.29. (a, b) Severe damage/dislodging of CMU wall (photos: (a) JBER and (b) DNR), (c) CMU vertical splitting (photo: DNR), and (d) CMU wall-floor interface cracking (photo: JBER).

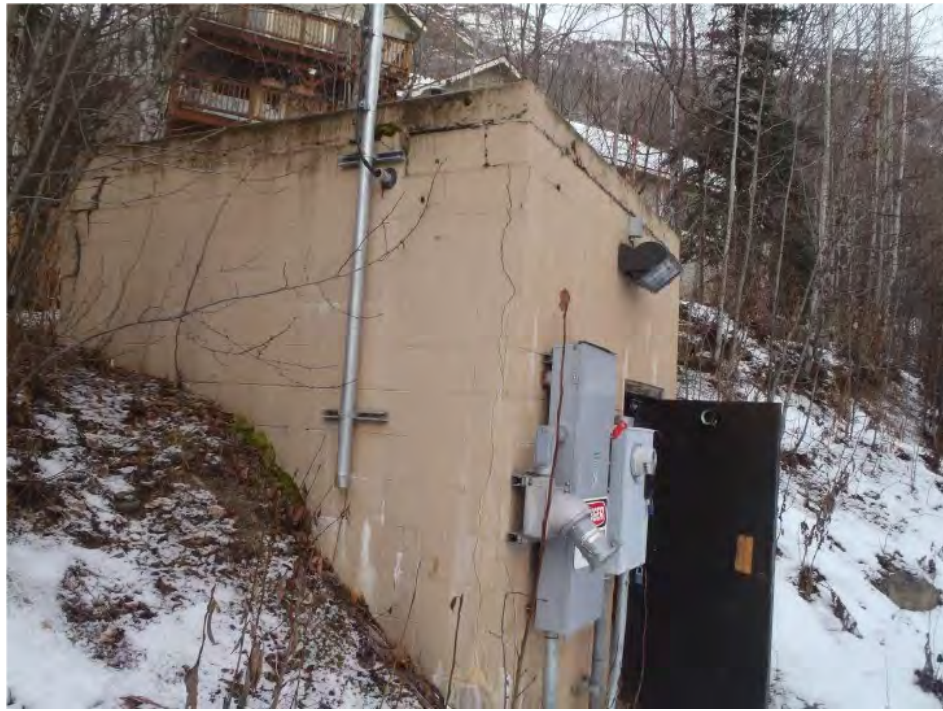
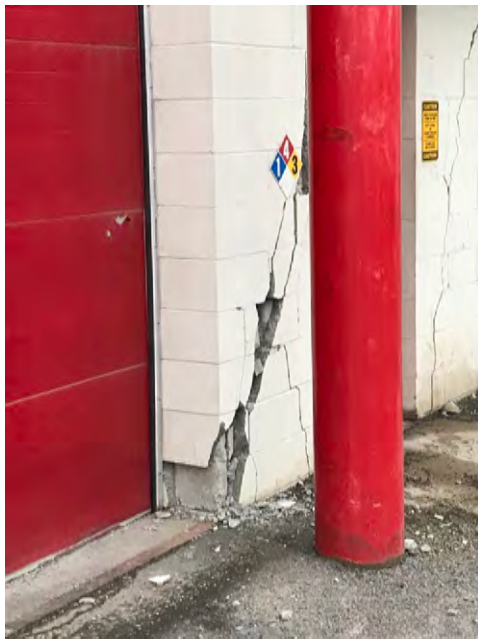
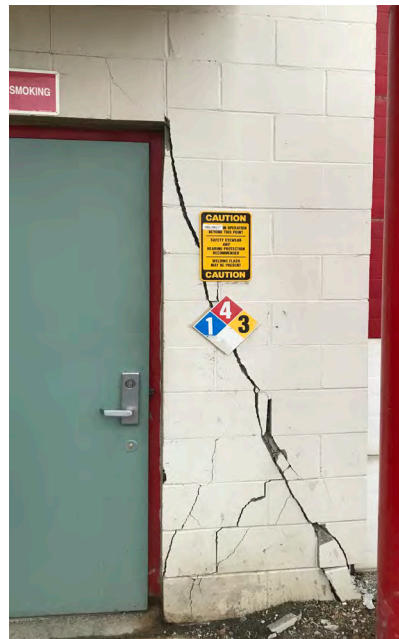
Figure 4.30. (a) Broken CMU at corners and shifted roof at Hyland Crest Booster Station in Eagle River (Photo: Anchorage Water and Wastewater Utility (AWWU)). (b,c) Heavy CMU wall damage at an Anchorage office building (photos: AWWU, MOA).

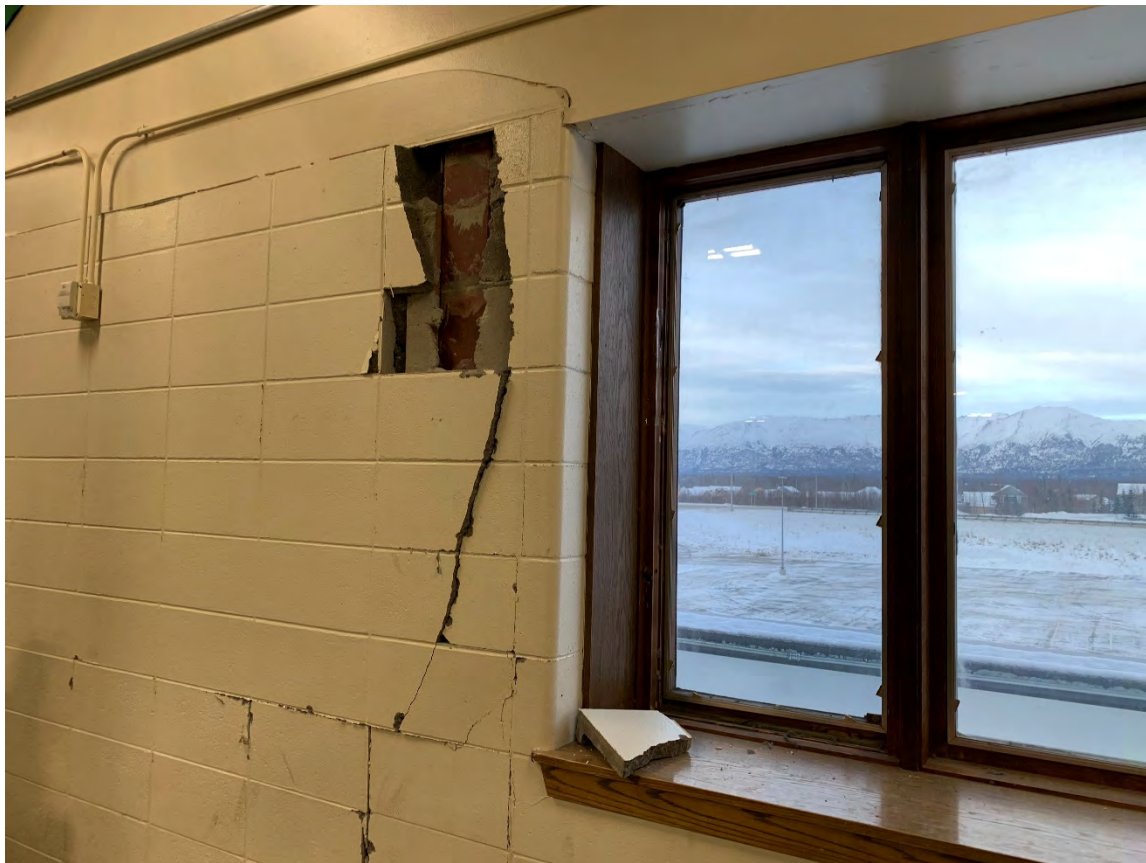
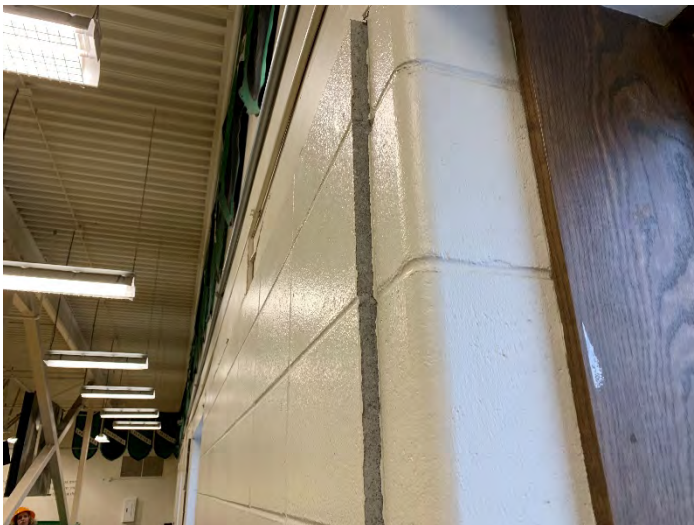
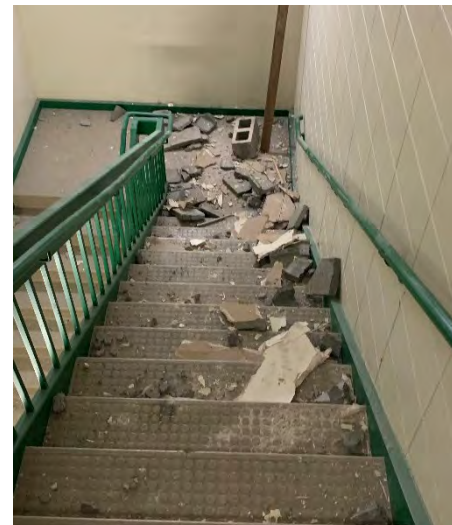
*Figure 4.31. (a) CMU wall damage at the vicinity of a steel column because of lack of deformation compatibility and absence of ductile details and (b, c) falling CMU block hazard (photos: Wael Hassan).*

Dislodged and fallen of CMU blocks due to shaking were also common during the inspections (Figure 4.31). In some cases, those fallen units represented serious life safety hazards, as they fell from large heights (35 feet) at the connection between the wall and floor or fell off severely cracked tall walls, even if these were classified as nonstructural walls. Other less common CMU failures included CMU and masonry chimney damage and fallen and CMU block foundation failure (Figures 4.32 and 4.33).

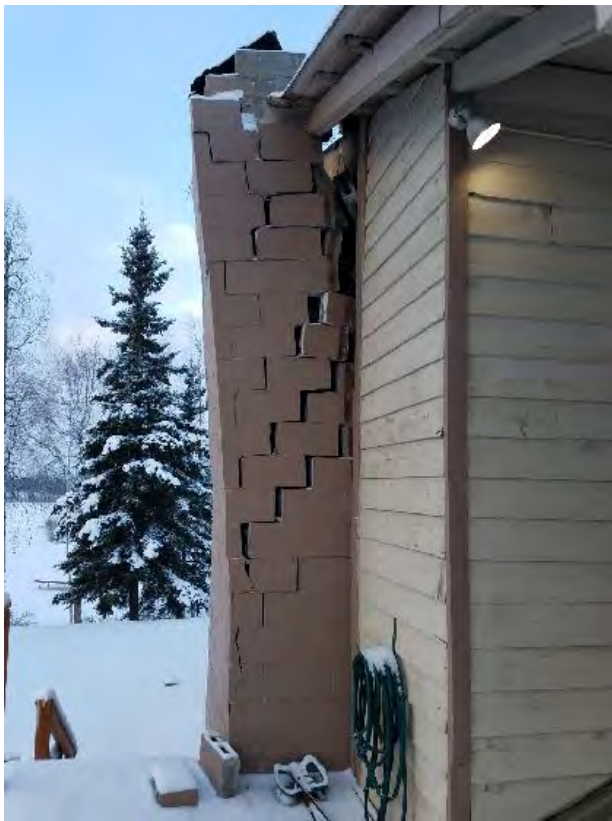
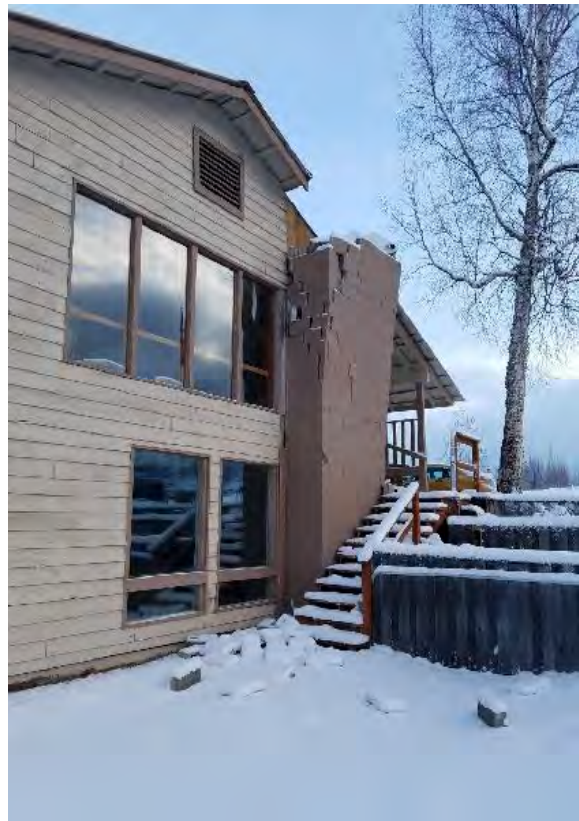
Figure 4.32. Masonry chimney partial collapse (photos: Janise Rodgers).

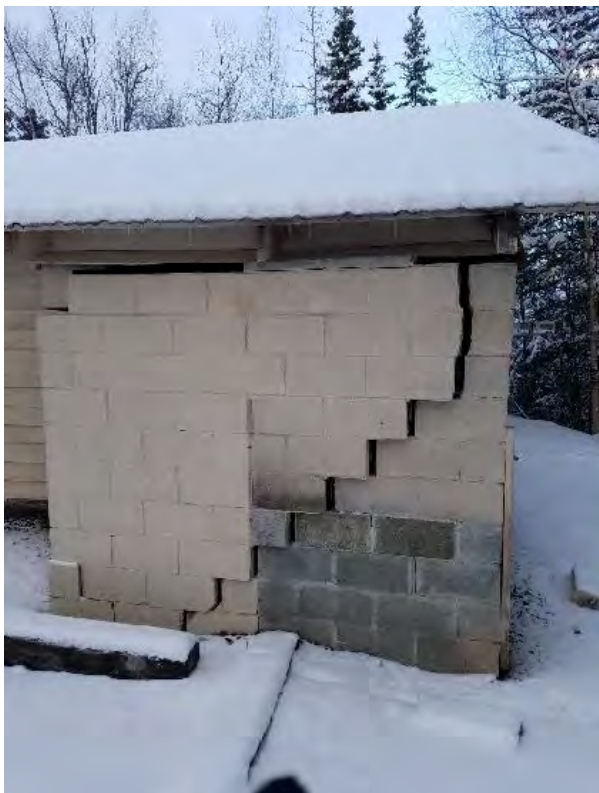
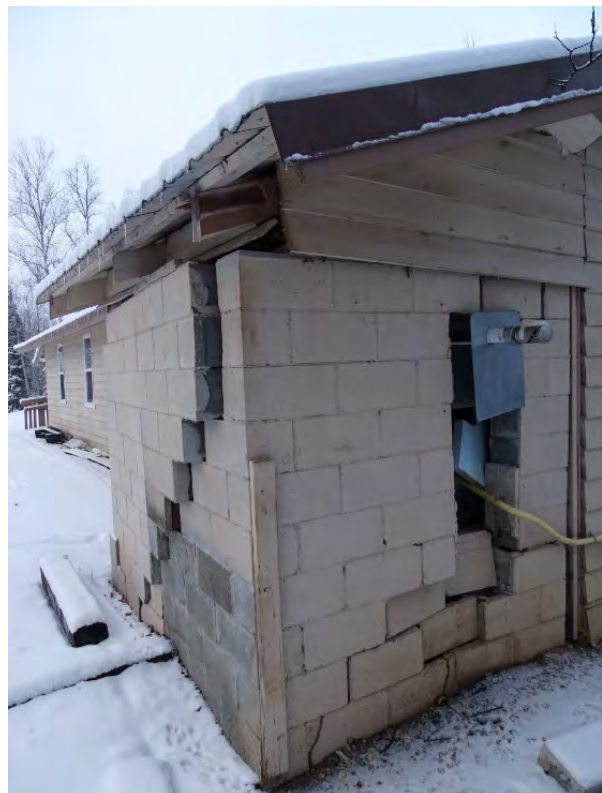
Figure 4.33. Severe masonry heater housing unit damage in Mat-Su (Photos Janise Rodgers).

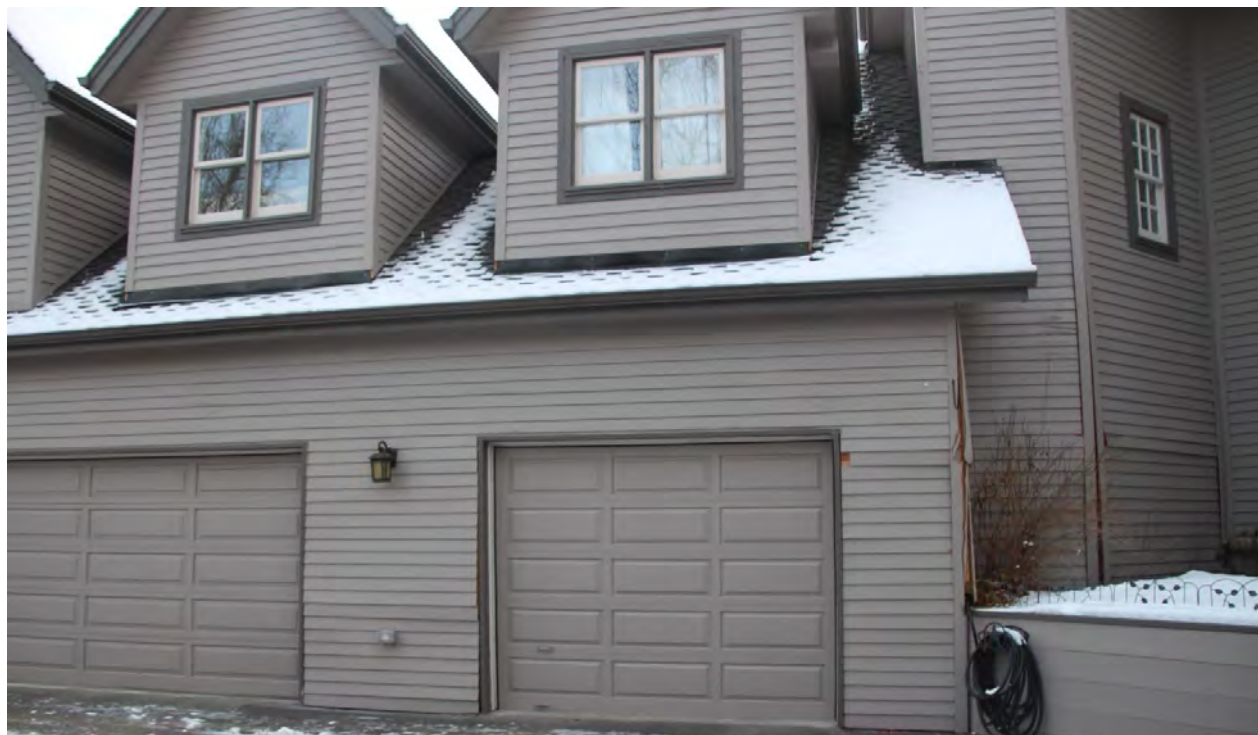
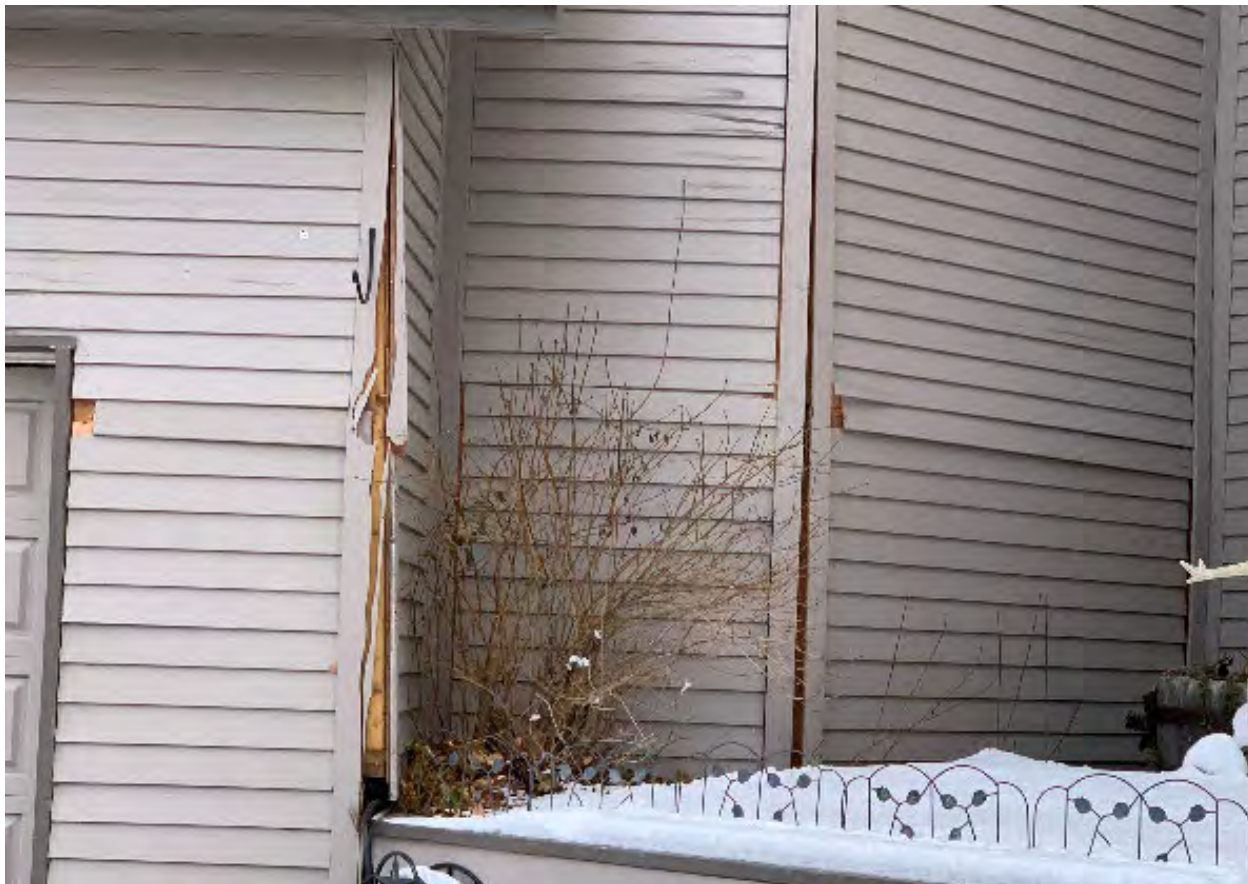
Mat-Su suffered significant structural damage to some residential wooden buildings and businesses, heavier than Anchorage Bowl, as seen from Figures 4.9–4.14. About 19 residential wooden buildings and 4 businesses suffered major structural damage or collapse. The prevailing shaking intensity in Mat-Su is believed to be about 0.3g, similar to that of Anchorage, yet causing more significant damage possibly due to lack of code enforcement in Mat-Su. An example house on the Finger Lake shore in Mat-Su Valley is seen in Figure 4.34.

*Figure 4.34.a. Examples residential building damage in Mat-Su (photos: (a) Chris Motter and (b) Wael Hassan).*

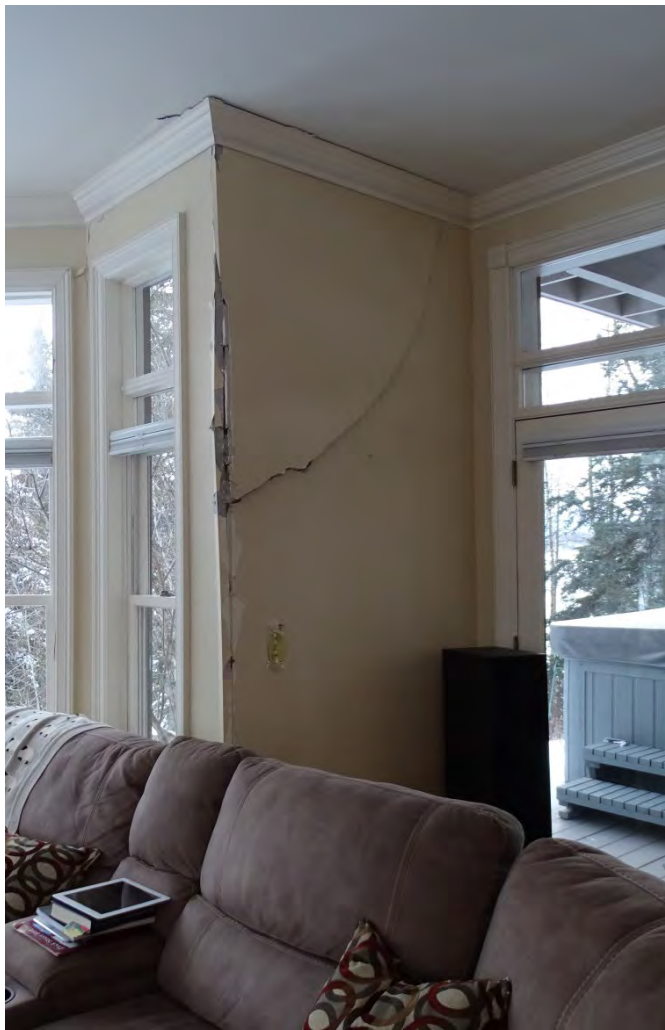
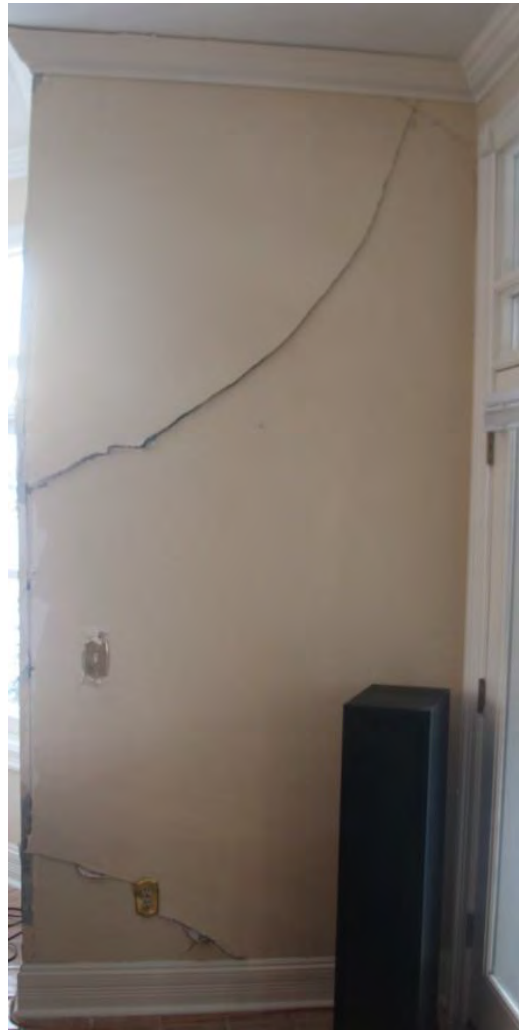
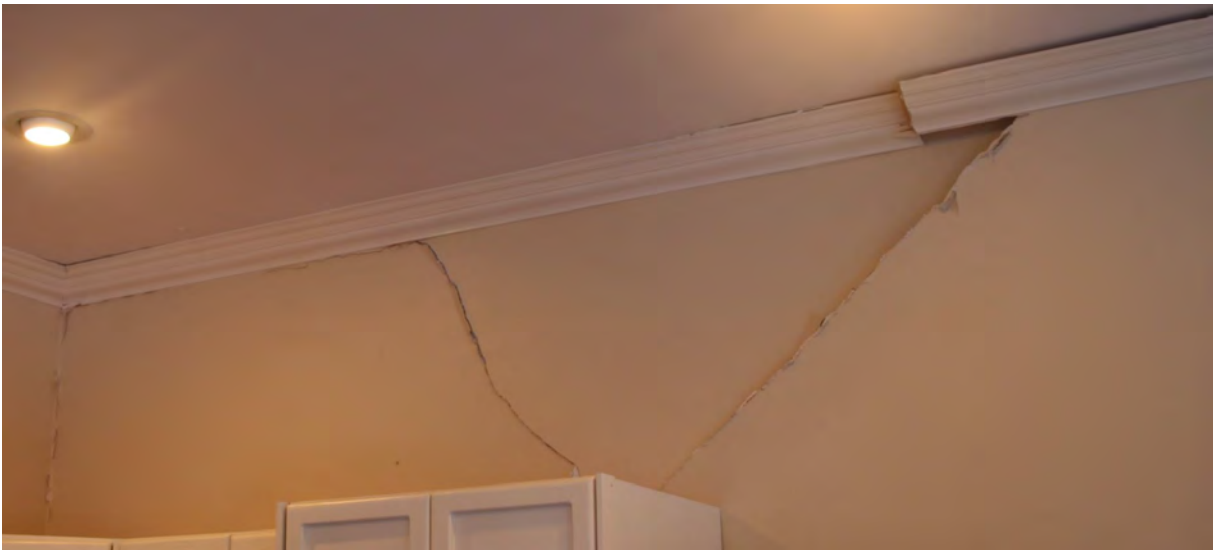
Figure 4.34.b. Example of inside damage to a residential building in Mat-Su (photos: Chris Motter).

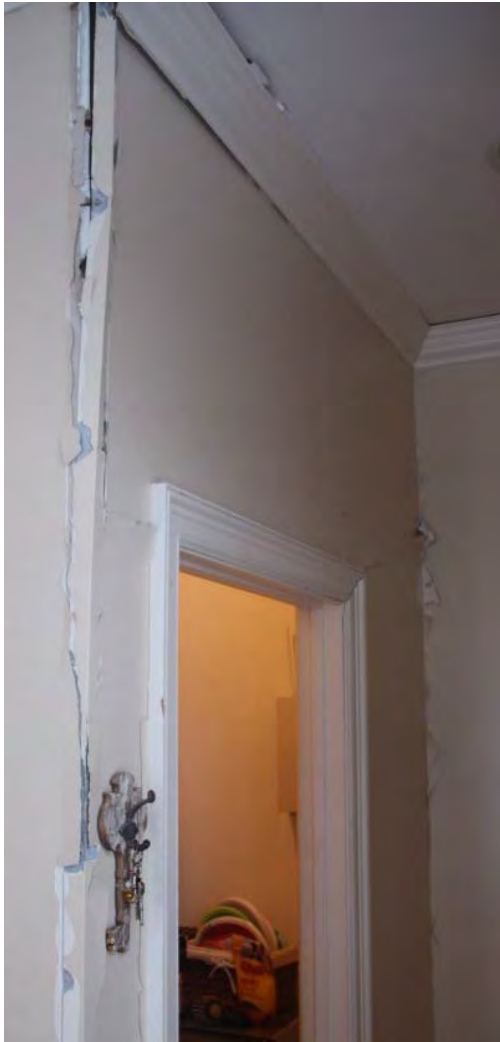
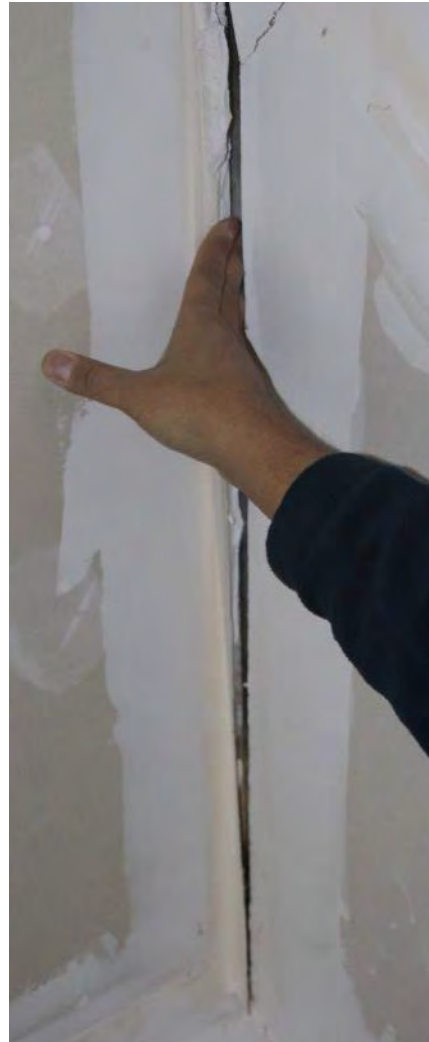
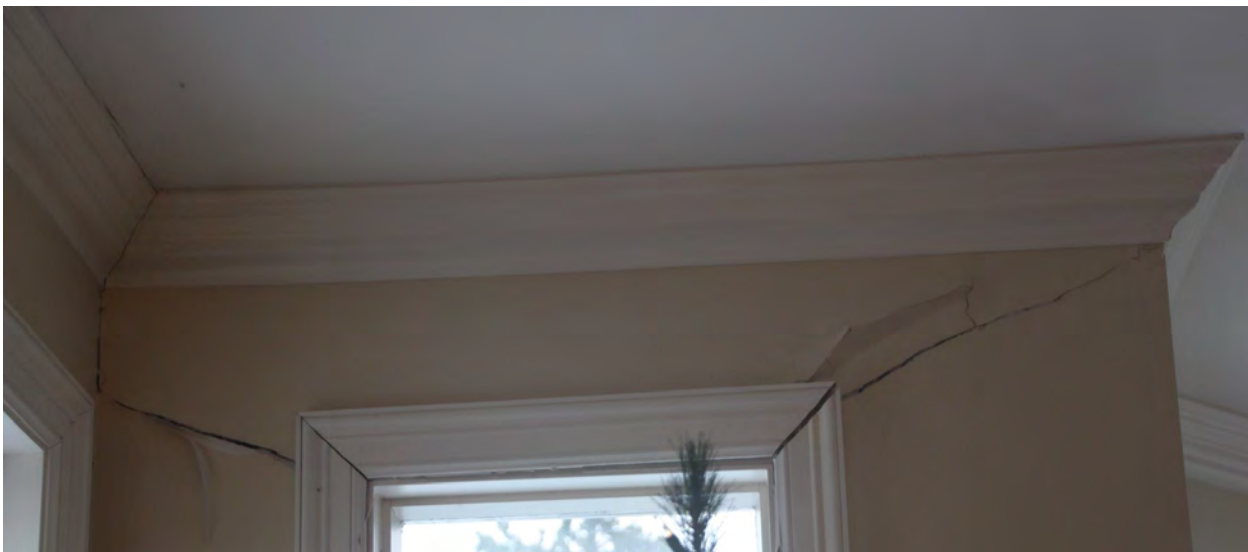
Figure 4.34.c. Example of inside damage to a residential building in Mat-Su (photos: Chris Motter).

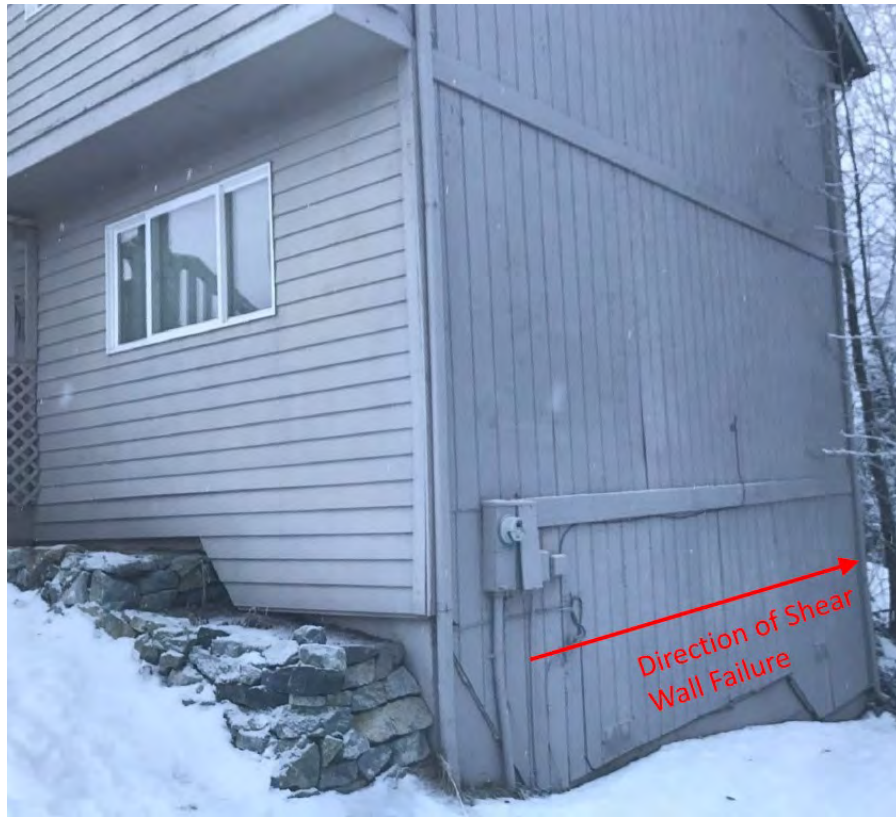
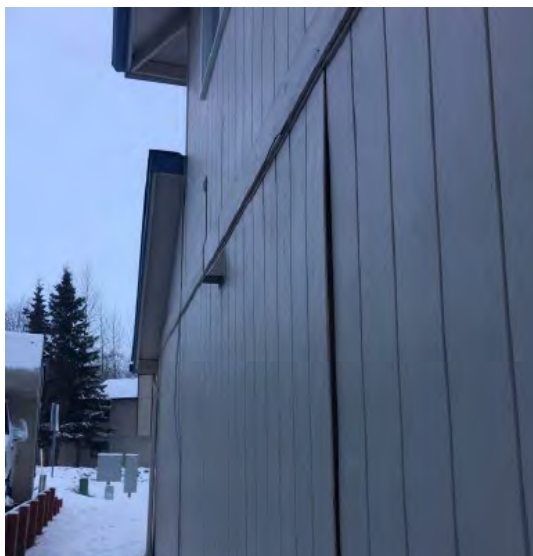
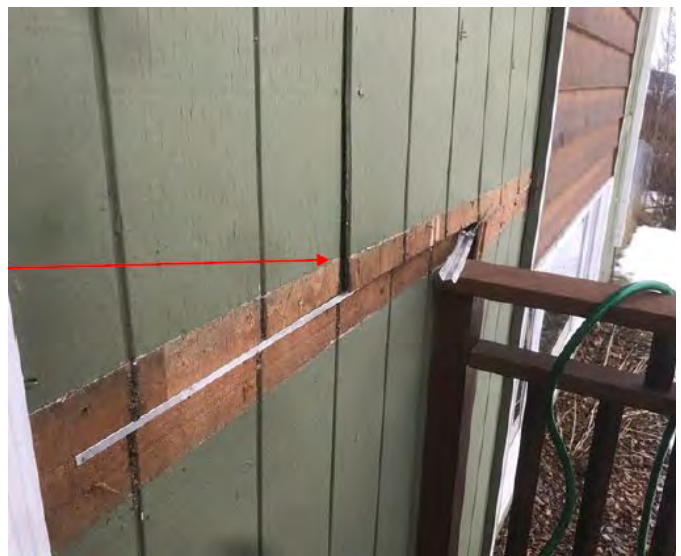
Figure 4.35.a. Shear wall damage in wood-frame residential buildings in Eagle River (photos: PND Engineers<sup>17</sup>).

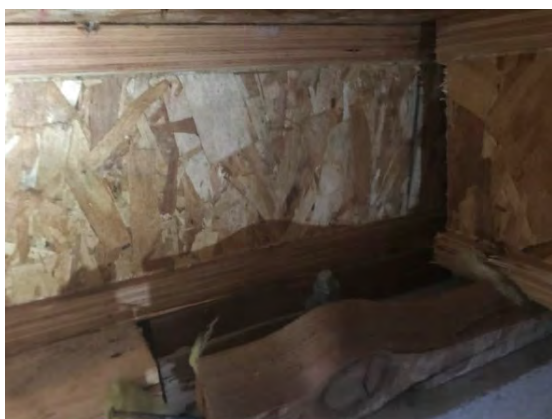
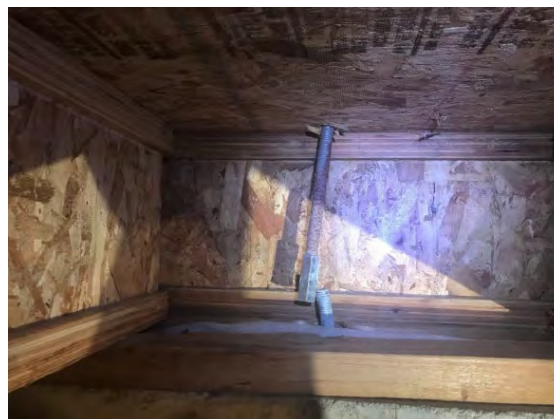
Figure 4.35.b. Shear wall damage in wood-frame residential building in Eagle River (photos: PND Engineers).

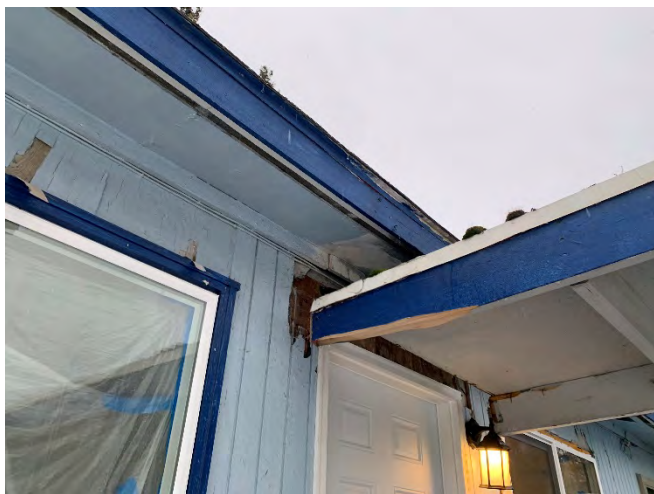
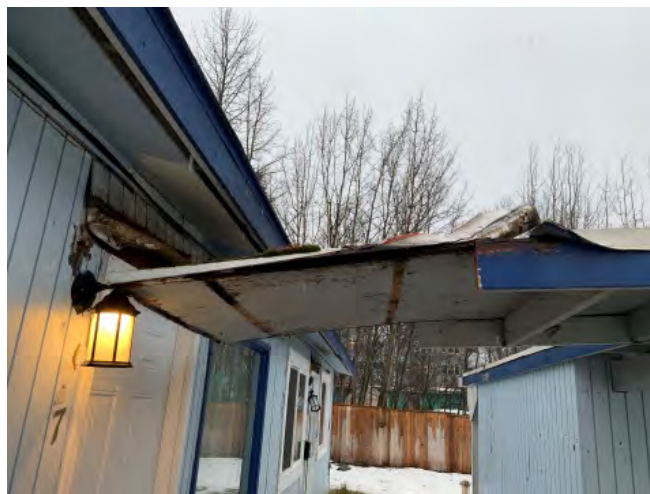
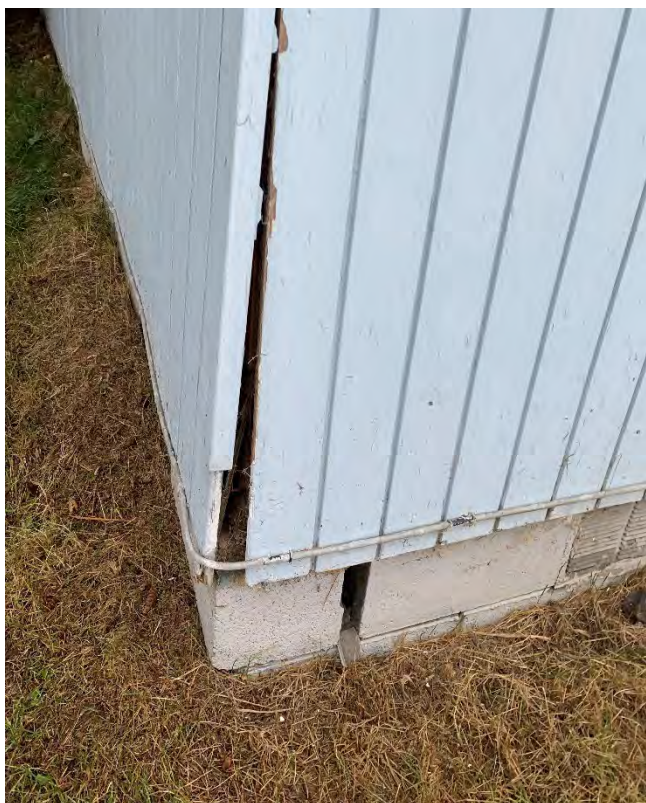
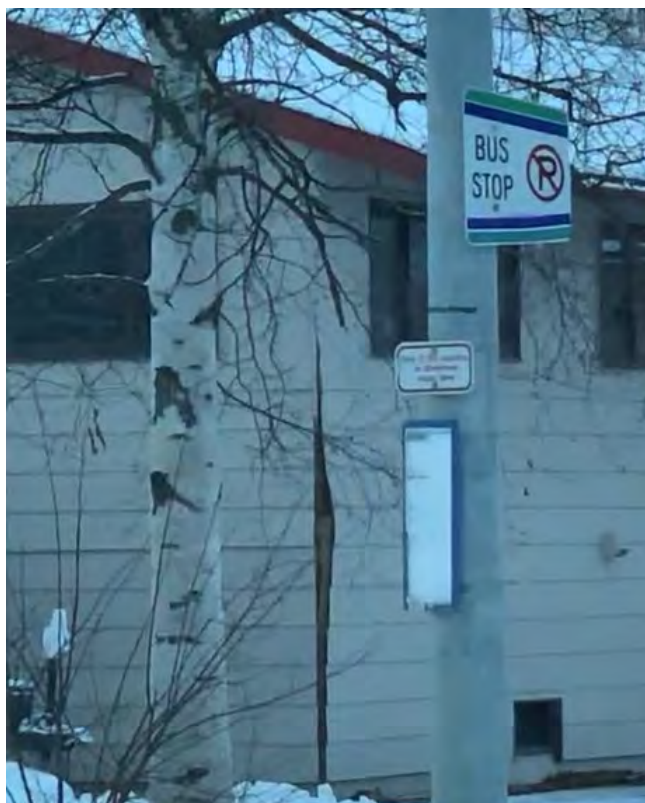
*Figure 4.35.c. Residential building damage in Eagle River (photos: Wael Hassan).*

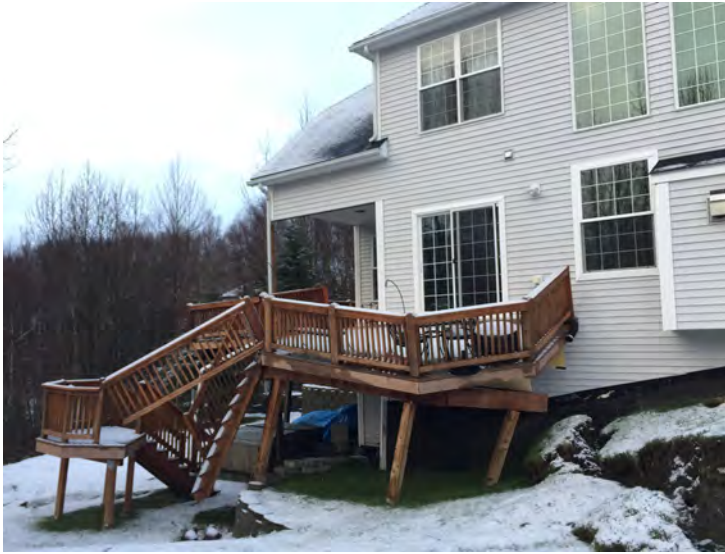
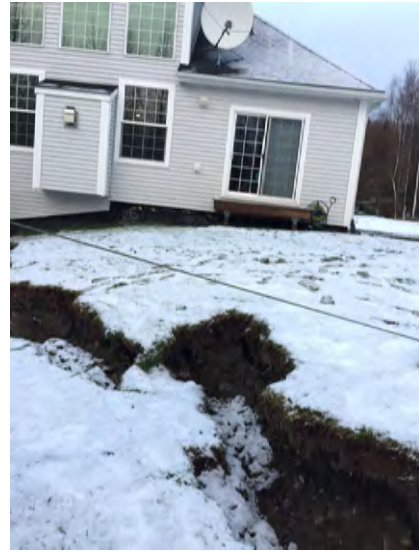
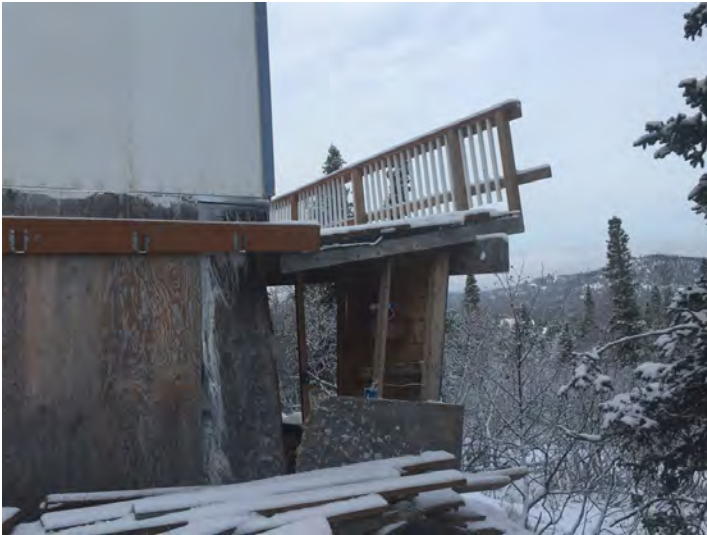
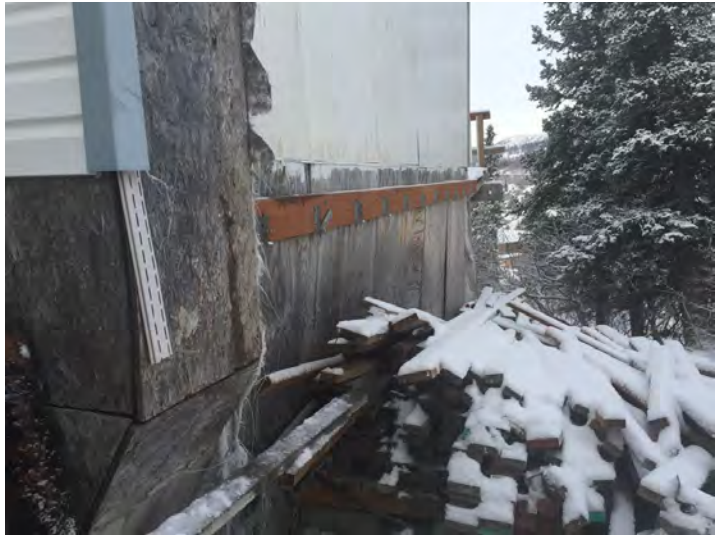
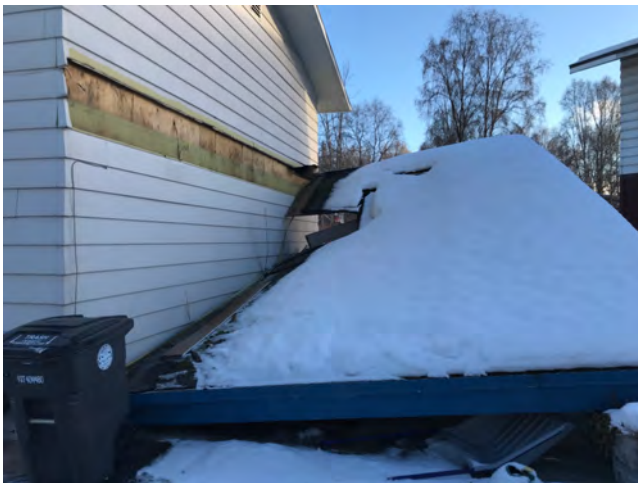
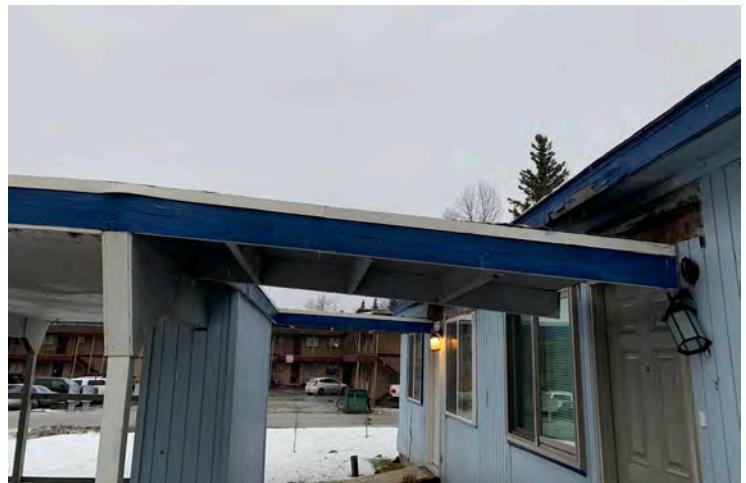
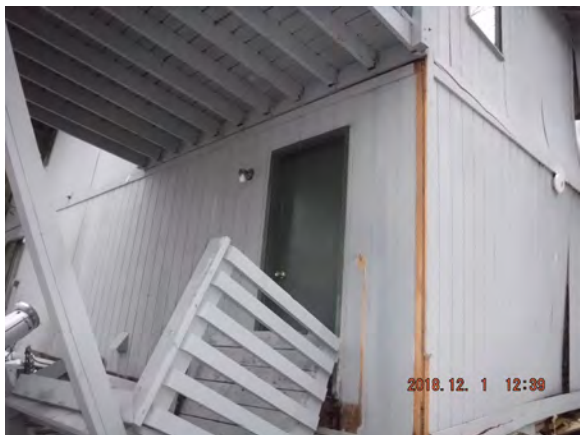
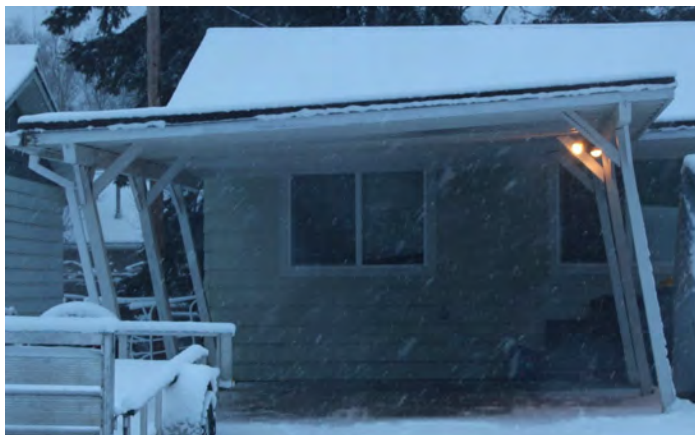
Figure 4.35.d. Example of residential single-family wood building attachment damage in (a-e, g) Anchorage and Eagle River (photos: MOA), (f) Eagle River (photo: Wael Hassan), (h) Eagle River (photo: Chris Motter).

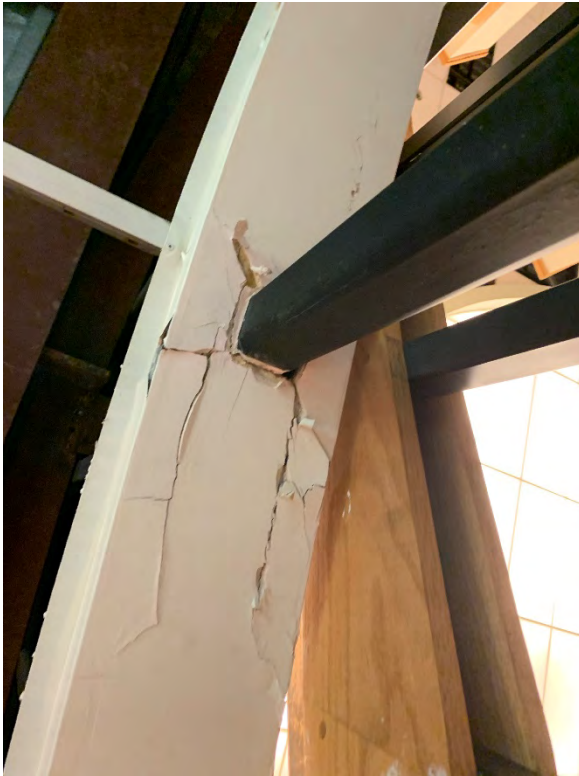
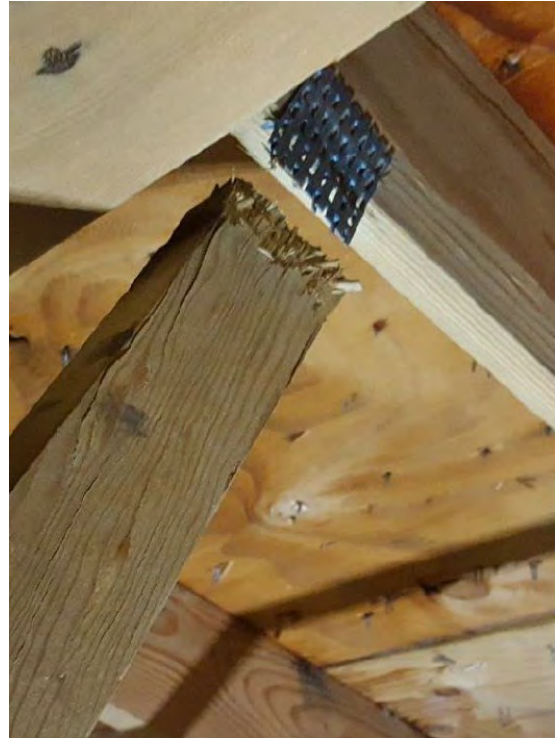
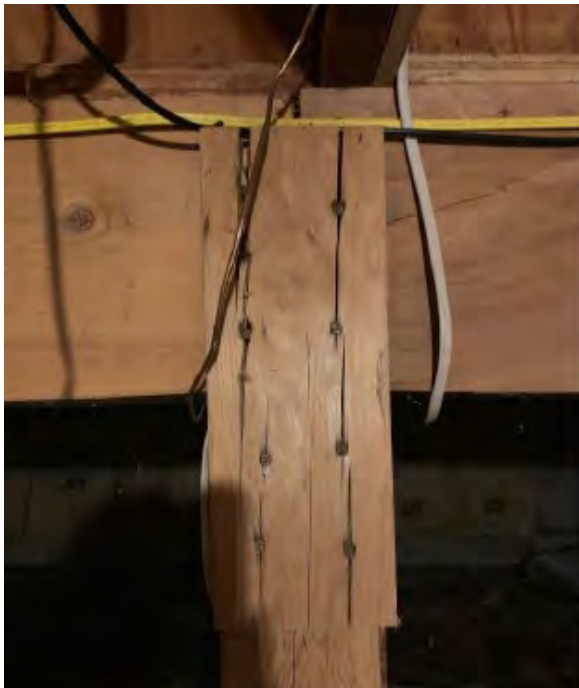
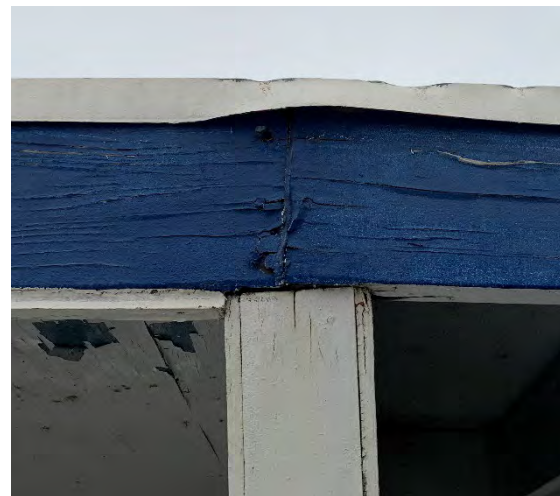
Common damage patterns observed throughout included damage to crawl-space posts and connections (Figures 4.35 and 4.36), foundation damage and differential settlement (Figures 4.37 and 4.38), permanent residual drift in single-story residential buildings (Figures 4.20 and 4.38), exterior sheathing damage (Figures 4.34 and 4.35), interior/partition-wall movement, permanent drift of parking sheds and balcony decks, and detachment from main residential structures (Figure 4.20), shear wall failures and deflections (Figures 4.34, 4.35, and 4.39), major diagonal wall cracking indicating serious structural damage (Figure 4.39), wall-foundation interface uplift/sliding/offset, detachment at wood wall corners, and detachment of floors from exterior walls (Figures 4.20, 4.34, 4.38, and 4.40). In particular, shear walls with small aspect ratios suffered the most damage (Figure 4.34).

Figure 4.36a. (a) Wooden post connection damage at an office building in Eagle River (photo: Wael Hassan), (b) crawl space after damage (photo: Bart Meindhurdt), (c) crawl-space connection damage (photo: PND Engineers), and (d) parking-shed connection damage in Eagle River (photo: Wael Hassan)

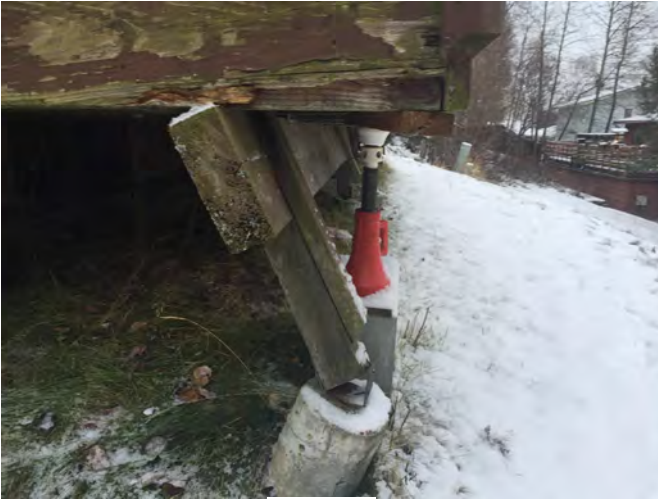
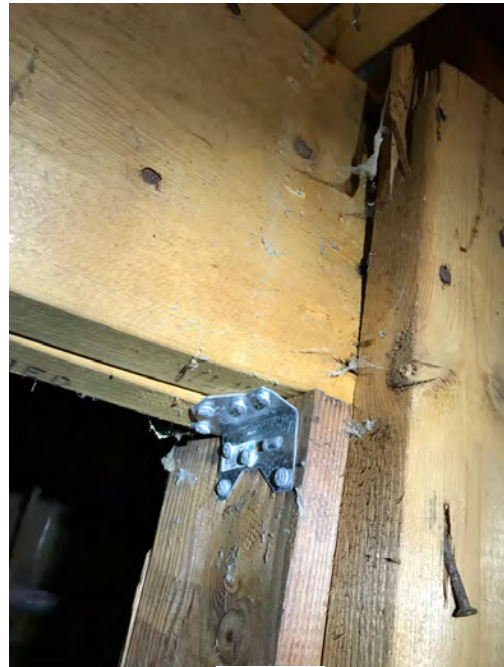
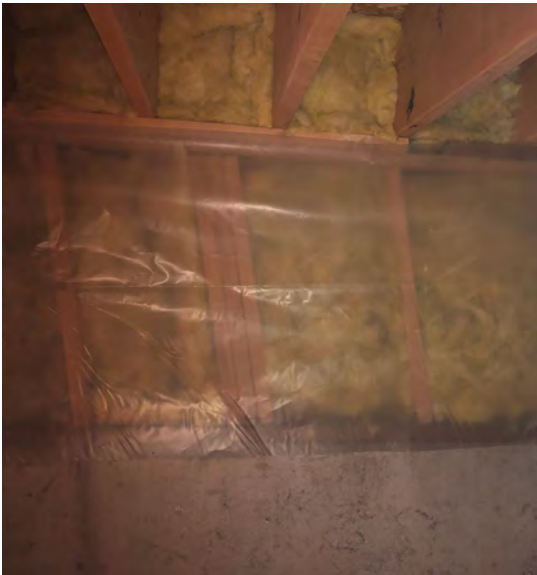
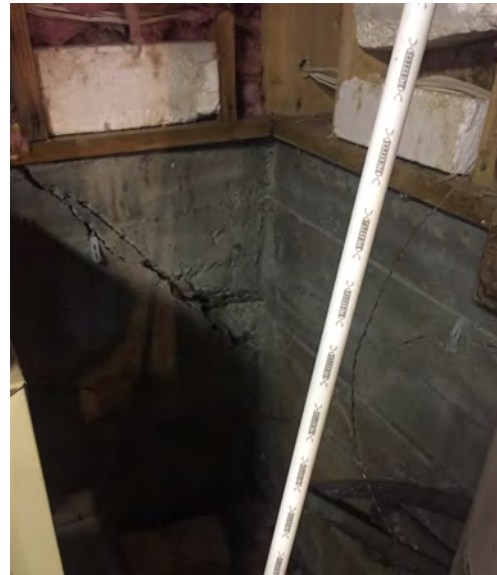
Figure 4.36b. (a-d) Example of residential single-family wood building crawl space and foundation damage (photos: MOA)
