# EERI Earthquake Reconnaissance Report: M7.1 Anchorage Earthquake on November 30, 2018

Wael M. Hassan, John Thornley, Janise Rodgers, and Christopher Motter

July 2021

*A product of the EERI Learning from Earthquakes Program*

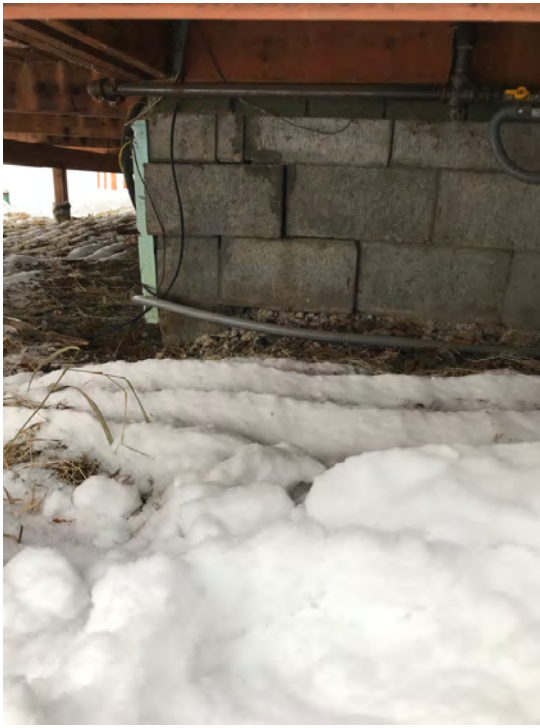
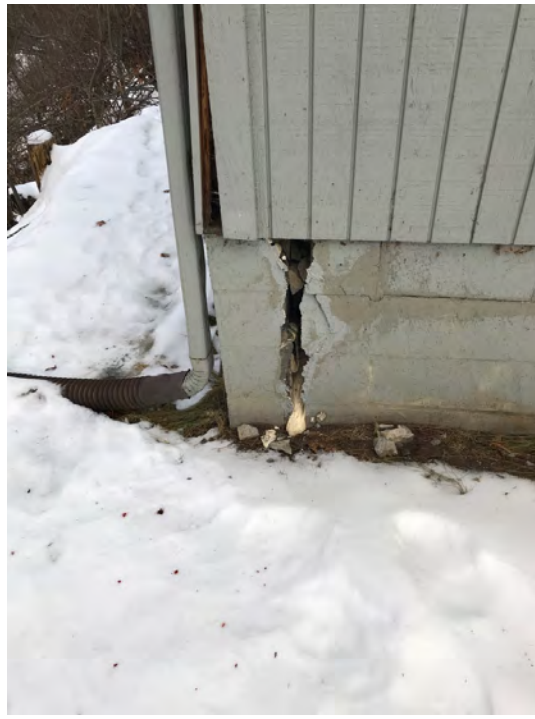
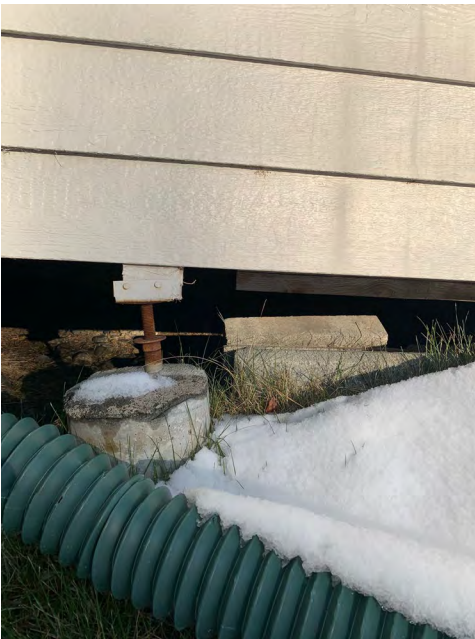
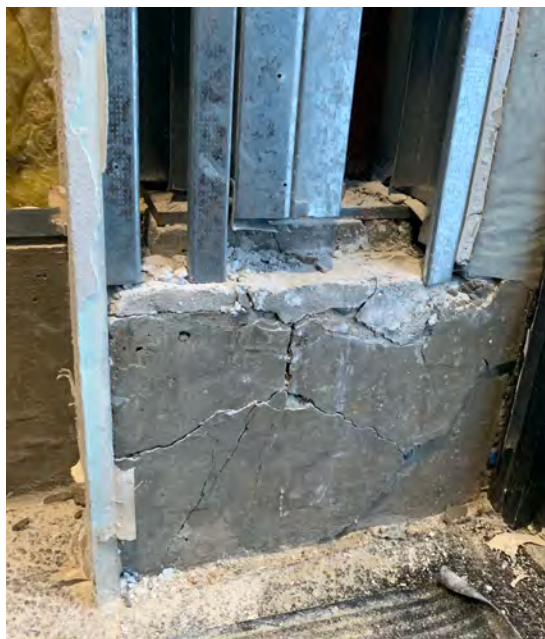
*Figure 4.36c. Examples of foundation wall damage in residential wood buildings (a, b photos: MOA); (c) Porch foundation damage in a wood residential building in South Anchorage (photo: Wael Hassan); and (d) Foundation wall damage in and Eagle River office building (photo: Wael Hassan).*

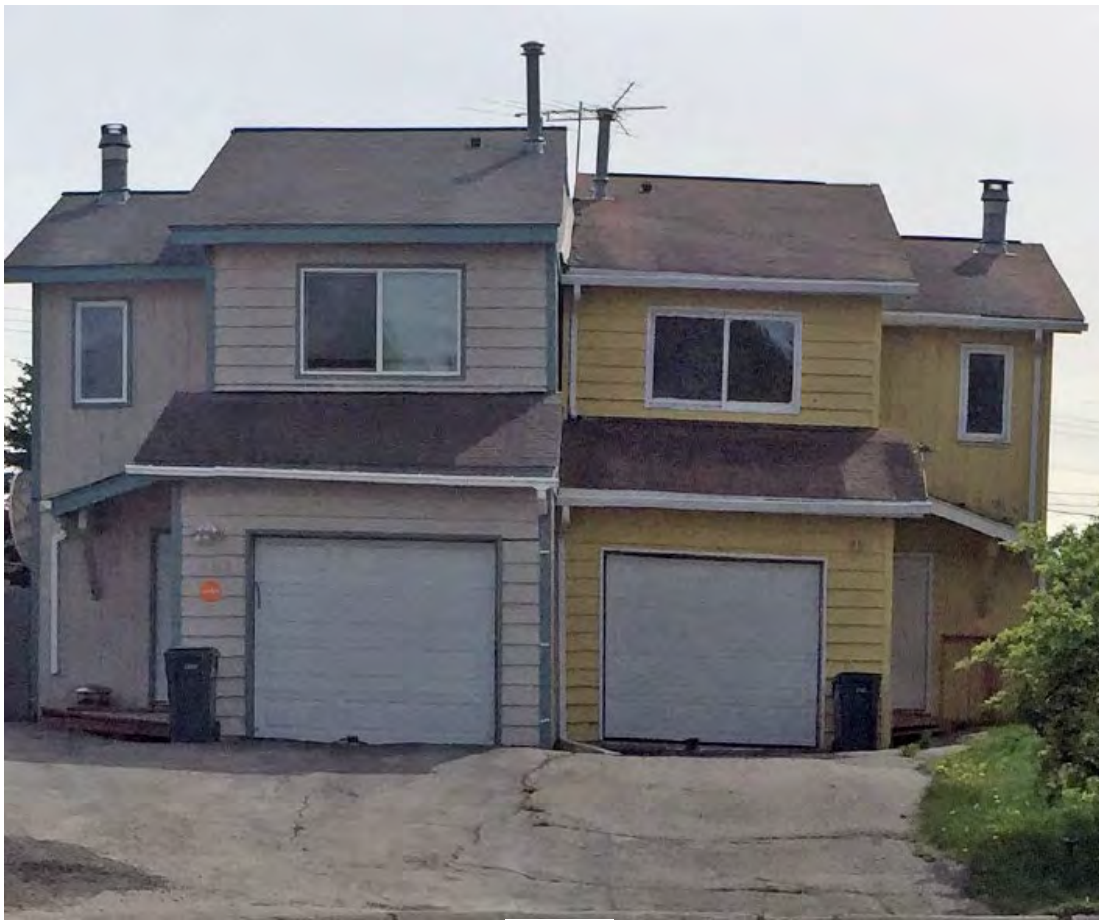
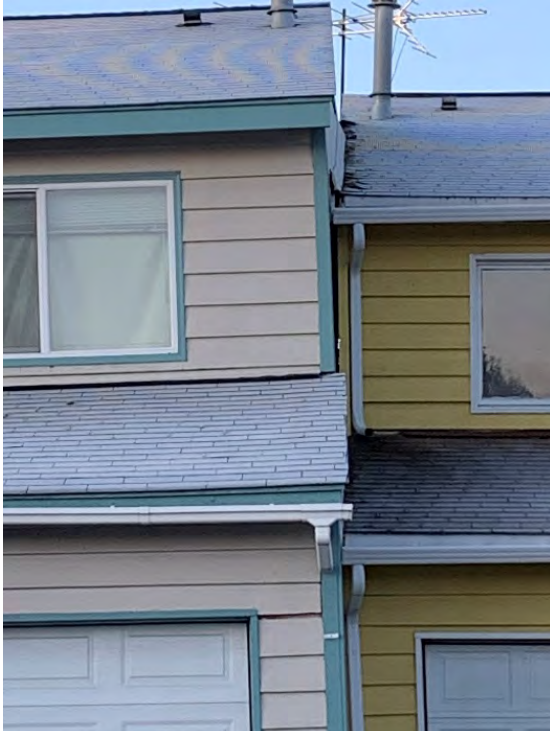
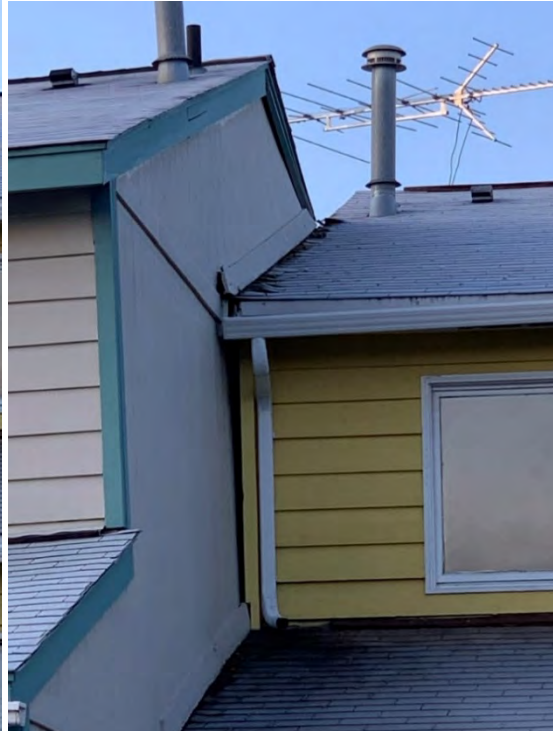
Common damage patterns observed throughout included damage to crawl-space posts and connections (Figures 4.35 and 4.36), foundation damage and differential settlement (Figures 4.37 and 4.38), permanent residual drift in single-story residential buildings (Figures 4.20 and 4.38), exterior sheathing damage (Figures 4.34 and 4.35), interior/partition-wall movement, permanent drift of parking sheds and balcony decks, and detachment from main residential structures (Figure 4.20), shear wall failures and deflections (Figures 4.34, 4.35, and 4.39), major diagonal wall cracking indicating serious structural damage (Figure 4.39), wall-foundation interface uplift/sliding/offset, detachment at wood wall corners, and detachment of floors from exterior walls (Figures 4.20, 4.34, 4.38, and 4.40). In particular, shear walls with small aspect ratios suffered the most damage (Figure 4.34).

Figure 4.37. (a) Damage to residential wood building in Anchorage (photo: West et al. 2019) and (b, c) building detached from garage because of soil failure (photos: Wael Hassan).

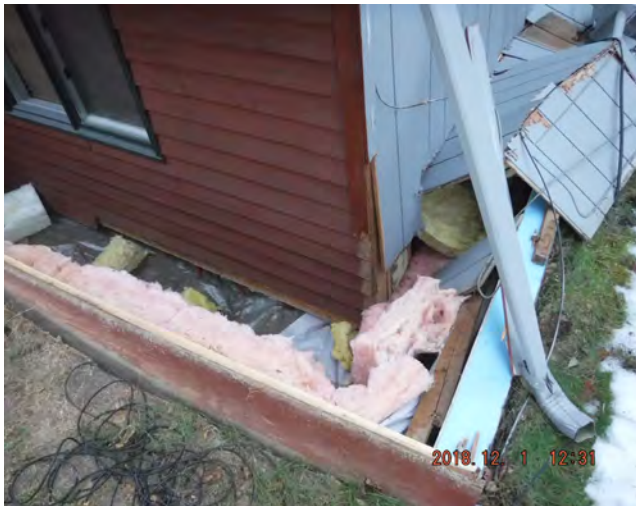
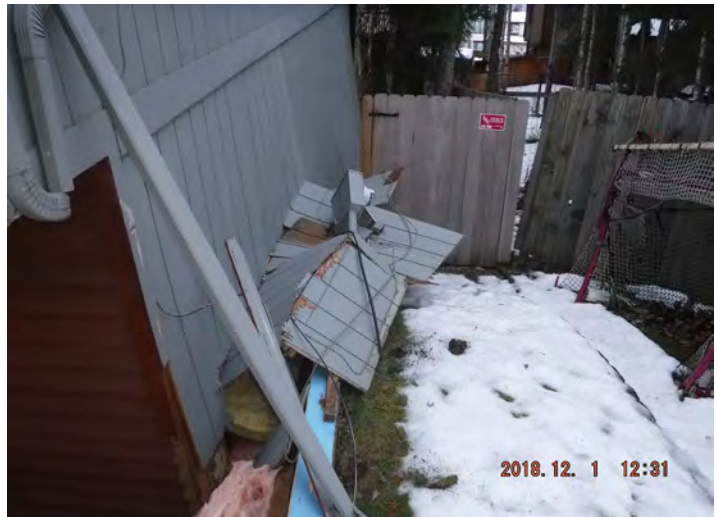
Figure 4.38.b. Residential single-family housing severe shear wall and nailed-connection sliding/uplift from foundation damage in a residential building in Anchorage (photos: MOA).

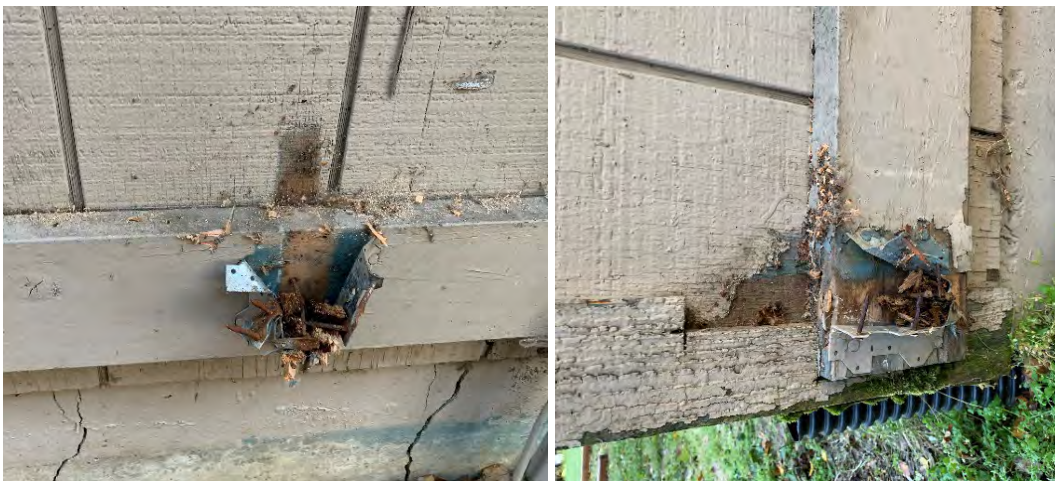
*Figure 4.39. Severe shear wall and nailed-connection damage in a residential building in Anchorage (photos: Wael Hassan).*

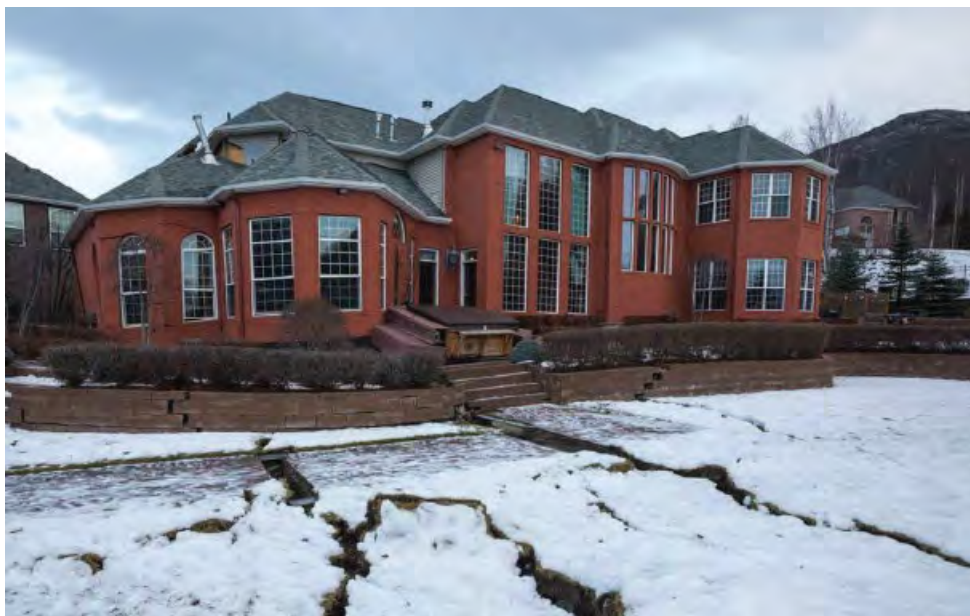
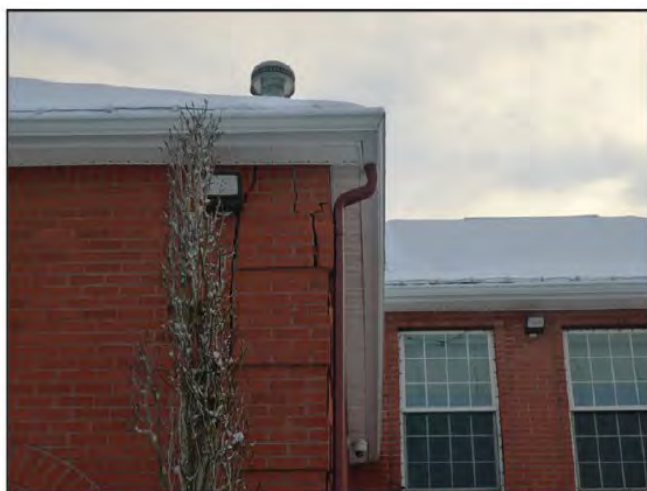
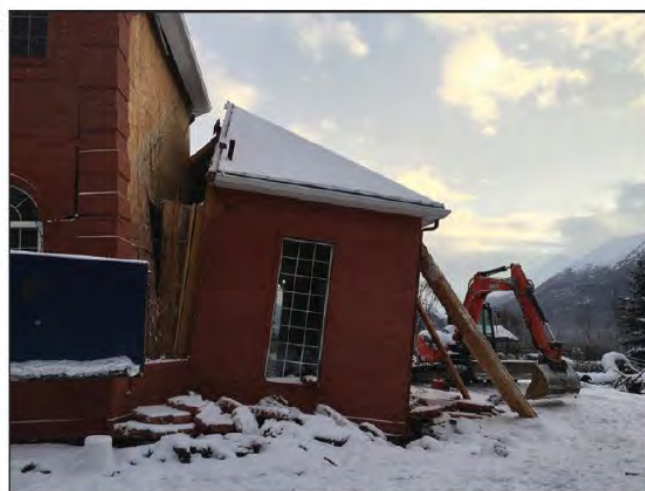
Figure 4.40. Partial collapse of a residential building in Eagle River related to uncompacted fill failure (photos: (a) Loren Holmes and (b, c) Geotechnical Extreme Event Reconnaissance<sup>18</sup>).

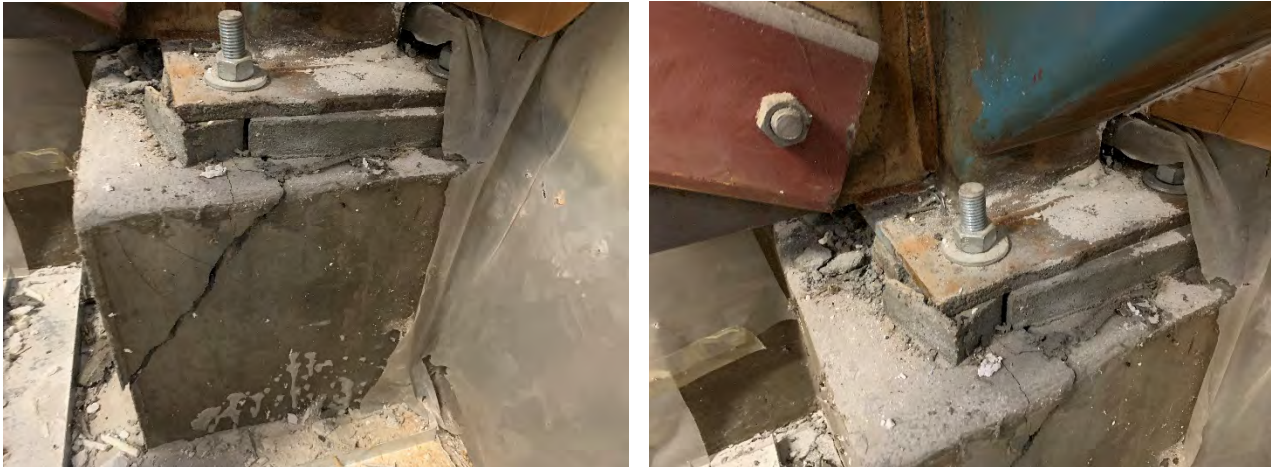
Concrete-foundation splitting and flexural cracking and crushing were evident in many buildings of different types, including steel, CMU, and timber buildings (Figures 4.20d and 4.41). In most cases, this foundation damage was attributed to geotechnical problems, and only a few cases were due to problems with superstructure design (Figure 4.41).

On one occasion, susceptible design errors may have led to steel-member foundation damage. This case was a two-story, light-gauge-steel office building constructed in 1974 that was retrofitted prior to the earthquake to upgrade its seismic resistance to code level. The seismic upgrade featured several cross and single steel braces (Figure 4.41). Inspecting the earthquake damage revealed severe brace foundation damage, including major splitting cracks, concrete crushing, and base-plate grout-pad damage (Figure 4.41). There were no signs of geotechnical or ground failure inside or near the building site. Upon further investigation of the building and its structural drawings, it appeared that two of the building's original steel braces were present, and they were likely not accounted for when upgrading the building with new braces, which may have led to major eccentricity that possibly added unexpected seismic demand to the new braces, leading to brace foundation damage consistent with that observed. Another possibility is not accounting for bidirectionality effects when designing foundations that support seismic steel braces in two orthogonal directions.

*Figure 4.41. Foundation damage and base plate grout pad crushing in several retrofit steel braces in the Anchorage office building. Bolts were loosened by the ground motions on several base plates. No evidence to support soil problems at the area and the damage is believed to be due to retrofit system design errors. (photos: Wael Hassan)*

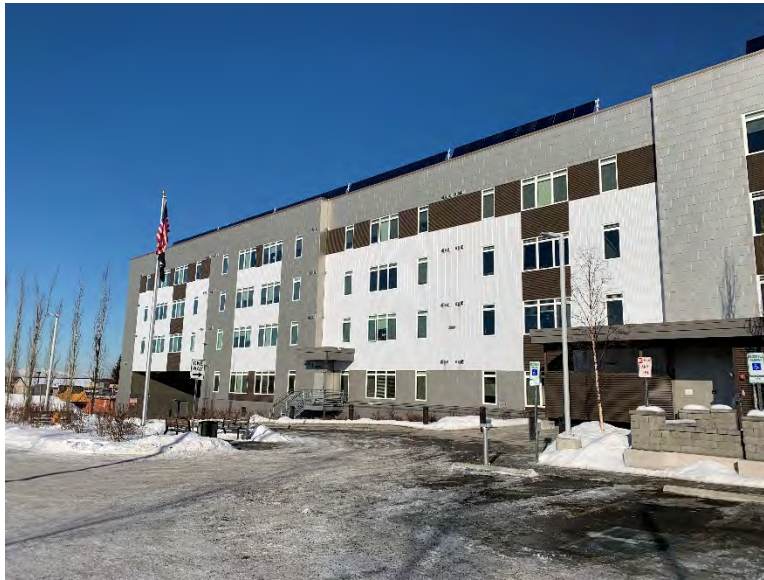
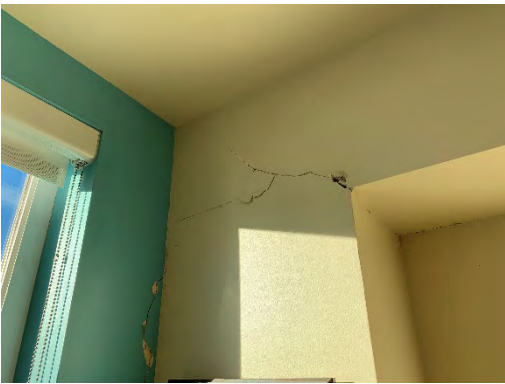
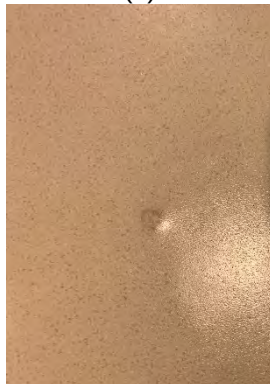
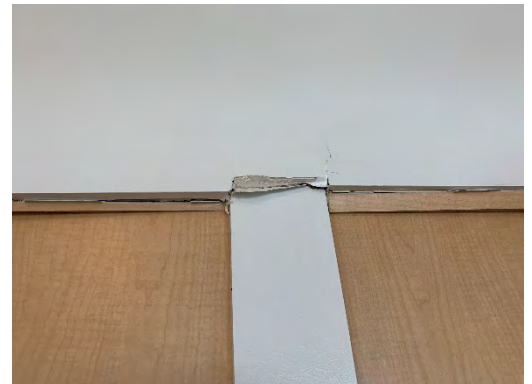
A typical case to present good structural mixed wood shear wall structural steel-floor building performance is a multistory, 2014 building for senior citizens in Eagle River (Figure 4.42). The building suffered significant sheetrock damage and moderate water flooding damage with an estimated repair cost of about \$602,000. The building is a 76,804-sq. ft., 56-unit senior-living facility with underground parking. The site footprint at garage level is approximately 18,900 sq. ft. The wood shear walls are supported at the ground level on a perimeter-reinforced concrete retaining wall. The ground grade on-site is rather steep, rendering the concrete wall to act as a shear wall for a large percentage of the building perimeter. Thorough inspection of the building revealed no structural damage to wooden walls or steel decks. However, a few concrete wall sections had vertical splitting and diagonal shear cracks (Figure 4.43). There was also some minor structural damage, such as some shear studs pultruded in a composite deck and minor crushing in wooden posts (Figure 4.42). Seismic and expansion joints in steel buildings performed as per the design intent, experiencing light-to-moderate nonstructural damage and protecting the structural elements.

Figure 4.42. (a) Eagle River senior-citizen facility with (b) beam-column connection drywall damage, (c) pultruded shear stud at a concrete-steel composite slab, and (d) bearing failure at the top of a wood post (photos: Wael Hassan).

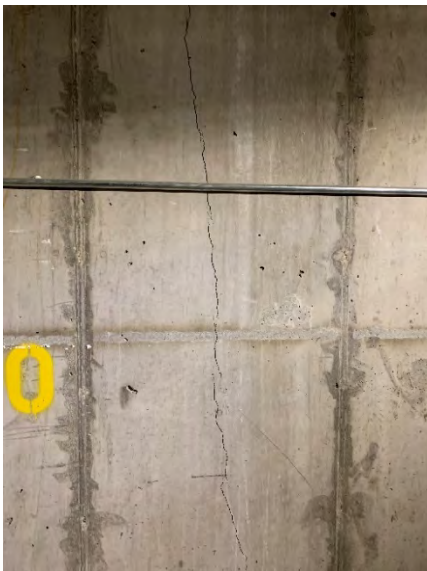
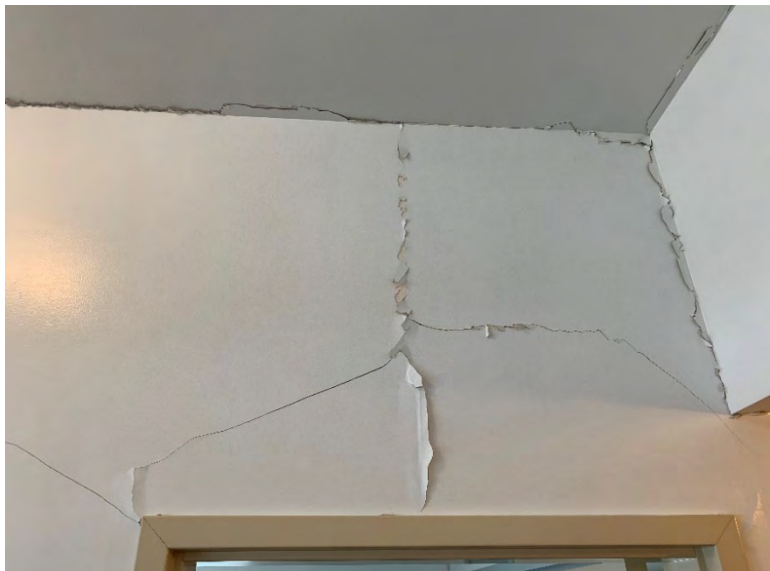
Figure 4.43. (a) Retaining-wall cracking and (b) sheetrock damage in an Eagle River senior-citizen facility (photos: Wael Hassan).

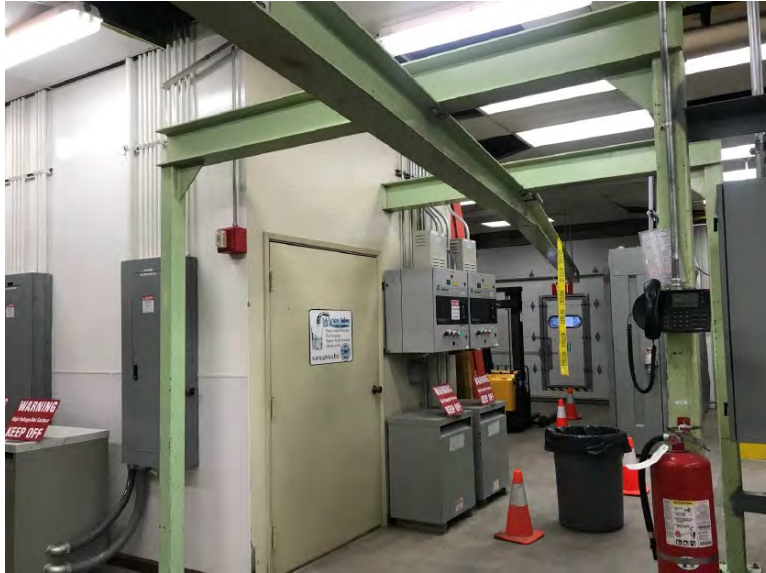
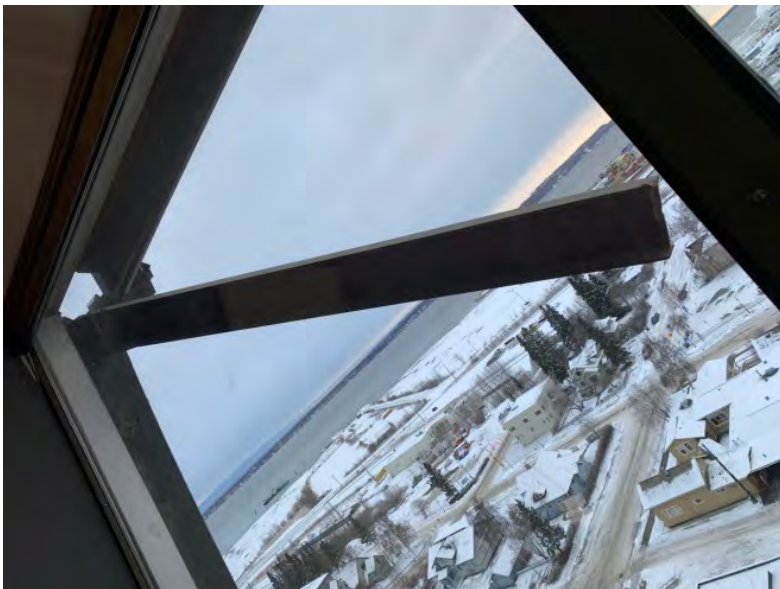
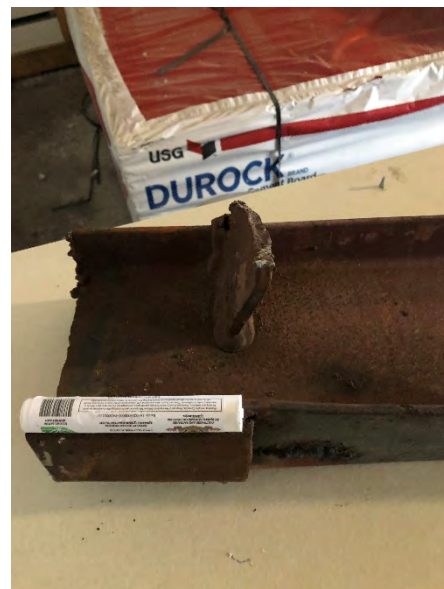
In some cases, there were sporadic steel-member failures, but this did not represent a common theme, as in the Girdwood AWWU facility with its damaged steel crane beam (Figure 4.44), the Hilton Tower in Anchorage with its soffit-beam failure (Figure 4.45), and the two steel braces in a diaphragm of a warehouse in Mat-Su. Anchorage School District reported a few isolated cases of floor bracing damage (Figure 4.45).

Figure 4.44. (a) Girdwood Wastewater Treatment Facility operations building with a sheared steel crane beam not connected at one end (photo: AWWU); (b,c) Hilton Anchorage steel soffit-beam failure (photo: PND Engineers).

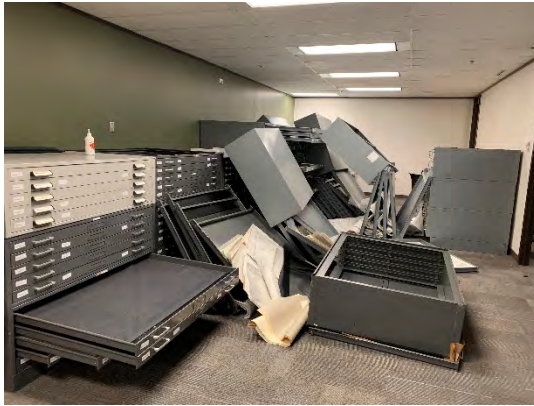
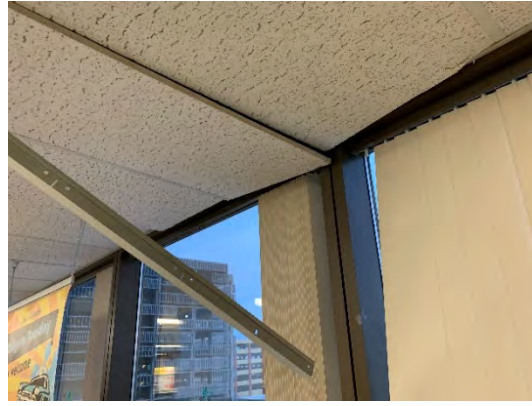
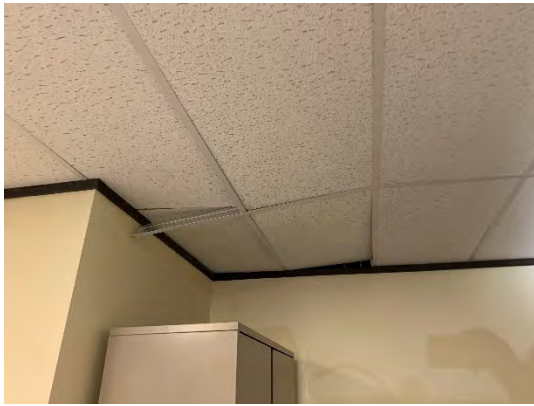
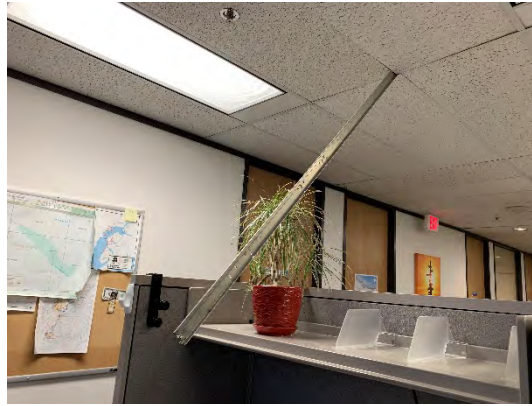
The building did not have any visible structural damage. However, it had water flooding and ceiling damage at one floor because of two piping-connection failures in the mechanical room (Figures 4.49 and 4.50). In addition, suspended-ceiling grid and tile failure occurred at three floors. Unrestrained furniture damage and overturning occurred at many floors (Figure 4.49). The building was yellow-tagged. Inspecting the roof fixtures and connections of the heavy heating, ventilation, and air conditioning and communication equipment/appendages did not reveal any damage related to the earthquake.

*Figure 4.49. Nonstructural damage at Atwood Building: (a) unrestrained bookcases and cabinets toppling and (b–d) ceiling tile and grid failure at various floors (photos: Wael Hassan).*

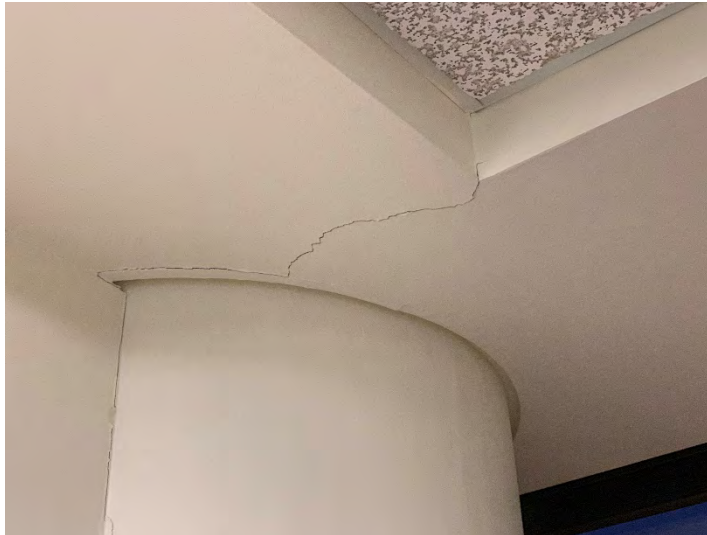
The building experienced light, nonstructural ceiling and partition-wall damage with no water damage (Figures 4.16, 4.53, 4.54, and 4.55). Stairwell sheetrock panels cracked in floors one through six, with some long, wider diagonal cracks in the sheetrock of stair walls at floors two and three. The building is relatively stiff, and it did not experience noticeable mechanical, electrical, and plumbing damage. Very few ceiling tiles fell, some ceiling grids were kinked, and some interior-partition walls cracked vertically, especially at lower levels. In all floors, the drywall separated from exterior and corner concrete columns. Two of their elevators went out of service because of counterweight and elevator-alignment problems. The only notable structural cracks are structural concrete-cover vertical-splitting cracks in most exterior and corner columns at floors three to five, which are indicative of overstress of these columns perhaps due to seismic overturning axial loads. These cracks ranged in width from 1/32 to 1/16 of an inch. Columns at floors one and two did not experience these cracks. A separate concrete parking structure on-site did not have any damage.

Figure 4.53. Third-floor column-head finish cracks; cracks in gypsum ceilings could potentially indicate hidden floor-diaphragm damage (photo: Wael Hassan).

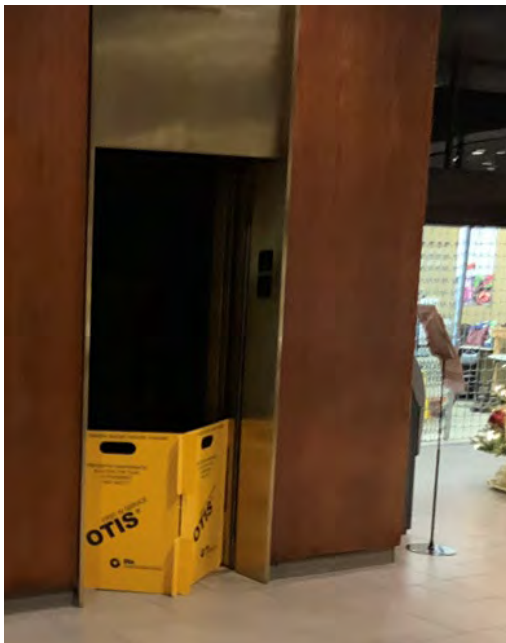
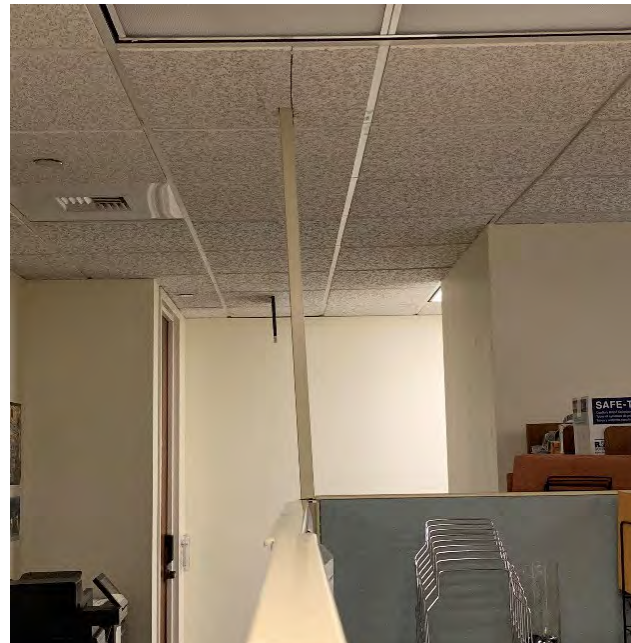
Figure 4.54. Frontier Building: (a) Elevator out of service because of counterweight damage. (b) Fifth floor electric after residual drift (photos: Wael Hassan).

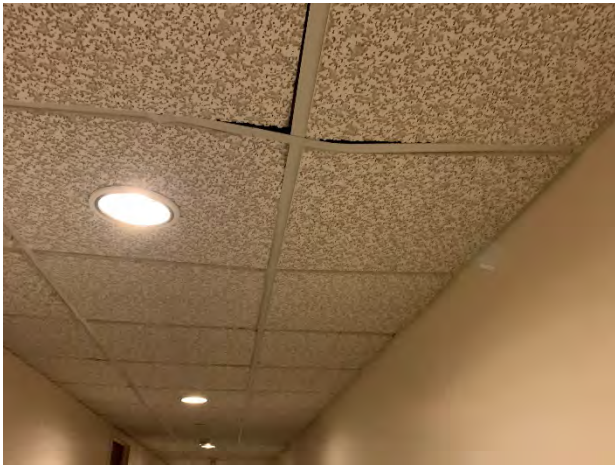
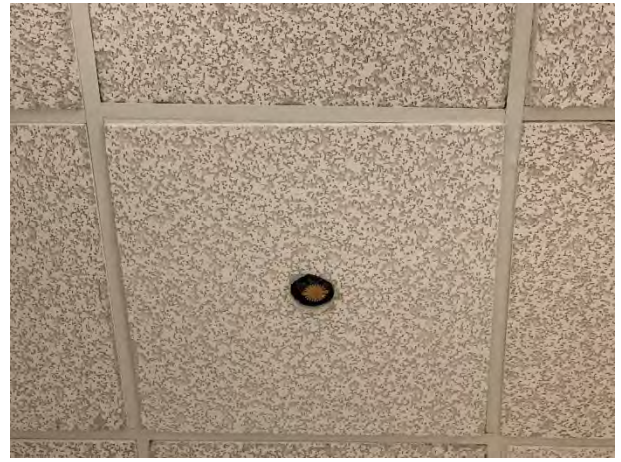
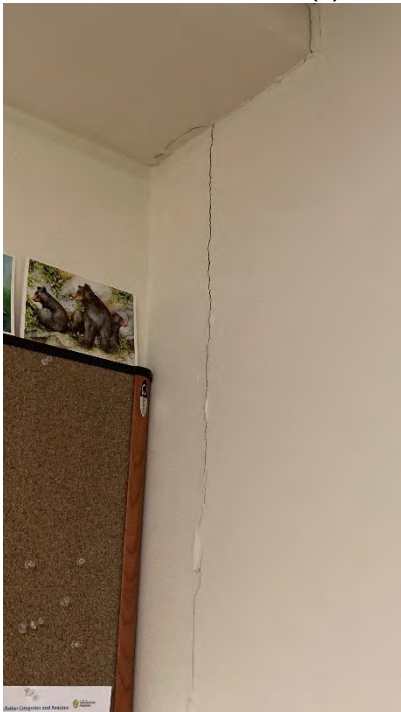
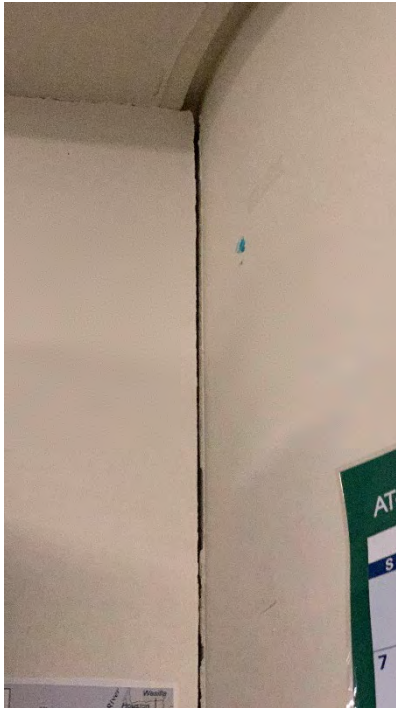
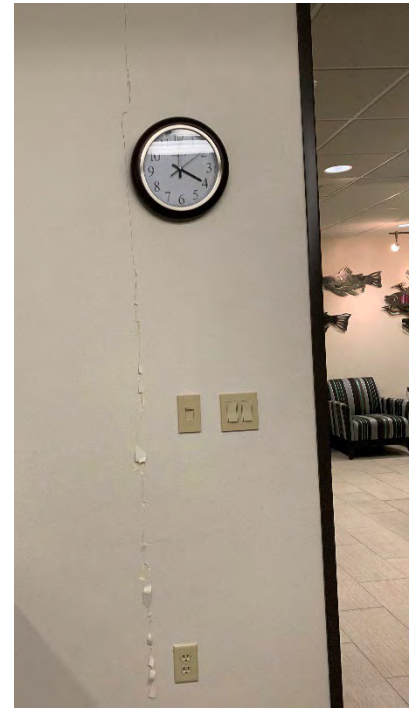
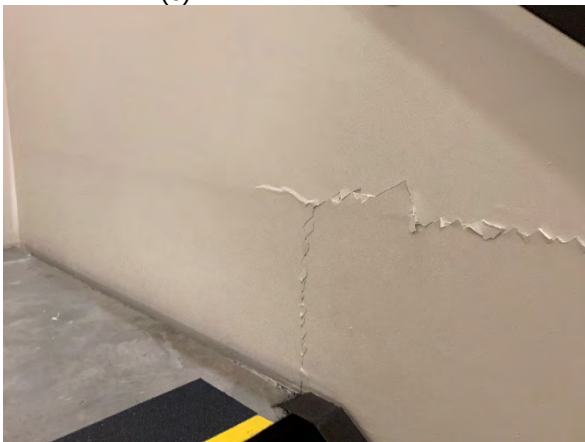
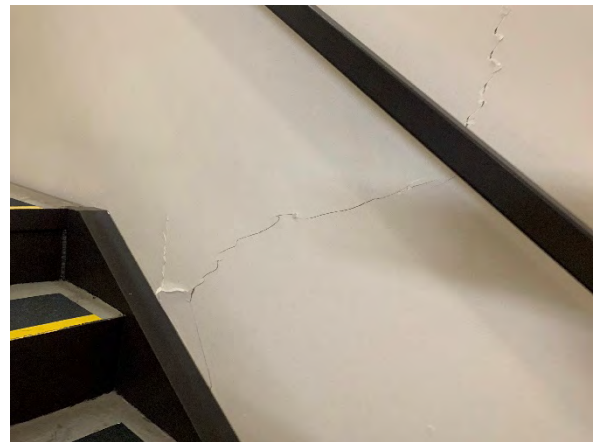
Figure 4.55. Frontier Building; (a) Third-floor ceiling damage, (b) partition-wall separation, (c–e) sheetrock cracks, and (f, g) typical stairwell drywall damage at third and fifth floors (photos: Wael Hassan).

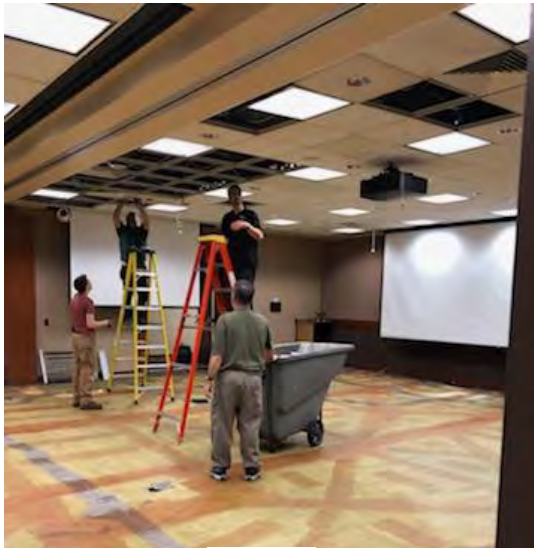
Figure 4.57. (a) Second-floor conference room with water damage from the third-floor mechanical room's connection failures in the low-rise building (photo: BP). (b) BP Tower and low-rise building (photo: Wael Hassan).

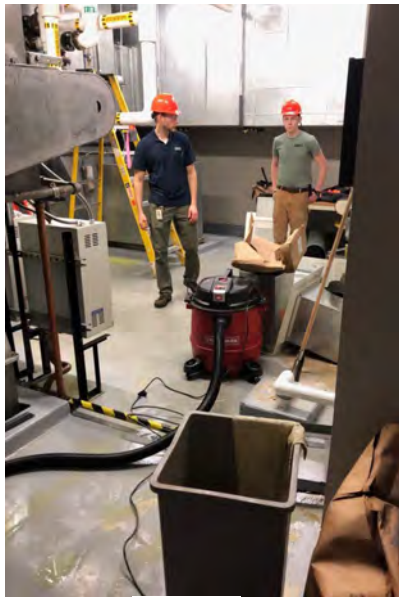
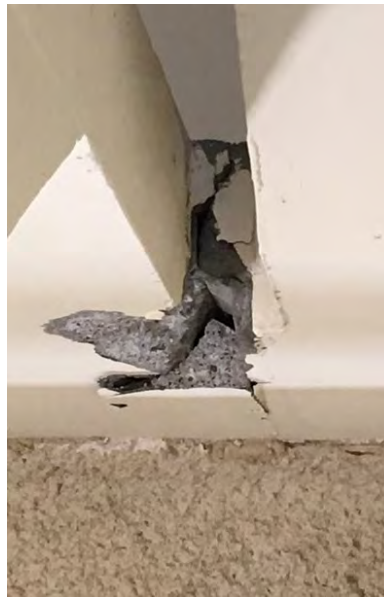
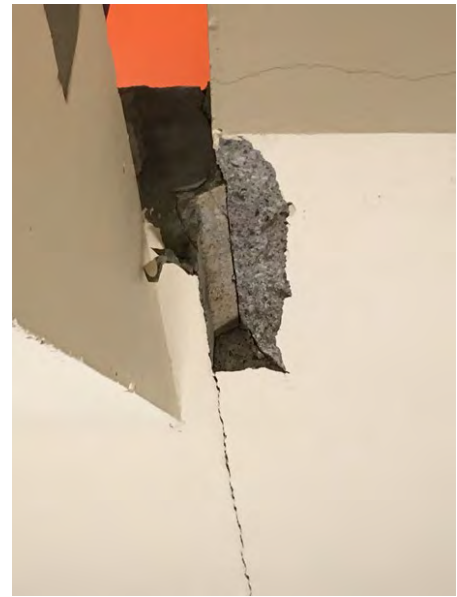
The BP Tower (Figure 4.58) experienced cosmetic nonstructural damage, water flooding, and some structural damage to staircases. However, the main structural elements did not experience any damage. The low-rise BP building also did not have noticeable structural damage. All four staircases in the main tower and the low-rise building had minor concrete cracking and some spalling and crushing in the corners, in addition to moderate sheetrock damage (Figure 4.57).

Figure 4.58. (a) Water and glycol flooding in the tower's ground-floor mechanical room; (b, c) tower stairwell concrete damage (photos: BP).

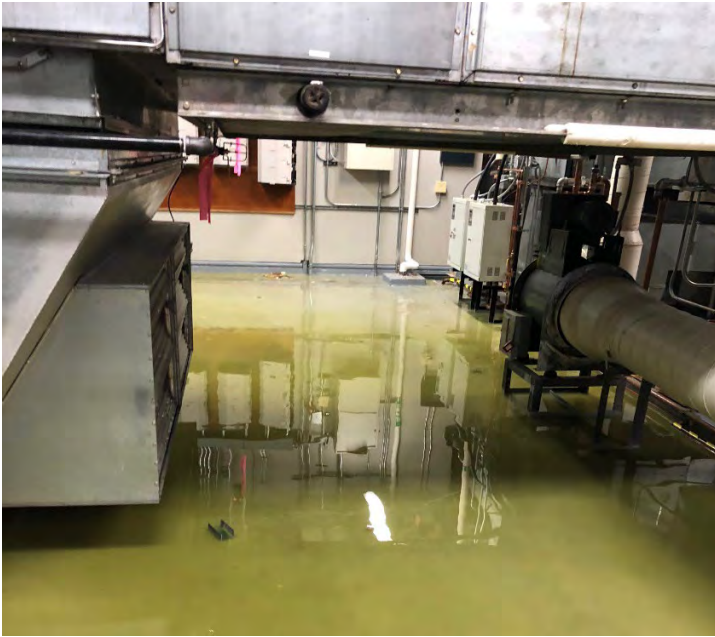
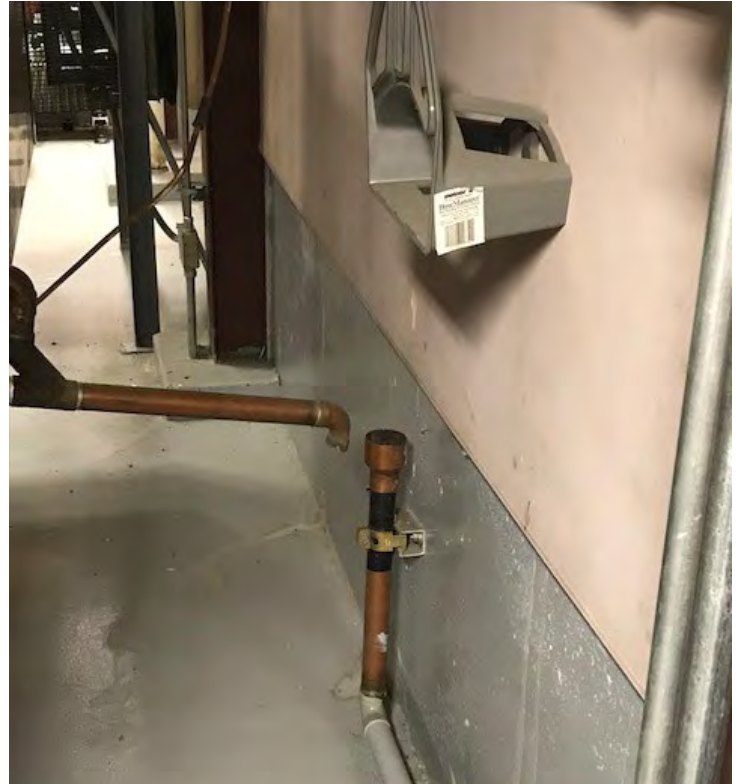
A water line broke in in the mechanical room on the third floor of the low-rise building, causing major water damage on the first two floors (Figure 4.59). Some nonstructural damage in light-gauge covers and in the ceiling tiles and grid occurred at several floors of the main tower and low-rise building. The sky bridge, with a seismic joint at the tower, experienced 2-inch displacement, leading to seismic joint damage and shattering of the bridge rail glass.

Figure 4.59. (a) Mechanical-room flooding and (b) pipe damage in the low-rise building (photos: BP).

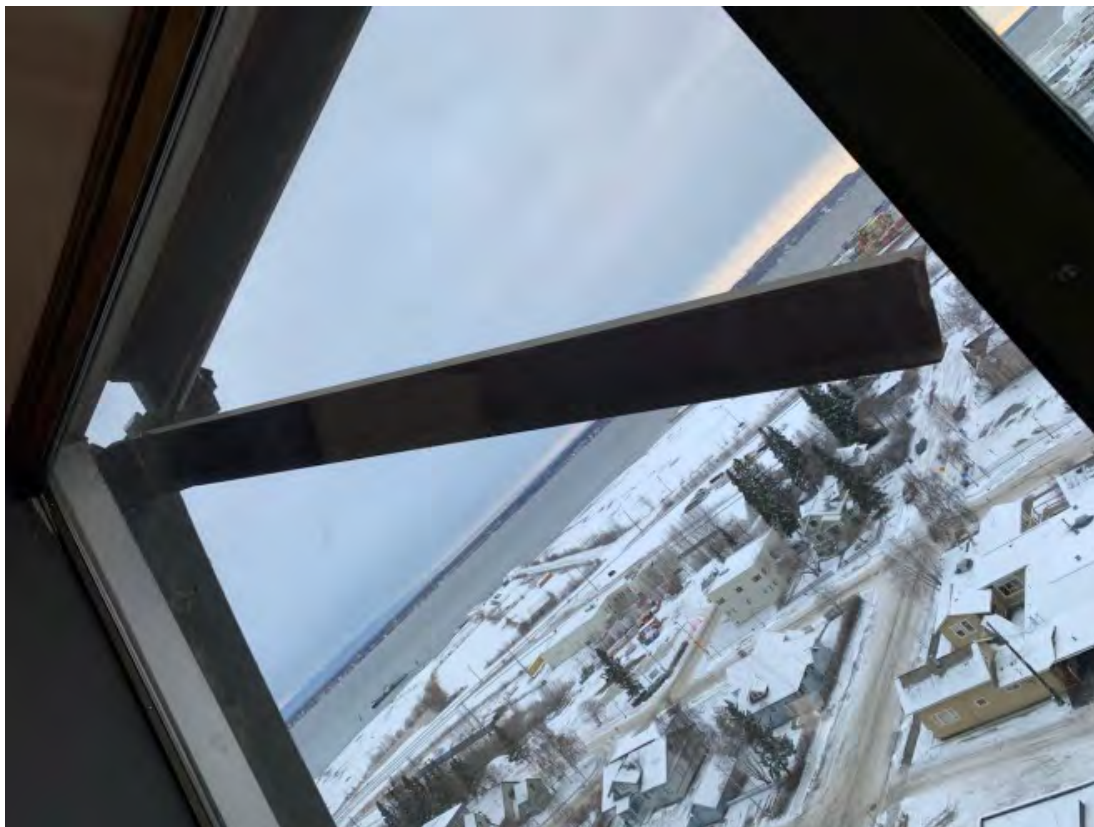
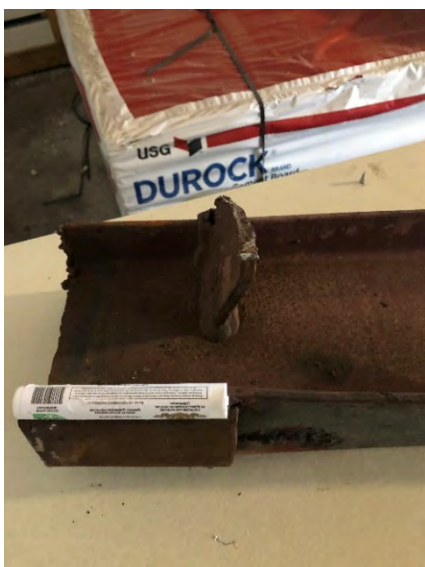
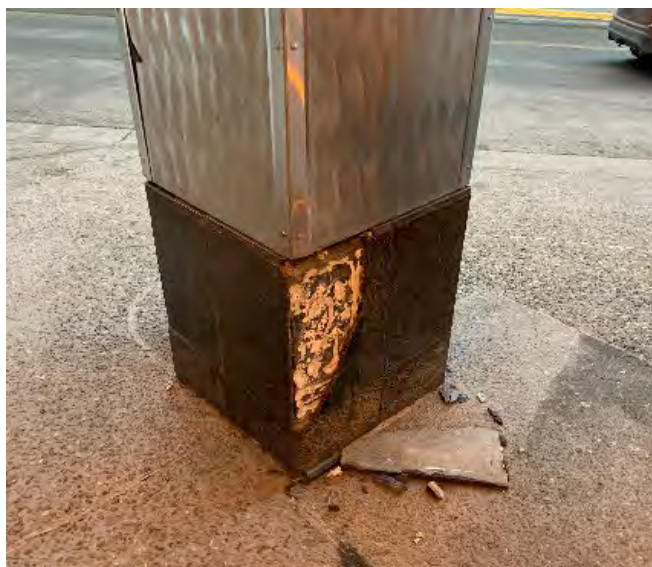
The Hilton Tower (Figure 4.63) is a 22-story, mixed-steel and steel-reinforced, concrete-composite construction built in 1971. The structural array consists of 12 accelerometers, some of which are triaxial, at five different levels. The building had minor nonstructural damage (Figure 4.64).

Figure 4.64. (a, b) Hilton Anchorage steel soffit-beam failure (photos: PND Engineers) and (c) exterior-column finish failure (photo: Wael Hassan).

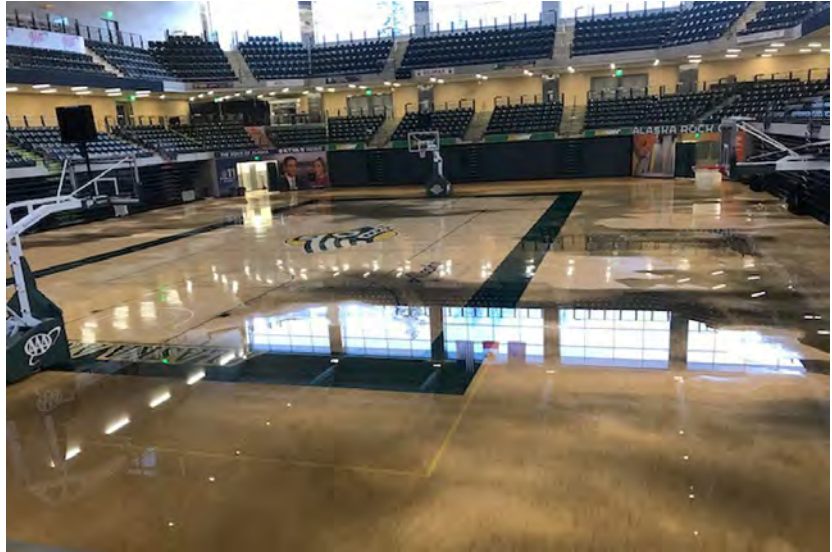
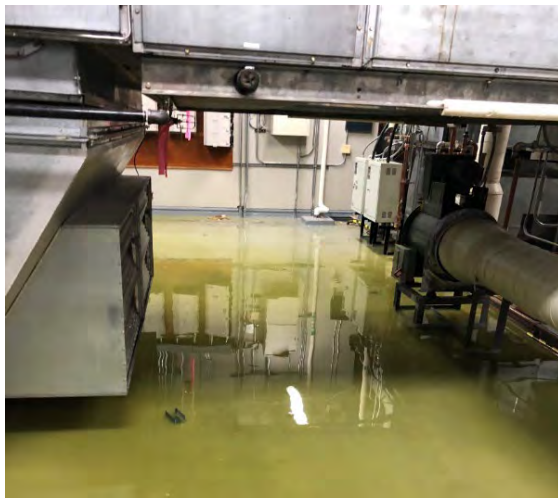
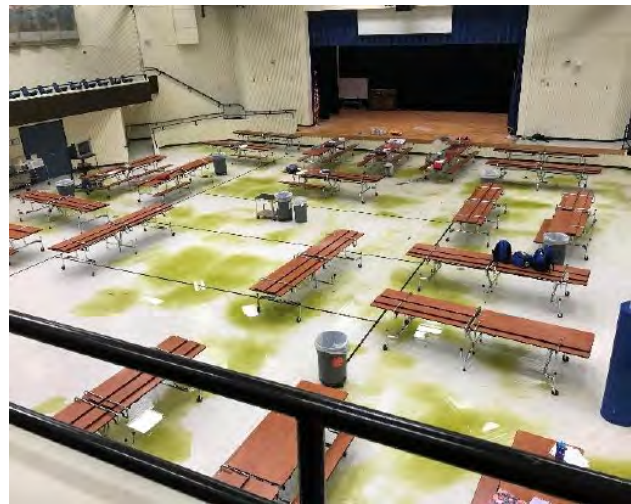
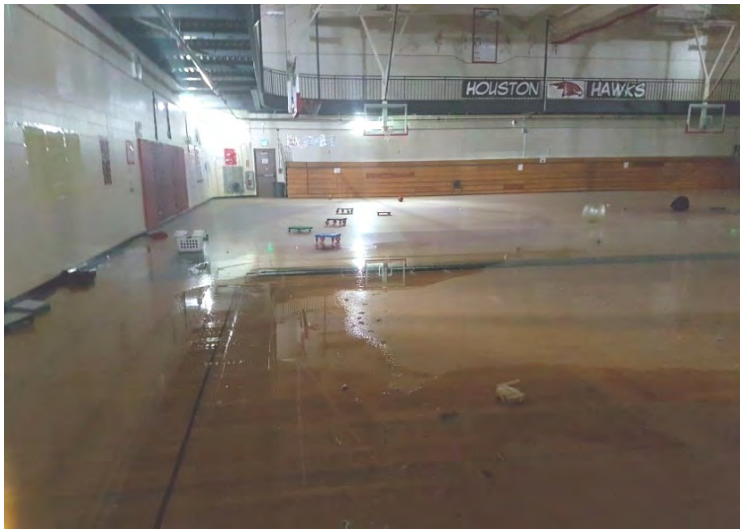
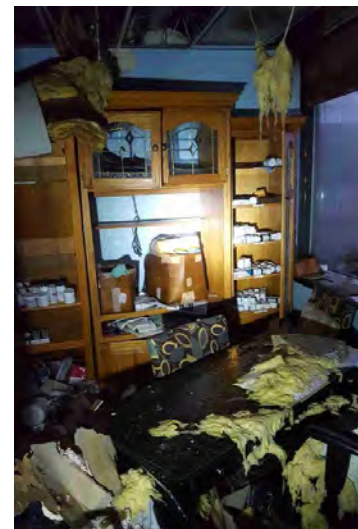
Figure 5.1. Examples of water flooding due to firefighting-system or heating-system failure: (a) an Anchorage school (photo: Anchorage School District (ASD)), (b) Alaska Airlines Center (photo: University of Alaska, Anchorage (UAA)), (c) office building (photo: BP), (d) glycol flooding at Gruening Middle School in Eagle River (photo: ASD), (e) Houston Middle School (photo: Matanuska-Susitna (Mat-Su) Borough School District), and (f) residential water damage (photo: Ben Meindhudt<sup>1</sup>).
