# EERI Earthquake Reconnaissance Report: M7.1 Anchorage Earthquake on November 30, 2018

Wael M. Hassan, John Thornley, Janise Rodgers, and Christopher Motter

July 2021

*A product of the EERI Learning from Earthquakes Program*

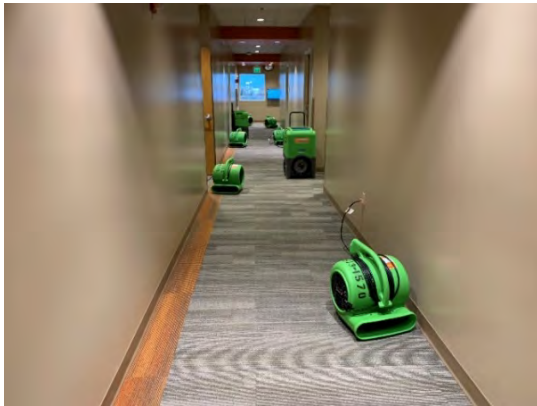
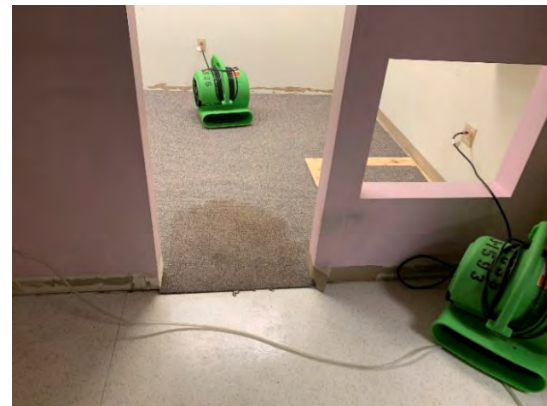
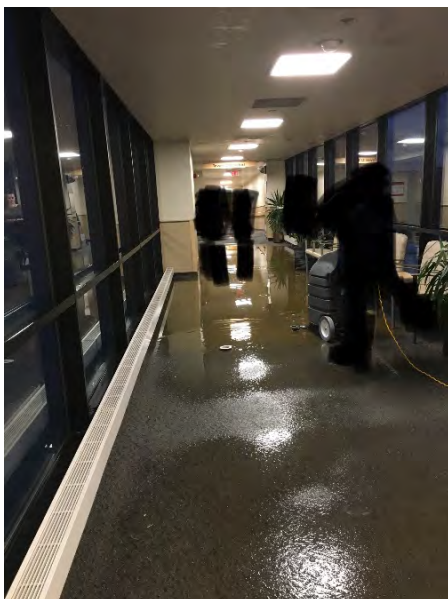
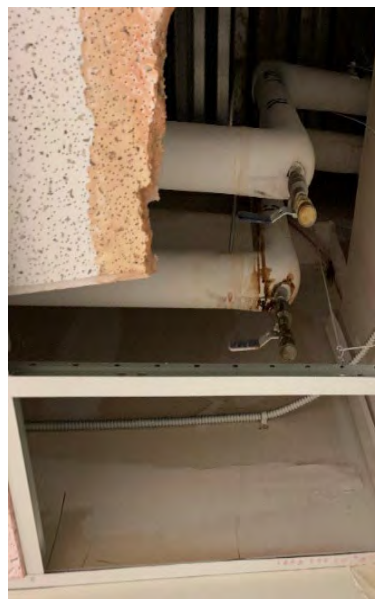
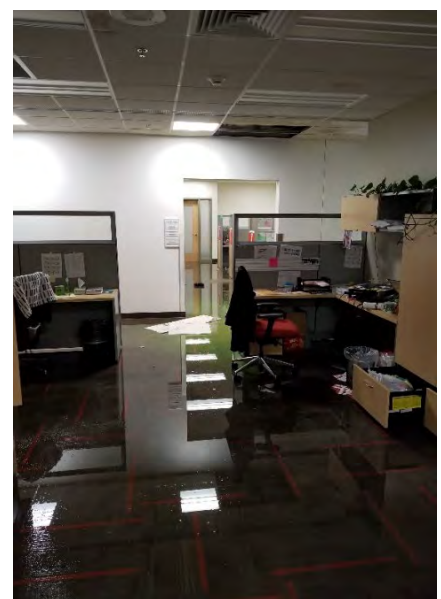
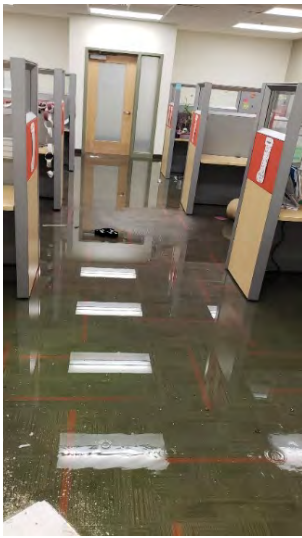
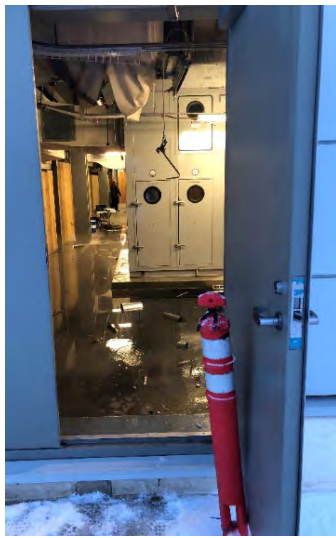
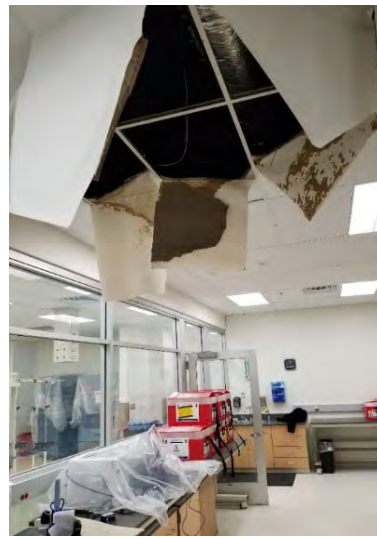
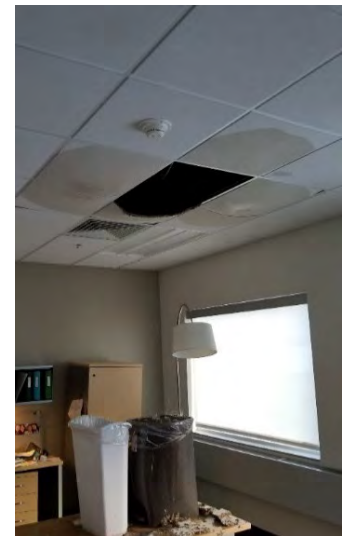
Figure 5.2. (a, b) Anchorage hospital blower drying after major sprinkler-system water flooding (photos: Wael Hassan), (c) Providence Alaska Medical Center (PAMC) Tower D water-sprinkler water damage (photo: PAMC), (d) Anchorage hospital with damaged ceiling and water-pipe connection failure (photo: Wael Hassan), (e) BBA glycol and sprinkler water flooding (photo: BBA), BBA water flooding at (f) office, (g) mechanical room, and (h) laboratories (photos: BBA).

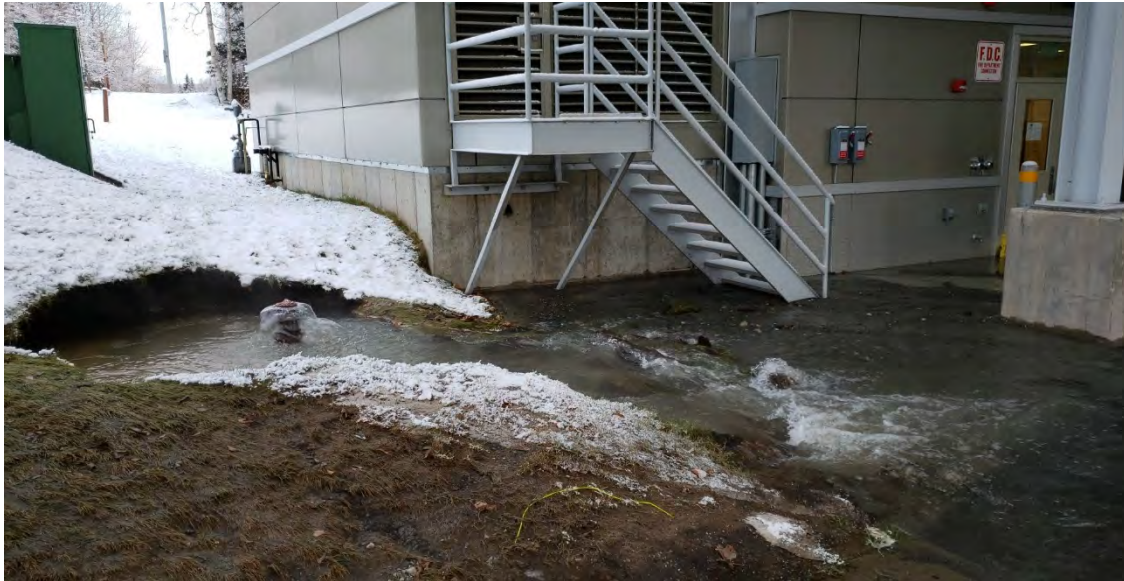
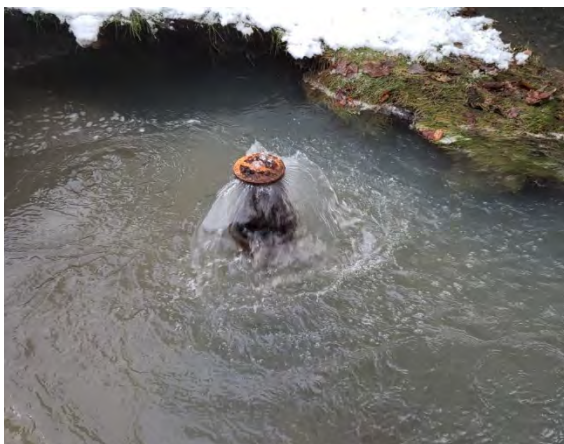
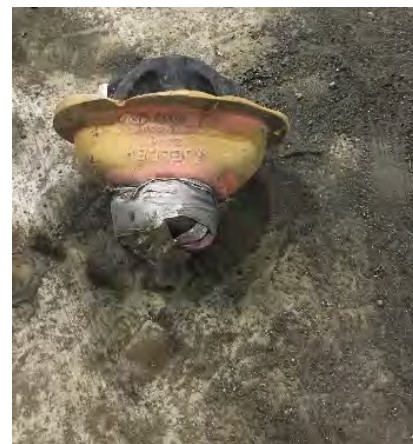
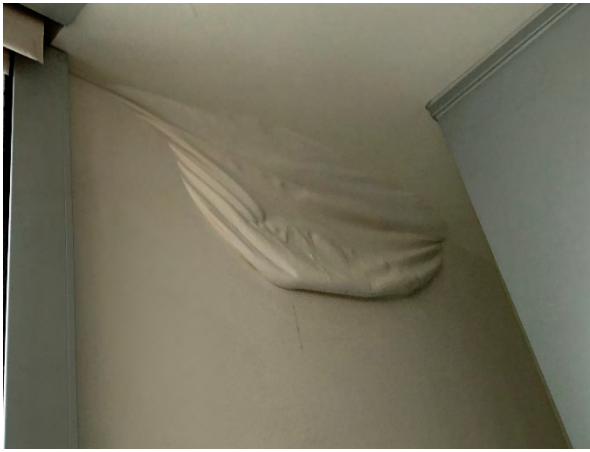
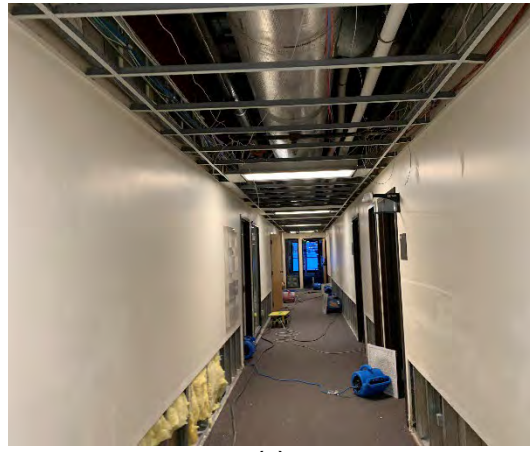
Figure 5.3. (a–c) Water-pipe connection damage at the Engineering and Computation Building, UAA; (d) water leaking through a wall at UAA Health Sciences Building (HSB) because of sprinkler pipe failure; and (e) UAA Eagle River campus ceiling damage and floor drying after major water flooding; notice that the bottom foot of drywall was water-damaged throughout (photos: Wael Hassan, UAA).

Water leakage and flooding was the most common nonstructural damage observed in office, commercial, hospital, and school buildings. It was also the most influential on building operation, and its resulting damage was the most expensive to repair. Water damage resulted from fire-suppression system failure, water-boiler rigid-piping failure due to boiler sliding, and mechanical-room water and glycol piping and connection failure. In most cases, water leaked through walls, floors, and elevator shafts (Figure 5.3), damaging several floors below the level of the failed component.

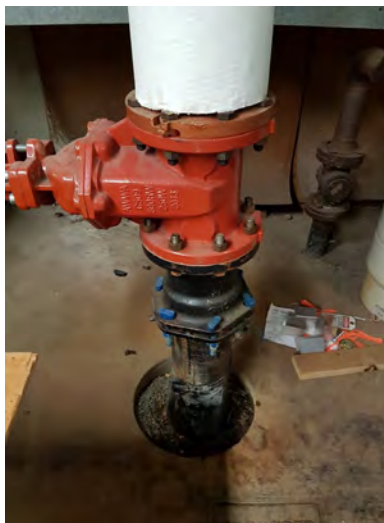
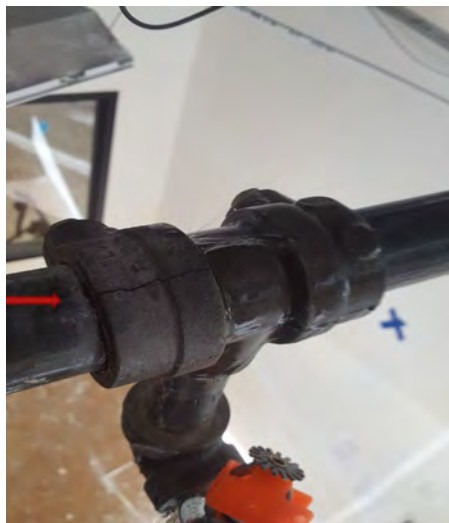
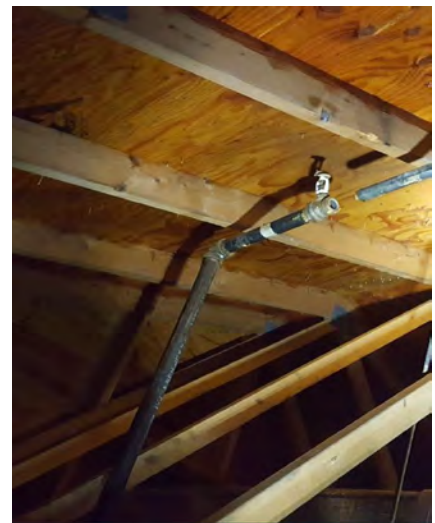
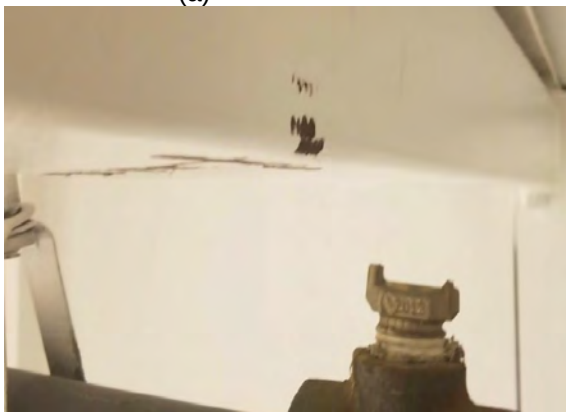
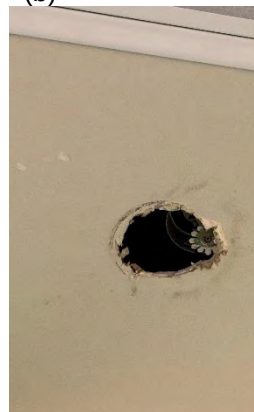
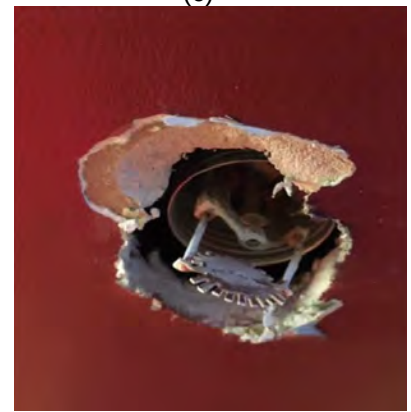
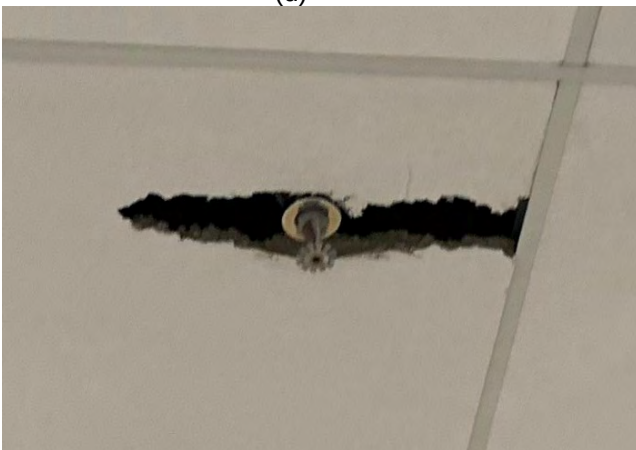
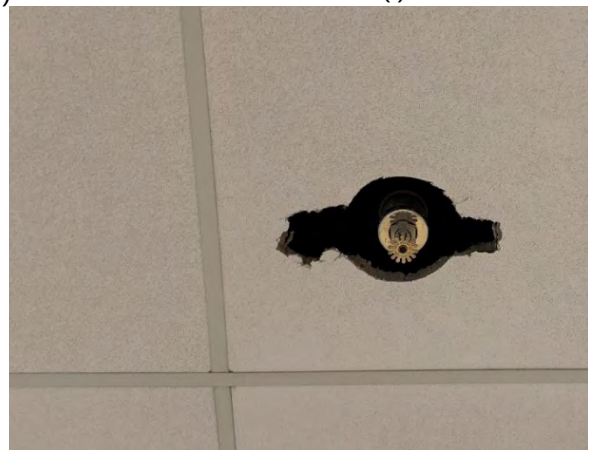
The first source of water damage was firefighting system failure. The Anchorage Fire Inspector<sup>1</sup> reported more than 200 firefighting system failures in Anchorage and Eagle River. The EERI team inspected many of these buildings with water flooding as a result of firefighting system damage. The most common root cause of firefighting system failure was rigidly connected sprinkler-head damage due to collision with other systems or interference with drop-ceiling panels (Figures 5.4 and 5.5), followed by rigid-sprinkler-piping connection/fitting failure due to poor restraint. In particular, rigid sprinkler pipes required restraint on a branch line if installed on rods smaller than 6 inches diameter<sup>6</sup>. In addition, thin, wall-threaded pipes suffered frequent damage. Collision of firefighting piping systems with orthogonal/different-plane neighbor systems was a common reason for failures. Long vertical hangers from the roof to lower ceilings led to significant movement of the ceiling and interacted with sprinkler pipes, leading to pipe and connection failure<sup>6</sup>. Hangers of pipes in older building not following spacing requirements failed, causing pipe damage. Another common pattern (according to the Anchorage Fire Inspector<sup>1</sup>) was cloud ceiling movement against sprinkler piping. These two systems needed to be tied together to avoid pipe damage. The flexible sprinkler piping performed satisfactorily with minimum damage (Figure 5.5). The polyvinyl-chloride-pipe failure mode was mostly shear failure, while the metal-pipe failure mode was detachment at connections<sup>6</sup>. When branch lines were restrained properly in relatively newly engineered buildings, water damage was prevented. The Anchorage Fire Inspector<sup>1</sup> reported good performance of firefighting systems in buildings constructed after 2003.

Figure 5.4. (a, b) Six-inch underground water main bent (code required four-inch annular space in place), (c) fitting cracks, (d) 1-inch pipe failure, (e) sprinkler-head failure due to collision with steel beam, (f) concealed sprinkler failure (photos: Bart Meinhudt<sup>1</sup>), (g) concealed sprinkler failure (photo: Wael Hassan), and (h) sprinkler-head failure due to moving against and damaging drop-ceiling tiles; notice the ground-motion directional orbits generated by the relative movement (photos: Wael Hassan).

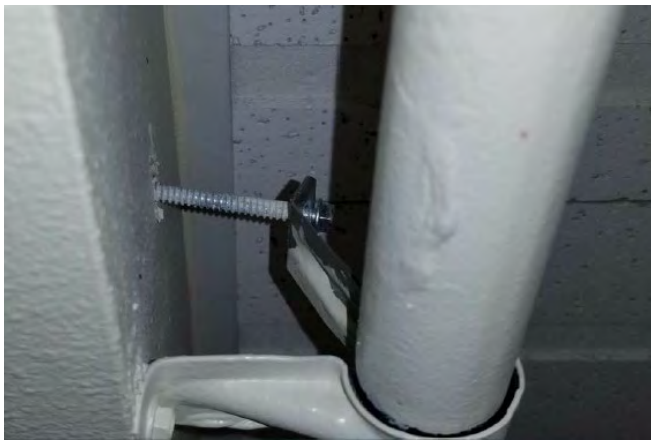
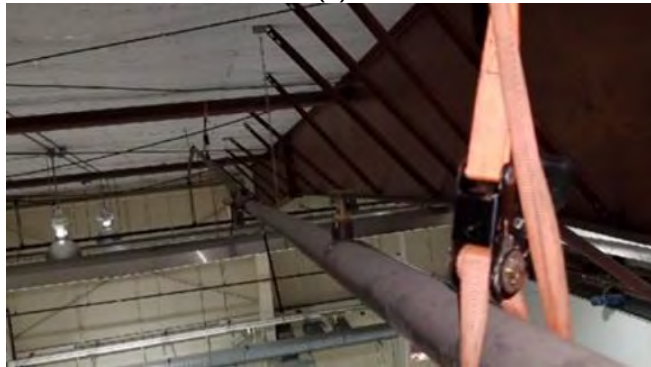
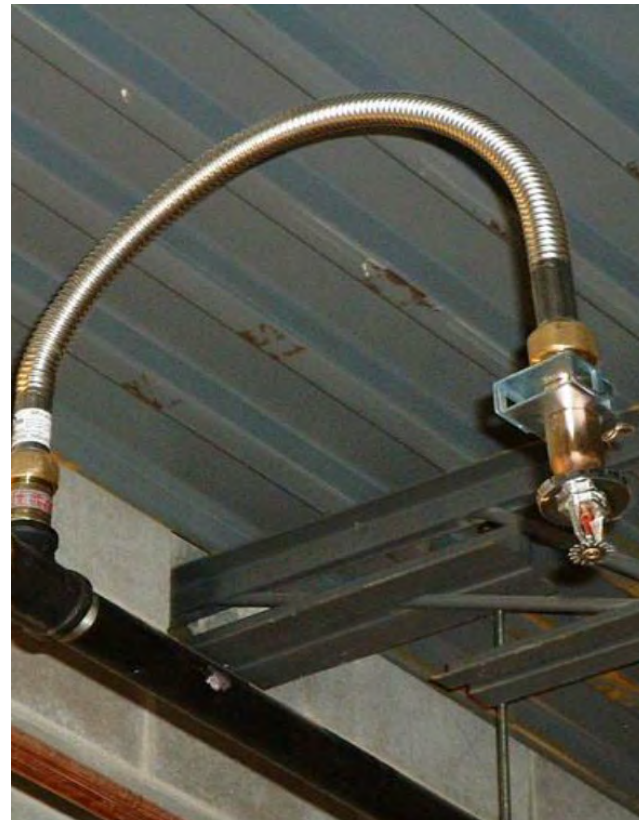
*Figure 5.5. (a, b) Failed hangers of fire-suppression-system pipes and (c) flexible sprinkler head without damage during the earthquake (photos: Bart Meinhudt<sup>1</sup>).*

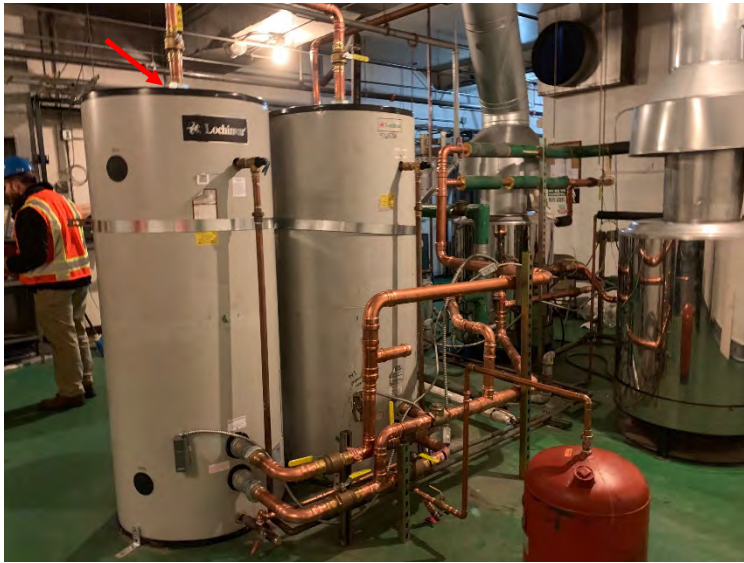
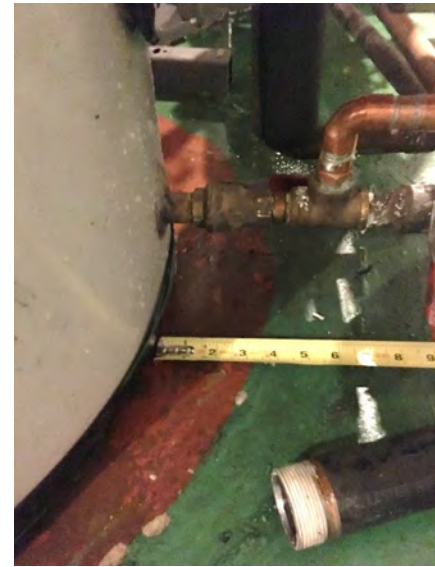
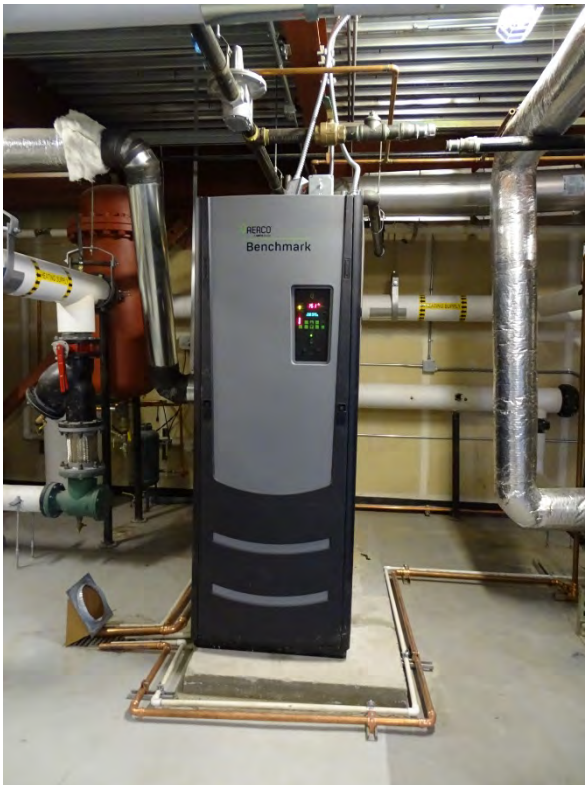
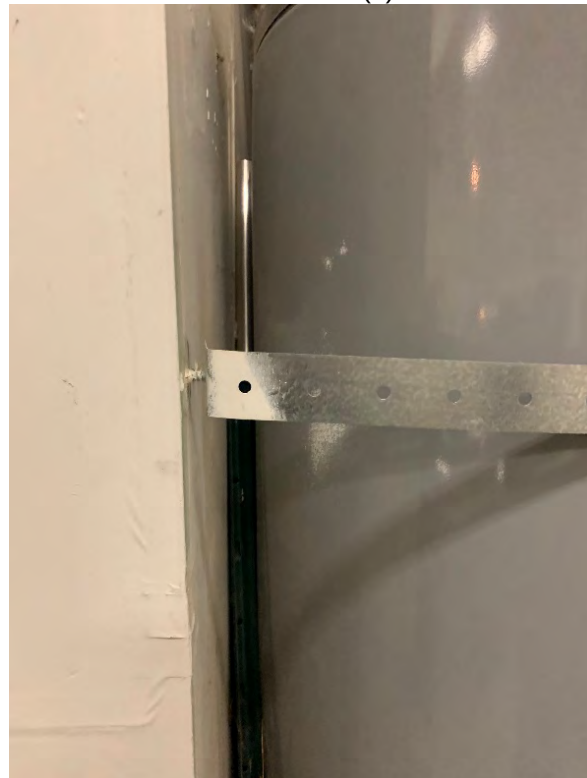
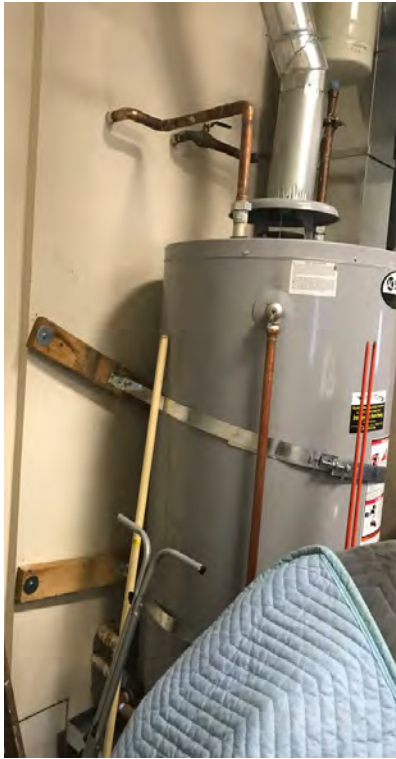
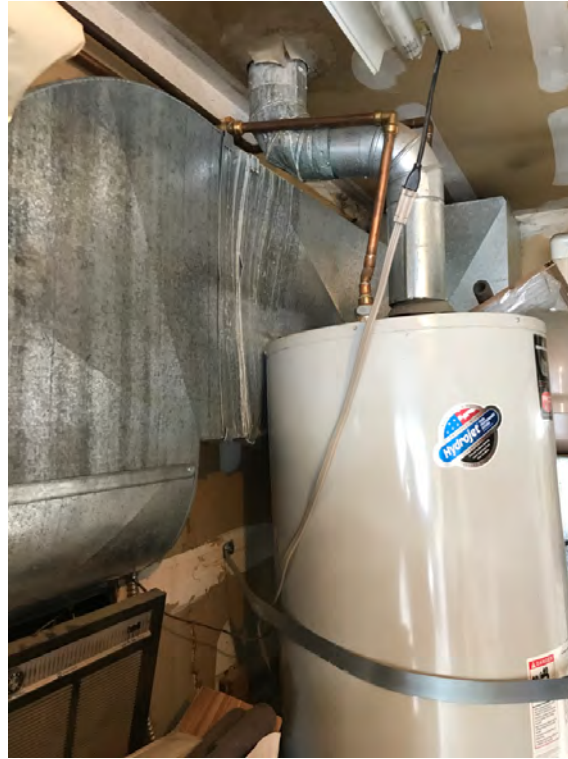
The second source of water damage was the failure of water boiler/tank connections to rigid pipes (Figures 5.6, 5.7, and 5.8). In most cases, water boilers were not seismically restrained either because of being in a non-engineered or non-inspected building or because of the large size of the boiler, which did not require restraint according to local codes. However, it should be noted that if the tank is not restrained, the code required piping connections to allow for several inches of movement, which implies the need to use flexible piping, essentially, with unrestrained tanks. The unrestrained-large-tanks provision in the code assumes the heavy weight of the tank will counterbalance the seismic overturning effect; however, many large tanks did slide several inches during the earthquake, causing major water flooding (Figure 5.6). Some local engineers reported that tanks with flexible connections moved more than those with rigid connections, causing leaks in the former ones. In many cases, straps of water boilers failed by pulling out because of insufficient bolting to the wall (Figure 5.6). It is important to note that the even with non-engineered straps/restraints provided by some building owners to their water tanks, many water-damage incidents were prevented. However, it seems that code provision language on unrestrained tanks being clearly tied to flexible piping is needed (Figure 5.9). It also seems that strict enforcement of the seismic design of water-boiler restraints in essential facilities is needed.

**Figure 5.6.** Unrestrained water boilers atop the Westmark hotel slid 3.5 inches, shearing top pipe connections; hotel personnel indicated that tank tie-down was not required by code, as it exceeds 1,000 gallons. (a, b) Makeshift angle restraints were placed after the earthquake, (photos: (a) Wael Hassan and (b) PDC Engineers). (c) The water boiler at Mat-Su Regional slid a few inches, breaking the top gas-pipe connection (photo: Janise Rodgers); (d) The failed strap of a 70-gallon residential water boiler (photo: Wael Hassan). Hundreds of residential water leaks and gas leaks resulted from unrestrained or poorly restrained water boilers; (e) example of strap failures of residential water boilers (photo: MOA); (f) Strong shaking failed water boiler strap, sheared top pipe, and caused collision damaging heating duct (photo: MOA).

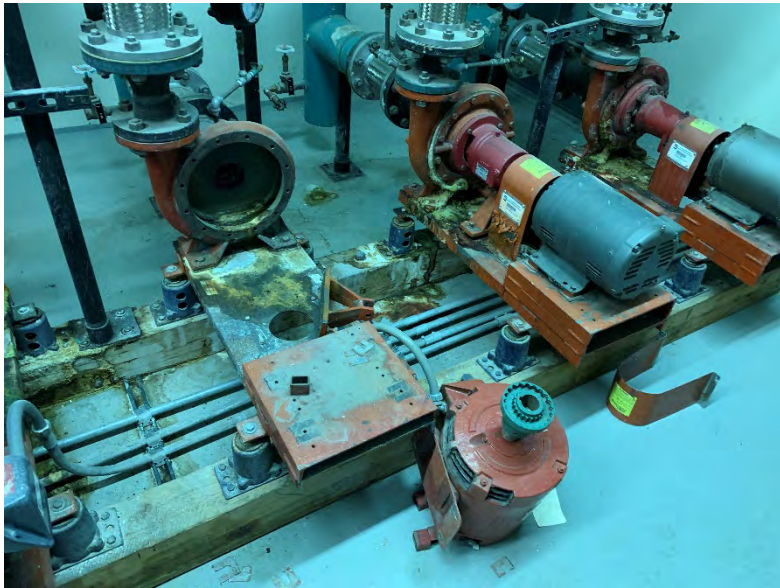
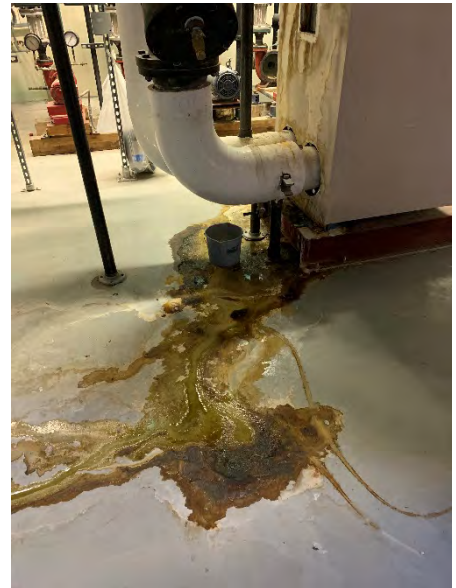
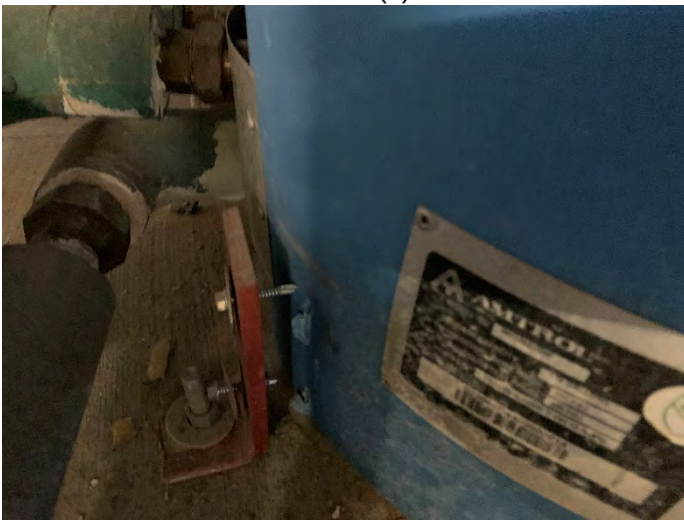
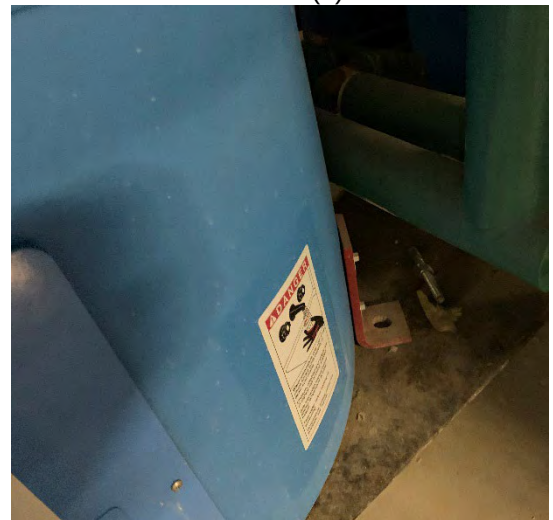
**Figure 5.7.** (a) Glycol-heating-pump connection failure and glycol leak at Gruening Middle School, Eagle River; (b) boiler-room elbow-pipe connection failure and leakage; (c, d) hot-water-tank angle-bolt failure at Gruening Middle School; (e) water-boiler strap sliding (notice markings above the strap); and (f) poor-restraint angle failure of water boiler in a multistory building in Eagle River (photos: Wael Hassan).

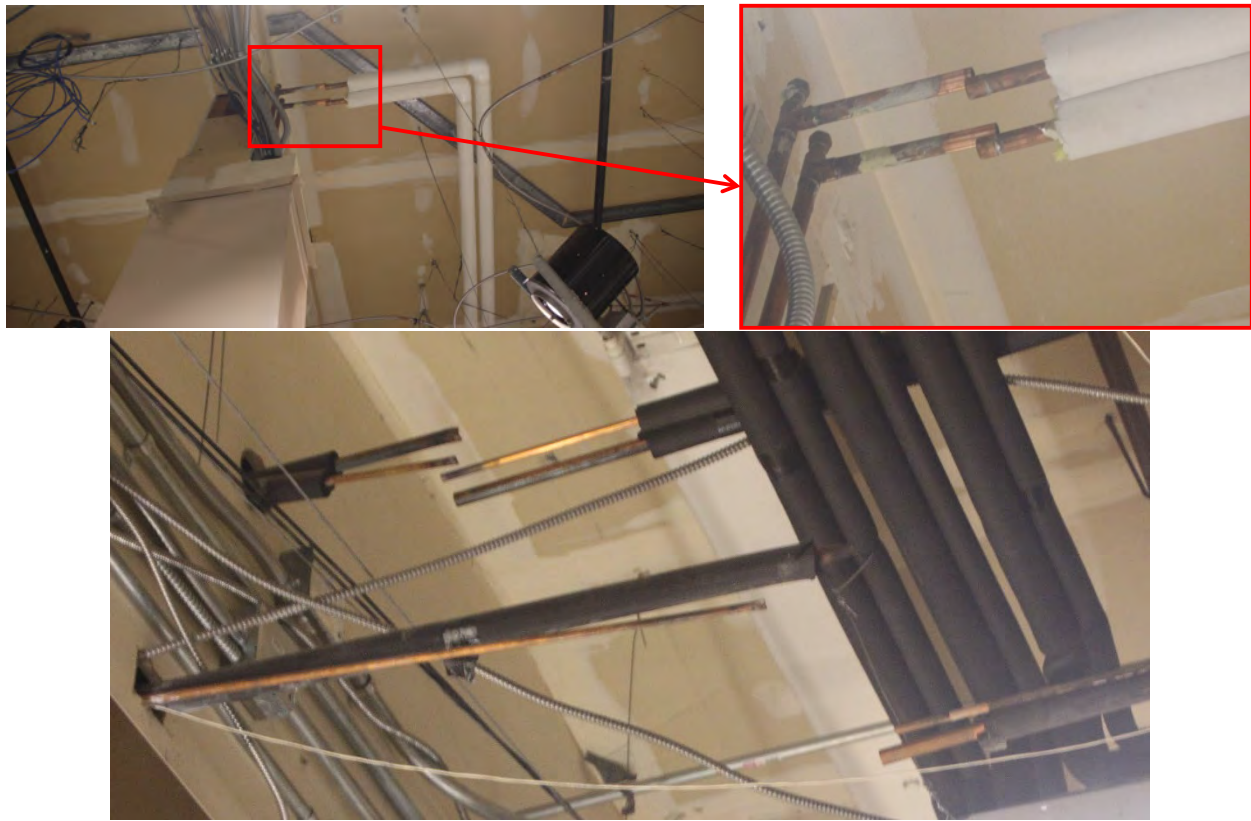
Figure 5.9. (a) Damage to pipes in a grocery store ceiling in Eagle River (photos: Chris Motter). (b) Glycol and water piping without lateral bracing in two Anchorage schools (photos: Reid Middleton (ASD)).

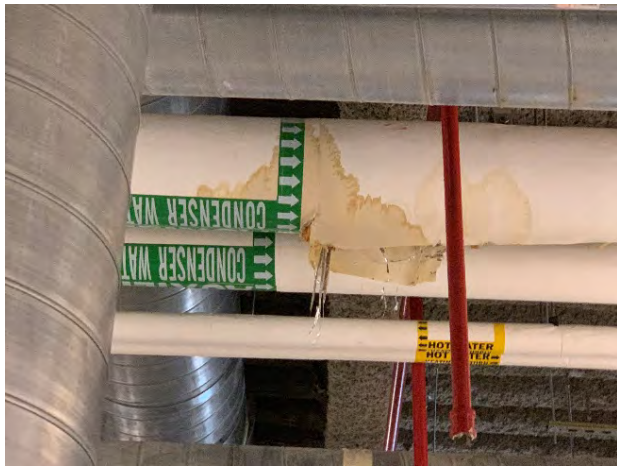
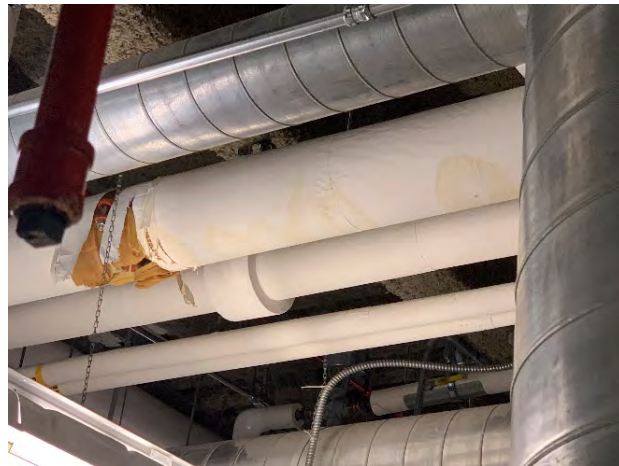
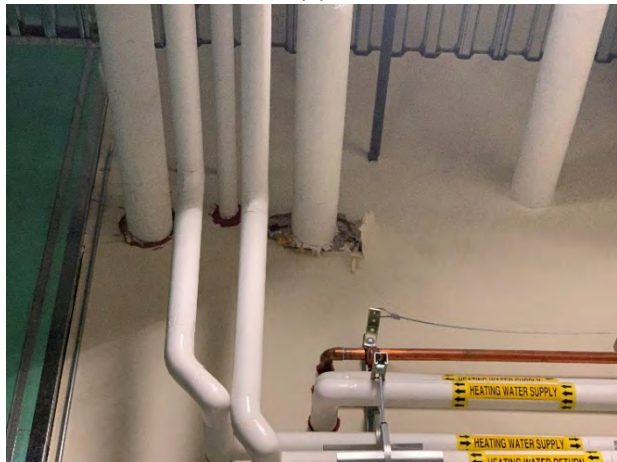
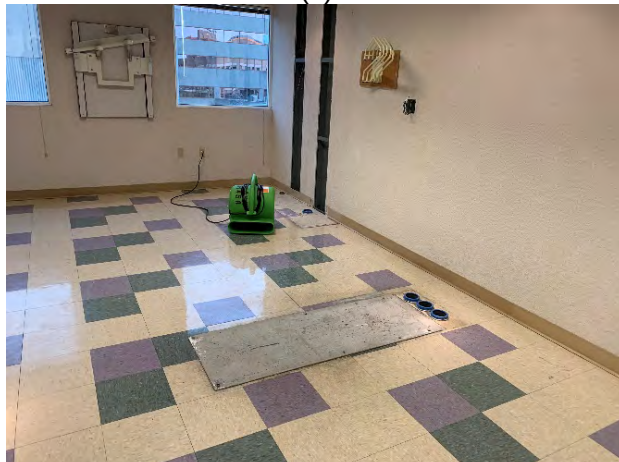
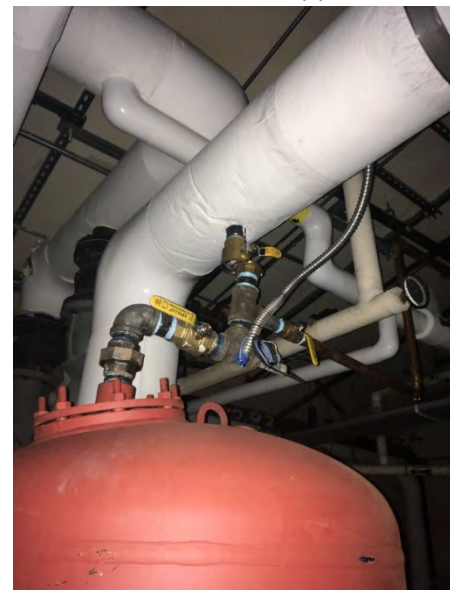
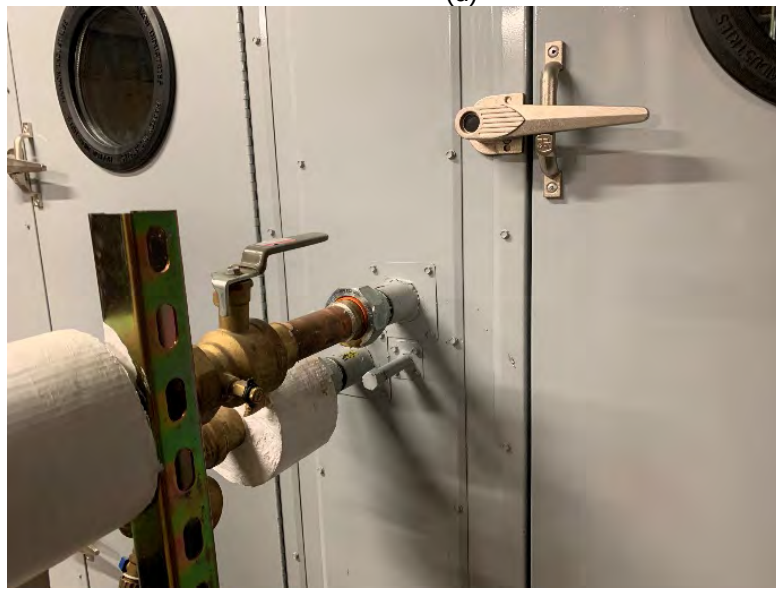
The third source of water/glycol damage was the mechanical-room piping failure of rigid glycol pipes/connections/pumps in the heater system, especially by collision with orthogonal systems and at their connections with poorly restrained mechanical equipment, such as pumps/heater/heat exchangers and other heavy equipment (Figures 5.7, 5.10, and 5.11). Glycol leaks resulted in major damage in many buildings, including schools, hotels, and hospitals. Gruening Middle School in Eagle River, the British Petroleum (BP) Building, and Blood Bank of Alaska (BBA) are quoted examples of such glycol damage. More details on the impact of water and glycol flooding on schools and hospitals can be found in subsequent chapters.

Figure 5.10. (a) Failed water pipe at an Anchorage hospital, pipe impact with surrounding walls causing damage to both (b) pipes and (c) walls, (d) water damage of electrical wiring and equipment at an Anchorage hospital (photos: Wael Hassan), (e) broken pipe connection to unbraced hot water generator at Bear Valley Elementary (photo: ASD), and (f) rigid-water-pipe connection failures in a mechanical room (photo: Wael Hassan).

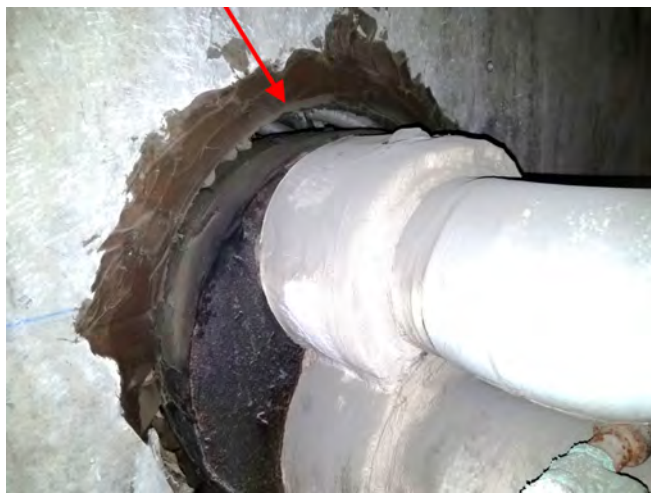
Figure 5.11. (a) Fire-hydrant connection failure (photo: Randy Williams); (b) an Extrol tank surviving the shaking, despite poor tie down restraint, (c) heat-exchanger connection failure and (d) glycol leak, and (e, f) water boiler connection failure (photos: Wael Hassan).

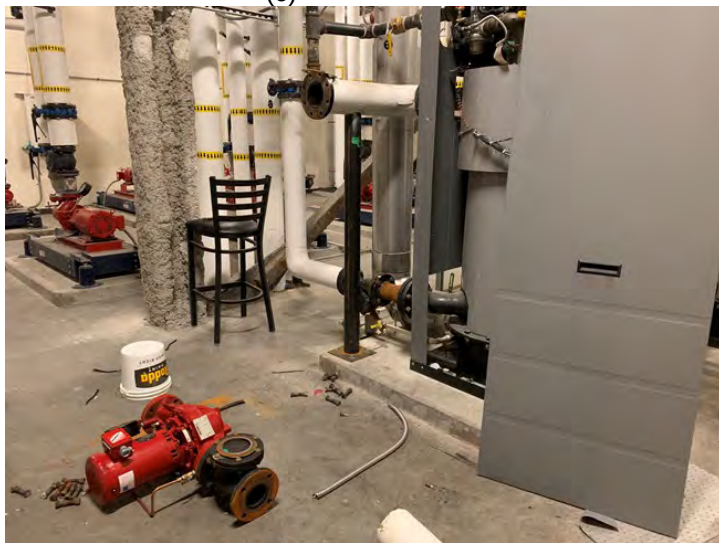
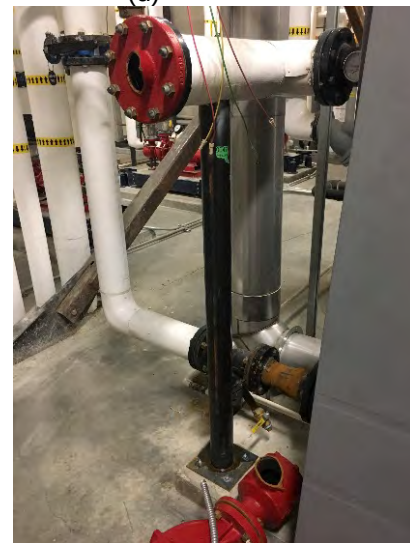
The most common mechanical-equipment damage observed was sliding of unrestrained (or poorly restrained) heavy equipment, causing damage to connected pipes and ducts and other systems (Figures 5.7, 5.11, 5.12 and 5.16). In some cases, the equipment itself was damaged because of collision with structural or other building systems (Figure 5.13). Some strapped/anchored equipment also suffered damage because of the pull-out failure of a strap or anchor from the wall or floor, which was caused by poor anchorage. It seems that flexible strapping worked better than rigid anchors in equipment restraints; however, the movement associated with flexible strapping is significantly higher than that associated with rigid strapping, and piping should be flexible enough to accommodate this movement. Inertia bases and vibration isolators were poorly bolted (or unanchored) to floors and suffered anchor damage<sup>2</sup> (Figures 5.14 and 5.15). Roof chillers<sup>2</sup> and other mechanical equipment were poorly restrained and suffered anchorage failures and sliding (Figure 5.16, 5.17 and 5.18). There were some cases of pump damage (Figures 5.7 and 5.11), but in most cases, the damage was in pipe connections to pumps. Counterweight dislocation and damage in elevators was very common during the earthquake. Many hospital and office buildings suffered reduced operations for hours to days following the earthquake until elevators were repaired.

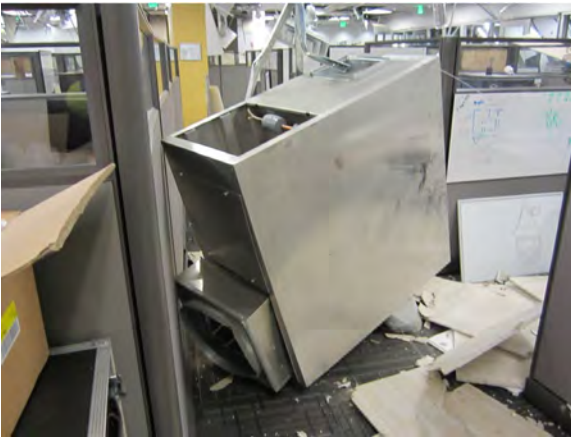
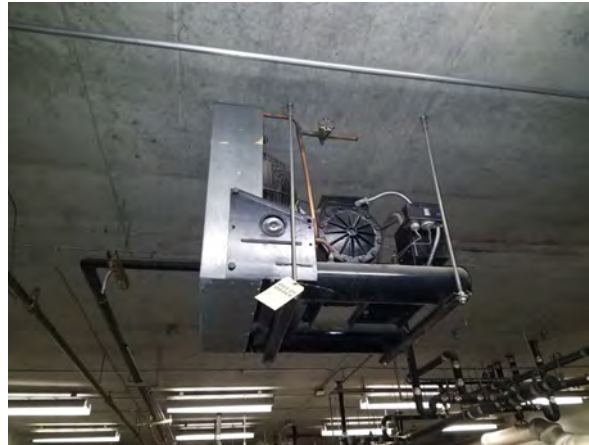
Figure 5.13. (a, b) Improperly restrained mechanical-equipment failure; (c–f) mechanical-component failure: duct flanges, VAV box, and VAV ducts (photos: Randall Williams<sup>2</sup>).

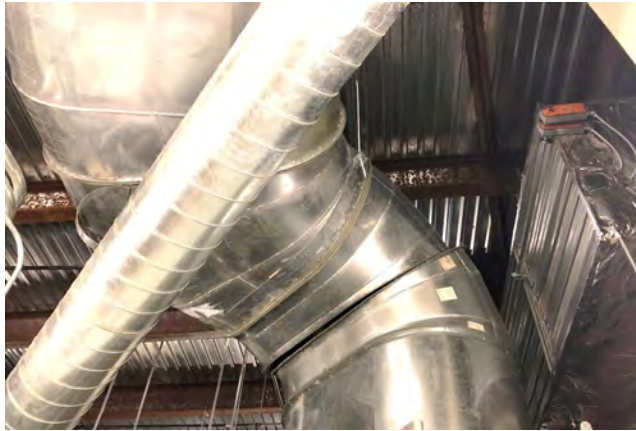
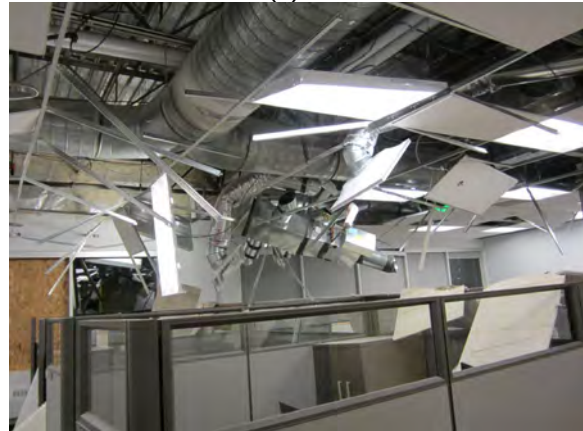
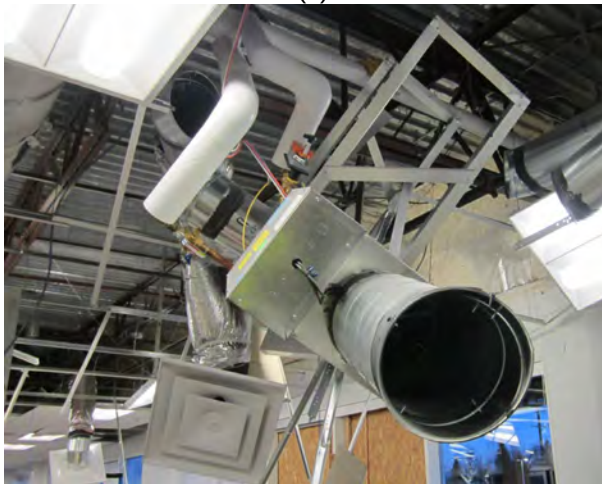
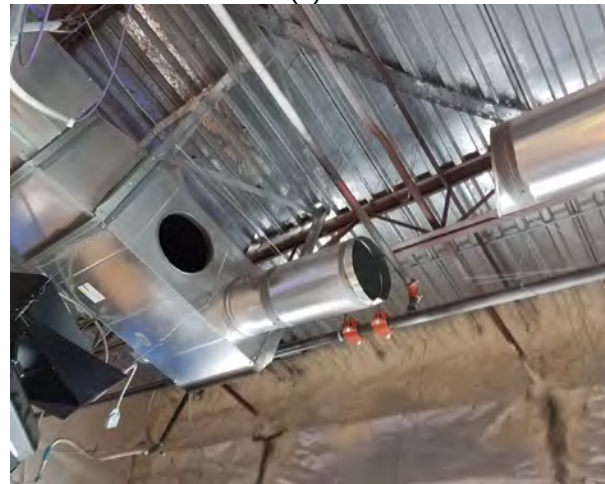
compression tests should be performed following any repairs in HVAC systems or upon reporting reduced heating efficiency following the earthquake. Duct-flange damage and variable-air-volume (VAV) box and duct damage were common during the earthquake<sup>2</sup> (Figure 5.13). In some cases, permanent residual displacement and major rotation occurred at HVAC ducts (Figure 5.19). New seismic gas valves were efficient, shutting off gas during the earthquake and preventing building damage<sup>6</sup>.

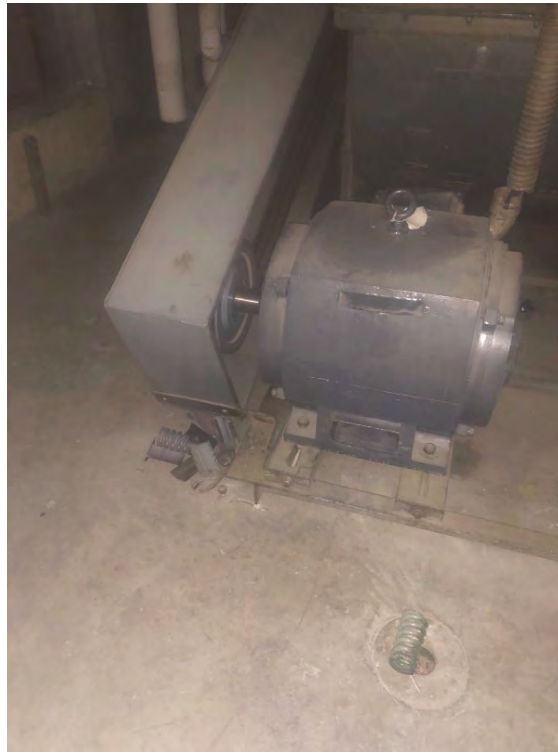
Figure 5.14. Broken nonseismic vibration isolator, Bartlett High School (photo: ASD).

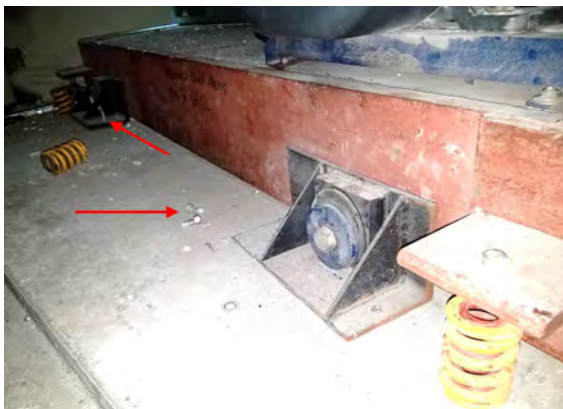
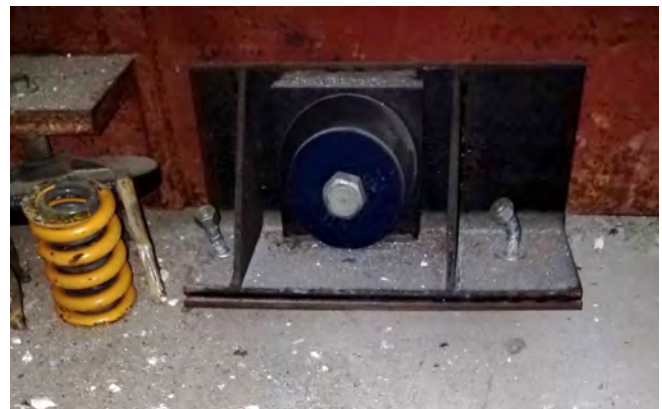
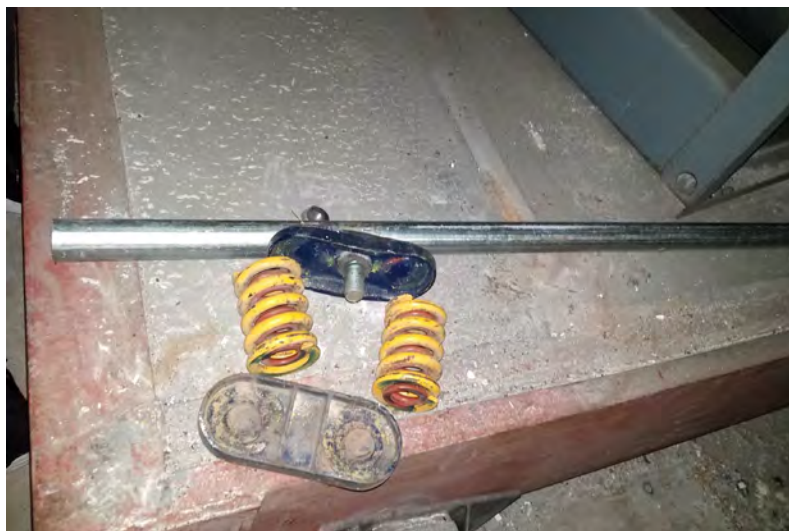
Figure 5.15. Isolator and snubber failures due to improper and undersized anchorage (photos: Randall Williams<sup>2</sup>).

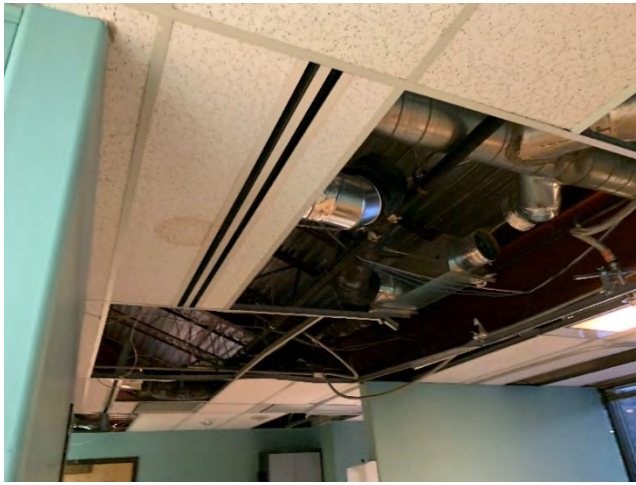
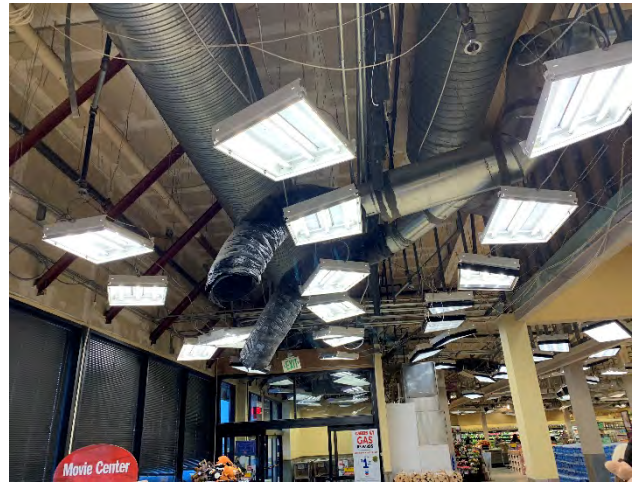
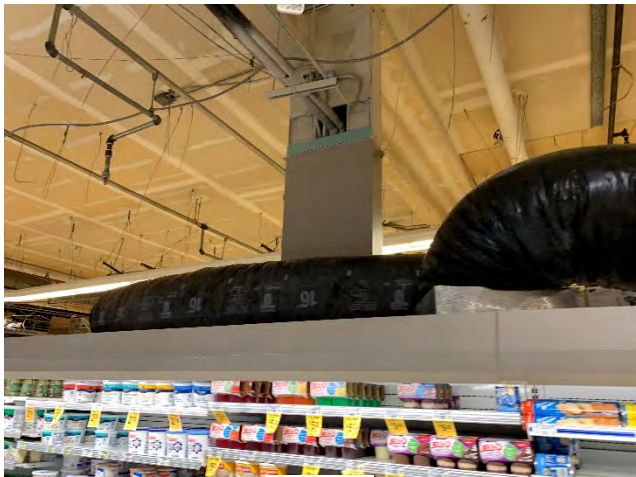
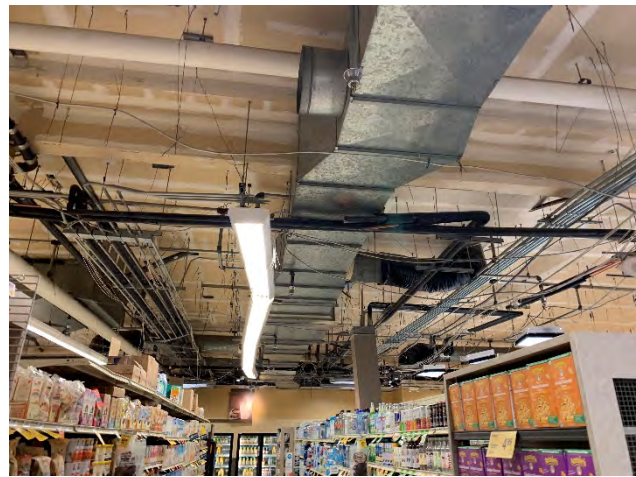
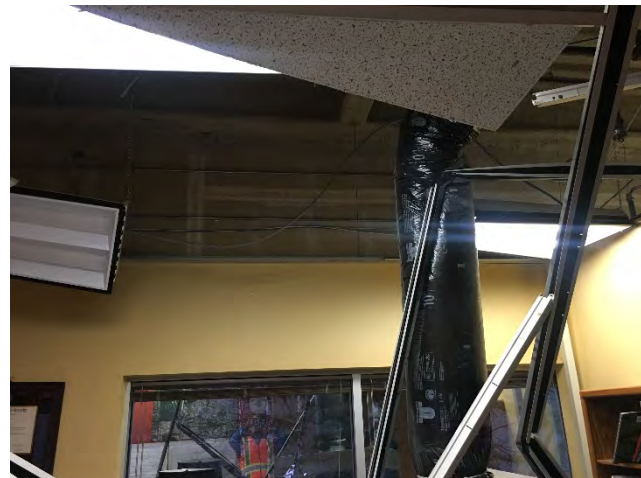
Figure 5.17. Mechanical-component duct failure: (a, b) University of Alaska, Eagle River, campus; (c, d) Eagle River commercial building; and (e) duct failure at UAA administrative building (photos: Wael Hassan, UAA).

HVAC systems suffered extensive damage during the earthquake in many older/non-engineered buildings with poor seismic restraints. The main damage was at HVAC ducts (Figures 5.13, 5.17, and 5.18), where duct detachment/separation occurred. Failure of duct straps and collision of ducts with other systems was also observed (Figure 5.19). In some cases, whole segments of ducts fell off the ceiling (Figures 5.13 and 5.17). Some building operators (such as BBA's) reported reduced heating-system efficiency upon restart, following the quick initial repairs, and attributed that to out-of-balance internal mechanical parts of chillers and other compressors. However, although this might be one contributing factor, another factor might be air-duct leakage due to unobserved cracks at connections. Full
