# EERI Earthquake Reconnaissance Report: M7.1 Anchorage Earthquake on November 30, 2018

Wael M. Hassan, John Thornley, Janise Rodgers, and Christopher Motter

July 2021

*A product of the EERI Learning from Earthquakes Program*

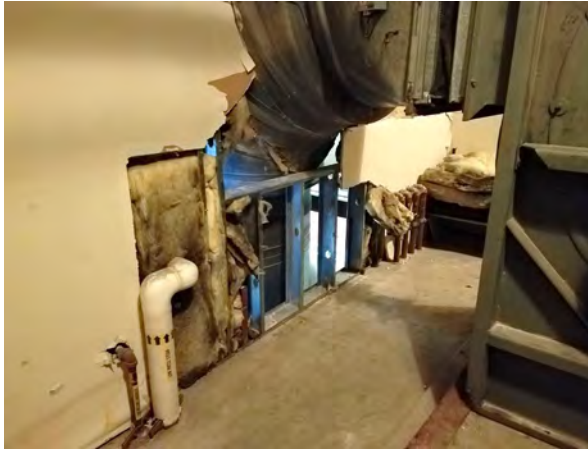
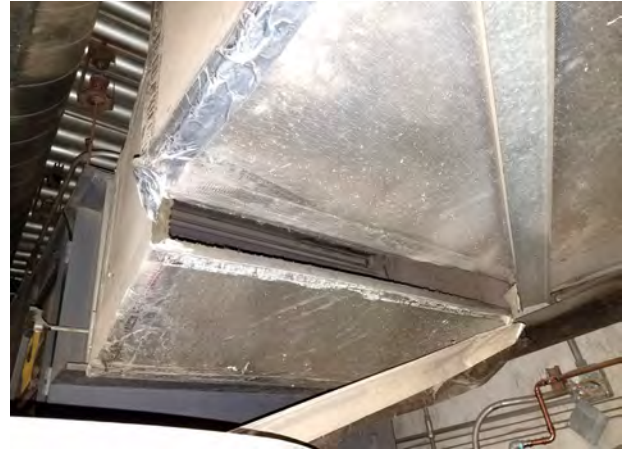
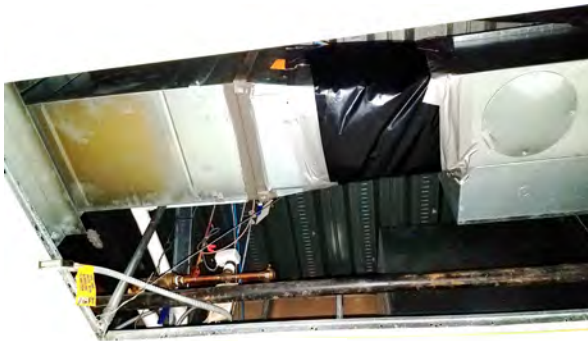
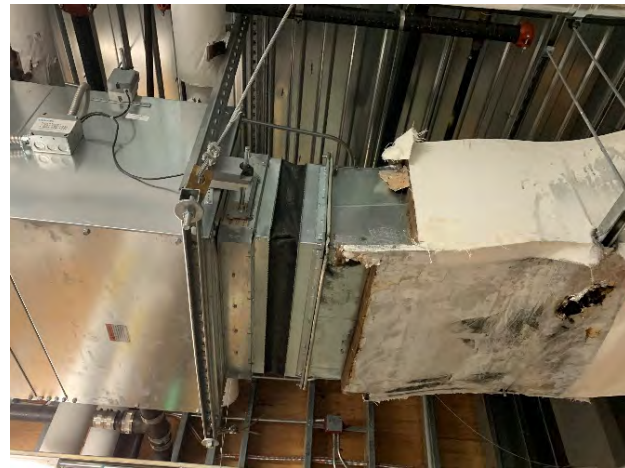
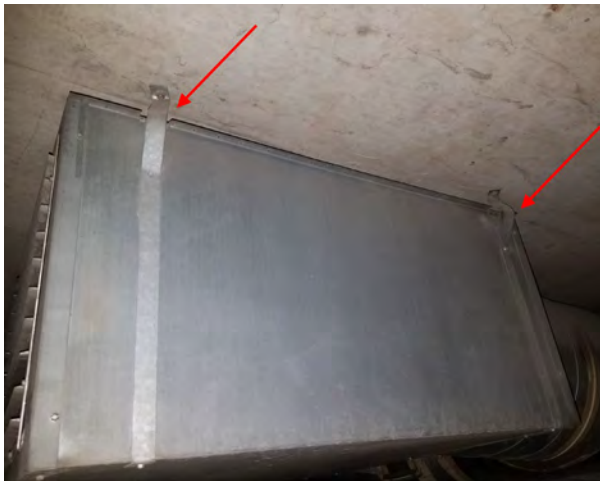
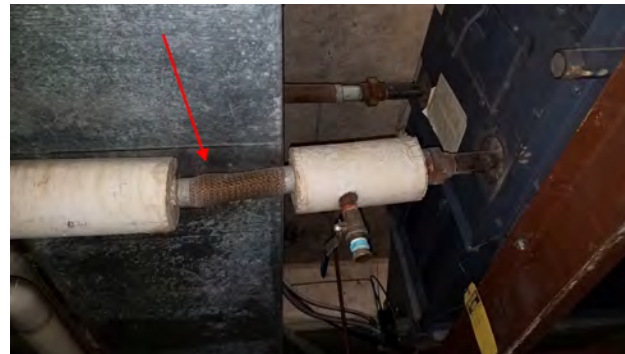
Figure 5.18. (a) HVAC duct damage to wall and (b, c) duct separation (photos: Randall Williams), (d) duct separation (photo: Wael Hassan), (e) equipment support bending, and (f) connector pipe bending (photos: Randall Williams<sup>2</sup>).

HVAC systems suffered extensive damage during the earthquake in many older/non-engineered buildings with poor seismic restraints. The main damage was at HVAC ducts (Figures 5.13, 5.17, and 5.18), where duct detachment/separation occurred. Failure of duct straps and collision of ducts with other systems was also observed (Figure 5.19). In some cases, whole segments of ducts fell off the ceiling (Figures 5.13 and 5.17). Some building operators (such as BBA's) reported reduced heating-system efficiency upon restart, following the quick initial repairs, and attributed that to out-of-balance internal mechanical parts of chillers and other compressors. However, although this might be one contributing factor, another factor might be air-duct leakage due to unobserved cracks at connections. Full

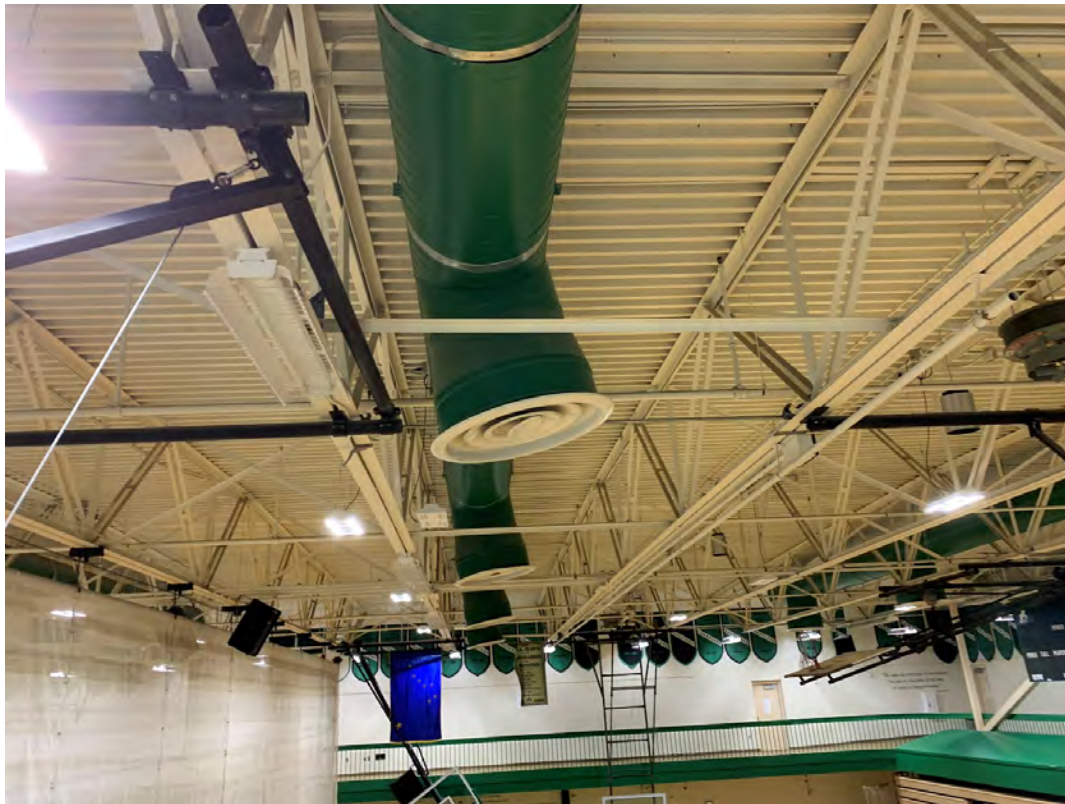
Figure 5.19. (a) HVAC duct rotation and residual deformation, Colony High School, Mat-Su (top photo: Wael Hassan); (b) seismic-strap failure of HVAC duct (photo: Randall Williams<sup>2</sup>); and (c) air-duct failure in a UAA building in Eagle River (photo: Wael Hassan).

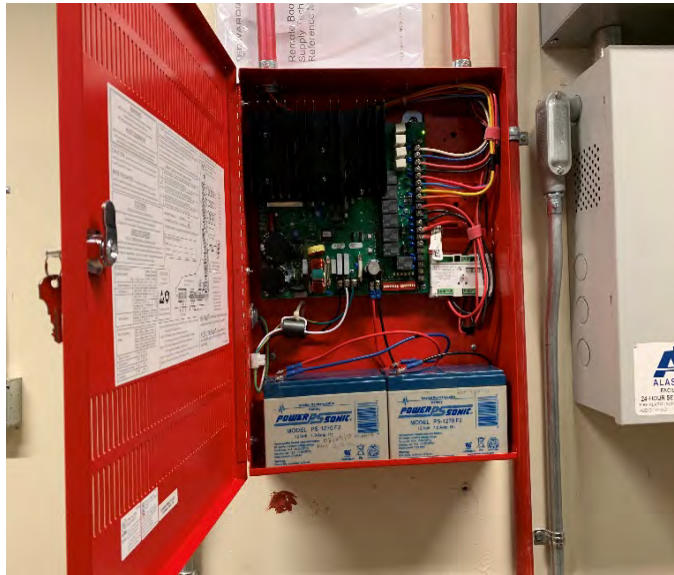
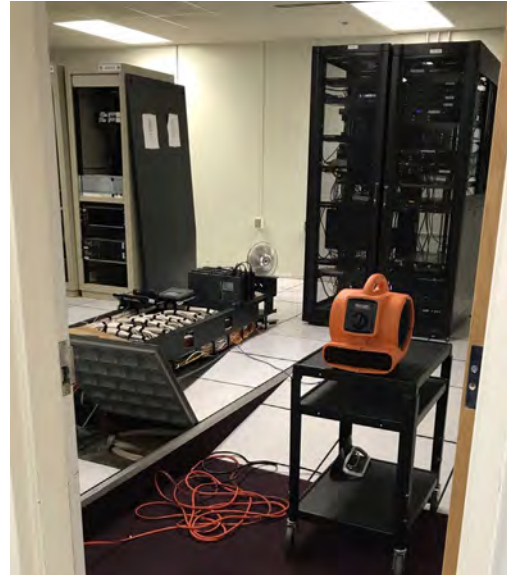
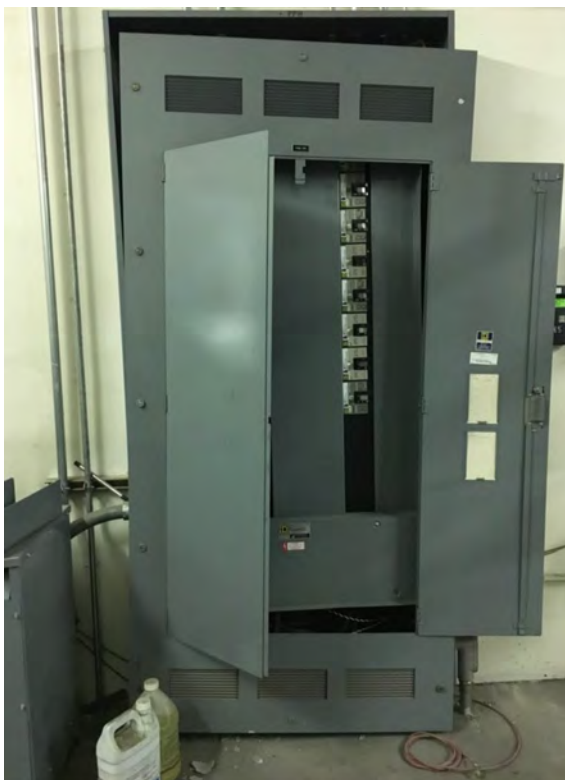
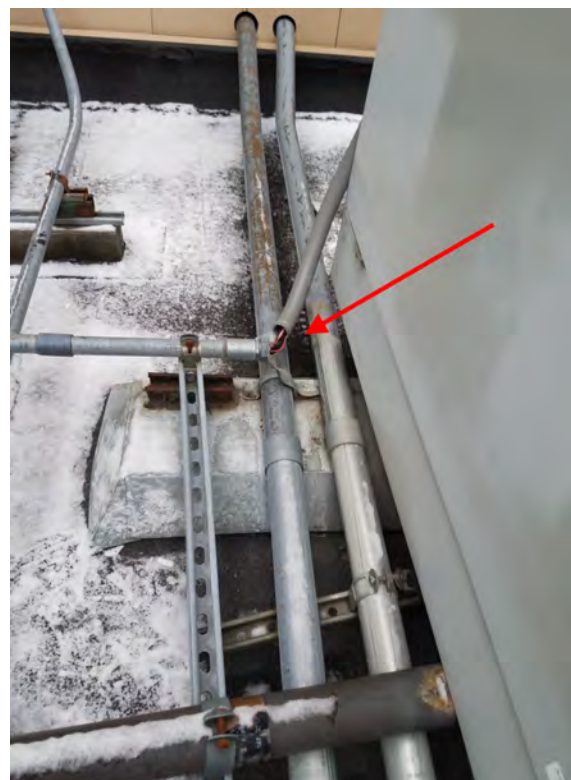
Pieces of heavy electrical equipment, such as data and telecommunication towers, were not restrained to floors or strapped to adjacent walls. As a result, they slid or overturned, causing equipment malfunctioning<sup>2</sup> and nonstructural damage to walls. Electrical poles in office buildings suffered permanent deformation. Some electrical-panel housings were damaged and detached (Figure 5.20). In one case, the team observed an electrical panel that suffered short-circuit damage due to water leakage, which triggered the fire alarm (Figure 5.20).

Figure 5.20. (a) Electrical panel short-circuit failure due to water leaks from mechanical room above (photo: Wael Hassan), (b) unrestrained telecom/data tower toppled (photo: Randall Williams), (c) electrical-panel housing detachment and failure, and (d) power-connection failures (photos: Randall Williams<sup>2</sup>).

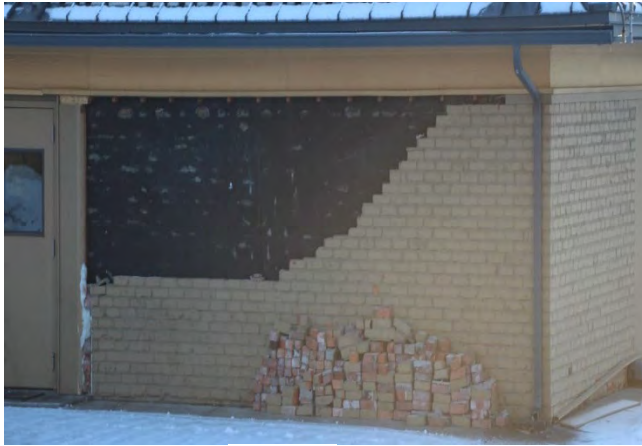
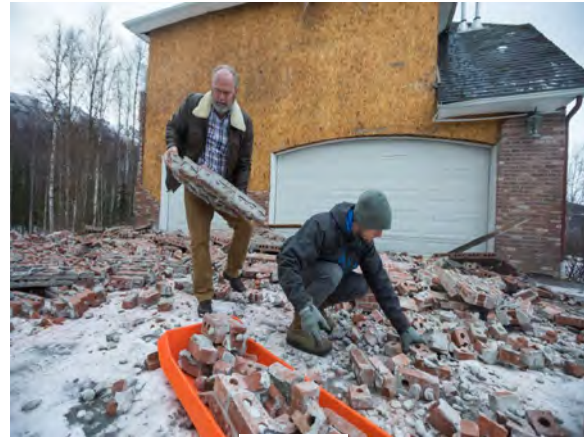
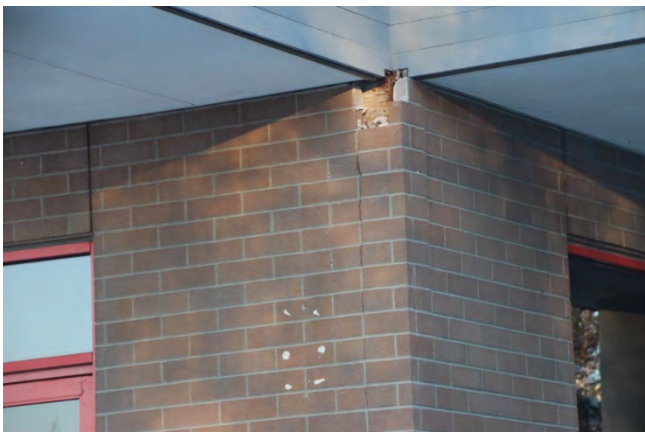
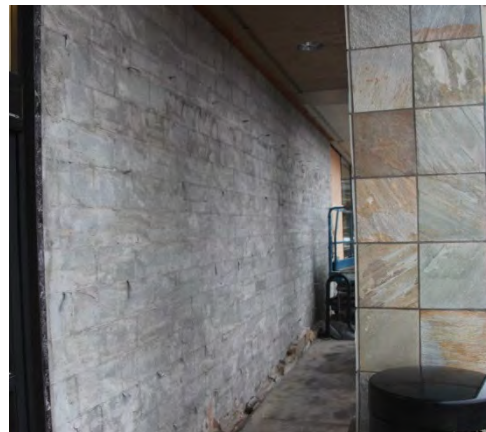
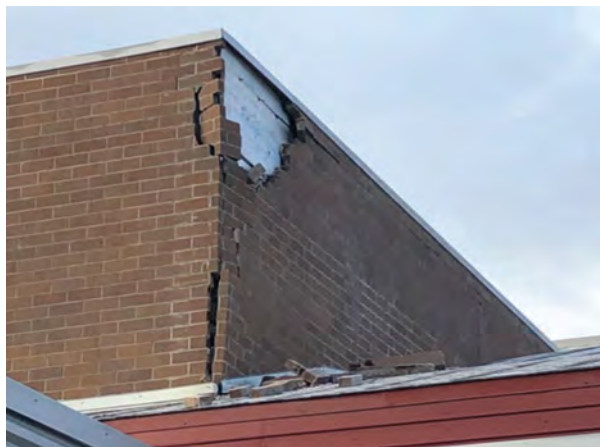
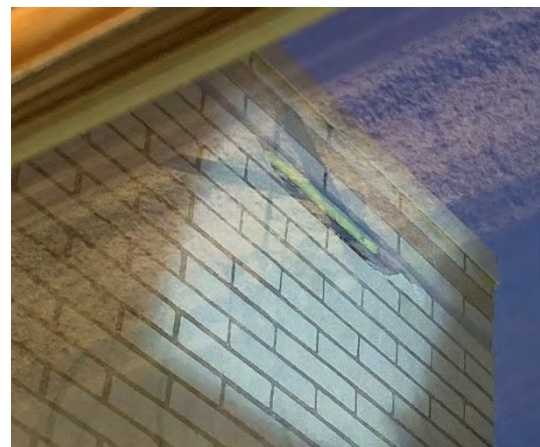
Extensive damage was observed to veneers and façades in Eagle River, and minor-to-moderate damage was observed in Mat-Su and Anchorage. Most of the veneer damage was concentrated in low-rise commercial and office buildings. Examples of damage to clay-brick masonry veneers are shown in Figure 5.21. The extent of damage varied, as evident in the figure. In some instances, damage concentrated at perpendicular corners, while in other instances, damage occurred along an open face.

*Figure 5.21. Damage to clay-brick-masonry veneer in buildings in Eagle River and Anchorage: (a,c) business damage, (b) residential damage, (photos a,c Chris Motter; b: ADN), (d, e) Eagle River Library (photo: Walker and Murren<sup>3</sup>), and (f) An Anchorage hospital building (photo: Wael Hassan).*

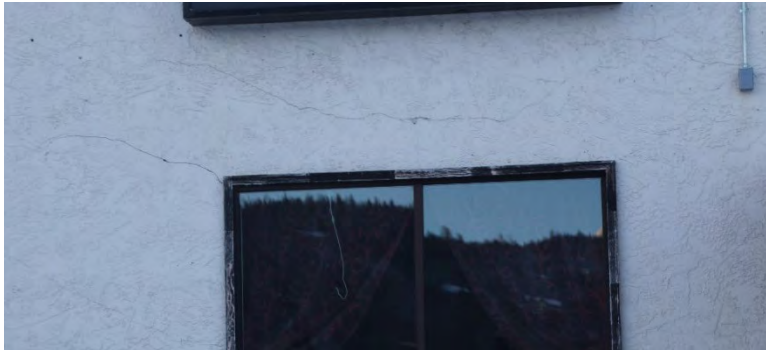
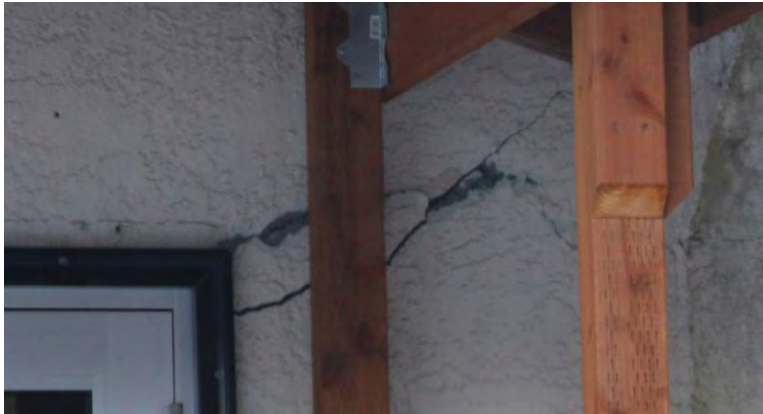
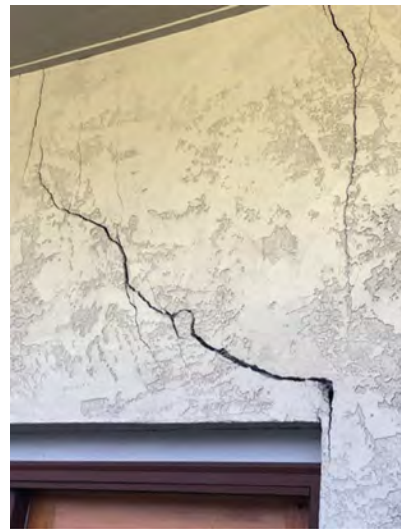
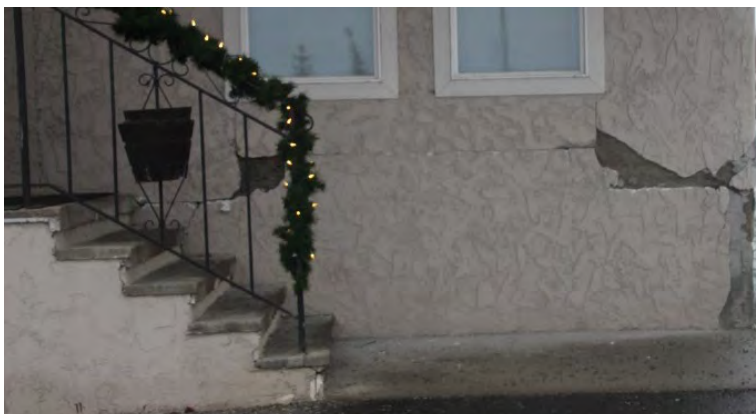
Examples of damage to concrete façades are shown in Figure 5.22. Damage at corners of openings and corners of perpendicular walls, as shown in the figure, was common. Examples of damage to stone façades are shown in Figure 5.23. Damage to concrete and gypsum façades was less common in Anchorage. Damage to architectural façade elements occurred in several buildings in Eagle River and Anchorage (Figure 5.24).

*Figure 5.22. Damage to concrete and brittle façades at exterior of buildings in Eagle River (photos: (a–c) Chris Motter and (d) Walker and Murren<sup>3</sup>).*

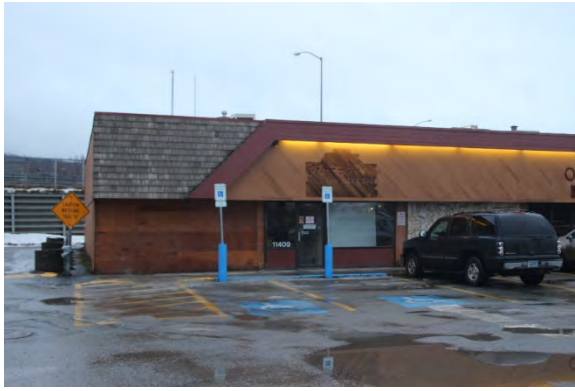
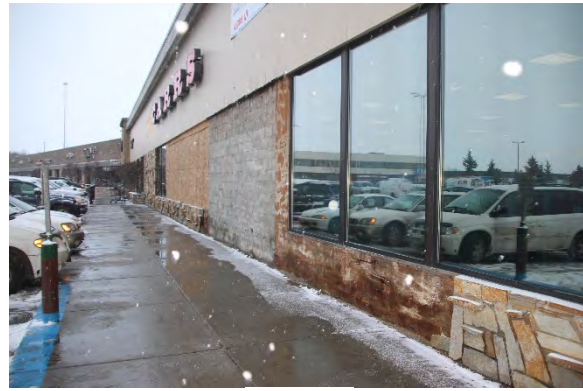
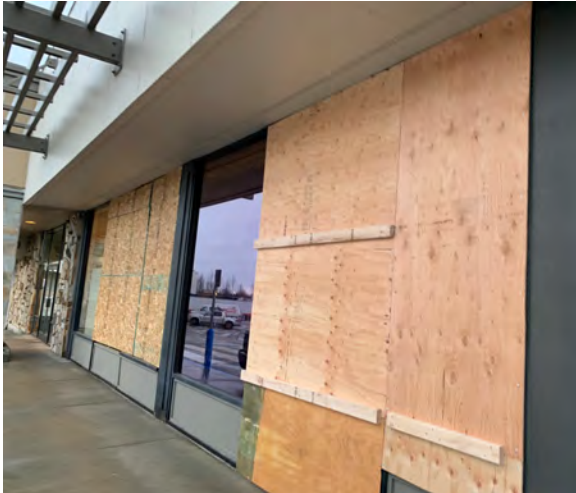
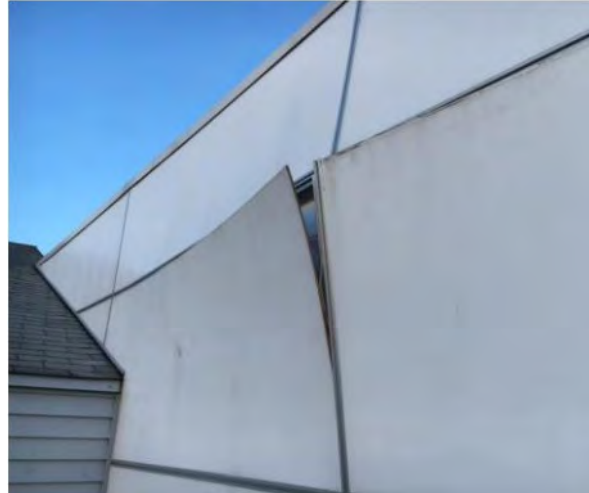
*Figure 5.23. Damage to stone façades at exterior of retail and supermarket buildings in (a) Eagle River and (b) South Anchorage (photos: Chris Motter) and (c) at a supermarket in Eagle River (photo: Wael Hassan). (d) Exterior metal façade school damage (photo: Reid Middleton, ASD).*

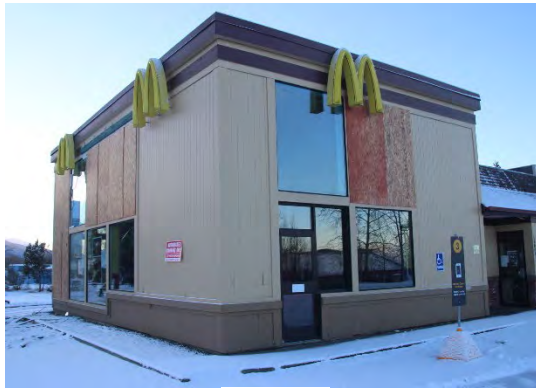
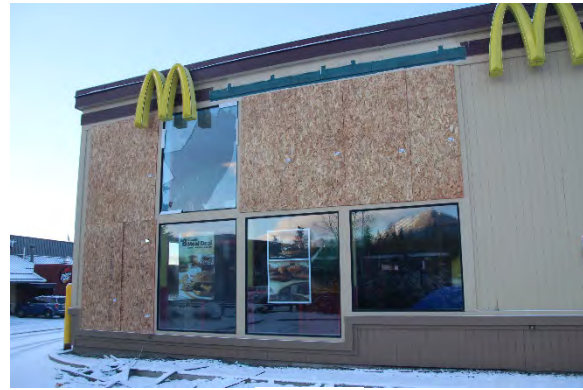
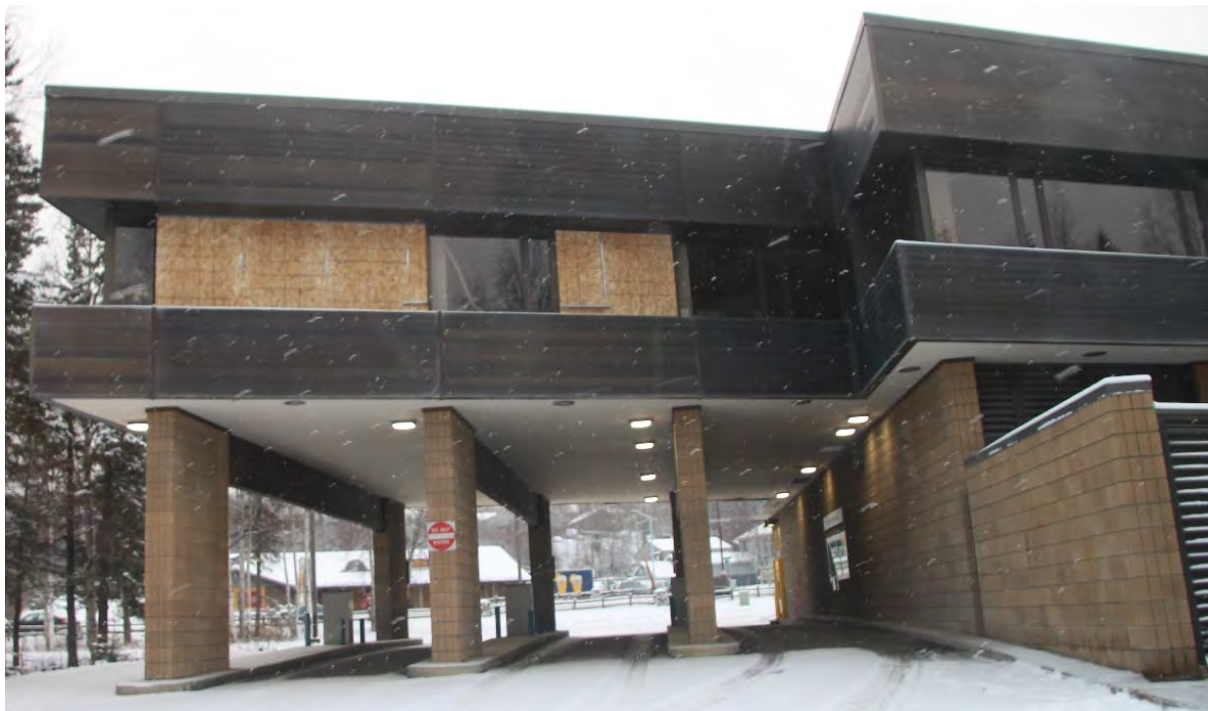
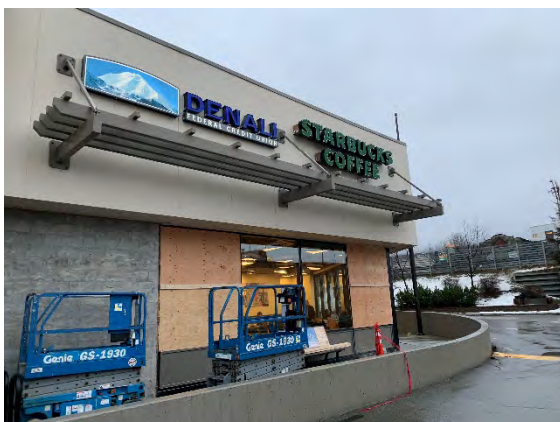
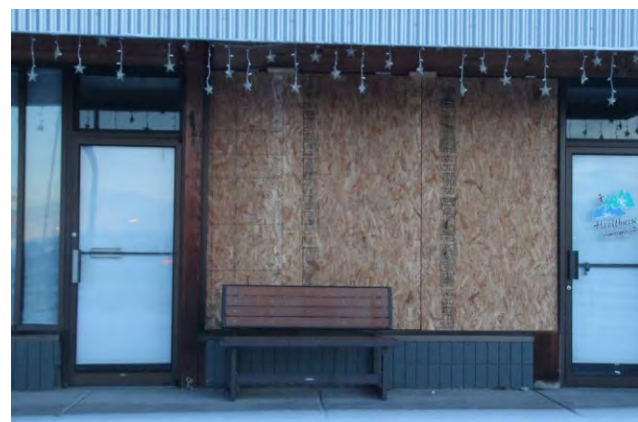
Damage to windows was extensive in Eagle River, and it was moderate in Anchorage (Figures 5.23, 5.25, and 5.26). One example of significant window damage occurred at the McDonald's, shown in Figure 5.25, which was red-tagged and closed. The building was later demolished. In some cases, window-opening equipment was also damaged (Figure 5.26). Business owners started repairing shattered glass windows soon after the main event; however, in many cases in which special, large glass panels with high thickness and wind resistance is used, such as in large commercial buildings and hospitals, it took several weeks to 2 months until new glass was installed, as it is manufactured and imported from other states. Estimated drift ratios at some mid-rise instrumented buildings exceeded the American Society of Civil Engineers 7-16 drift limit for glass shattering; however, rare incidents of glass shattering problems were found in mid-rise and high-rise buildings in Anchorage.

Figure 5.25. (a, b) Window damage at a red-tagged McDonald's (later demolished), (c) at a bank in Eagle River (photos: Chris Motter), (d) at a spread mall in Eagle River (photo: Wael Hassan), and (e) at a retail building in Eagle River (photo: Chris Motter).

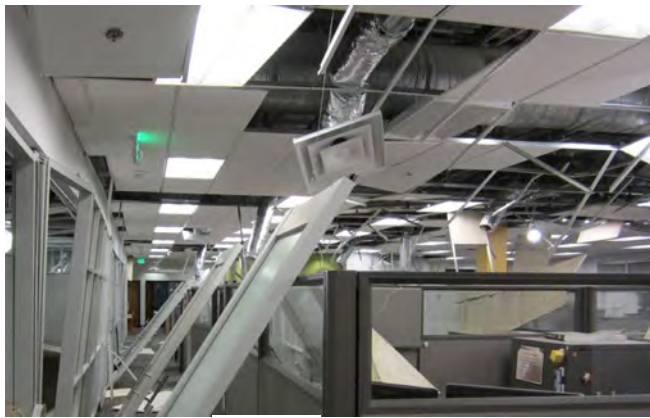
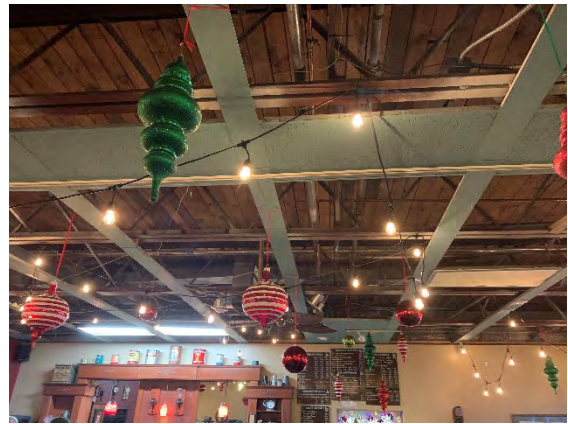
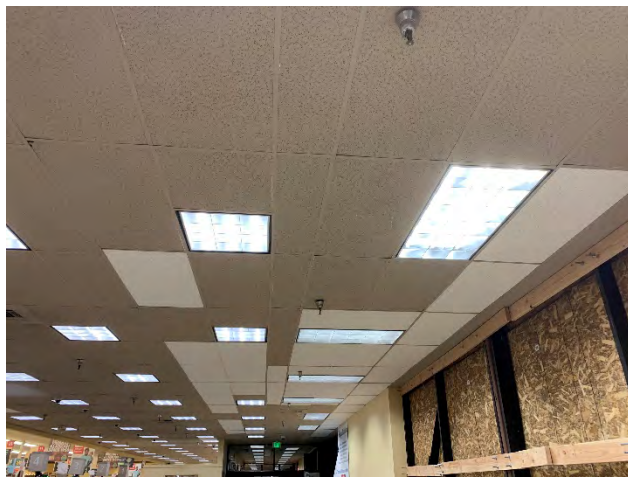
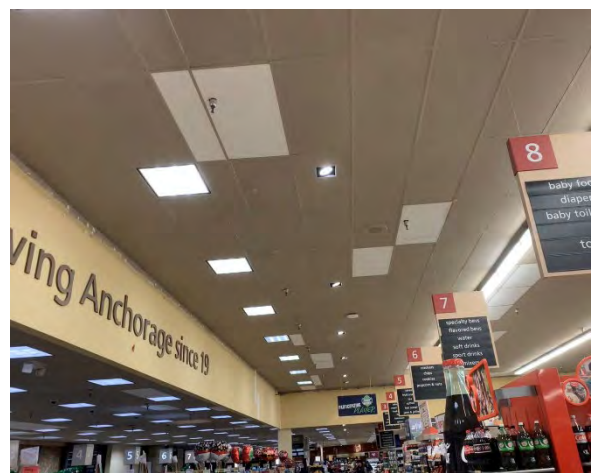
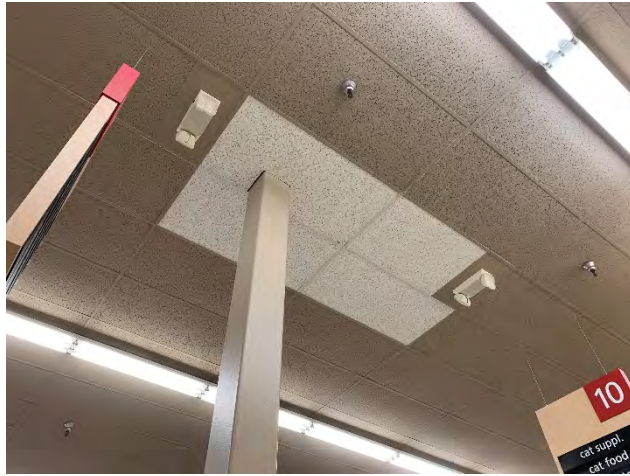
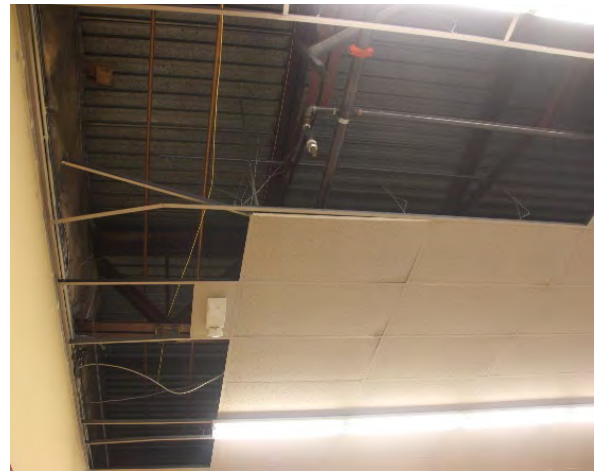
Extensive damage to suspended ceilings was observed at Carr's (Albertson) Supermarket in Eagle River, as shown in Figure 5.27. Much of the information provided in this paragraph was based on accounts of the damage and aftermath provided by a store manager and employees. Following the earthquake, a structural inspection was conducted, but no significant structural damage was reported. The observed damage was primarily nonstructural. Severe damage to suspended ceilings was observed, and this included localized failed grid ceilings, tiles falling, and the residual downward deformation of the suspended ceiling grid. Pipe connections of various sizes failed, leading to misalignment of pipe segments following the earthquake. Damage to the storefront was also observed, and this included glass and the façade. Minor cracking in one column was observed. According to multiple store employees, the earthquake felt like an impulse followed by shaking. No employees were reported to be injured in the earthquake. Flooding occurred; however, the main financial losses were attributed to loss of refrigeration and spoilage of product. The store was reopened on Saturday, December 8, 2019. The drop-ceiling grid was not replaced in order to leave an open ceiling. In comparison, the nearby Fred Meyer supermarket in Eagle River did not have a suspended ceiling and had minimal damage. In comparison to another Carr's (Albertson) Supermarket built in 1982 in South Anchorage, close to the maximum recorded peak ground acceleration (PGA) of 0.55g, the store has the same footprint and structural system of its Eagle River counterpart, but other than glass façade damage and a few ceiling-tile falls, minimum damage was observed (Figure 5.28).

*Figure 5.28. Ceiling damage: (a) office building (photo: Randall Williams<sup>2</sup>), (b) coffee shop in Eagle River (photo: Wael Hassan), (c–e) supermarket in South Anchorage (photos: Wael Hassan), and (f) grocery store in South Anchorage (photo: Chris Motter).*

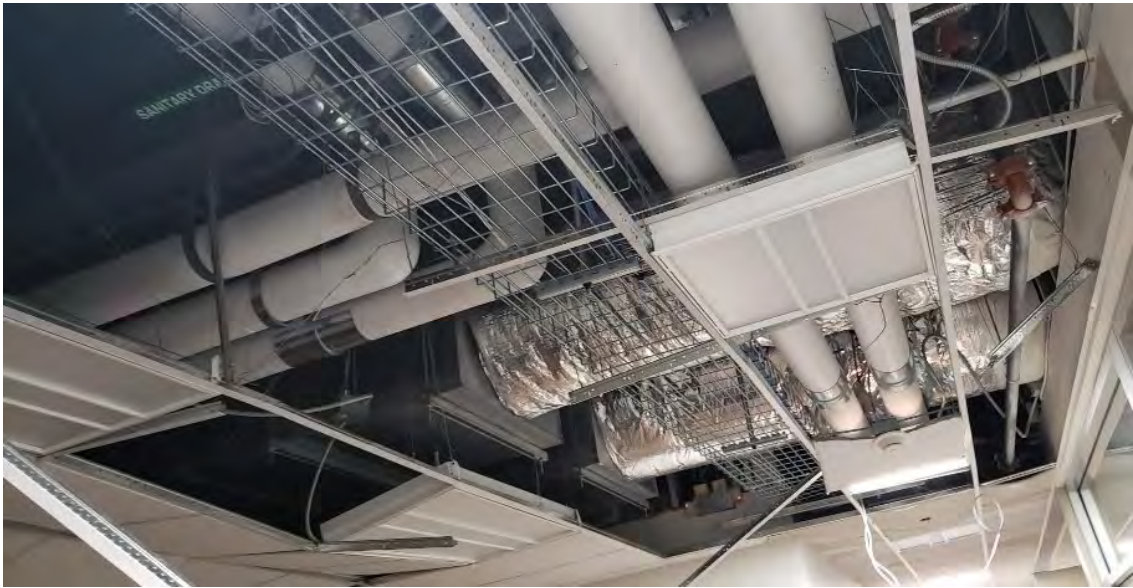
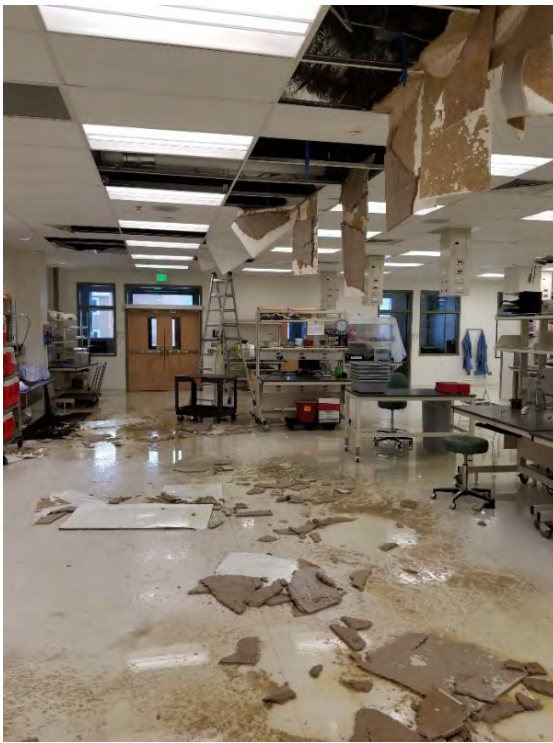
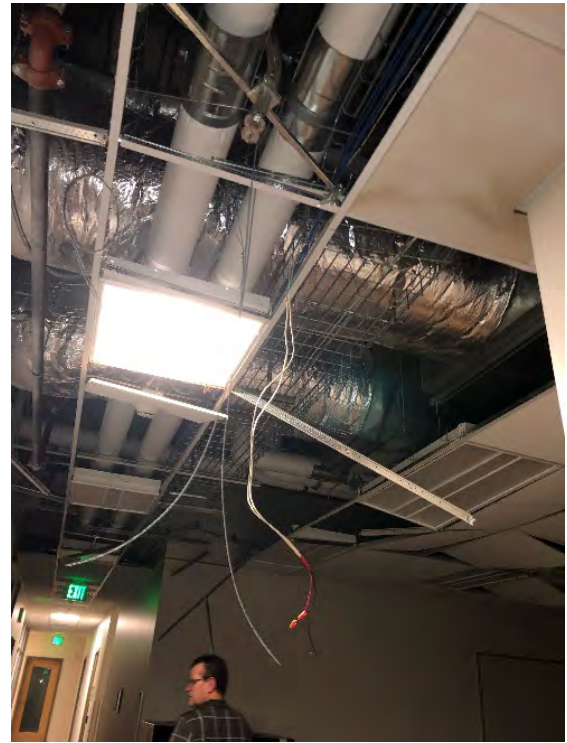
Extensive ceiling damage due to water and glycol flooding was observed in many school, hospital, and office buildings in Anchorage, Eagle River, and Mat-Su. One example is shown in Figure 5.29, where the first-floor ceiling of the BBA in Anchorage was severely damaged because of water and glycol flooding from the penthouse-mechanical-room connection failures. Another example is shown in Figure 5.30. The reader is referred to Chapters 6 and 7 of this report for more details about hospital and school damage. Repairing the impact of water flooding and replacing ceiling tiles (and grids sometimes) was the most time-consuming and costly repair item in many buildings, delaying restoration of full operation of the building to many weeks following the main event.

Figure 5.29. Ceiling damage at the BBA (photos: BBA).

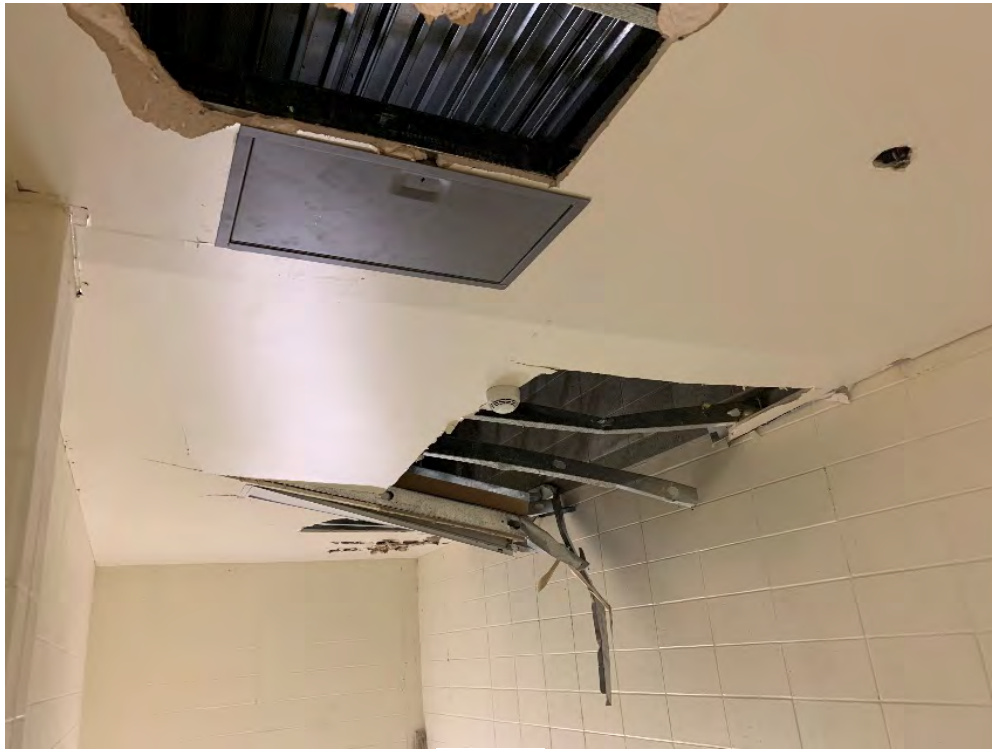
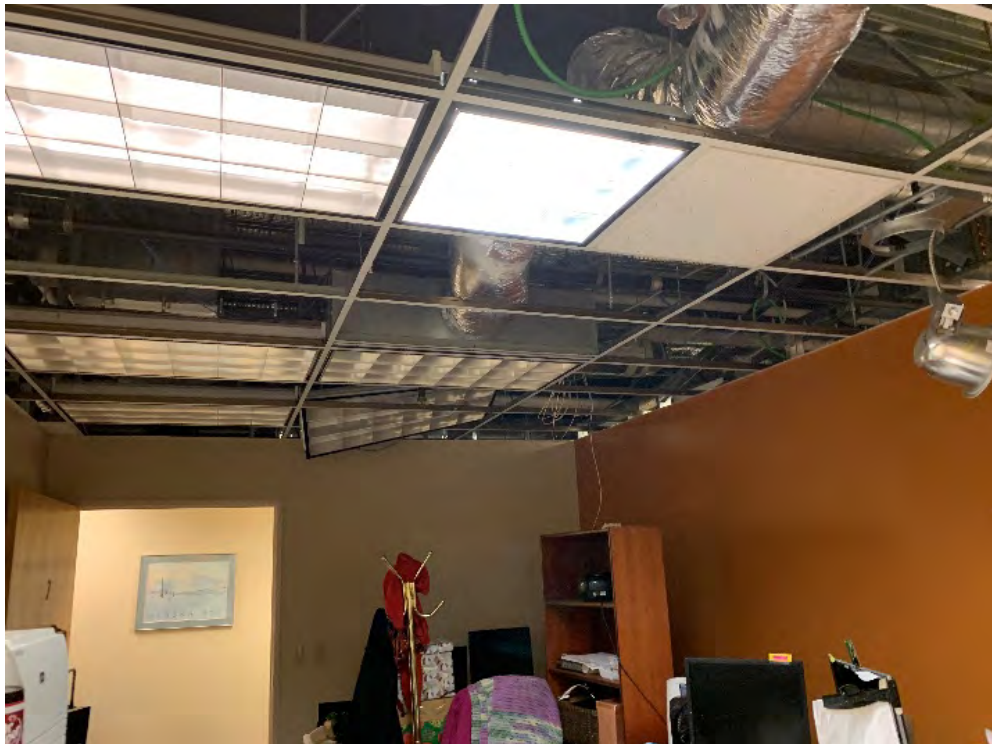
*Figure 5.30 Ceiling damage in (a) a Mat-Su Valley Colony High School and (b) an Anchorage hospital (photos: Wael Hassan).*

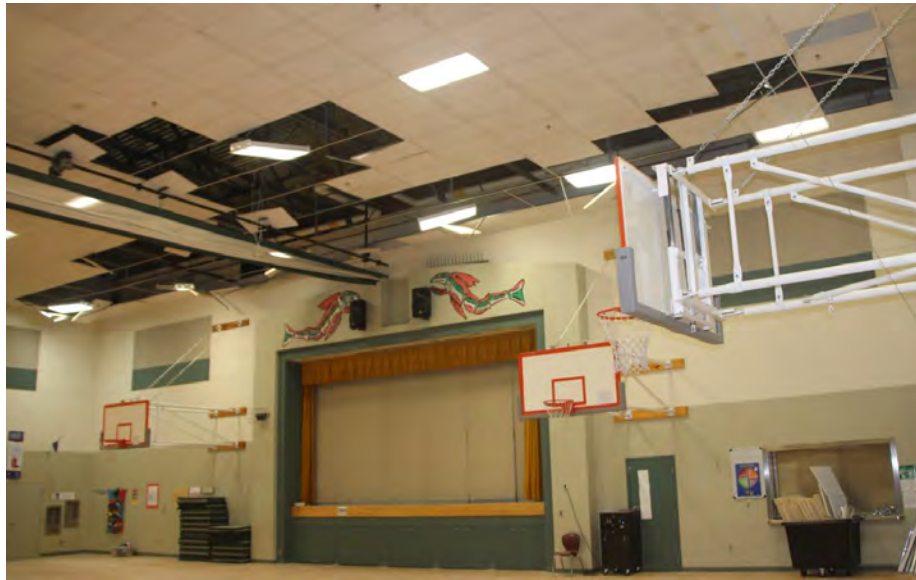
Although nonstructural damage in South Anchorage was not as widespread as in Eagle River and Mat-Su, there were some observations of damage to suspended grid ceilings in department stores in South Anchorage, with one example shown in Figure 5.33. Damage to ducts was evident at many schools and at the UAA building in Eagle River.

Figure 5.33. Damage to a suspended grid ceiling at Finger Lake Elementary School in Mat-Su (photo: Chris Motter).

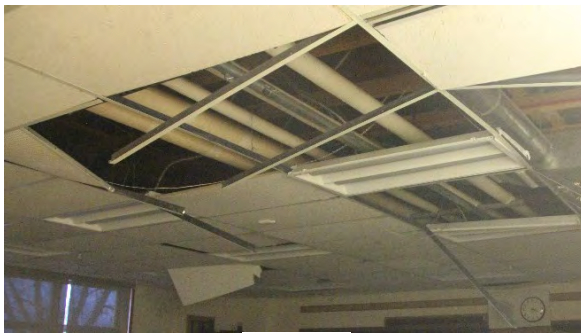
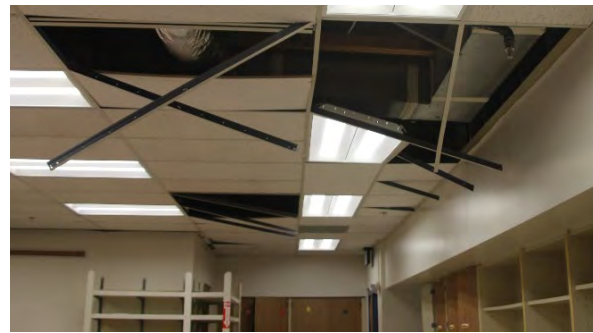
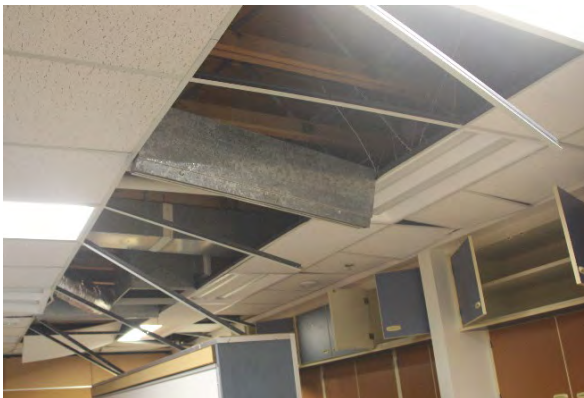
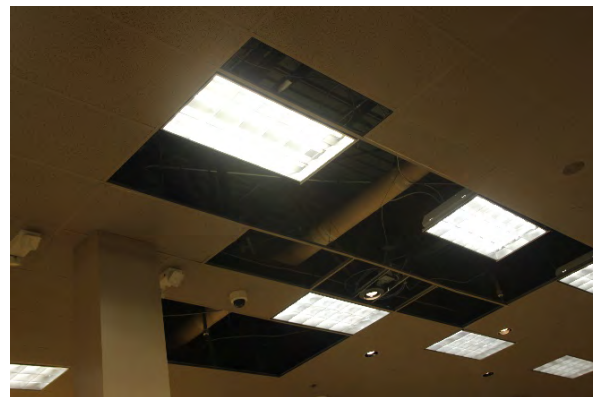
Damage to suspended grid ceilings was also observed at schools. Examples are shown for Eagle River in Figure 5.34 and Mat-Su in Figure 5.35. It is worth noting that falling ceiling tiles can pose substantial life safety hazards in some cases, such as the case of a Mat-Su school basketball court (Figure 5.35), where heavy wooden ceiling tiles (weighing 30 lb each) fell off a height of 40 feet onto the court, fortunately not injuring or killing any student, as it was still early in the morning. In addition to damage to suspended grid ceilings, damage to ceiling tiles was also observed. One example was the gymnasium at Eagle River Elementary School, shown in Figure 5.36, where many ceiling tiles had fallen during the earthquake.

Figure 5.34. Damage to suspended grid ceilings in (a–c) Eagle River Elementary School and (d) a grocery store in Anchorage (photos: Chris Motter).

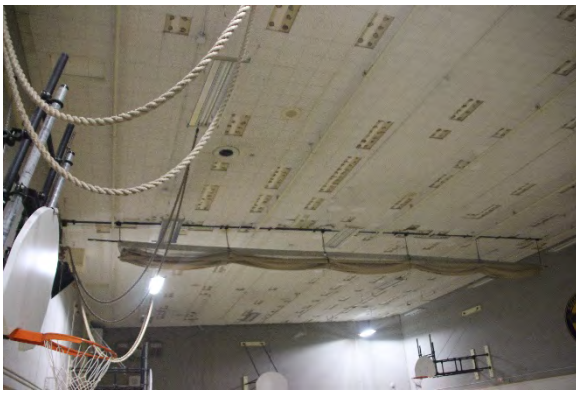
(a)

Figure 5.35. Damage to ceiling tiles in a (a, b) gymnasium and (c) classroom of Eagle River Elementary School (photos: Chris Motter).

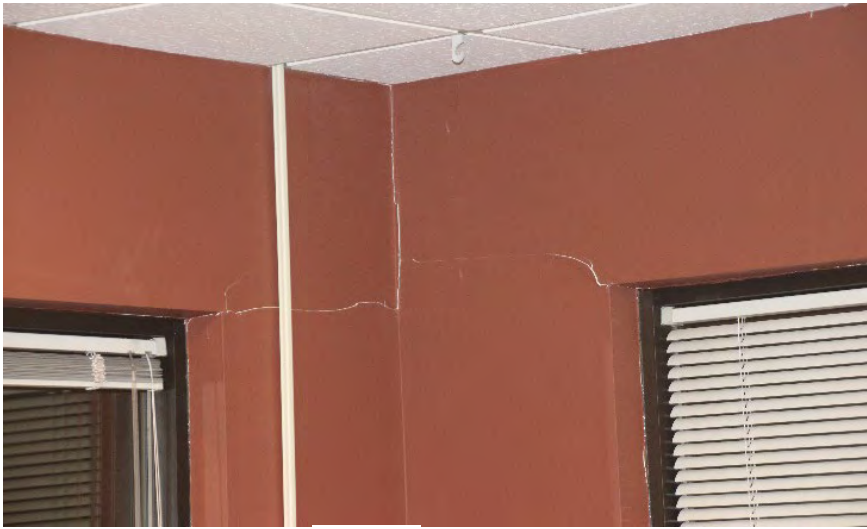
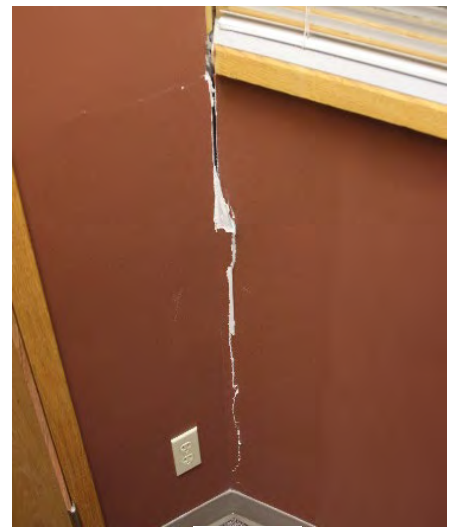
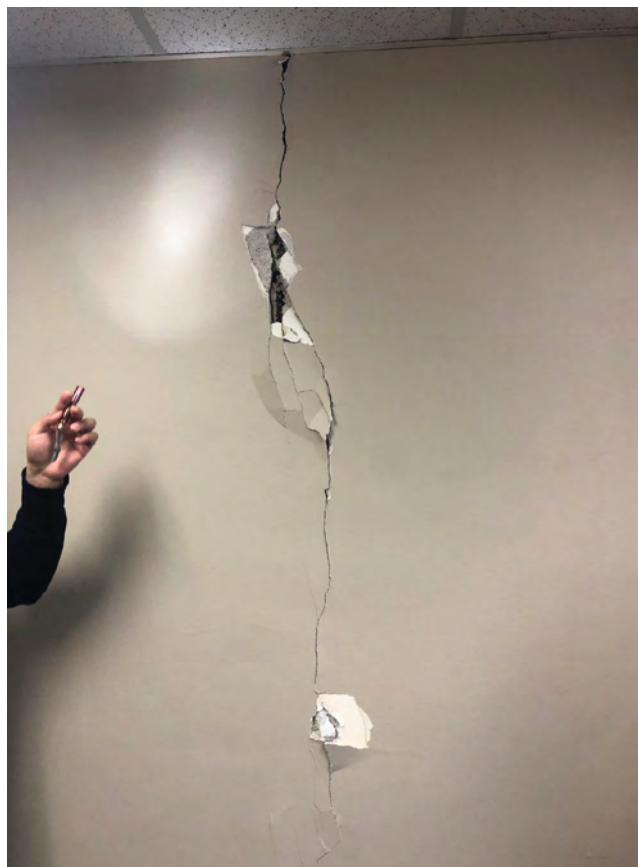
Figure 5.36. (a, b) Damage to nonstructural walls at an office building in Anchorage (photo: Chris Motter) and (c) partition-wall cracks at a concrete-core-wall interface in an office building in Anchorage (photo: Patrick Murren<sup>3</sup>).

Typical partition-wall and stairwell-wall sheetrock damage patterns in Anchorage and Eagle River office buildings are depicted in Figures 5.36, 5.39, and 5.40. Damage ranged from cosmetic to extensive. Even in those buildings receiving less than 0.2g PGA, sheetrock damage was widespread. Aftershocks have exacerbated the sheetrock damage problems in the region. The cost of repair of this type of crack can be relatively high, especially with stairwells needing scaffolding. This cost constituted a significant portion of the total earthquake damage repair cost at many facilities in Anchorage and Eagle River. Some preexisting sheetrock cracks were the result of previous earthquakes in the past few years that have not been repaired. Similarly, some facility owners decided to defer fixing the sheetrock cracks to future building improvement projects. Since it was widespread damage, FEMA has denied earthquake assistance to some facilities that had only this type of damage. The local practicing engineering community is discussing the need for more ductile wall-finishing material in seismically active Southcentral Alaska.

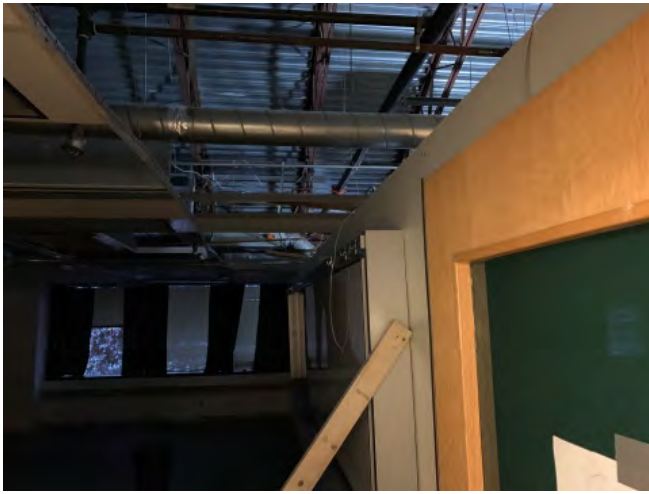
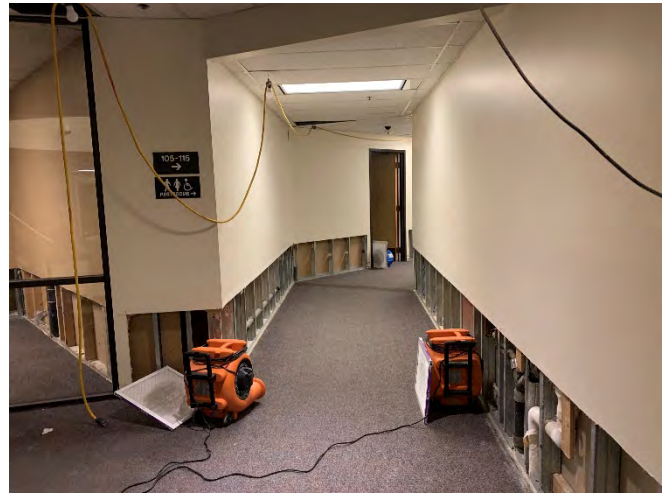
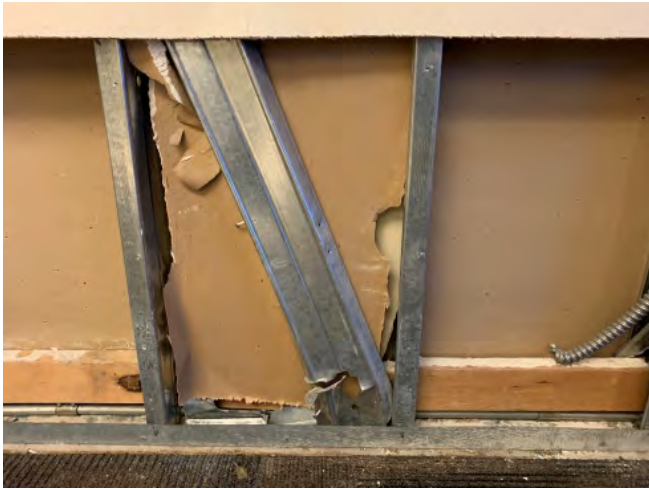
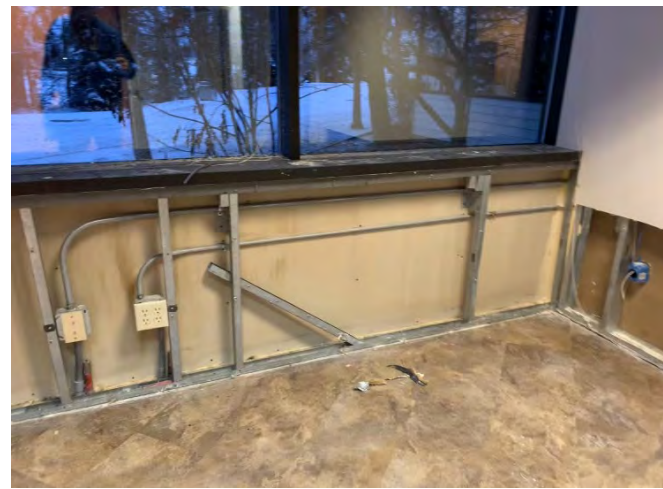
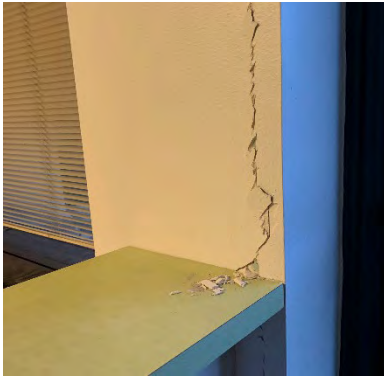
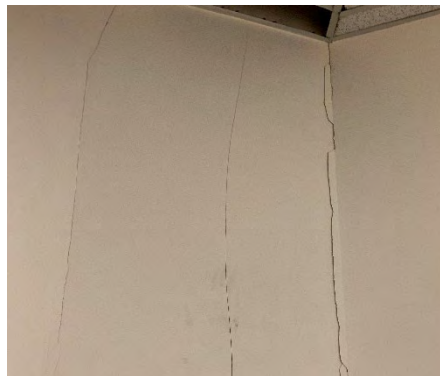
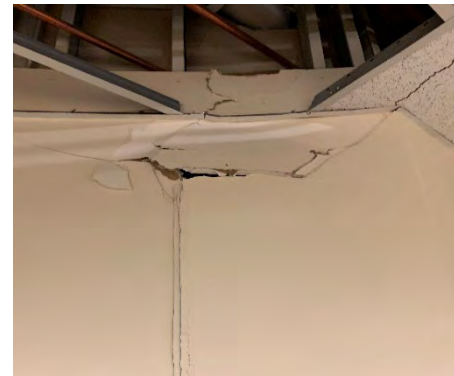
*Figure 5.38. University of Alaska, Eagle River campus, partition and nonstructural wall damage. The top left photo shows an unstable partition wall with out-of-plane deformation. The building is flexible steel-moment frame, and the nonstructural wall components were not compatible with withstanding the large frame deformations (photos: Wael Hassan).*

At the UAA Eagle River building, extensive damage to partition walls was observed, as shown in Figure 5.38. Residual deformation was evident in some partition walls, while others had failed connections such that the walls were no longer attached. Flooding had occurred in the building as well, which led to damage at the base of all partition walls, as shown in Figure 5.38. The building has a flexible steel-moment frame, and the nonstructural wall components were not compatible with withstanding the large frame deformations.
