# EERI Earthquake Reconnaissance Report: M7.1 Anchorage Earthquake on November 30, 2018

Wael M. Hassan, John Thornley, Janise Rodgers, and Christopher Motter

July 2021

*A product of the EERI Learning from Earthquakes Program*

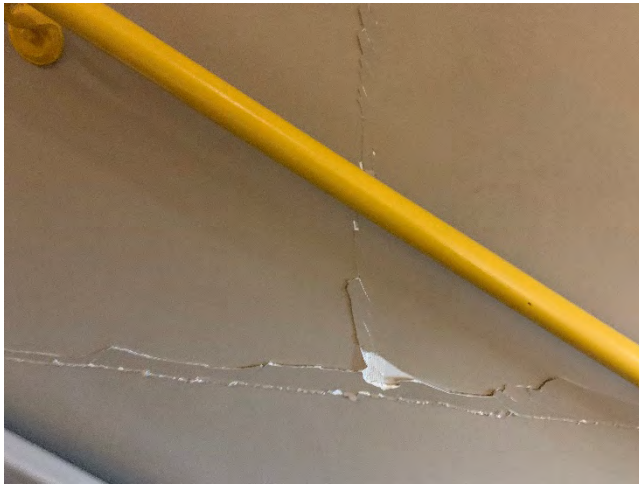
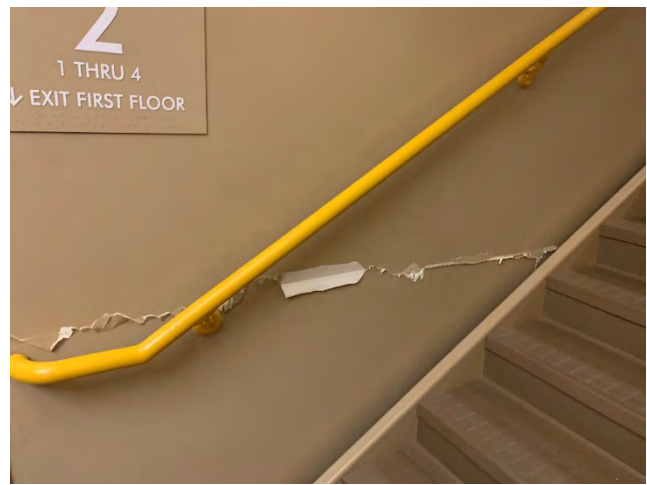
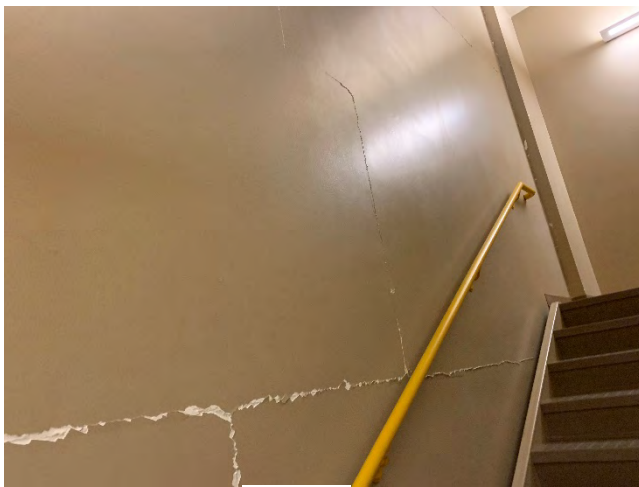
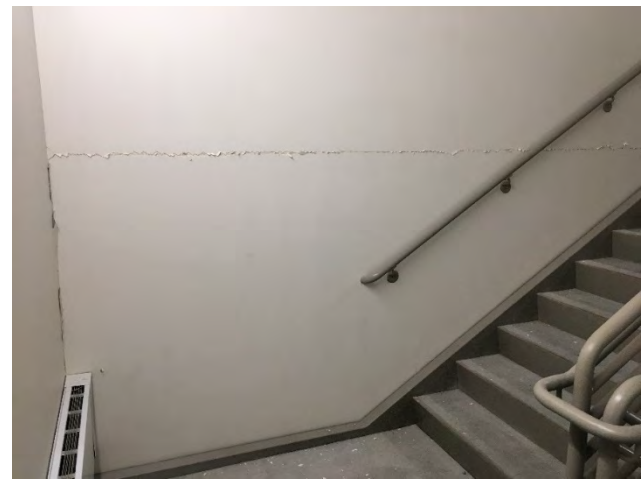
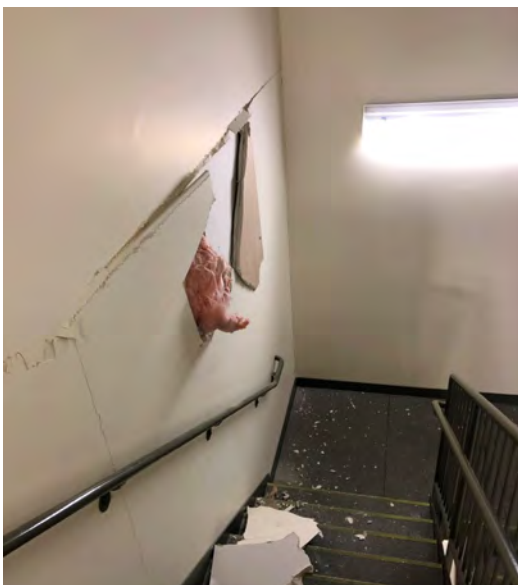
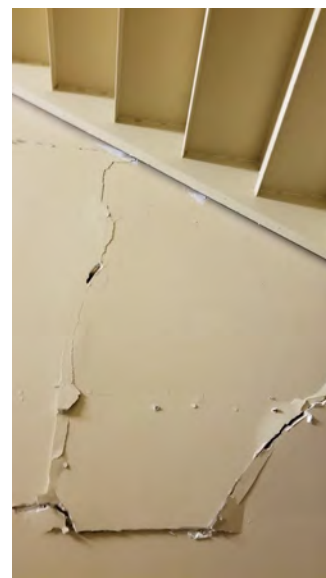
Figure 5.39. Typical stairwell sheetrock damage in office buildings and hospitals in Anchorage (photos: (a–d) Wael Hassan, (e) Randall Williams<sup>2</sup>, and (f) Greg Latrielle<sup>7</sup>)

Typical partition-wall and stairwell-wall sheetrock damage patterns in Anchorage and Eagle River office buildings are depicted in Figures 5.36, 5.39, and 5.40. Damage ranged from cosmetic to extensive. Even in those buildings receiving less than 0.2g PGA, sheetrock damage was widespread. Aftershocks have exacerbated the sheetrock damage problems in the region. The cost of repair of this type of crack can be relatively high, especially with stairwells needing scaffolding. This cost constituted a significant portion of the total earthquake damage repair cost at many facilities in Anchorage and Eagle River. Some preexisting sheetrock cracks were the result of previous earthquakes in the past few years that have not been repaired. Similarly, some facility owners decided to defer fixing the sheetrock cracks to future building improvement projects. Since it was widespread damage, FEMA has denied earthquake assistance to some facilities that had only this type of damage. The local practicing engineering community is discussing the need for more ductile wall-finishing material in seismically active Southcentral Alaska.

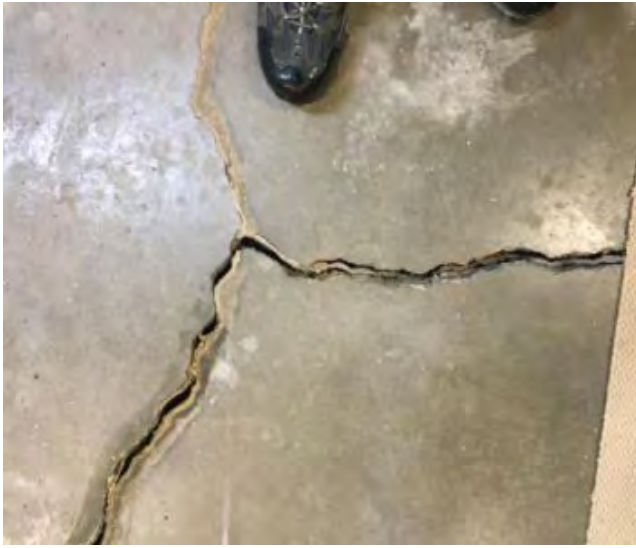
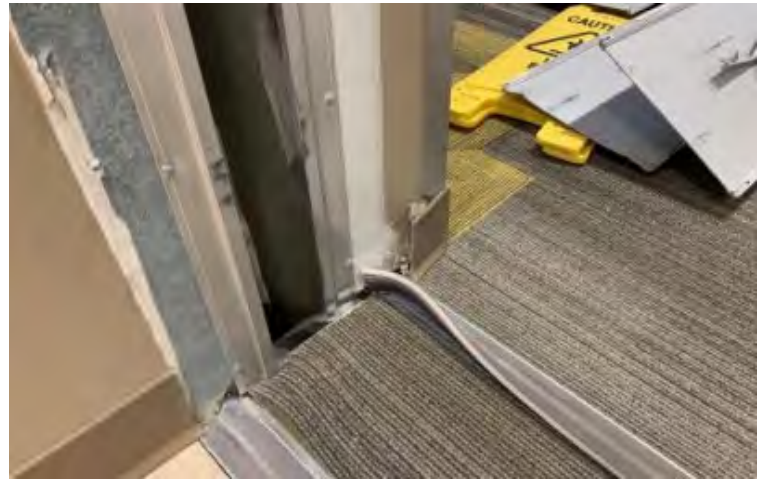
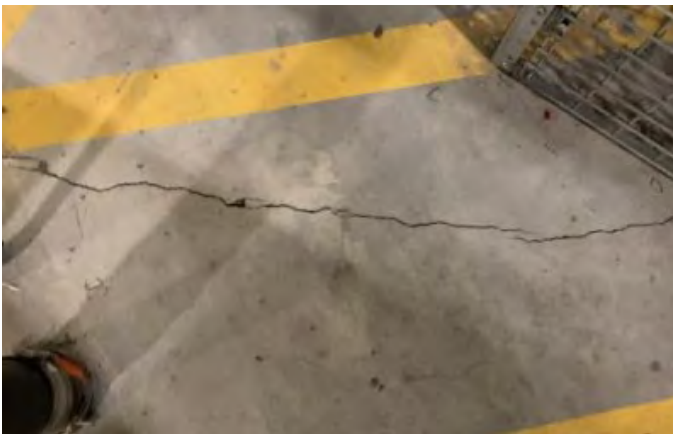
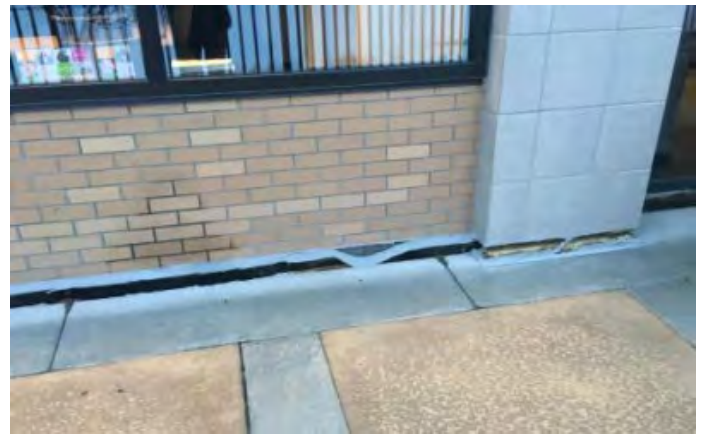
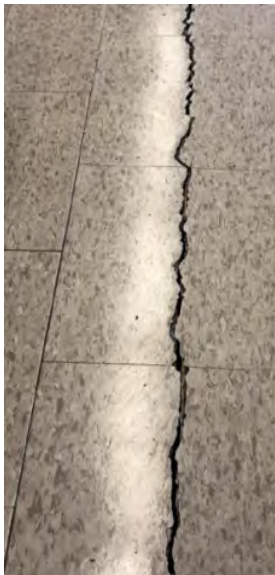
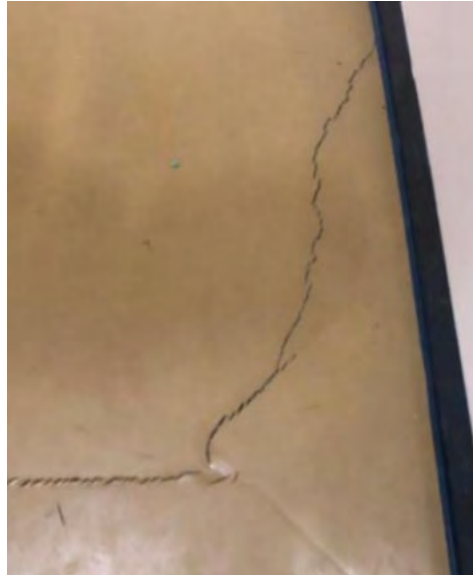
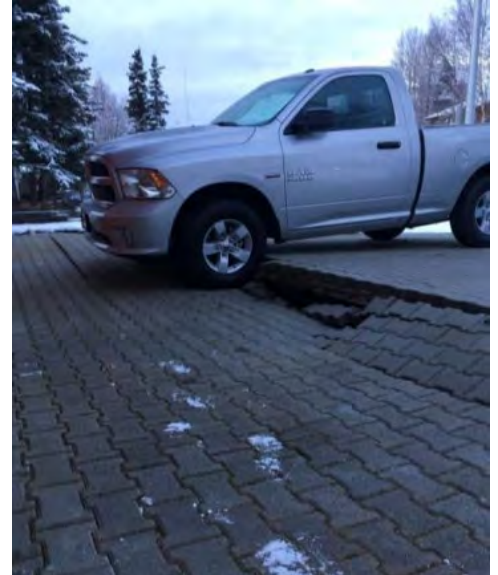
*Figure 5.41. Sample floor damage due to soil failure; (a) residential wood building (photo: MOA); (c) 2014 multistory building in Eagle River (photo: Wael Hassan); (d) An Anchorage hospital (photo: Wael Hassan); (e) school building (photo: Reid Middleton, ASD); (f) Gym damage following control joint (photo: Reid Middleton, ASD); (g) residence driveway (photo: MOA).*

Floor concrete and finished cracking and damage due to soil failures was widespread in all types of buildings. Residential single family houses garages and driveways were the most affected, (Figure 5.41).

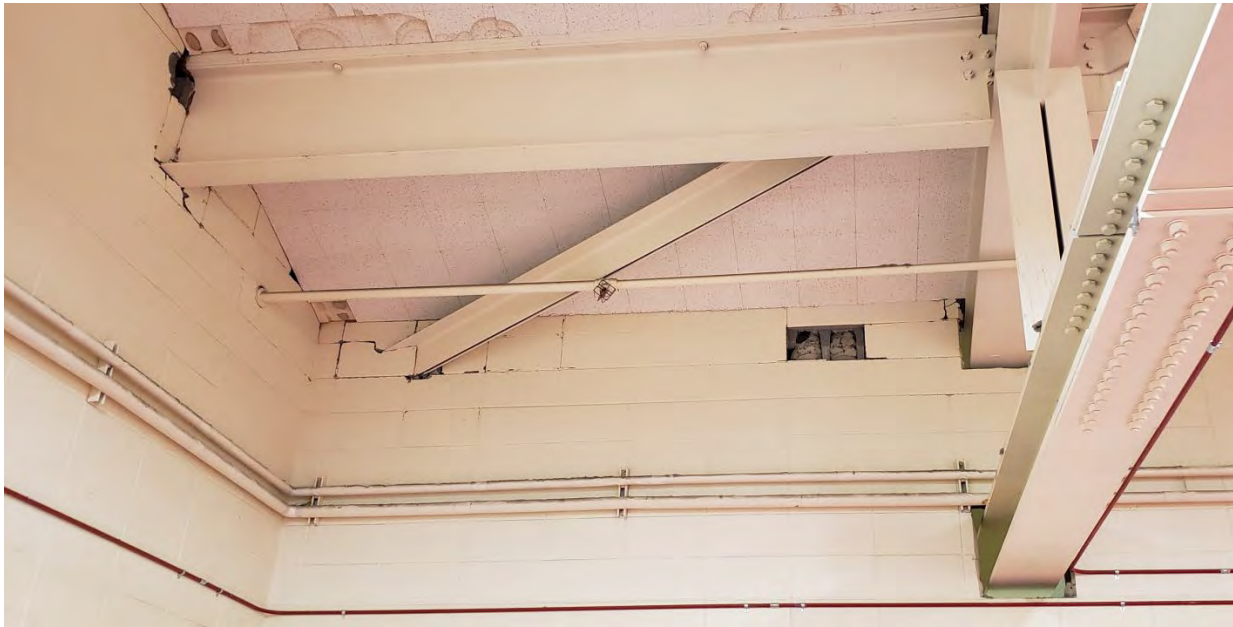
Other damage at Houston Middle included significant cracking of the partially grouted stack-bond classroom-wing CMU walls (both shear walls and partitions) and CMU wall cracking in numerous other locations. Cracked vertical joints in the stack-bond masonry were widespread. In some locations, fallen and loose blocks created a significant safety hazard, including in the gymnasium, where differential movement of the steel roof trusses cracked the surrounding CMU (Figure 6.3). Post-earthquake investigations determined that CMUs were installed without reinforcement in some isolated locations at the tops of walls and around structural steel members and that reinforcing was 48 inches on center, twice the spacing that the current code (*TMS 402-16*)<sup>8</sup> requires for walls with this bond type (BCA et al., 2019). The building also experienced extensive nonstructural damage, including major damage to suspended ceilings, lighting, and ductwork and damage to finishes and other building systems.

*Figure 6.3. CMU block at top of wall cracked and loosened because of differential motion of steel roof framing, Houston Middle School. Loose blocks pose a falling hazard to those below (photo: MSBSD).*

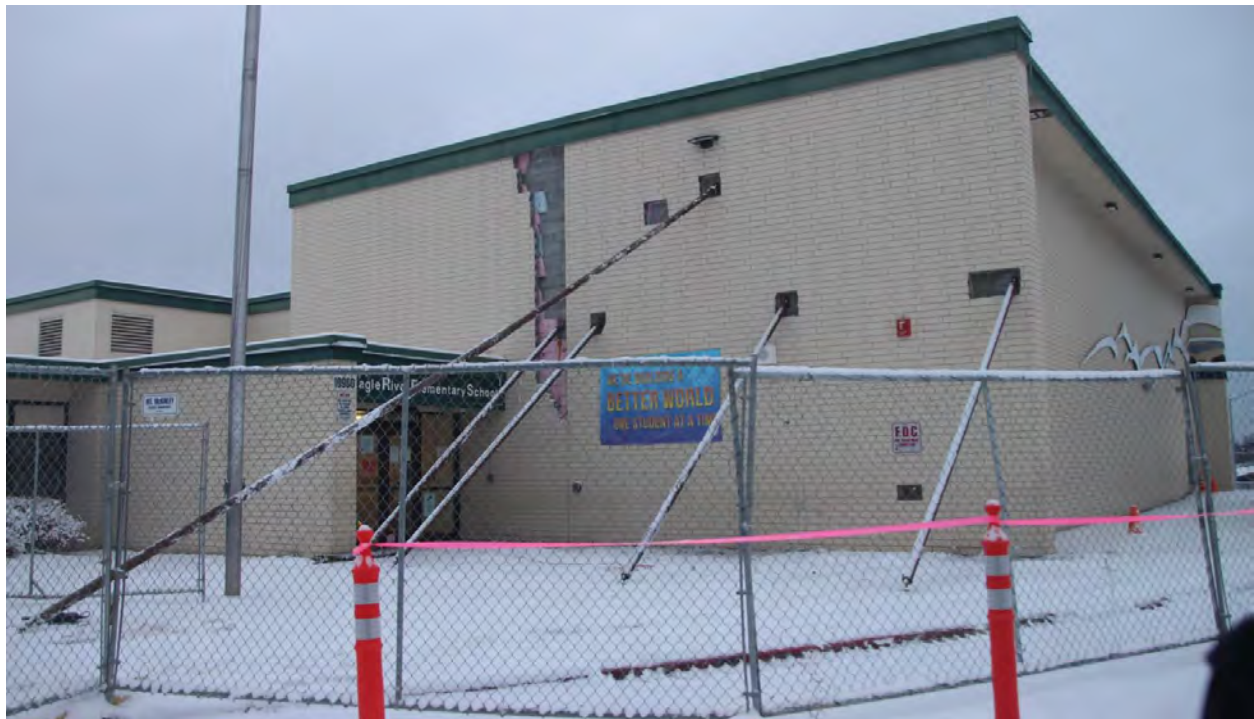
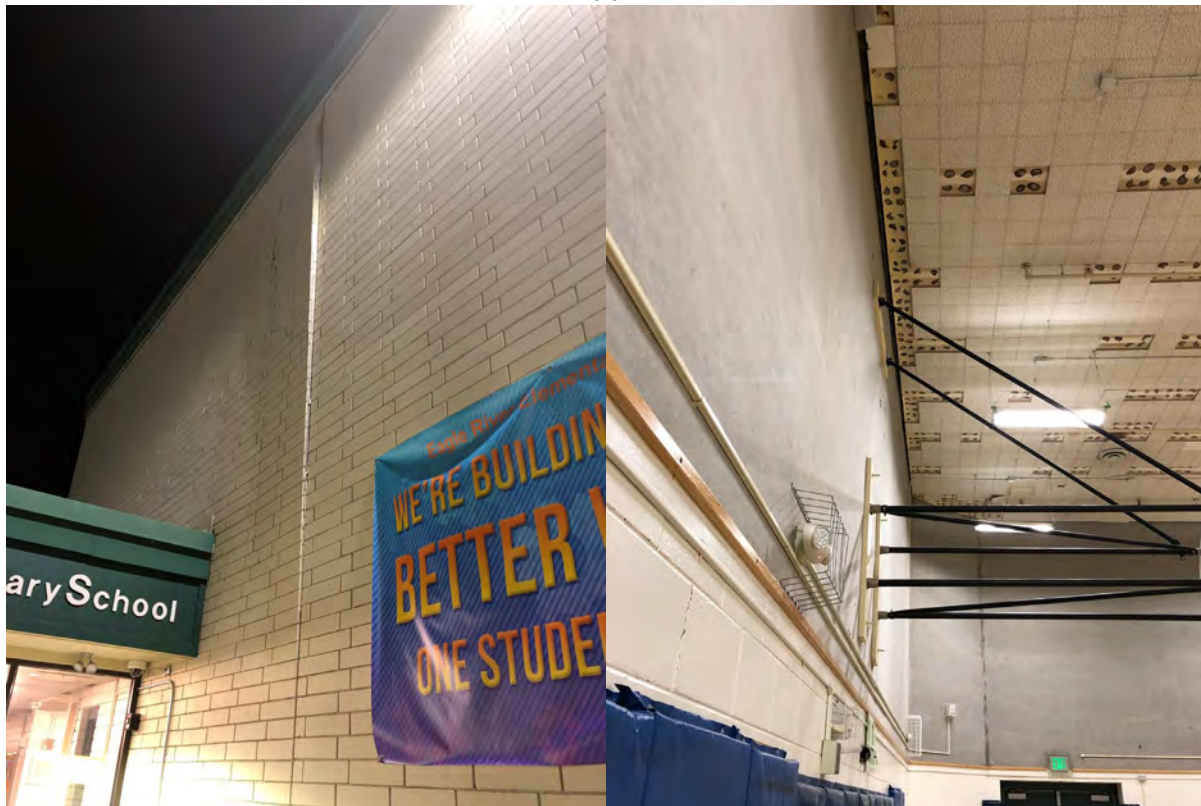
Significant damage was observed in the gymnasium of Eagle River Elementary. The CMU masonry walls separated from the mezzanine because of failure of the wood nailer atop the CMU wall in cross-grain tension (BDS Architects, 2019a)<sup>9</sup>. The damage resulted in post-earthquake installation of vertical bracing to support the mezzanine. Additional damage in the gymnasium was observed in the masonry walls. An exterior masonry veneer had partially separated from the structural CMU wall, which had displaced outward by a small amount. The masonry walls of the gymnasium were braced out of plane from the outside of the building, as shown in Figure 6.4. The clay-brick veneer had been removed to anchor the braces directly to the CMU wall. Aside from the damage in the gymnasium, damage to shear walls was observed in other locations in the building. This damage includes shear cracking in masonry walls (diagonal and stepwise), as shown in Figures 6.5, 6.6, 6.7, and 6.8, and vertical cracking at the interface of perpendicularly oriented masonry walls, as shown in Figure 6.7. A member of the maintenance staff who was in the building during aftershocks reported that the walls vibrated severely during aftershocks. Cracking was observed in the concrete floors in the basement of the building, as shown in Figure 6.9.

Figure 6.4. Exterior shoring for gymnasium wall at Eagle River Elementary: (a) loose portion of exterior masonry veneer removed, (b) displacement of exterior veneer, and (c) interior photo showing separation between gymnasium ceiling and wall (photos: (a) Chris Motter and (b, c) ASD).

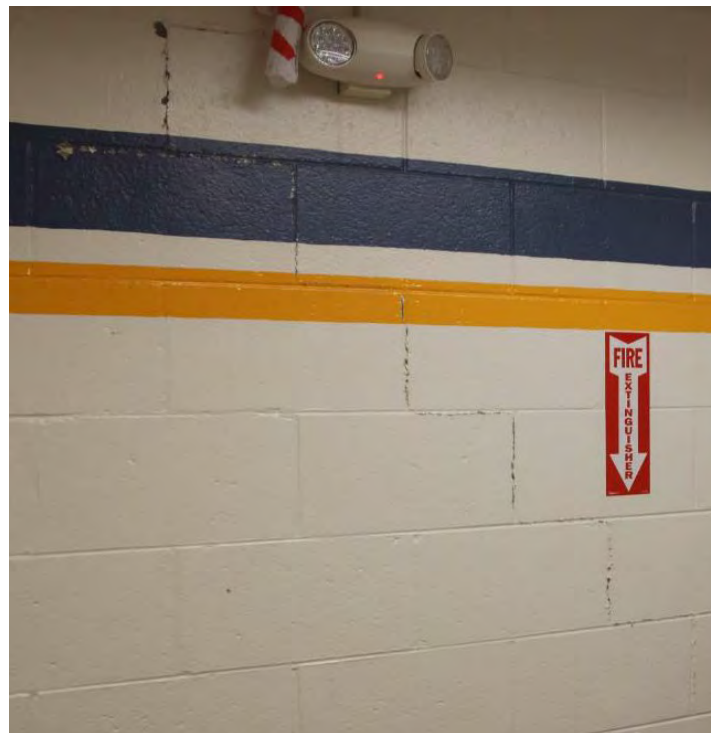
Figure 6.6. Stepwise shear cracking along mortar joints in masonry wall at Eagle River Elementary (photo: Chris Motter).

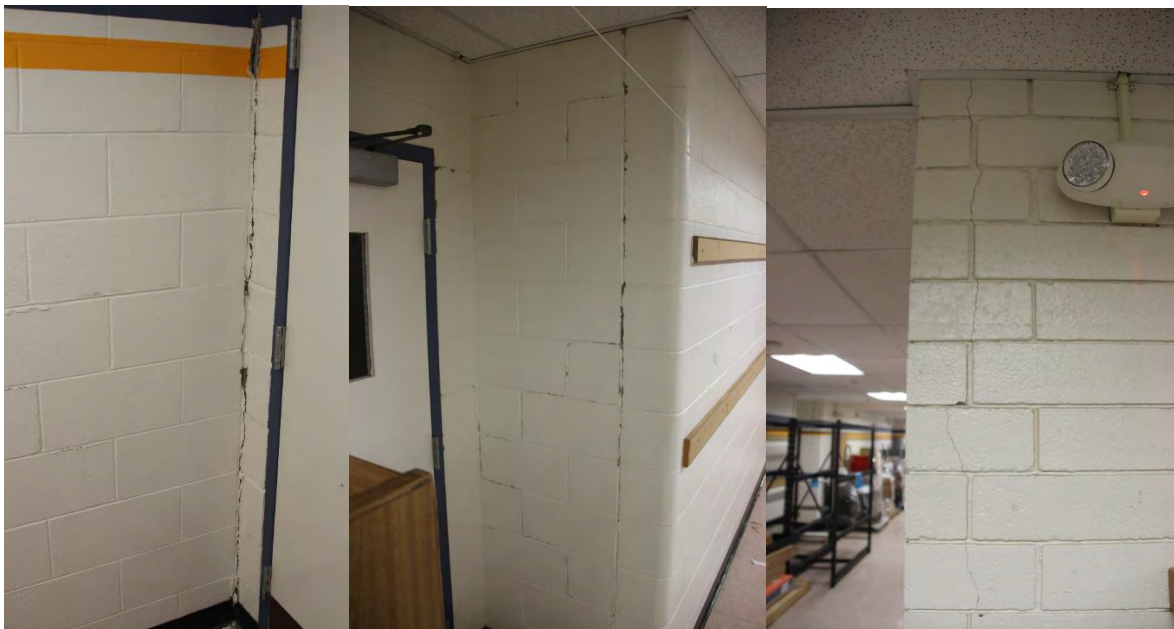
Figure 6.7. Vertical cracking at interface of perpendicularly oriented masonry walls at Eagle River Elementary (photos: Chris Motter).

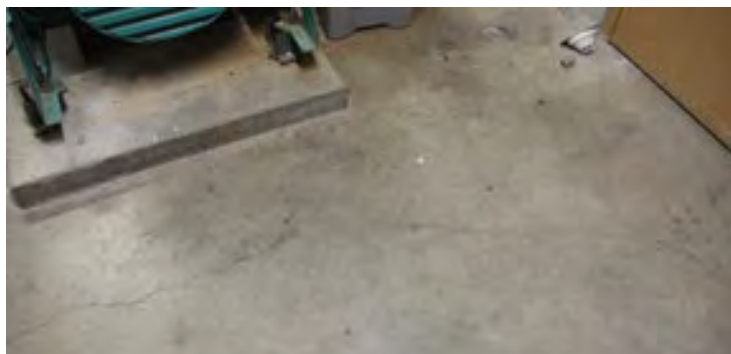
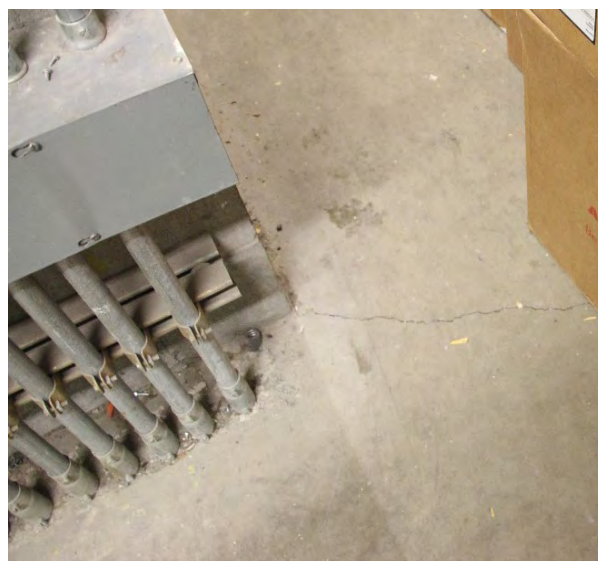
Figure 6.9. Cracking in reinforced concrete basement floor at Eagle River Elementary (photos: Chris Motter).

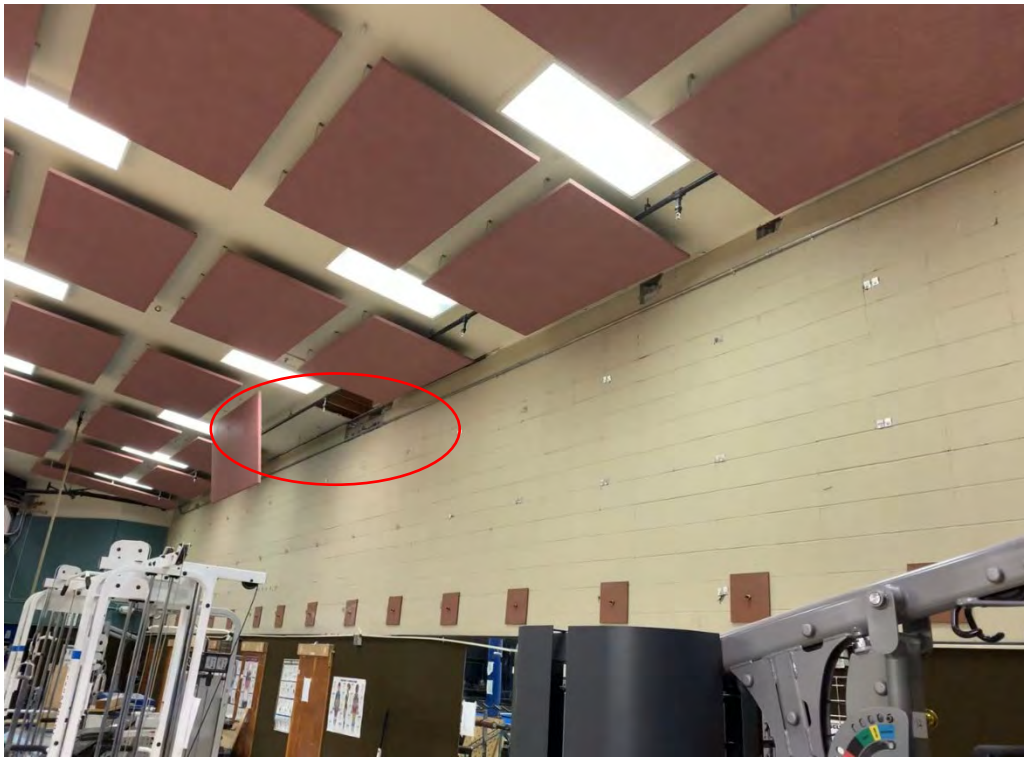
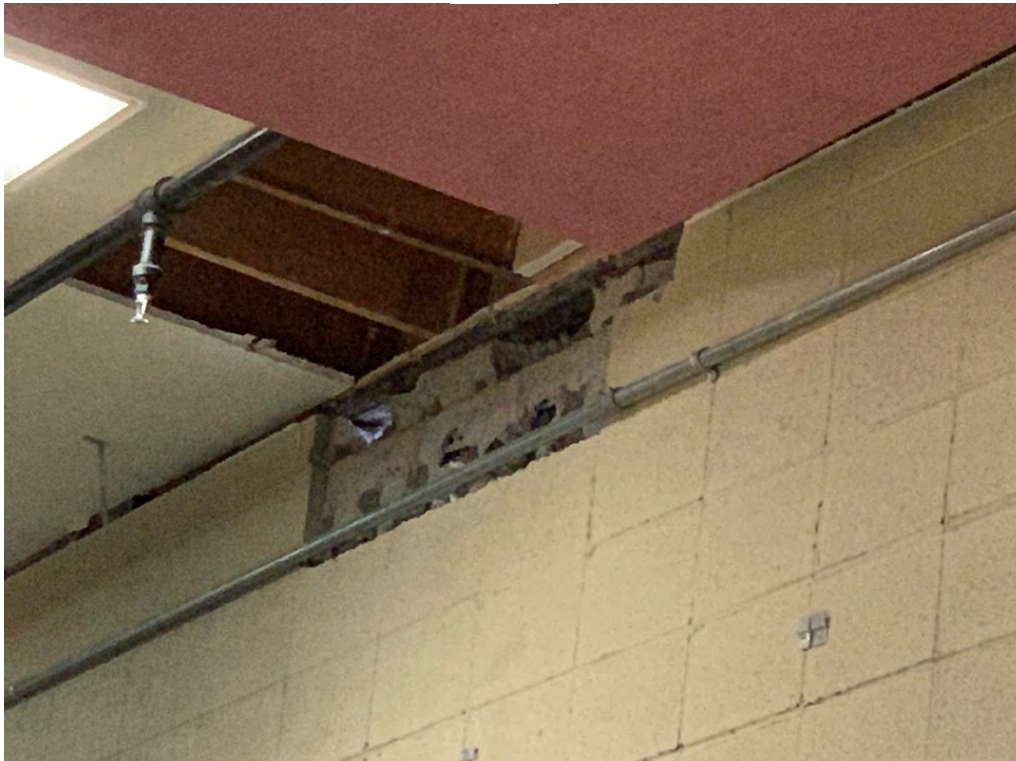
Earthquake damage included a failed top-of-wall connection between CMUs and wood diaphragms at two known locations, causing the CMU walls to separate from floor and lean. Figure 6.10 depicts the damaged CMU wall-floor connections and the braced leaning CMU wall. The earthquake also led to damage to and spalling of CMUs around steel columns and cracking in the stack-bond CMU walls (BDS Architects, 2019a). Other structural damage included permanent residual drift in two steel columns supporting the gymnasium roof (Figure 6.11). Earlier assessments had identified that the CMU walls were inadequately reinforced; plywood shear walls were not connected between floors, continuous, or adequately nailed; and unblocked diaphragm spans were too long, with unreinforced openings, among other deficiencies (BDS Architects, 2019a).

Figure 6.10. (a) Separated gymnasium CMU wall from floor joists because of failure of connection at Gruening Middle School with (b) detail (photos: Wael Hassan).

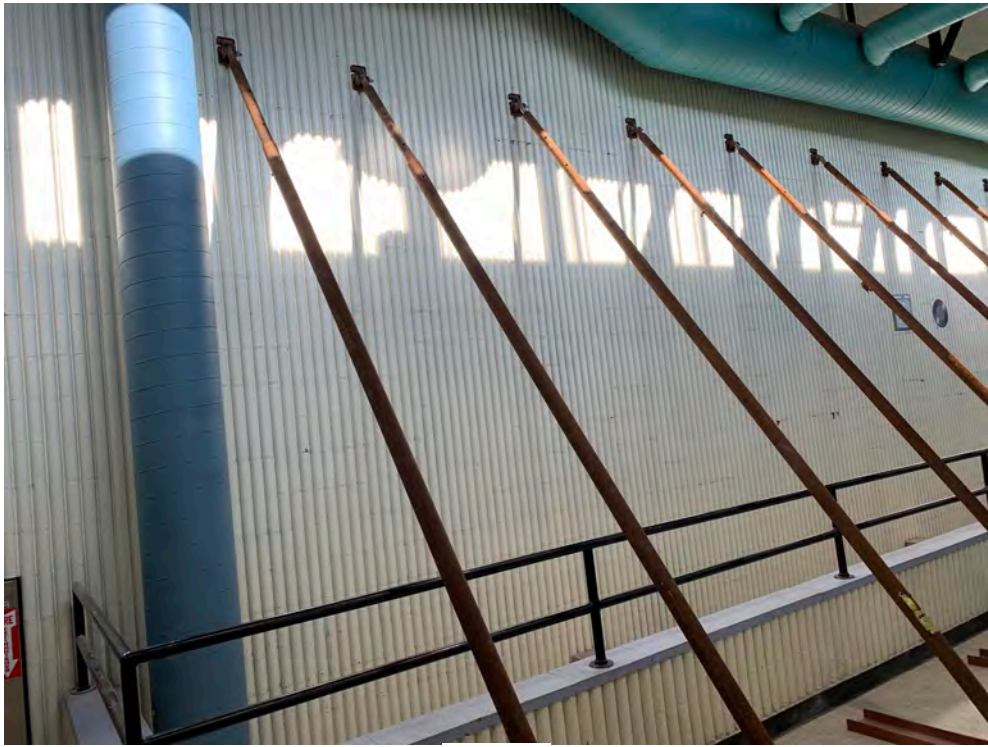
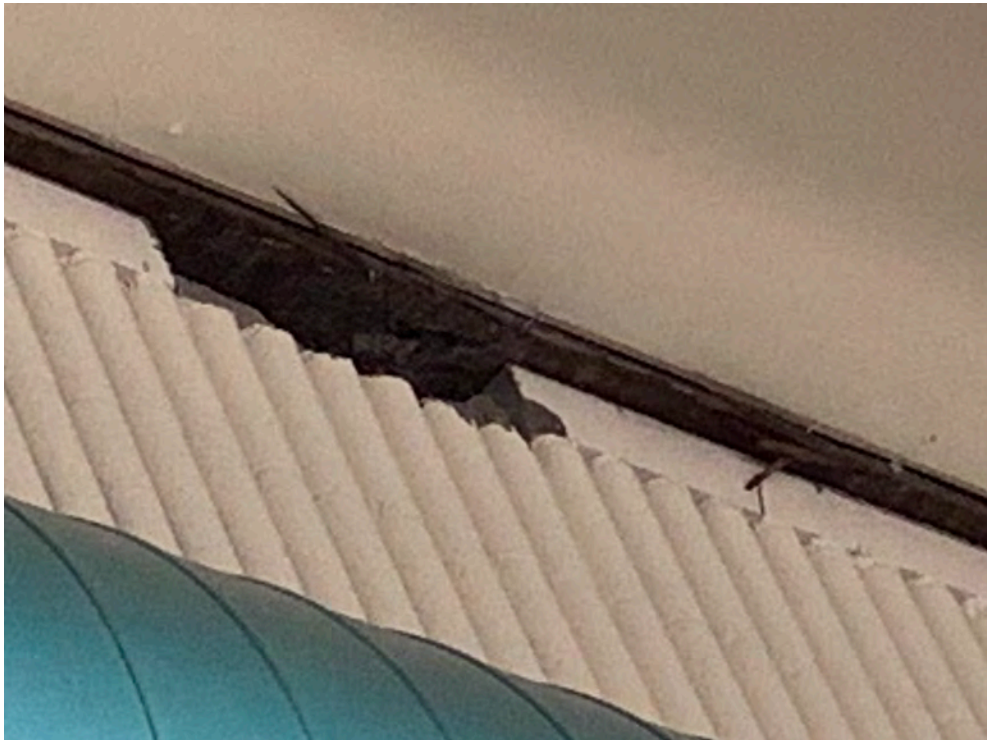
Figure 6.11. (a) Separated gymnasium CMU wall from floor out-of-plane supports at Gruening Middle School and (b) wall-floor connection damage and separation from outside (photos: Wael Hassan).

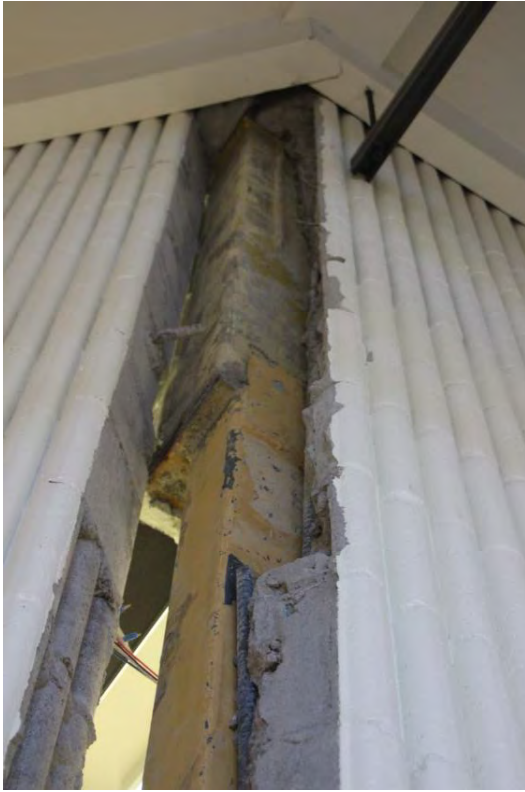
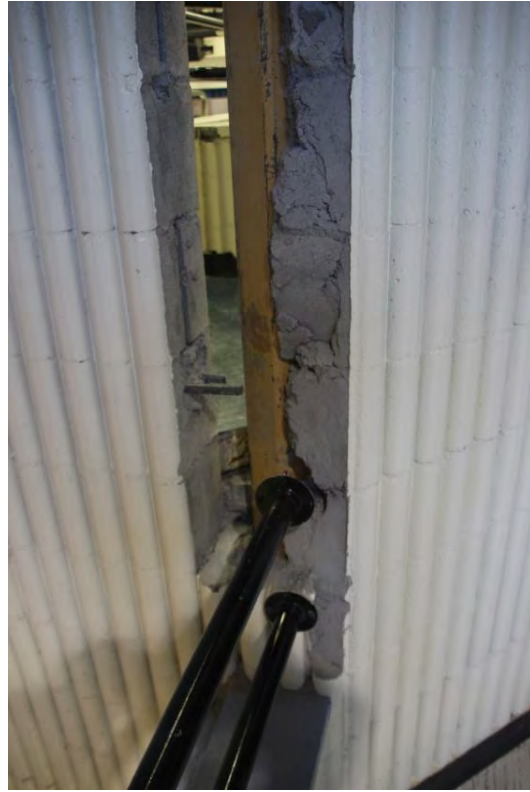
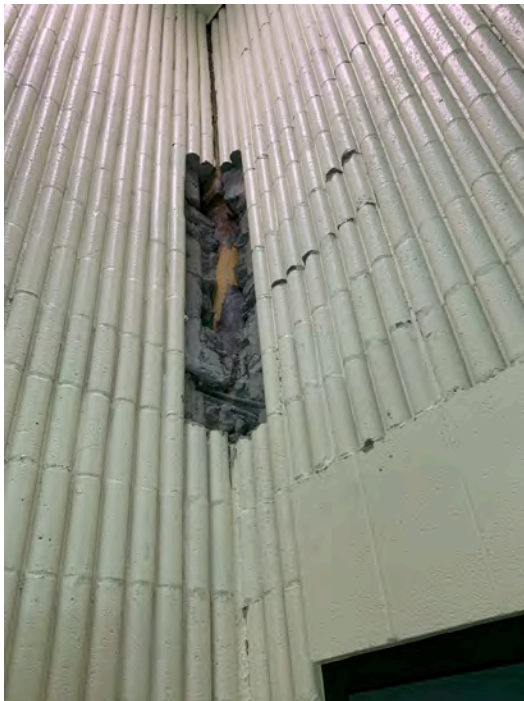
Damage to CMU masonry infill included crushing of masonry and exposure of rebar along the interface between the reinforced masonry infill walls and steel columns, as shown in Figures 6.12 and 6.13. The absence in integrity reinforcement can be observed in between the steel columns and the CMU walls. The steel columns supported long-span steel trusses that spanned across the gymnasium. The observed damaged may have occurred because of incompatibility in deformation between the steel columns and the masonry infill walls and the associated pounding that occurred between the two components.

Figure 6.12. Spalled CMU around steel columns. (photos: (a, b) Chris Motter and (c, d) Wael Hassan).

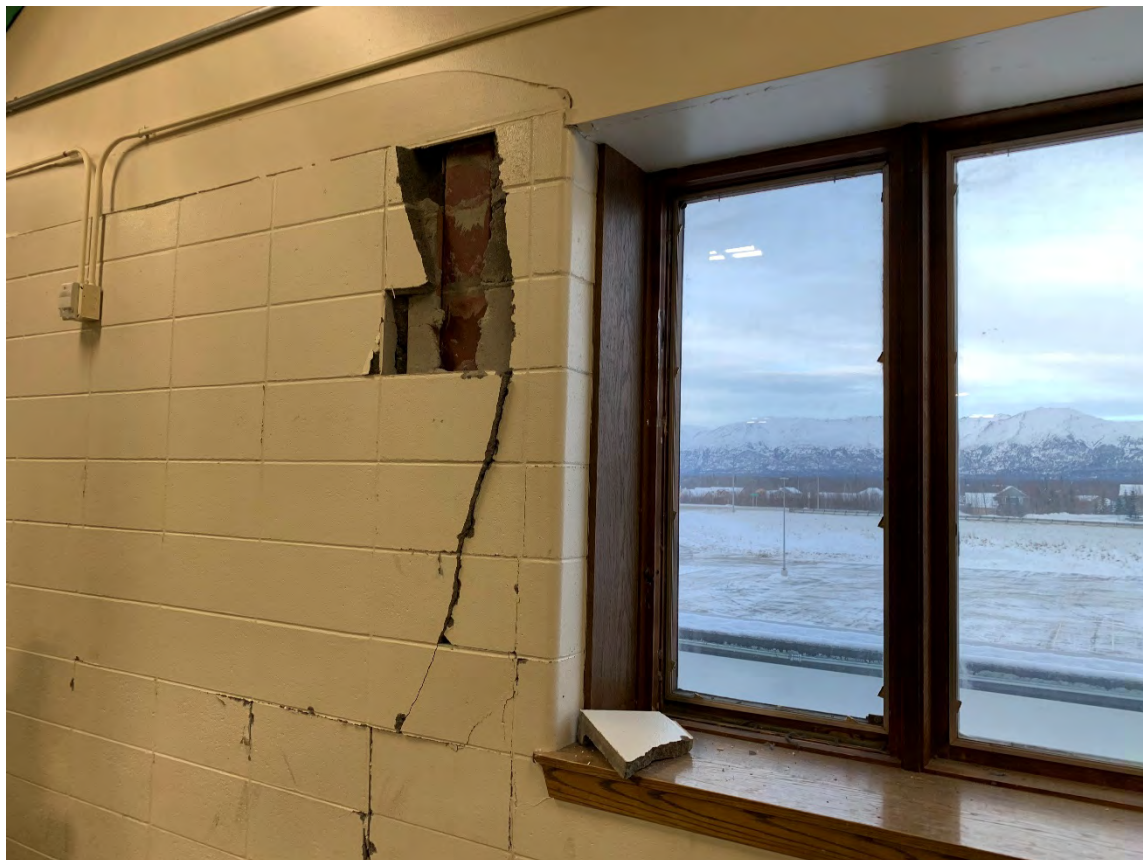
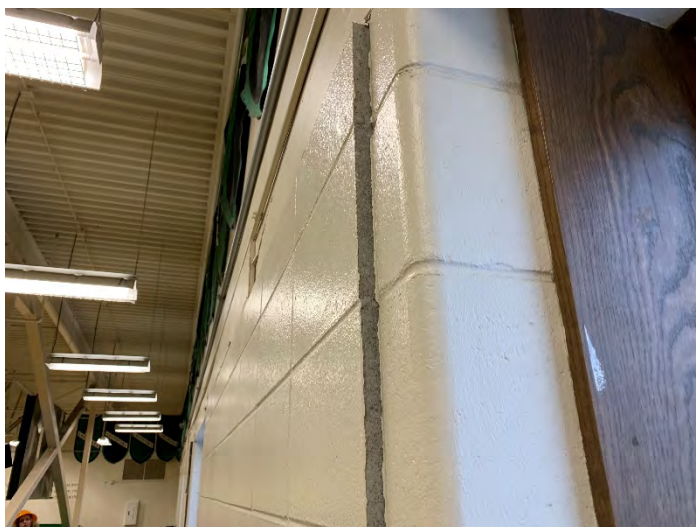
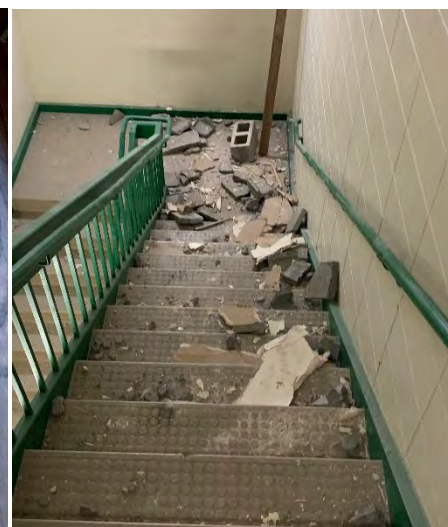
Reinforced CMU walls in the Colony High gymnasium, at the upper running track and in a stairwell, suffered severe cracking and block dislodging (Figure 6.14). The observed damaged at the upper running track may have occurred because of incompatibility in deformation between the flexible steel columns and the brittle masonry units and the associated pounding that occurred between the two components.

Figure 6.14. (a) Damage to CMU wall at upper running track, (b) out-of-plane separation/dislodging of CMU wall blocks, and (c) fallen block in stairwell (photos: Wael Hassan)

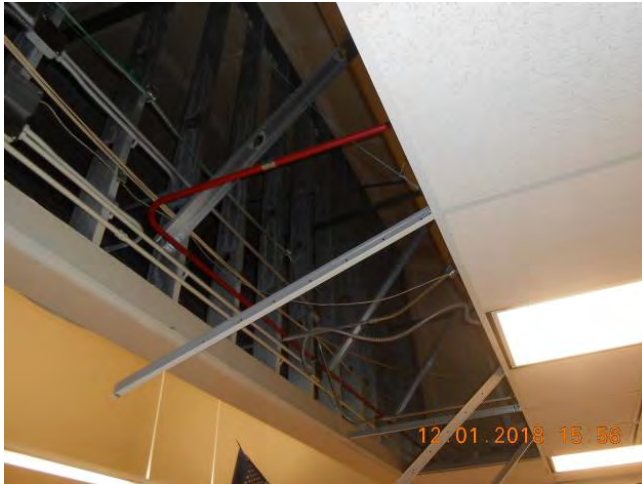
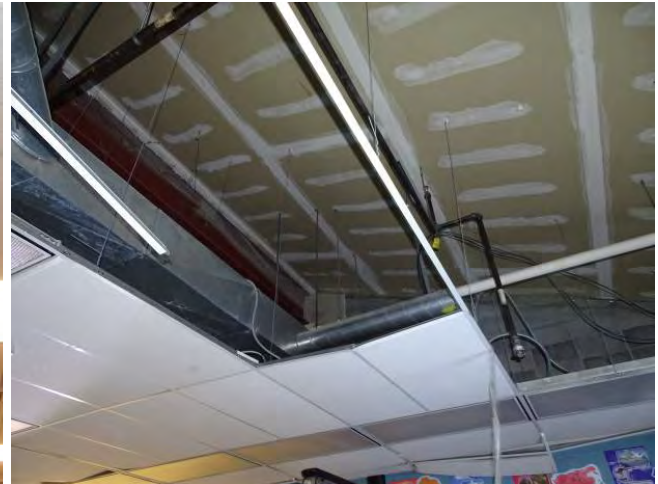
Schools in both districts had suspended ceilings of various ages, built under code editions with nonstructural provisions ranging from nonexistent to current. Although some upgrades and ceiling replacements took place over the years, many schools still had ceilings with inadequate seismic detailing. As expected, many ceilings with seismic deficiencies performed poorly, especially those in the top stories of multistory buildings, as Figure 6.17 shows.

Figure 6.17. Damaged suspended ceilings with (a) inadequate (Bear Valley Elementary) or (b) nonexistent (Houston Middle) seismic bracing (photos: (a) ASD and (b) Janise Rodgers).

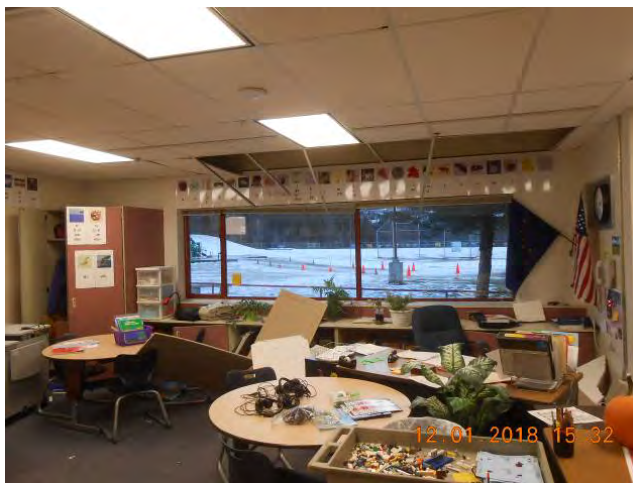
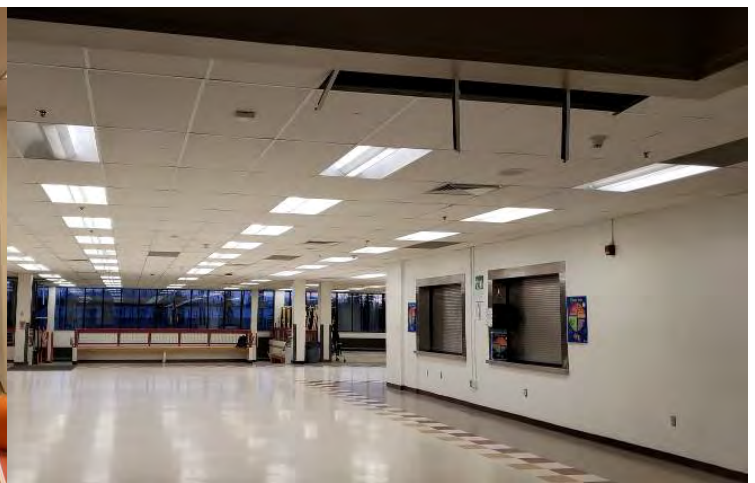
Anchorage schools experienced widespread ceiling damage, with major damage to ceilings in the top (fifth) floor of Bartlett High (Figure 6.16), in Bear Valley Elementary (Figure 6.17), and in some rooms of additional schools. A number of ceilings experienced moderate damage, with grid damage near walls caused by the ceiling swinging and impacting the wall, as Figure 6.18 shows. Interactions with fire sprinklers caused additional damage (Figure 6.19).

Figure 6.18. Moderate suspended ceiling damage with grid damage at wall at (a) Bear Valley Elementary, which also had some ceilings with major damage, and (b) Wasilla High School (photos: (a) J. Shaw, ASD, and (b) MSBSD).

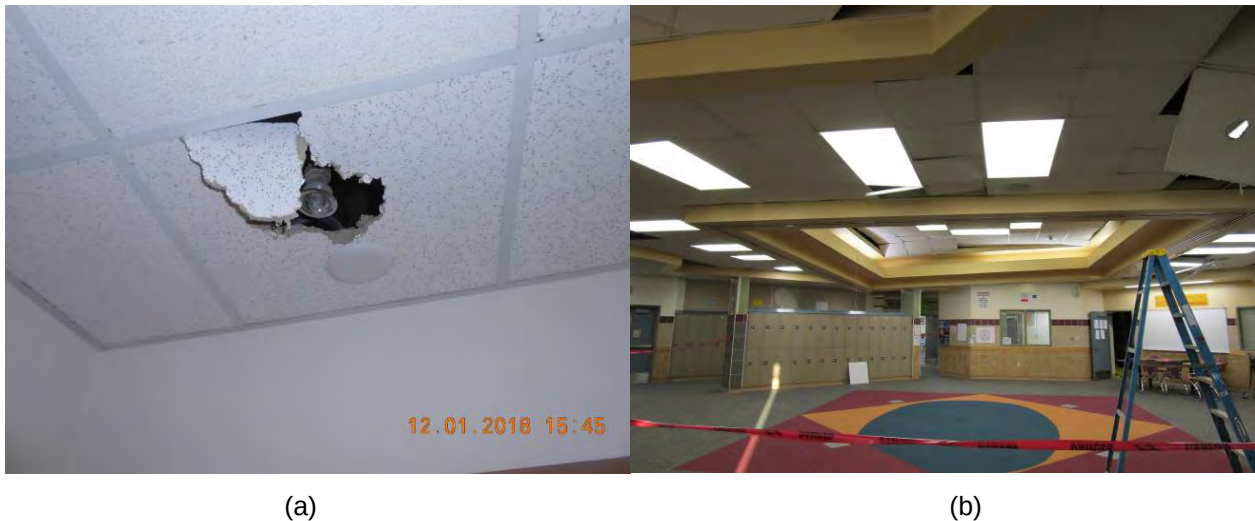
Figure 6.19. (a) Fire-sprinkler drop and head movement with respect to suspended ceiling, damaging the acoustical tile; (b) ceiling damage due to inadequately braced soffit at Dimond High. Note the hole from the fire sprinkler in hanging tile at right (photos: ASD).

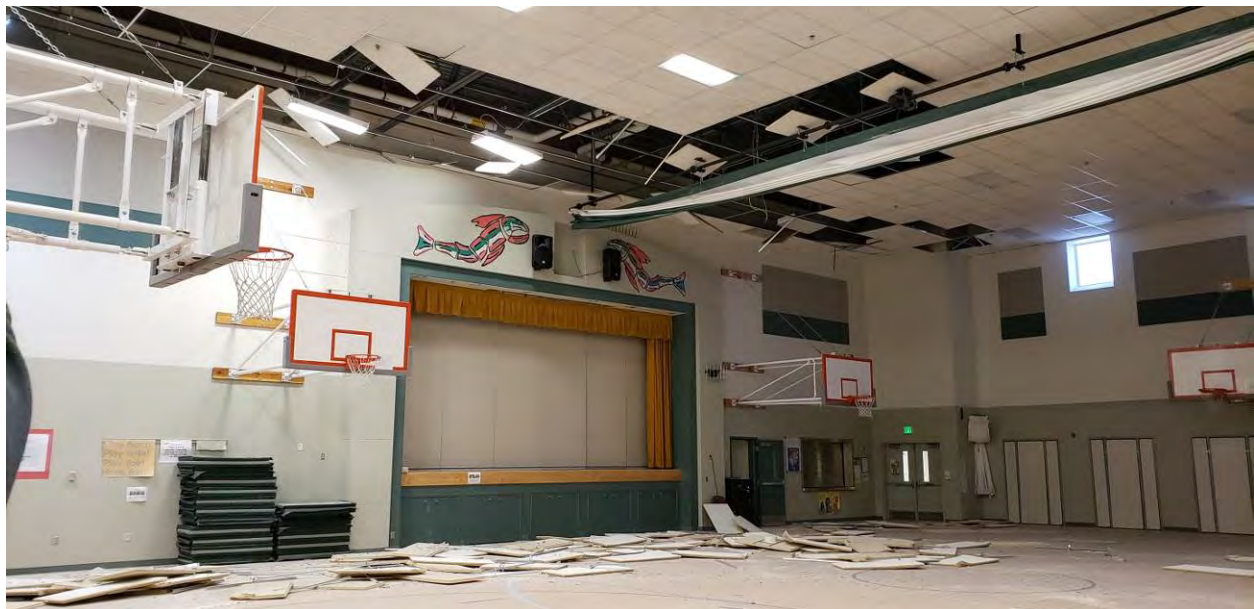
Some newer suspended ceiling systems also suffered unexpected damage. The relatively new (2007) suspended ceiling of the Knik Elementary gymnasium, an unusual design with heavy (estimated about 30 lb each) acoustical panels rather than lightweight acoustical tile, experienced major grid damage and lost a number of panels, as Figure 6.20 shows. Children who would have normally been in the gym at that time were elsewhere, fortunately, according to the principal. This incident could trigger redefinition of the “Life Safe” performance level for this type of heavy tile ceiling. Some schools, gyms, and commercial buildings in Southcentral Alaska abandoned this type of ceiling, and the suspended ceiling concept altogether, in their repairs following the earthquake. Some newer ceilings (~2003) at Dimond High in Anchorage also suffered damage at the edges because of movement and because of interaction with an inadequately supported soffit.

Figure 6.20. Ceiling damage at Knik Elementary; this ceiling had unusually thick and heavy panels (photo: MSBSD).

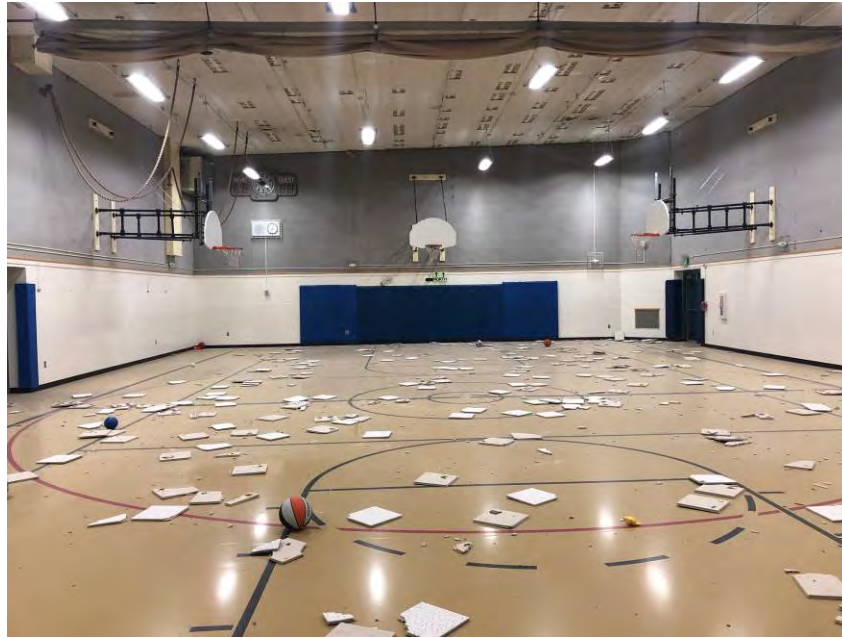
Some schools in both districts also had adhered acoustical tile dislodge and fall during shaking, particularly in gymnasiums, as in Figure 6.21.

*Figure 6.21. Fallen adhered acoustical tiles in gymnasium, Eagle River Elementary (photo: ASD).*

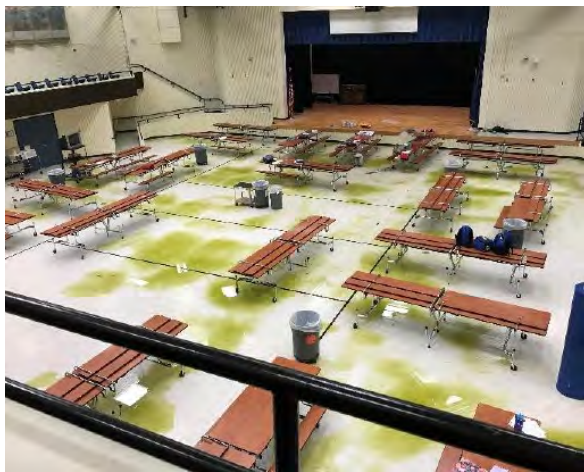
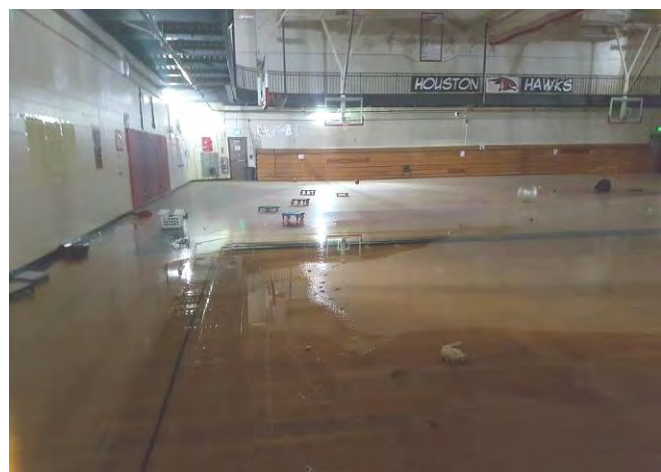
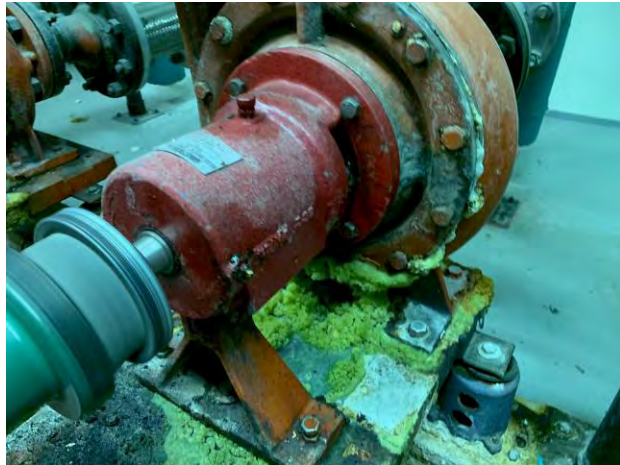
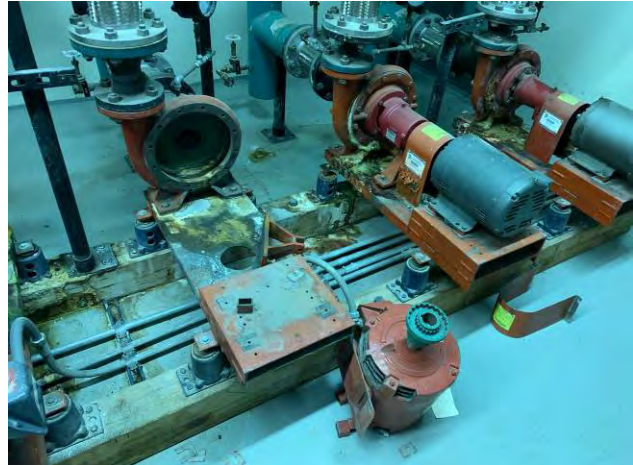
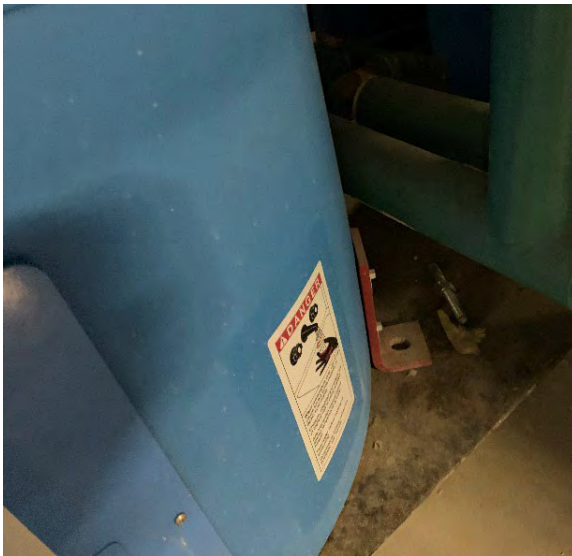
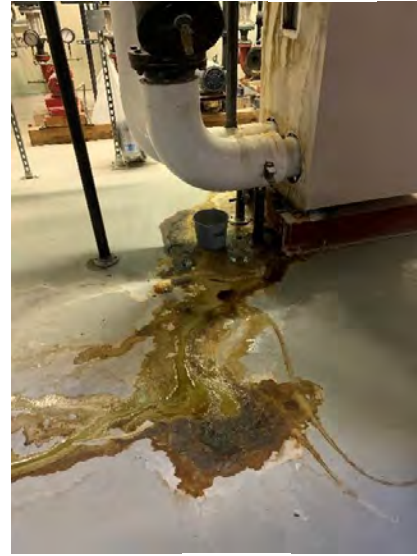
Many schools have heating systems with glycol piping above the suspended ceilings. Numerous glycol leaks were reported in both districts, as well as leaks from water pipes in ceilings with the worst glycol leak reported in Gruening Middle in Eagle River (see Figure 6.23). Fire-sprinkler drops damaged tiles or were damaged by differential movement of suspended ceilings, leading to leaks in some schools.

Figure 6.23. (a) Water damage to gymnasium floor at Houston Middle (photo: MSBSD); (b) glycol leak, Gruening Middle (photo: Reid Middleton); and Gruening Middle (c–f) mechanical room piping failure and glycol leak with (e) tank-restraint failure and (f) elbow-connection failure (photos: Wael Hassan).
